**Revised**  
**FULL RESERVE STUDY**  
**Ranch at Roaring Fork**  
**Homeowners Association, Inc.**

**Carbondale, Colorado**  
**Inspected - April 21, 2020**  
**Revised - July 23, 2020**

Ranch at Roaring Fork Homeowners Association, Inc.  
Carbondale, Colorado

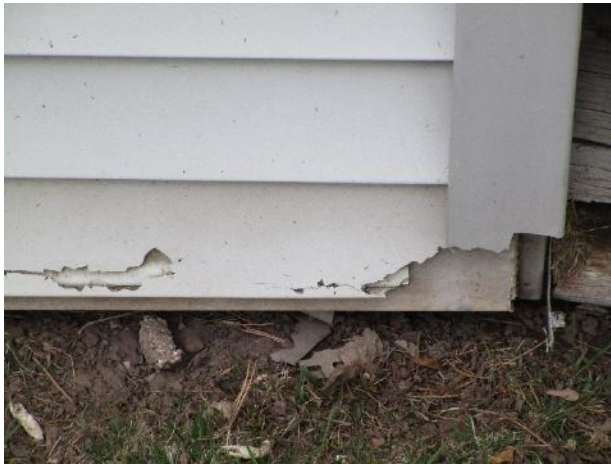
**Condition:** Good to fair overall with siding damage and warp, and loose siding evident

Siding damage at Building 255-258

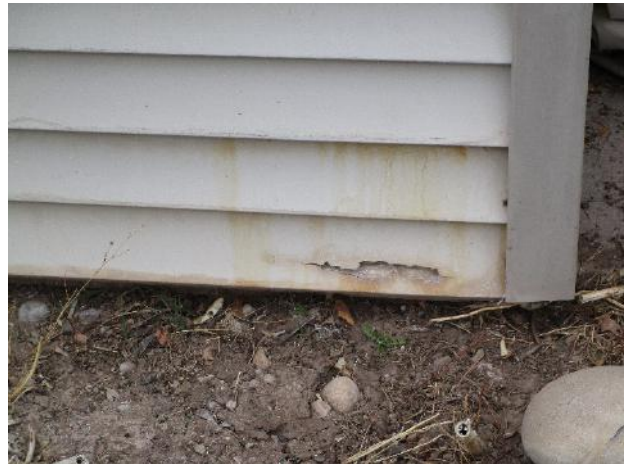
Siding damage at Building 283-286

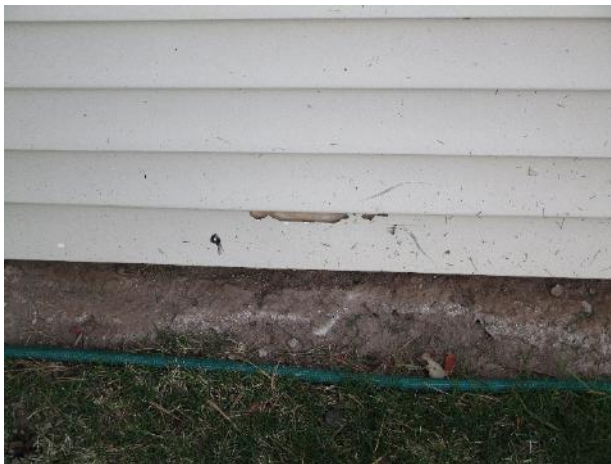
Siding damage at Building 115-118

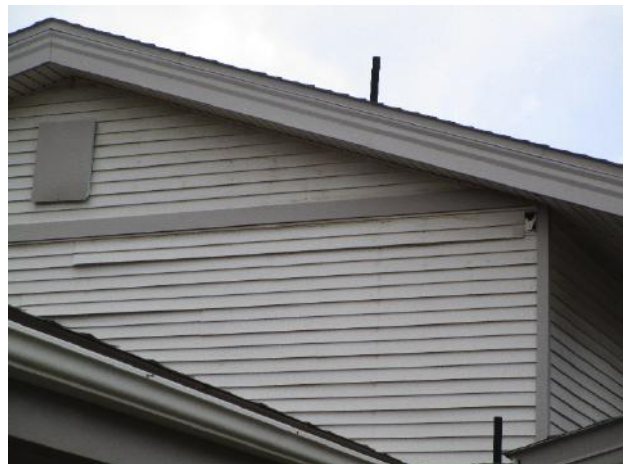
Loose siding at Building 260-269

The lack of water-vapor permeable building paper underneath the siding can result in premature loosening of the siding fasteners from water damage to the substrate sheathing. Therefore, the Association should anticipate a decreased useful life due to the lack of water proofing beneath the siding.

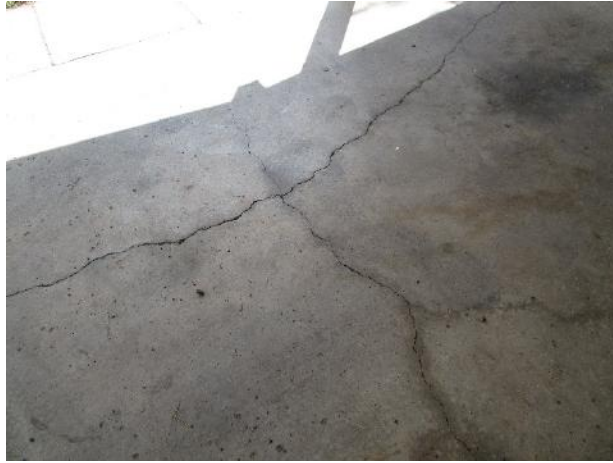
**Condition:** Good to poor overall with cracks, concrete spall and settlement evident

Concrete cracks at Building 101-102

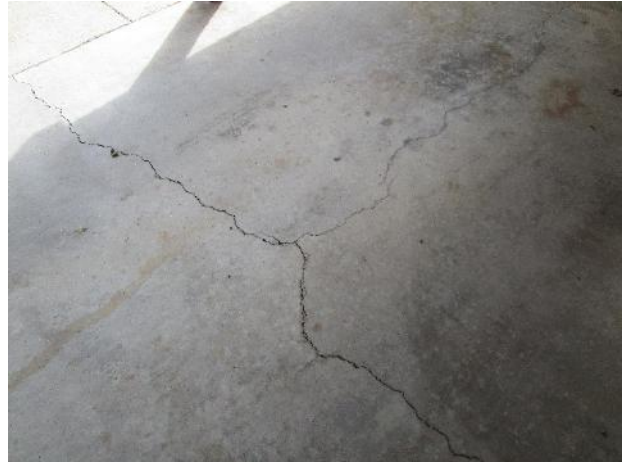
Concrete cracks at Building 135-138

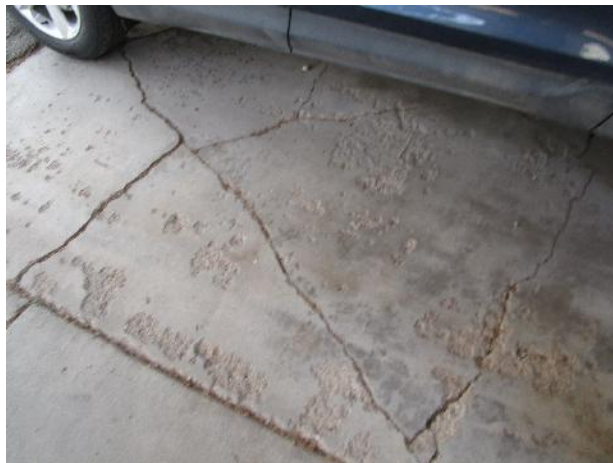
Concrete cracks and concrete spall at Building 103-113

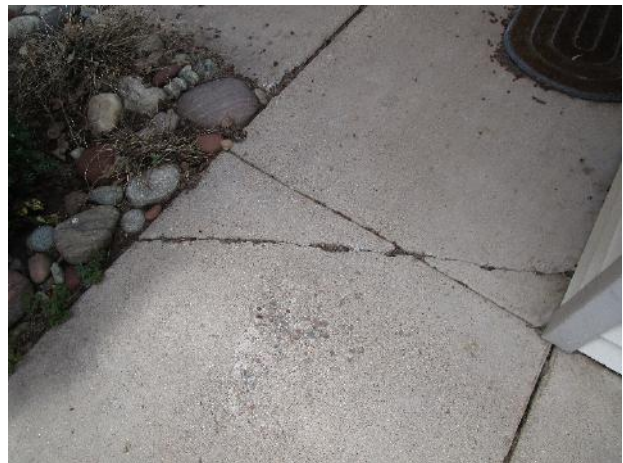
Concrete cracks and concrete spall at Building 135-138

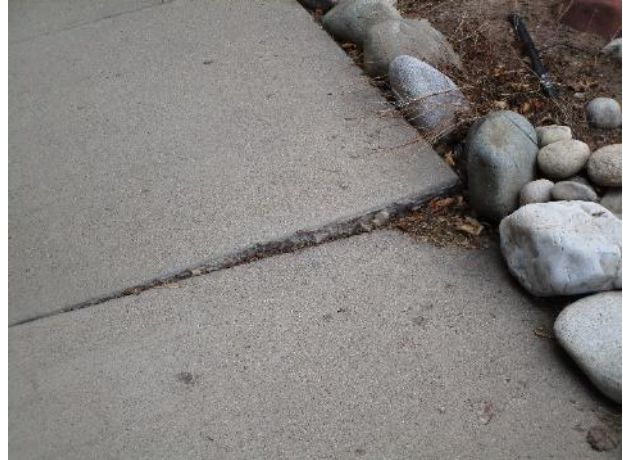
**Concrete settlement at Building 255-258**

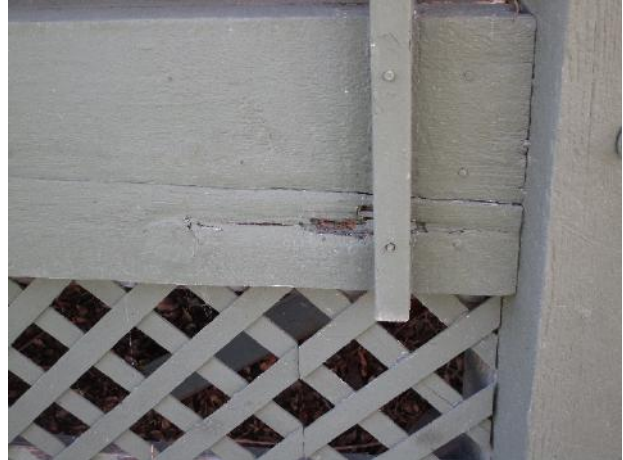
***Condition:*** Fair overall condition with split wood, wood rot and damage evident

**Deck frame split wood and wood rot**

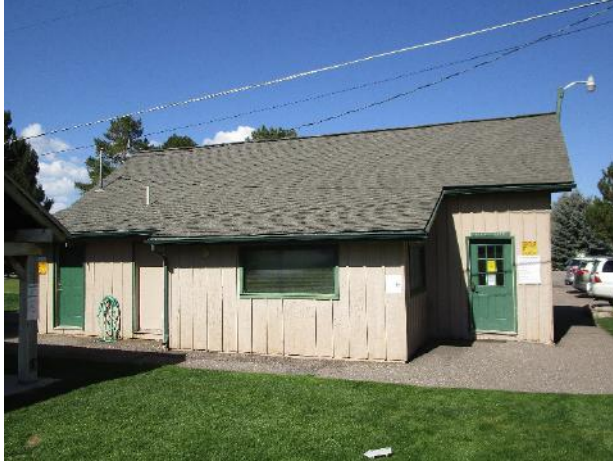
**Condition:** Good overall with minor shingle lift at the office building evident from our visual inspection from the ground. Management and the Board do not report a history of leaks.

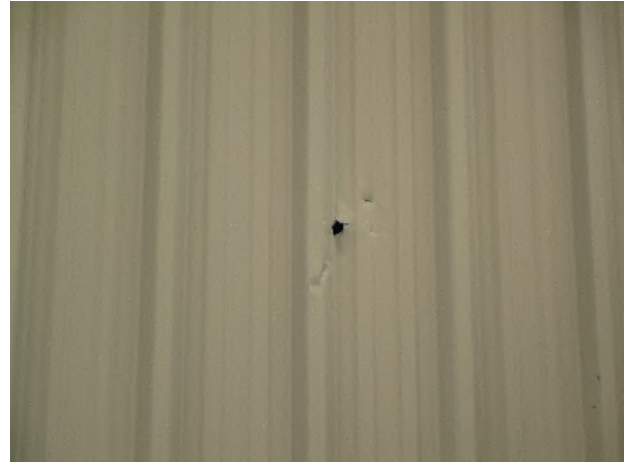
**Condition:** The siding is in fair overall with damage evident

**Siding damage**

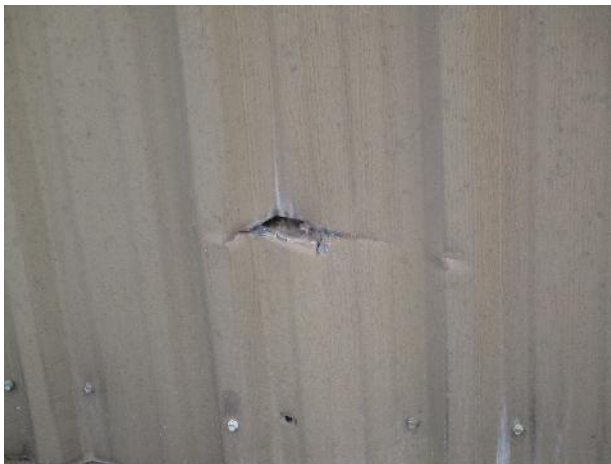
**Siding damage**

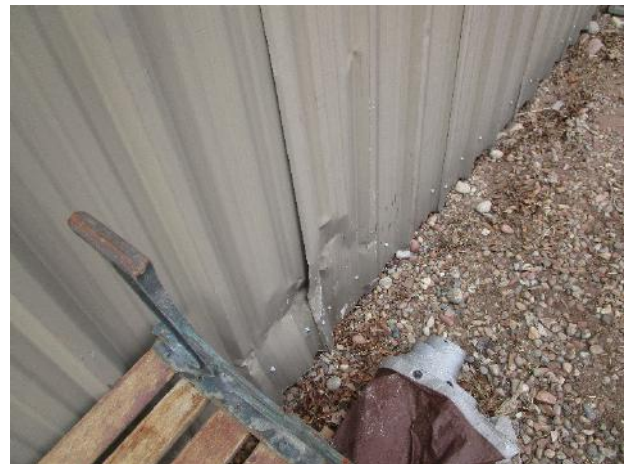
**Siding damage**

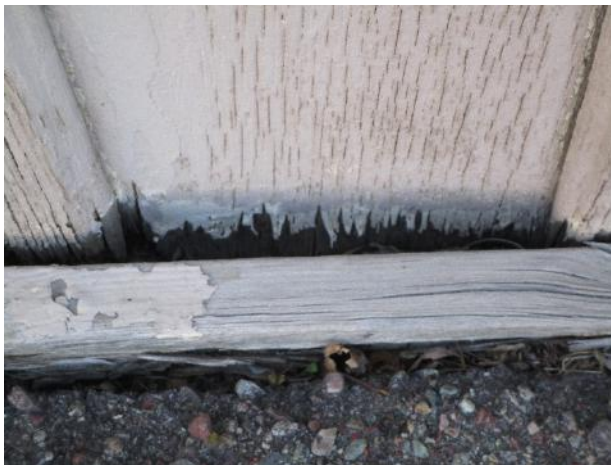
**Siding damage and finish deterioration at the Golf Shop**

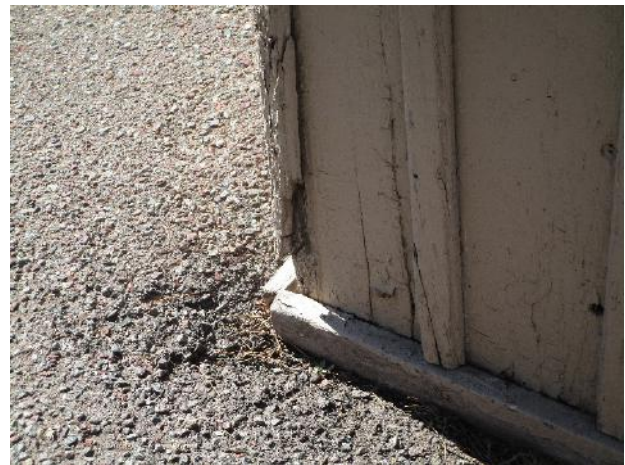
**Siding damage and finish deterioration at the Golf Shop**

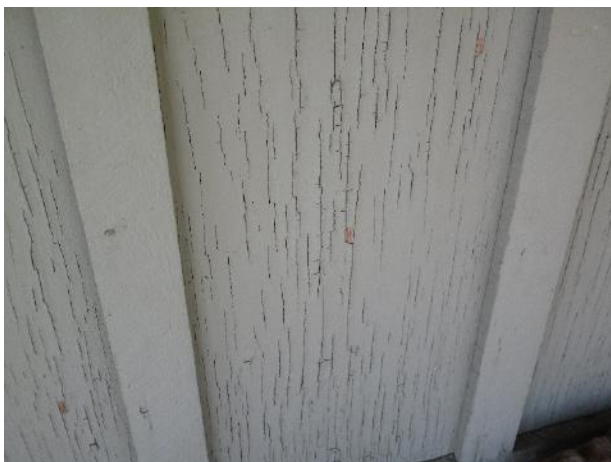
**Siding damage and finish deterioration at the Office Building**

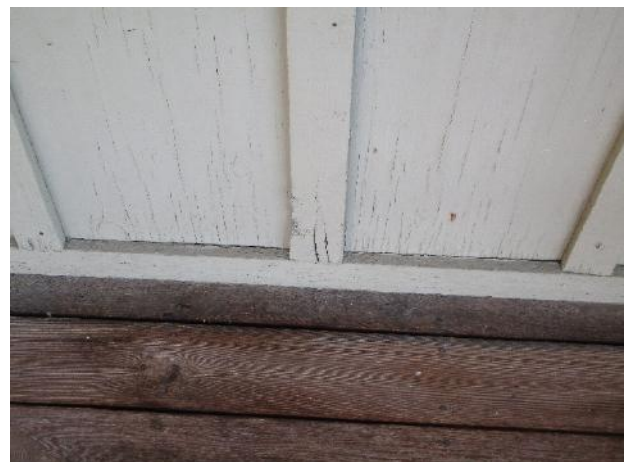
**Siding damage and finish deterioration at the Office Building**

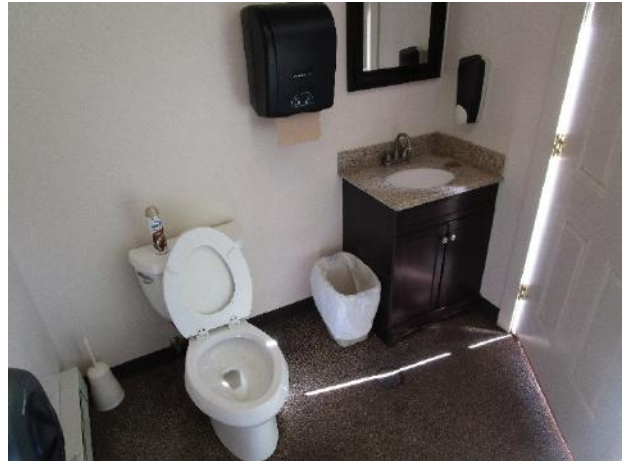
**Golf shop common interior**

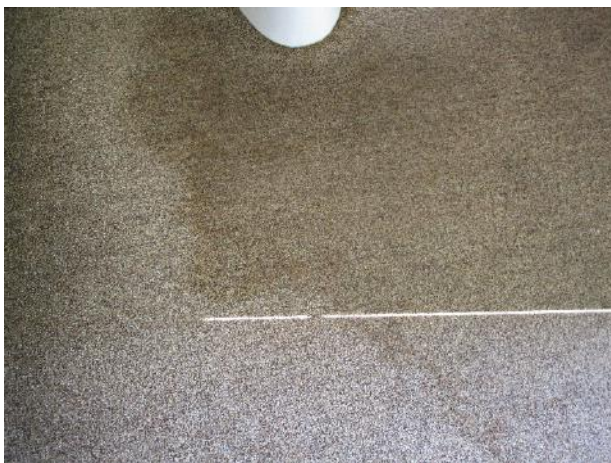
**Carpet stain**

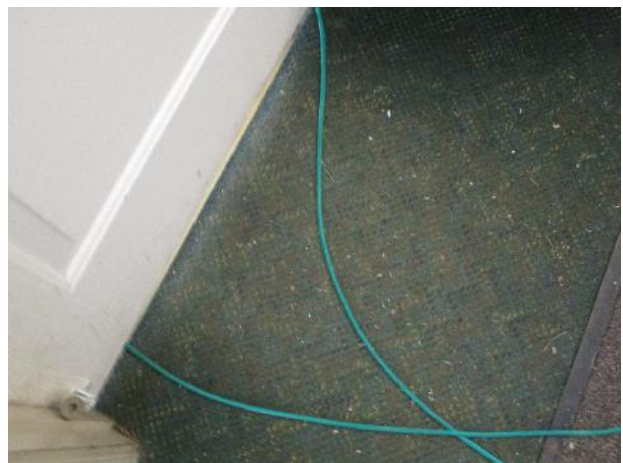
**Carpet stain**

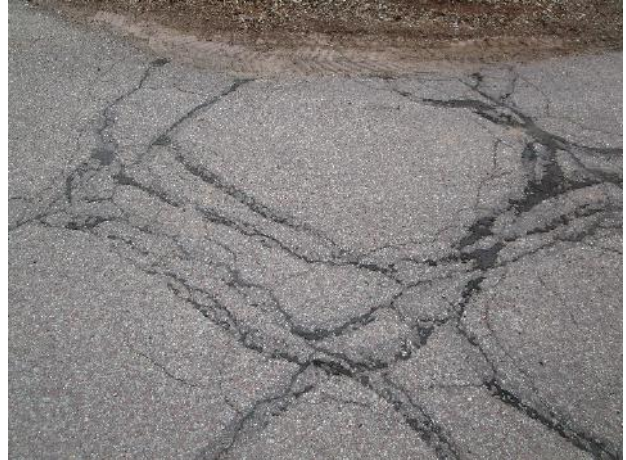
**Condition:** Varying conditions ranging from good to poor overall with cracks and pot holes evident

**Pavement cracks at Rainbow Court**

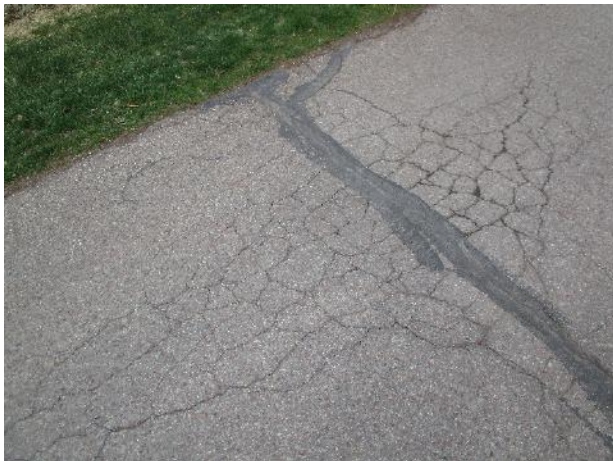
**Pavement cracks at Surrey Street**

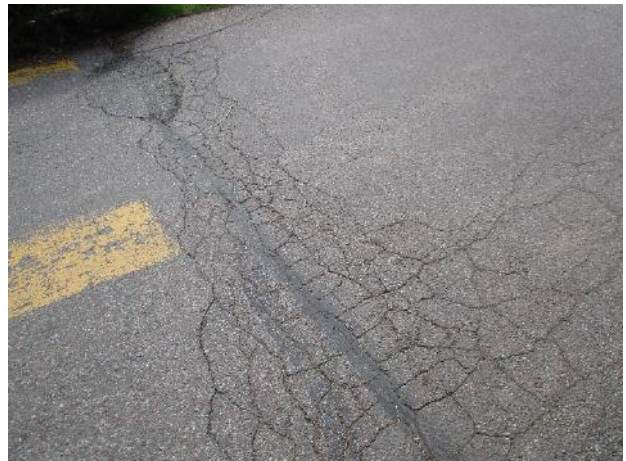
**Pavement cracks at Stagecoach Lane**

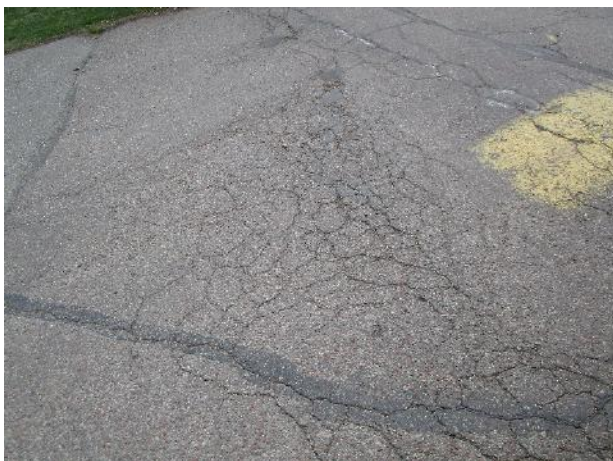
**Pavement cracks at Stagecoach Lane**

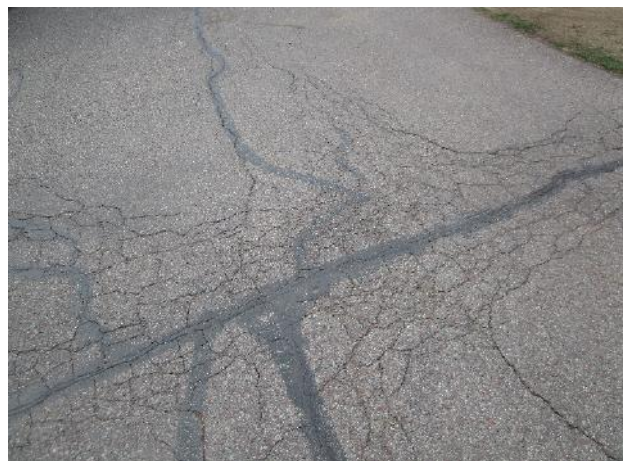
**Pavement cracks at Stagecoach Lane**

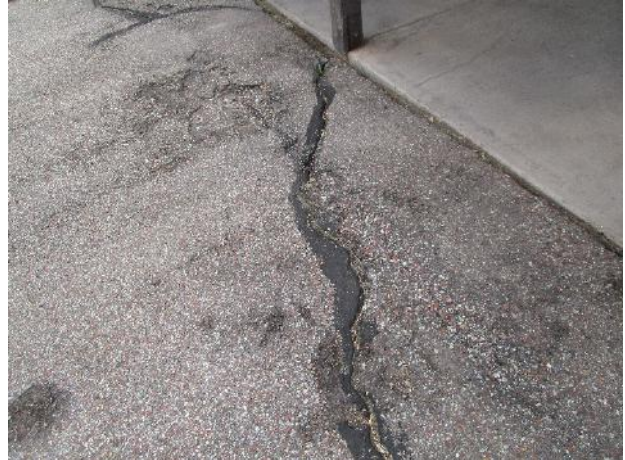
**Pavement cracks at Building 271-274**

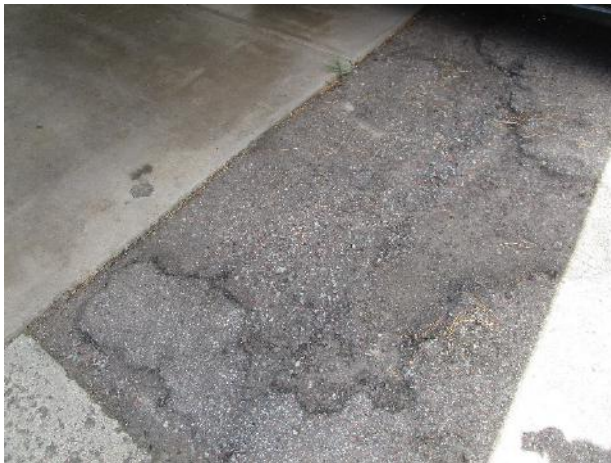
**Pavement deterioration at Building 119-125**

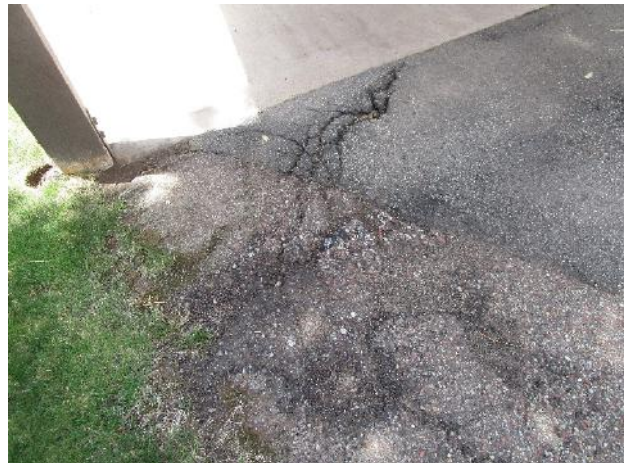
**Pavement cracks and deterioration at Building 119-125**

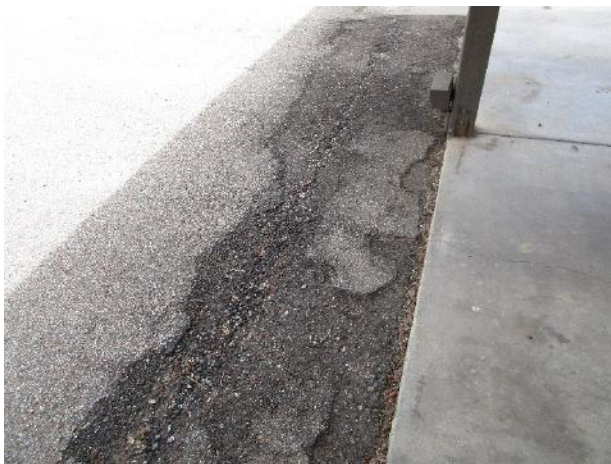
**Pavement deterioration at Building 135-138**

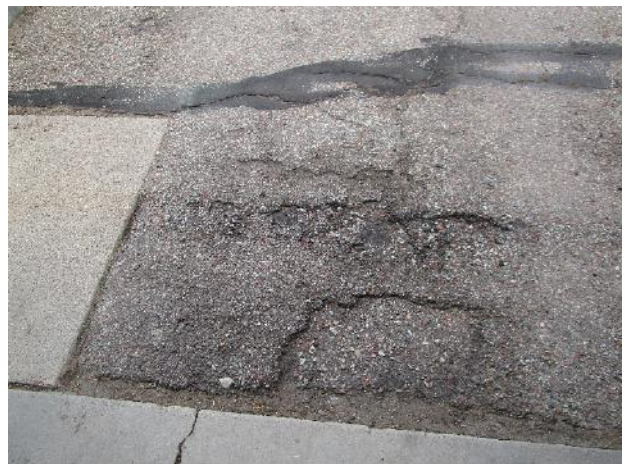
**Pavement deterioration at Building 285-288**

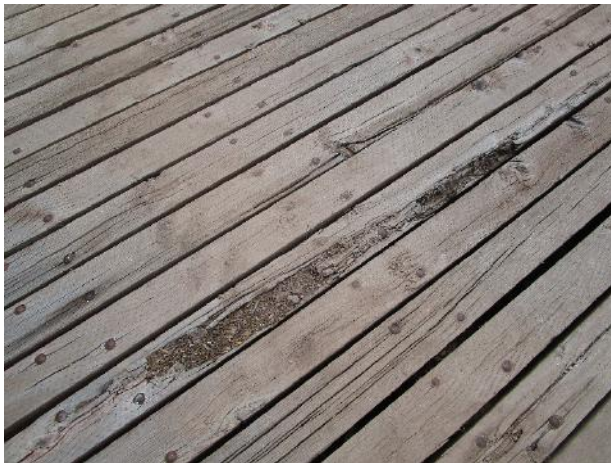
Wood rot and split deck boards

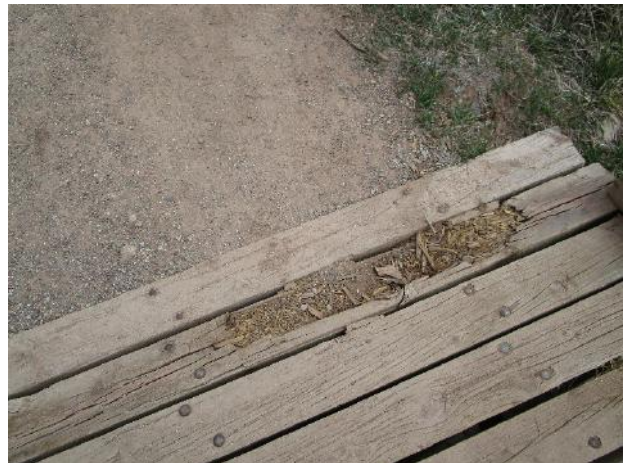
Wood rot and split deck boards

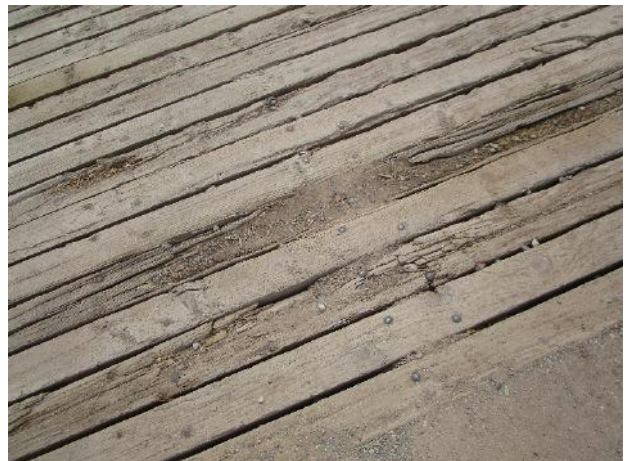
Wood rot and split deck boards

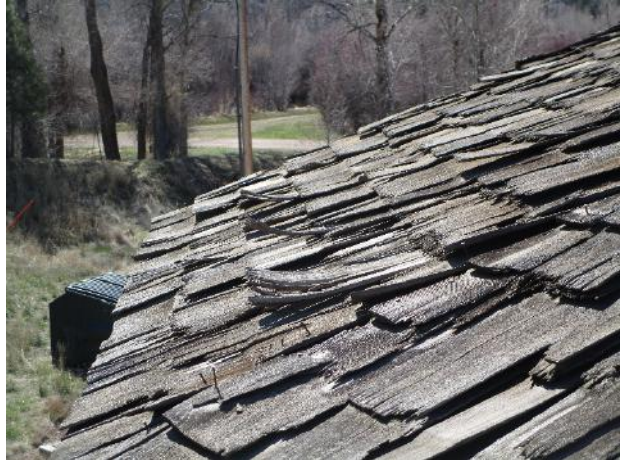
**Damaged and curled shingles**

The Association should install new cedar shakes to meet the requirements of *Cedar Shake and Shingle Bureau*. Once replacement is complete, the Association must develop a maintenance policy for the new cedar shake roofs. Ranch at Roaring Fork should fund all maintenance to the roofs through the operating budget.

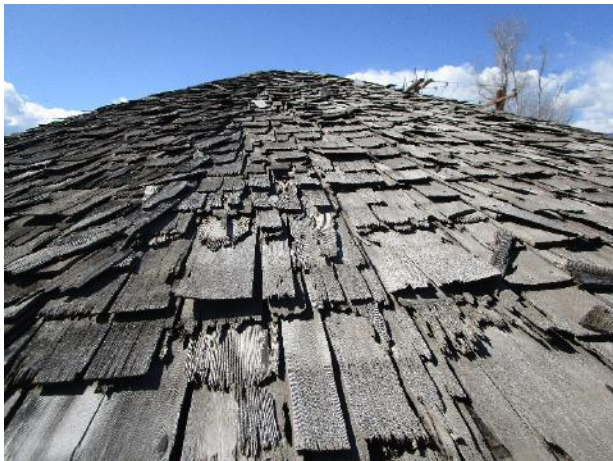
**Damaged and curled shingles**

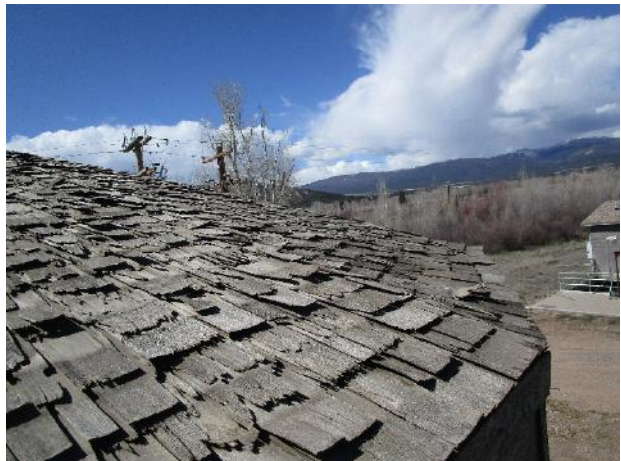
**Damaged and curled shingles**

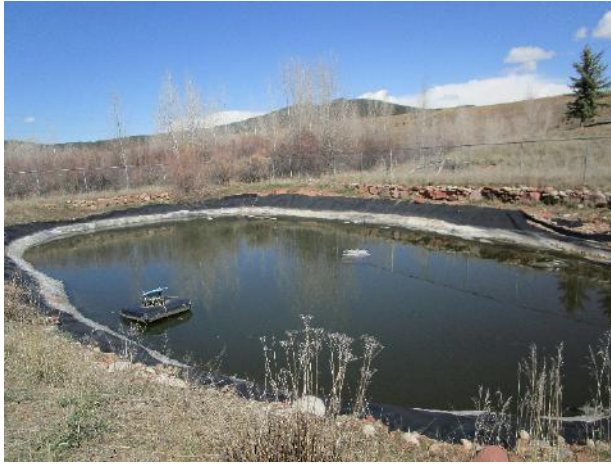
**Condition:** Good to fair overall with folds and debris evident

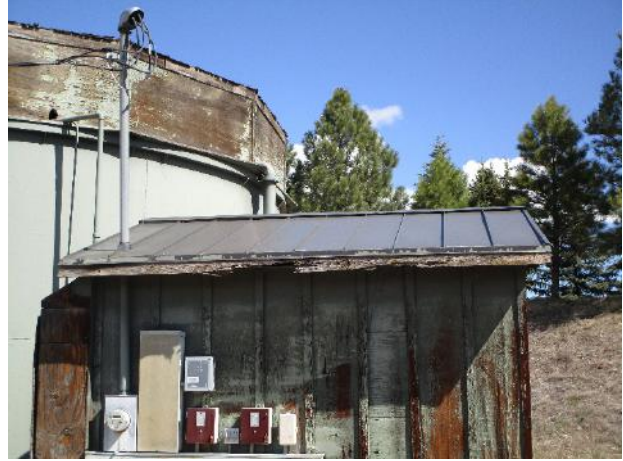
**Siding finish deterioration and damage**

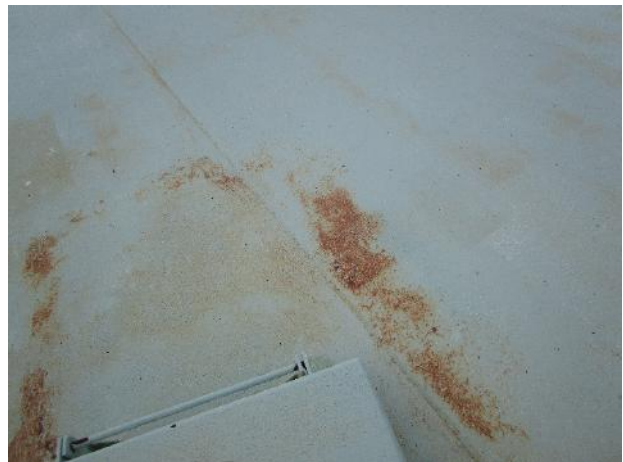
**Rust**
