## Campus View COA *Harrisonburg, VA*

Report #: 35509-1  
Beginning: January 1, 2025  
Expires: December 31, 2025

# RESERVE STUDY Update "With-Site-Visit"

October 4, 2024

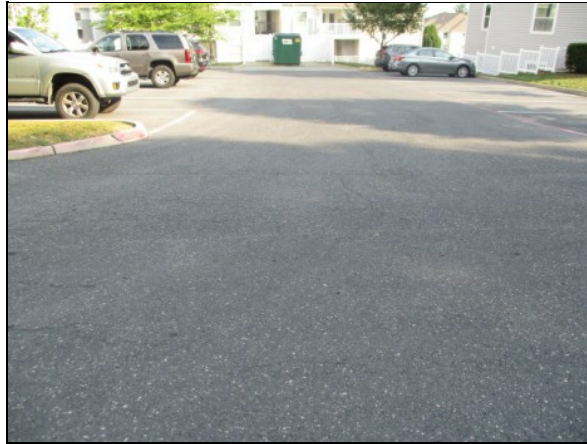
**Comp #: 2123 Asphalt - Seal/Repair**

Useful Life:  
4 years

Remaining Life:  
0 years

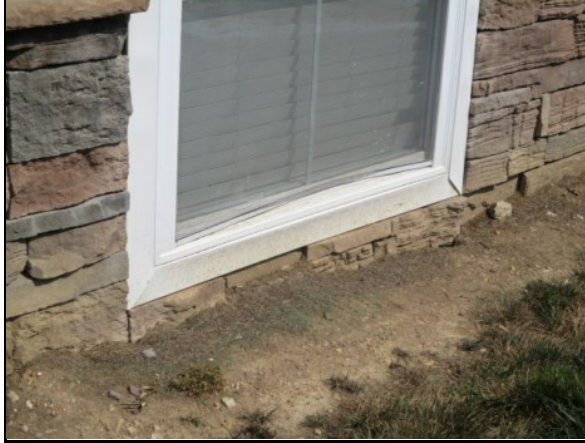
Comments: An allowance for repairs has been added due to observed conditions. While this is typically a long life component, poor installation/materials may be contributing to the deterioration. Brick or other masonry siding is typically a low maintenance surface that requires minimal, infrequent repair. However, in some cases, the original mortar between bricks may require repointing to restore appearance and adequately protect against water intrusion. Repointing involves raking out a portion of the existing mortar and installing new mortar and continuing on until all affected sections have been replaced. Timeline and cost estimates shown here are recommended for budgeting purposes. We strongly recommend further inspection by a qualified engineer and/or masonry specialist to diagnose existing conditions and recommend a formal scope of work. If new information is obtained by the Client, the Reserve Study should be adjusted as-needed going forward.

Useful Life:  
5 yearsRemaining Life:  
0 years
