# Seawall Inspection Report

## Aston Martin Residences

300 Biscayne Blvd Way  
Miami FL 33131

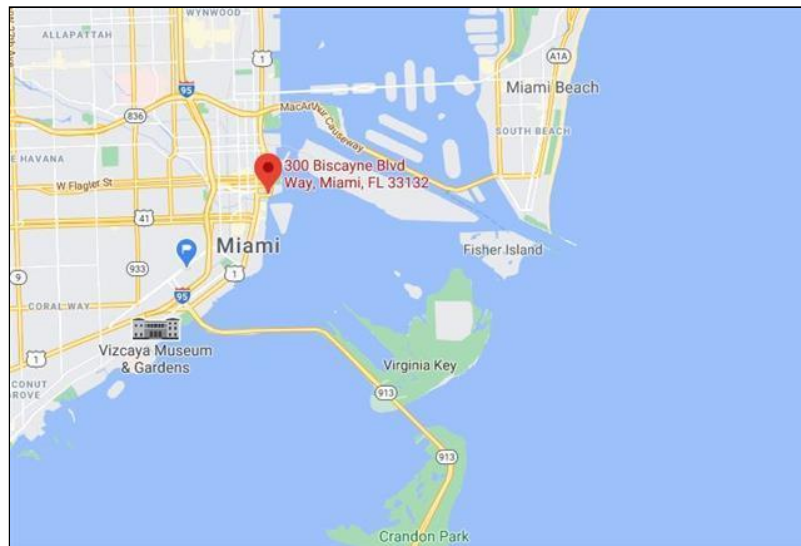
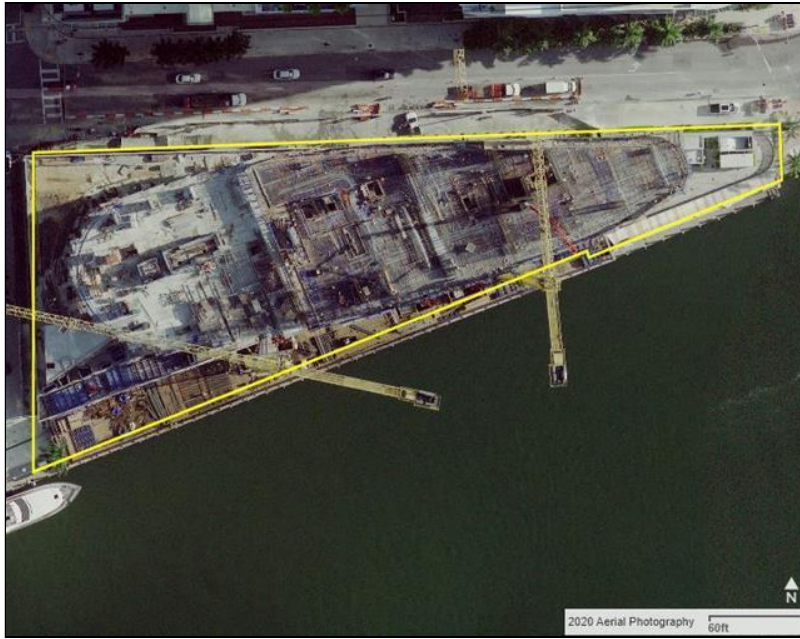
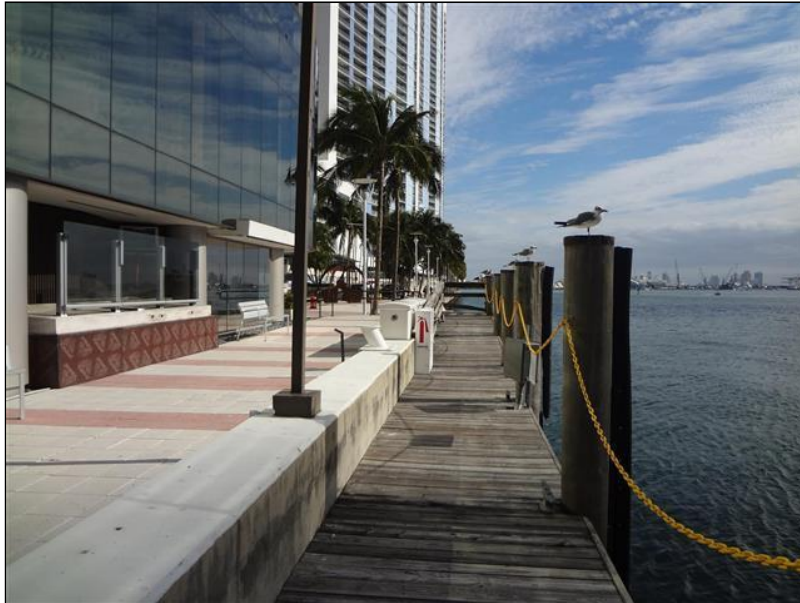
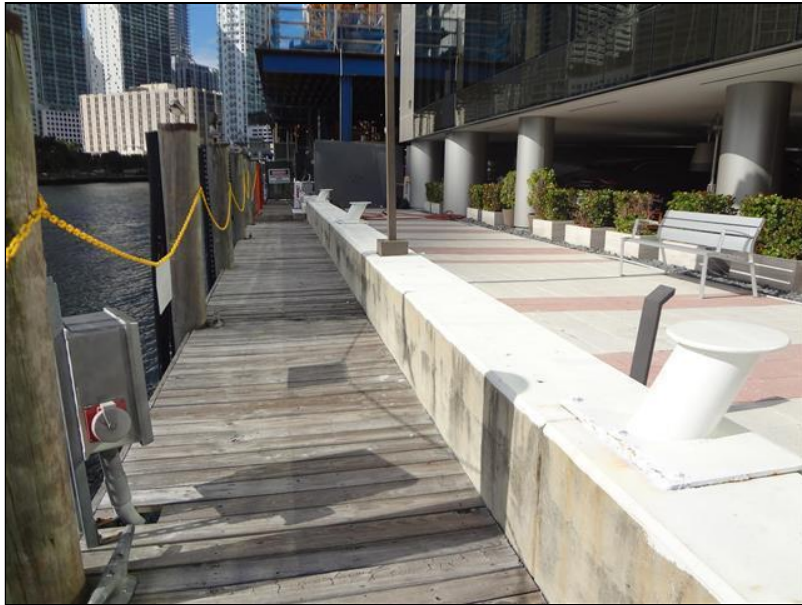
The inspection was done from both the water and the land side of the seawall. Water visibility was +/- 5LF depth at the wall, +/- 10 LF depth outside of the dock piles, clear skies. Inspector found the grounds on the land side to be leveled, well kept, and undergoing major construction with the construction of the Aston Martin Residences.

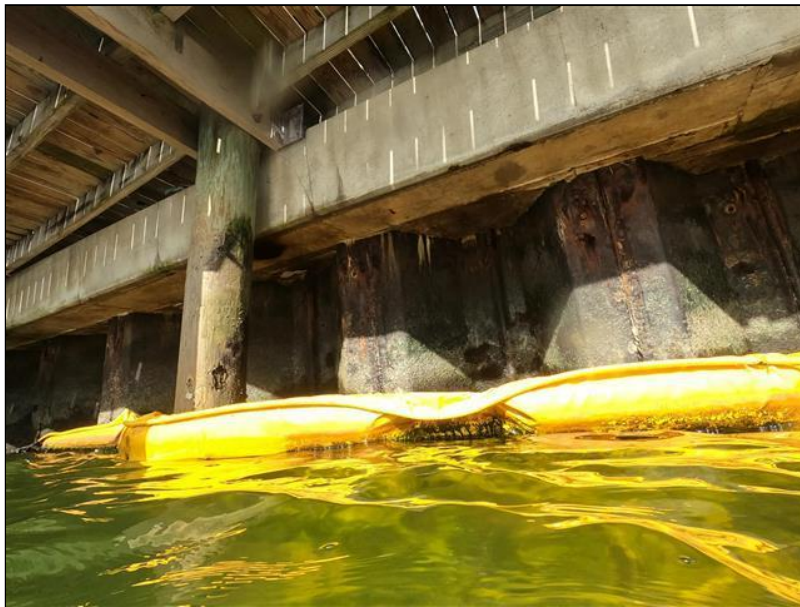
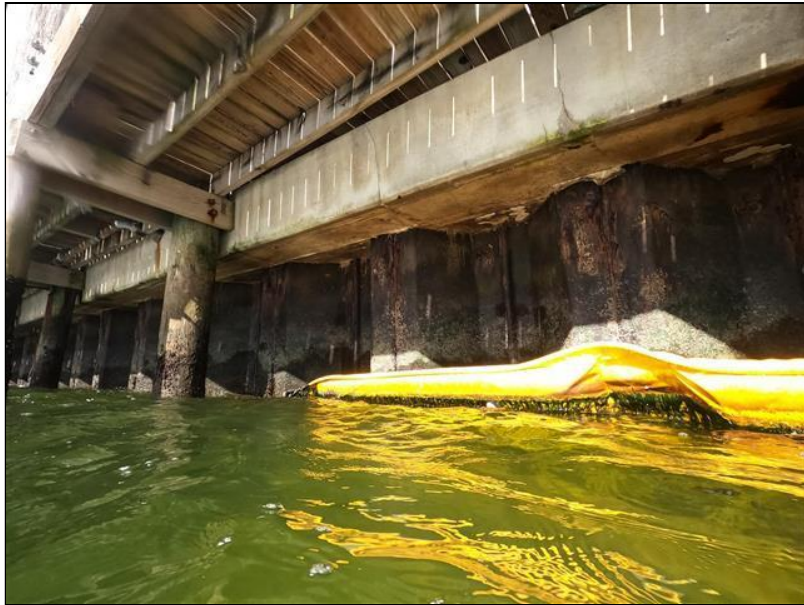
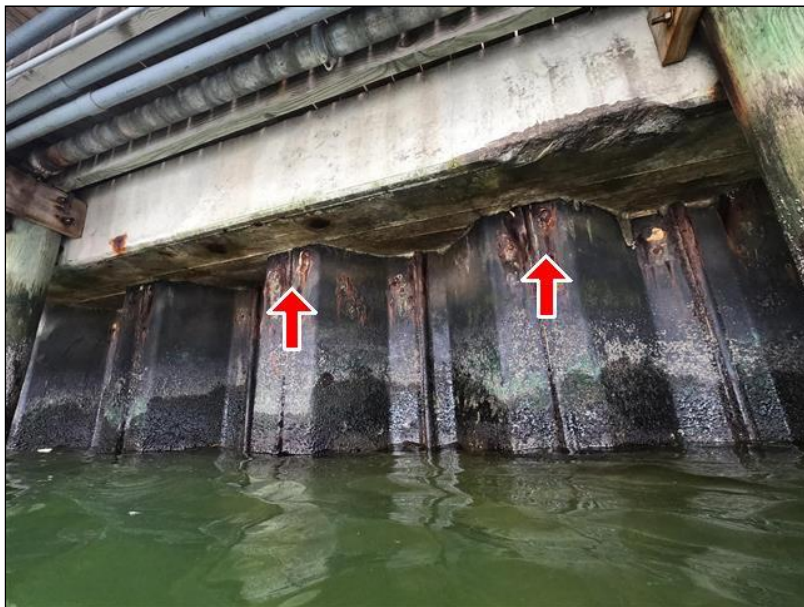
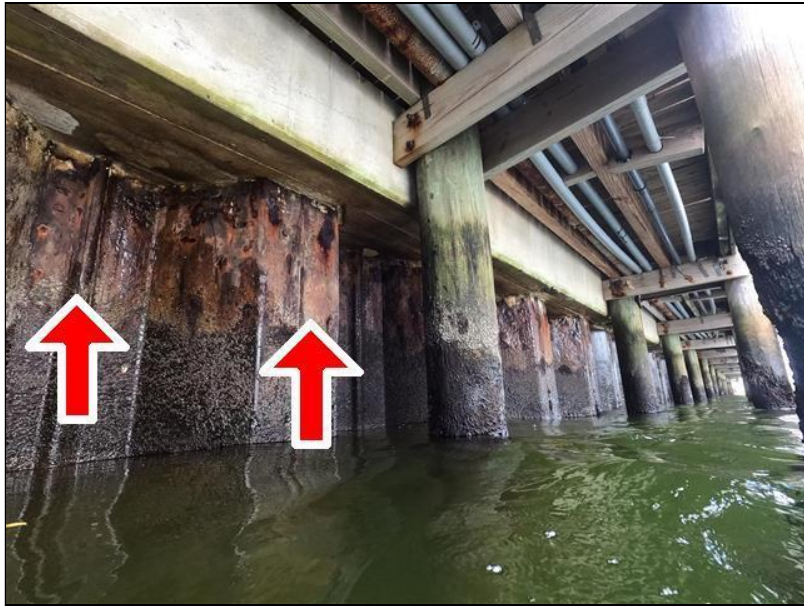
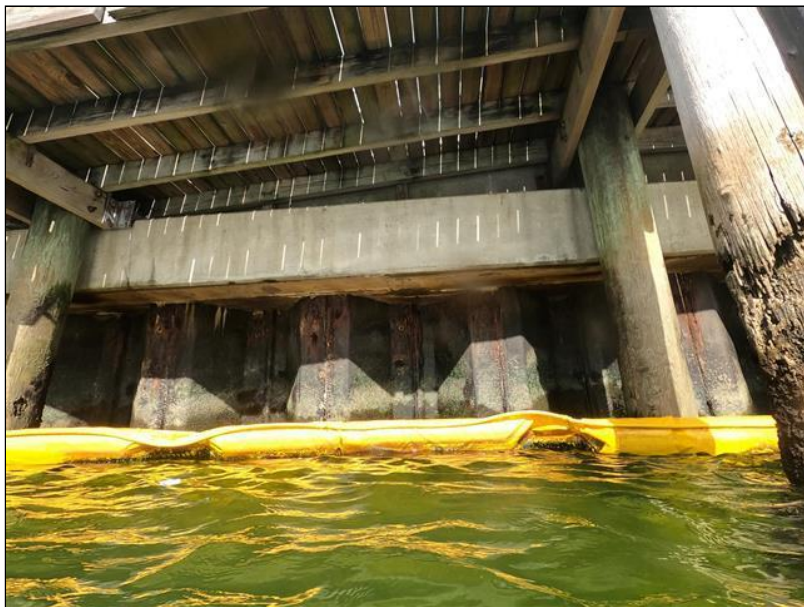
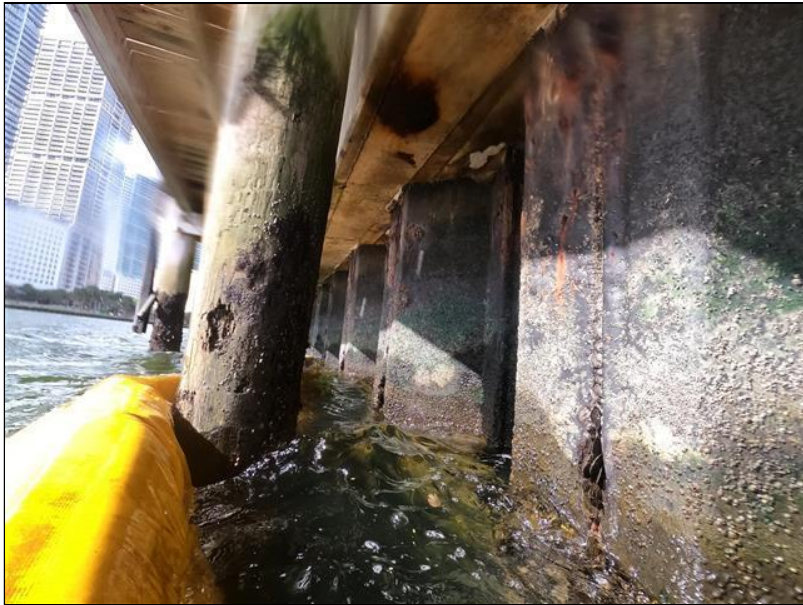
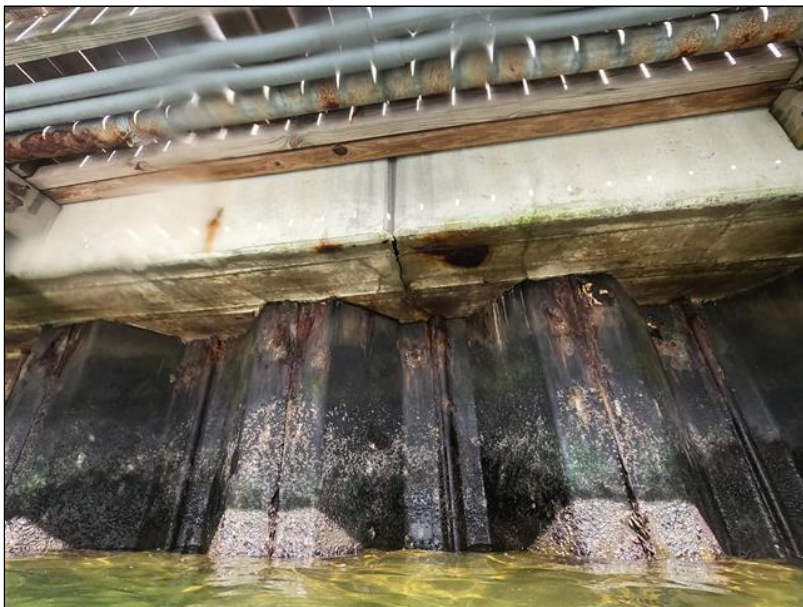
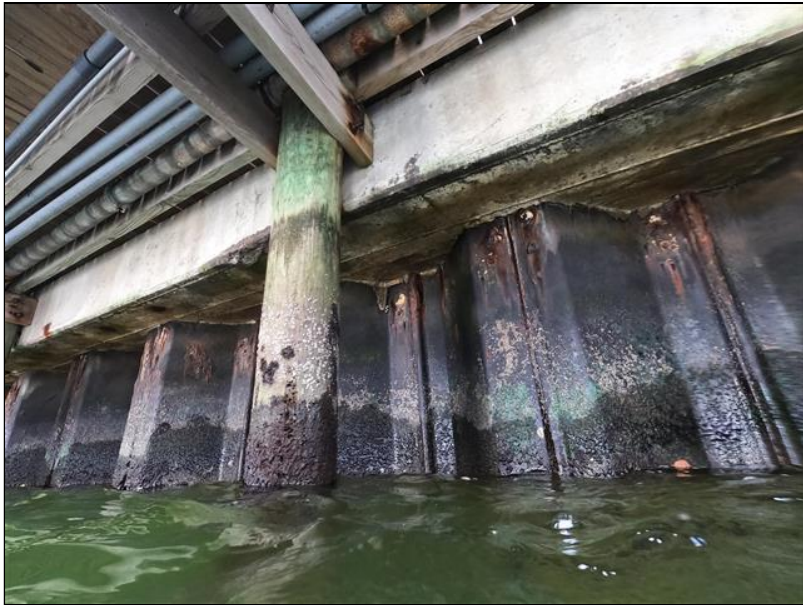
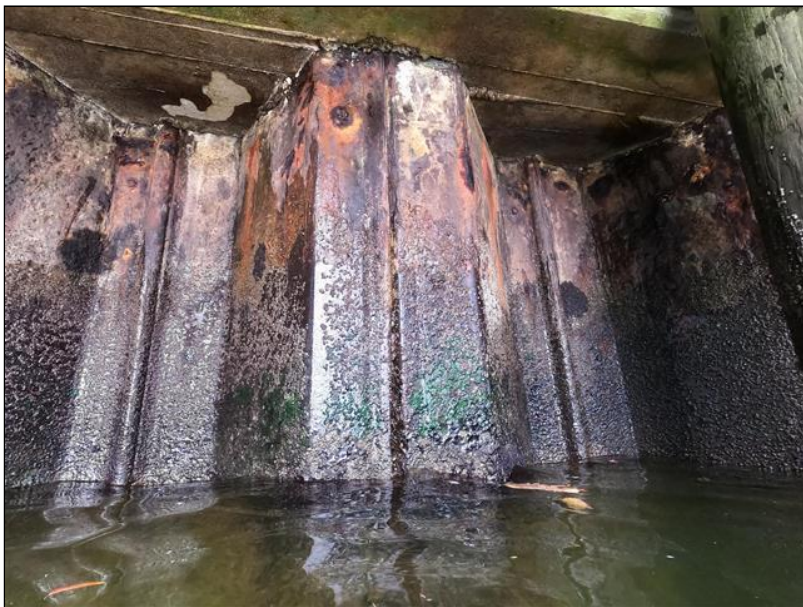
Inspector observed the face of the seawall above the water line (splash zone). The splash zone is where the most serious corrosion activity occurs. The splash zone comprises the area of steel pilings at and immediately above the high tide line, which is subject to frequent wetting from splashing water. The splash zone on this 470 LF seawall is showing minor to moderate levels of pitting corrosion. Pitting corrosion is a localized attack on a metal wherein the corrosion rate is higher in some exposed areas. Pitting corrosion can create shallow craters or deep holes. Item 1(Picture) Item 2(Picture) Item 3(Picture) Item 4(Picture) Item 5(Picture) Item 6(Picture) Item 7(Picture) Item 8(Picture) Item 9(Picture)

Inspector was unable to determine the precise age of the Heavyweight Steel Piles on this seawall. Historical images with the Miami Dade Property Appraiser shows extensive work went into the project between 2006 and 2007. Recommend consulting a qualified marine contractor and begin seawall mitigation plan by encapsulation or application of protective coating.

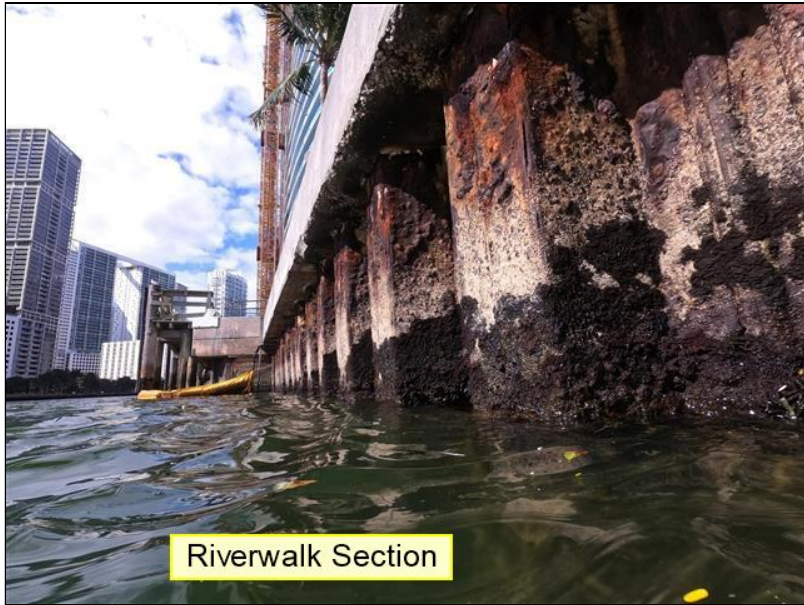
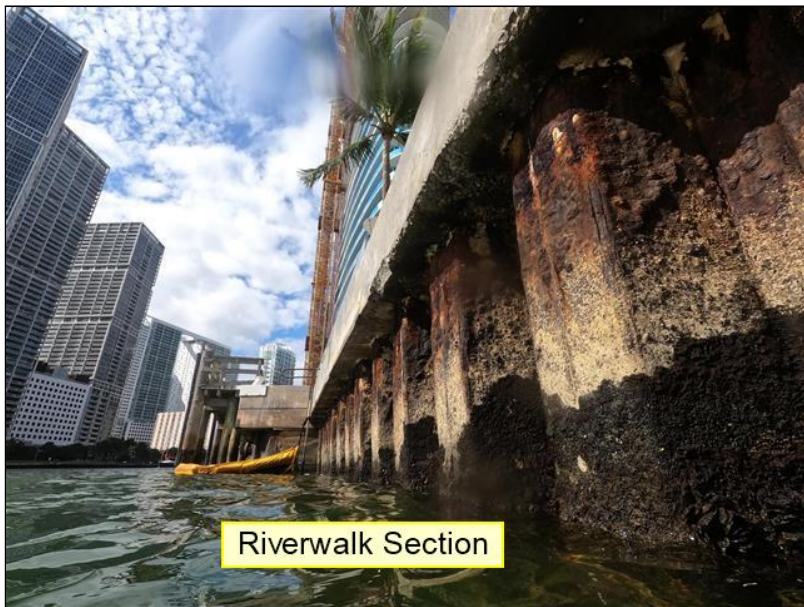
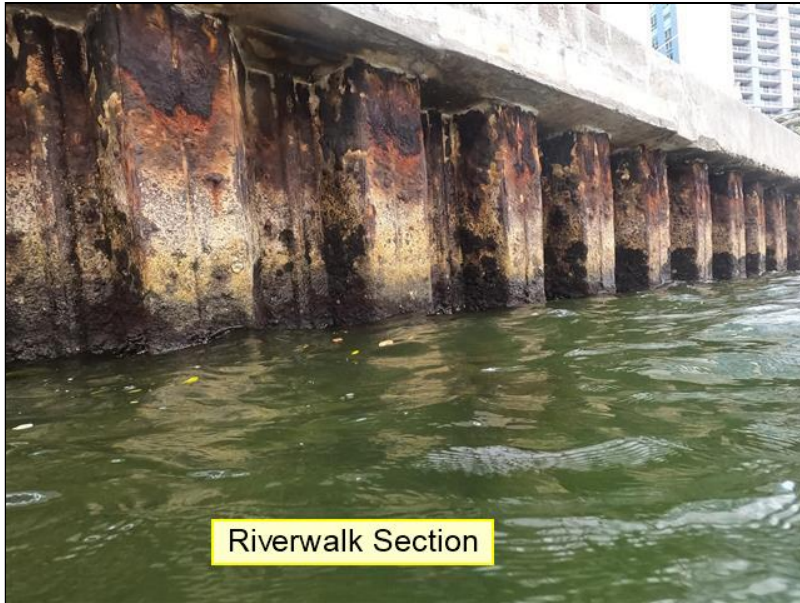
Observation: The segment of the seawall that continues east of the Aston Martin Project known as the Miami Riverwalk is severely deteriorated when compared to the subject's wall. Item 10(Picture) Item 11(Picture) Item 12(Picture)

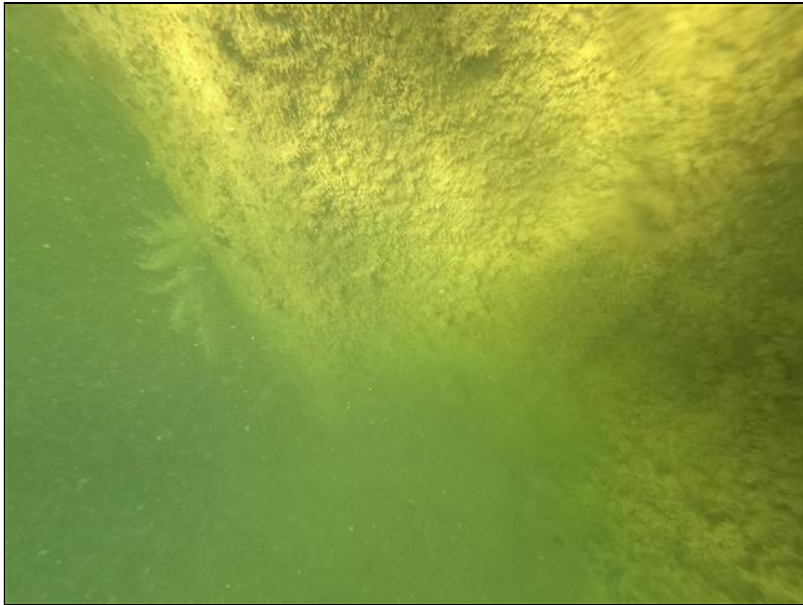
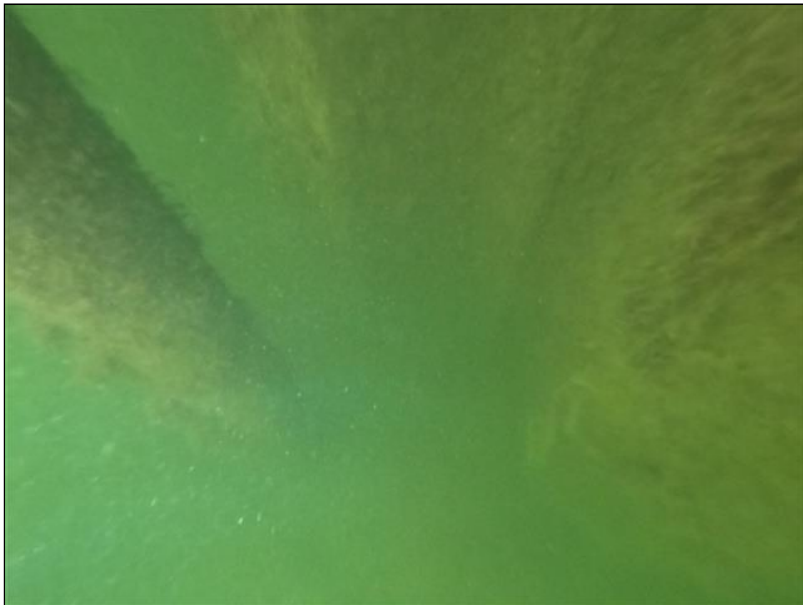
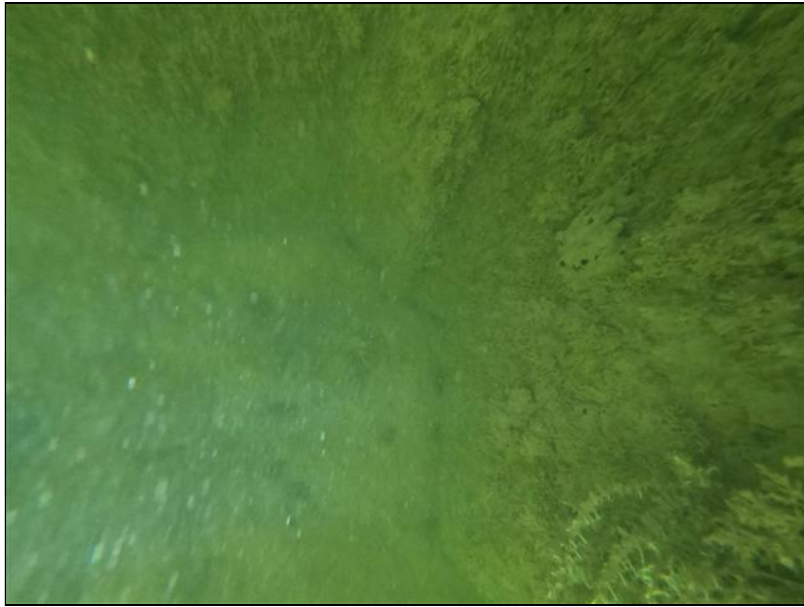
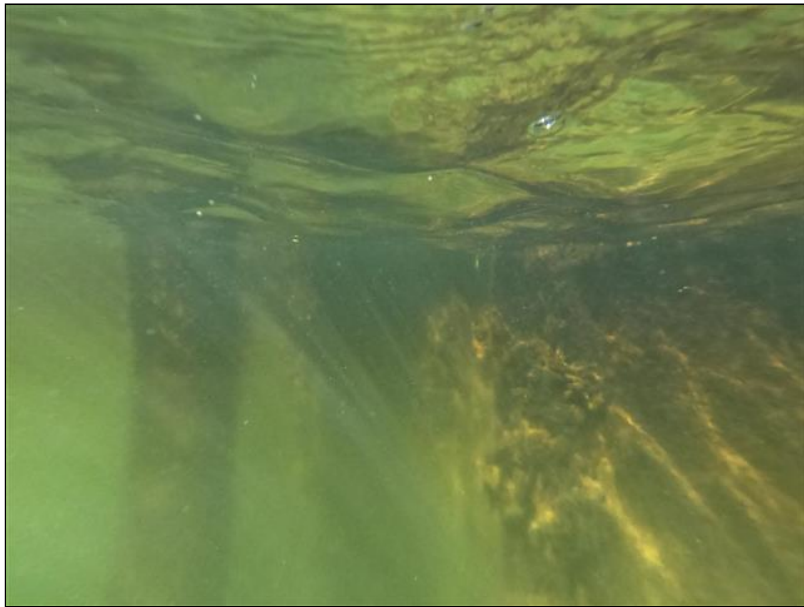
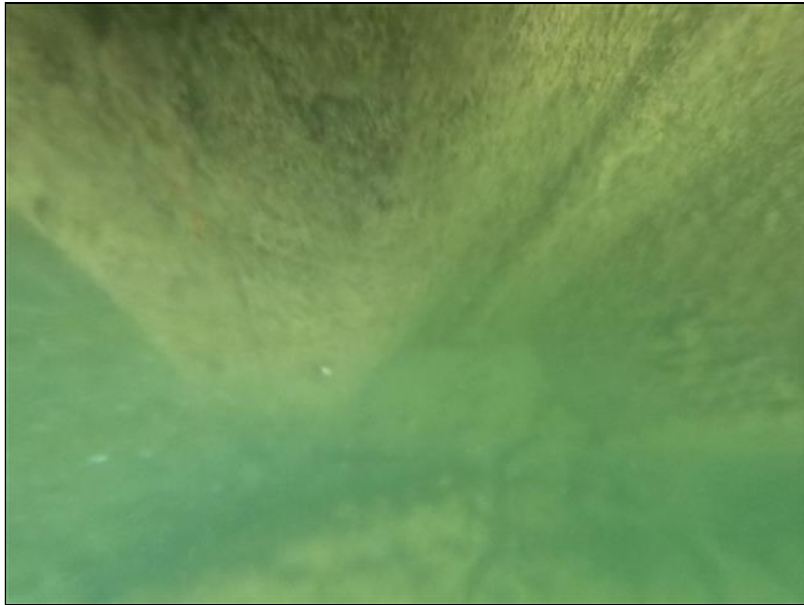
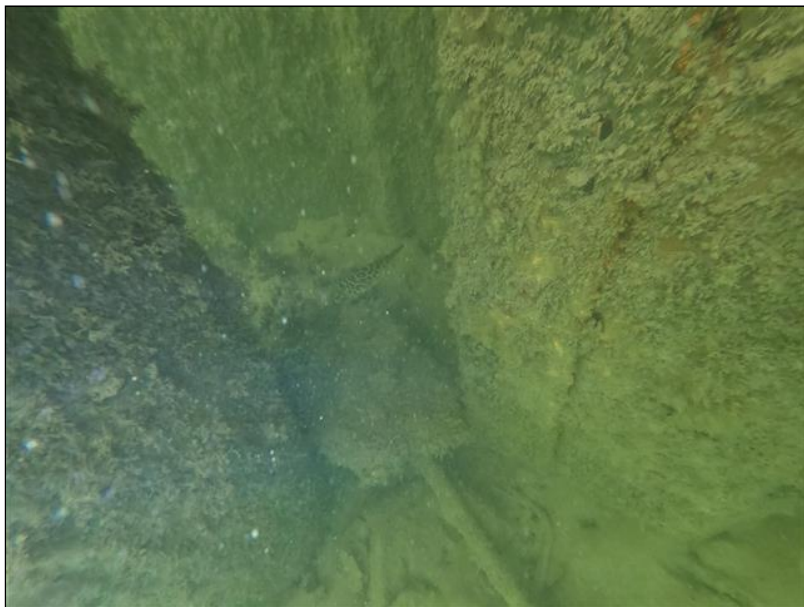
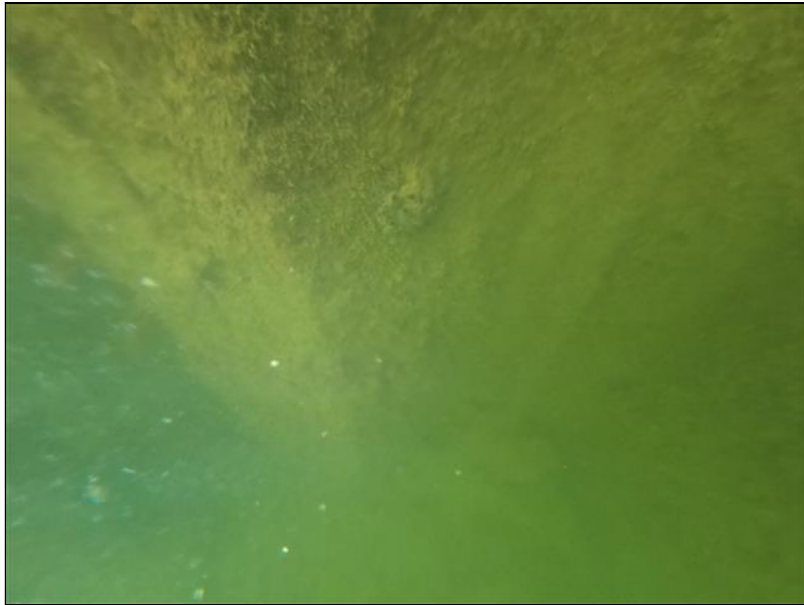
Inspector observed the face of the seawall below the water line. Below the water line (tidal zone), is the area that is continuously submerged. Shortage of oxygen at the water-metal interface equates to a low corrosion rate in areas that are fully immersed. While underwater, inspector found the submerged piles to be in serviceable condition at the time of the inspection. Inspector found moderate levels of marine growth such as barnacles, worms, and other types of biological organisms attached to the steel piles. This marine growth can lead to fouling which can impede or interfere and cause adverse wear of the panels. Item 1(Picture) Item 2(Picture) Item 3(Picture) Item 4(Picture) Item 5(Picture) Item 6(Picture) Item 7(Picture) Item 8(Picture) Item 9(Picture)

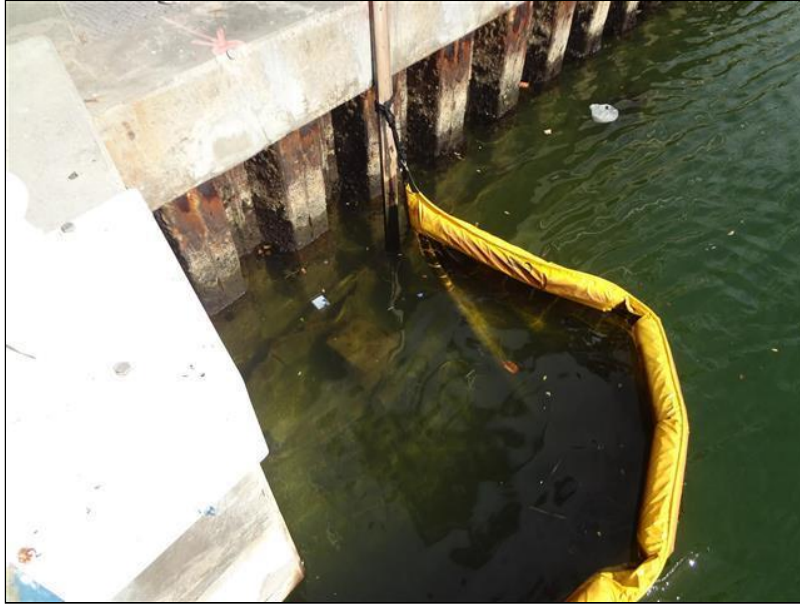
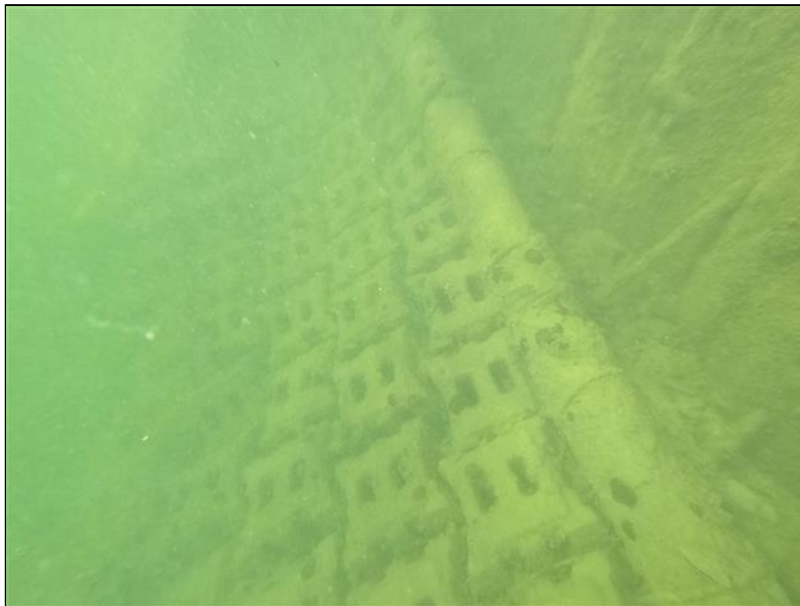
Observation: The segment of the seawall that continues east of the Aston Martin Project known as the Miami Riverwalk is severely deteriorated when compared to the subject's wall. A cinder block stack was laid out at the bottom, at the junction between the two walls in what appears to be an attempt to protect this section of wall. Item 1(Picture) Item 2(Picture)

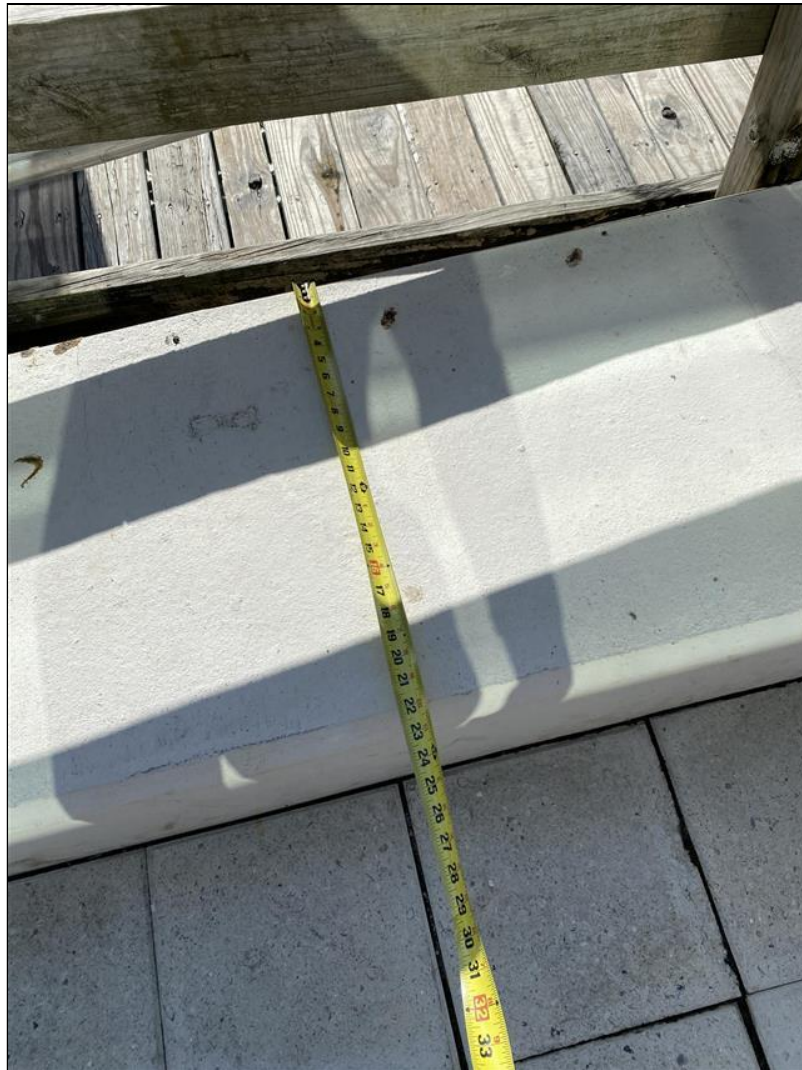
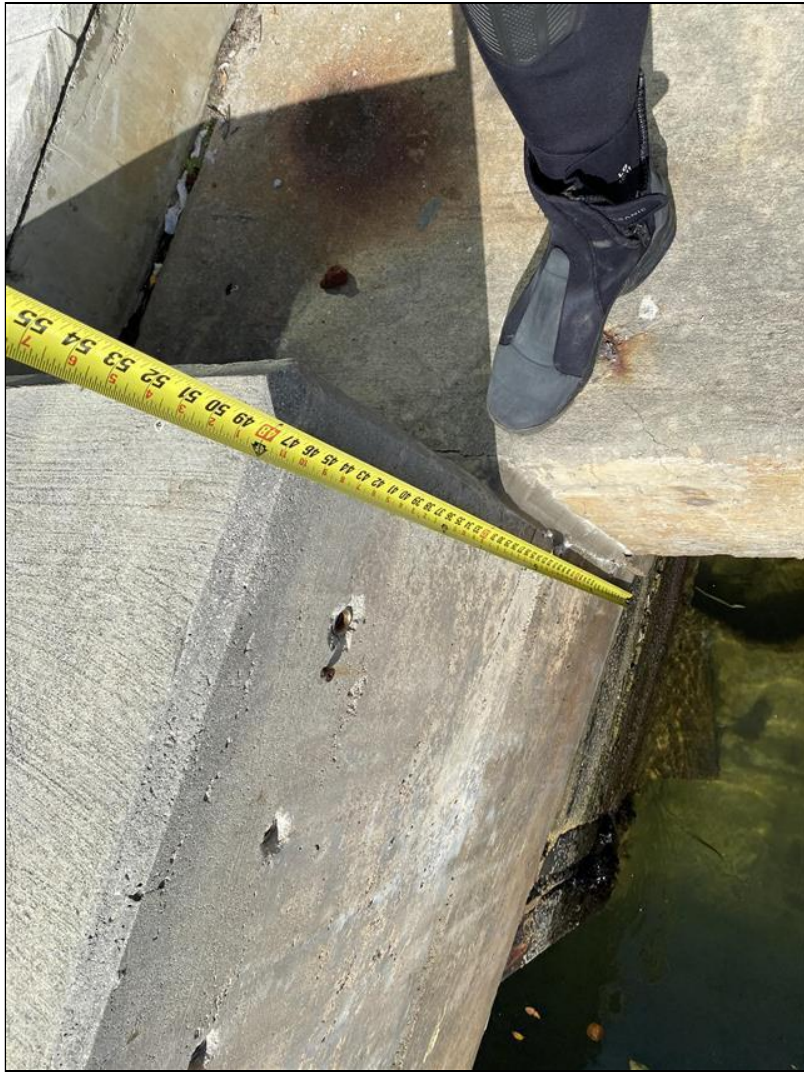
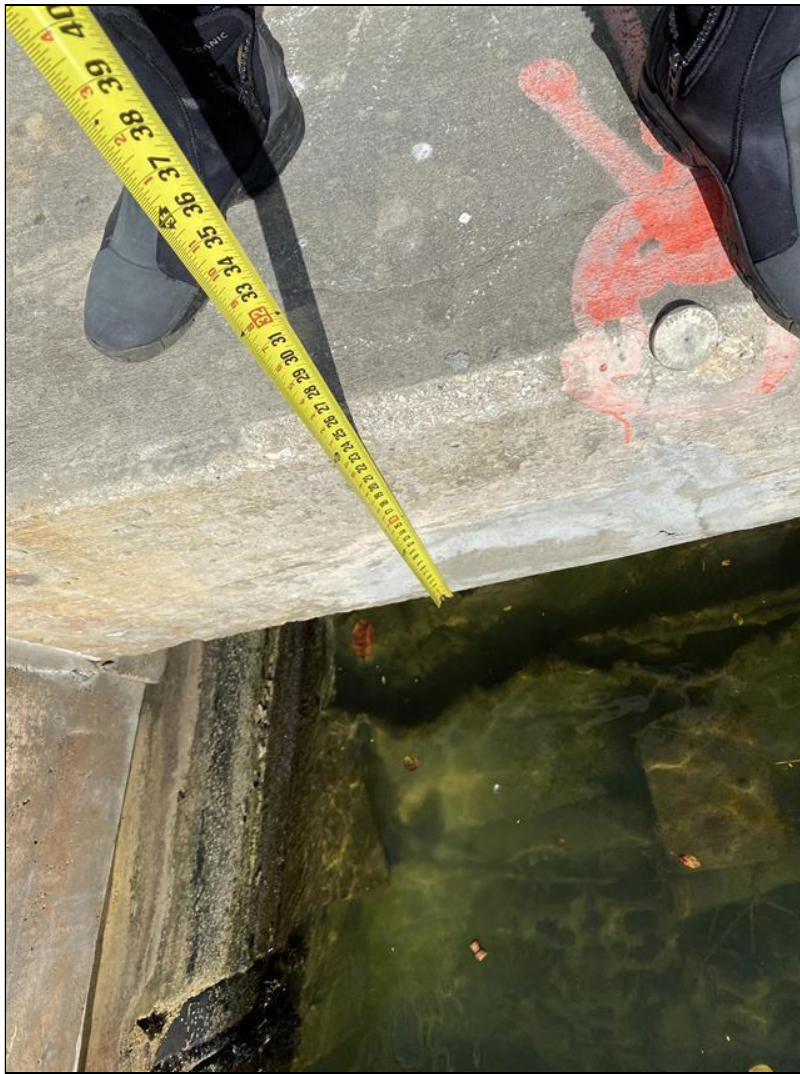
This seawall has a concrete CAP that measures +/- 470 LF in length and is 48" h x 24" w. The CAP is positioned +/- 15 LF tall measuring from the berm (bottom of canal). There is no sign of CAP rotation or movement at this time. The CAP shows minor signs of deterioration with very minor concrete spalling. The seawall CAP was in serviceable condition at the time of the inspection.
