Rugby Model Engineering Society Ltd

Safety Management Manual

APPENDIX 1: Safety Concern Register

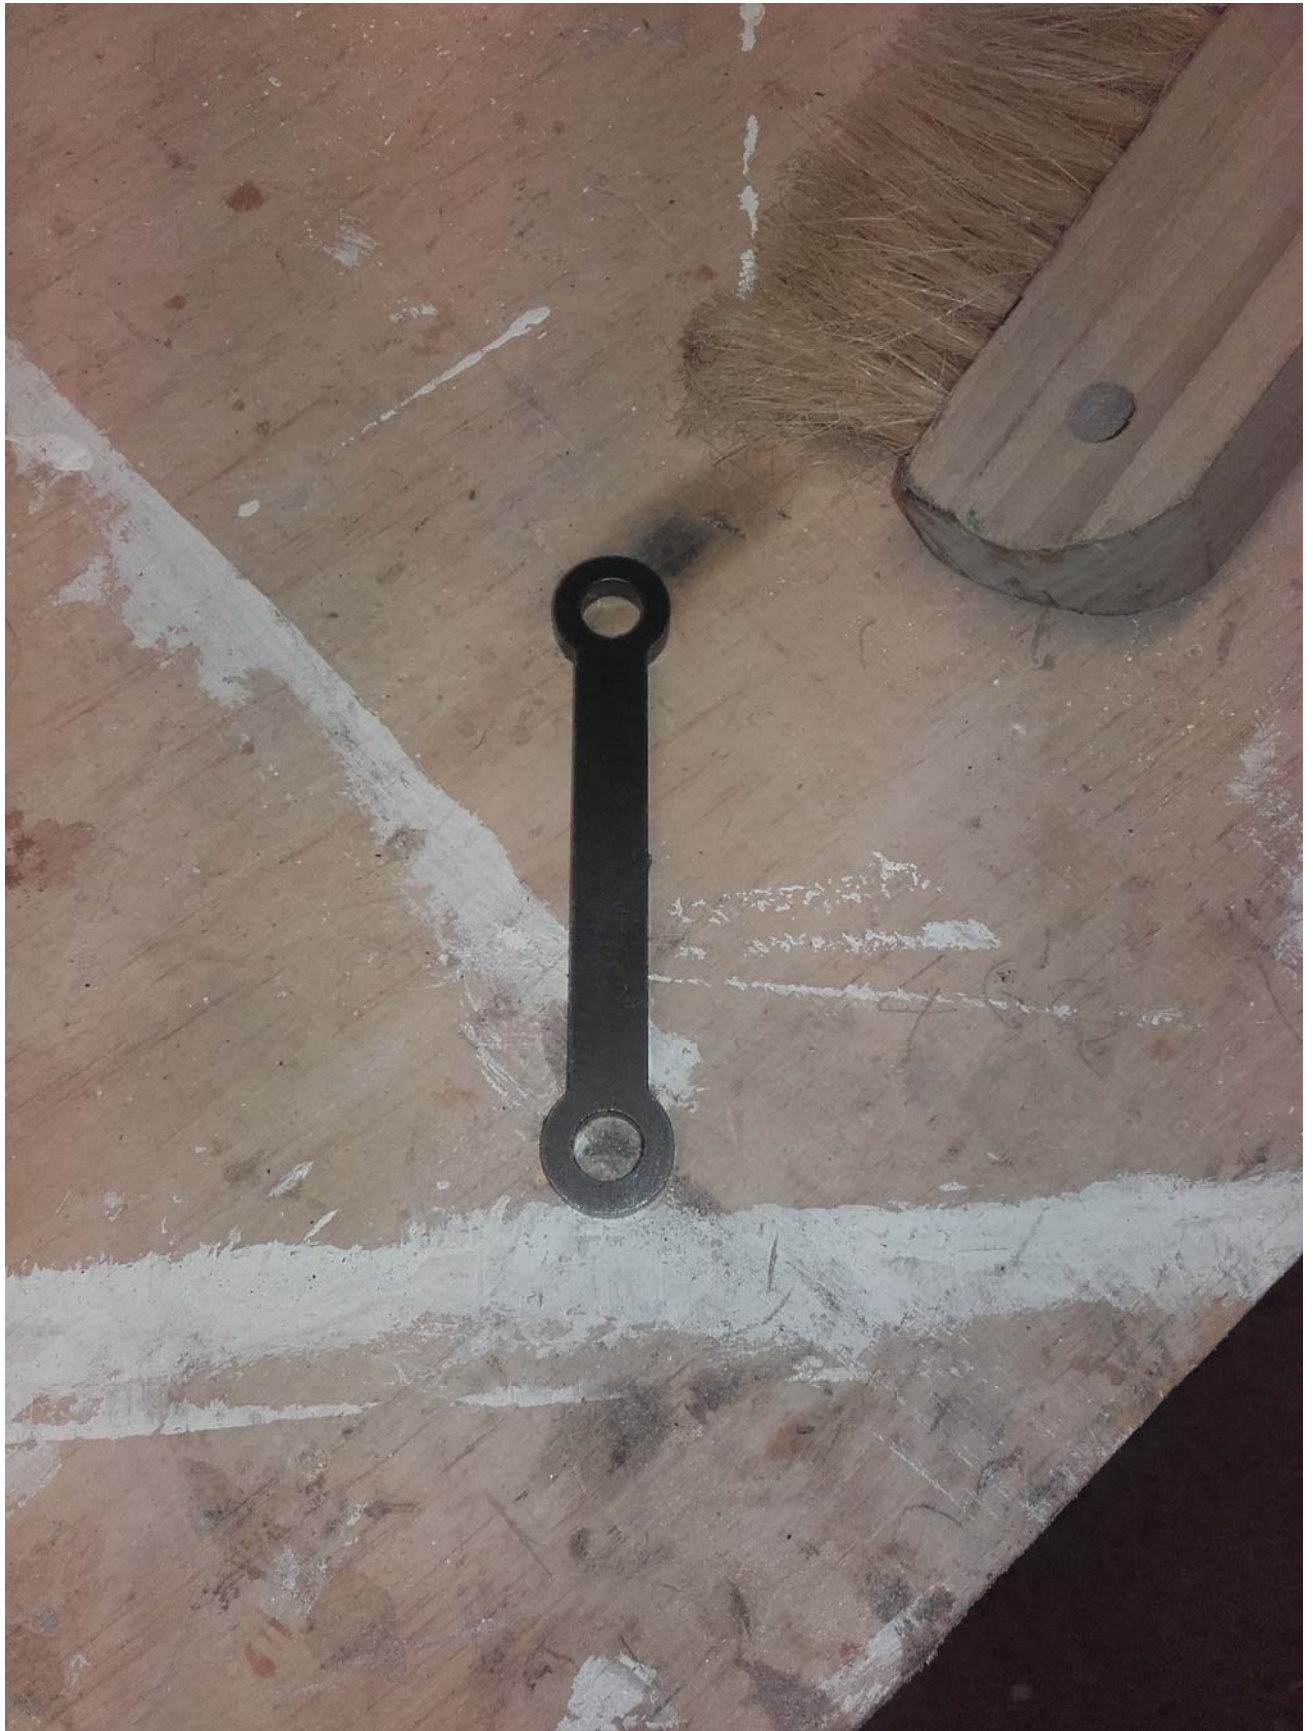
Rugby Model Engineering Society Ltd SAFETY CONCERN	Ref. No: 07/2016 <small>(Safety Officer to Allocate)</small>
Equipment/Operation Affected: Couplings on 7.25" stock	
Perceived Problem: <small>(Continue overleaf if required)</small> Discovered dangerous couplings on last public running day (photo attached to email). The coupling I found was a fixed link with two holes. This type of coupling is totally unsuitable for use with rolling stock with centre buffer / couplers. The fixed centres of the link are keeping the buffer apart from each other by about 2", totally preventing them from doing their job – they might as well not be there. In the case of a heavy shunt caused by collision from front or rear, or in the case of heavy braking in the forward part of the train, the buffers are unable to do their job, the coupling will take the load. Because of this, you are in a situation where you have 3 links and 4 pivots in a chain, comprised of the two buffer coupling units and their connecting pin, plus the coupling link and 2 pins. Try pushing 3 links on a table and see what happens. The links which push to the side and will not move in a straight line. We have opened up the possibility of carriages being pushed sideways and derailed. This situation can also present itself when trains are propelled, especially over curves, such as into the carriage sheds. Con't >>

Couplings for centre buffer/coupling units of the type we use should always allow the buffer faces to come into contact. They should be slotted links which allow movement. Buffer faces should be kept to a minimum separation distance when in normal use, faces must be allowed to contact under braking or propelling situations. That is why all our old coupling links are slotted bars, or made from single links of chain. If you're not going to use the correct type of couplings, then you might as well get rid of the buffers, as they're doing nothing.

Originator's Suggestions for Improvement: <small>(Continue overleaf if required)</small> Dispose of dangerous links. Obtain more slotted links of single links of chain as per the original couplings.	
Originator E J Parrott	Date 27/6/2016
Committee's Response: <small>(Continue overleaf if required)</small> This error had already been spotted and action taken directly with the project leader for the new carriage stock. As a result of this, remedial action was put in place immediately and the errant links removed and replaced with short pattern links that ensure the "buffer" faces meet when coupled. The error had occurred due to a lack of knowledge on how these couplings worked and the fault was easily and quickly remedied.	
Safety Officer Comment: Closure Recommended.	
Signed Howard Brewer (for RMES Committee)	Date 9 July 2016
