O'BRIEN
BUILDING INSPECTIONS INC.

SAMPLE
INSPECTION REPORT
3576 Main Street
Goleta, CA

Prepared for Island Investments LLC

12/8/2025

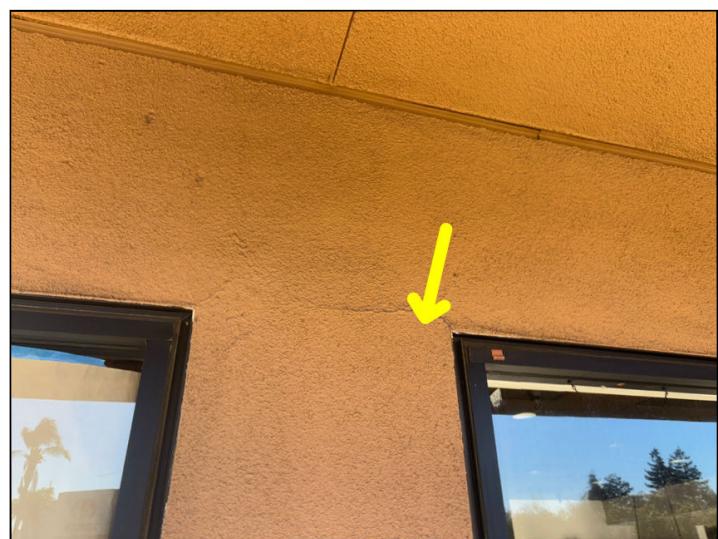
Cracks and patching were noted in many places at the exterior walls.

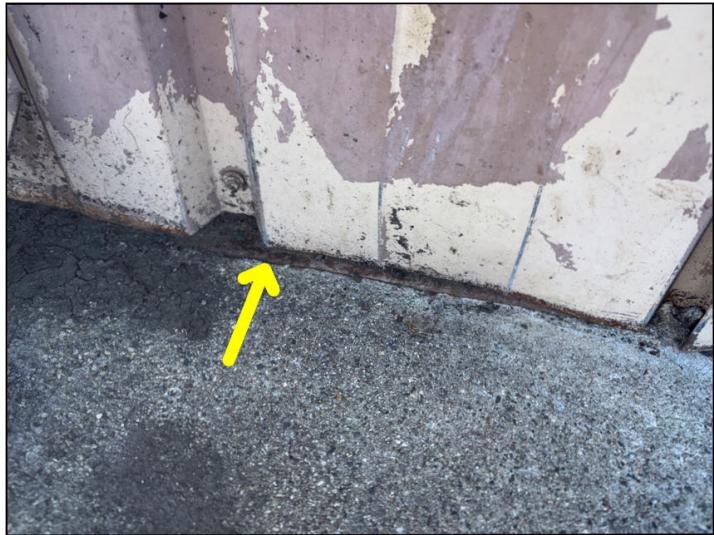
The stucco weep screed is blocked by paving at various places. This can cause moisture problems.

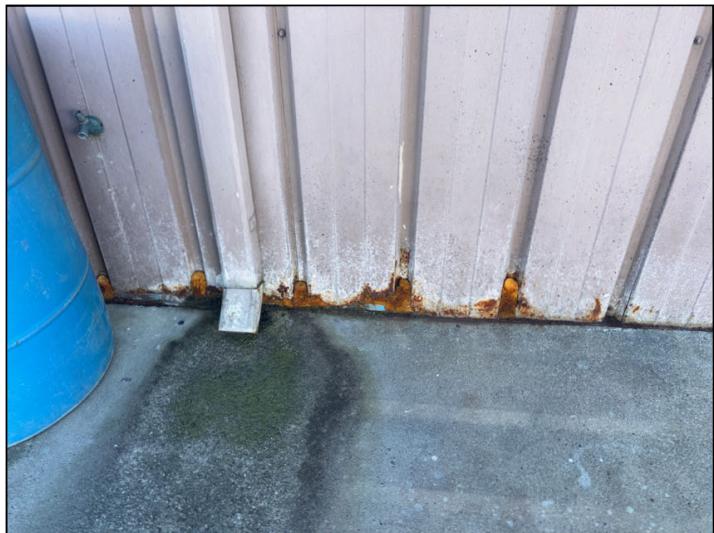
corrosion was noted in various places at the base of the rear exterior metal siding.

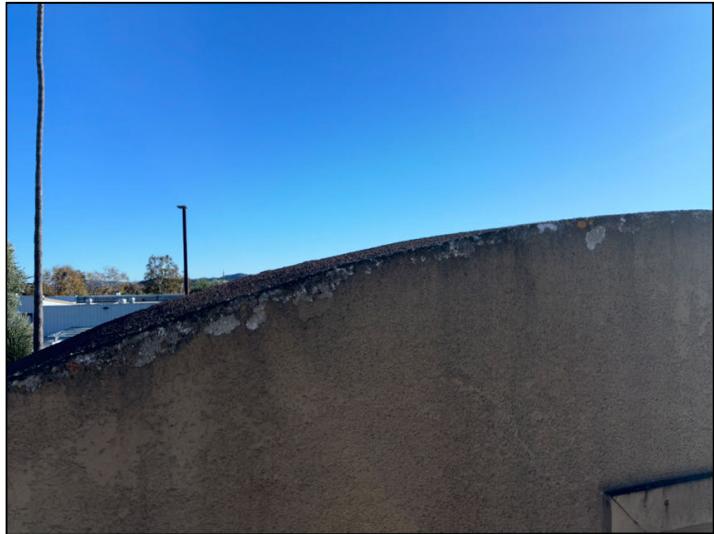
Damaged and flaking stucco color coat was noted in various places at the stucco arch detail over 12328.

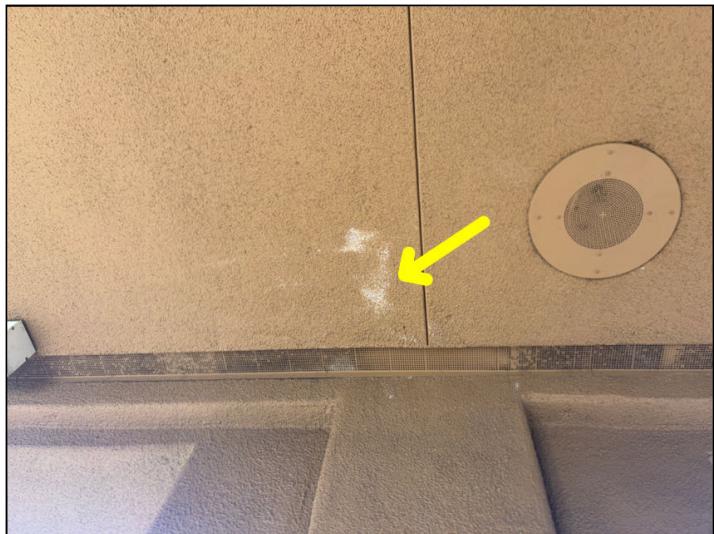
Patched cracks were noted in many places at the stucco trim and eave details.

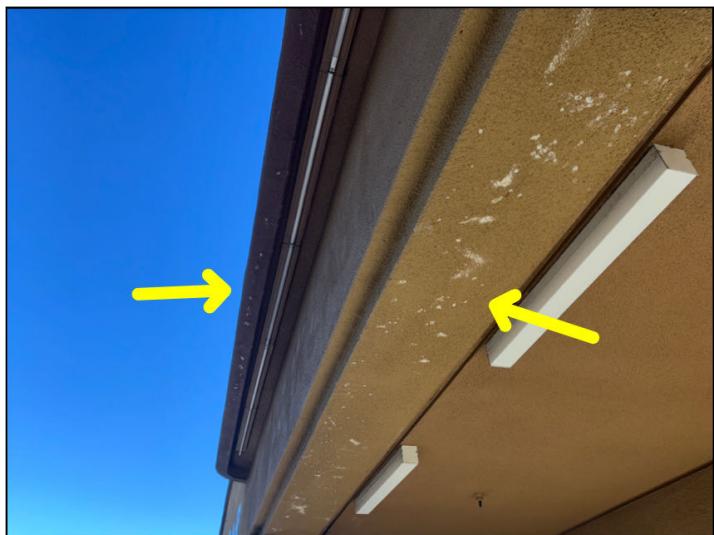
Efflorescence was noted at the underside of the eaves adjacent to the common restrooms.

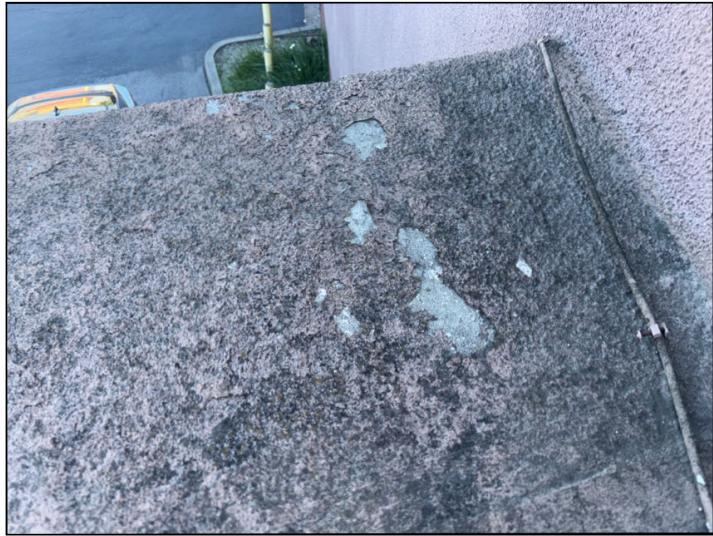
Peeling paint and deteriorated stucco was noted in many places at the horizontal surfaces of the parapet walls.

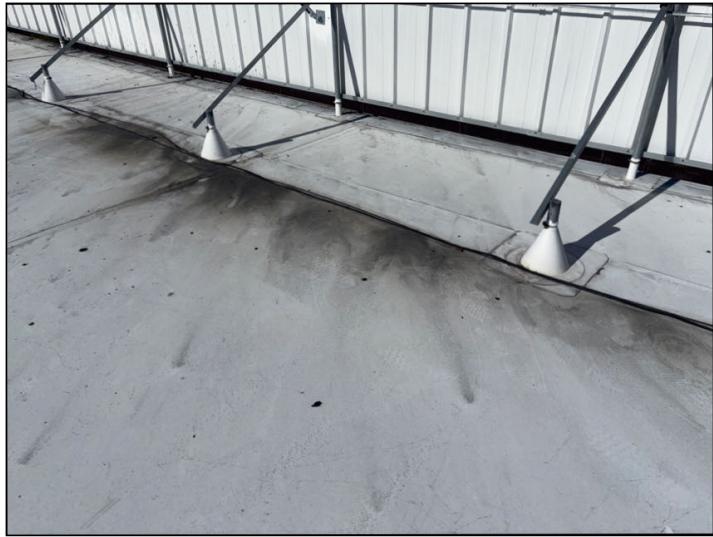
The roof is due for cleaning at various places.

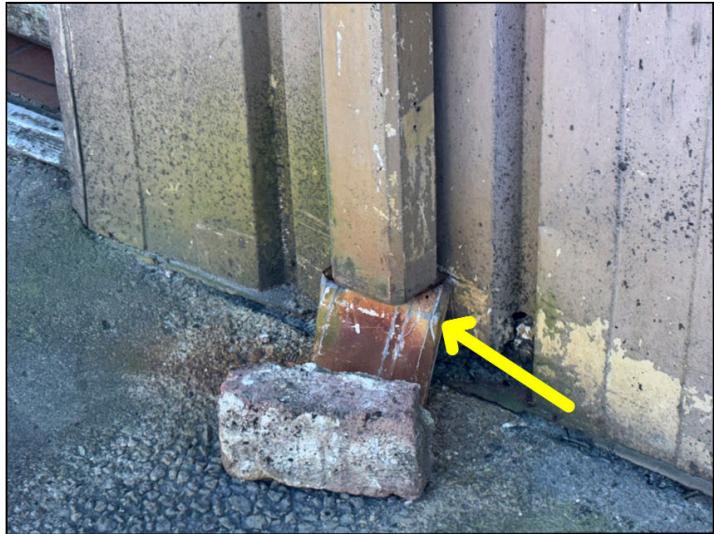
Corrosion was noted where a downspout is connected to the gutter at the rear of 12308.

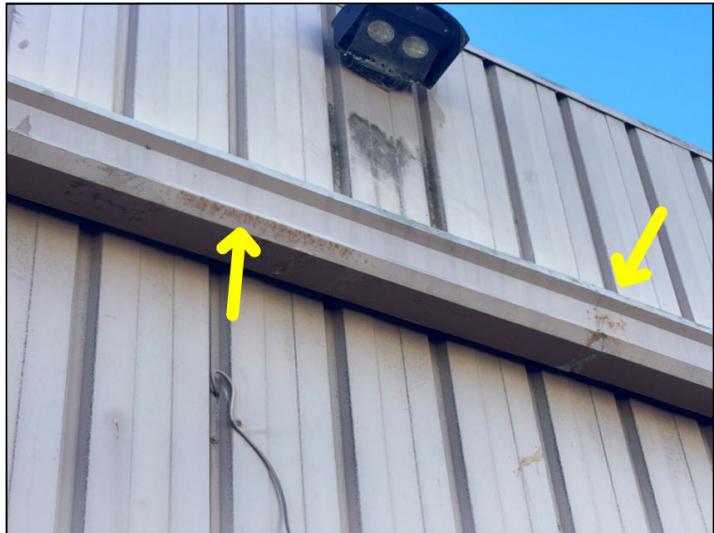
Stains and evidence of leakage were noted in many places at gutter seams.

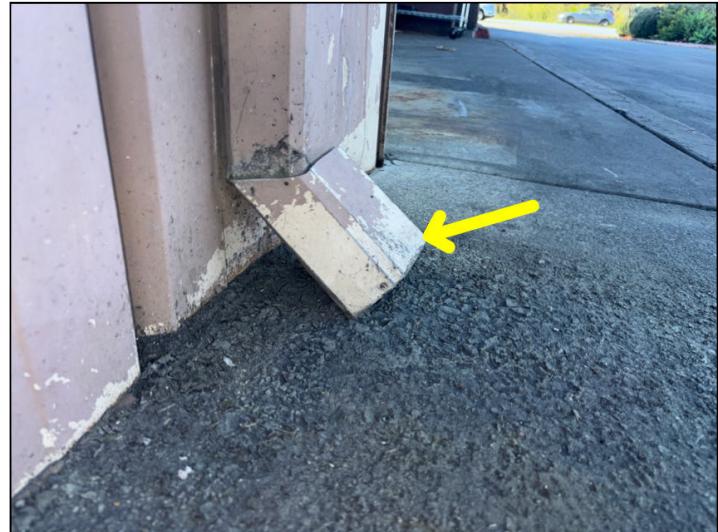
Corrosion was noted at the gutter in various places at the rear of 12320 and 12322.

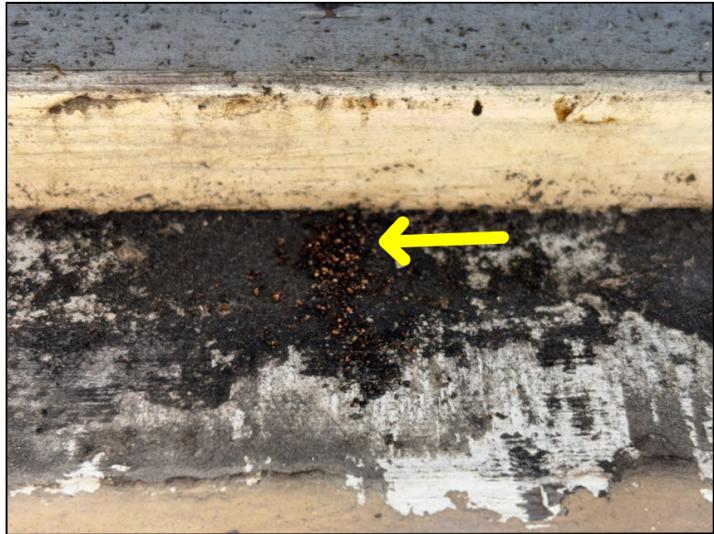
Moisture stains were noted in the attic of the stucco arch detail over 12338. The stains were dry at the time of the inspection.

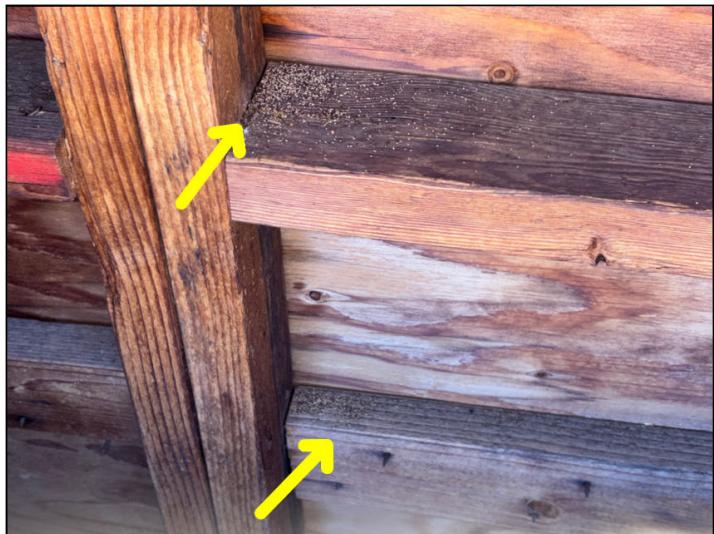
Apparent insect droppings were noted at various places in the attics of the stucco arch details on the roof.

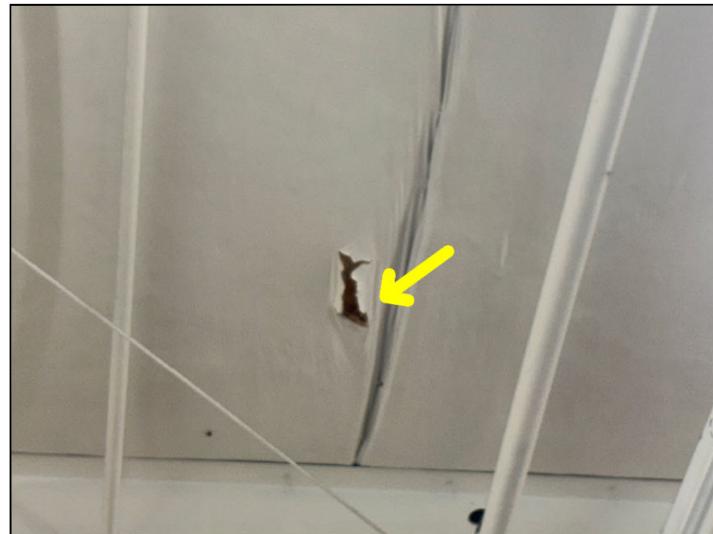
Damaged thermal barrier was noted in various places at the insulation of the exposed frame ceilings. Recommend further evaluation and improvements be made as needed by a qualified professional.

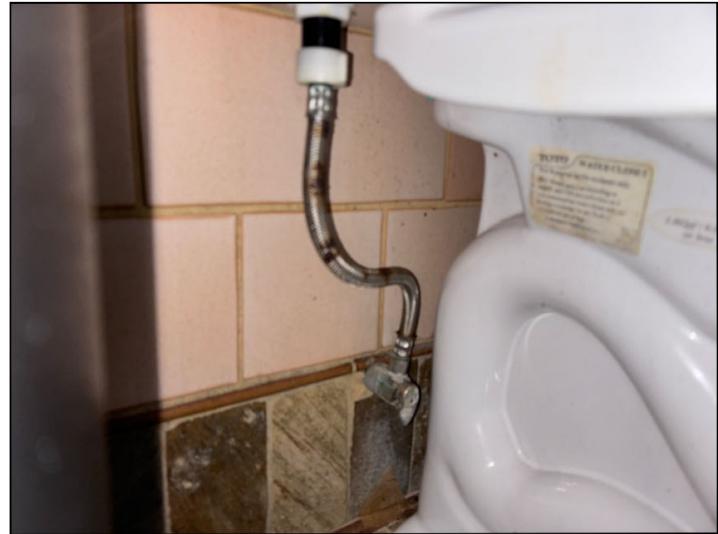
Stains and evidence of leakage were noted at a supply valve in the rear interior of 12300 adjacent to the water softener.

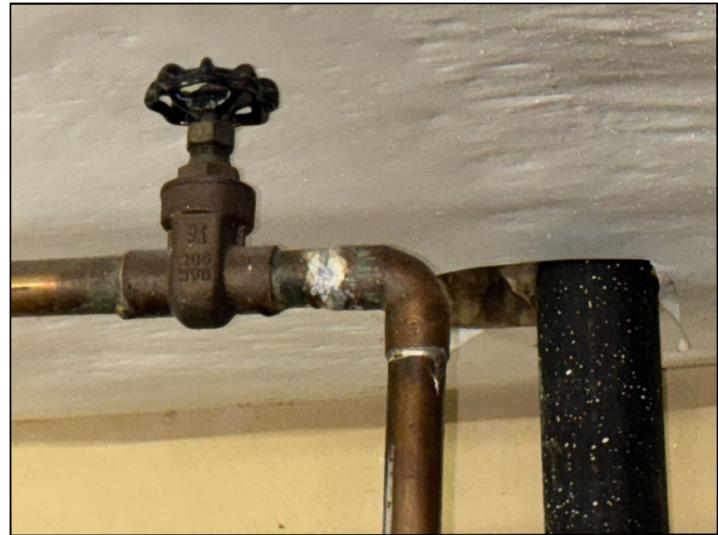
Corrosion was noted at the supply valves and adjacent connectors in the restroom of 12306.

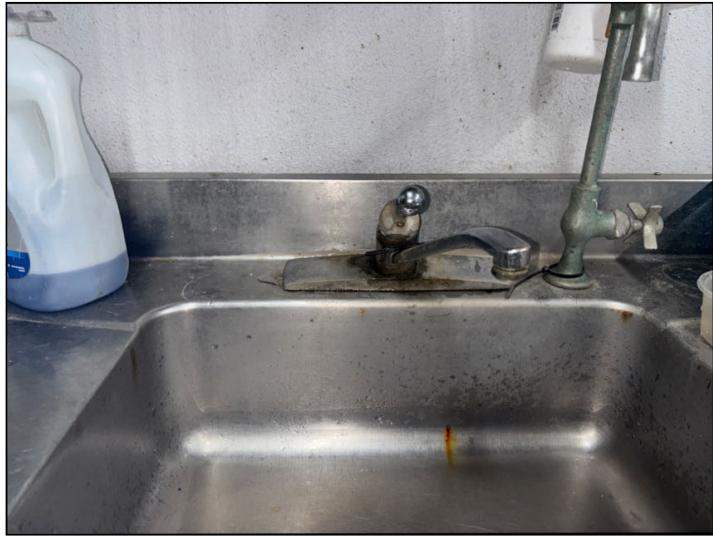
Mineral deposits were noted throughout the worker sink in 12322.

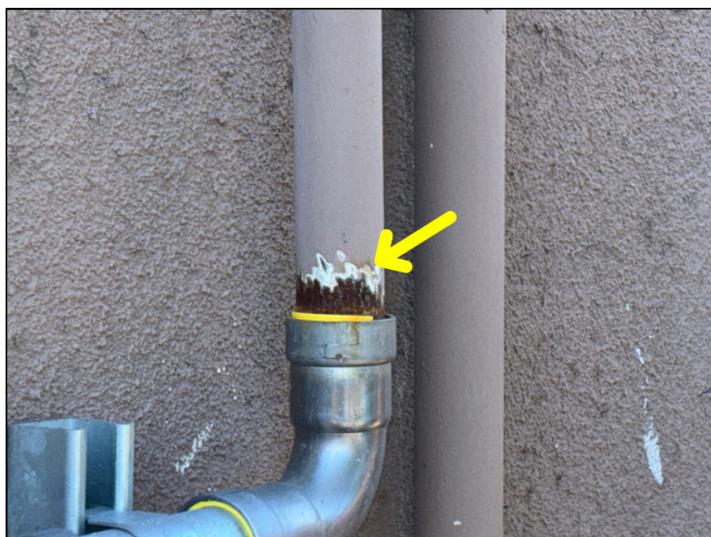
Corrosion was noted in many places at the gas lines on the roof.

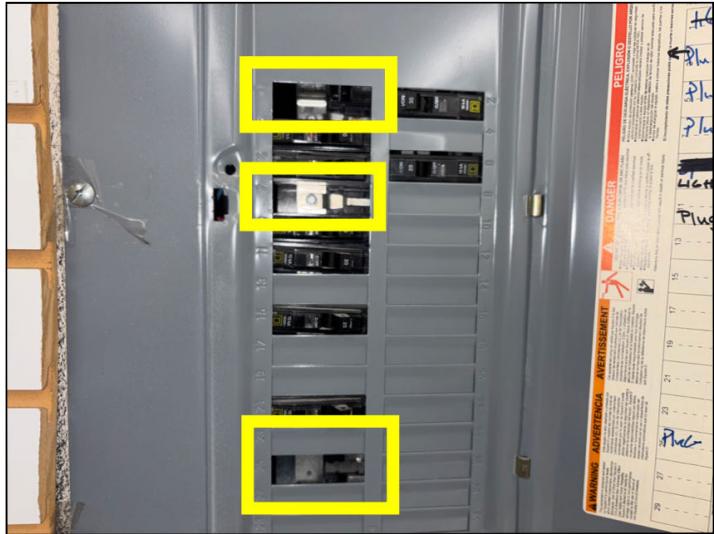
Incomplete breaker identification labeling was noted at the subpanel in the rear of 12310.

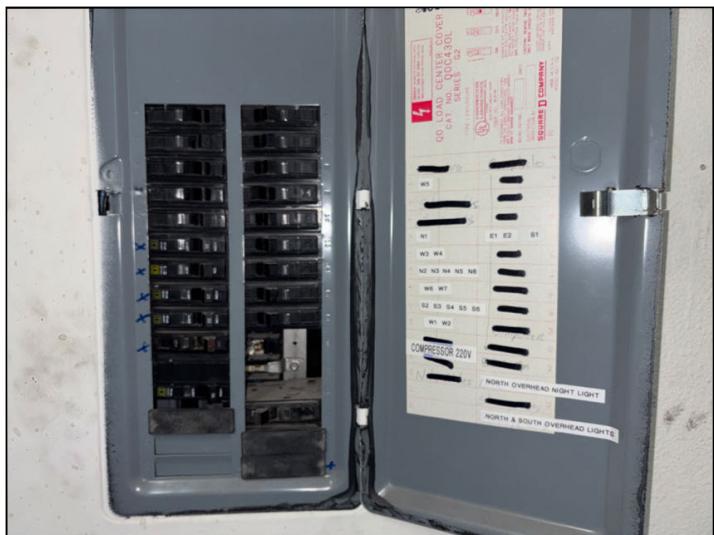
Missing filler plates were noted at the subpanel in the rear storage area of 12322.

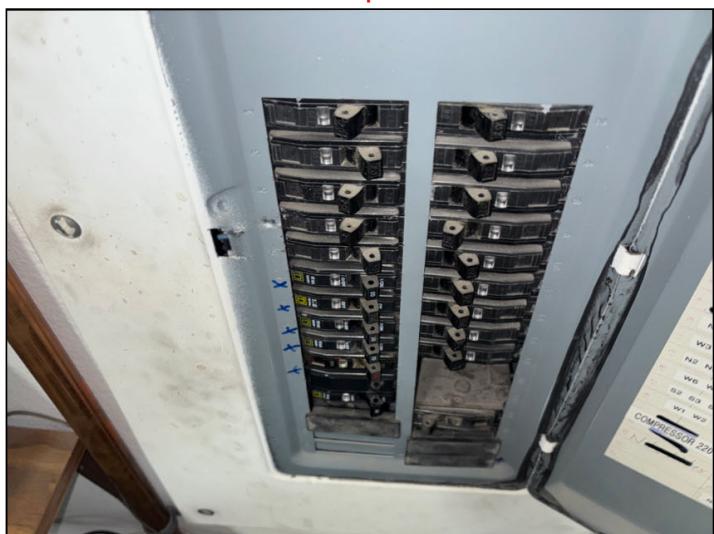
Various breakers are taped in the off position at the rear interior of 12300.

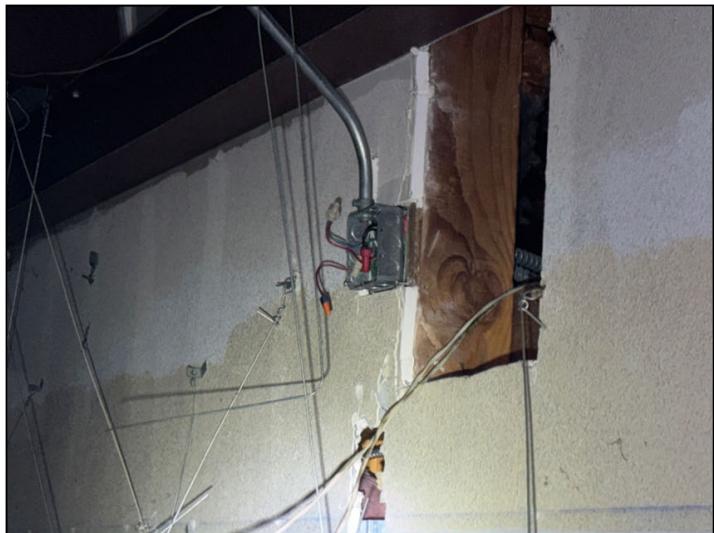
Open junction boxes were noted at various places in the stucco arch detail attic spaces.

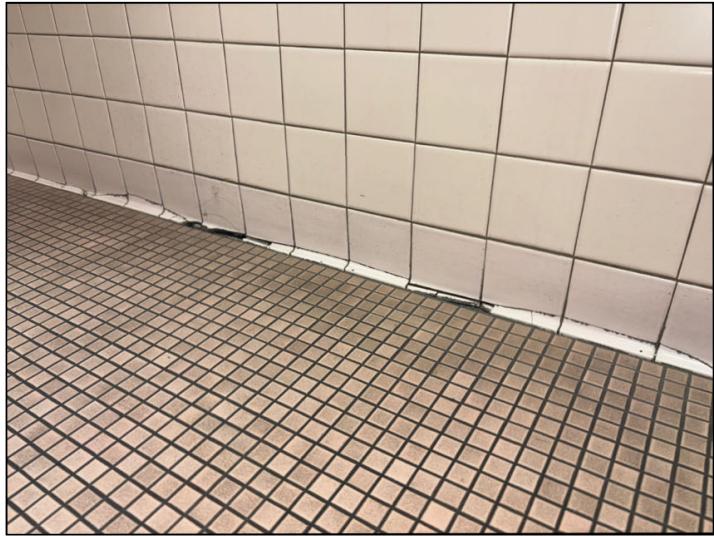
Cracked and damaged tiles were noted at many places where the walls meet the floors in the men's common restroom.

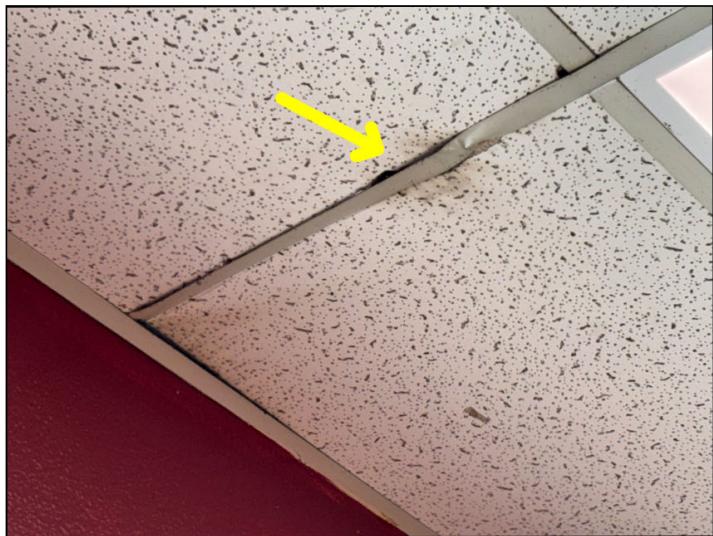
A moisture stain and evidence of water intrusion were noted at a ceiling tile at the front of 12308.

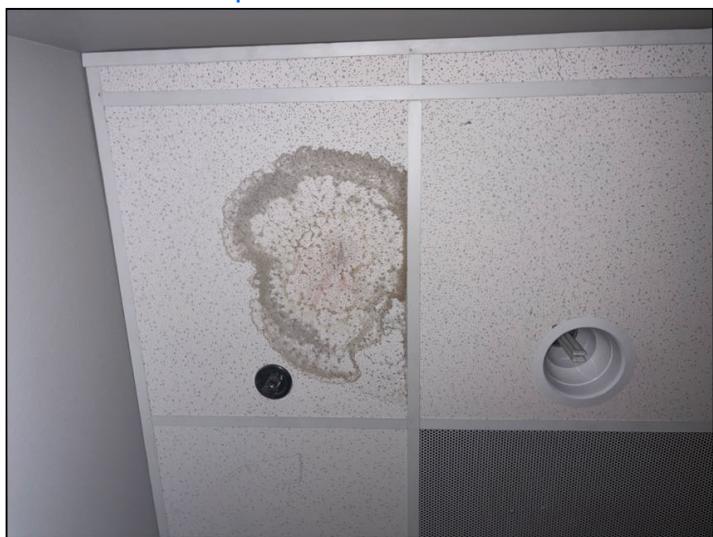
Damaged and displaced ceiling tiles were noted in various places at the front of 12308.

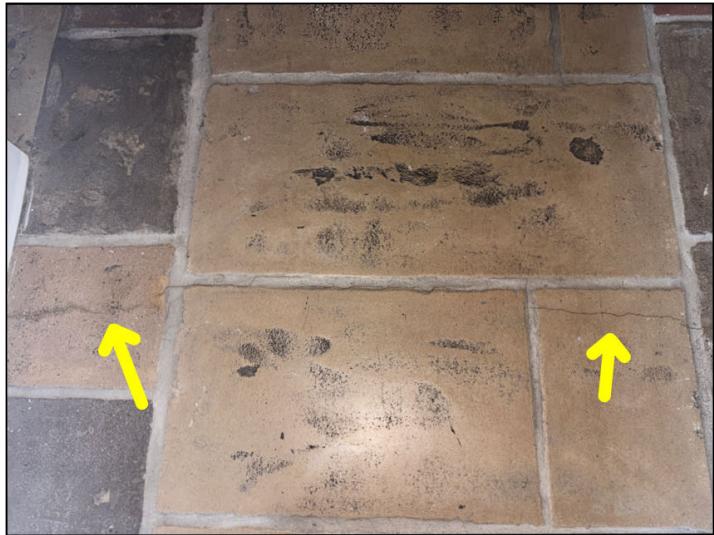
Damaged floor material was noted at various places in the rear storage room of 12314.

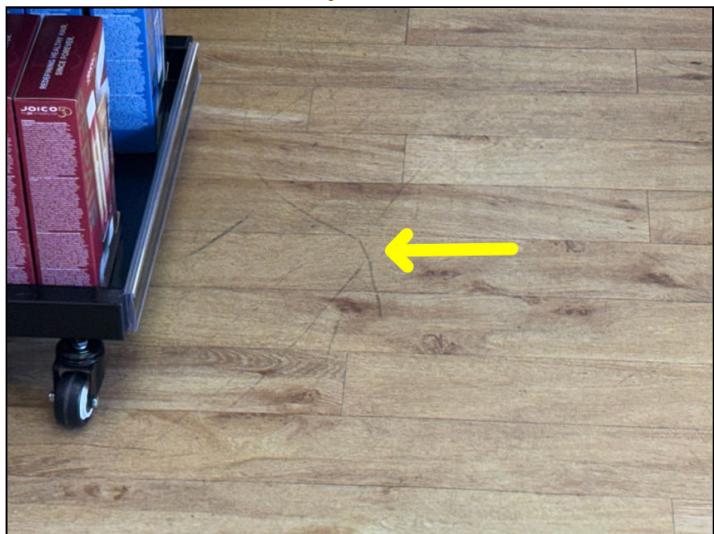
Cracked tiles were noted in various places at the hallway in 12324.

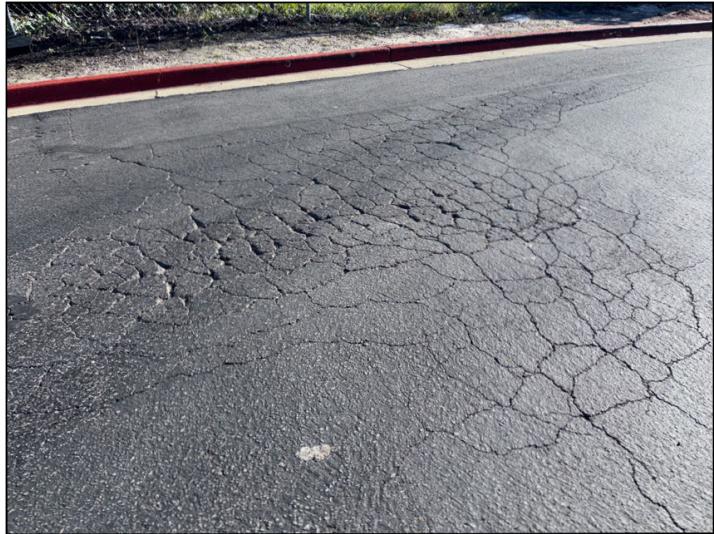
Cracked and fragmented asphalt was noted in many places at the driveway and parking areas.
