SB-721 INSPECTION REPORT

1025 Olive Street
Santa Barbara, CA

10/2/2025

Inspected by Tio Turrini-Smith and Jay O'Brien

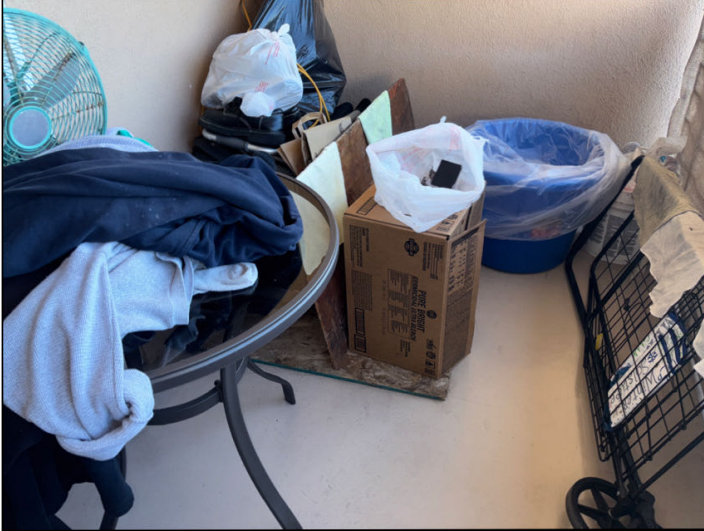
The balconies were not fully visible due to storage.

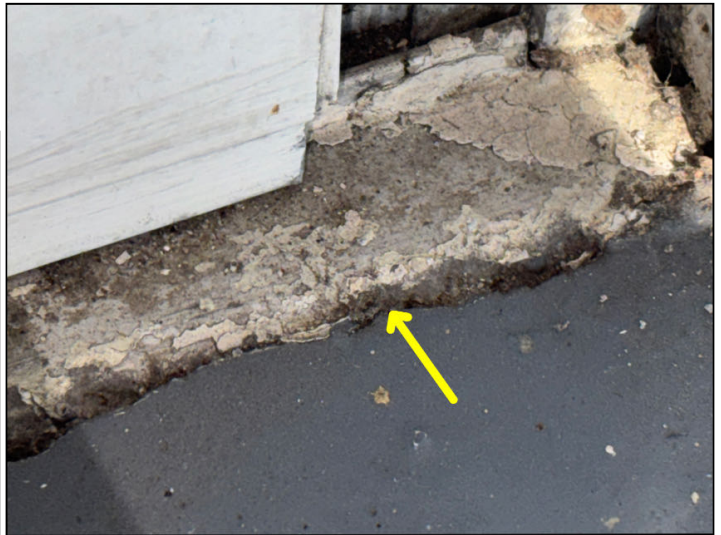
A gap was noted between the balcony surface and the slider door threshold at #33.

A gap was noted between the balcony surface and the slider door threshold at #33. Recommend this gap be filled.

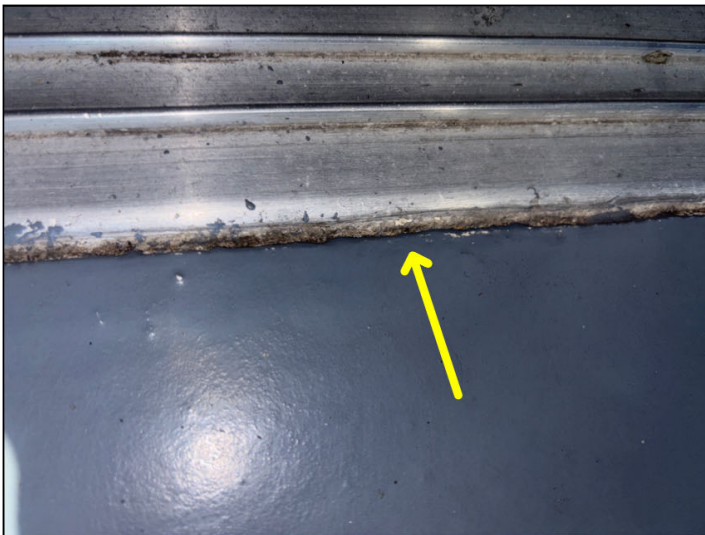
A gap was noted between the balcony surface and the slider door threshold at #33.

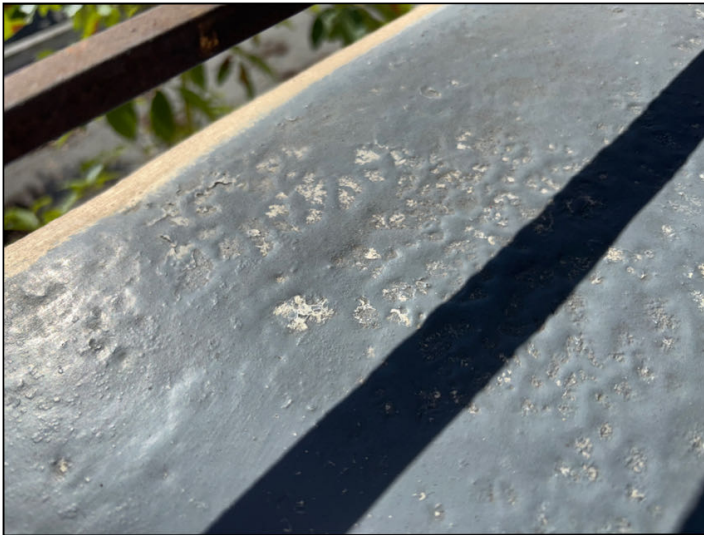
Worn, deteriorated, and cracked waterproof coating was noted at the #33 and #35 balcony surfaces in many places.

Worn, deteriorated, and cracked waterproof coating was noted at the #33 and #35 balcony surfaces in many places. Recommend these balconies be re-coated.

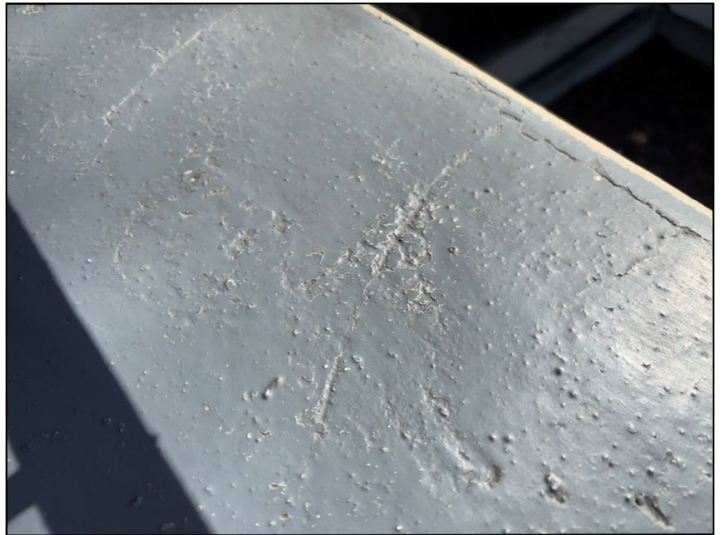
Worn, deteriorated, and cracked waterproof coating was noted at the #33 and #35 balcony surfaces in many places.

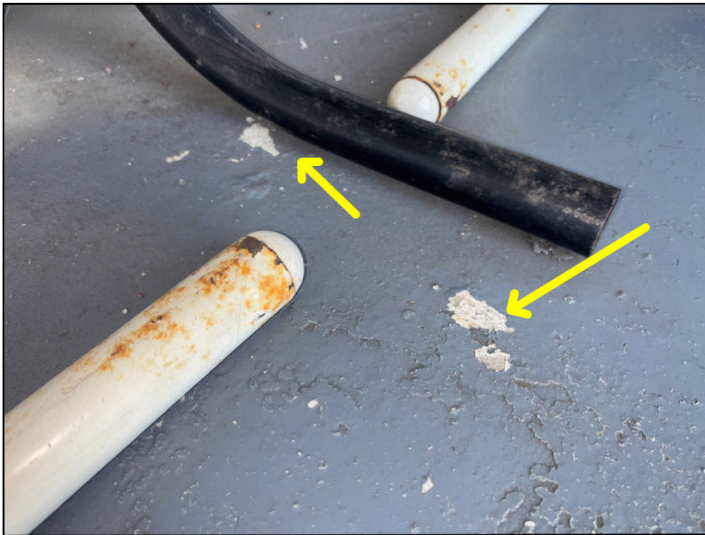
Worn, deteriorated, and cracked waterproof coating was noted at the #33 and #35 balcony surfaces in many places.

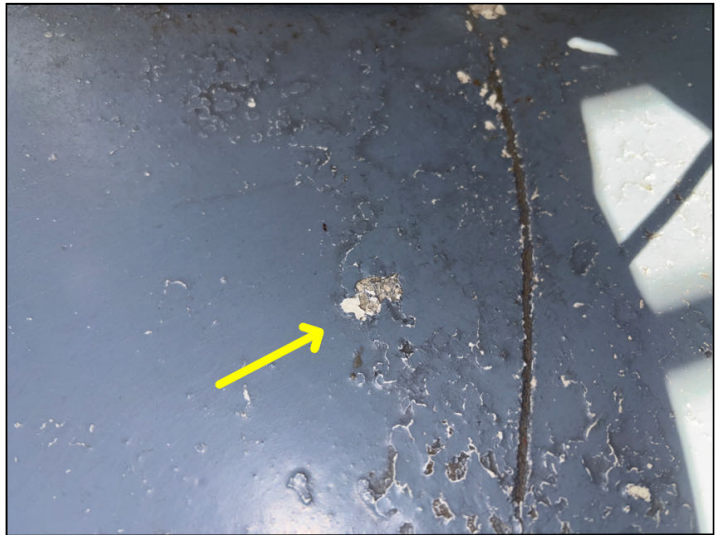
Worn, deteriorated, and cracked waterproof coating was noted at the #33 and #35 balcony surfaces in many places.

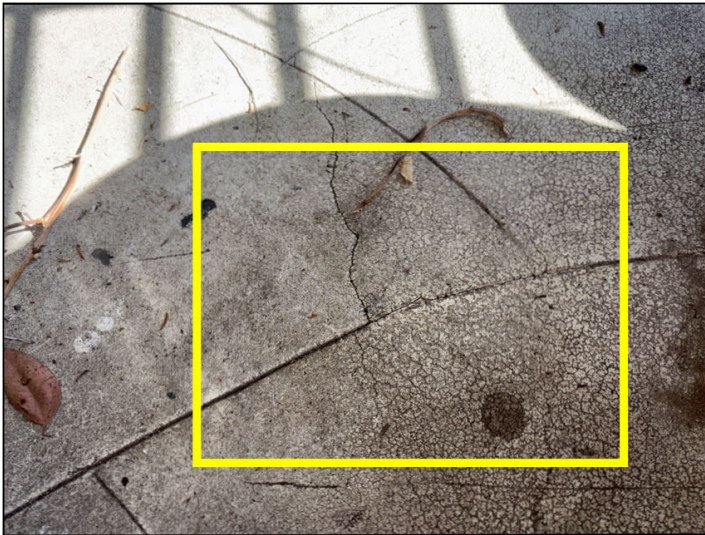
Worn, deteriorated, and cracked waterproof coating was noted at the #33 and #35 balcony surfaces in many places.

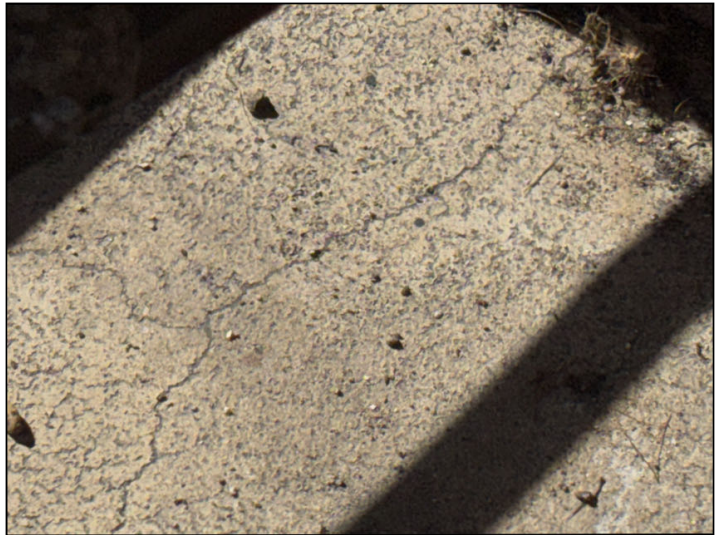
Worn, deteriorated, and cracked waterproof coating was noted at the #33 and #35 balcony surfaces in many places.

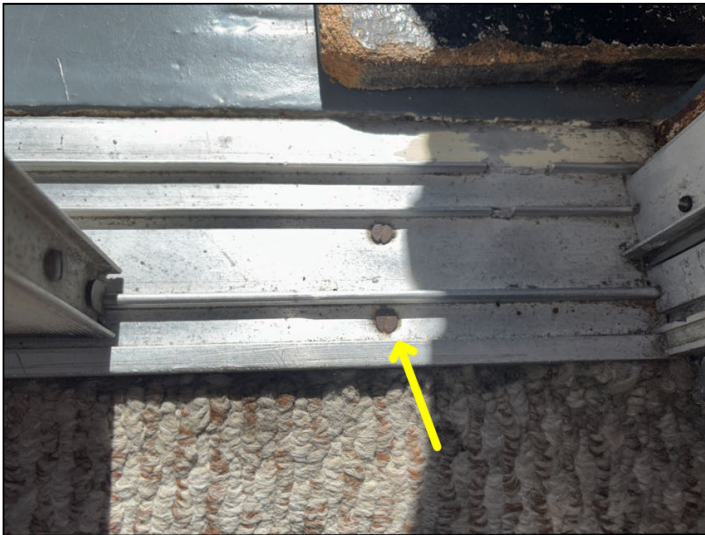
Fasteners have been installed through the #33 balcony slider door threshold.

Fasteners have been installed through the #33 balcony slider door threshold. The holes in the threshold will make this area more susceptible to water intrusion. Recommend these fastener heads be kept well sealed.

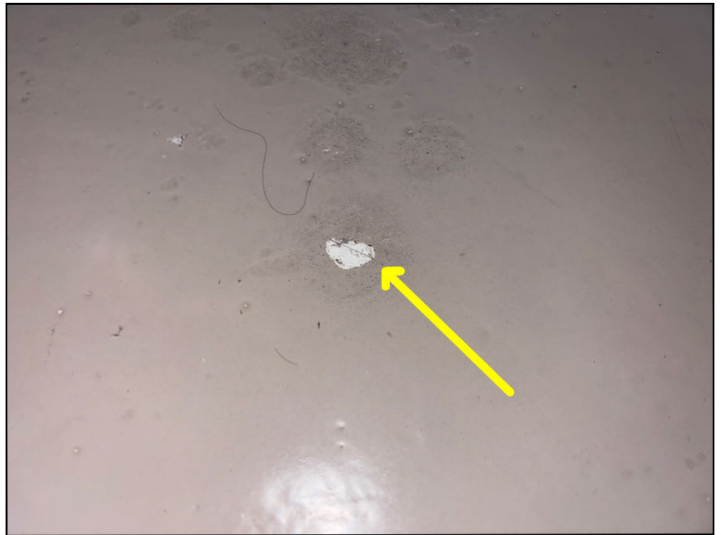
Chipped waterproof coating was noted at the #31 balcony surface.

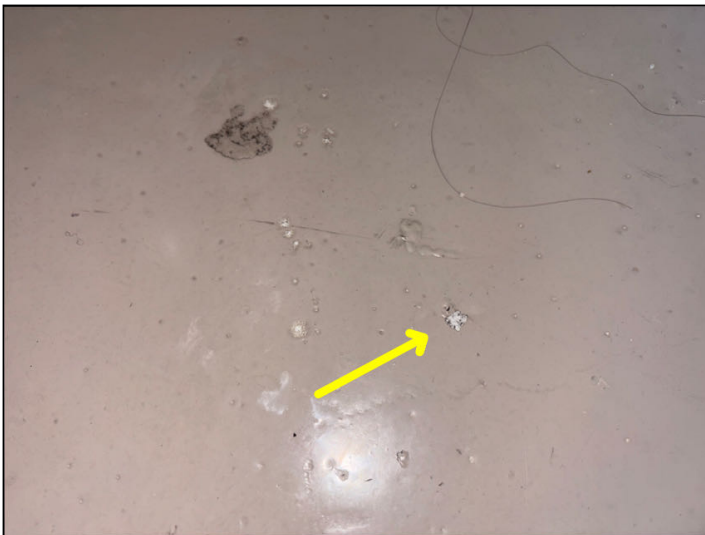
Chipped waterproof coating was noted at the #31 balcony surface.

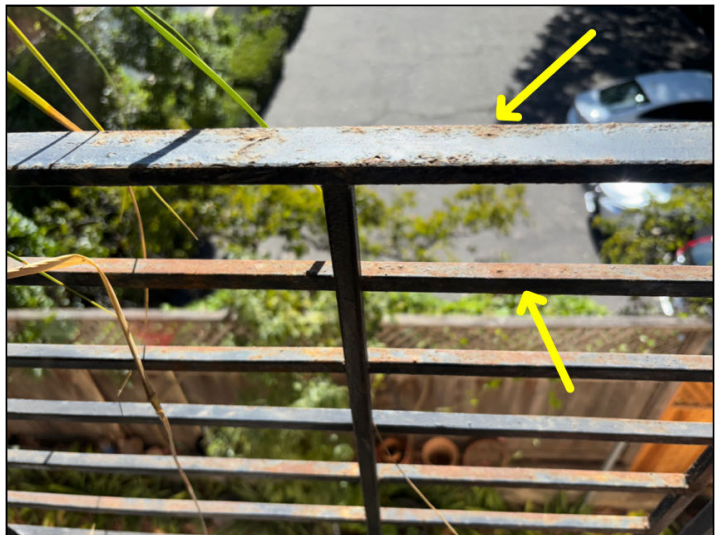
Rust was noted at the balcony guardrails in various places.

Rust was noted at the balcony guardrails in various places. Recommend painting with a rust resistant material to help prevent corrosion.

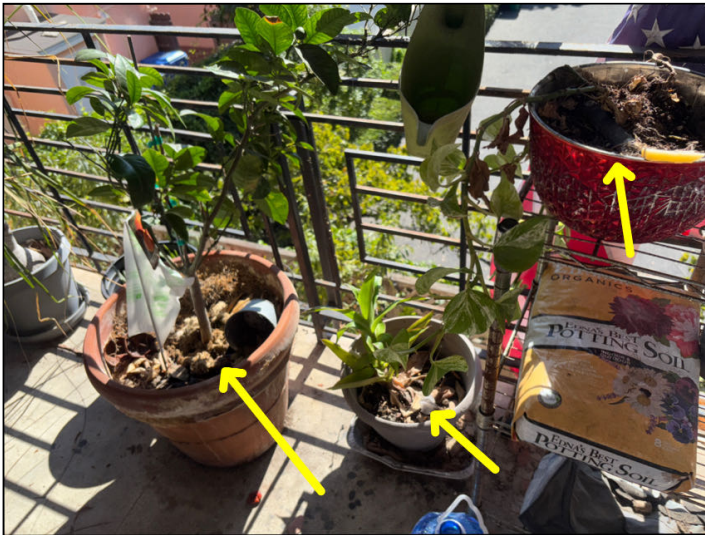
Recommend the watering of potted plants be limited at the balconies to help extend the lifespan of the adjacent balcony materials.

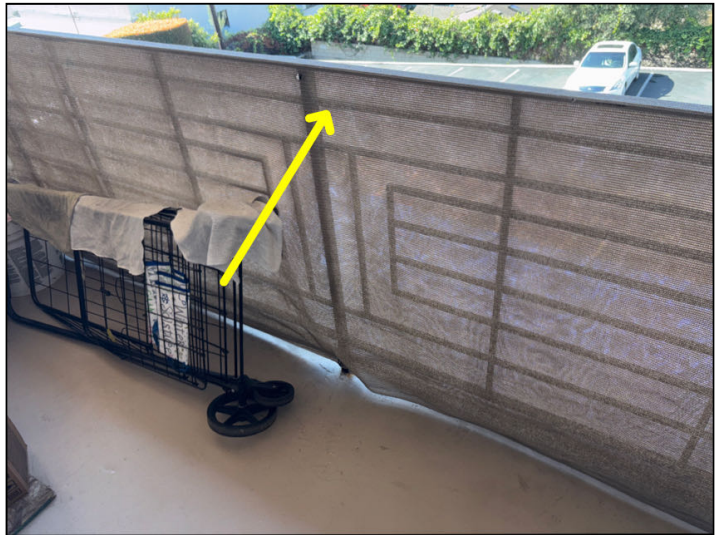
The height of the railings was not to current standards at the balconies, walkways, and exterior stairs.

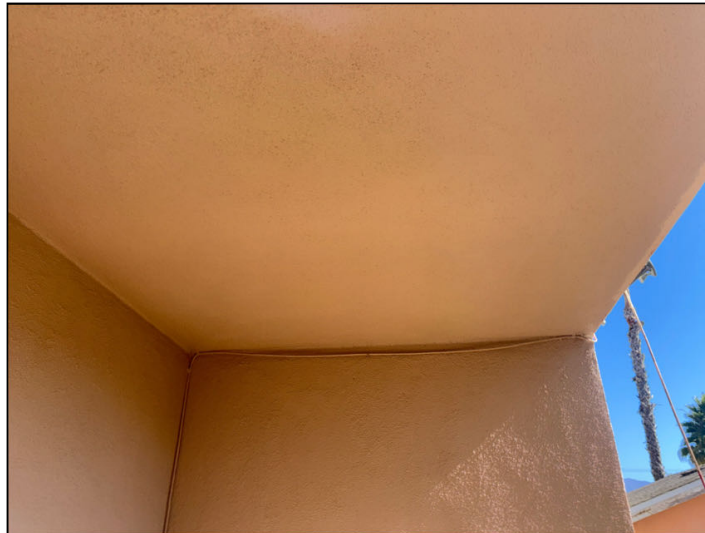
Fresh paint was noted at various balcony soffits including #35.

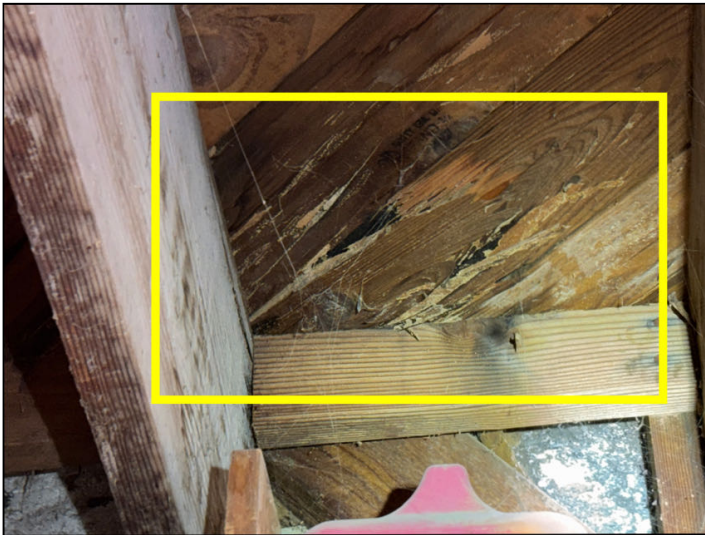
Moisture damage and possible insect damage were noted in many places at the terrace framing.

Moisture damage and possible insect damage were noted in many places at the terrace framing. Recommend the entire property be inspected by a licensed structural pest control operator. Recommend obtaining a written report from this specialist. See wood destroying organism (WDO) report for more information.

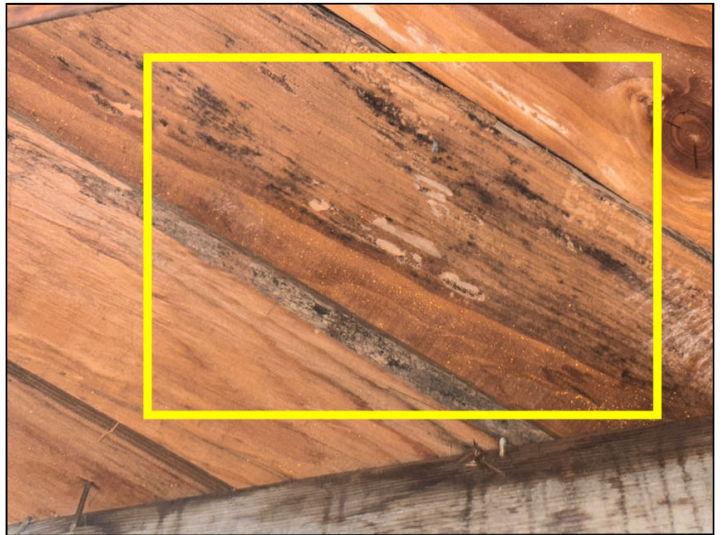
Moisture damage and possible insect damage were noted in many places at the terrace framing.

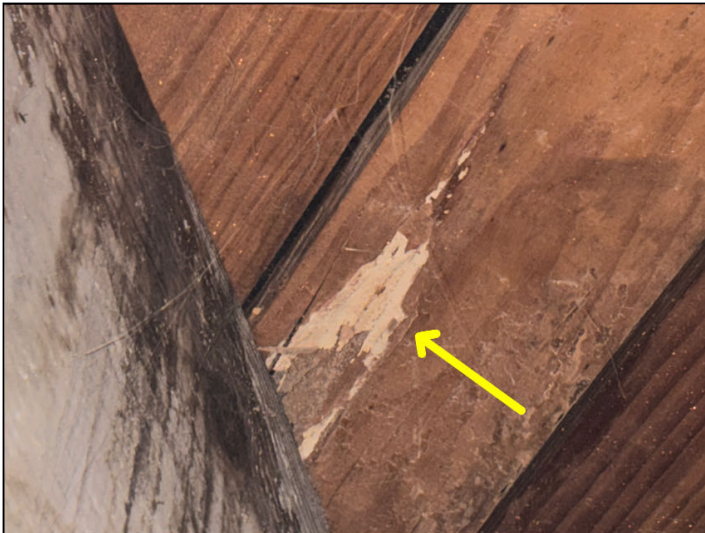
Moisture damage and possible insect damage were noted in many places at the terrace framing.

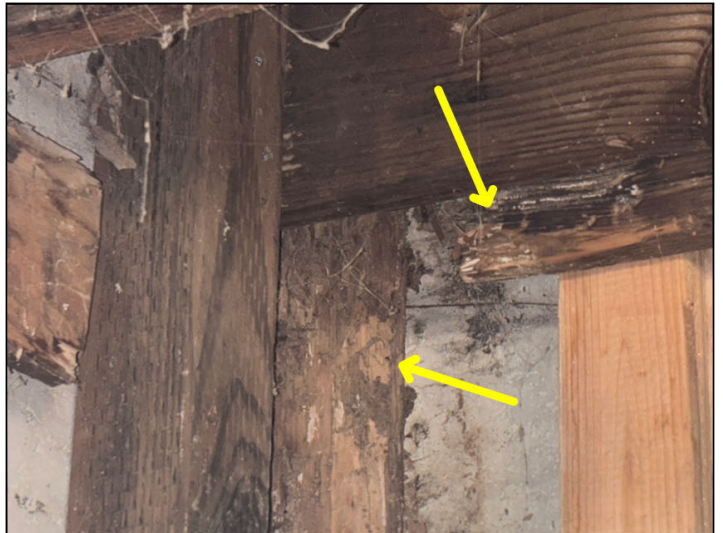
Moisture damage and possible insect damage were noted in many places at the terrace framing.

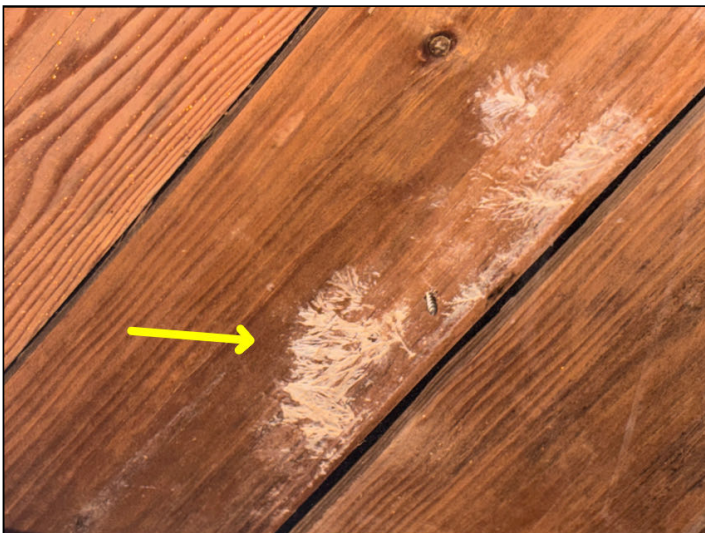
Organic growth was noted at the terrace framing in many places.

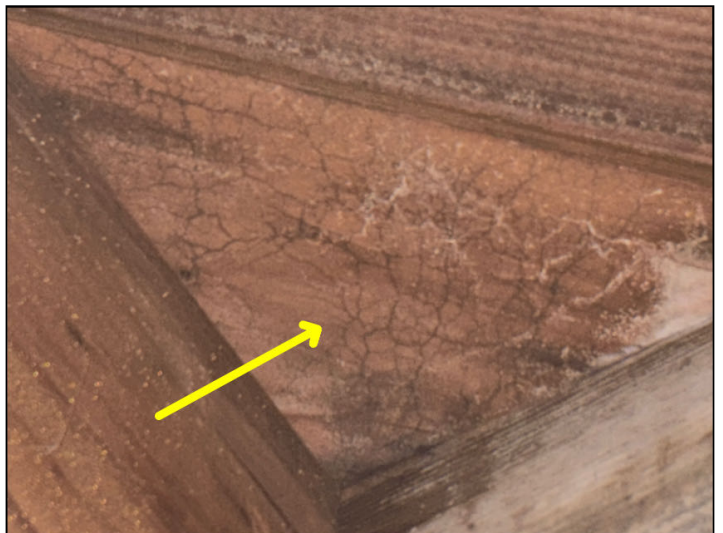
Organic growth was noted at the terrace framing in many places.

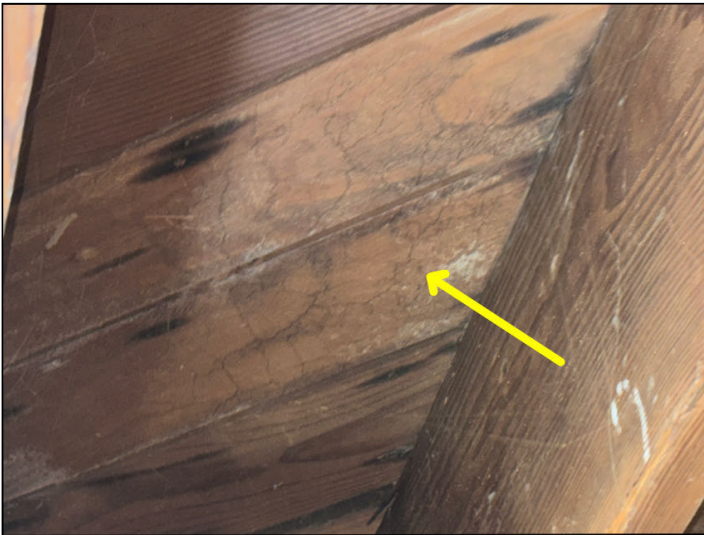
Organic growth was noted at the terrace framing in many places.

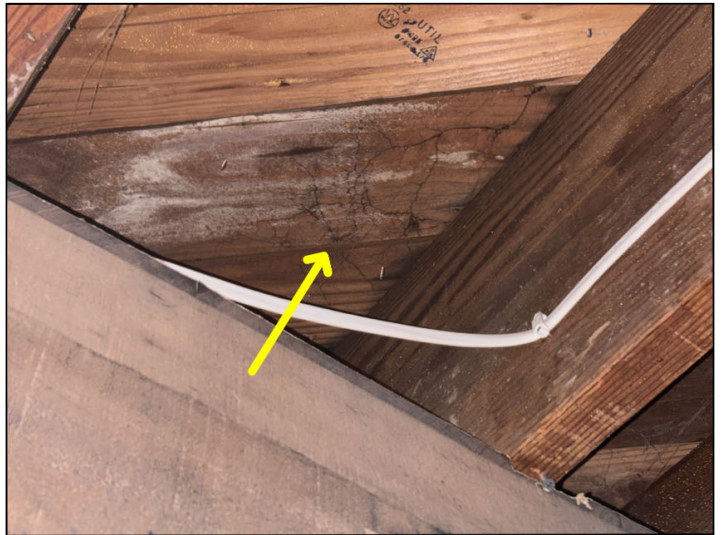
Organic growth was noted at the terrace framing in many places.

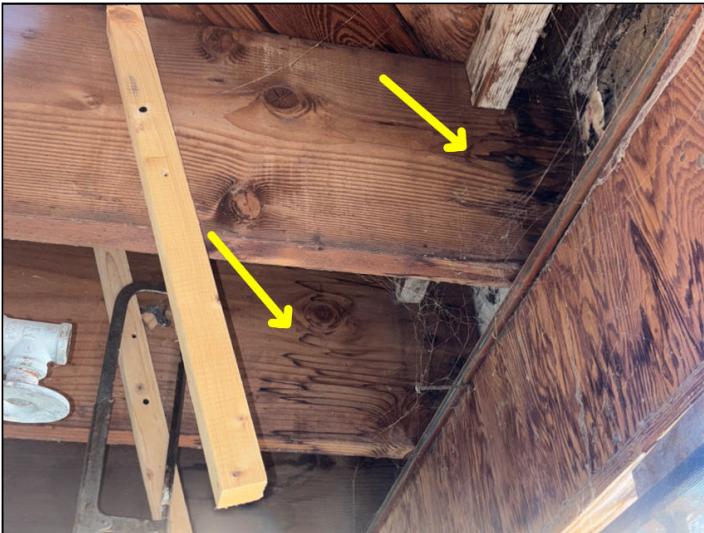
Dry water stains were noted at the terrace framing in many places.

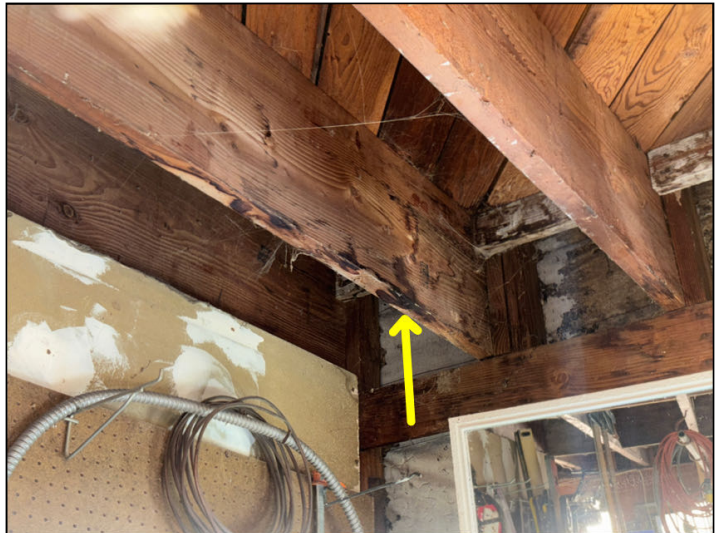
Dry water stains were noted at the terrace framing in many places.

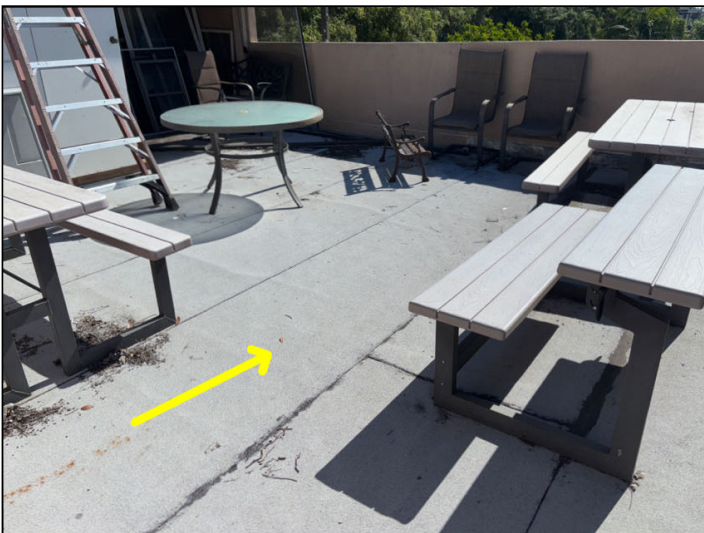
The surface of the terrace is rolled composition roof material.

The surface of the terrace is rolled composition roof material. Recommend the terrace surface be replaced with a material designed for foot traffic.

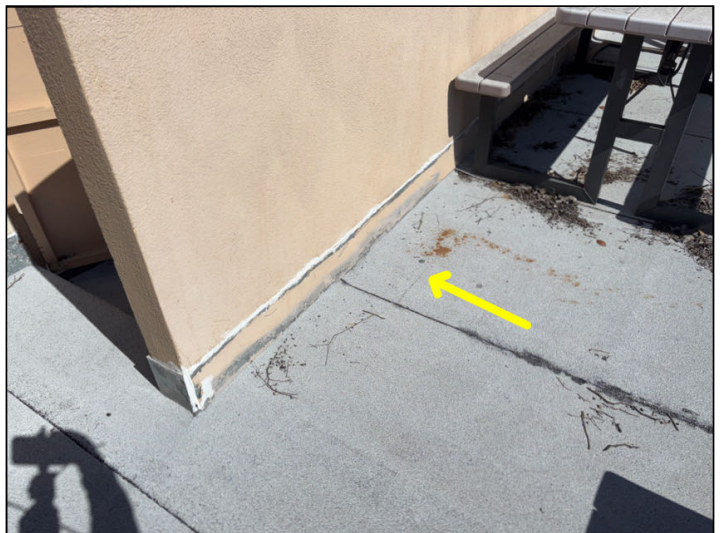
A soft area was noted at the terrace surface adjacent to the stairs.

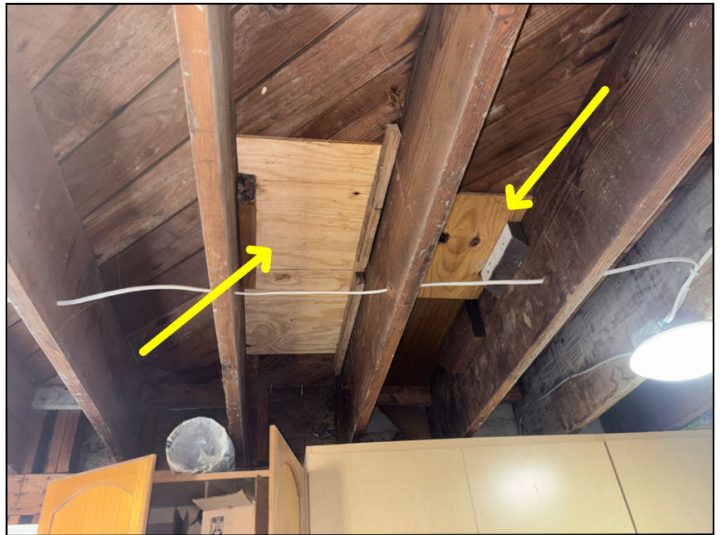
Temporary repairs were noted at the terrace framing.

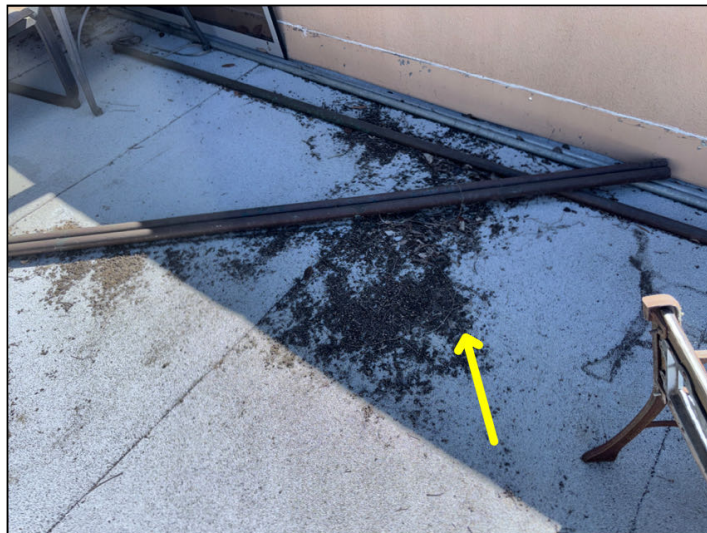
Recommend removing tree debris from the terrace surface.

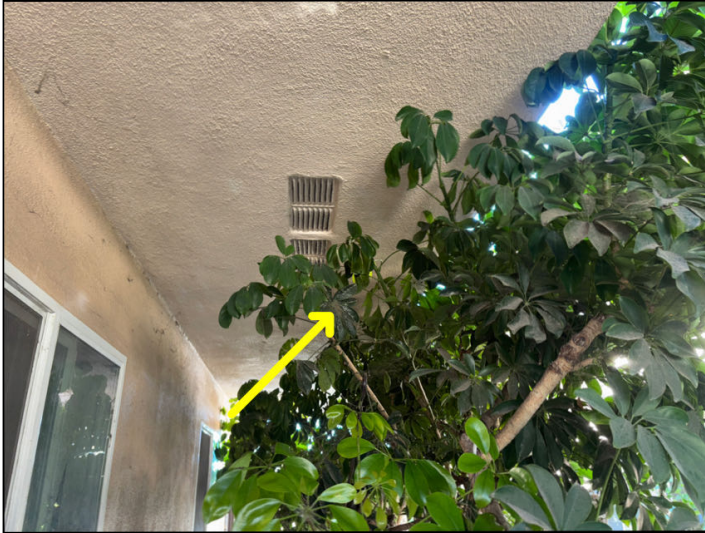
The walkway soffit between #29 and #30 was not fully accessible due to foliage.

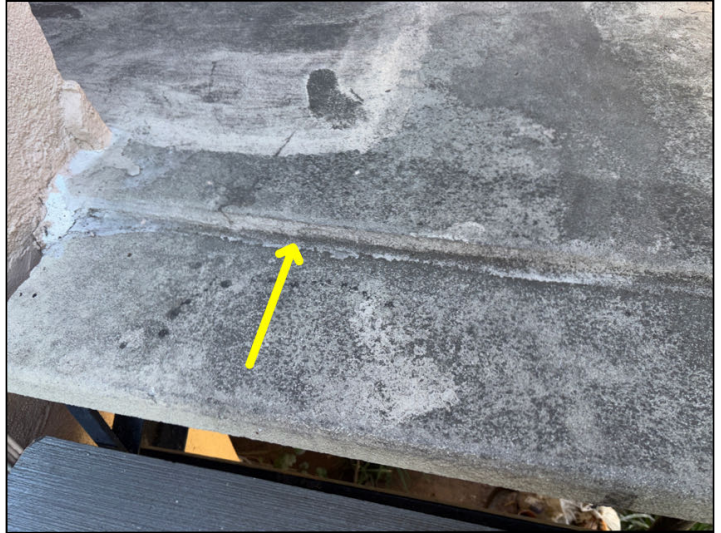
A trip hazard was noted at the edge of the walkway adjacent to the stairs and #29.

A trip hazard was noted at the edge of the walkway adjacent to the stairs and #29. Recommend the visibility at this area be improved. Recommend improvements be made by a qualified professional.

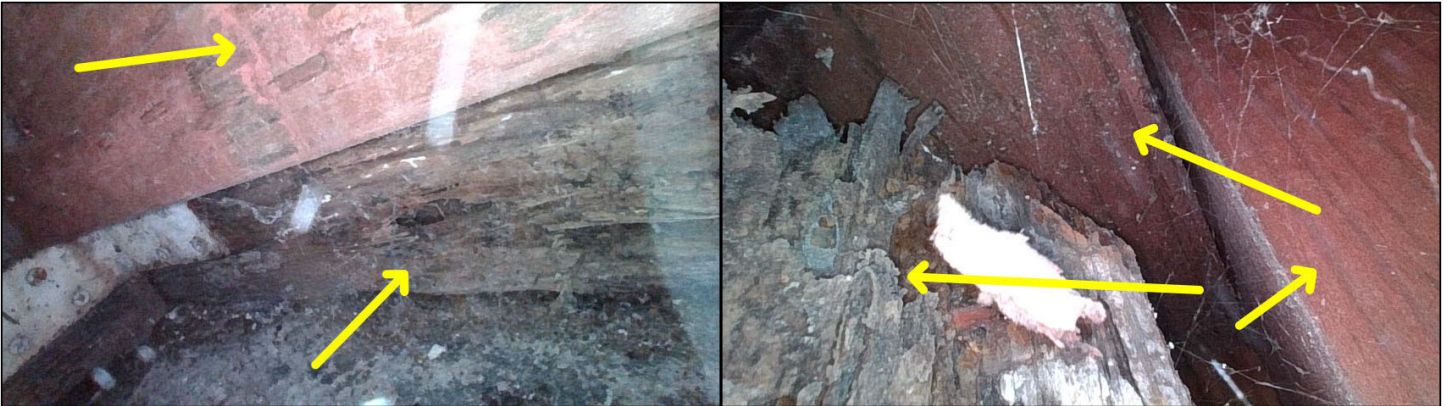
Damaged wood was observed next to newer wood in many places with the borescope camera. Damaged wood was observed next to newer wood in many places with the borescope camera.

Evidence of repairs were noted at the walkway framing in many places adjacent to #29. Damaged wood was observed next to newer wood in many places with the borescope camera. Recommend all damaged wood be replaced and removed from the soffit.

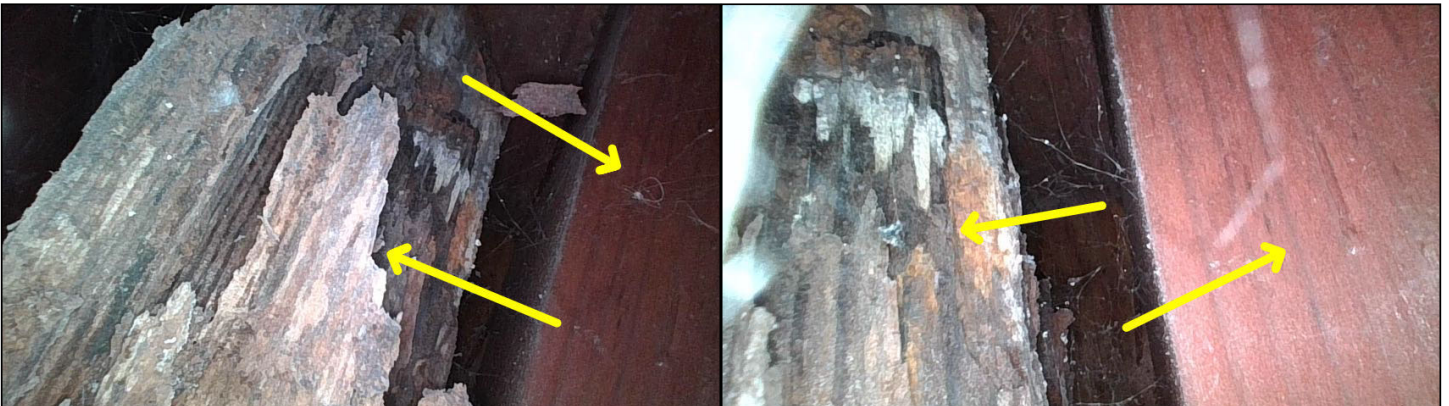
Damaged wood was observed next to newer wood in many places with the borescope camera. Damaged wood was observed next to newer wood in many places with the borescope camera.

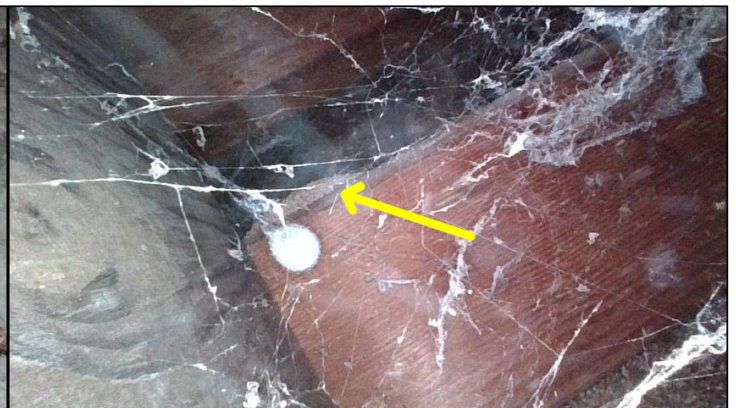
Possible insect droppings were observed in the walkway soffits at many places with the borescope camera.

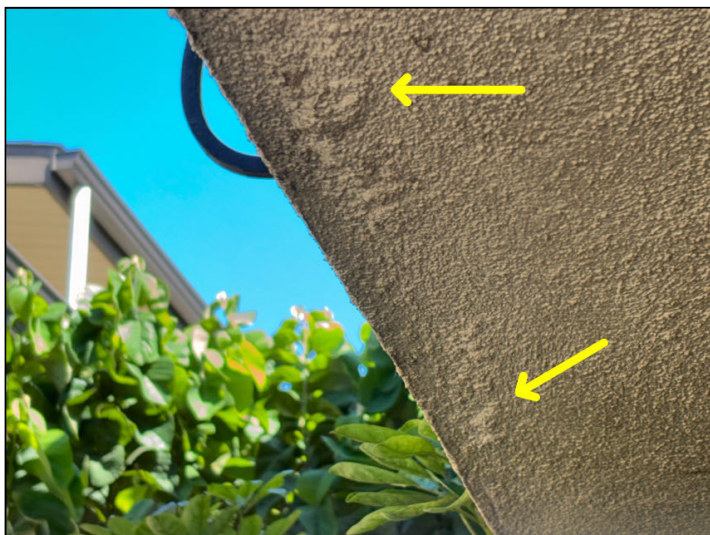
Bubbled paint and efflorescence were noted at the ends of the walkway soffit adjacent to #29 and #30.

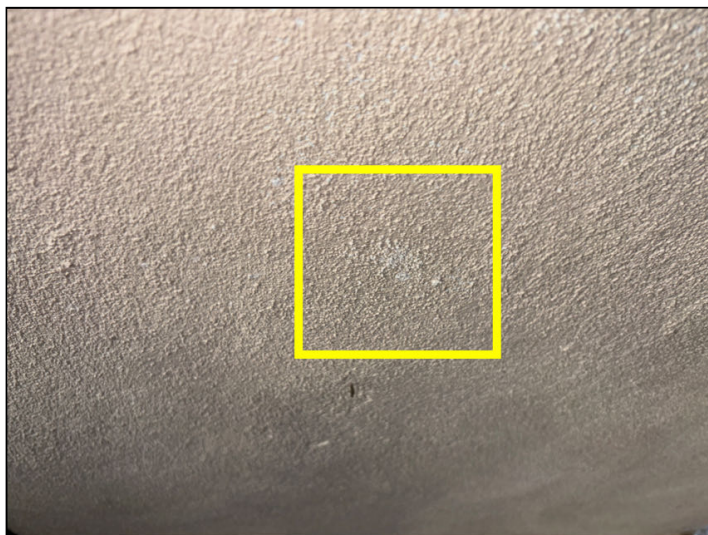
Bubbled paint and efflorescence were noted at the ends of the walkway soffit adjacent to #29 and #30.

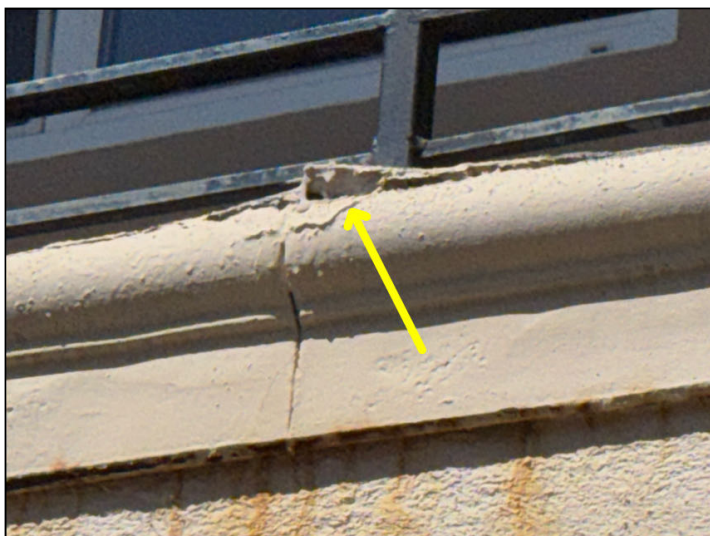
Cracked and uplifted walkway surface material was noted adjacent to #25 and between #29 and #30 at the edge of the walkway.

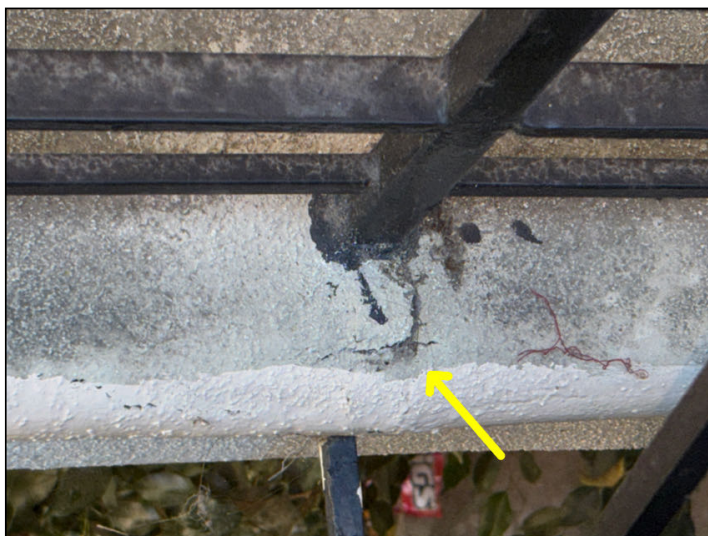
Cracked and uplifted walkway surface material was noted adjacent to #25 and between #29 and #30 at the edge of the walkway.

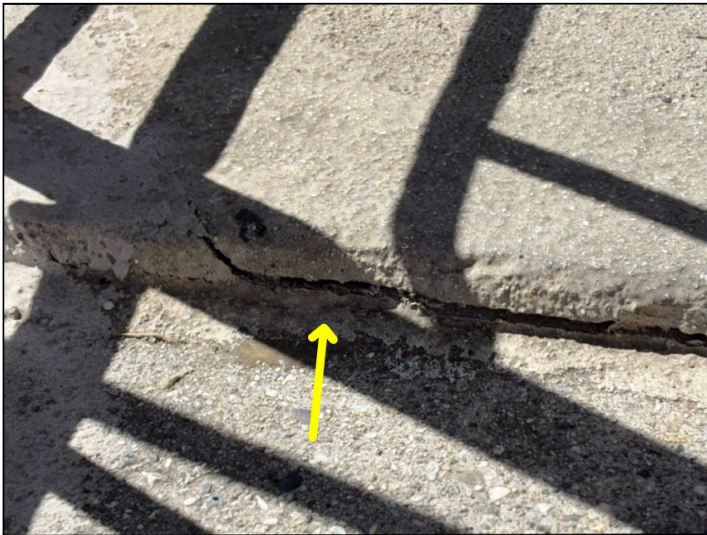
A crack with uplifted material was noted at the walkway adjacent to the #25 stairs.

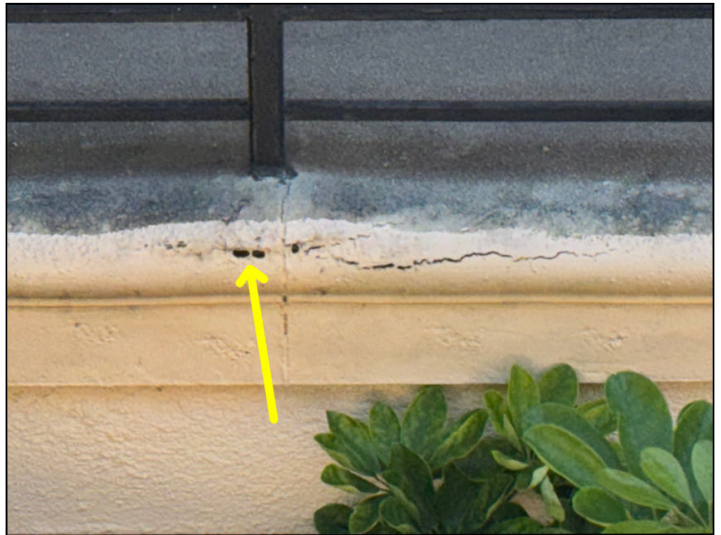
Open cracks were noted at the edge of the walkway between #29 and #30 and adjacent to #25.

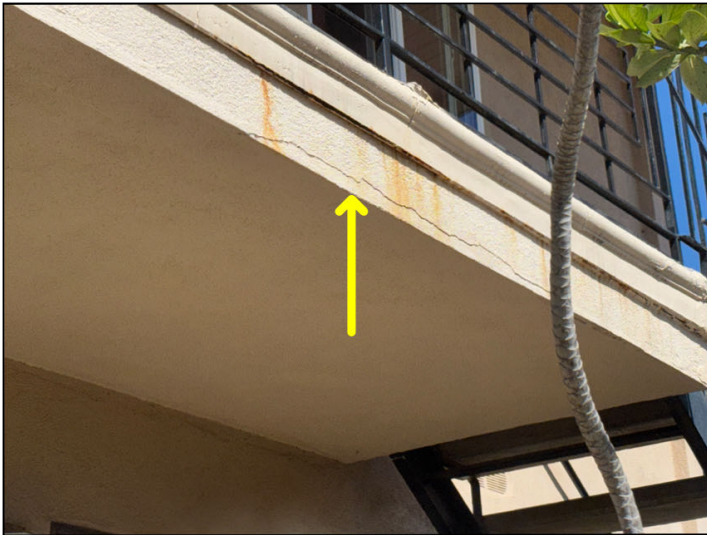
Open cracks were noted at the edge of the walkway between #29 and #30 and adjacent to #25.

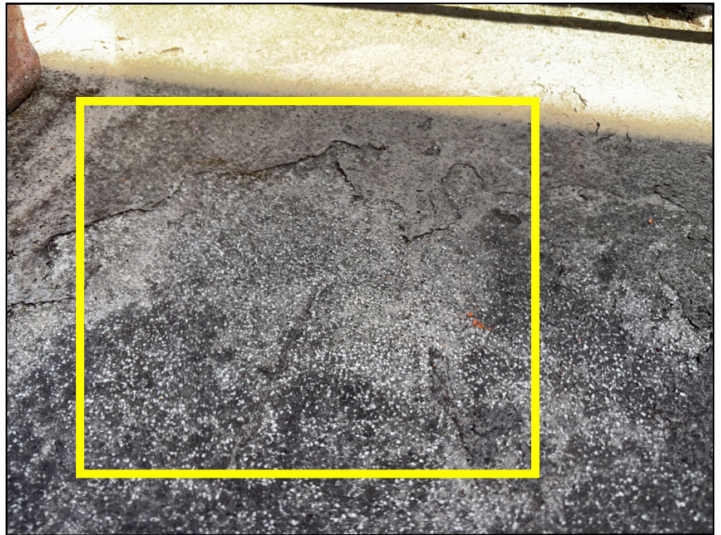
Deteriorated waterproof coating was noted at the walkway surface adjacent to the stairs and #29 in many places.

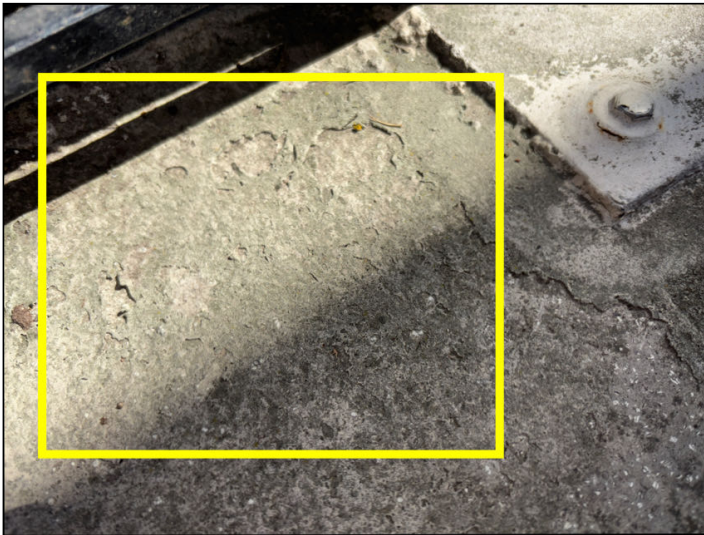
Deteriorated waterproof coating was noted at the walkway surface adjacent to the stairs and #29 in many places.

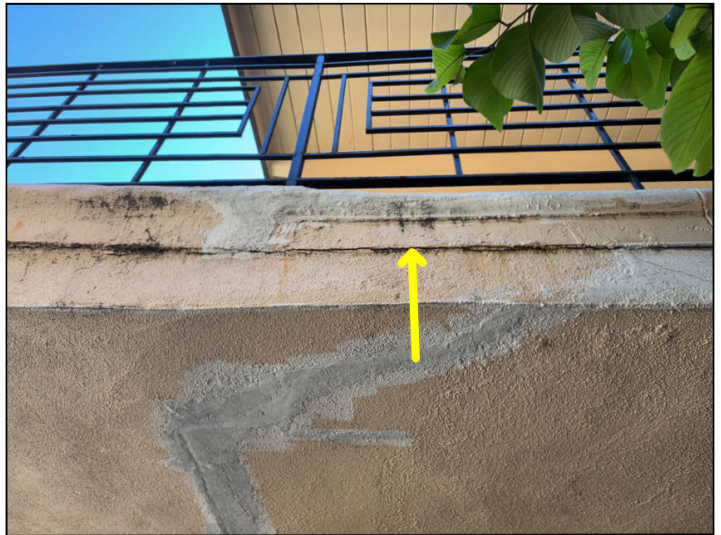
Gaps were noted at the edge of the walkway adjacent to #25 and #29.

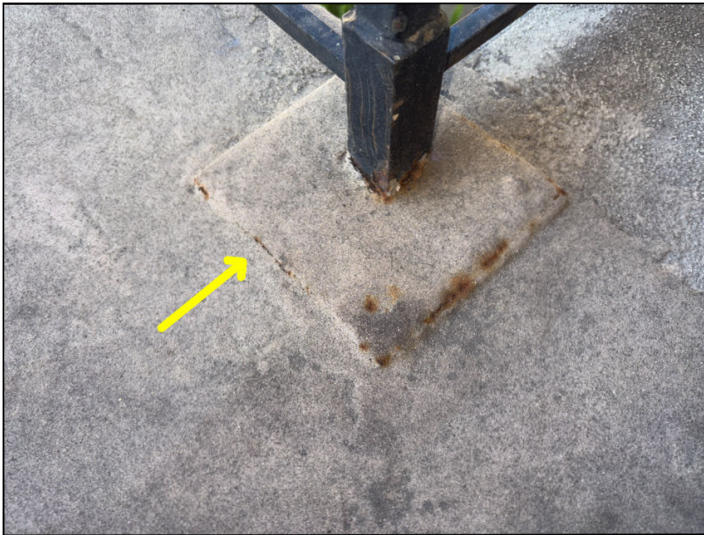
Cracked waterproof coating and rust stains were noted at the walkway surface adjacent to a guardrail post and #30.

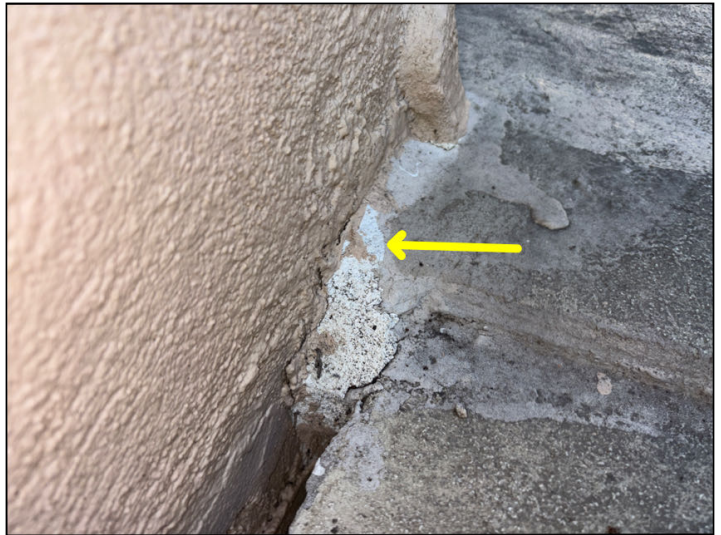
Cracks were noted between the walkway and the exterior wall adjacent to the stairs and #29.

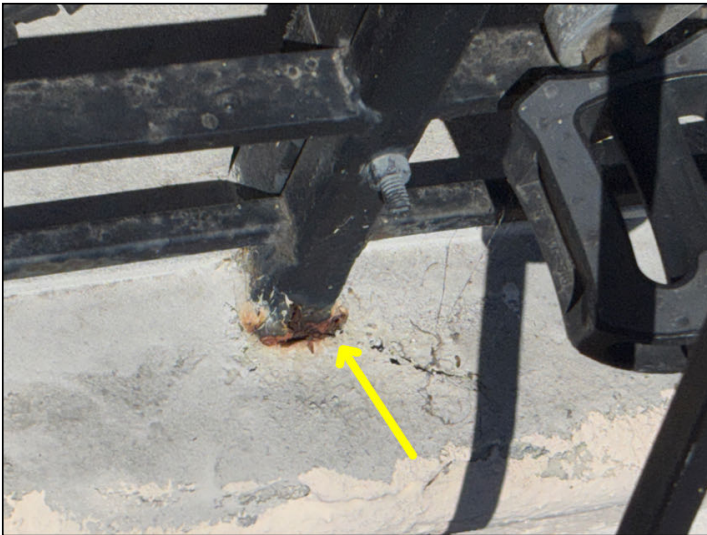
Corrosion was noted at a walkway guardrail post adjacent to #25.

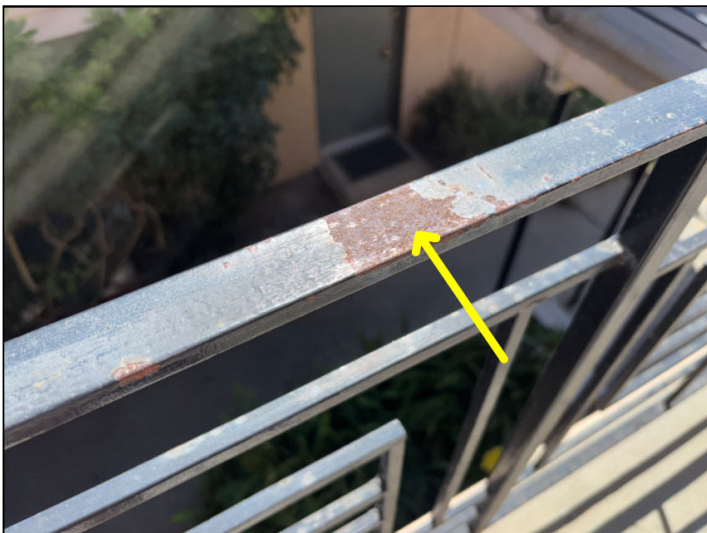
Rust was noted at the walkway guardrails in various places.

Rust was noted at the walkway guardrails in various places. Recommend painting with a rust resistant material to help prevent corrosion.

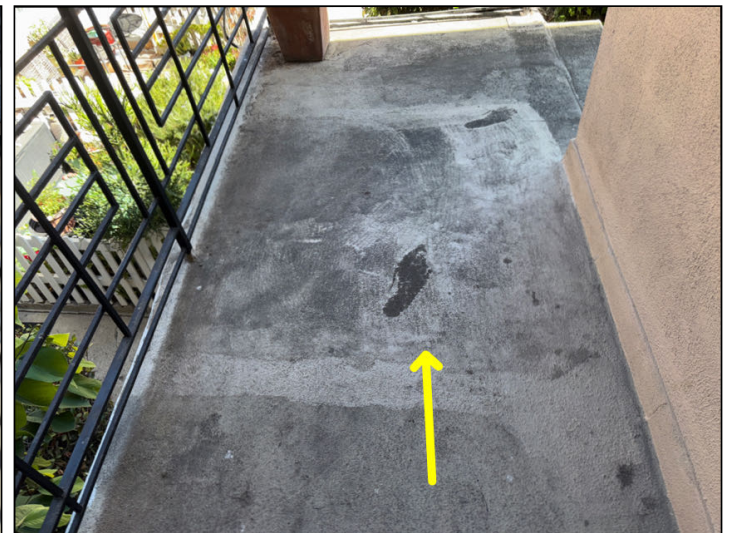
Patching was noted at the walkway surface in many places.

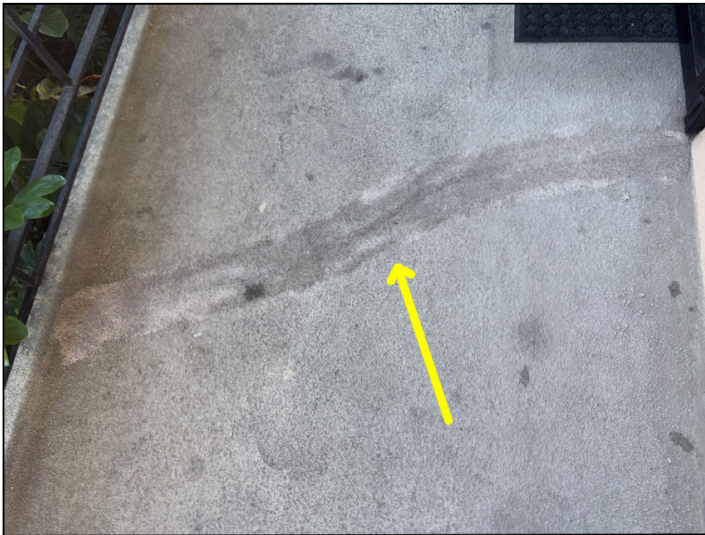
Patching was noted at the walkway surface in many places.

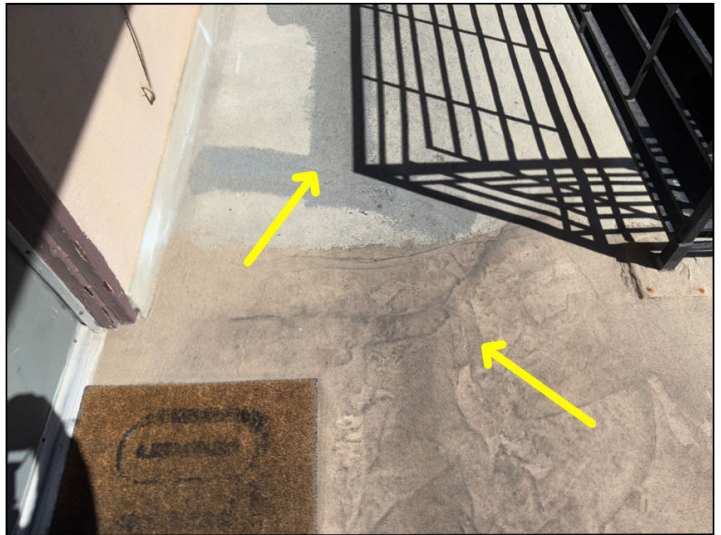
Patching was noted at the walkway surface in many places.

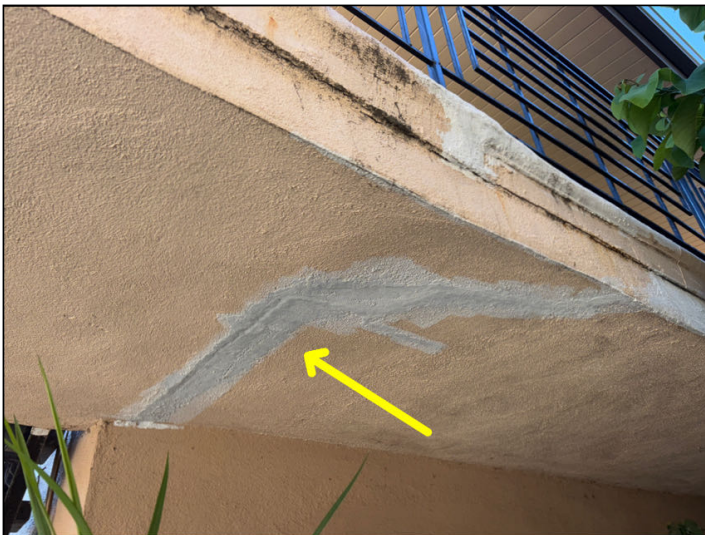
Patching was noted at the walkway soffit adjacent to #29.

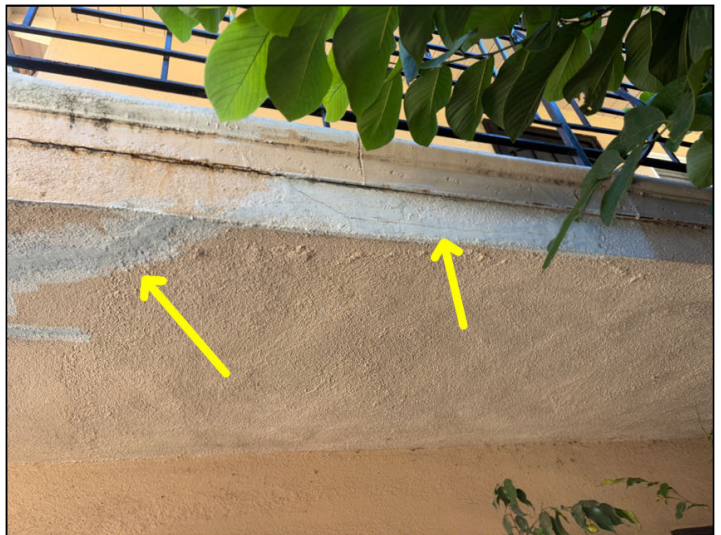
Patching was noted at the walkway soffit adjacent to #29.

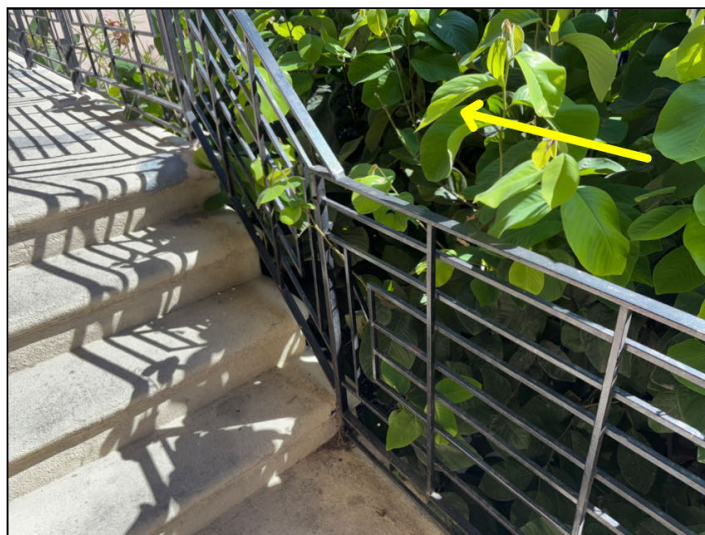
Recommend trimming foliage away from the walkways
