SB-721 INSPECTION REPORT

1025 Olive Street
Santa Barbara, CA

10/2/2025

Inspected by Tio Turrini-Smith and Jay O'Brien

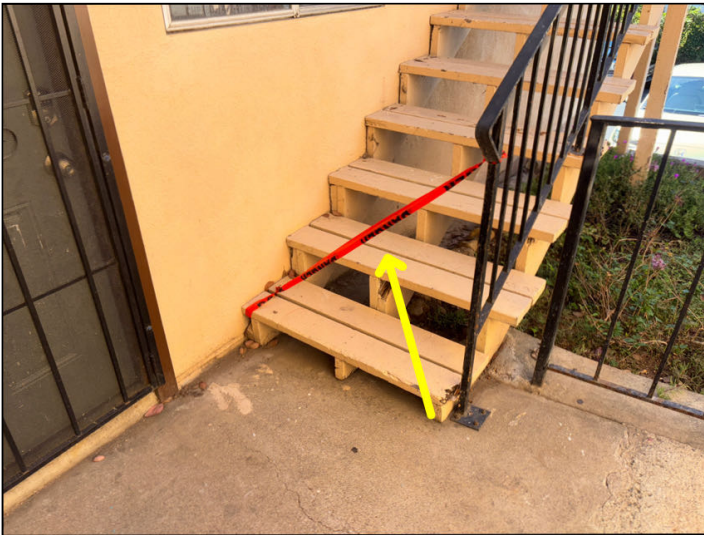
The terrace stairs have been blocked off with red caution tape.

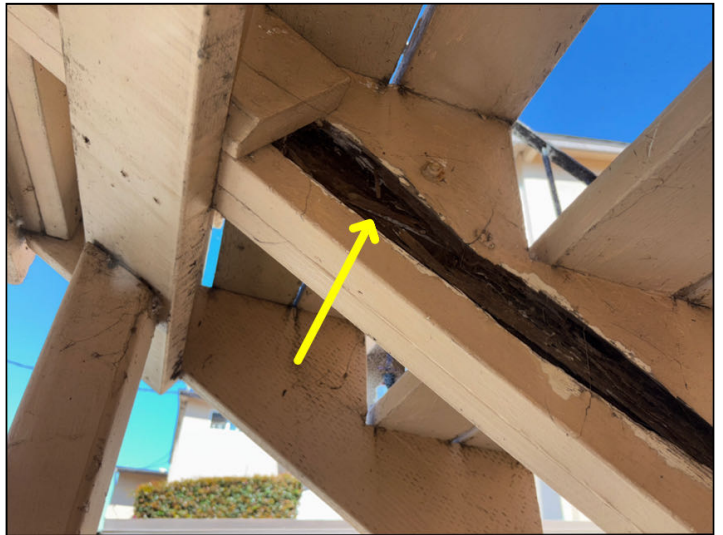
Extensive moisture damage and possible insect damage were noted at the terrace stairs.

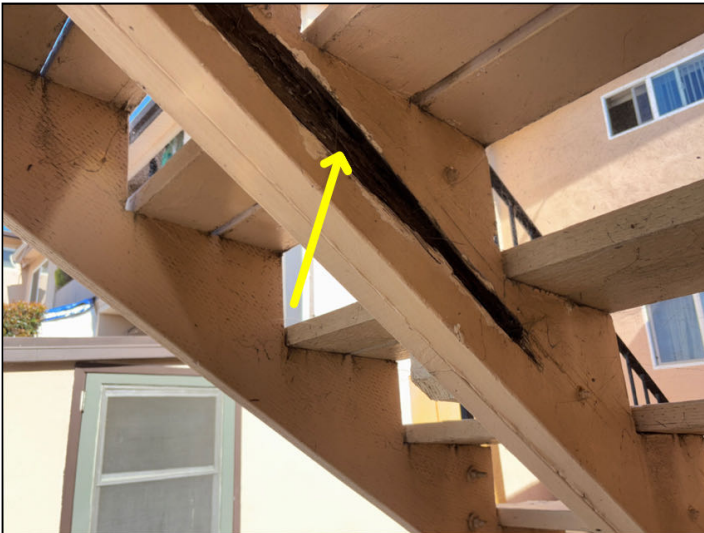
Extensive moisture damage and possible insect damage were noted at the terrace stairs.

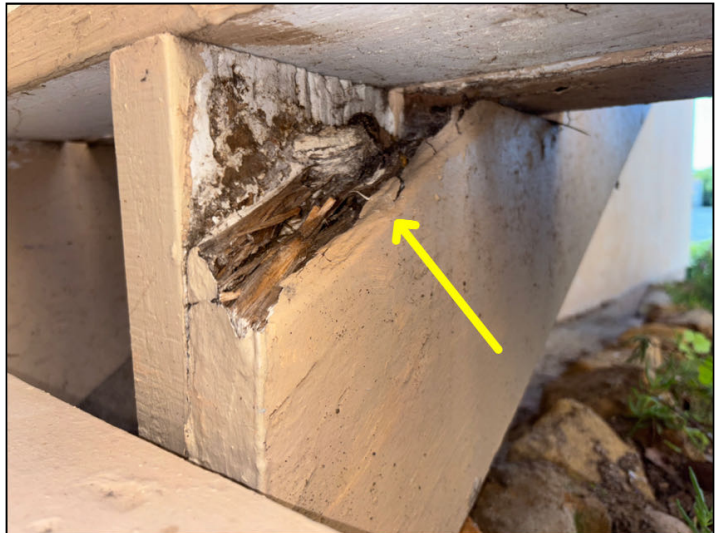
Extensive moisture damage and possible insect damage were noted at the terrace stairs.

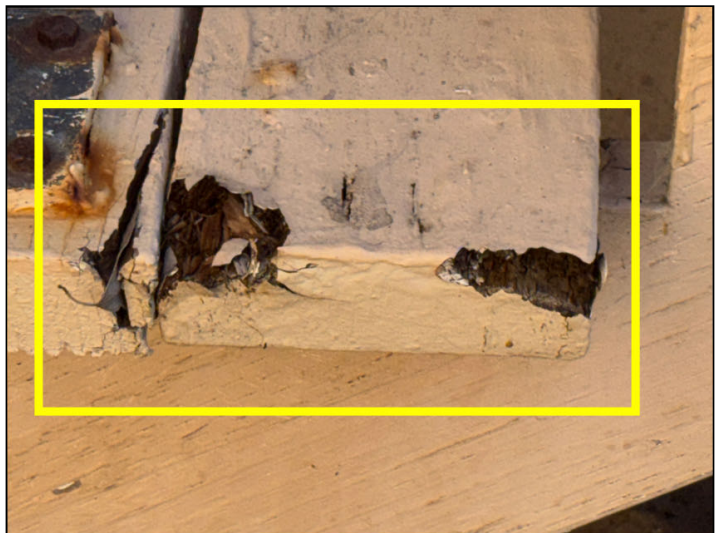
Extensive moisture damage and possible insect damage were noted at the terrace stairs.

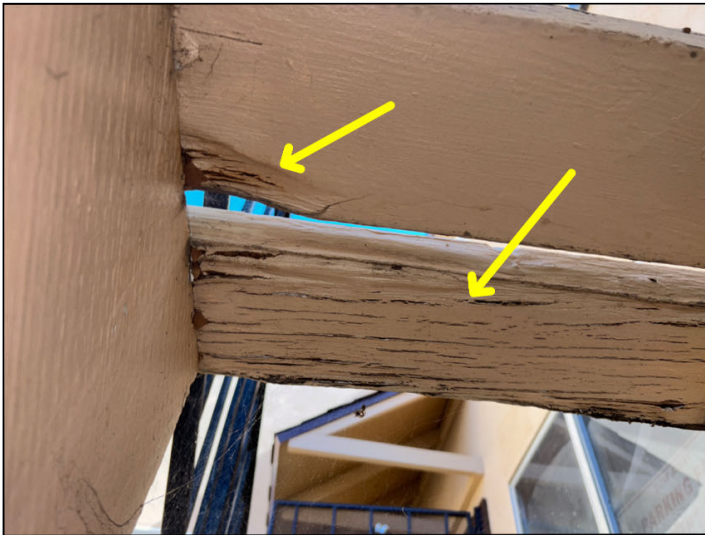
Extensive moisture damage and possible insect damage were noted at the terrace stairs.

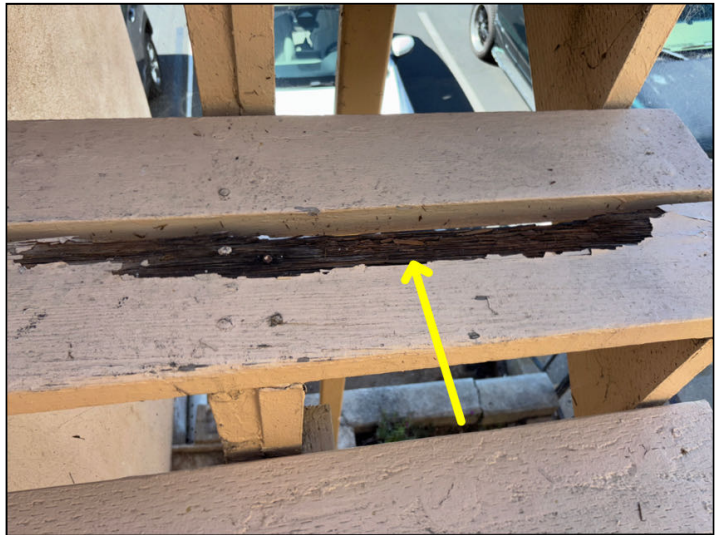
Extensive moisture damage and possible insect damage were noted at the terrace stairs.

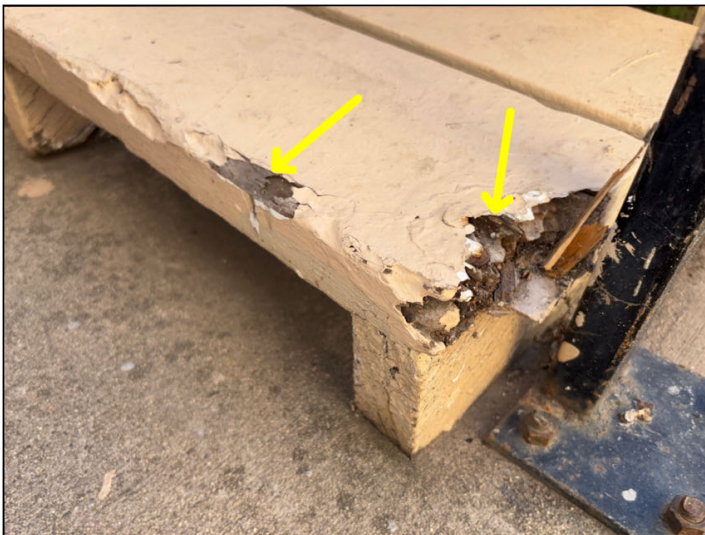
Extensive moisture damage and possible insect damage were noted at the terrace stairs.

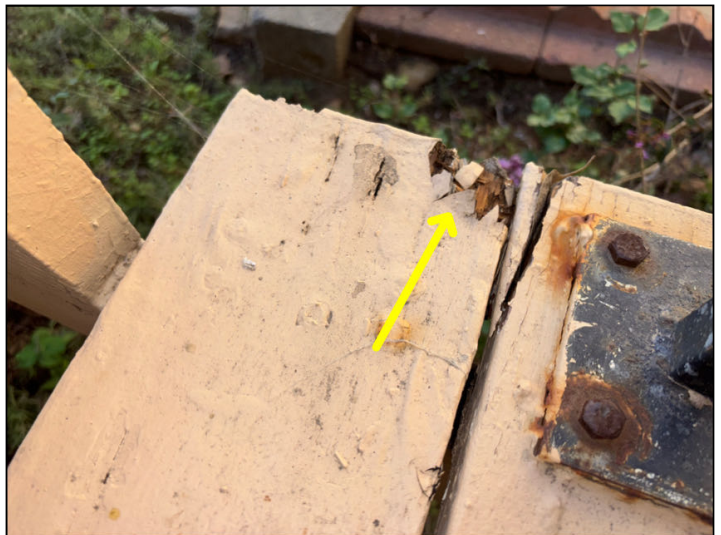
Extensive moisture damage and possible insect damage were noted at the terrace stairs.

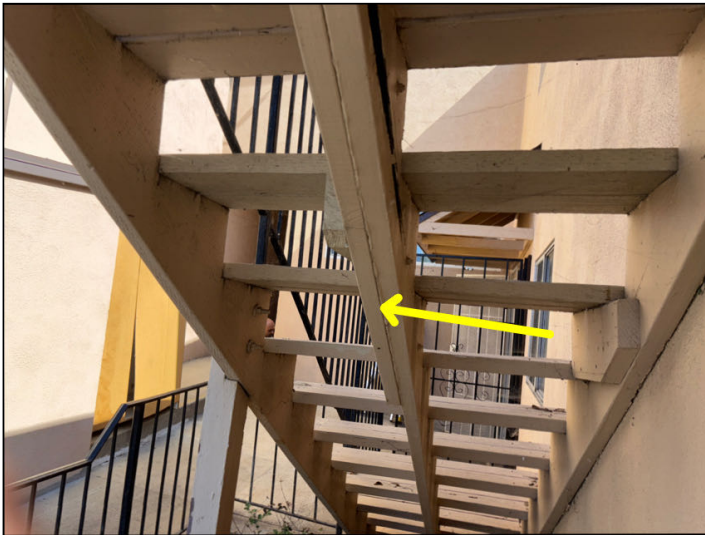
Temporary repairs were noted at the terrace stairs.

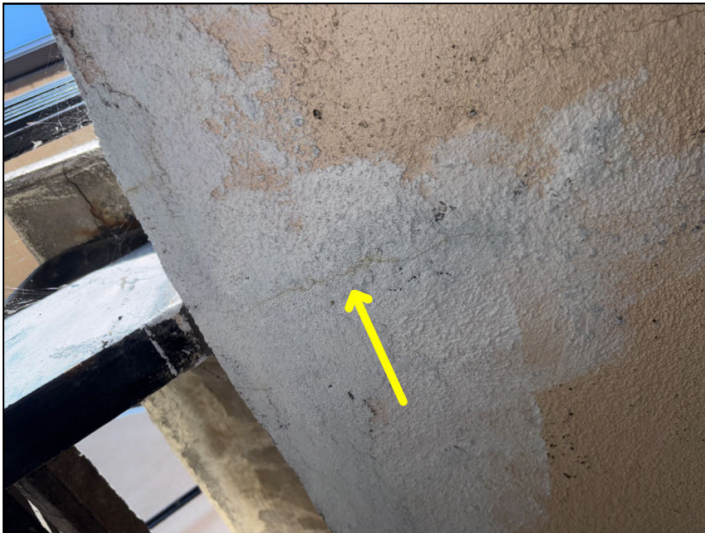
Cracks and slight water stains were noted at the stair landing soffit adjacent to #28.

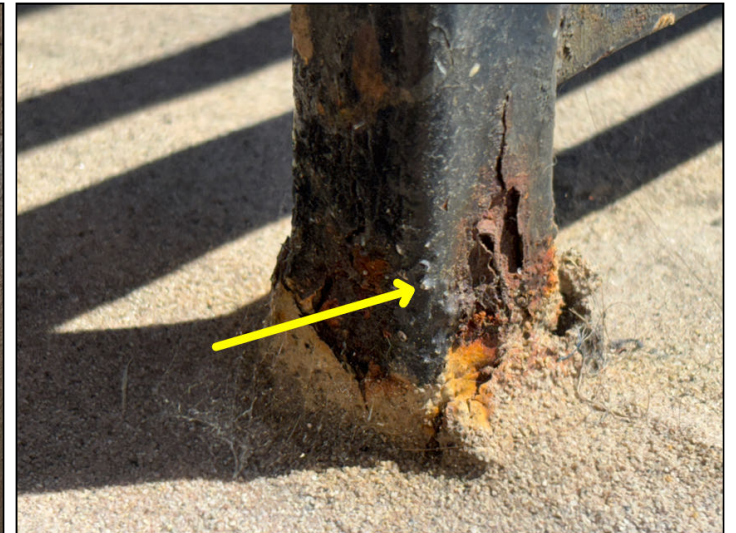
Corrosion was noted at the stair railing post adjacent to #28.

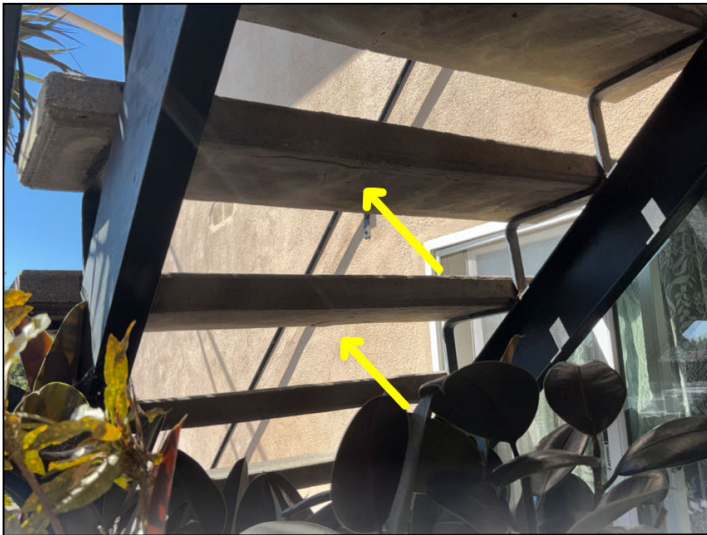
Cracked concrete was noted at the #28 stair treads in various places.

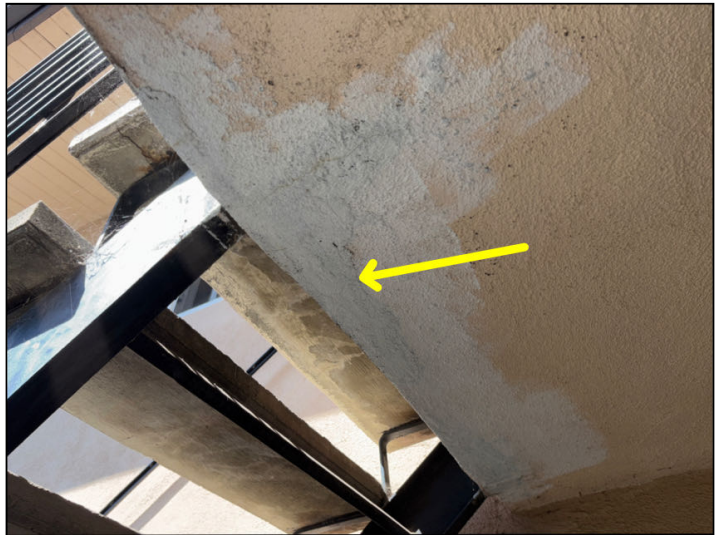
Patching was noted at the stair landing soffit adjacent to #28.

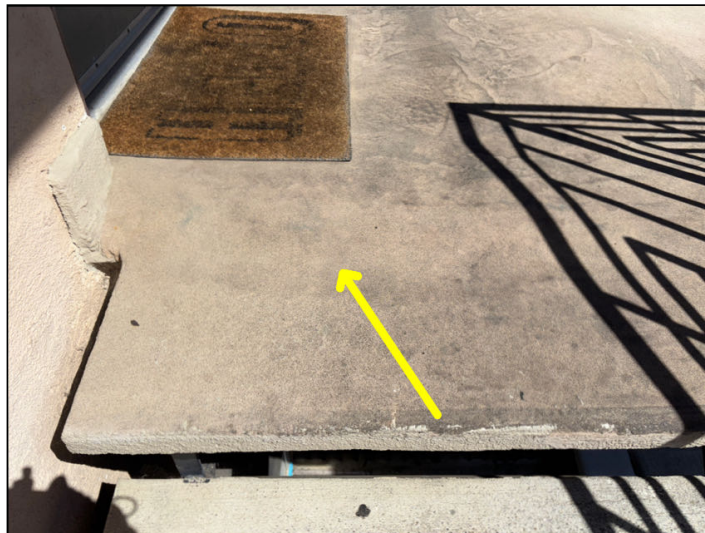
The walkway surface is uneven at the upper stair landing adjacent to #28.
