O'BRIEN
BUILDING INSPECTIONS INC.

SB-721 INSPECTION REPORT

43726 Sunset Avenue

9/15/2025

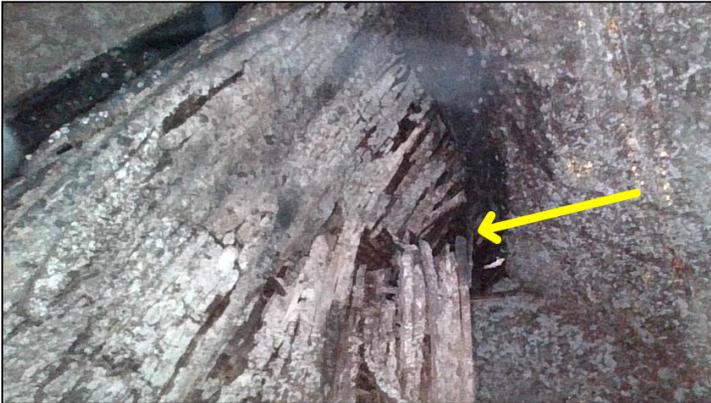
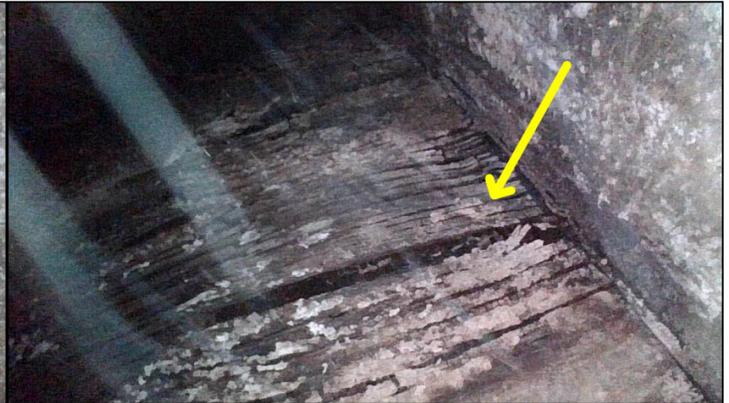
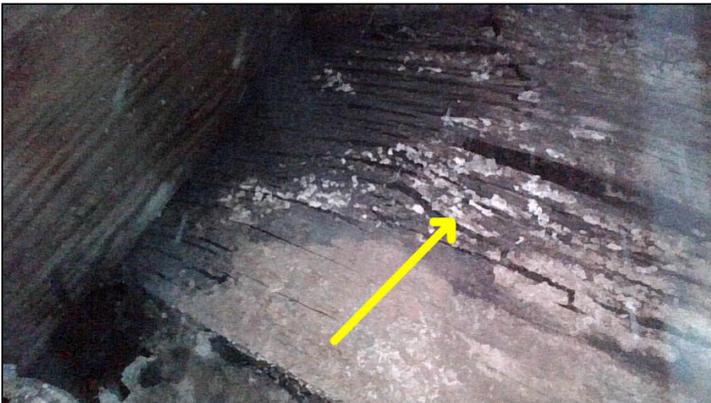
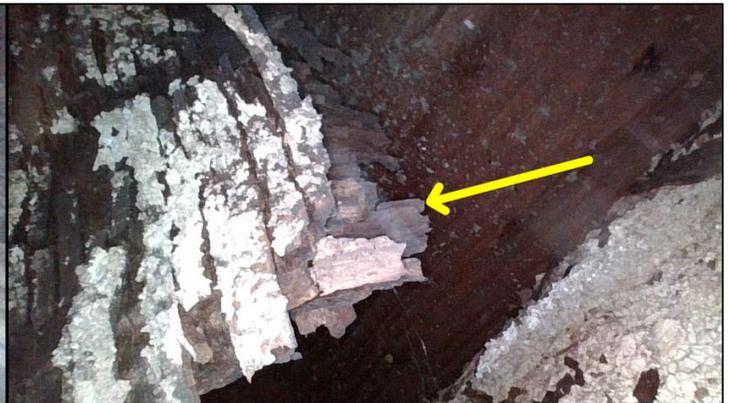
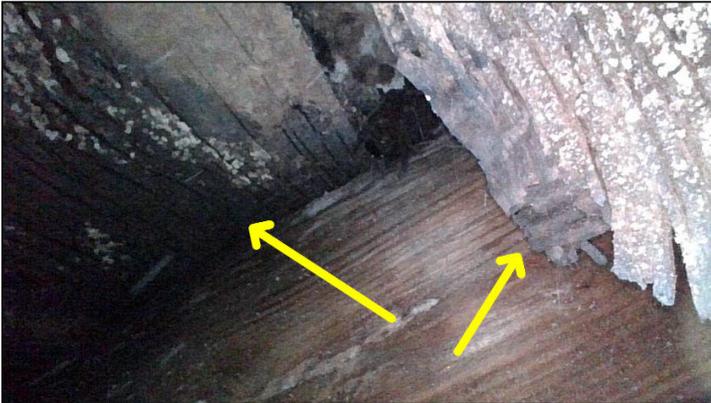
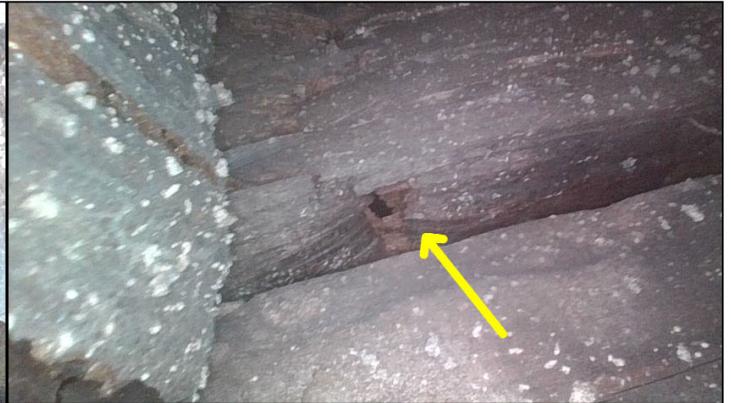
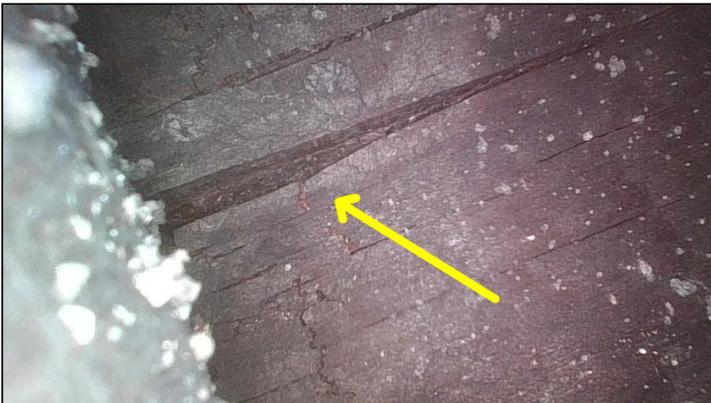
Moisture damage and possible insect damage were observed at the #203 and #303 balcony framing with the borescope camera. Recommend the entire property be inspected by a structural pest control operator. Recommend obtaining a written report from this specialist. See wood destroying organism (WDO) report for more information.

Moisture damage and possible insect damage were observed at the #303 balcony framing with the borescope camera.

Recommend all of the balconies be inspected with a borescope camera. Recommend all of the balconies be evaluated and improved as needed by a qualified licensed contractor to help prevent moisture damage. Lack of proper repairs and maintenance can cause health and safety concerns to occur in the future.

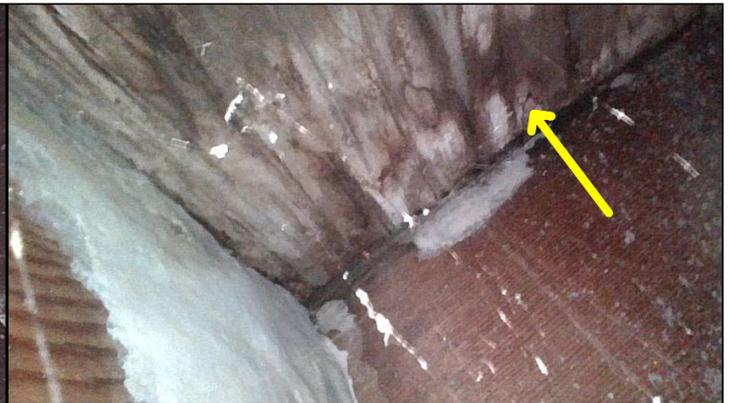
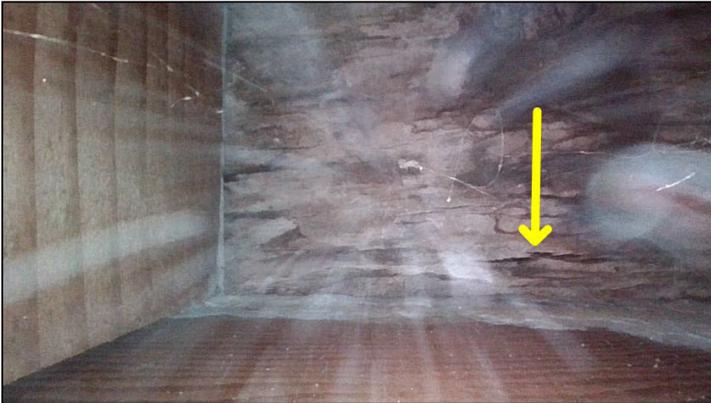
Moisture damage and possible insect damage were observed at the #203 balcony framing with the borescope camera.

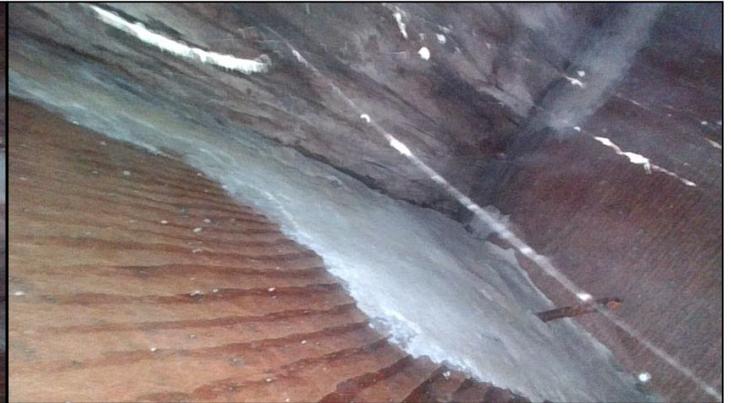
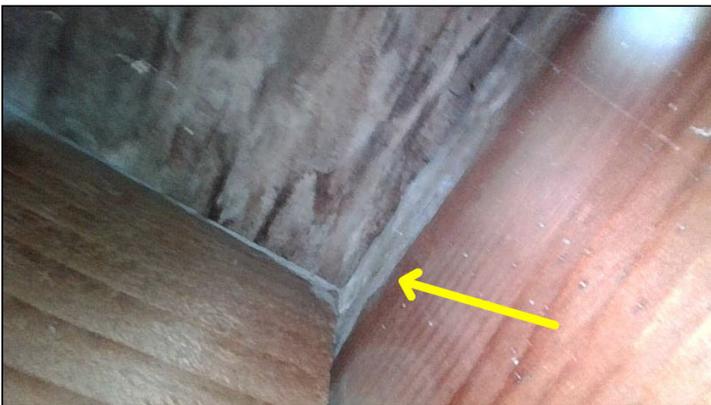
Organic growth was observed at the #203 balcony framing with the baroscope camera. See WDO report for more information.

Organic growth was observed at the #203 balcony framing with the baroscope camera.

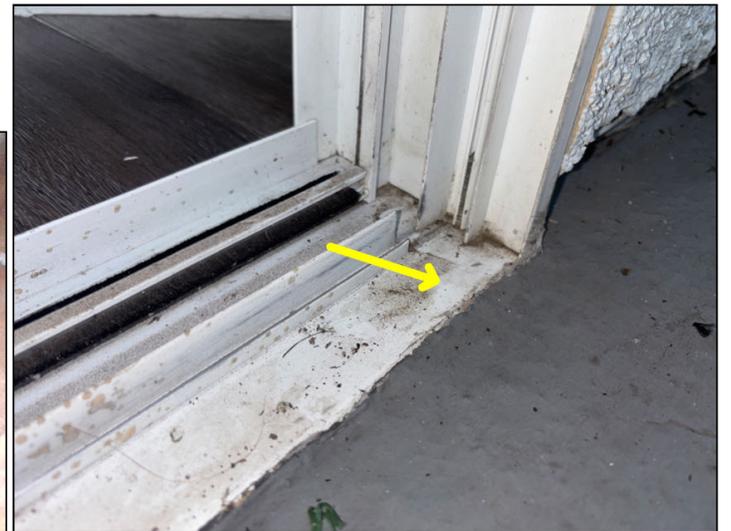
The #203 slider door threshold slopes at the corner of the door. This area of the threshold is lower than the surface of the balcony. This area is susceptible to water intrusion. Recommend improvements be made by a qualified licensed contractor when the balcony is eventually reconstructed. This condition is present at the #207 terrace slider door as well.

The #203 slider door threshold slopes at the corner of the door.

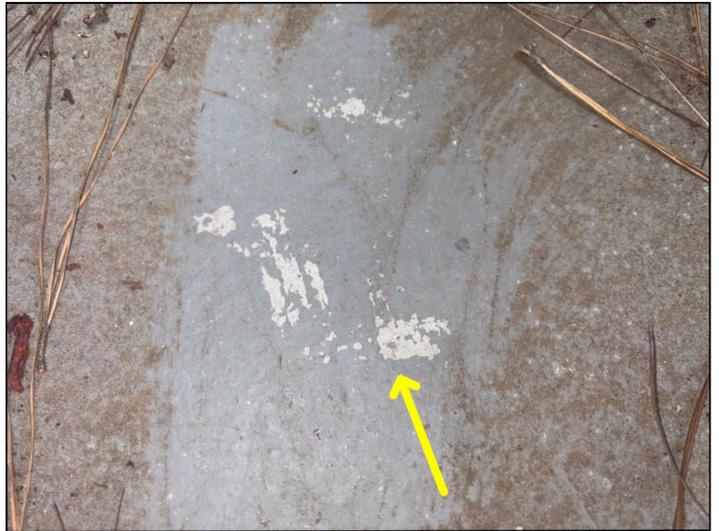
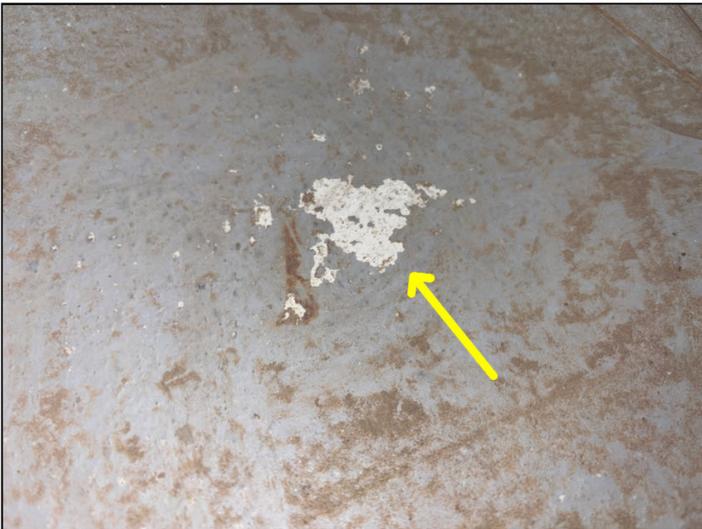
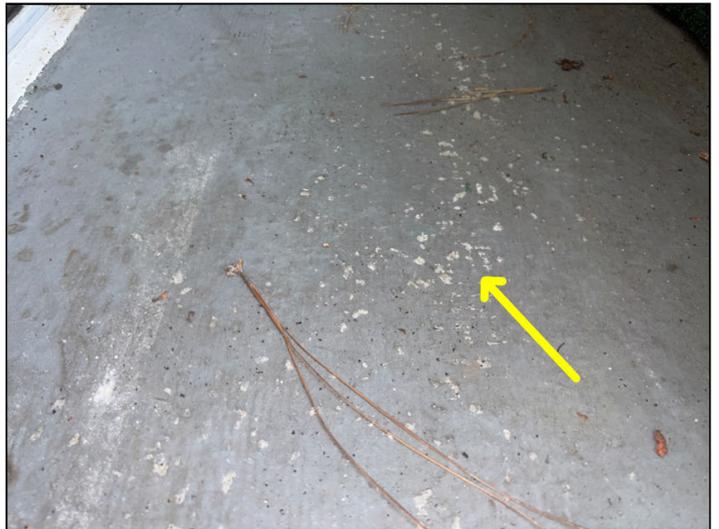
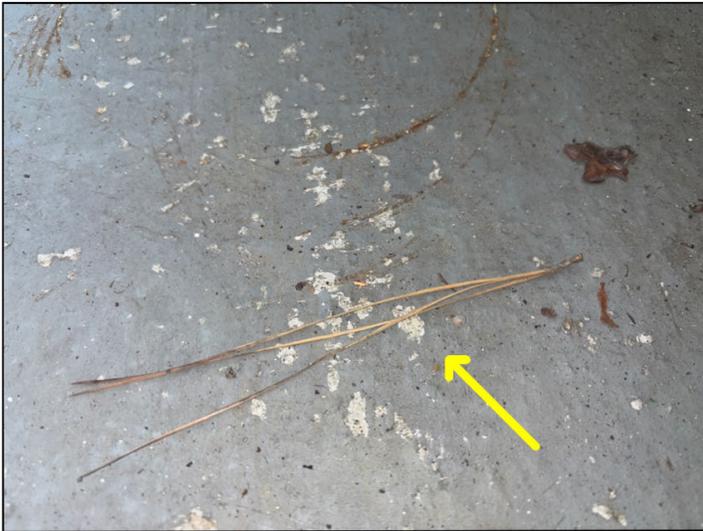
Worn waterproof coating was noted at the #203 and the #303 balcony surfaces.

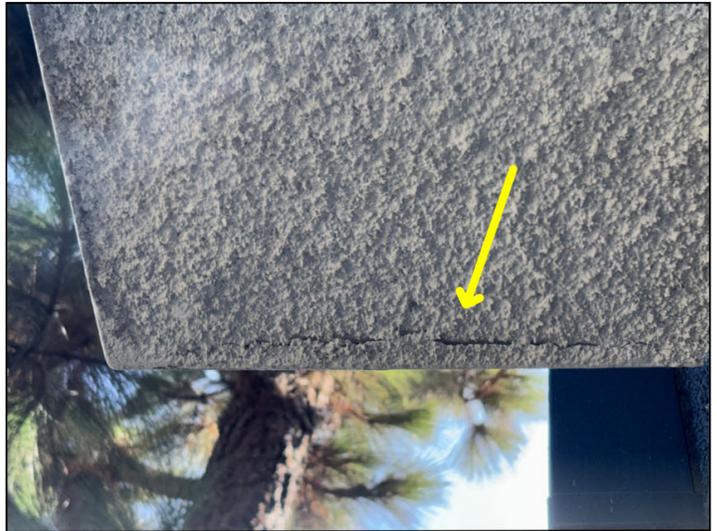
Cracked stucco was noted at the edge of #303 balcony soffit.

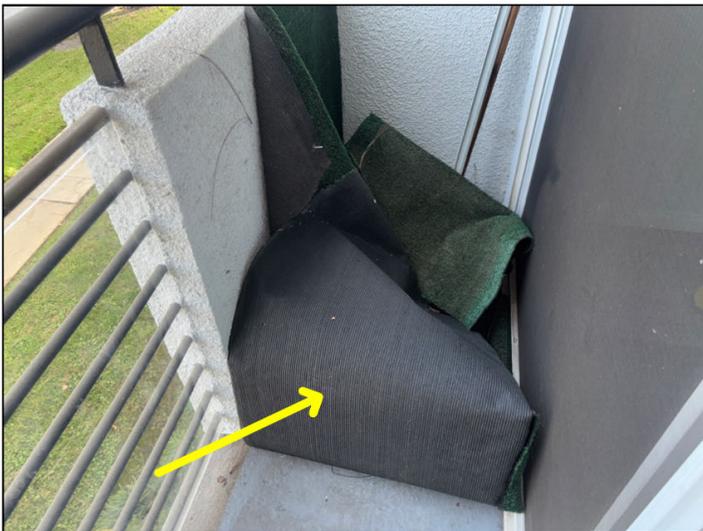
Artificial turf was noted at the #203 balcony. Artificial turf can trap water against the balcony surface resulting in moisture damage. Removal is recommended.

Artificial turf was noted at the #203 balcony.

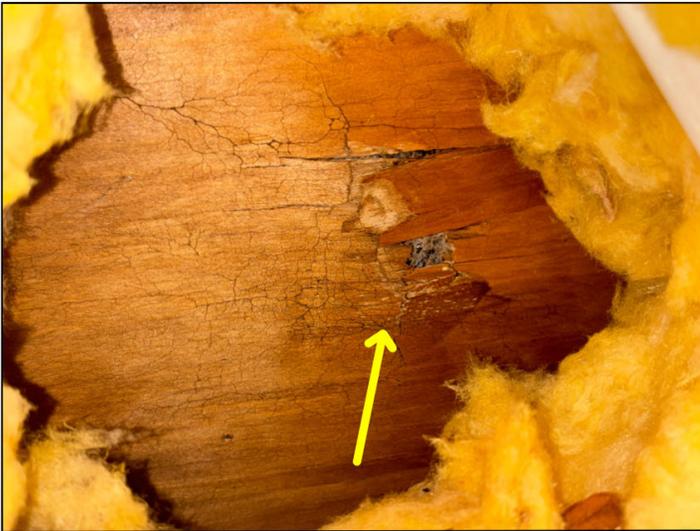
Damaged sheathing was noted at the #207 terrace framing where visible at #100.

Recommend all of the terraces be inspected with a borescope camera. Recommend all of the terraces be evaluated and improved as needed by a qualified licensed contractor to help prevent moisture damage. Lack of proper repairs and maintenance can cause health and safety concerns to occur in the future.

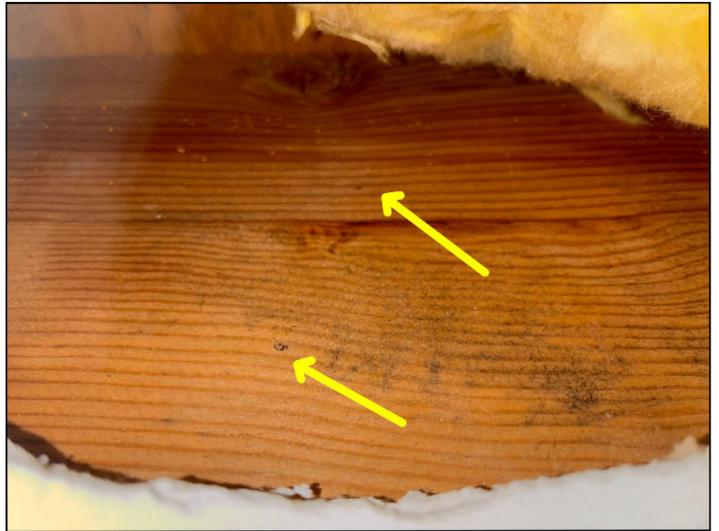
Possible insect damage was observed at the #207 terrace framing where visible in #100. See WDO report for more information.

Possible insect damage was observed at the #207 terrace framing where visible in #100.

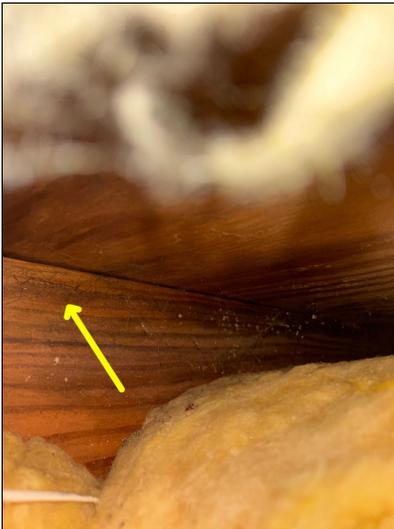
Organic growth was noted at the terrace framing in various places where light fixtures were removed at #100. See WDO report for more information.

Organic growth was noted at the terrace framing in various places where light fixtures were removed at #100.

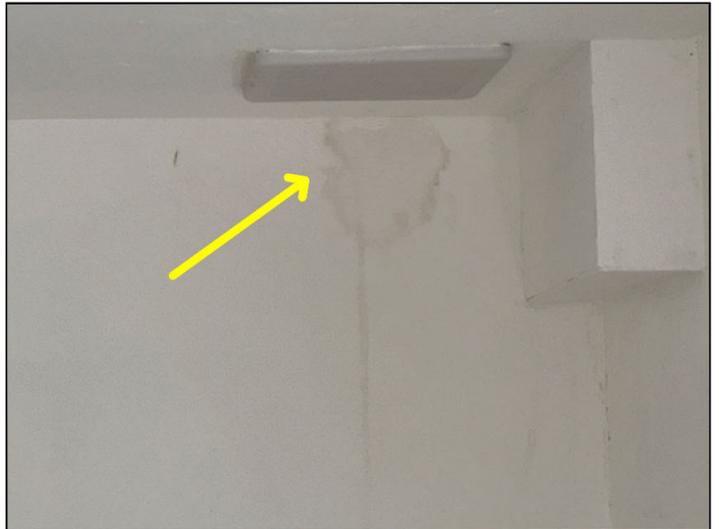
Dry water stains were noted at the #100 ceiling and wall below the #207 terrace. Hidden damage may be present.

Dry water stains were noted at the #100 ceiling and wall below the #207 terrace.

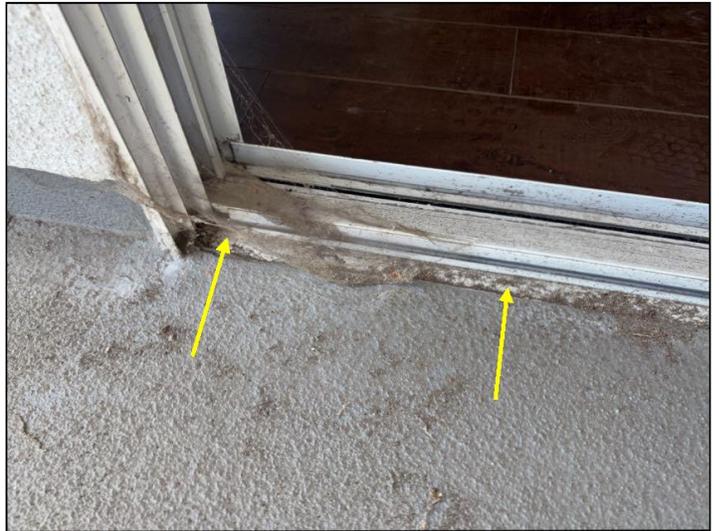
The slider door threshold at the #207 terrace is lower than the surface of the terrace in various places.

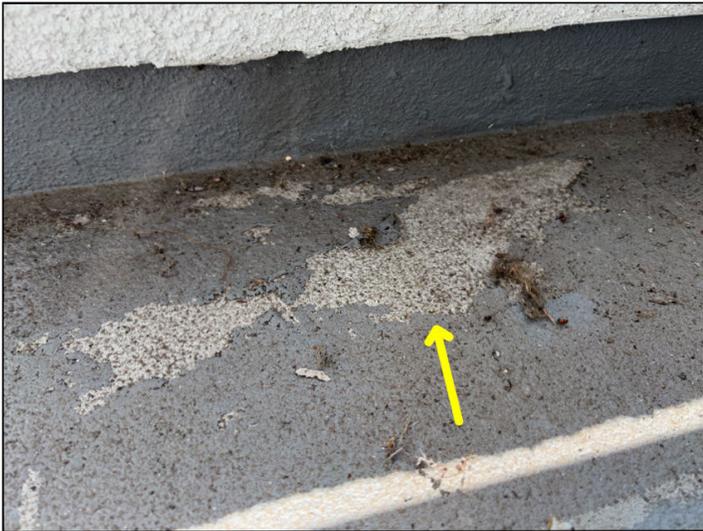
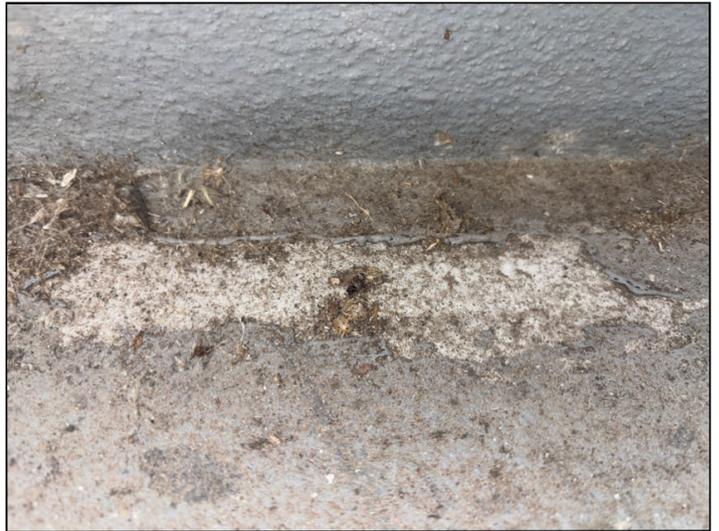
Damaged waterproof coating was noted at the surface of the terrace.

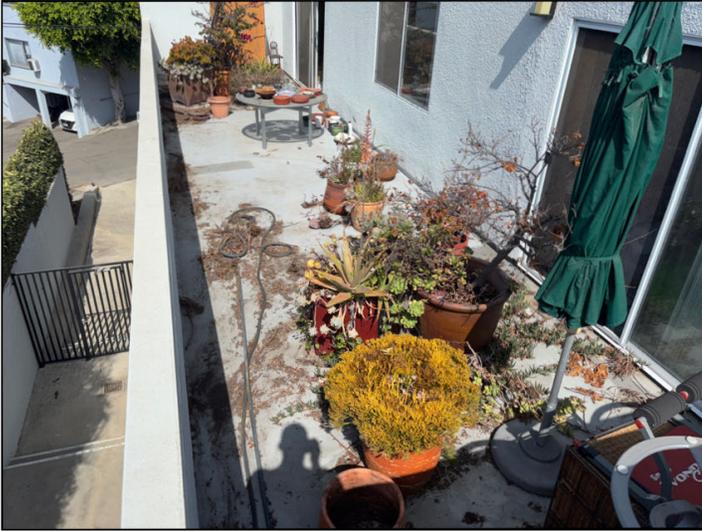
Excessive plants and debris were noted at the #205 terrace. Removal of all plants and debris is recommended. This terrace was otherwise not inspected.

Excessive plants and debris were noted at the #205 terrace.

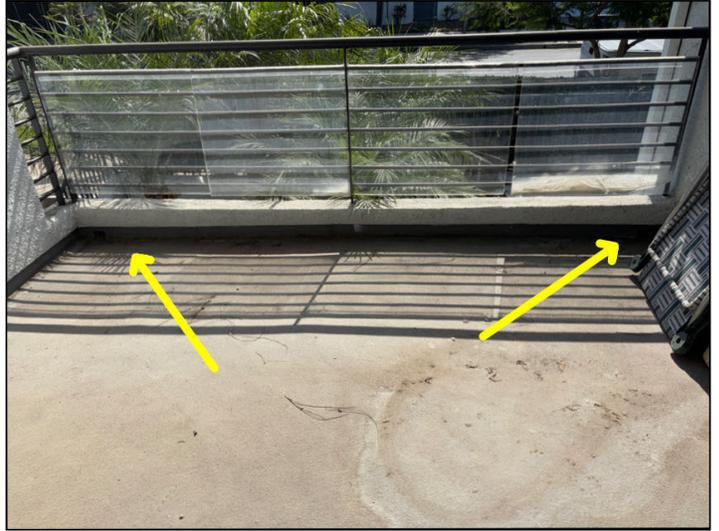
The size and quantity of the #207 terrace drains is not to current standards. Consult a qualified licensed contractor for more information.

The size and quantity of the #207 terrace drains is not to current standards.

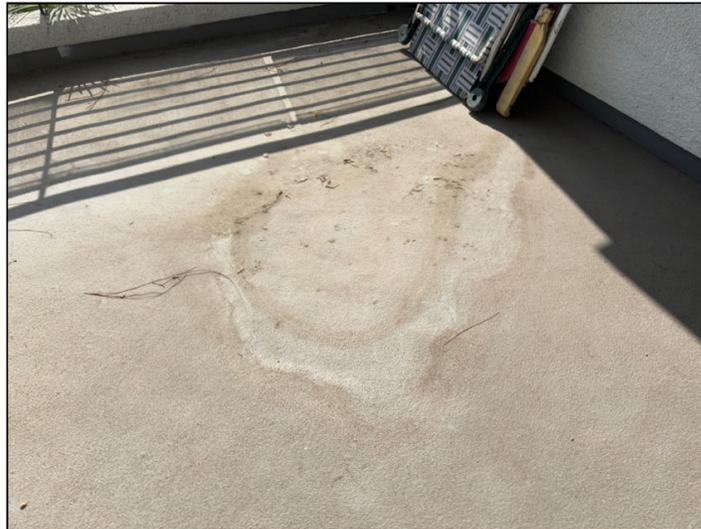
Poor drainage was noted at the surface of the terrace.

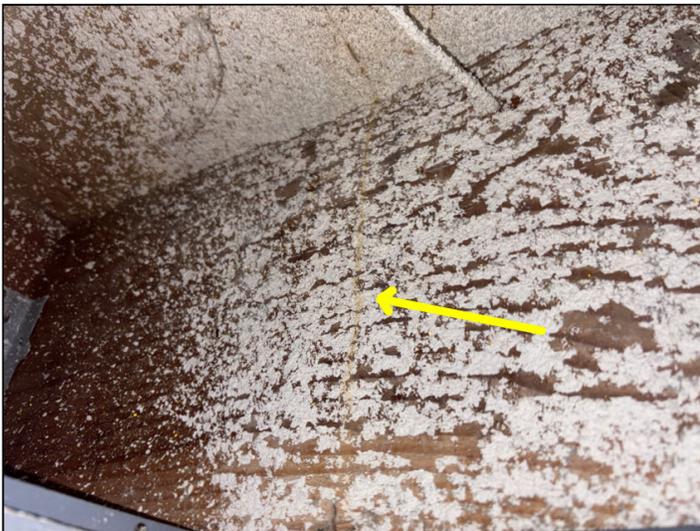
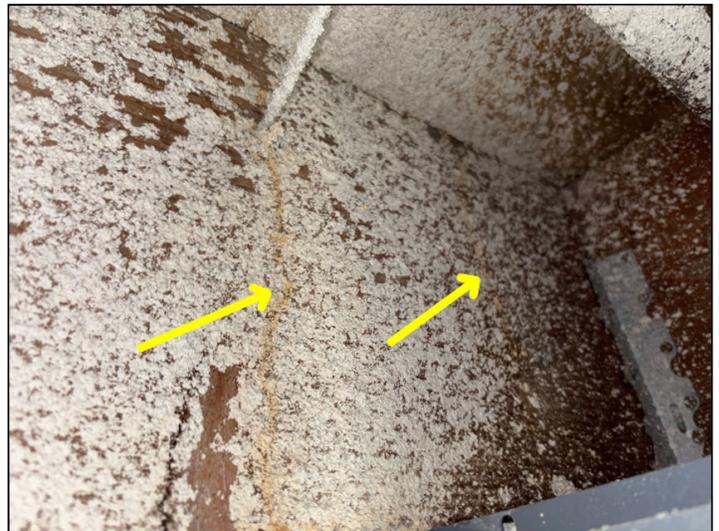
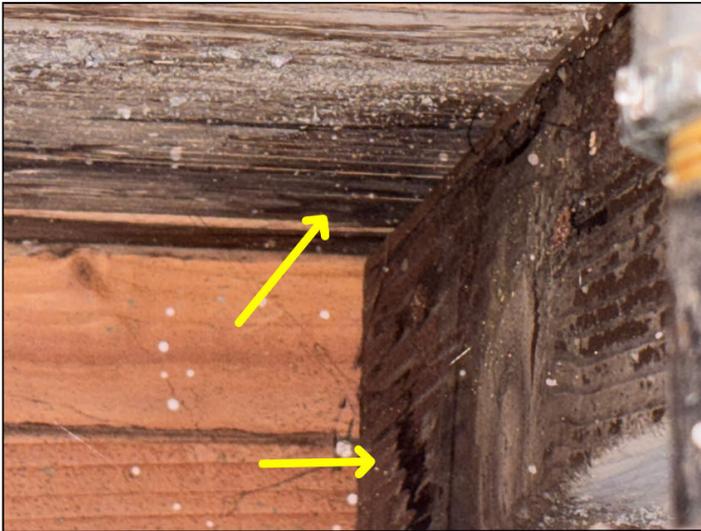
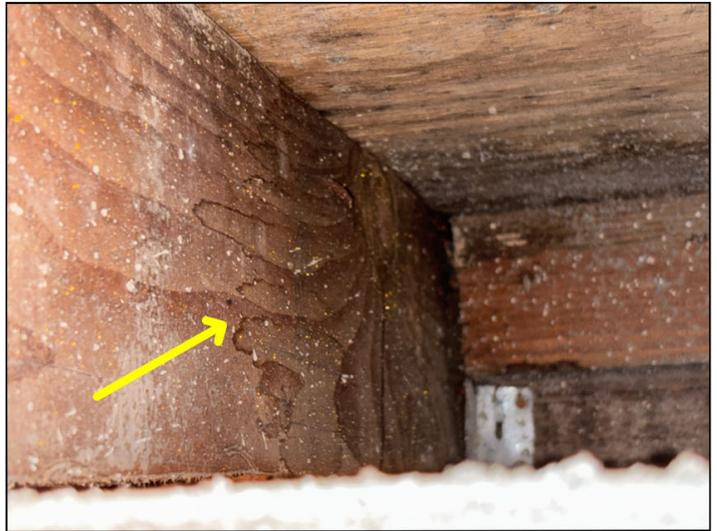
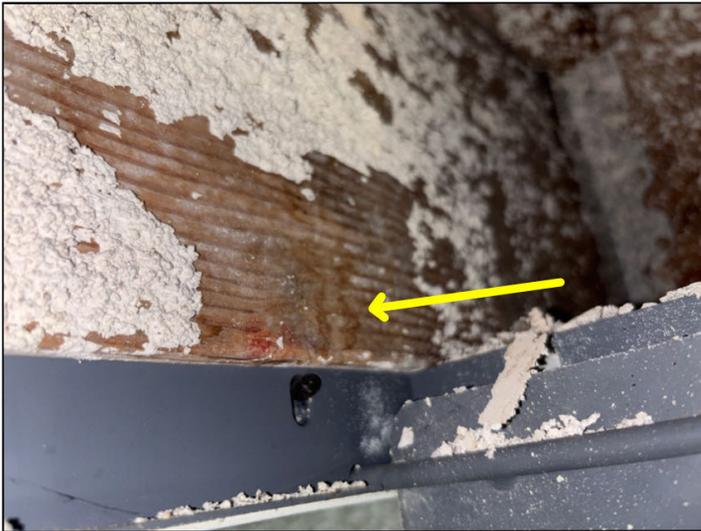
Dry water stains were observed at the walkway framing through plumbing accesses adjacent to #202 and #203.

Recommend all of the walkways be evaluated and improved as needed by a qualified licensed contractor to help prevent moisture damage. Lack of proper repairs and maintenance can cause health and safety concerns to occur in the future.

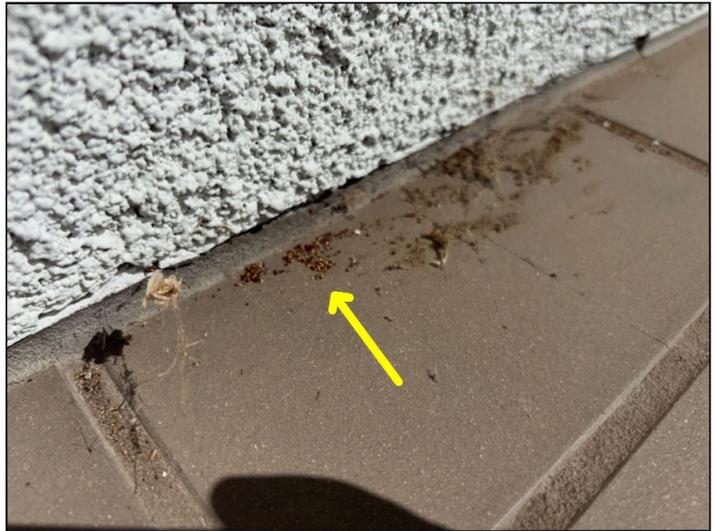
Possible insect droppings were noted at the surface of the walkway in various places adjacent to the exterior walls. See WDO report for more information.

Possible insect droppings were noted at the surface of the walkway in various places adjacent to the exterior walls.

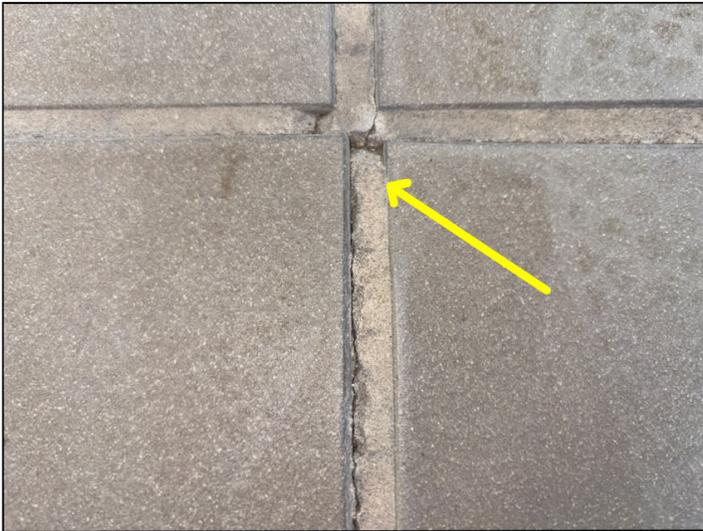
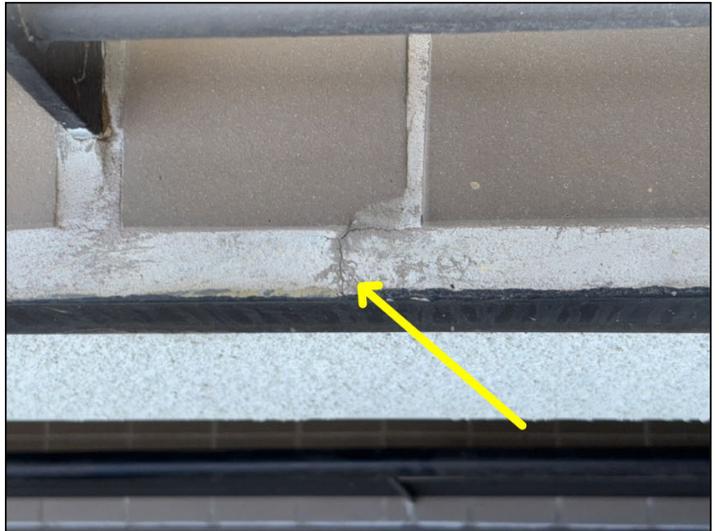
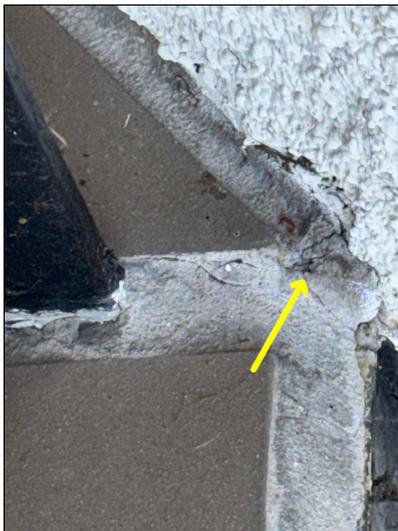
Cracked and missing grout was noted at the walkway surface in various places.

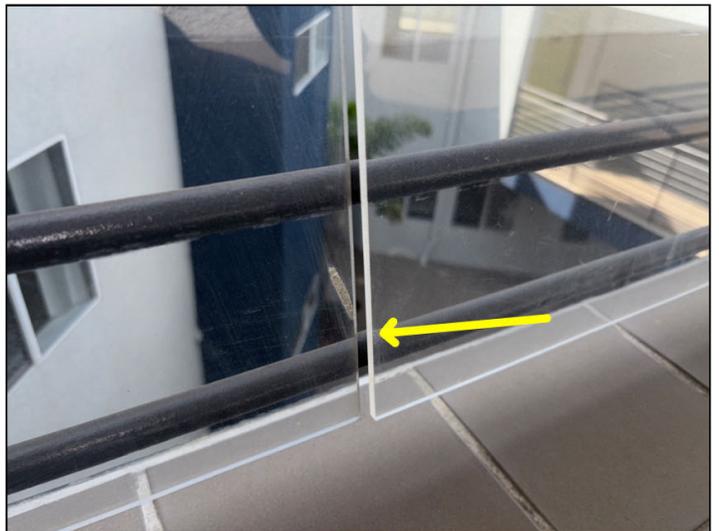
A cracked plastic barrier was noted at the walkway adjacent to #301.

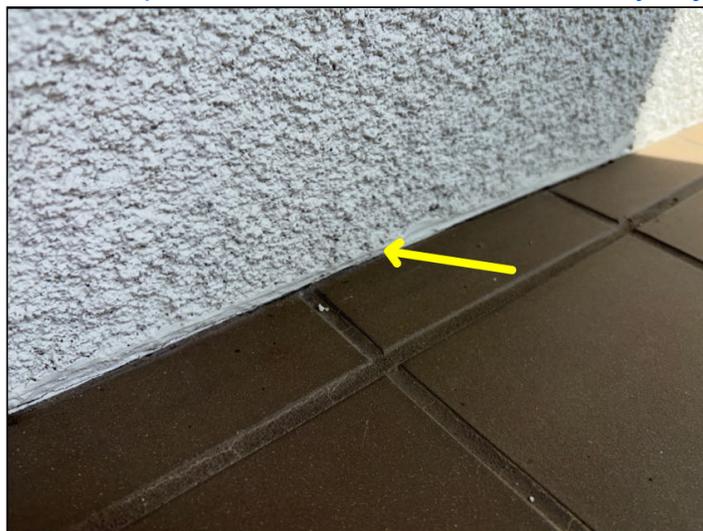
The stucco weep screed is blocked by the tile walkway surface at many places. This can cause moisture problems. Recommend monitoring for moisture problems and improving if needed.

The stucco weep screed is blocked by the tile walkway surface at many places.
