O'BRIEN
BUILDING INSPECTIONS INC.

SAMPLE
INSPECTION REPORT
43726 Sunset Avenue
Los Angeles, CA

Prepared for John Smith

9/15/2025

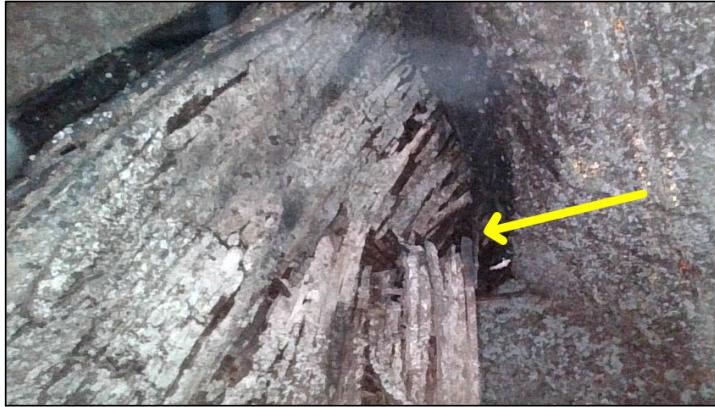
Moisture damage and possible insect damage were observed at the #303 balcony framing with the borescope camera.

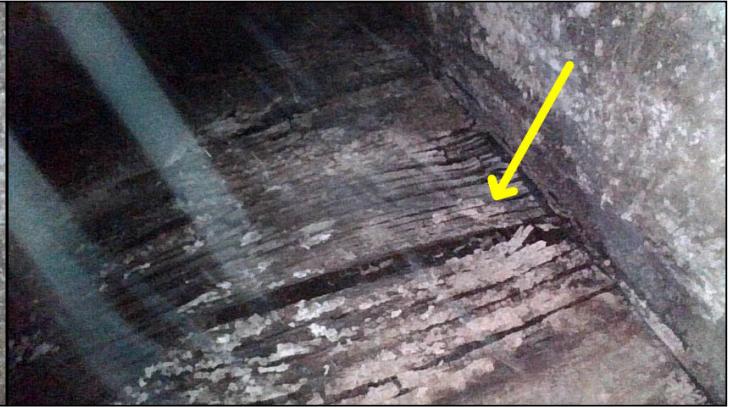
Moisture damage and possible insect damage were observed at the #303 balcony framing with the borescope camera.

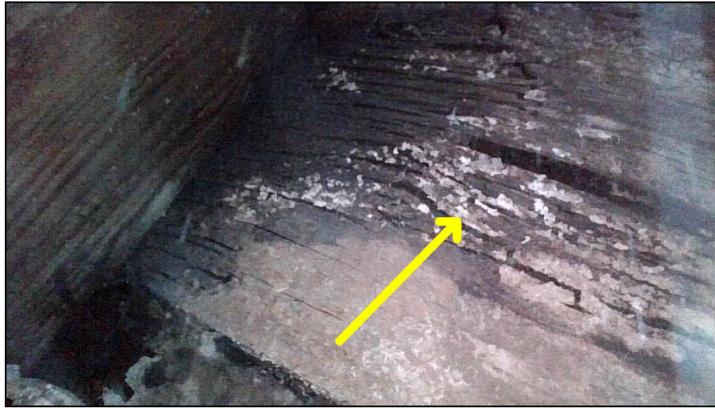
Moisture damage and possible insect damage were observed at the #303 balcony framing with the borescope camera.

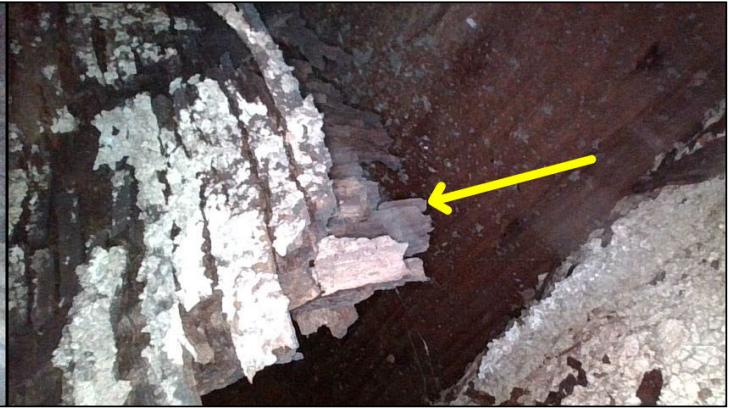
Moisture damage and possible insect damage were observed at the #303 balcony framing with the borescope camera.

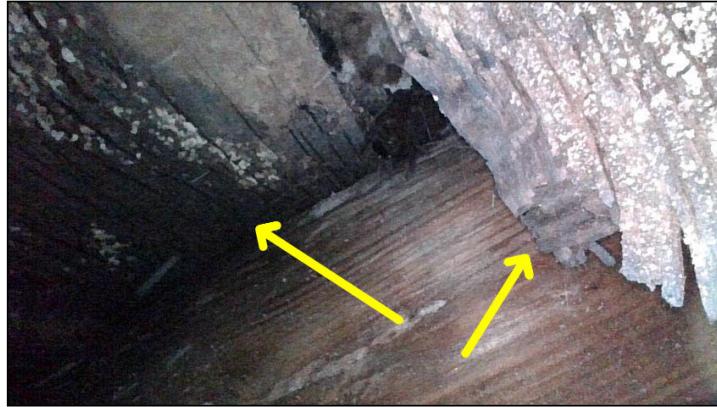
Moisture damage and possible insect damage were observed at the #303 balcony framing with the borescope camera.

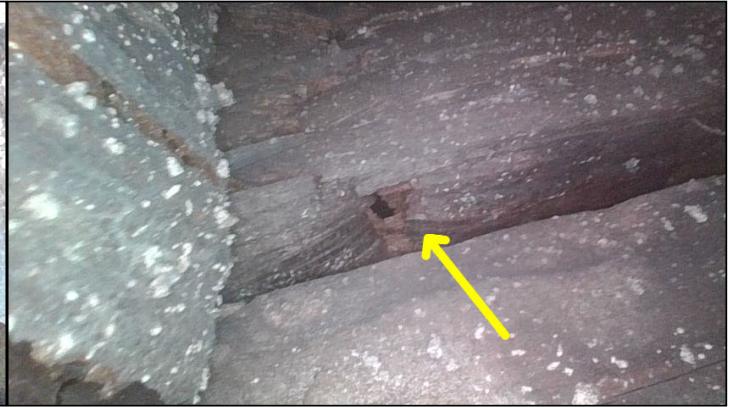
Moisture damage and possible insect damage were observed at the #303 balcony framing with the borescope camera.

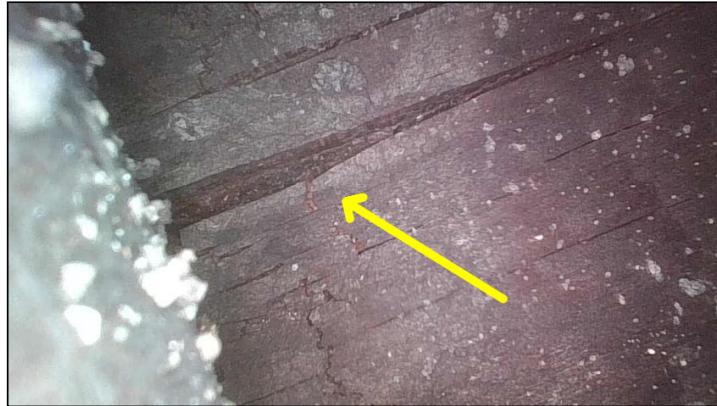
Moisture damage and possible insect damage were observed at the #303 balcony framing with the borescope camera.

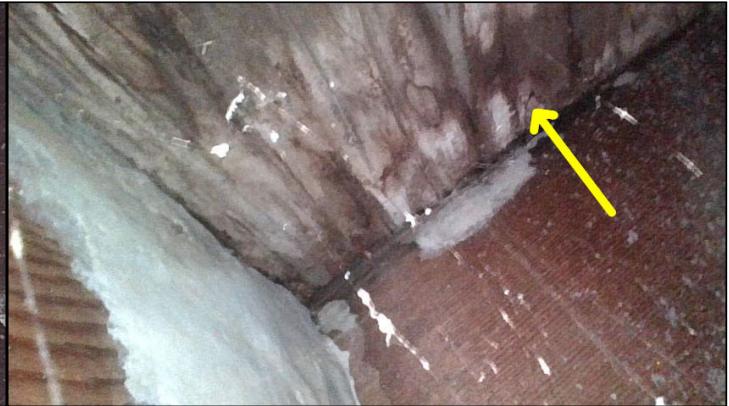
Moisture damage and possible insect damage were observed at the #203 balcony framing with the borescope camera.

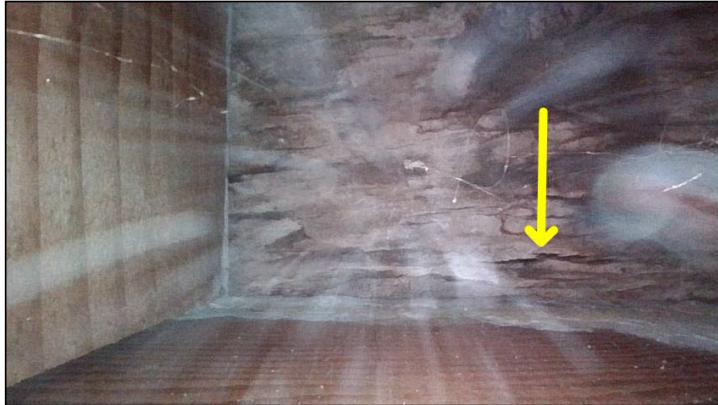
Moisture damage and possible insect damage were observed at the #203 balcony framing with the borescope camera.

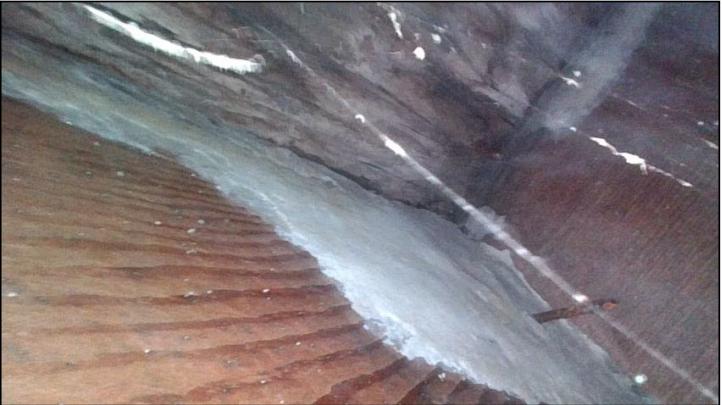
Organic growth was observed at the #203 balcony framing with the baroscope camera.

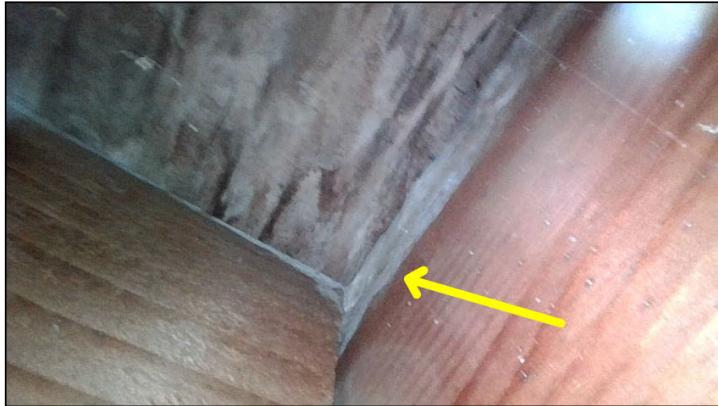
Organic growth was observed at the #203 balcony framing with the baroscope camera.

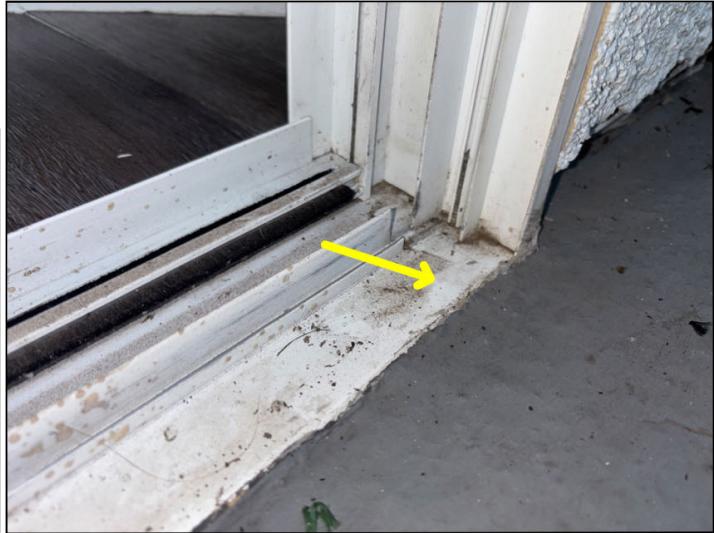
The #203 slider door threshold slopes at the corner of the door. This area of the threshold is lower than the surface of the balcony. This area is susceptible to water intrusion. Recommend improvements be made by a qualified licensed contractor when the balcony is eventually reconstructed. This condition is present at the #207 terrace slider door as well.

The #203 slider door threshold slopes at the corner of the door.

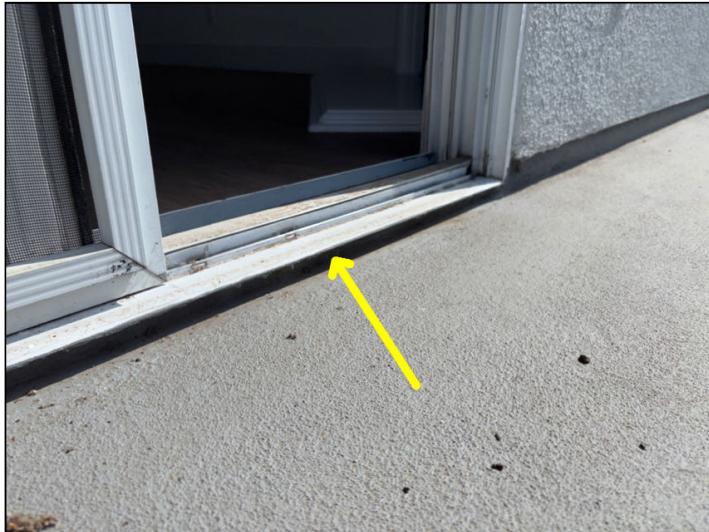
The slider door threshold at the #206 terrace is shown in this image. This is an example of a slider door threshold installed at the proper elevation above the exterior walking surface.

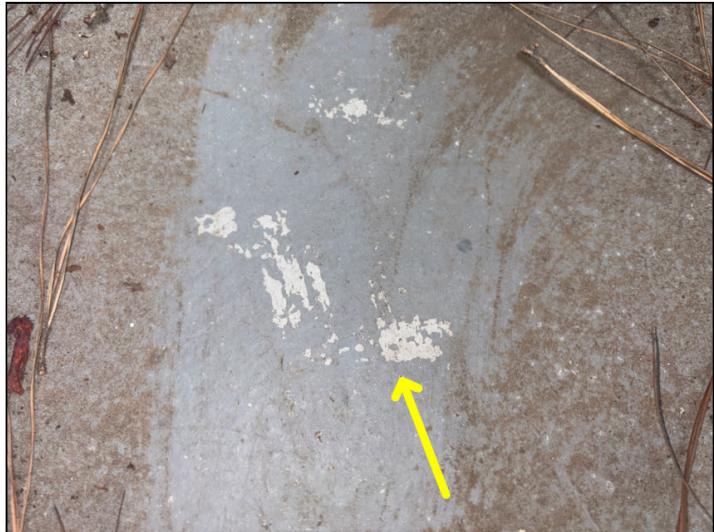
Worn waterproof coating was noted at the #203 and the #303 balcony surfaces.

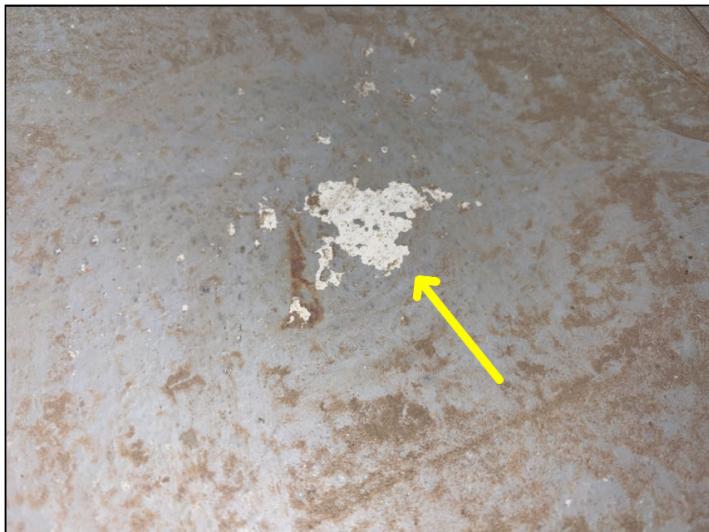
Worn waterproof coating was noted at the #203 and the #303 balcony surfaces.

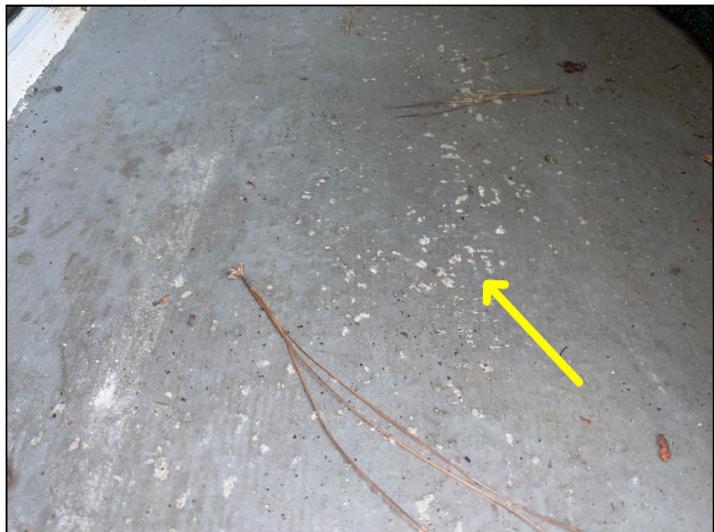
Worn waterproof coating was noted at the #203 and the #303 balcony surfaces.

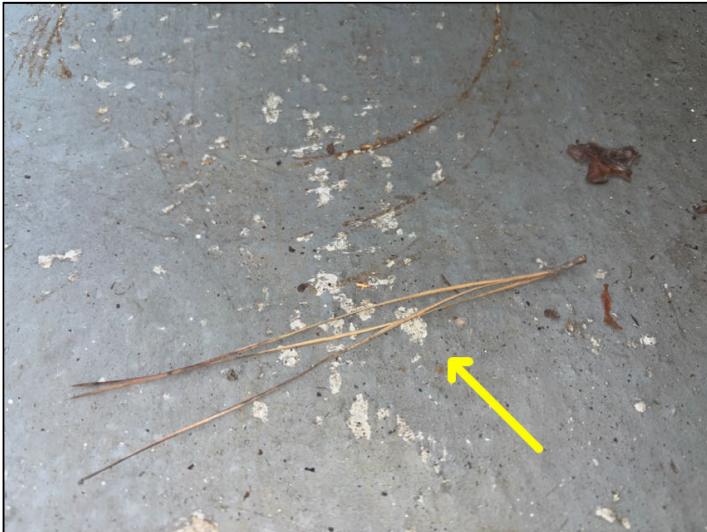
Worn waterproof coating was noted at the #203 and the #303 balcony surfaces.

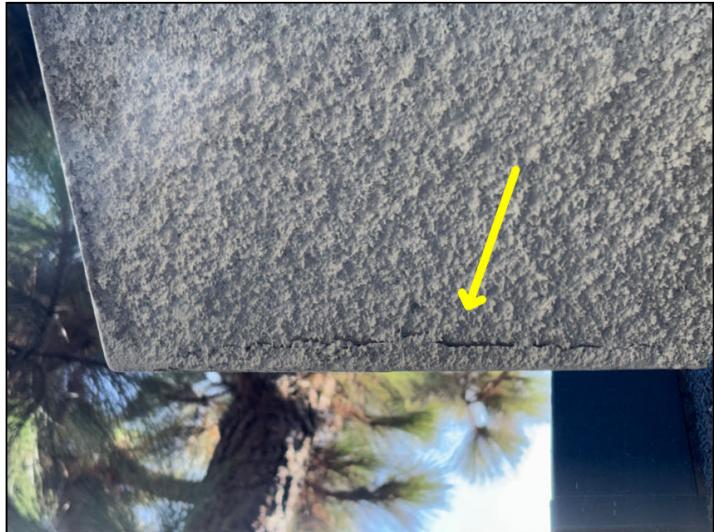
Cracked stucco was noted at the edge of #303 balcony soffit.

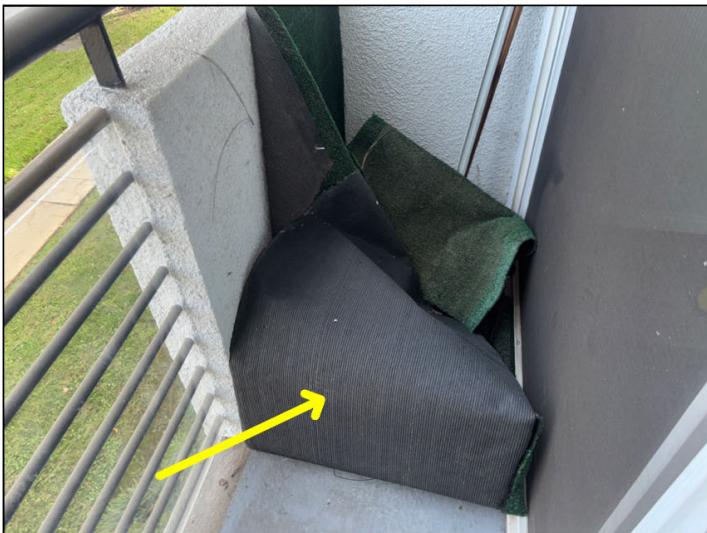
Artificial turf was noted at the #203 balcony. Artificial turf can trap water against the balcony surface resulting in moisture damage. Removal is recommended.

Artificial turf was noted at the #203 balcony.

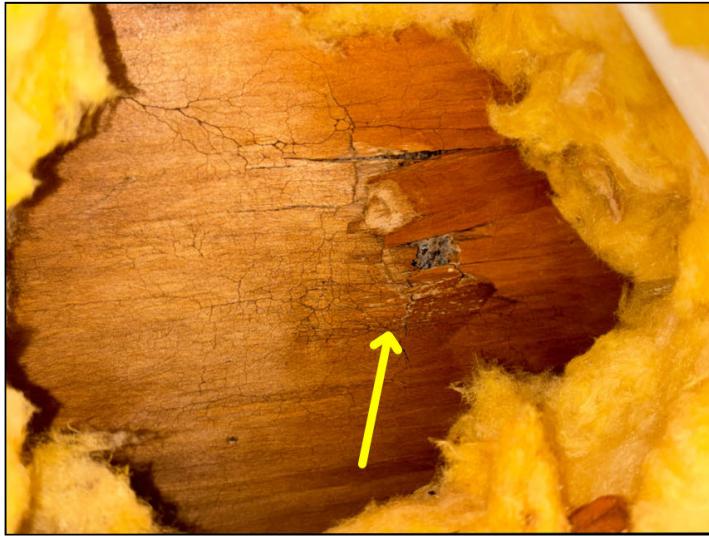
Damaged sheathing was noted at the #207 terrace framing where visible at #100.

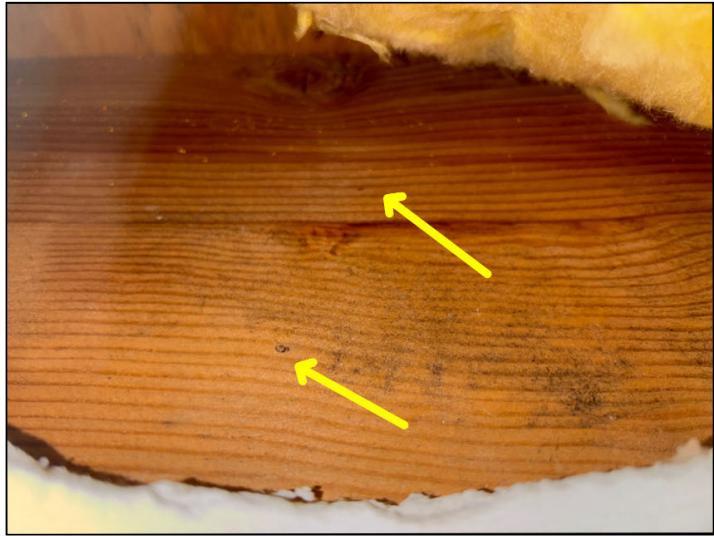
Possible insect damage was observed at the #207 terrace framing where visible in #100.

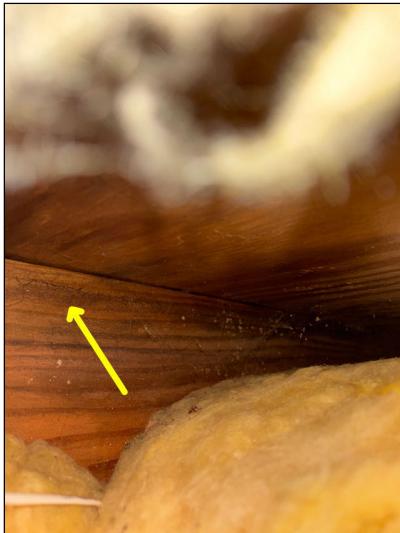
Organic growth was noted at the terrace framing in various places where light fixtures were removed at #100.

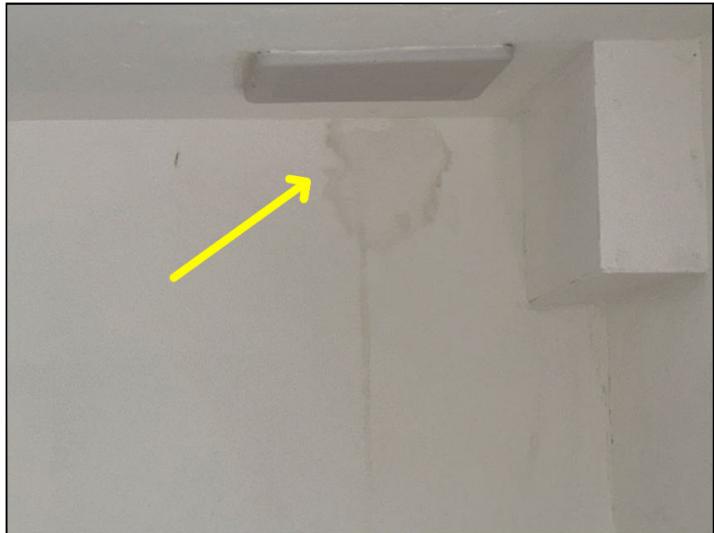
Dry water stains were noted at the #100 ceiling and wall below the #207 terrace. Hidden damage may be present.

Dry water stains were noted at the #100 ceiling and wall below the #207 terrace.

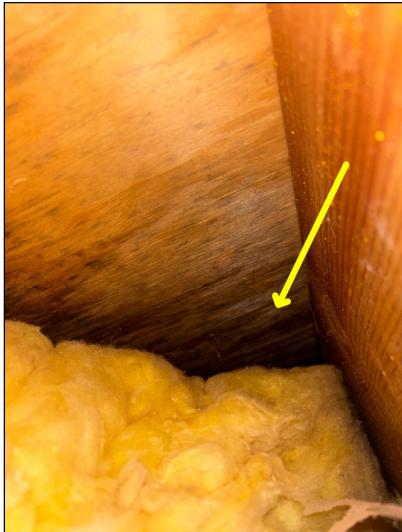
Dry water stains were not noted at the #207 framing where visible at #100.

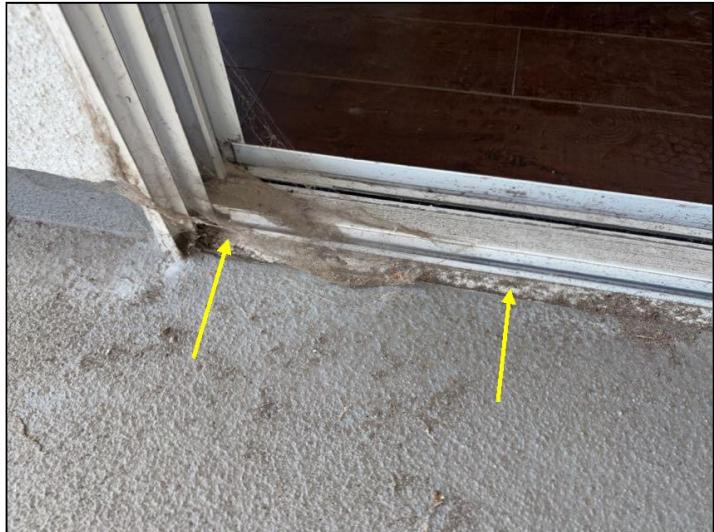
The slider door threshold at the #207 terrace is lower than the surface of the terrace in various places.

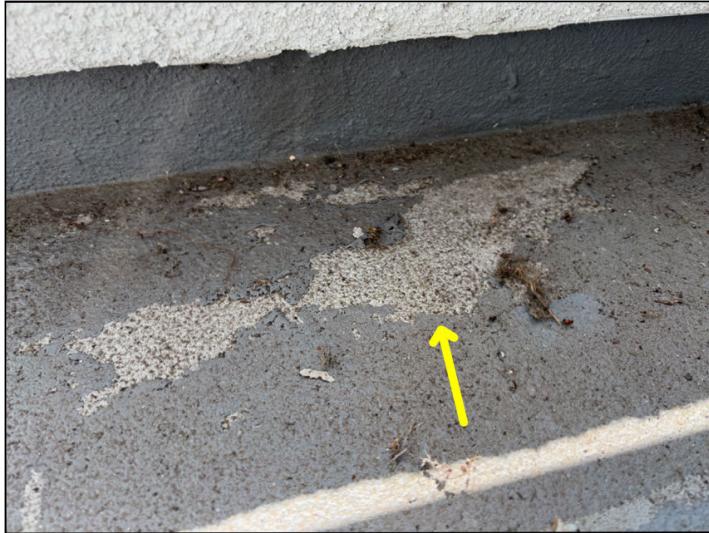
Damaged waterproof coating was noted at the surface of the terrace.

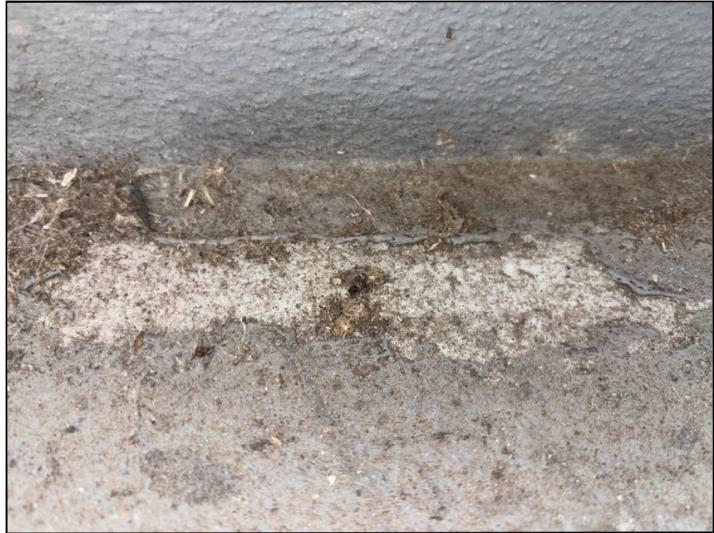
Damaged waterproof coating was noted at the surface of the terrace.

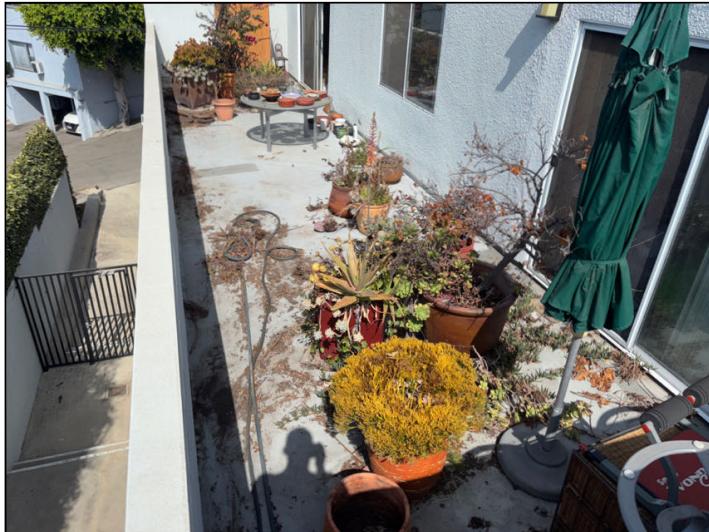
Excessive plants and debris were noted at the #205 terrace.

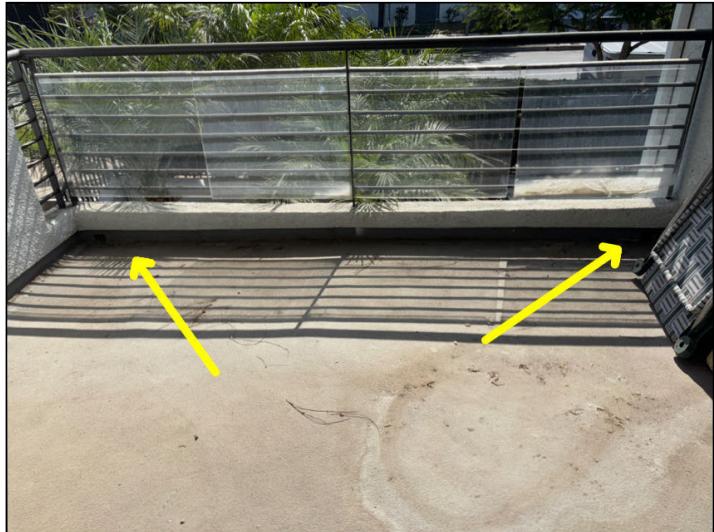
The size and quantity of the #207 terrace drains is not to current standards.

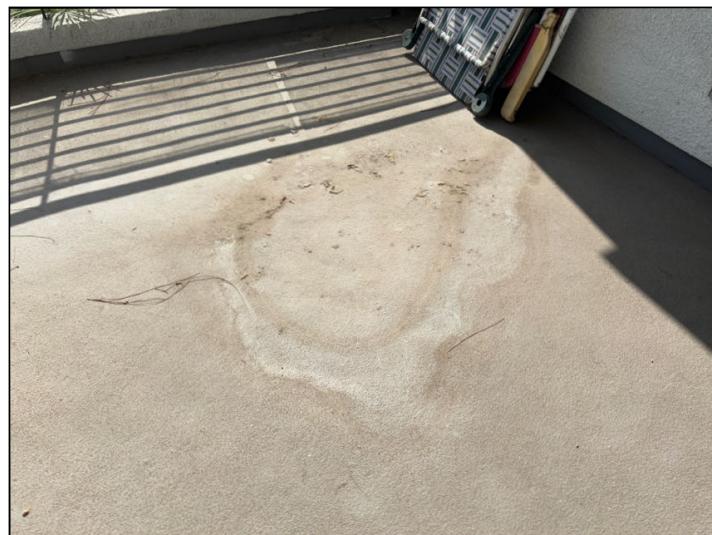
Poor drainage was noted at the surface of the terrace.

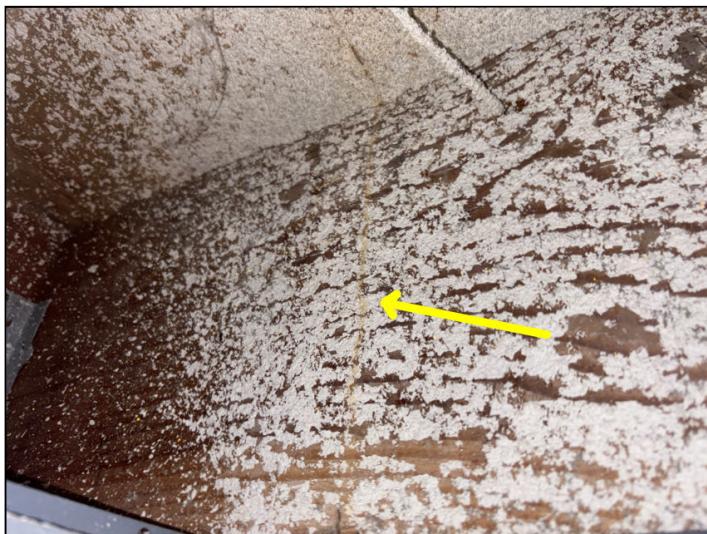
Dry water stains were observed at the walkway framing through plumbing accesses adjacent to #202 and #203.

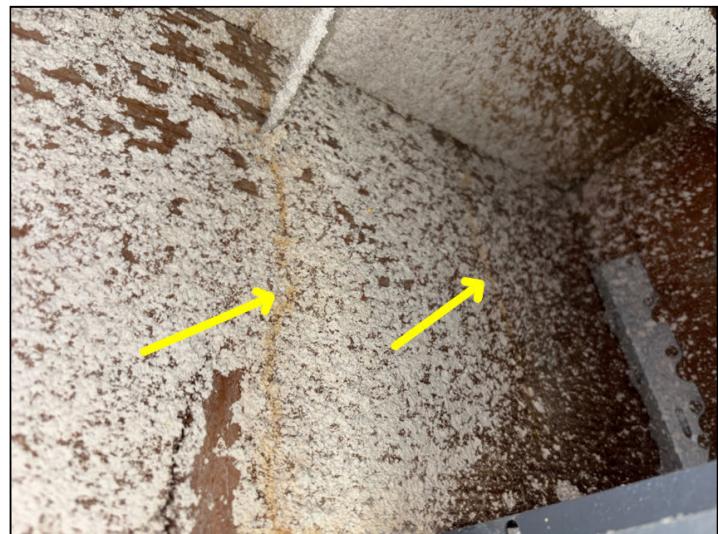
Dry water stains were observed at the walkway framing through plumbing accesses adjacent to #202 and #203.

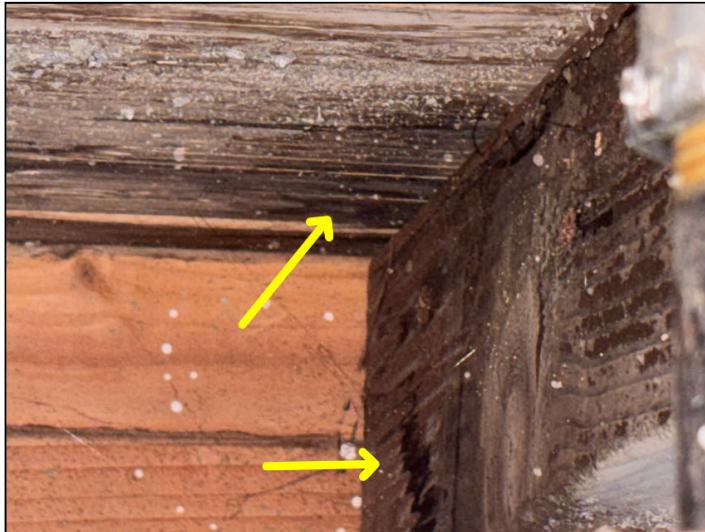
Dry water stains were observed at the walkway framing through plumbing accesses adjacent to #202 and #203.

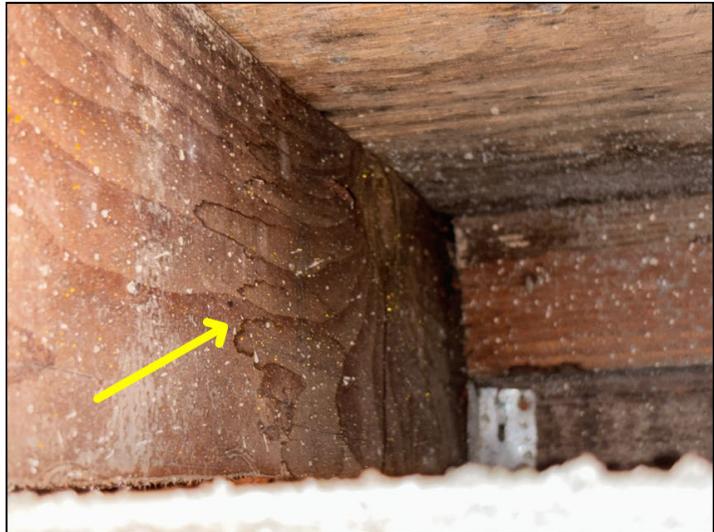
Dry water stains were observed at the walkway framing through plumbing accesses adjacent to #202 and #203.

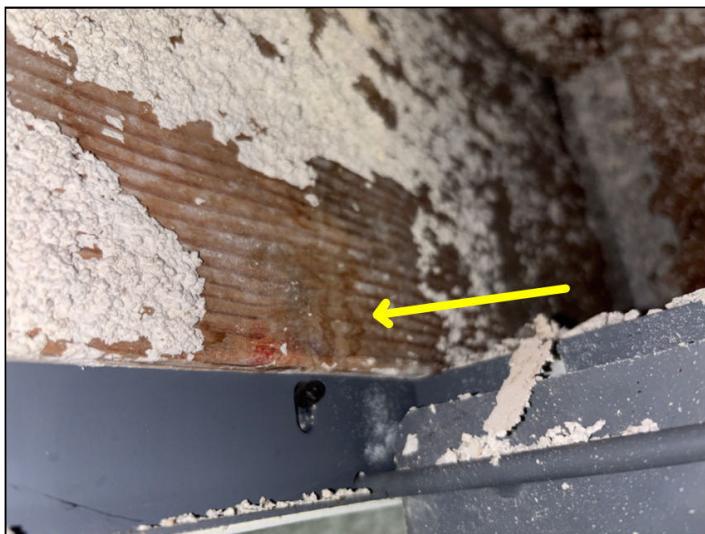
Dry water stains were observed at the walkway framing through plumbing accesses adjacent to #202 and #203.

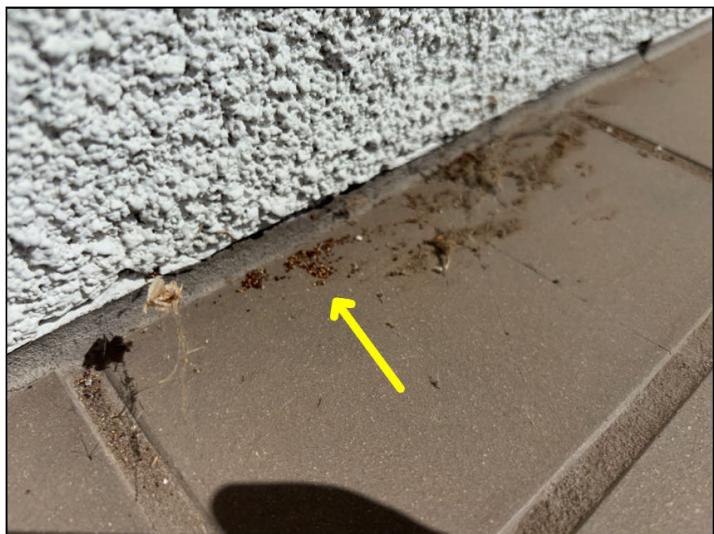
Possible insect droppings were noted at the surface of the walkway in various places adjacent to the exterior walls.

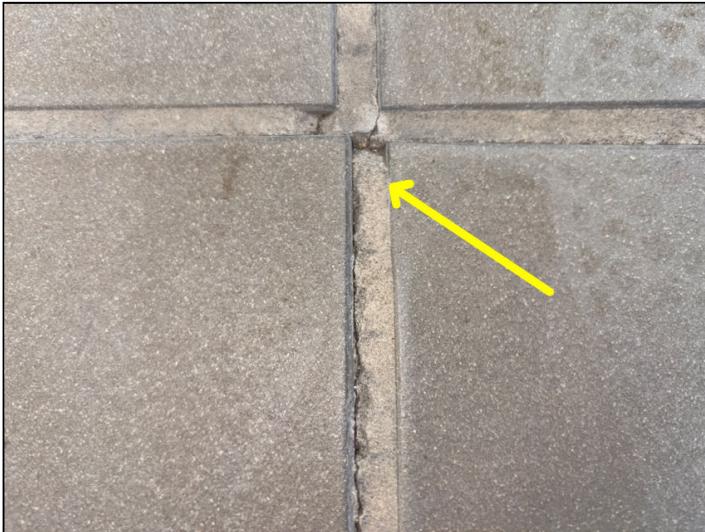
Cracked and missing grout was noted at the walkway surface in various places.

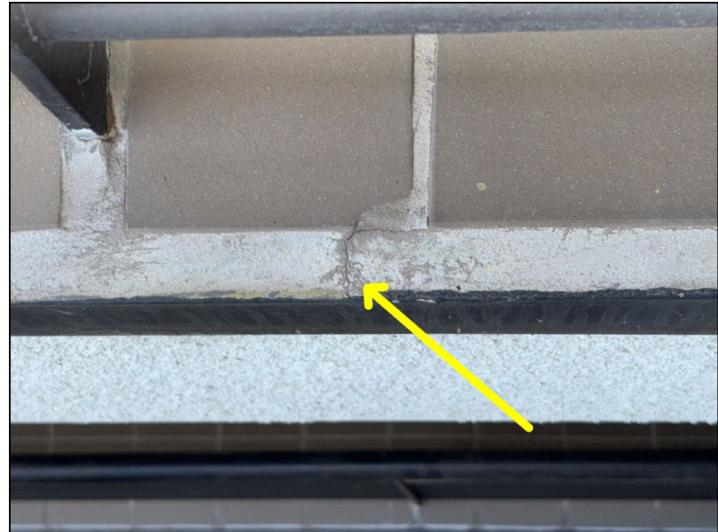
Cracked and missing grout was noted at the walkway surface in various places.

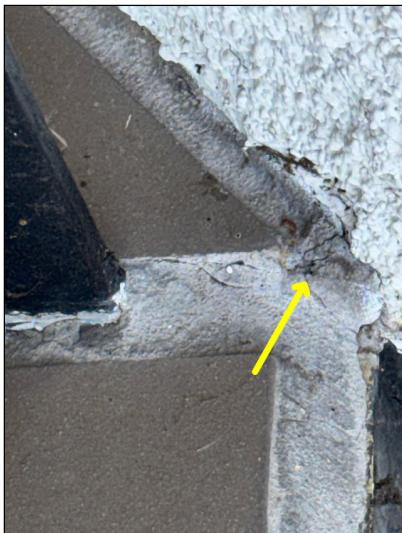
Cracked and missing grout was noted at the walkway surface in various places.

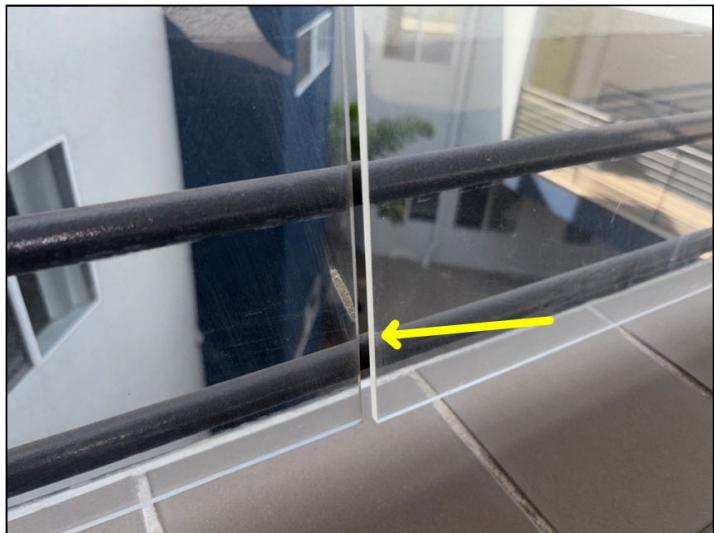
A cracked plastic barrier was noted at the walkway adjacent to #301.

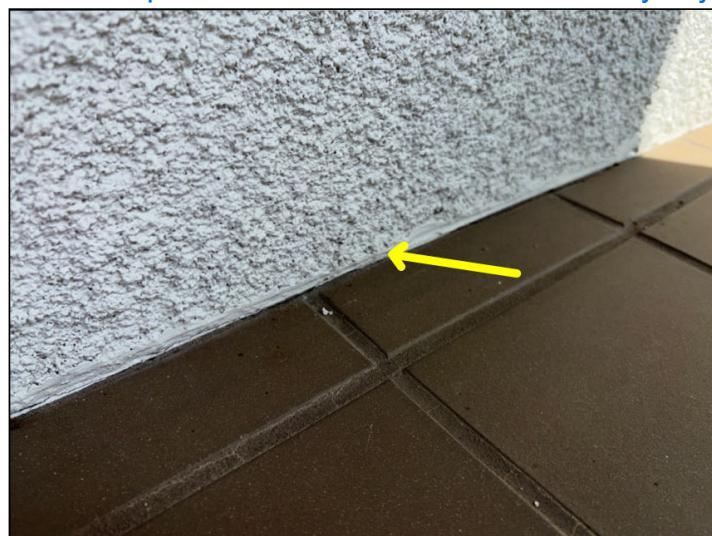
The stucco weep screed is blocked by the tile walkway surface at many places. This can cause moisture problems. Recommend monitoring for moisture problems and improving if needed.

The stucco weep screed is blocked by the tile walkway surface at many places.
