Inspected For: Brand New Home January 24, 2022

PROPERTY INSPECTION REPORT FORM

Brand New Home Name of Client	01/24/2022 Date of Inspection
123 Somewhere St, Fort Worth, TX 76000 Address of Inspected Property	
Charles Tod Brooks Name of Inspector	TREC #9842 TREC License #
Name of Sponsor (if applicable)	TREC License #

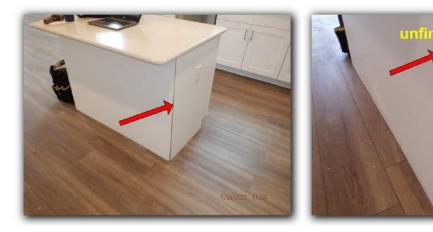
The kitchen island appears to be missing some trim in one or more areas.
