**Inspected For:  
Large 5000+ SF Home  
February 2, 2022**

# PROPERTY INSPECTION REPORT FORM

567 FM 1234, Millsap, TX 76000

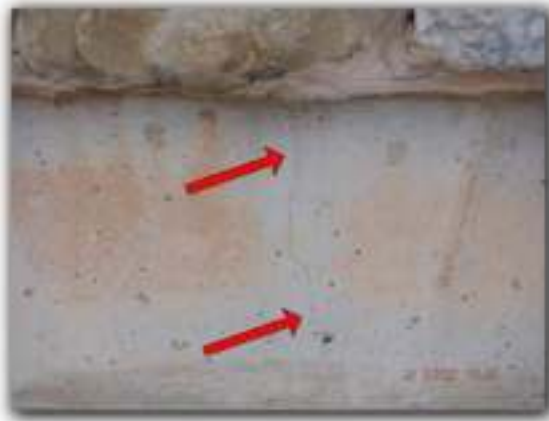
- Stress cracks were observed in the exterior foundation perimeter beam in one or more areas.

The concrete foundation / basement appears to have had movement that is beyond normal or typical. A Professional Engineer licensed by the State of Texas and / or a qualified foundation repair specialist should be consulted on the current integrity of the foundation and any repairs that may be necessary (If Any).

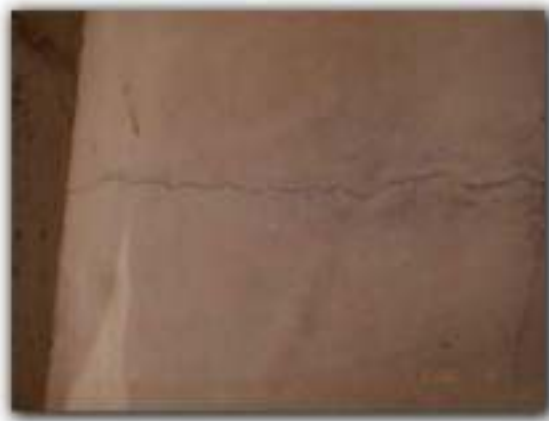
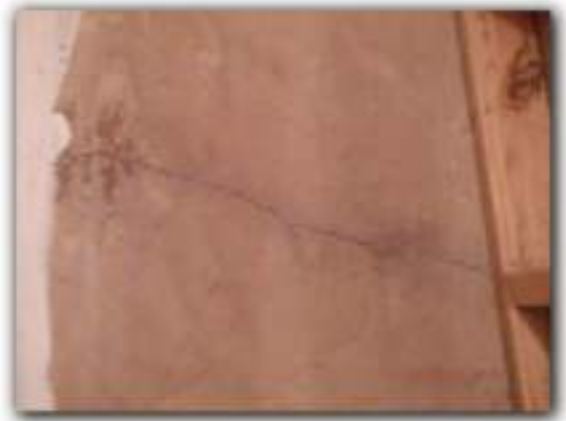
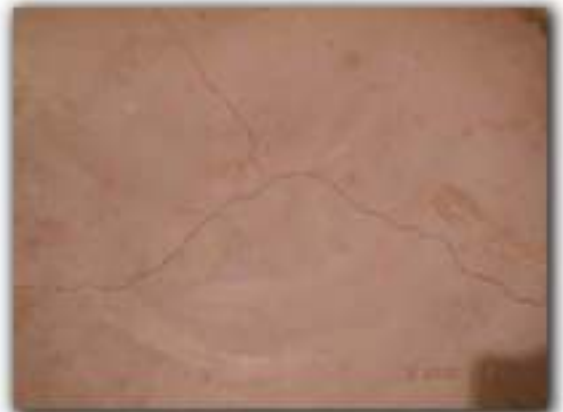
- Cracks were observed in the basement concrete floor of the foundation in several (various) areas; many appear to be greater than common or typical.

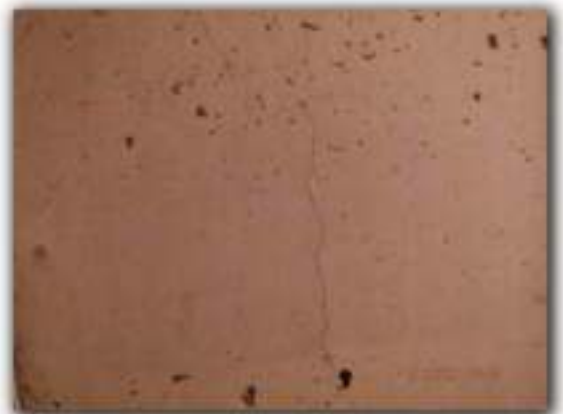
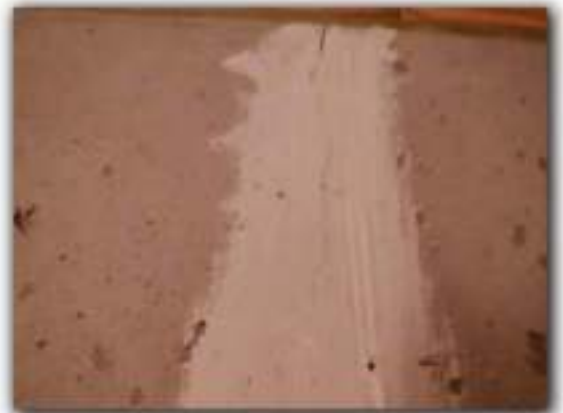
- Stress cracks were observed on the interior of the basement concrete foundation wall in one or more areas; some appear to have been patched or sealed. Recommend further evaluation by a specialist to determine the overall structural condition and concern for possible water intrusion; in need of repair.

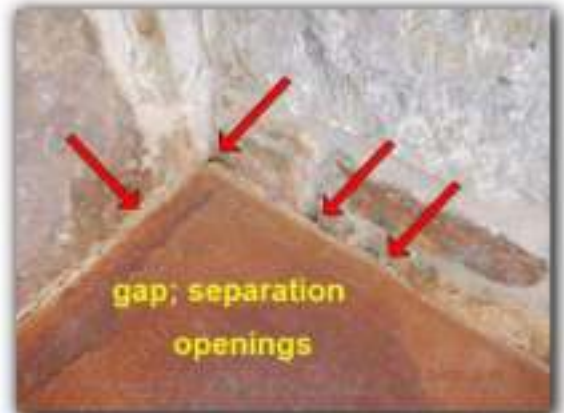
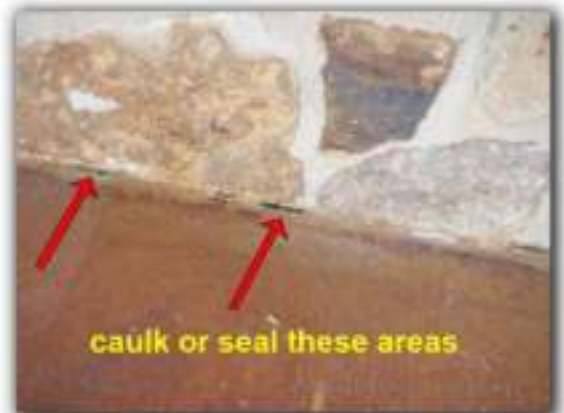
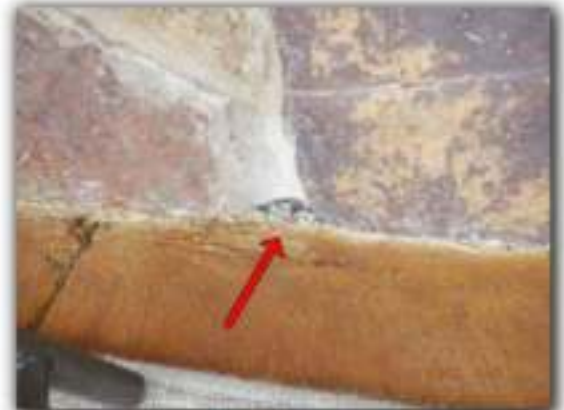
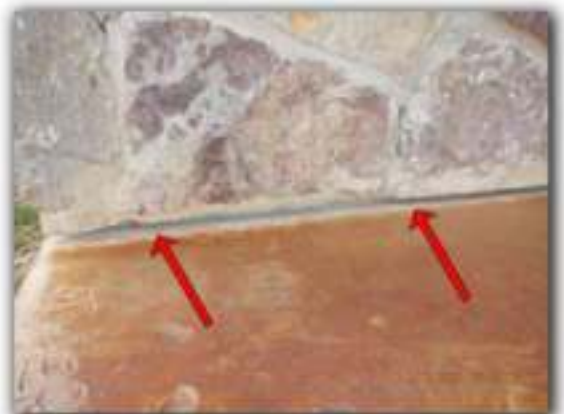
- Separation of the concrete flatwork (porches and/or sidewalks) from the actual foundation of the structure were observed in one or more areas. This condition should be further evaluated and corrected as necessary. This could allow water intrusion or seepage down along or into the basement concrete wall.

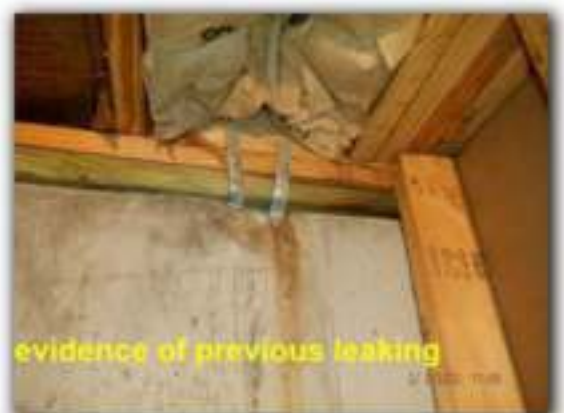
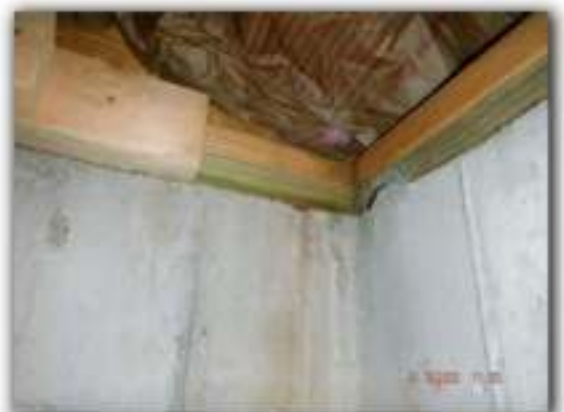
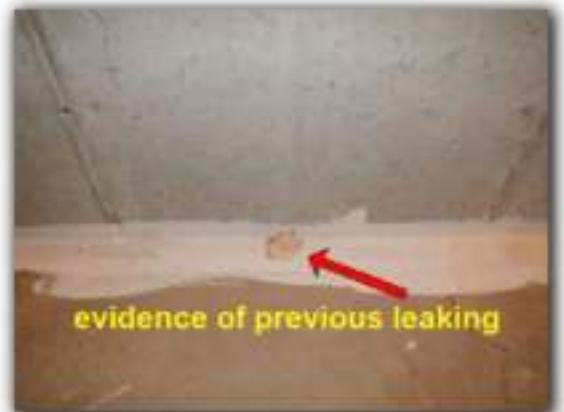
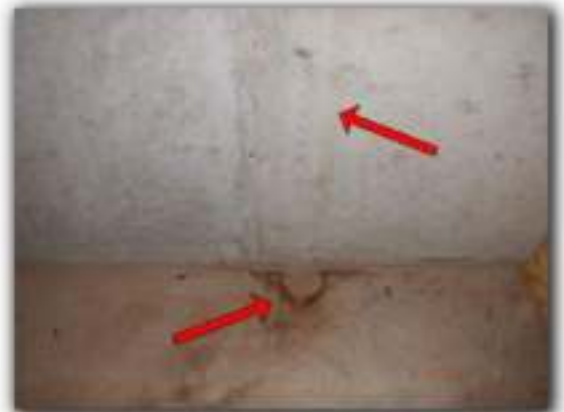
- Visible evidence of previous water intrusion was observed in several areas down in the basement area. Unable to determine the cause and whether the water intrusion came from the exterior, from plumbing related issues, or both. The cause and remedy should be investigated and corrected as necessary.

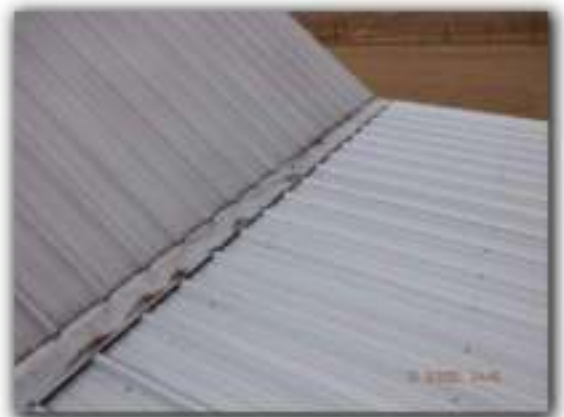
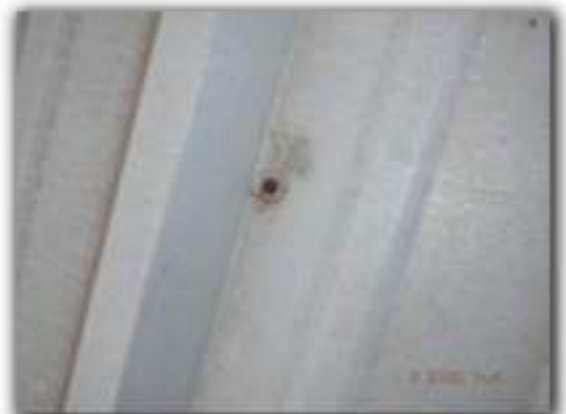
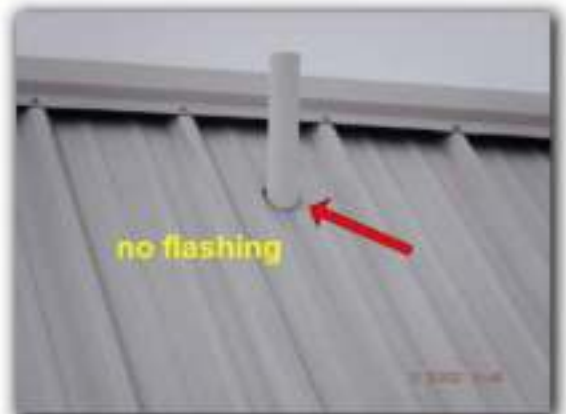
- One or more of the metal roof flashing components was found rusted and/or deteriorated.
- The roof level flashing details at or around the front dormers needs to be checked, reset or repaired. There is visible evidence of water intrusion at and around this location.

- Some of the metal roofing material and/or flashing along the lower edges was observed to not be properly or adequately sealed or enclosed to help keep out unwanted water intrusion, as well as other bird or vermin infestation.

- Some of the roof fastener (screws) neoprene seals (rubber washers) were observed to be damaged or missing in various locations. This condition can allow for water intrusion. These fasteners should be checked every 2-years for deterioration; and repaired or replaced as necessary.

- One or more of the plumbing vent stacks do not have the proper flashing installed. They are caulked or sealed rather than having the appropriate flashing installed.

The metal roof covering generally looks good and appears to be performing as intended on the day of the inspection; however, some repairs are needed. You are encouraged to have a properly certified roofing contractor and / or your insurance provider to physically inspect the roof, prior to the expiration of any time limitations such as option or warranty periods, to fully evaluate the condition of the roofing material. The observation made to support the rendering of this opinion are listed but not limited to the following:

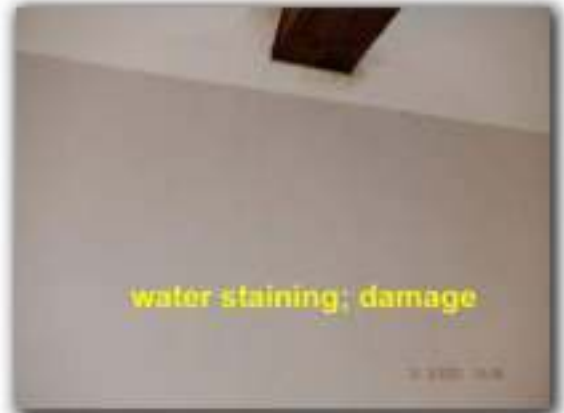
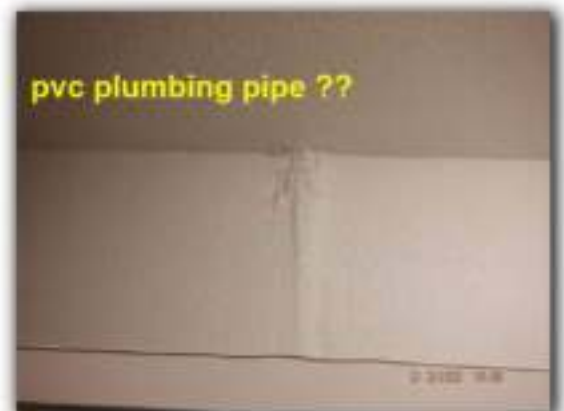
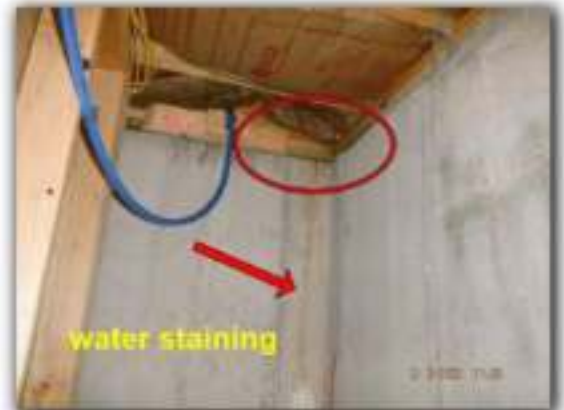
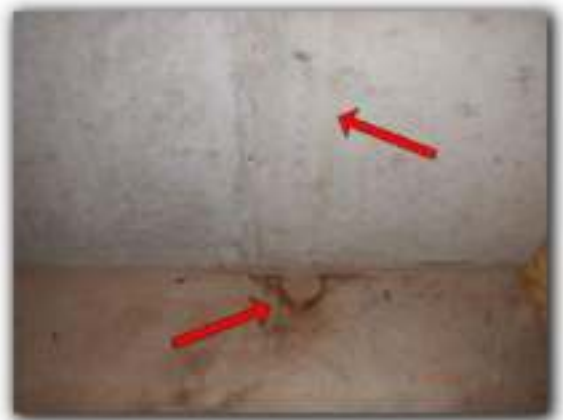
- Water staining and evidence of previous water intrusion was observed on the concrete walls in the basement area; in multiple areas around the perimeter. Unable to determine if coming from plumbing areas on the main floor and/or if coming in from the exterior. The cause and remedy should be further evaluated and corrected as necessary.

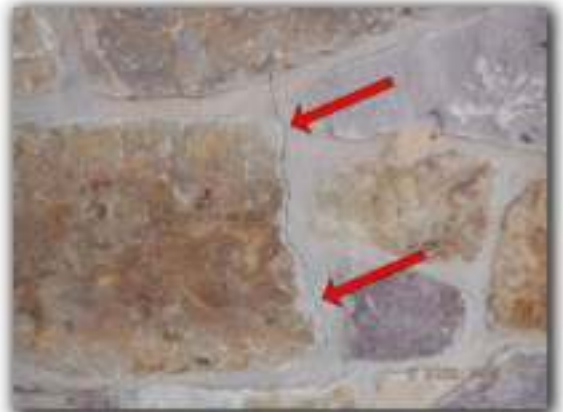
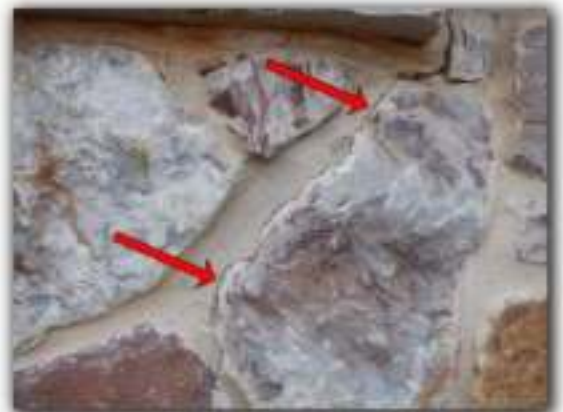
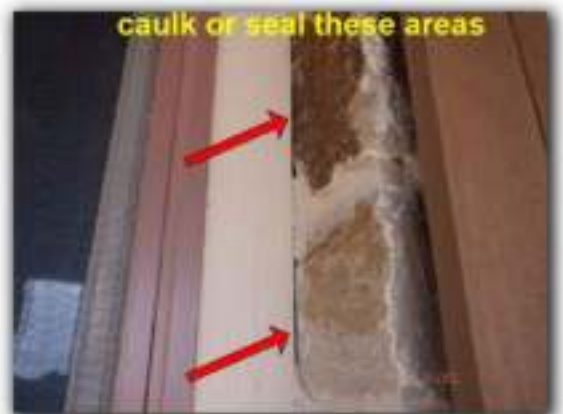
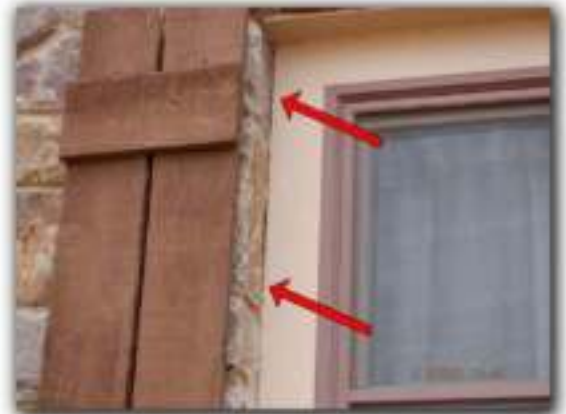
- The siding material was observed to be damaged in one or more areas around the structure; mainly observed on the back side.
- Mortar cracks were observed in the exterior masonry veneer in one or more locations around the structure. This is a common condition and does not appear to be significant at this time; however, it does imply that some movement of the structure has occurred.
- Caulking improvements are recommended for the area between the exterior veneer and one or more of the window and/or door frames. It is recommended to use elastomeric caulking.

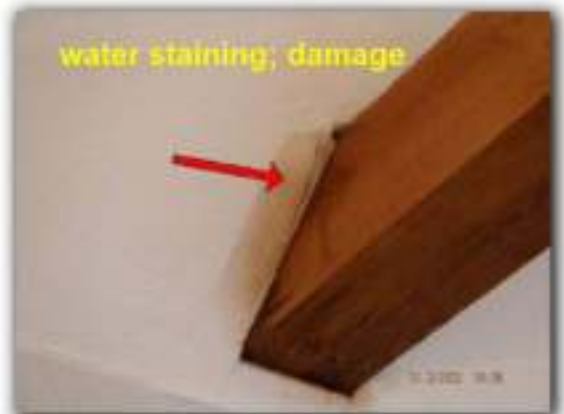
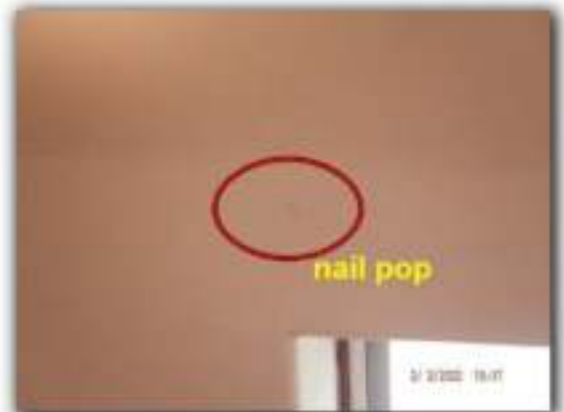
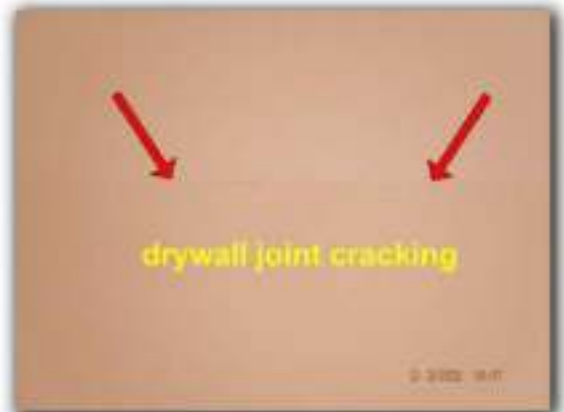
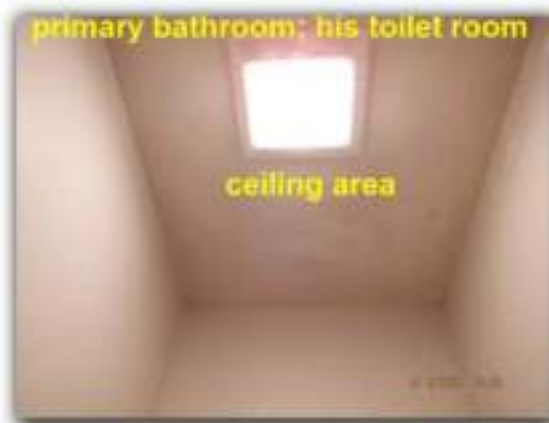
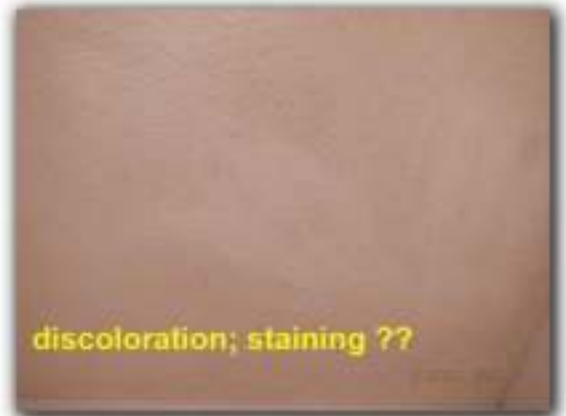
- Water staining and/or damage was observed on the ceiling finish in the living room (front wall). The cause and remedy should be further evaluated and corrected as necessary.

- Ceiling drywall joint cracks were observed in one or more areas, mainly in the primary bedroom. Generally, this condition is common and considered cosmetic.

- Nail heads (nail pops) were observed to be pushing or backing through the interior drywall finish in one or more of the sme sloped ceiling areas; this is typically a common condition and generally considered to be cosmetic.

- An unusual staining and/or discoloration was observed on the ceiling finish in the primary bathroom (his toilet room). The cause and remedy should be further evaluated and corrected as necessary.

- There was an unknown dark (mold-like) substance observed in the hall bathroom. Evaluation of this substance is beyond the scope of this inspection. If any concerns exist on the type and/or nature of this substance, we recommend further evaluation by a professional in the Air Quality sampling field.

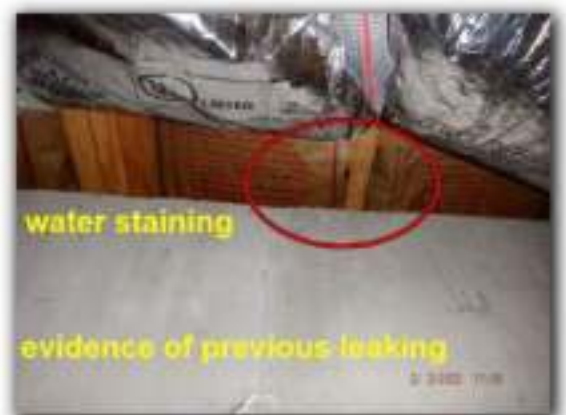
- Water staining and/or leaking was observed on the basement ceiling (insulation) in the small hidden room behind the moveable bookcase at the bottom of the stairs. The cause and remedy should be further evaluated and corrected as necessary.

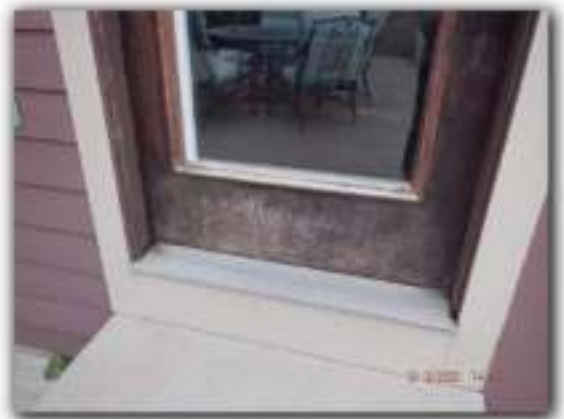
- The living room (left side) sliding glass door lock does not appear to be functioning properly.
- One or both of the living room sliding glass door(s) is not rolling smoothly in its tracks. Adjustments or Improvements are recommended so the door will function properly when operated.
- One or more of the back exterior doors has surface damage and/or deterioration on the outside.

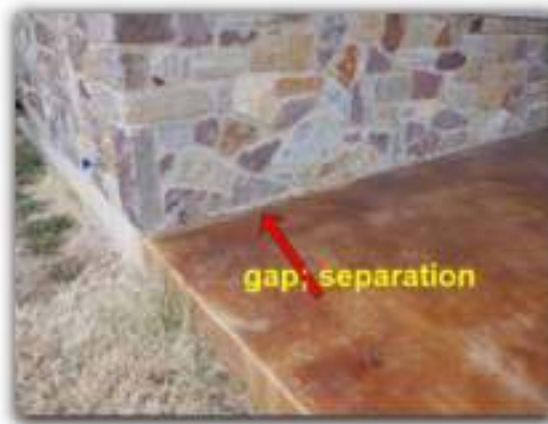
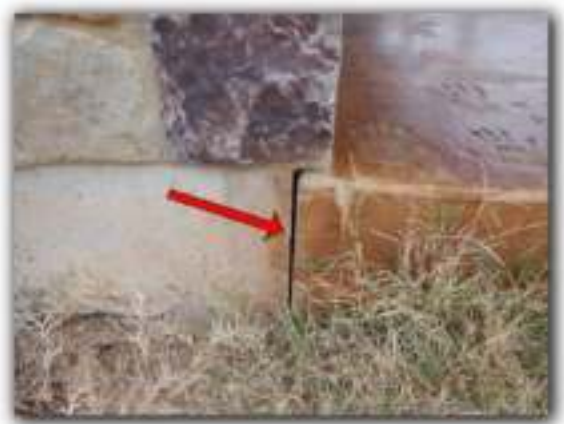
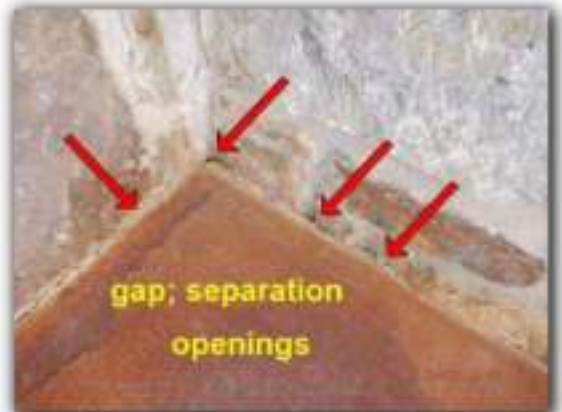
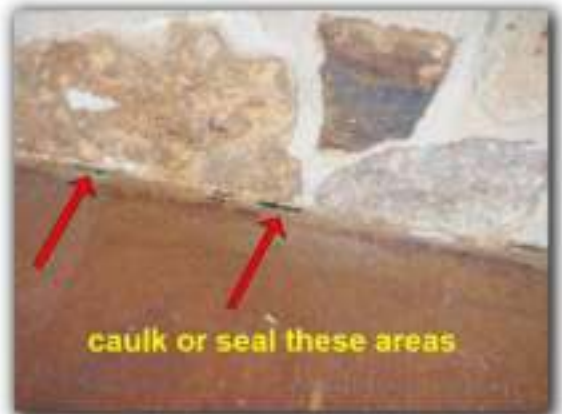
- The front porch appears to have settled somewhat; visibly at the front left side/corner. Recommend further evaluation to determine the cause and possible remedy if necessary.
- There were several areas observed where the concrete porches have gaps or openings at the foundation; these areas need to be properly sealed to keep out unwanted water intrusion to the basement area.

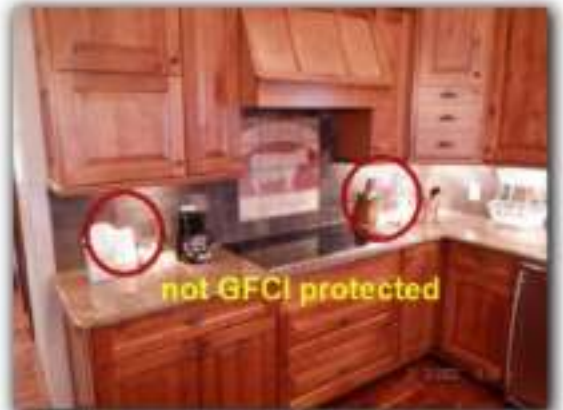
- Not all of the kitchen counter top receptacles appear to be connected to a ground fault circuit interrupter (GFCI) device. Under current electrical standards, all of the kitchen counter top receptacles should have GFCI protection.
- **Note:** Some of the receptacles in the home were inaccessible and could not be reached for inspection due to personal effects, heavy storage, furniture or conditions outside the control of the inspector.

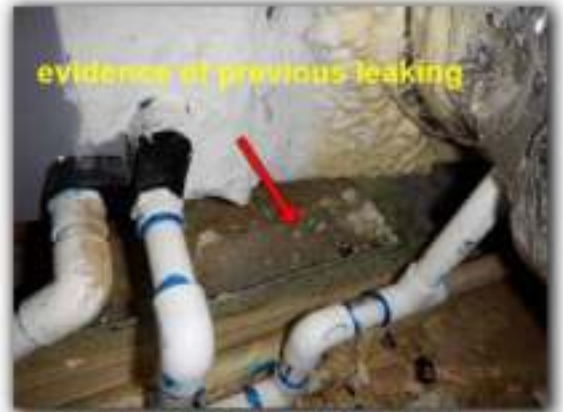
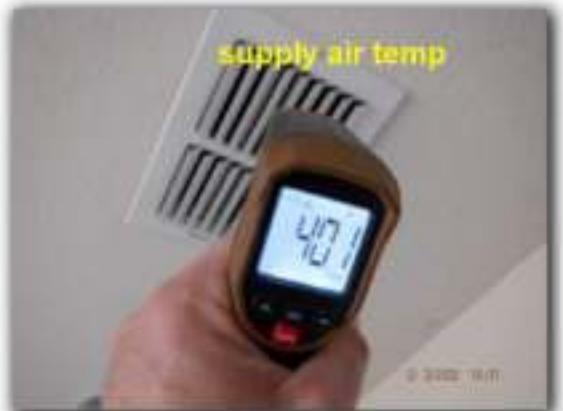
- The auxiliary/secondary drain pan under the indoor coil housing of the cooling system has some water staining and/or rust build-up. This would indicate that the pan has held water in the past and should be closely monitored. It is recommended to have the cooling system further evaluated and serviced.
- Note: The auxiliary/secondary drain pan under the coil housing should be free of all debris. The debris in the pan could clog the drain line and cause water to leak to the interior of the house.

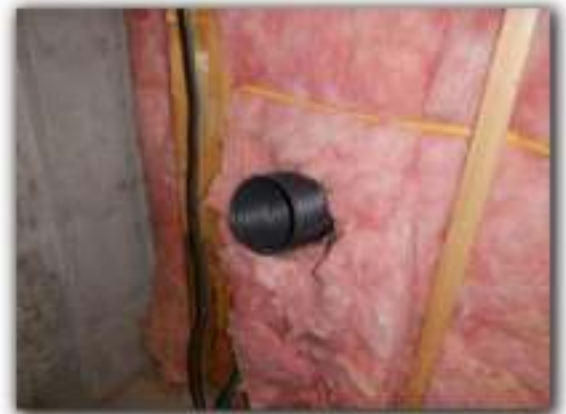
- The basement portable cooling system exhaust duct vents into the equipment room and not to the exterior.

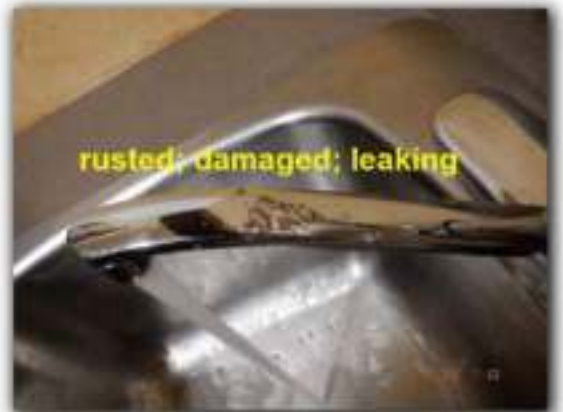
- The faucet fixture was rusted or damaged and leaking at the fill spout; recommend replacement.

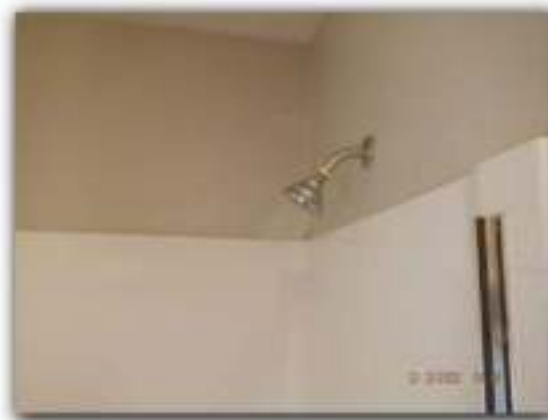
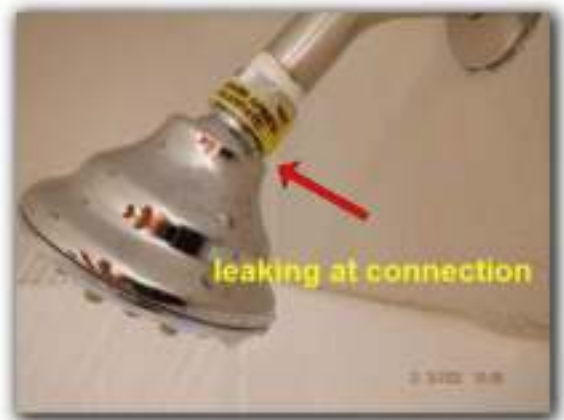
- The shower head is leaking and/or may be damaged; repair or replace as necessary.

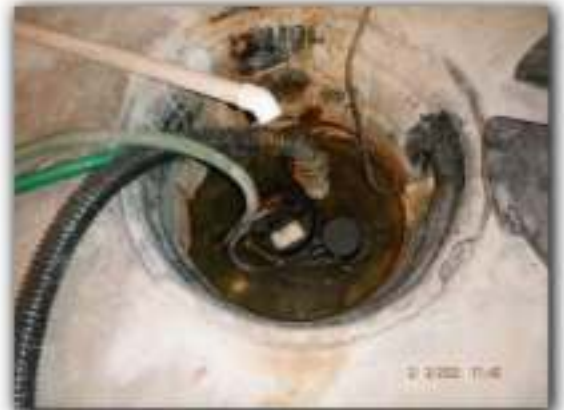
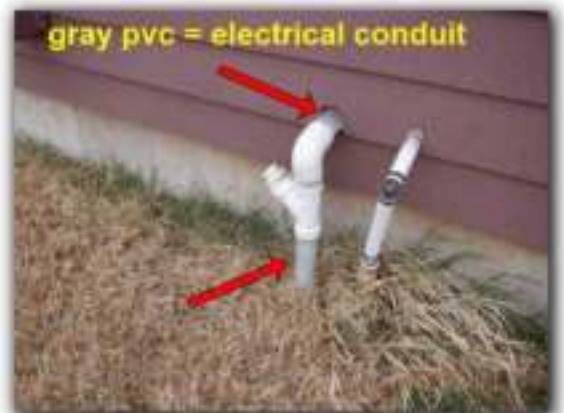
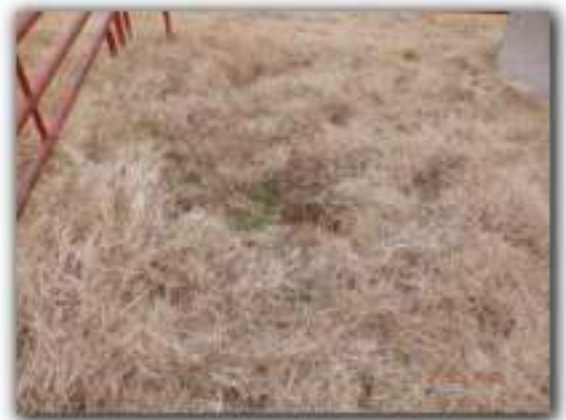
- The PVC drain piping for the sump pump is exposed on the back side of the structure; and showing signs of deterioration. Also, the drain piping is not the correct type of material; appears that some is for electrical use. It is recommended to replace at least this section of exposed drain piping.
- It should be noted that it appears the sump pump is draining to the exterior or out gray water and not into the main sanitary sewer system. This is not considered acceptable practice any longer.

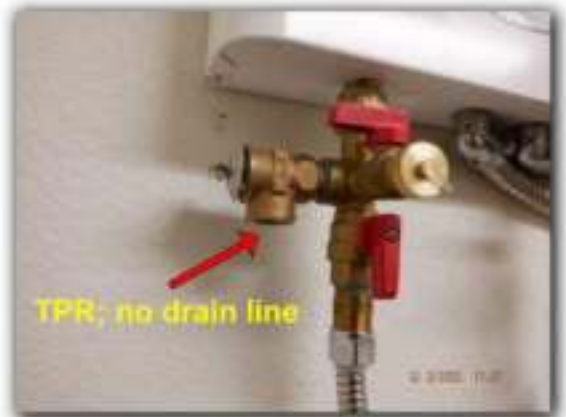
- There is no temperature and pressure relief valve (TPR) discharge pipe in place at the time of this inspection. For safety reasons, it is recommended that a TPR valve discharge pipe be installed. Under current building standards, the discharge pipe should run downward to the exterior of the structure, turn downward, and terminate within 6-inches of the ground.
- There is no safety or emergency drain pan installed under the water heater. Current building standards require a drain pan under all water heaters. However, not all municipalities enforce this requirement for units installed in garages.
