345 Anywhere St Weatherford, TX 76000

> Inspected For: Small Typical Home January 12, 2022

PROPERTY INSPECTION REPORT FORM

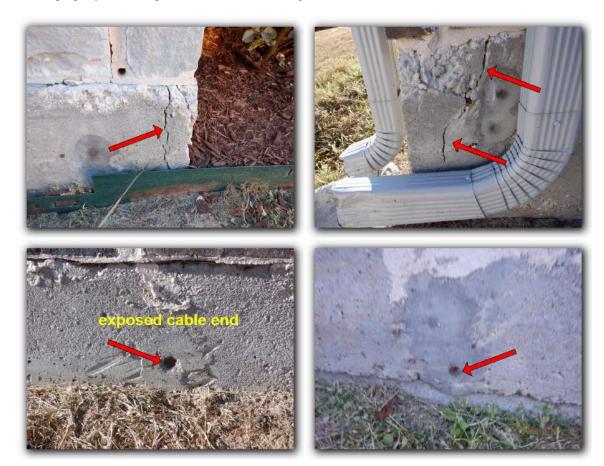
- One or more corners of the foundation were observed to have cracks. This is a common condition in
 many slab on grade foundations. This condition typically does not adversely affect the performance of
 the foundation. However, in some cases, cosmetic improvements may be necessary.
- One or more of the post tension cable ends are exposed on the exterior of the beam wall, and need to be properly sealed to prevent corrosion or rusting.

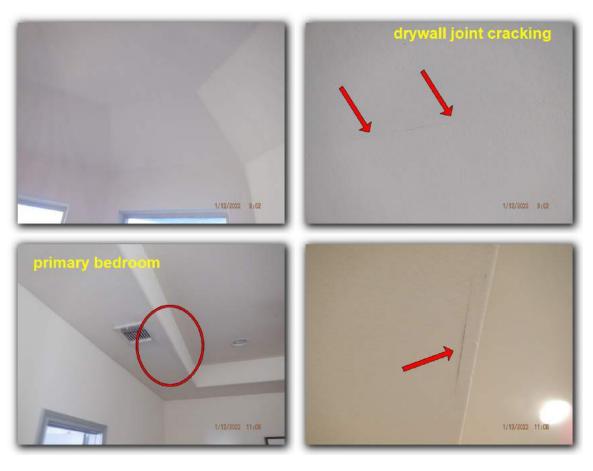
- Ceiling stress or settlement cracks were observed in one or more areas of the home; primarily at the sloped and/or pop-up ceiling areas. Generally, this condition is common and considered cosmetic.
- The tape lines or joints are pulling loose and/or separating at the pop-up ceiling area in the primary bedroom. This condition is sometimes related to adverse foundation performance and should be further evaluated.
