# Under Sandy Boulevard

## Value Engineering Trenchless Solution for Rehabilitation of Trunk Sewer in Portland

Fahim Rahman, P.E.

City of Portland Engineering  
Services, Portland, OR

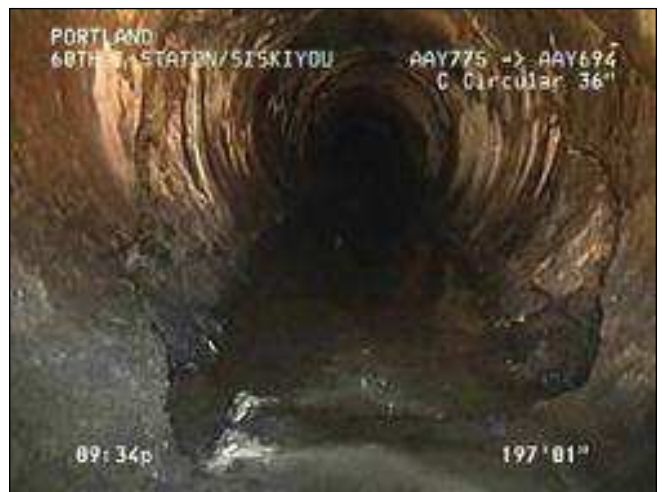
In June 2008, a video inspection was made of Halsey Combined Trunk Sewer in northeast Portland, Oregon. This trunk sewer runs approximately 35 feet beneath NE 60th Avenue and passes underneath Sandy Boulevard, a busy arterial. The video inspection revealed longitudinal cracks in the pipe at 10, 12 and 2 o'clock throughout the entire length from Klickitat Street down to Brazee Street, with ovality of 10-25% in some areas. NE 60th Avenue is only 23 feet wide curb-to-curb; therefore, open-cut replacement was not an acceptable option. The other problem with the trunk sewer was its existing lateral connections to the surrounding properties, made through deep vertical risers. Most of these deep vertical connection risers were found to have settled and dropped into the trunk sewer.

*Existing deteriorated 36-inch sewer pipe*

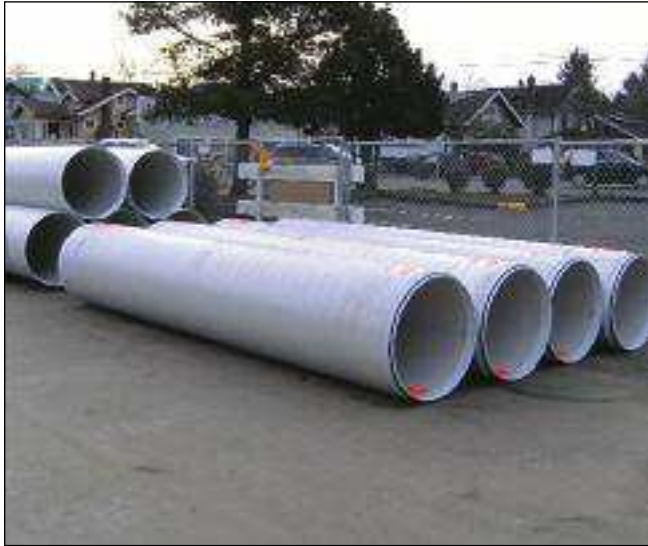
*31-inch ID PVC Vylon pipe*

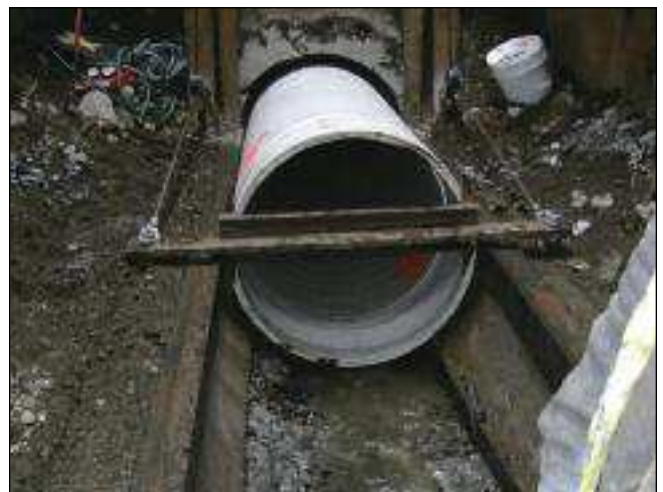
*PVC Vylon pipe being installed*
