Inspection Report

0 Elm St
Danvers MA

Omega Home Inspections, LLC

Date: 3/18/2020	Time: 12:45 PM - 04:15 PM	Report ID: 2020SampleSF
Property: 0 Elm St Danvers MA	Customer: Bob Smith	Real Estate Professional:

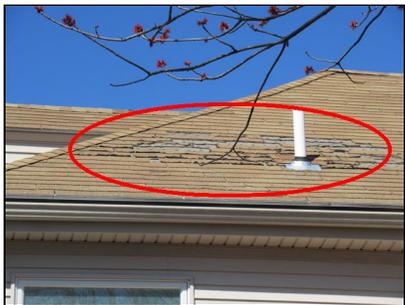
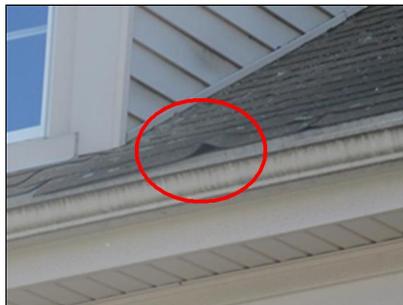
**1.0 (1)** The roof covering on this house was asphalt shingles, which typically last between 20 and 30 years. This roof appeared to be 30-35 years old. The shingles were brittle and crumbling at the back side of the house. This roof is fully depreciated. There were also two layers of shingles on this roof. Upon replacement both layers of shingles will have to be stripped off and a new layer applied directly over the roof sheathing. This will add to the cost of roof replacement. I recommend that a licensed roofer replace this roof.

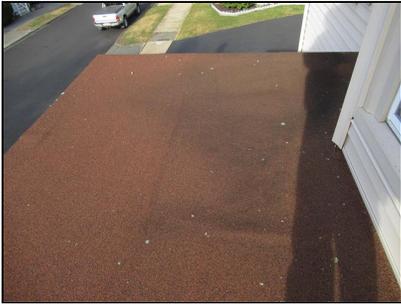
1.0 (2) There was a rolled asphalt roof above the front porch. This roof generally lasts between 15-20 years. This roof appeared to be 10-15 years old. This is for your information.

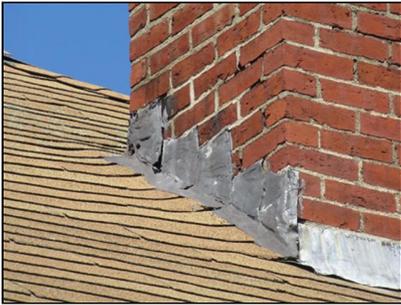
1.1 The chimney flashing was tarred over. If flashing is installed properly tar is not necessary. The flashing may have been tarred because of a leak at the chimney penetration through the roof. When the roof is replaced I recommend that the old flashing is removed and new flashing be installed properly at the chimney.

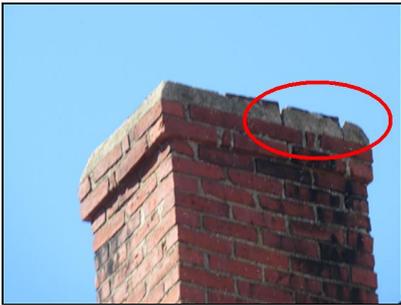
1.2 The chimney crown, a beveled layer of concrete applied to the top of the chimney to promote proper water run off, was decayed. There were cracks in the crown. Water may enter these cracks, freeze in cold weather, and cause further damage. Water can also seep down the chimney and into the house. I recommend that a masonry contractor repair this crown, or install a stainless steel cap over the entire chimney.

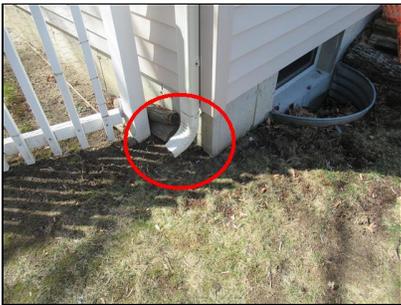
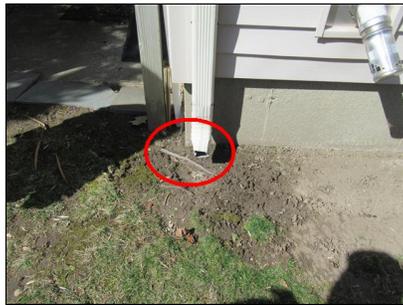
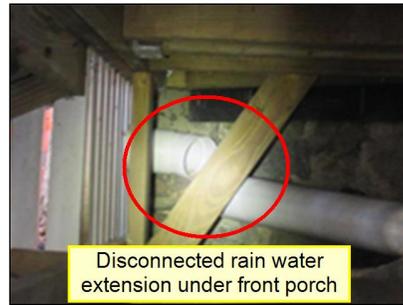
1.3 There were missing and disconnected downspout extensions. Downspouts carry roof water to the ground and should have extensions that direct the water to an appropriate distance, 5 or 6 feet, from the foundation. If there are no downspout extensions, or if the extensions are too short, the roof water may eventually end up in the basement. I recommend that downspout extensions be installed to carry the water to an appropriate distance from the house.

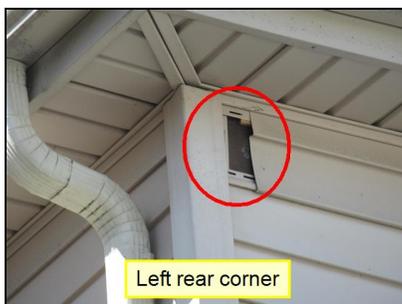
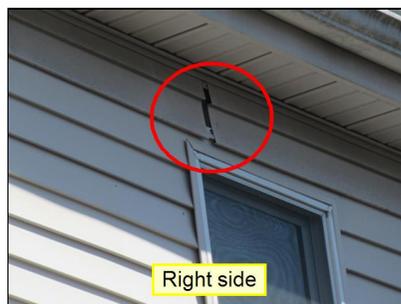
2.0 (2) There were a couple of places under the eaves where the vinyl siding panels did not overlap. I recommend that a siding company replace one of these panels with a longer panel to ensure proper overlap of the panels. I recommend that the siding company inspect the siding on the rest of the building to ensure that there are no other places where there is insufficient overlap of the siding panels.

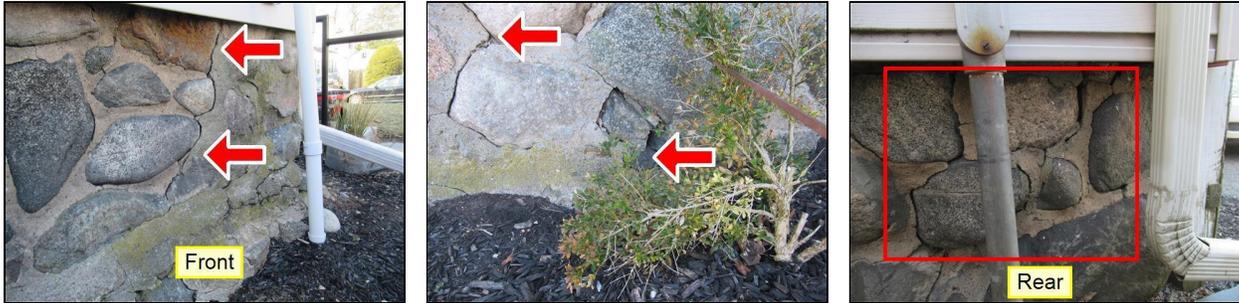
2.2 (1) There was a crack in the foundation at the left front and left rear corner of the house. The cracks appeared to be from settlement. I recommend that these cracks be repaired by a qualified mason and then monitored for further movement.

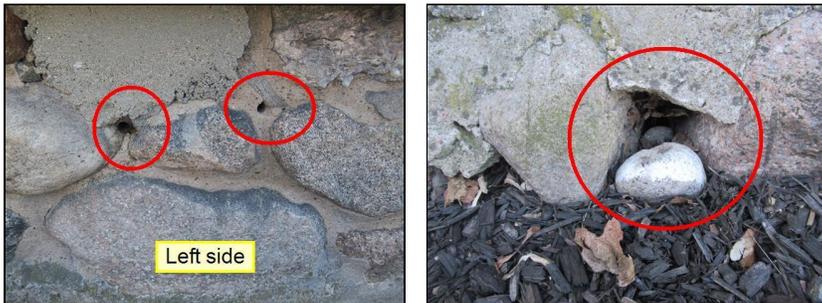
2.2 (2) At various locations around the foundation, the masonry needs re-pointing. Re-pointing is a process where the old grout between the stone is scraped out and new mortar is applied. I recommend that a qualified mason prep and re-point the deteriorated areas.

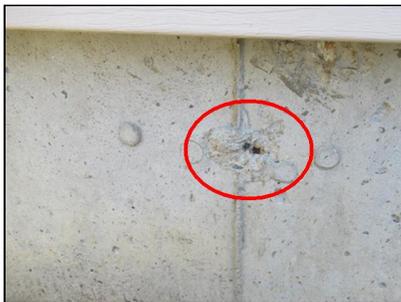
2.2 (3) There were unsealed holes from where form ties had been removed from the foundation at rear addition. Steel form ties are used during construction to keep the forms in place while the concrete foundation is poured. These form ties are then broken off from the interior and exterior and the small voids are filled with concrete. If the form ties are left exposed the metal can expand due to rust. This will crack adjacent areas of the foundation. I recommend that the form ties be sealed with concrete to prevent rusting.

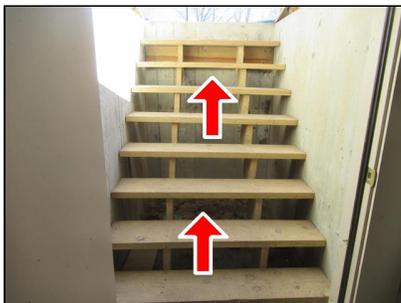
+ 2.6 There were open risers at the bulkhead stairs to the exterior. There is the potential for someone to get their foot caught in one of the steps while ascending the stairs. I recommend that risers be installed at these steps.

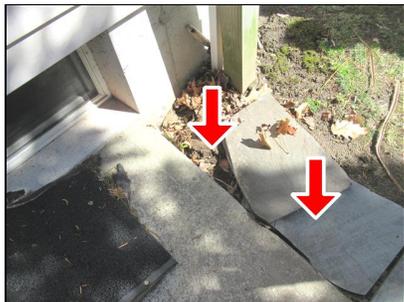
2.8 (2) There were loose blue stone pavers at the right rear walkway adjacent to the concrete landing. This is a tripping hazard. I recommend that the voids underneath these stones be filled with gravel for stability.

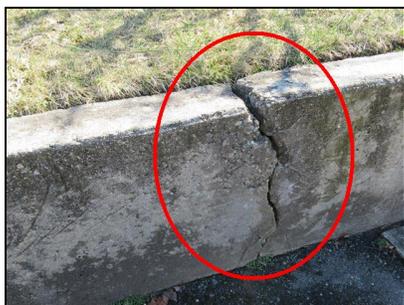
2.9 The masonry retaining wall at the front of the property was cracked. This crack looks as if it was a result of upward pressure, maybe from tree roots of a large tree that has since been removed. I recommend that a qualified mason repair this crack and that it be monitored for any further movement.

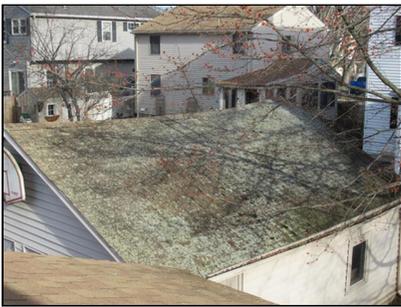
🔨 **3.0 (1)** The roof covering on the garage was asphalt shingles, which typically last between 20 and 30 years. Variations in the quality of manufacture and installation of shingles, weather conditions, and other factors can result in a shorter life span. This roof appeared to be roughly 35-40 plus years old and is fully depreciated. Upon replacement the shingles will have to be stripped off and a new layer applied directly over the roof sheathing. This will add to the cost of roof replacement. I recommend that a licensed roofer replace this roof.

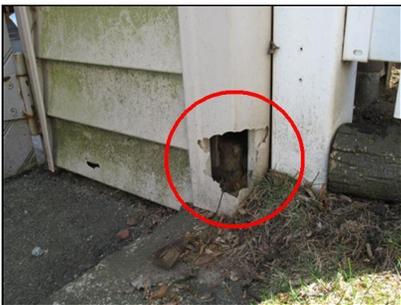
3.0 (2) There were signs of decay/ insect damage at the right front corner of the garage where the trim is damaged. I recommend the decayed areas be repaired or replaced by a licensed contractor.

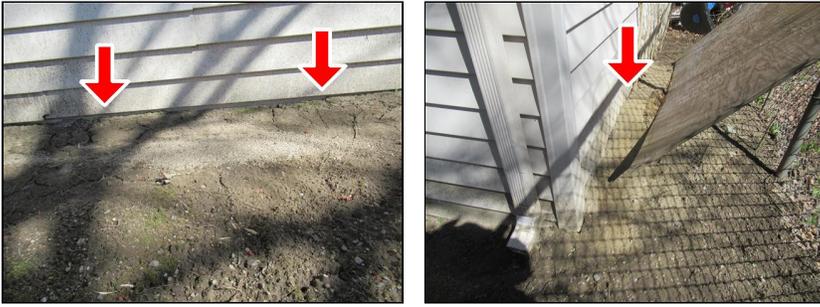
3.0 (3) The vinyl siding around the garage was buried in the ground. The wood structure behind this siding is at risk for wood destroying insect infiltration. I recommend removing the dirt away from the siding or contracting with a pest control company for ongoing monitoring to ensure that the garage stays pest free.

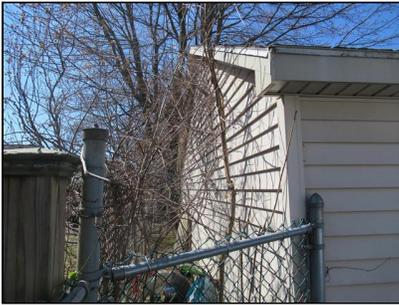
3.0 (4) Vines and brush were growing up against and on the building. Vegetation can damage the siding and trim. I recommend that a landscape contractor remedy this situation.

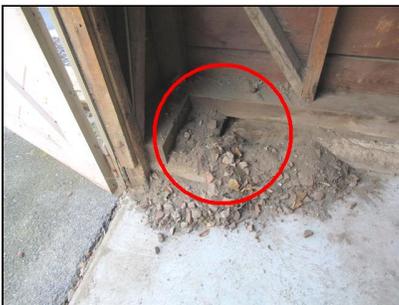
3.1 (1) There was a hole in the concrete sill at the left front of the garage. There were rocks and dirt by the hole suggesting it may be an access point for rodents of some kind. I recommend that the concrete sill be a patched.

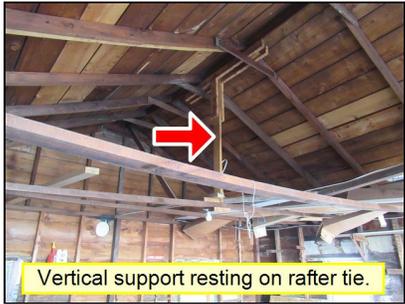
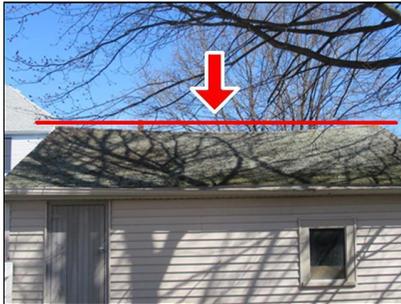
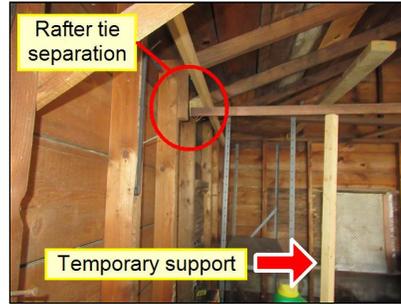
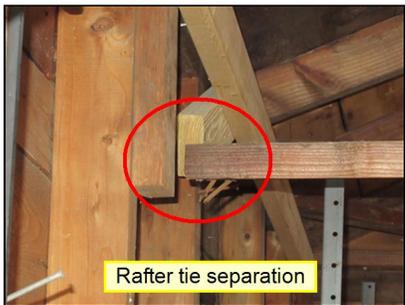
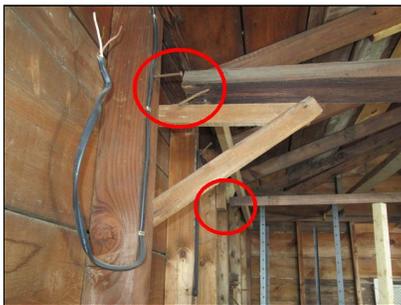
3.1 (2) The rafter ties have detached from the wall structure on the left side allowing the walls to bow outward and the roof structure to sag. There are several temporary measures in place that may or may not be supporting the existing structure. It's hard to determine how long the roof will remain in place. I recommend that a licensed contractor investigate and provide repair options based on your budget as soon as possible. I also recommend not parking your cars in the garage or storing anything of value in the garage until the structure can be evaluated by a licensed and qualified contractor.

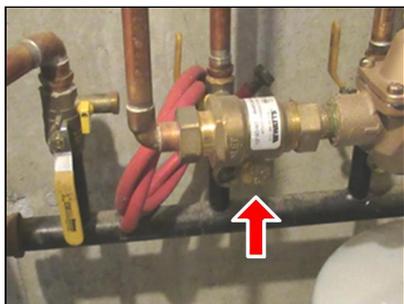
+ 5.2 (1) The extension on the boiler back flow preventer was missing. All boilers are required to have a back flow preventer with an extension to release hot water and steam if there is a drop in the municipal water supply. These prevent cross connection of waste water and supply water. The extension should end between 6 and 12 inches from the floor so that a person will not get scalded should the back flow preventer release. A boiler without a back flow preventer or an improper extension is a safety hazard. I recommend that a licensed plumber remedy this situation.

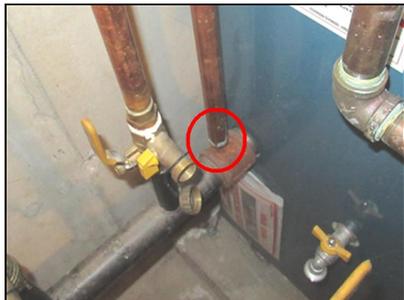
+ 5.2 (2) The pressure relief valve extension on the boiler was poorly located in that it is directly above one of the boiler pipes and too short. All boilers are required to have a pressure relief valve with an extension to release hot water and steam if the boiler is not functioning properly. The extension should end between 6 and 12 inches from the floor so that a person will not get scalded should the boiler malfunction. A boiler without a pressure relief valve or an improper extension is a safety hazard. I recommend that a licensed plumber remedy this situation.

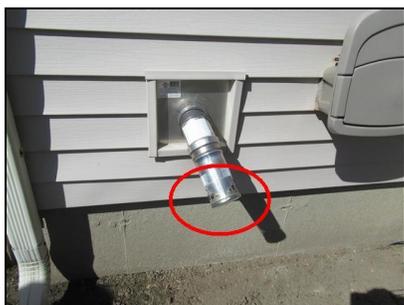
+ 5.3 There was a gas exhaust vent at the rear of the building. This vent was roughly 1-2 feet off the ground; generally these vents are 3-4 feet off the ground. If this vent becomes covered with snow or other debris the system can vent into the basement creating dangerous carbon monoxide conditions. This is a safety issue. I recommend that this vent be kept clear of snow and other debris at all times.

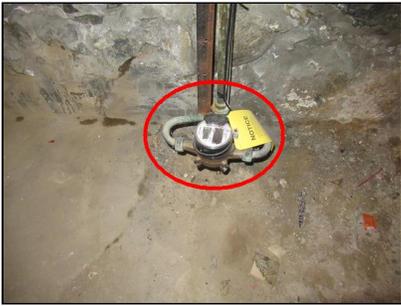
6.0 (2) The main shut off for the water supply was an old gate valve that could fail when used. I recommend that a licensed plumber install a ball valve for ease of use in an emergency.

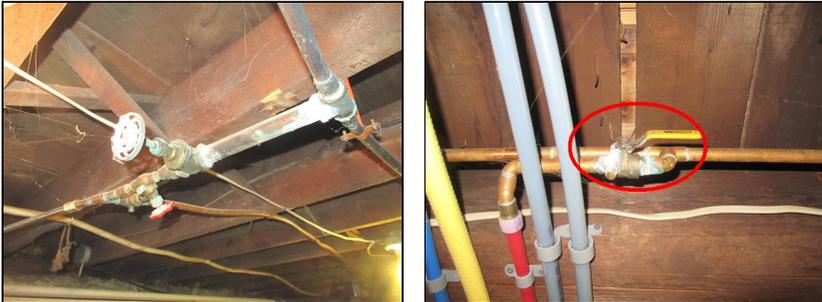
6.1 (1) Starting at the water main, there were corroded water supply pipes and valves in the basement of the original house. In addition to the corrosion, there appeared to be shoddy workmanship with a number of cut, crooked, unsupported and abandoned pipes. I recommend further investigation by a licensed plumber and repair or replacement of the water supply pipes and valves as needed.

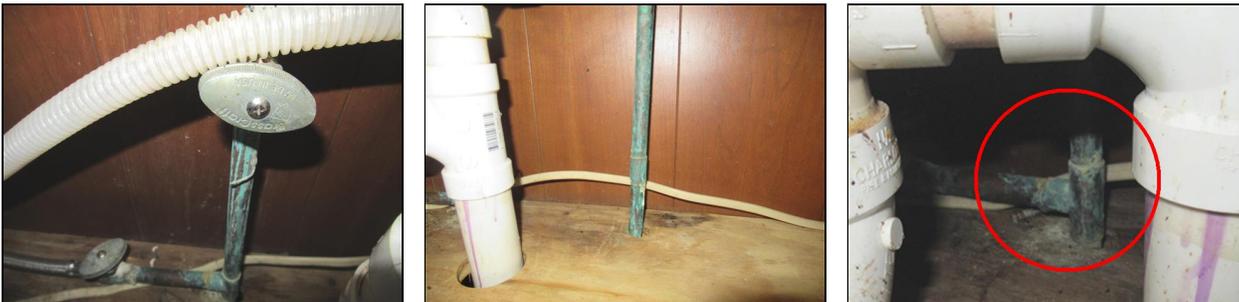
6.1 (2) There were corroded water supply valves and pipes under the kitchen sink. There is the potential for leaks at this location. I recommend that a licensed plumber evaluate and repair or replace these supply pipes and valves.

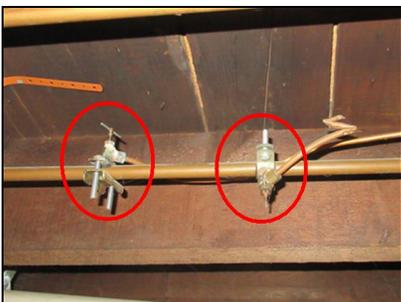
6.1 (3) There were saddle valves in the basement. These valves often leak. I recommend that a licensed plumber replace these valves with a T and a proper shut off valve.

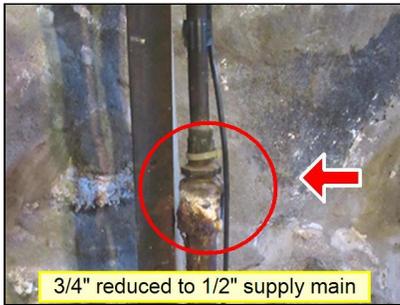
6.1 (4) The supply piping in the house was 1/2 inch copper. Generally the main runs of supply piping are 3/4 inch and the branch piping feeding the individual fixtures is 1/2 inch. 1/2 piping can reduce the water pressure. If found to be a problem the system should be further inspected by a licensed plumber and repaired or replaced as necessary.

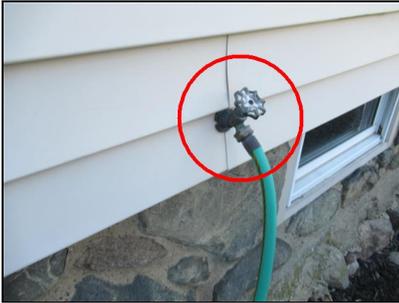
6.2 (2) The exterior hose bib (outdoor faucet) did not have a back flow preventer that removes the potential for a cross connection. If a hose is hooked up to the spigot a cross connection is present. Cross-connections in a plumbing system are a safety issue. A cross-connection is a condition that allows waste water to be siphoned back into the potable water system. I recommend installation of a back flow prevention fitting on the existing hose bib.

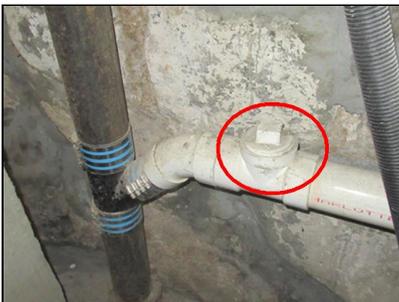
6.4 (1) The main plumbing clean out was located at the rear of the basement. This is for your information.

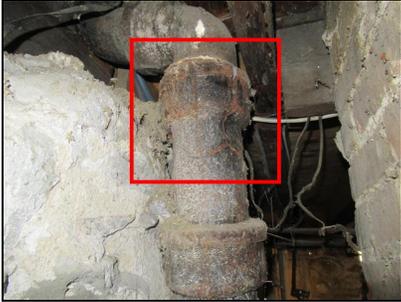
+ 6.4 (2) There was a crack in the cast iron main waste piping behind the chimney. This can vent sewer gas into the home which is considered a safety hazard. I recommend that a licensed plumber repair this section of piping and that consideration be given to replacement of all the cast iron waste pipe if needed. To determine this, I recommend that a reputable sewer waste line inspection company be hired to inspect the interior of the cast iron waste pipe with a camera.

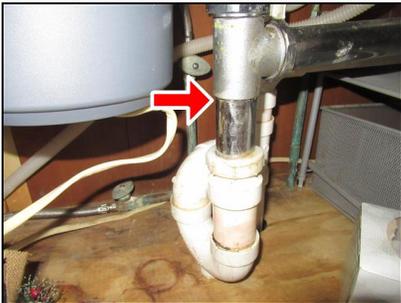
6.4 (4) There was a leak at the tail pipe above the trap below the kitchen sink. I recommend that the leak be repaired by a licensed plumber.

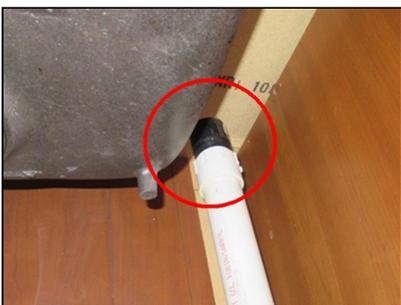
6.4 (5) There was an internal vent at the drain in the kitchen. These vents often malfunction and can allow sewer gasses to enter the house. I recommend further evaluation of this vent by a licensed plumber and installation of proper venting as determined.

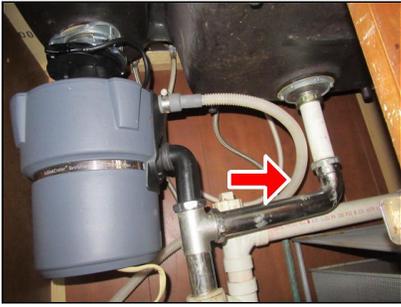
6.4 (6) Under the kitchen sink, the dishwasher high loop drain, was not secured to the underside of the counter. The purpose of this is to create an air-gap so that the contents of the sink don't drain in to the dishwasher. This is a cross connection and considered to be a safety hazard.

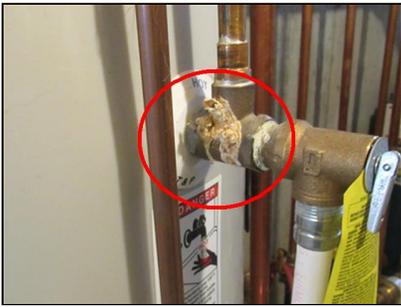
6.5 (2) There was corrosion on the hot water fitting at the pressure relieve valve for the water heater. I recommend that a licensed plumber replace this fitting.

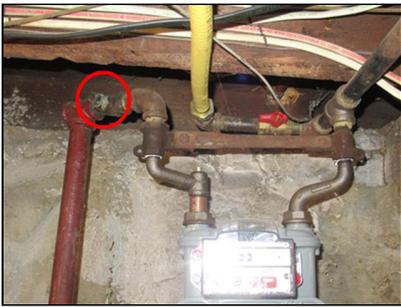
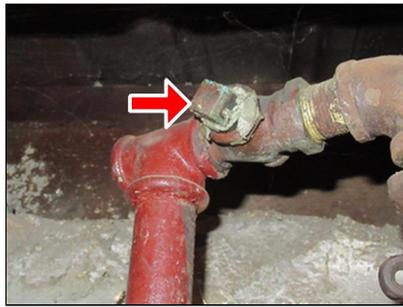
6.9 The main gas shut off was an older ball valve located to the upper left of the gas meter. The valve and pipe aren't marked with an 'on' or 'off' symbol, therefore I recommend that a licensed plumber mark it with an on/off position so it's clear in the event of an emergency. This is for your information.

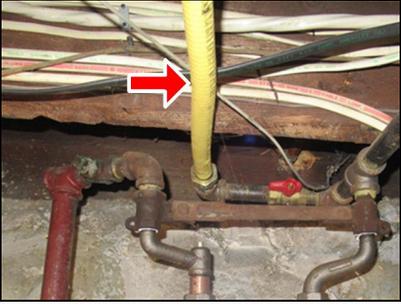
+ 6.10 (1) The natural gas corrugated stainless steel tubing (CSST) in the house was not bonded to the electrical system and is no longer permitted to be installed. In the event of a lightning strike near the property this type of CSST can fail and develop pin holes. I recommend that a licensed plumber bond the gas piping to the main ground or replace the tubing. (There is a new type of CSST that does not fail in this manner.)

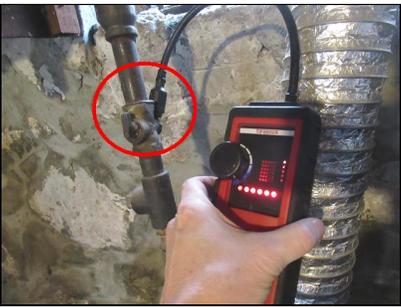
+ 6.10 (2) There was a gas leak at the basement dryer shut off valve. This leak was detected with a TIFFF 8800 combustible gas detector and by smell. I recommend that a licensed plumber repair this leak as soon as possible.

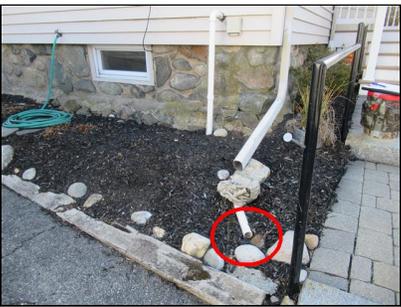
6.11 There was a sump pump discharge pipe at the left front of the building. It is important to keep this pipe free and clear of snow, ice and other debris so that the pump can drain properly. This is for your information.

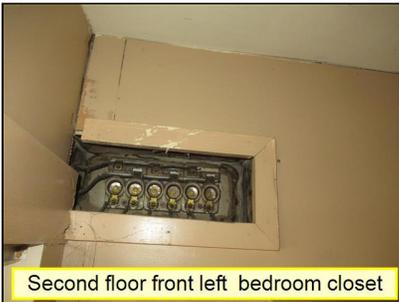
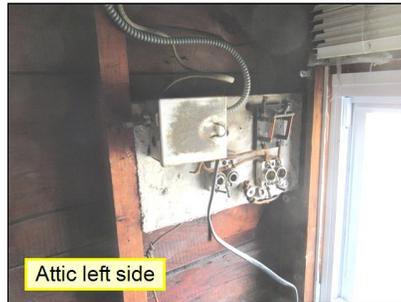
+ 7.3 (1) There were a number of missing and damaged cover plates throughout the house. There were live wires exposed at these locations. I recommend that cover plates be installed.

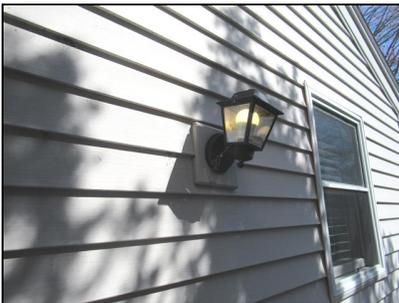
+ 7.3 (2) There was a loose light fixture at the right rear exterior door. All fixtures should be properly affixed to the wall. I recommend that a licensed electrician properly secure this fixture.

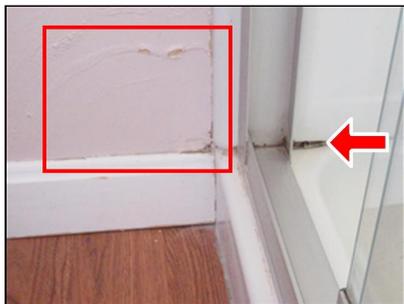
8.0 (2) There were signs of leaks in the wall adjacent to the shower in the second floor bathroom. It may have been leaking under the glass door track and on to the wall. I recommend that old sealant be removed and replaced along the door track and wall/shower pan joint.

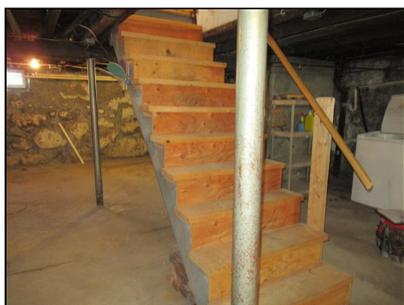
8.2 (1) There was no hand railing at the right side of the basement stairs and the balusters were missing from the left side of the same stairs. All stairs with four risers or more should have a handrail. I recommend that a handrail be installed.

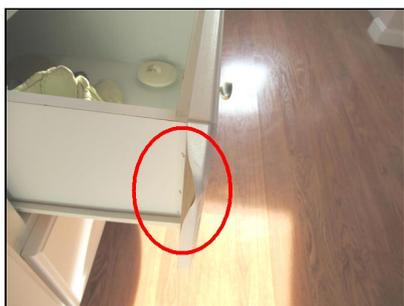
8.3 The protective coating on the left edge of the lavatory drawer in the second floor bathroom was separating from structure underneath. I recommend that a qualified handyman repair this if you feel the need to.

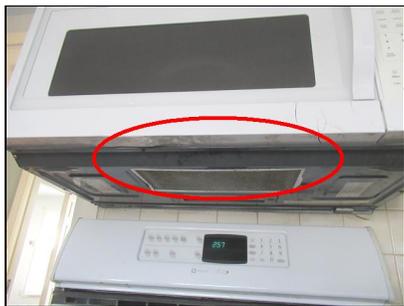
8.4 The microwave oven above the range was damaged. The bottom edge was melted in one place and cracked in another. The microwave was operating at the time of the inspection but it is dangerously close to the burners below..hence the melted edge. You may want to consider replacing this with a smaller unit or a counter top model and then installing a vent hood in its place, which is what was originally there, evidenced by the hole in the cabinet above.

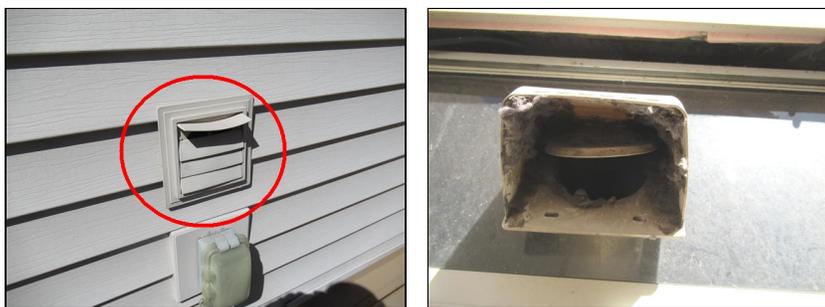
8.5 The exterior flaps on both dryer vent hoods did not close all the way when the dryers were not in use. This reduces the energy efficiency of the house. I recommend that these dryer vent hoods be repaired or replaced.

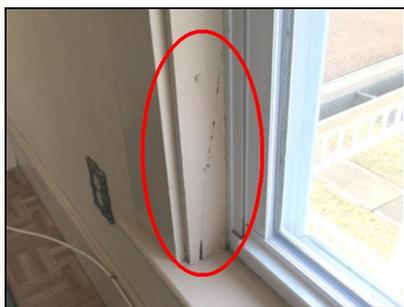
+ **8.7 (1)** The window sash balance system that holds the sashes in place was not functioning at the left side attic dormer and left rear bedroom windows. The top sash dropped suddenly when the sash lock was unlocked. This is a safety hazard. I recommend that a qualified contractor repair these windows.

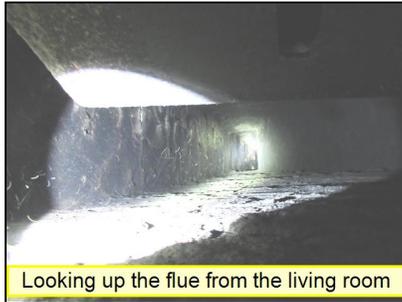
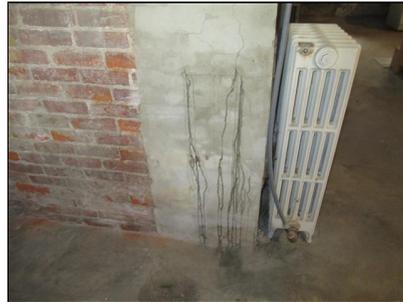
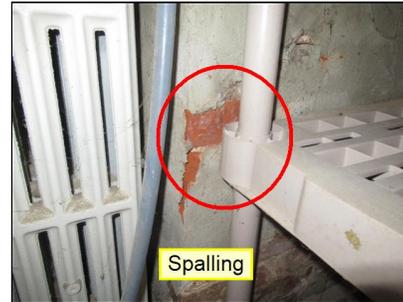
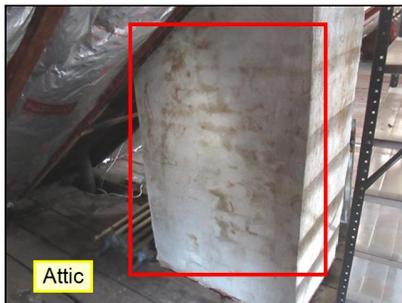
9.1 There was no flue liner which could explain the dark stains coming through the parge coat at the base of the chimney in the basement and up in the attic. The ash pit clean out door was not accessible. I recommend a level 2 chimney inspection be performed by a qualified chimney sweep. Level 2 inspections use a camera that runs into the flues to inspect the condition of the interior of the flues, liners, liner joints etc. Damaged flues can lead to costly repairs. Recommended accreditations for chimney sweeps; CSIA Chimney Sweep Institute of America and NFI National Fire Place Institute.
