Broken Head Quarry

Enforceable Undertaking Progress Report  
Report #6 – January 2019

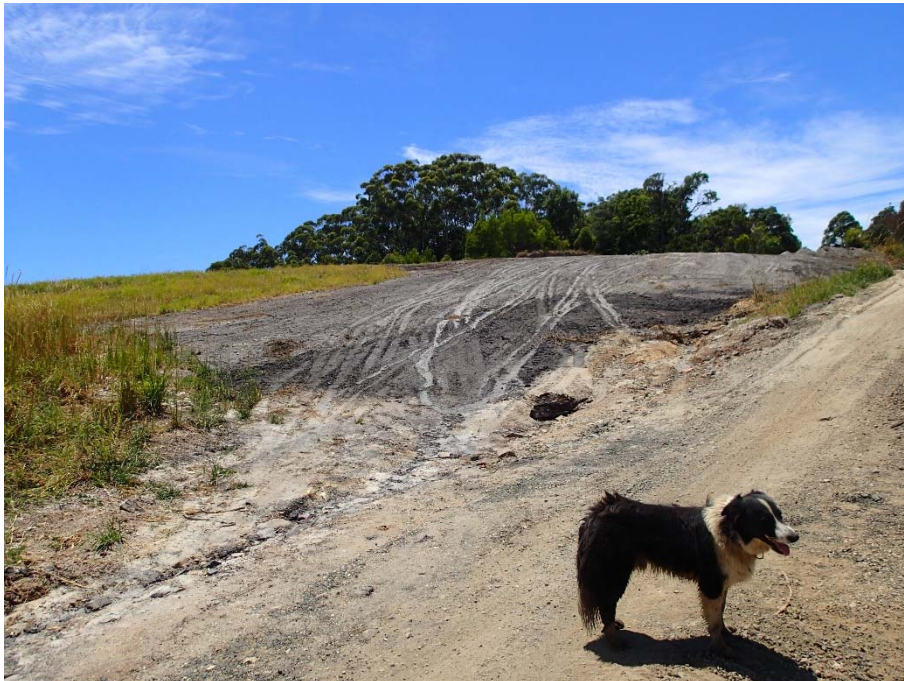
Area PZW11 was completely reprofiled and its final batter shape created and topsoil applied. Grass was not seeded due to unsuitable weather conditions over January 2019, meaning it was unlikely that any germination would be successful. Grass will be seeded when weather conditions are more conducive.

Figure 2 – PZW11 looking northeast from Central Dam bypass road

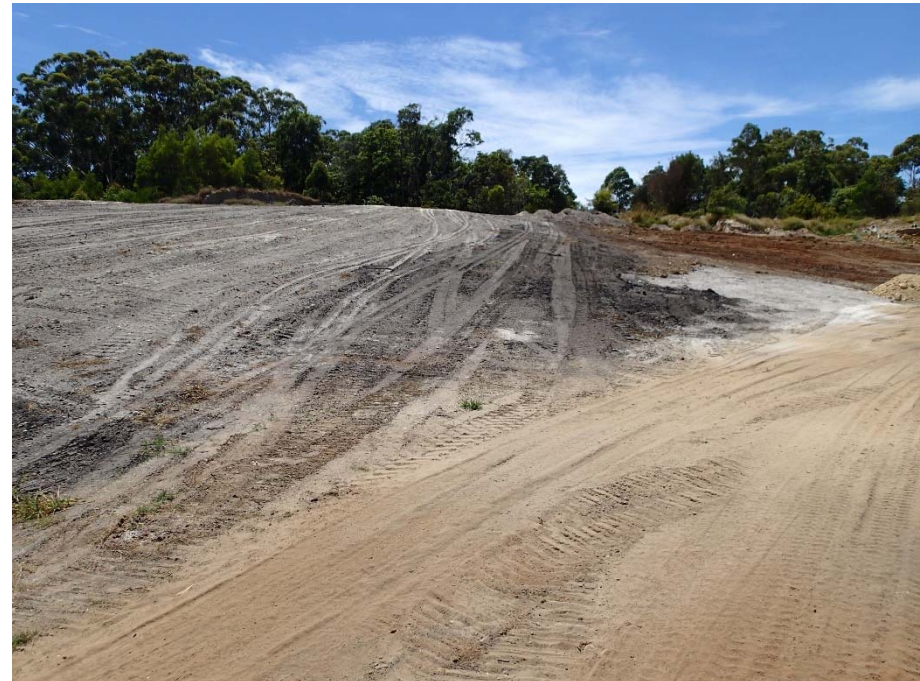
Figure 3 – PZW11 looking east from Central Dam bypass road

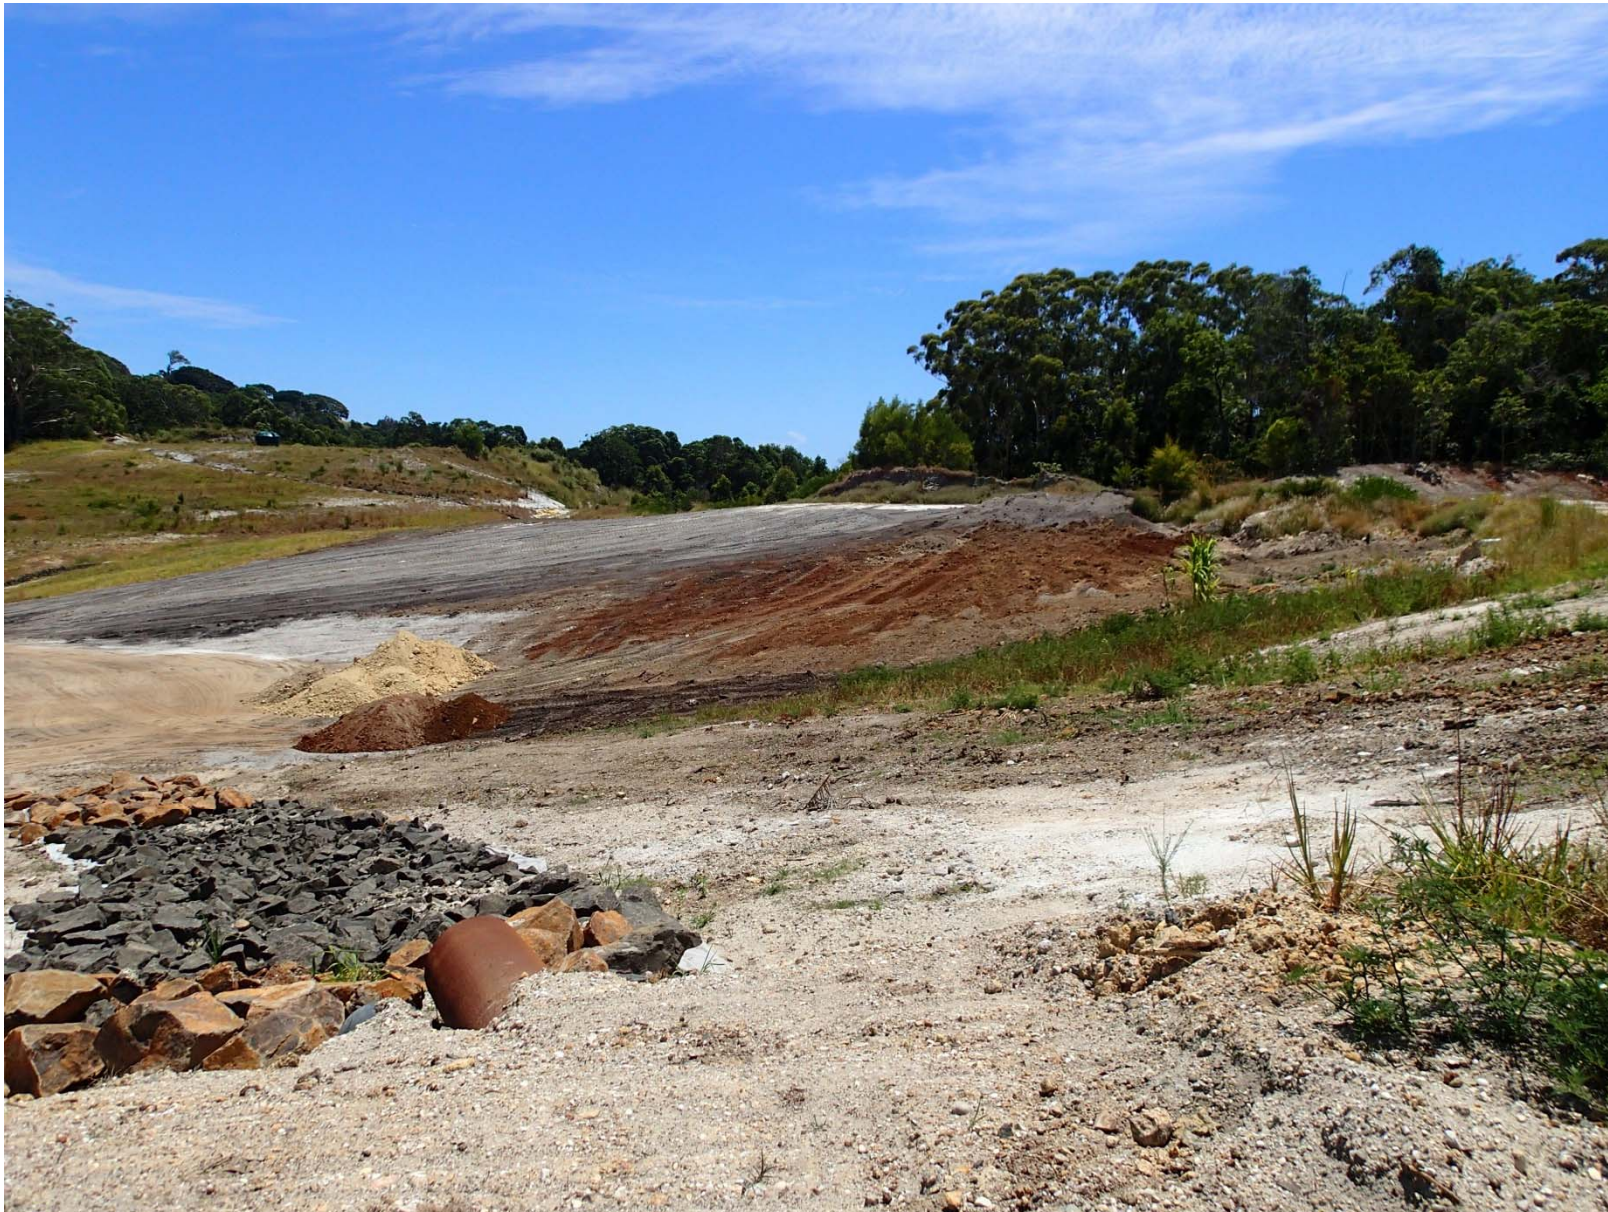
**Figure 4 – PZW11 looking north from PZW24 at top of new drain**

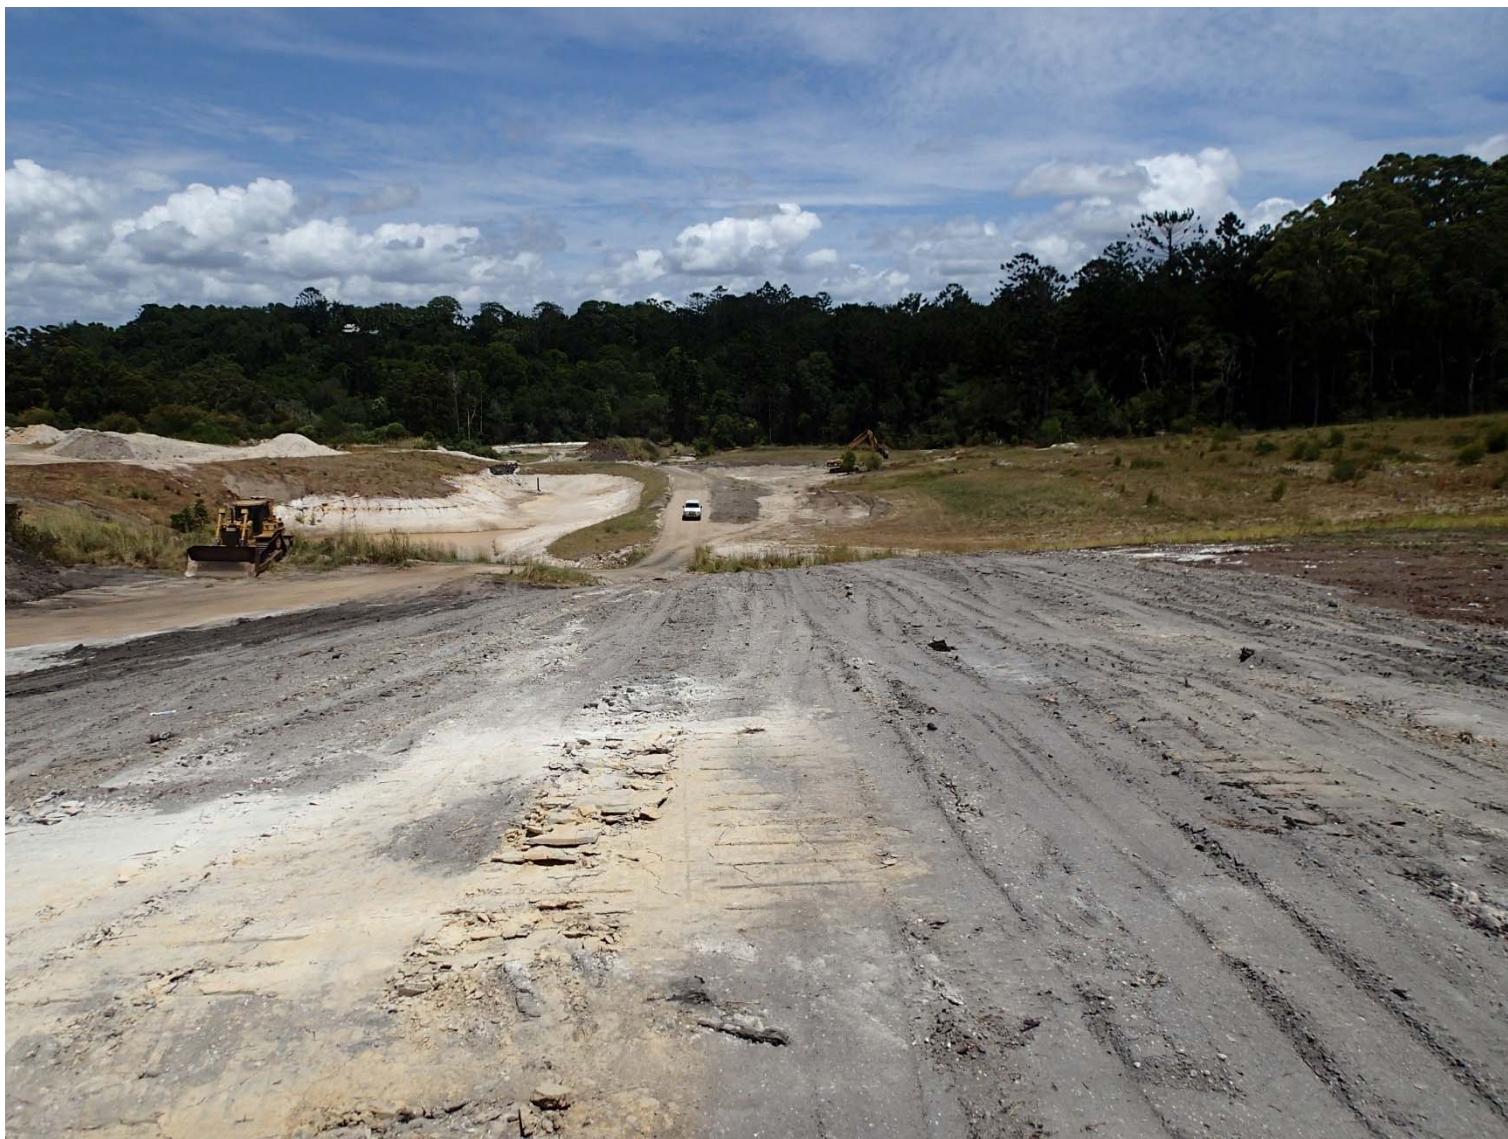
**Figure 5 – PZW11 looking west from top of PZW11 at boundary with PZW24**

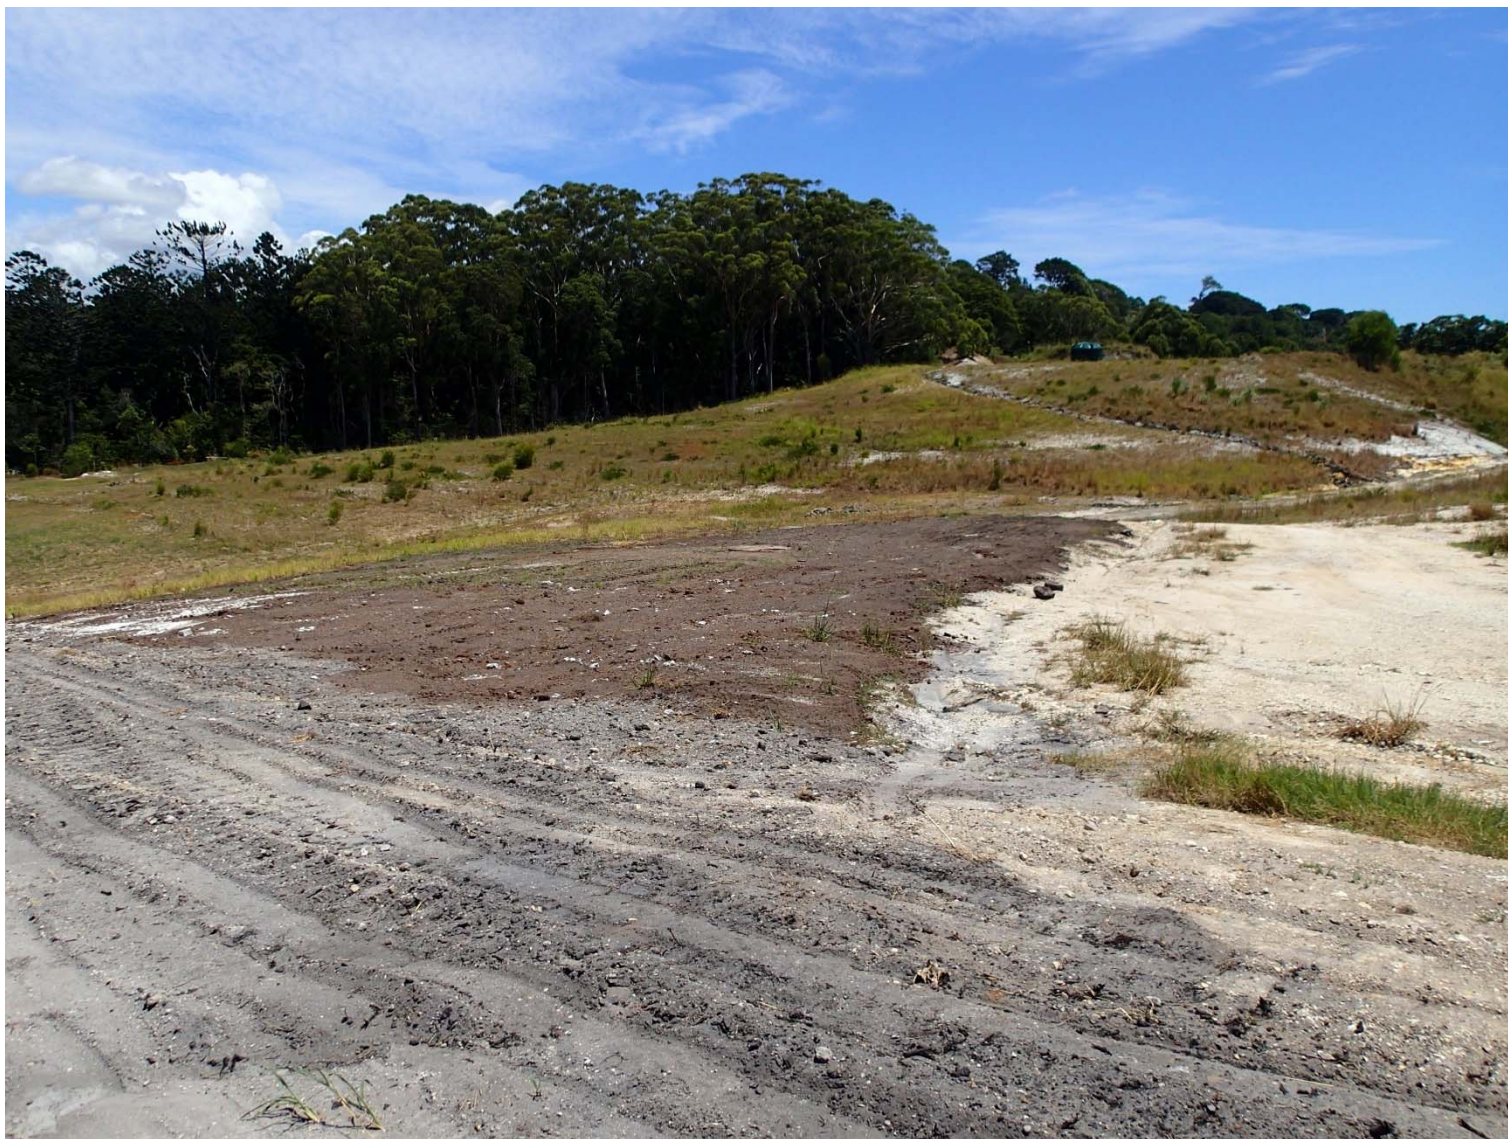
**Figure 6 – PZW11 looking northwest from PZW24 at boundary with PZW24**

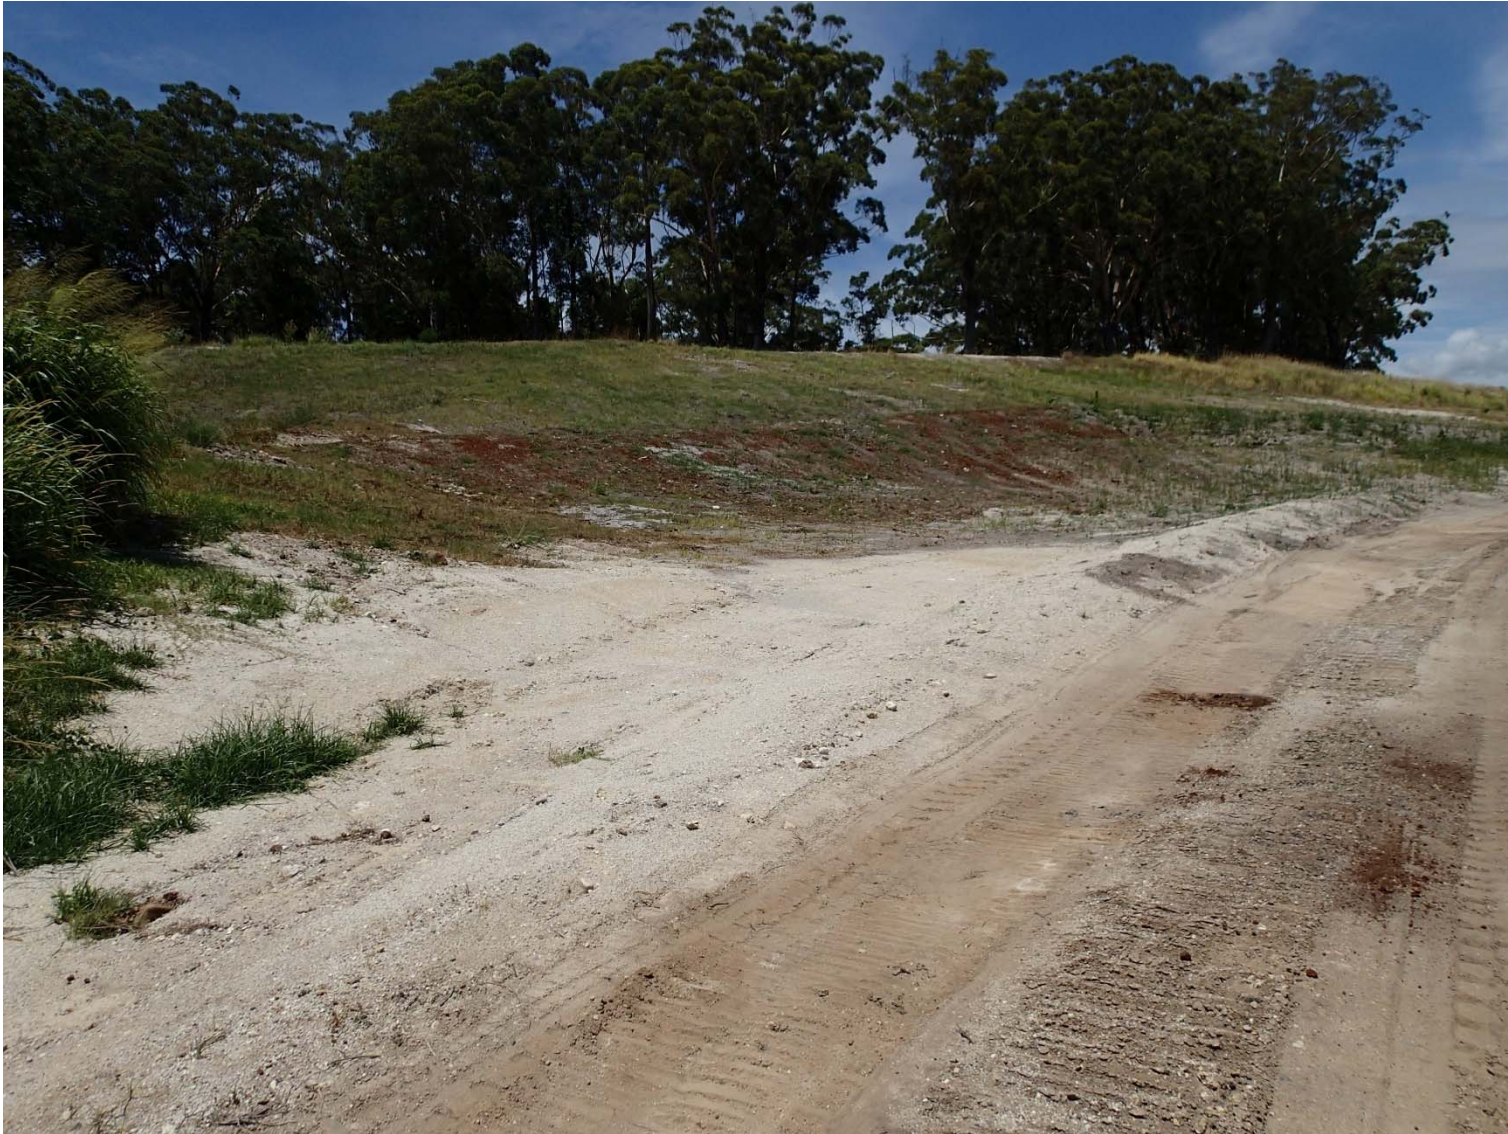
Work continued in area PZW21. In particular the works previously undertaken in PZW21 has been continued further east, with the batter below PZW24 now close to complete. The bund and drain on the lower portion of PZW21 were finalised. A new drain in the midpoint of PZW21 has been installed to manage stormwater run-off from the road and other areas on PZW24 ensuring it flows to the new Central Dam without causing erosion.

**Figure 7 – Finalised batter on eastern part of PZW21 looking southwest towards boundary with PZW23**

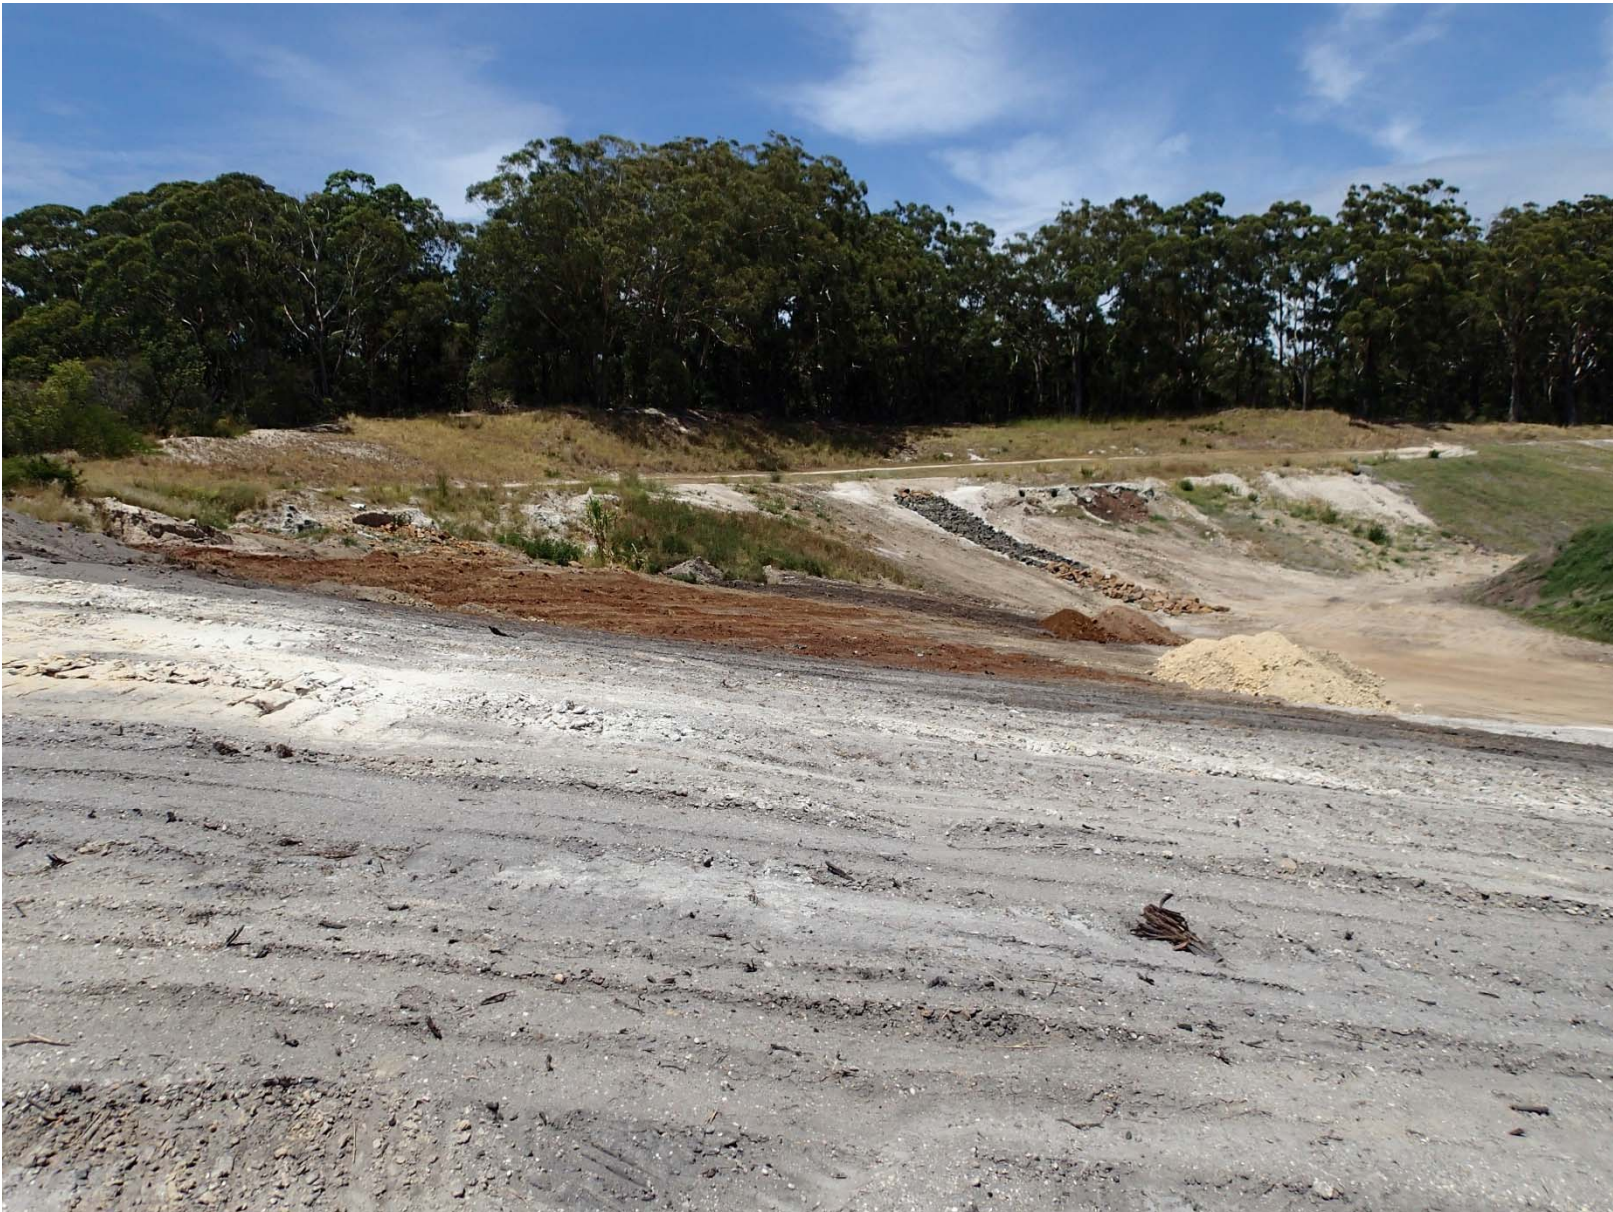
**Figure 8 – PZW21 from PZW11 looking south, new drain in centre**

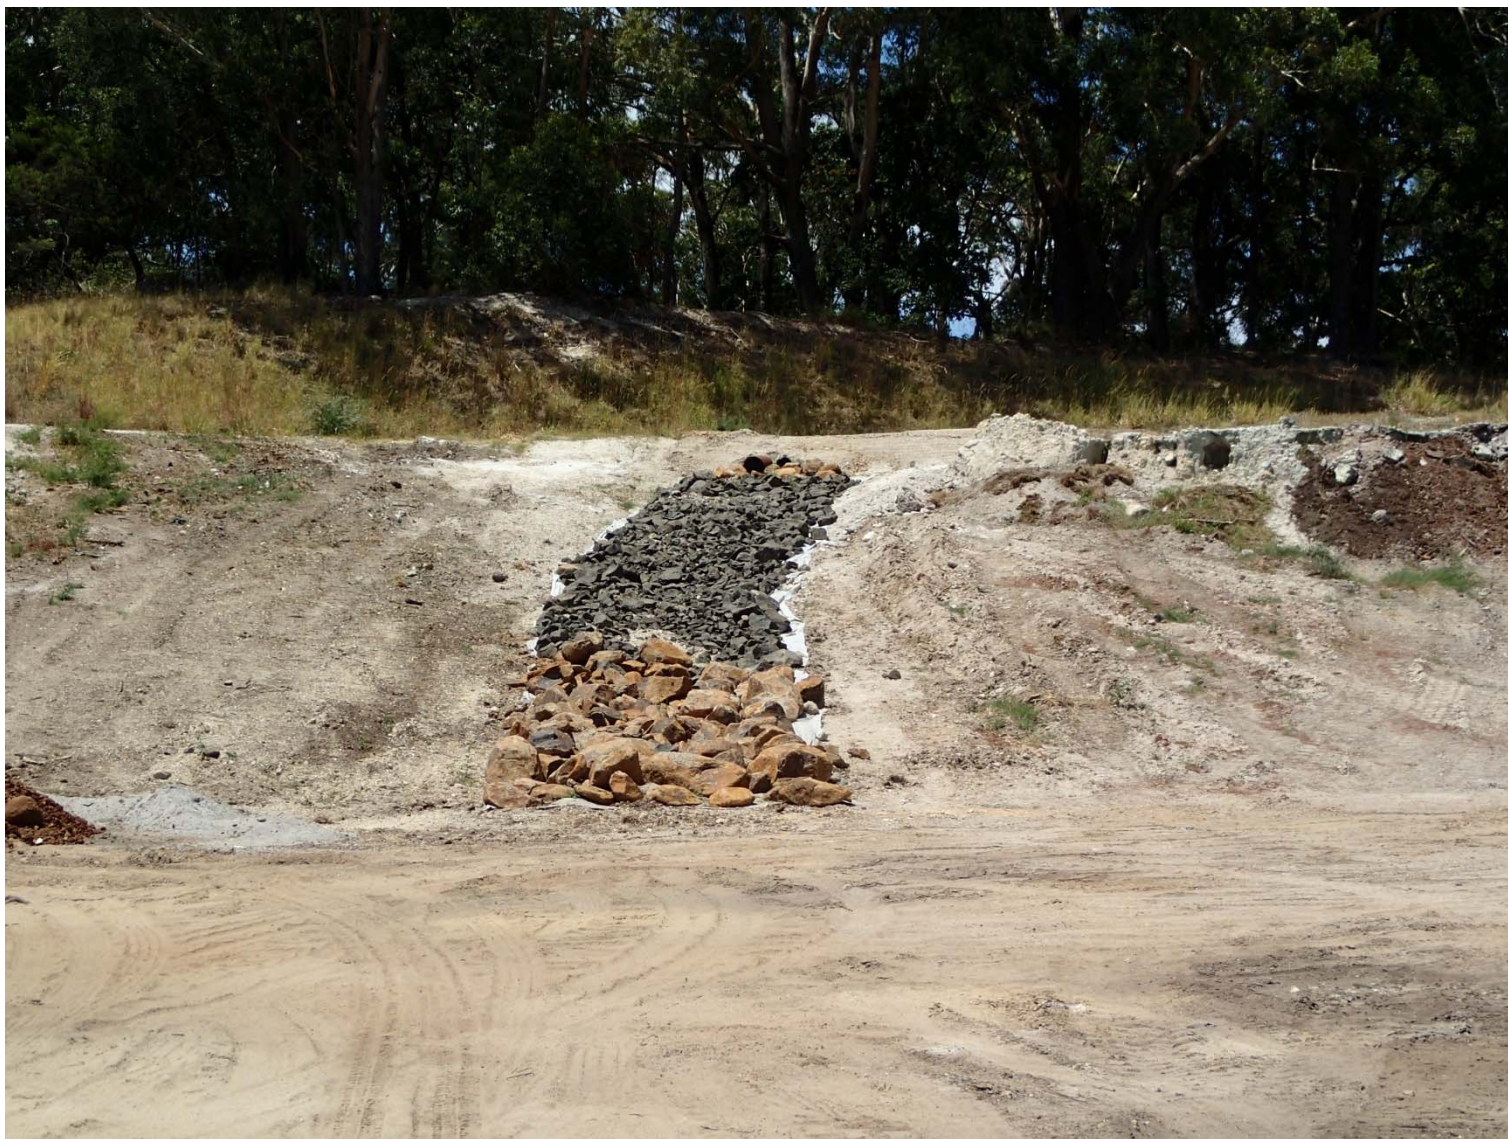
**Figure 9 – New drain in PZW21 looking south from boundary of PZW21 and PZW11**

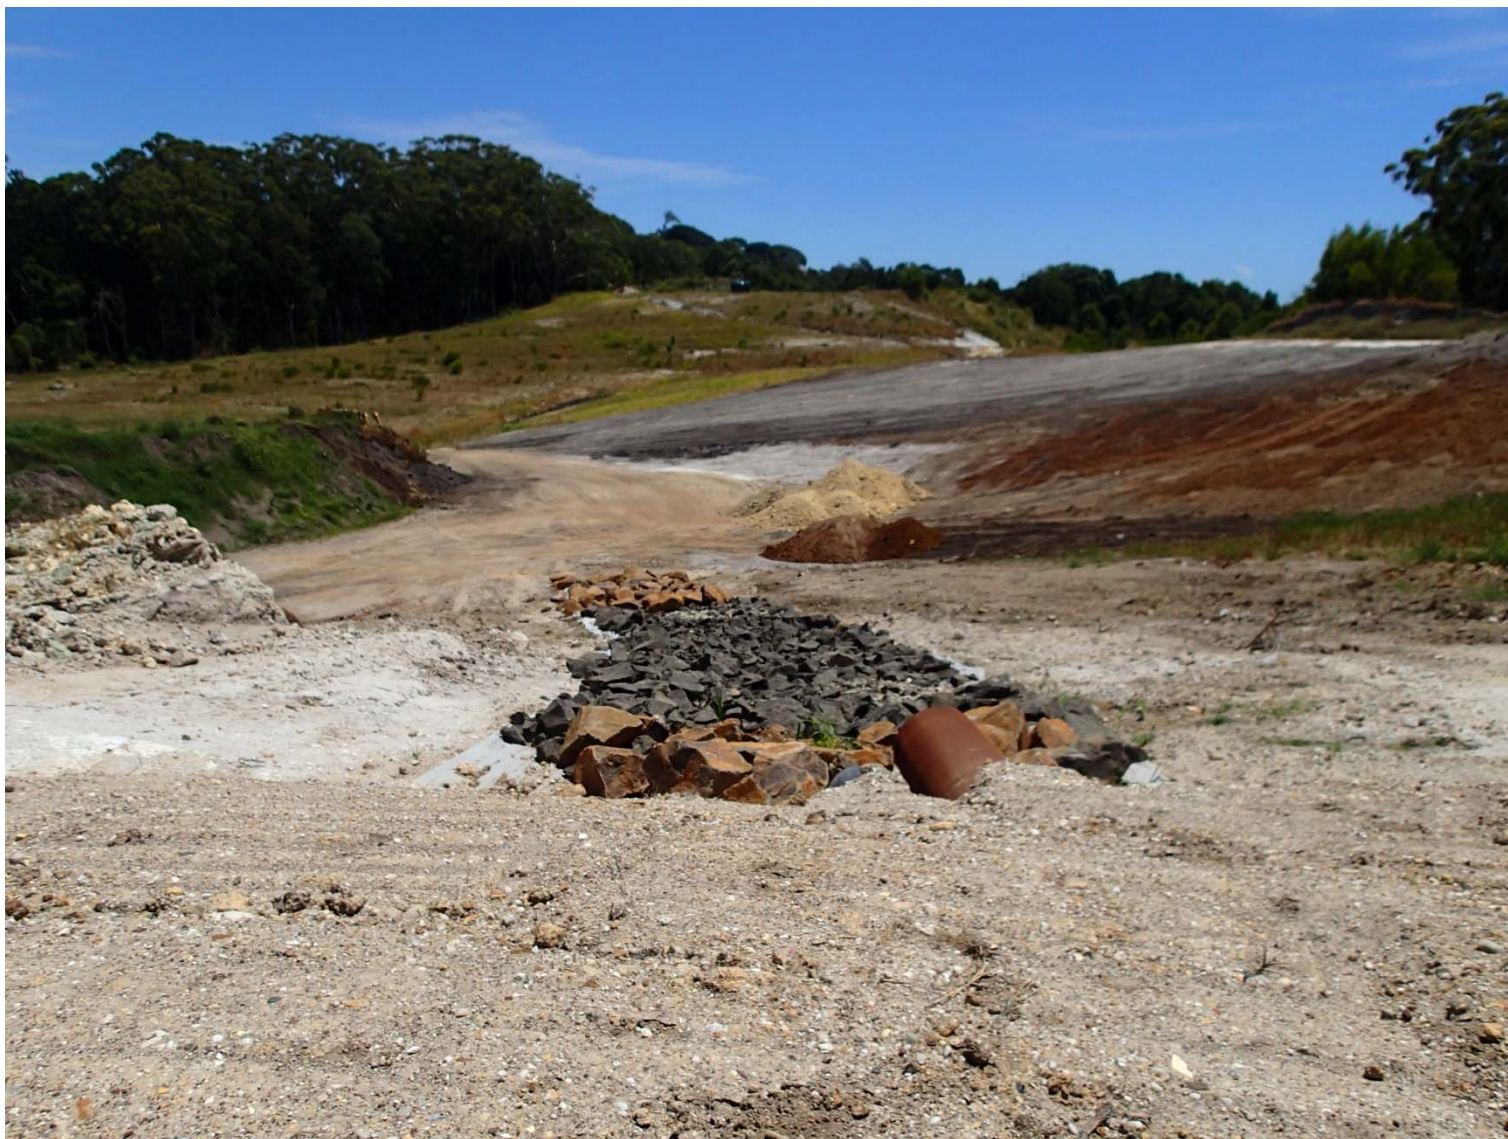
**Figure 10 – New drain in PZW21 looking north from top at boundary of PZW24 towards PZW11**

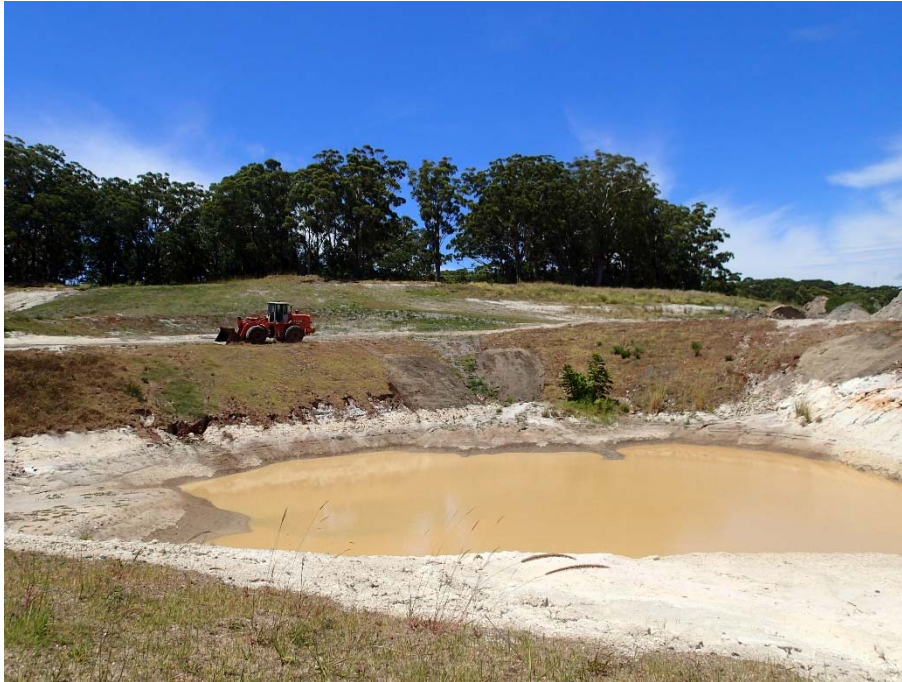
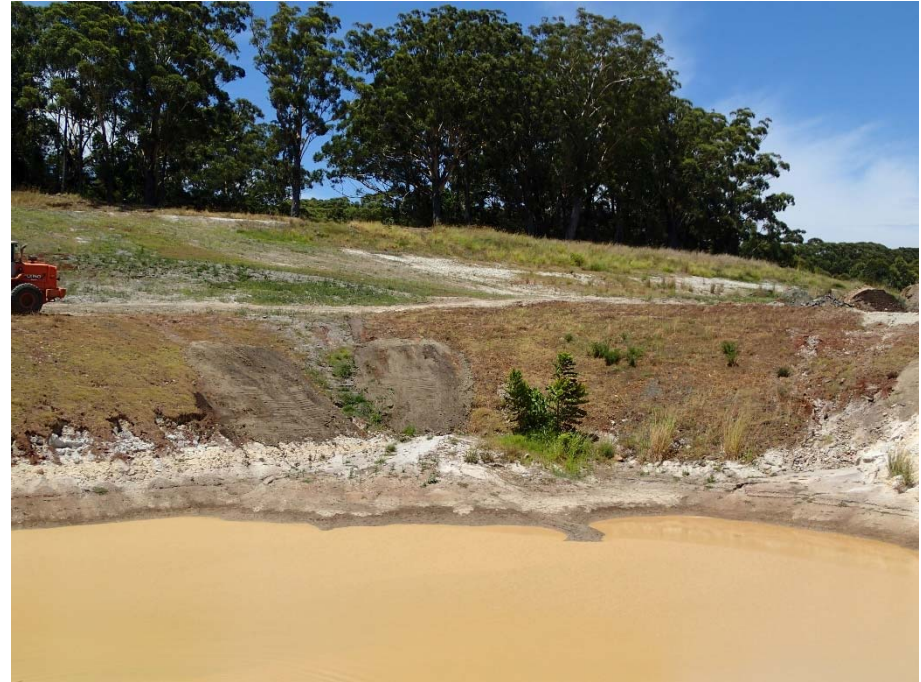
In addition, an inlet watercourse from PZW21 into the new Central Dam that had previously been filled before the diversion bund referred to in paragraph 4.1 of Report #4 was formed had partly eroded (which triggered the need to install that bund). With the installation of the bund, the erosion source has been removed. So this eroded fill has been filled again and is now expected to be stabilised. Other more minor rilling in the southern banks of the new Central Dam have also been filled now the bund is fully installed.

**Figure 11 – PZW21 looking south from Central Dam bypass road showing repaired bank**

**Figure 12 – Zoomed in version of Figure 11**

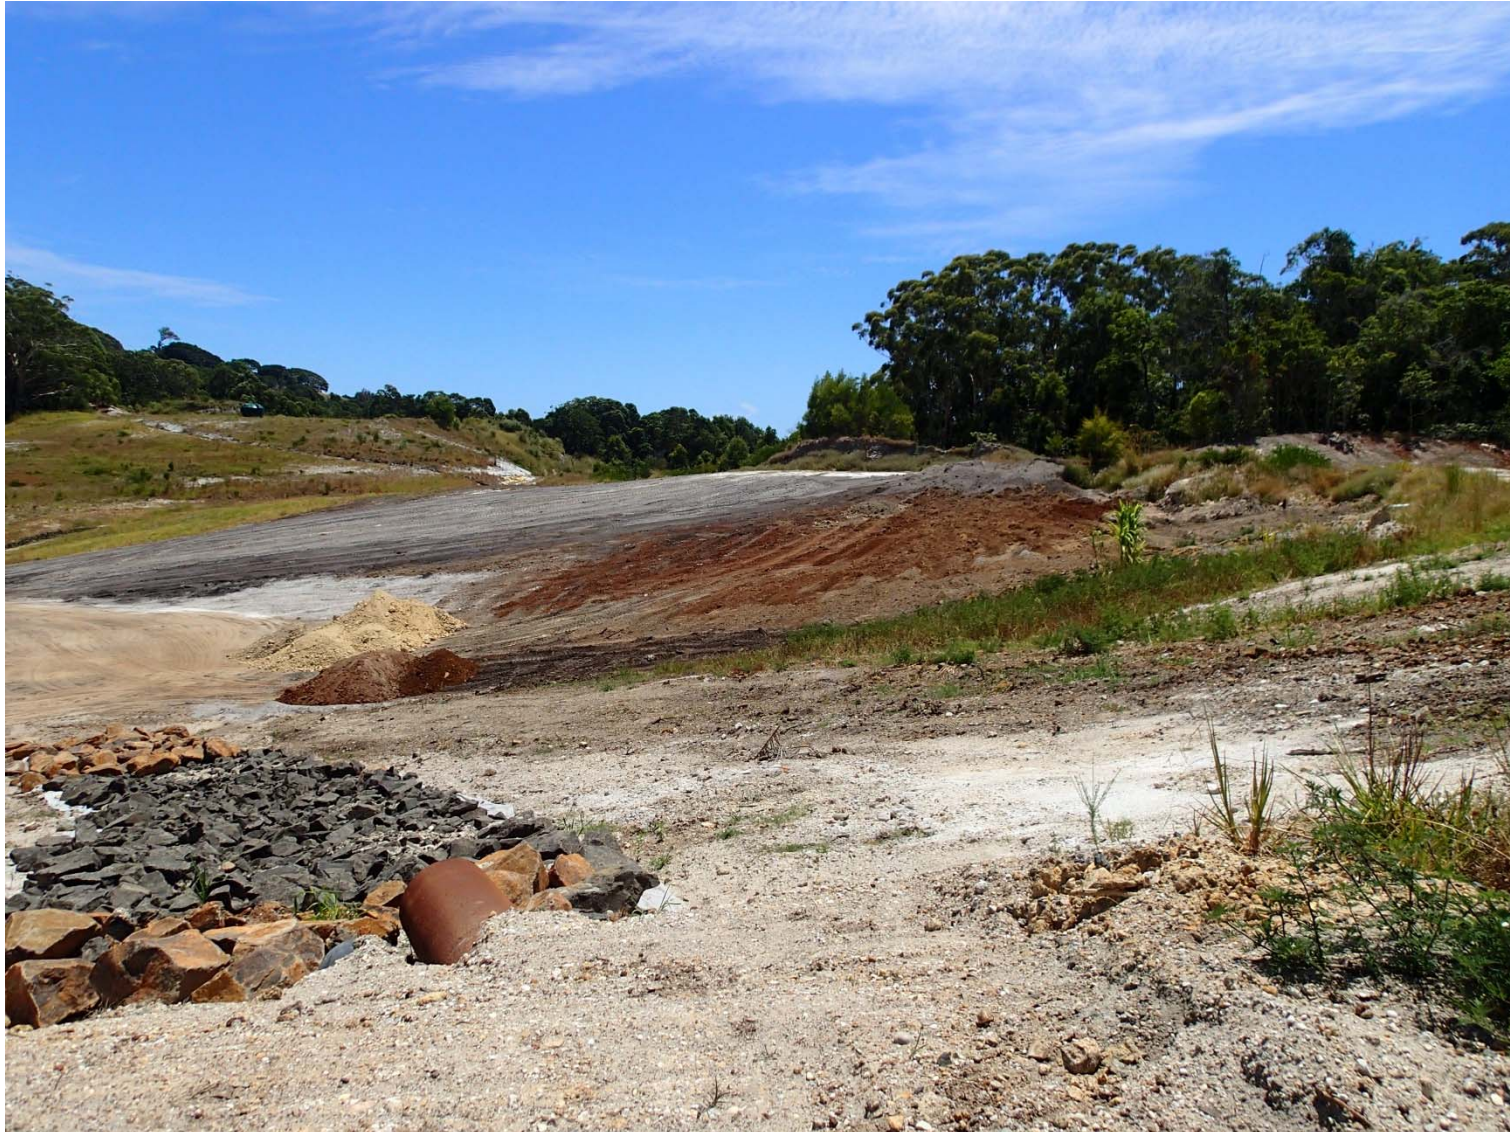
The completion of the filling and batter works on PZW21 and drainage from the road on PZW24, being the last major landforming work at the Quarry, is now close to complete and should be finalised by the end of February 2019, or possibly by early March 2019. Some further fill works will be undertaken in PZW22 (which is very flat) to ensure it drains to the new Central Dam.

**Figure 13 – Areas of PZW21 still requiring fill to right, taken from top of new drain looking north with PZW11 at rear**

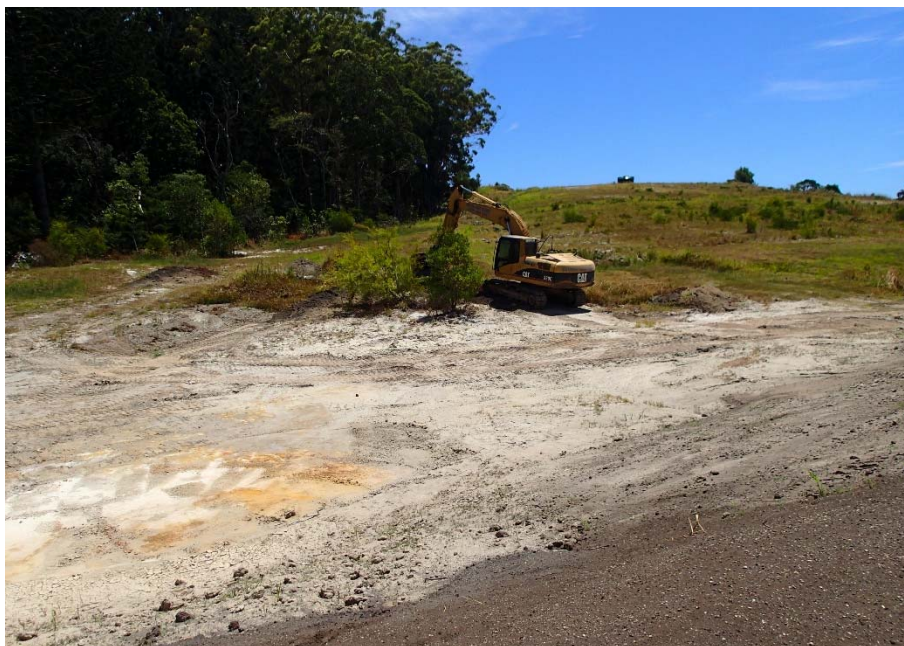
The proposed wetland on PZW9 was completely cleared of material extracted from the new Central Dam and a dam wall, spillway and drain constructed. The dam wall has been topsoiled but not seeded. Further work is required to complete the dam wall north west of the spillway and to line required parts with clay, and to construct a macrophyte zone.

**Figure 15 – Wetland basin looking north from Central Dam bypass road**

Further work is also required to the check dam system upstream of the wetland area. Detailed discussions were had with Andrew Norris as to the required works for the wetland to have the best chance of success. Work commenced on these activities on 1 February 2019, based on that input.

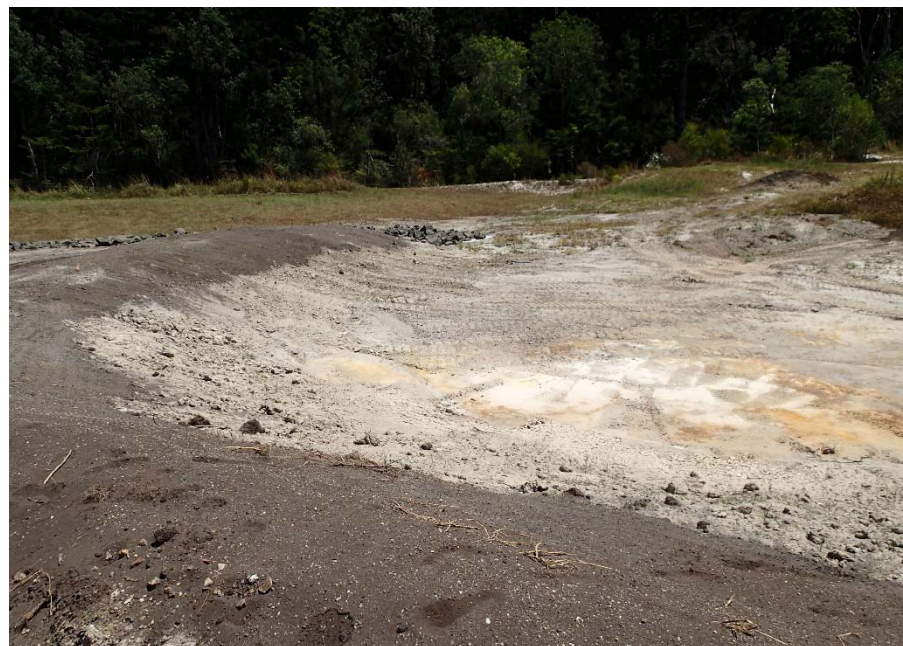
**Figure 16 – Wetland basin wall looking northwest from Central Dam wall**

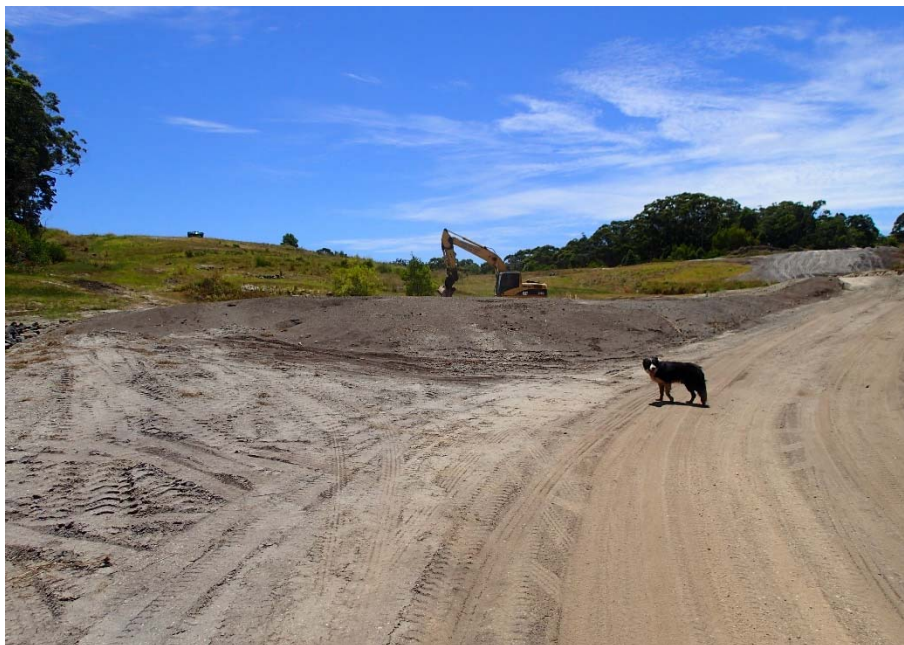
**Figure 17 – Wetland basin wall looking northeast from Central Dam approach road**

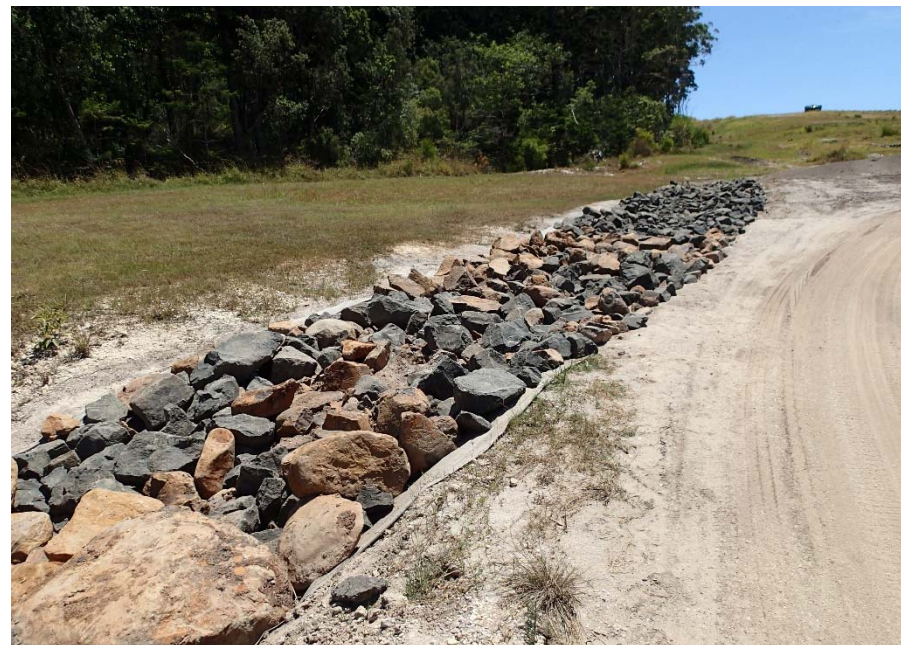
**Figure 18 – wetland spillway drain looking north**

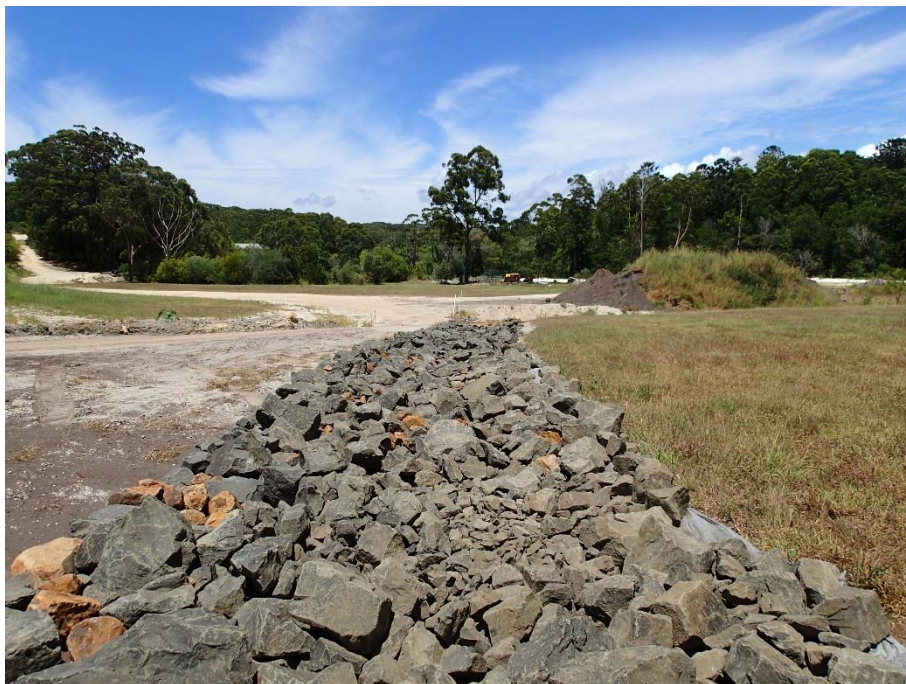
**Figure 19 – Wetland basin spillway drain looking southwest**

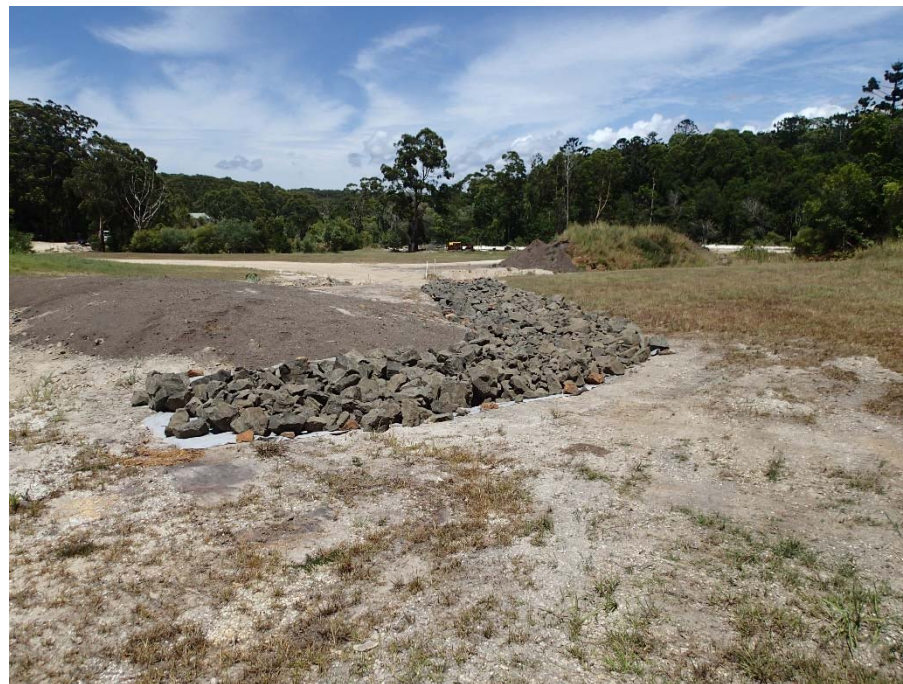
**Figure 20 – Wetland basin wall and spillway looking southwest**

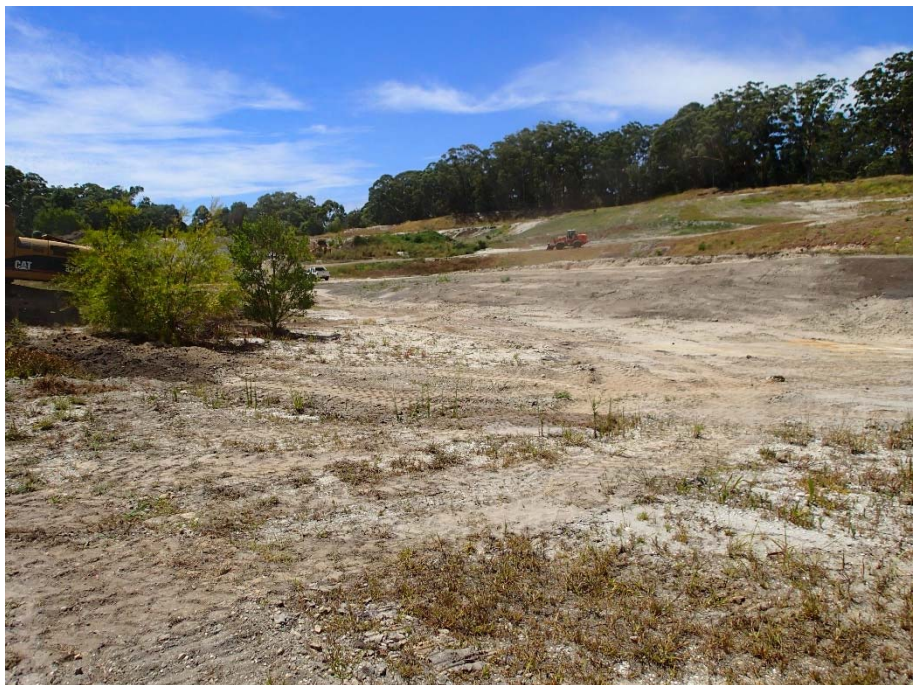
**Figure 21 – Wetland basin looking east from spillway**

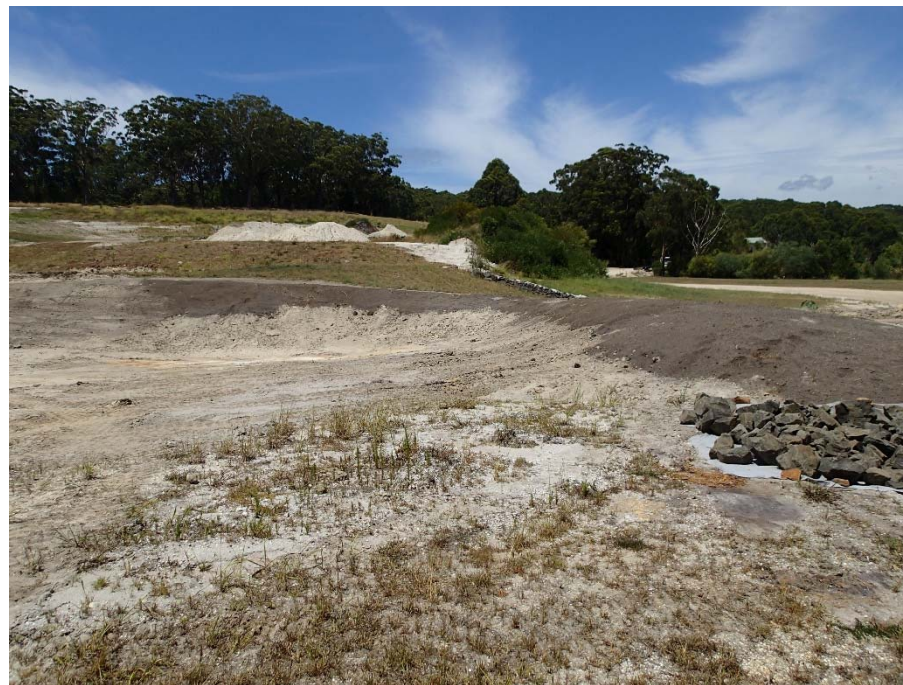
**Figure 22 – Wetland basin and wall looking southeast from area requiring further bunding**
