Broken Head Quarry

Enforceable Undertaking Progress Report  
Report #6 – January 2019

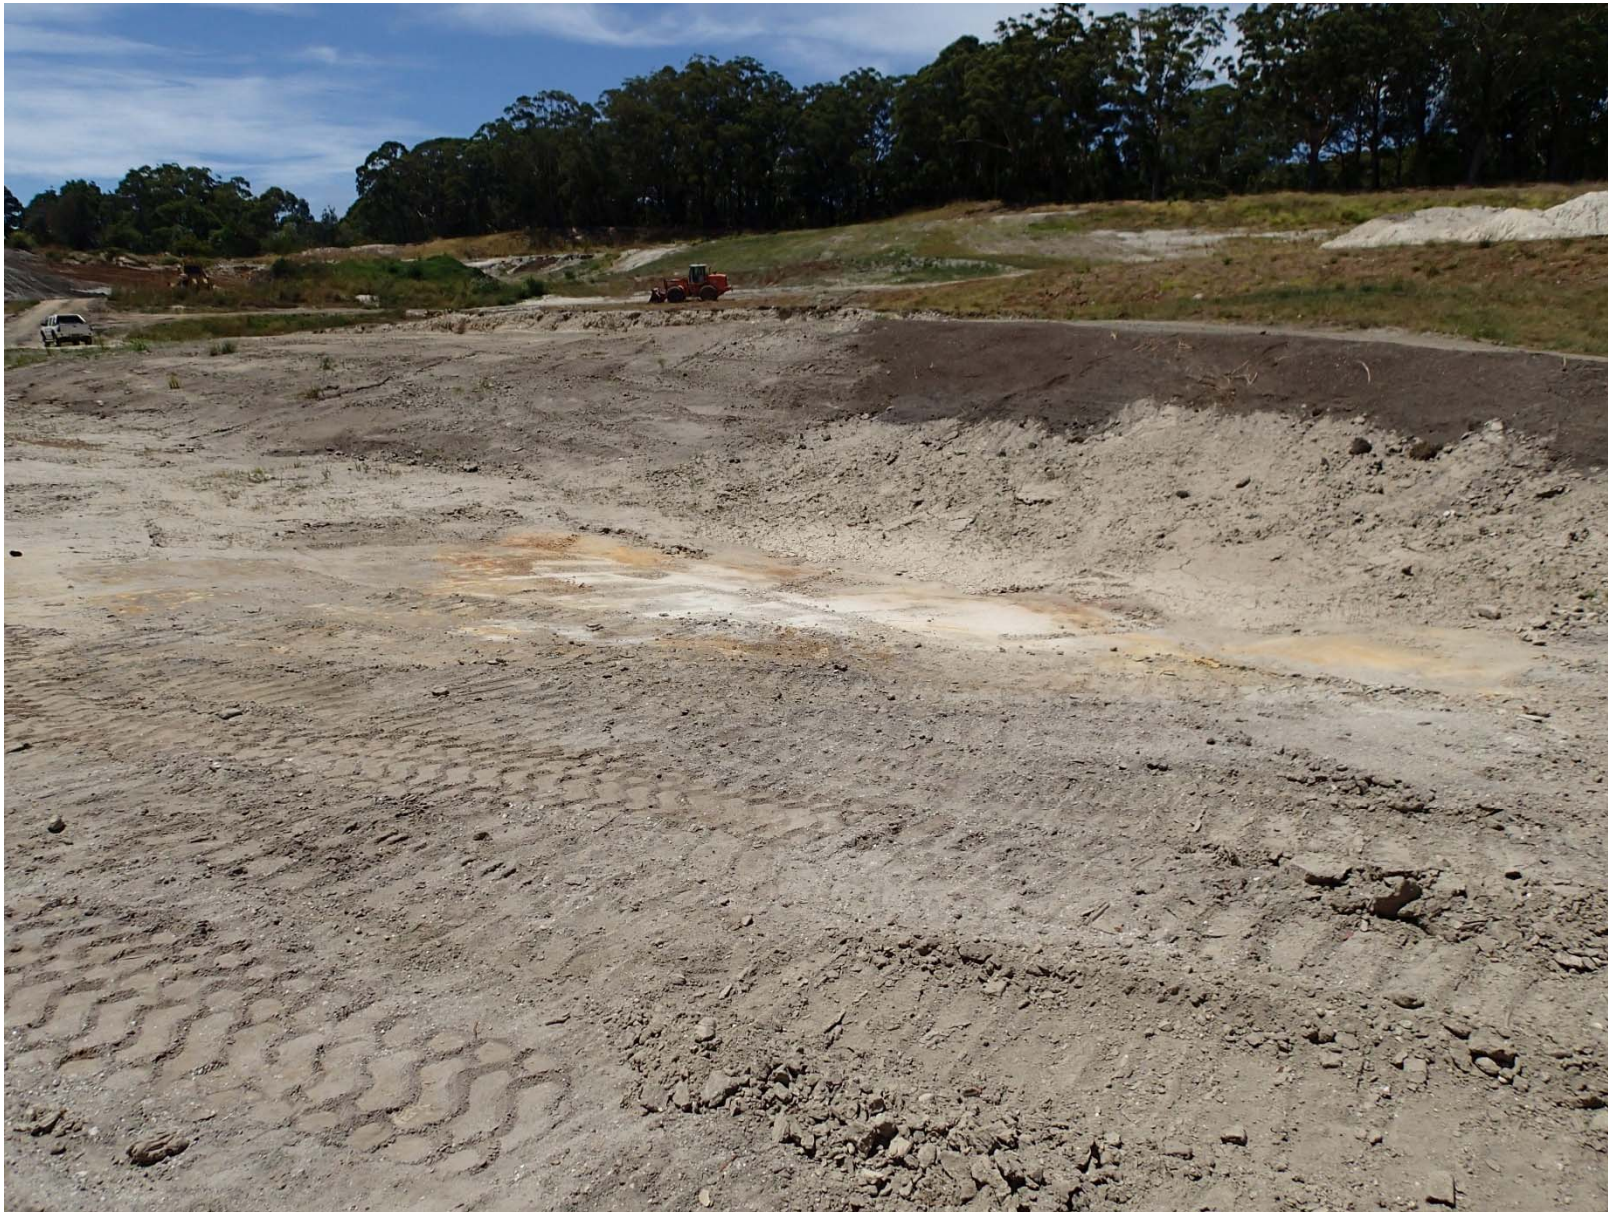
**Figure 23 – Wetland basin and wall looking southeast**

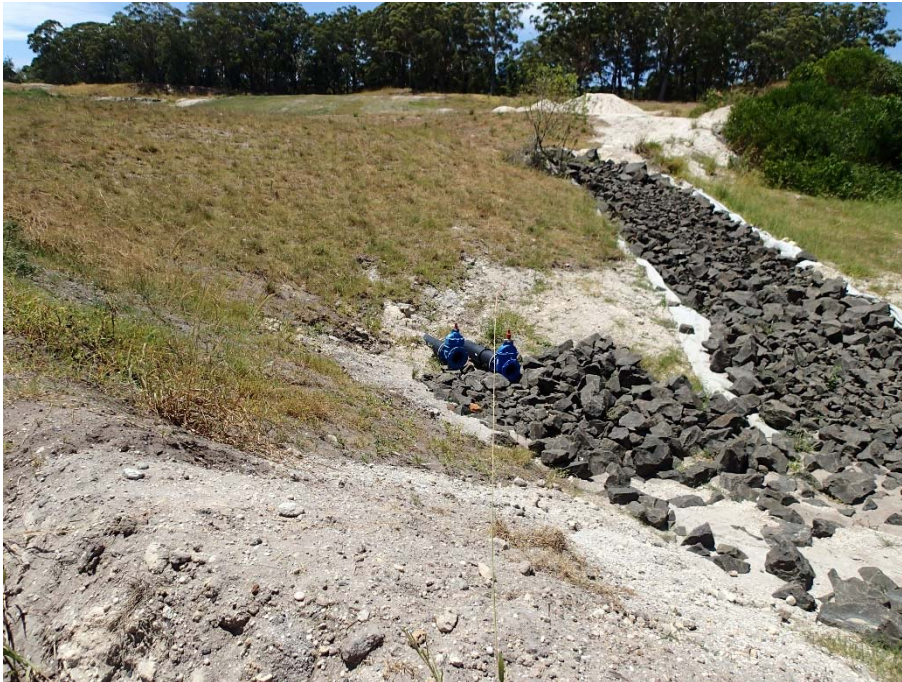
Manually operable valves to operate the Central Dam outlet pipes were installed on the afternoon of Christmas Eve 2018 (correction to Report #4).

**Figure 24 – Central Dam outlet pipe valves shown near spillway**

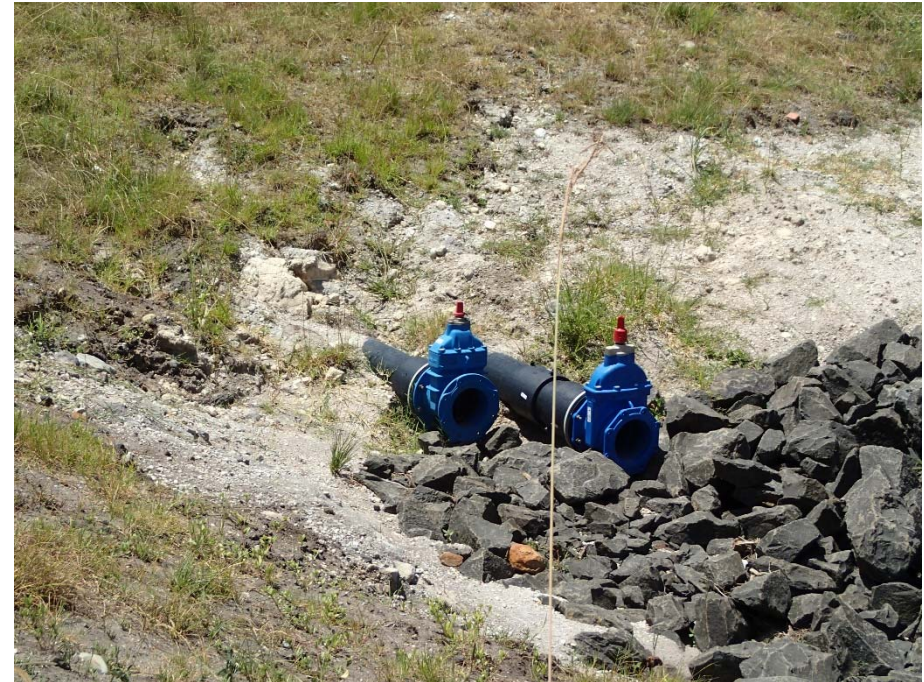
**Figure 25 – Central Dam outlet pipe valves close-up**
