Broken Head Quarry

Enforceable Undertaking Progress Report

Report #8 – March 2019

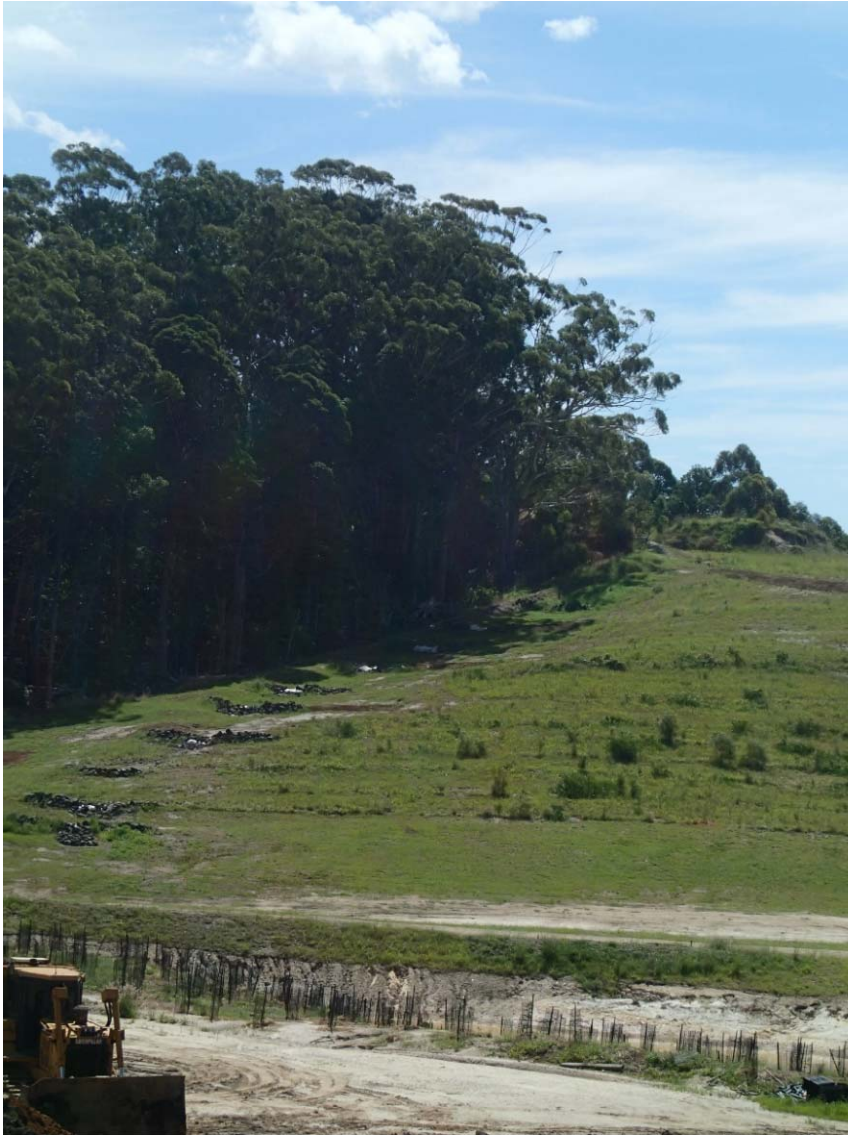
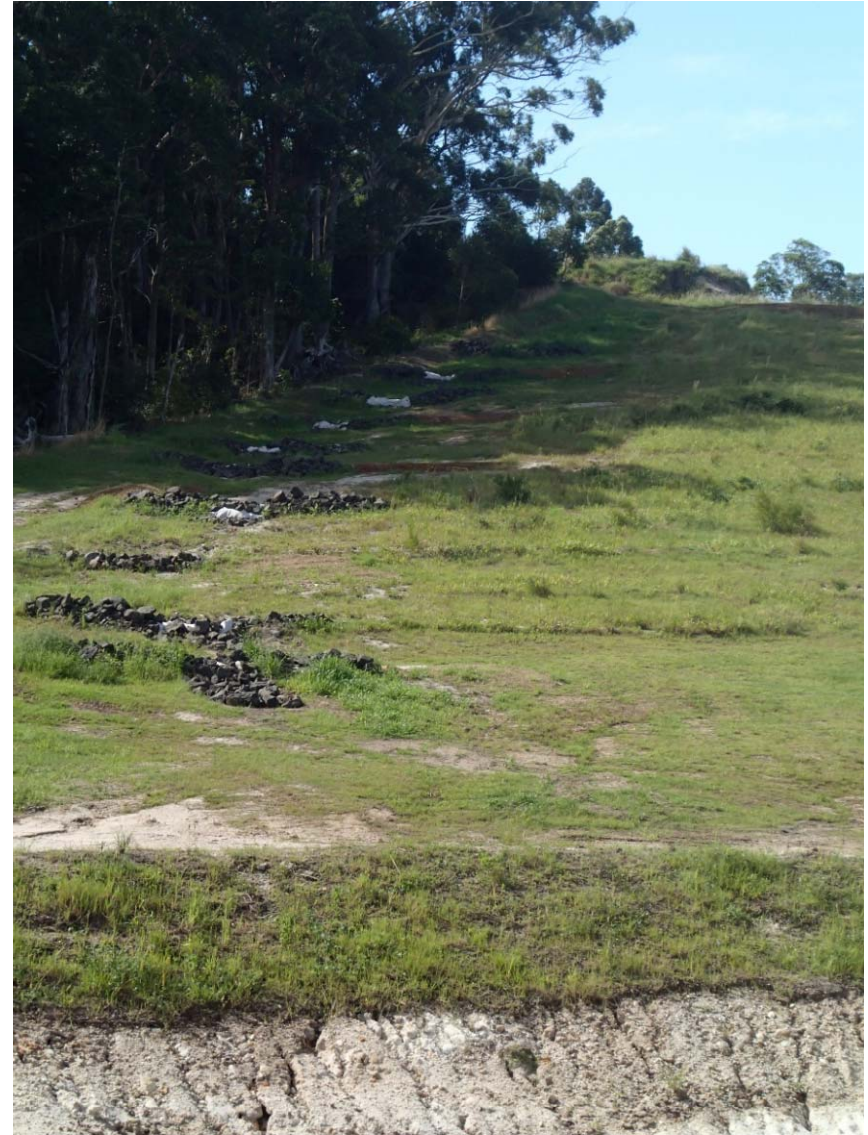
Although check dam replacement and upgrade works were undertaken during February 2019 in areas PZW3, PZW6 and PZW9 as reported in section 4.10 of Report #7, these were incomplete as at 28 February 2019. These works were completed with the installation of the final rock supplies and reinstatement/expansion of soil bunds to ensure water flows across and not around the check dams. Grassing of the soil bunds will be carried out in April 2019.

**Figures 4 and 5 – Area 7 Works viewed from above Central Dam looking north**

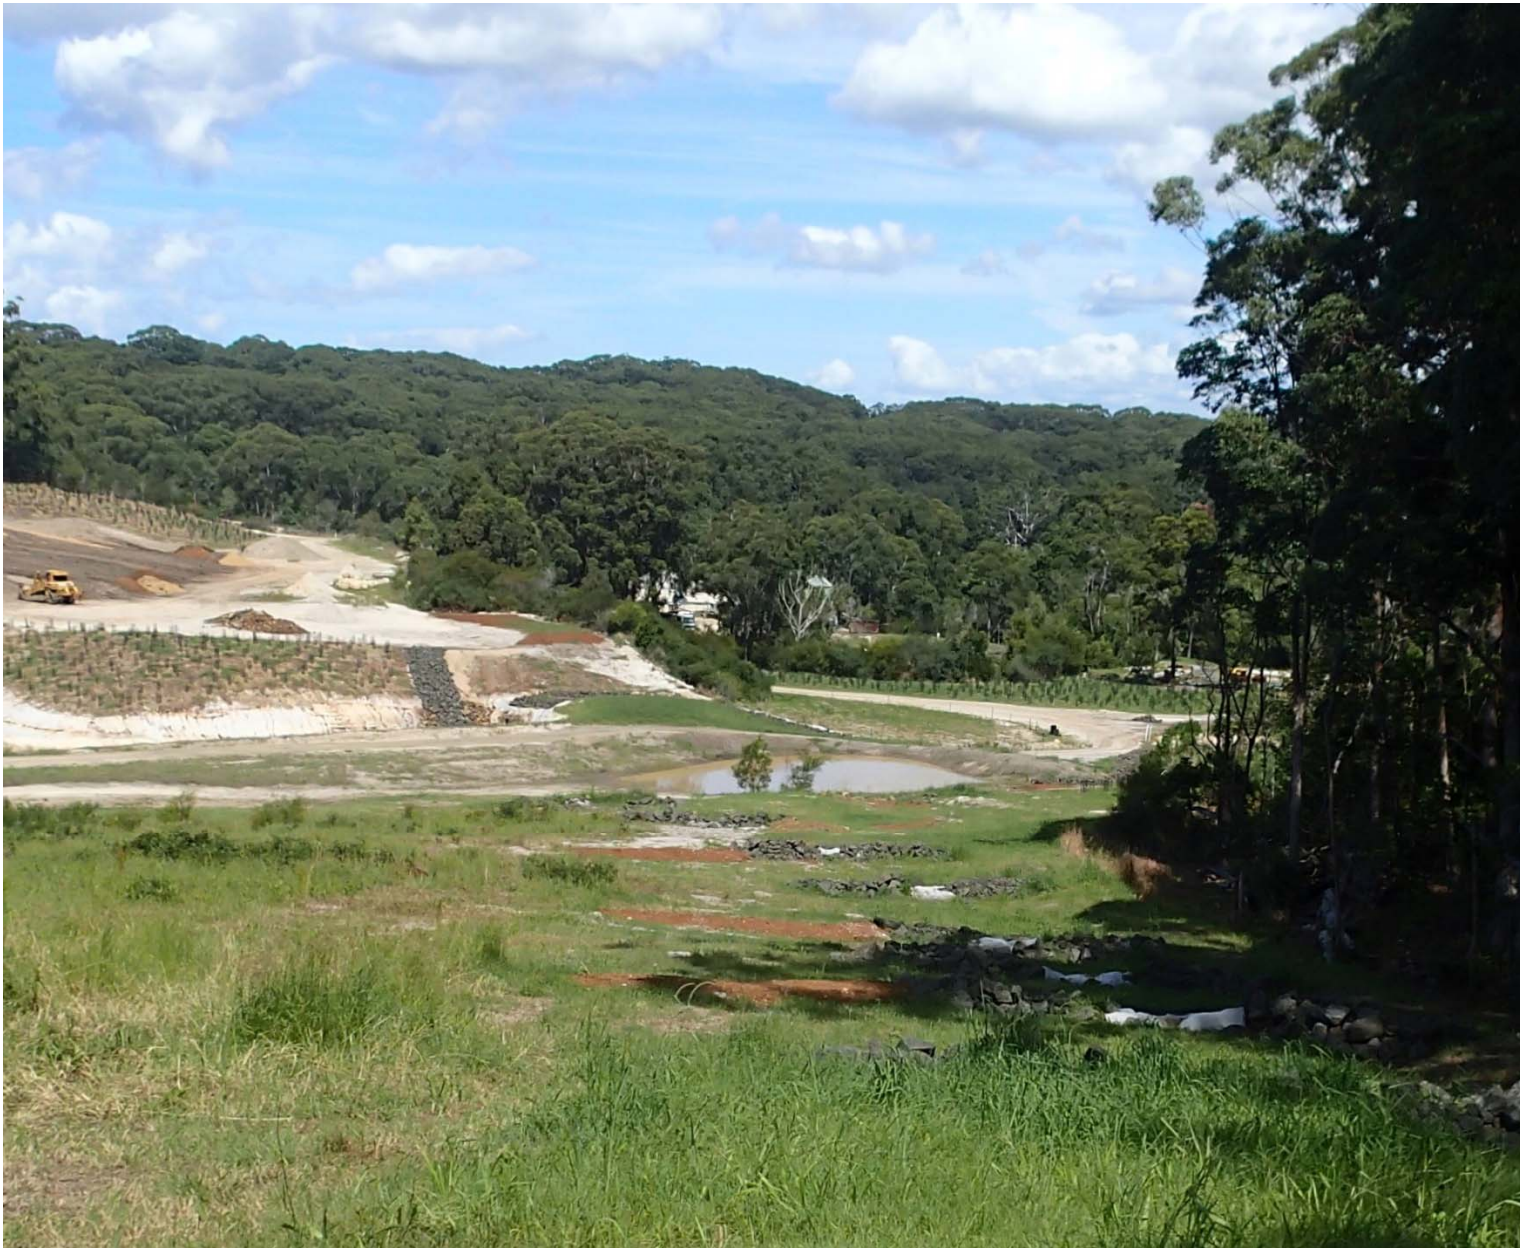
**Figure 6 – Area 7 Works viewed from PZW2 looking south**

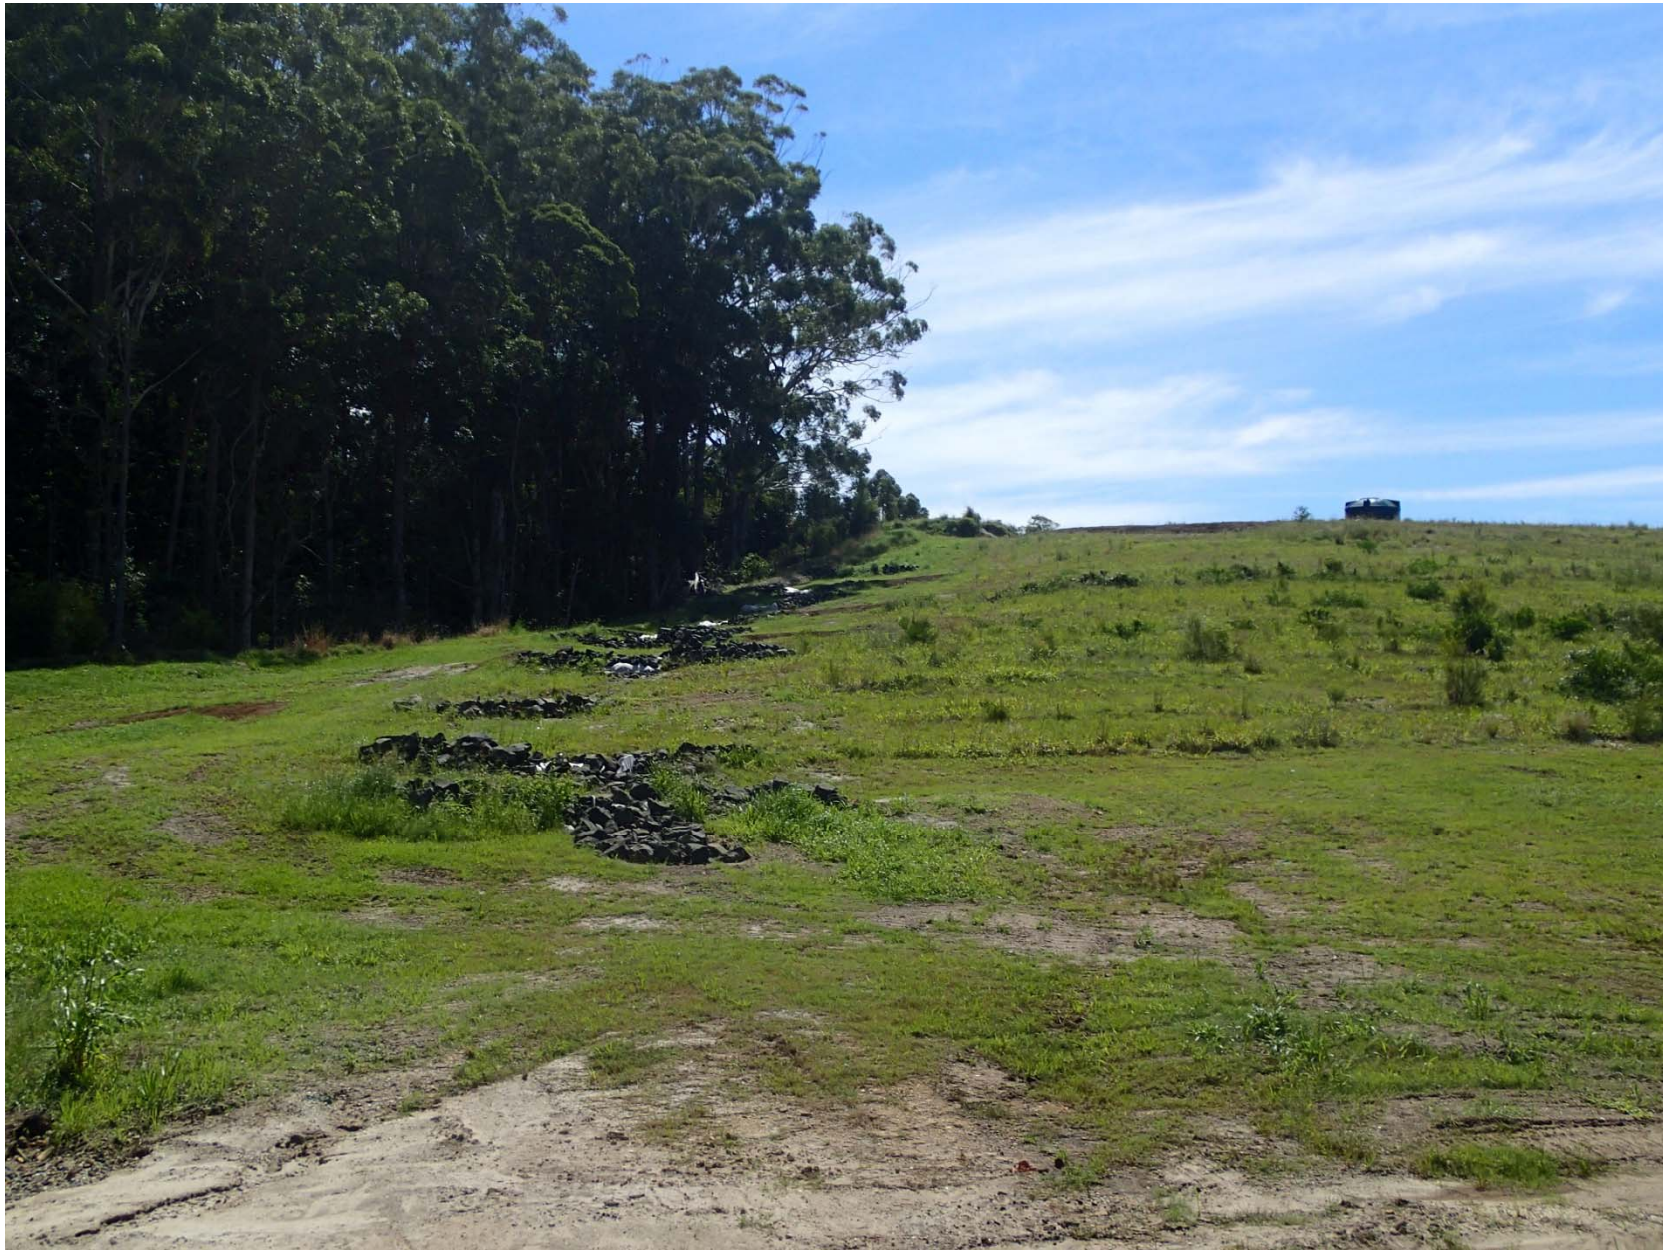
**Figure 7 – Area 7 Works viewed from northern edge of PZW9 wetland looking north**

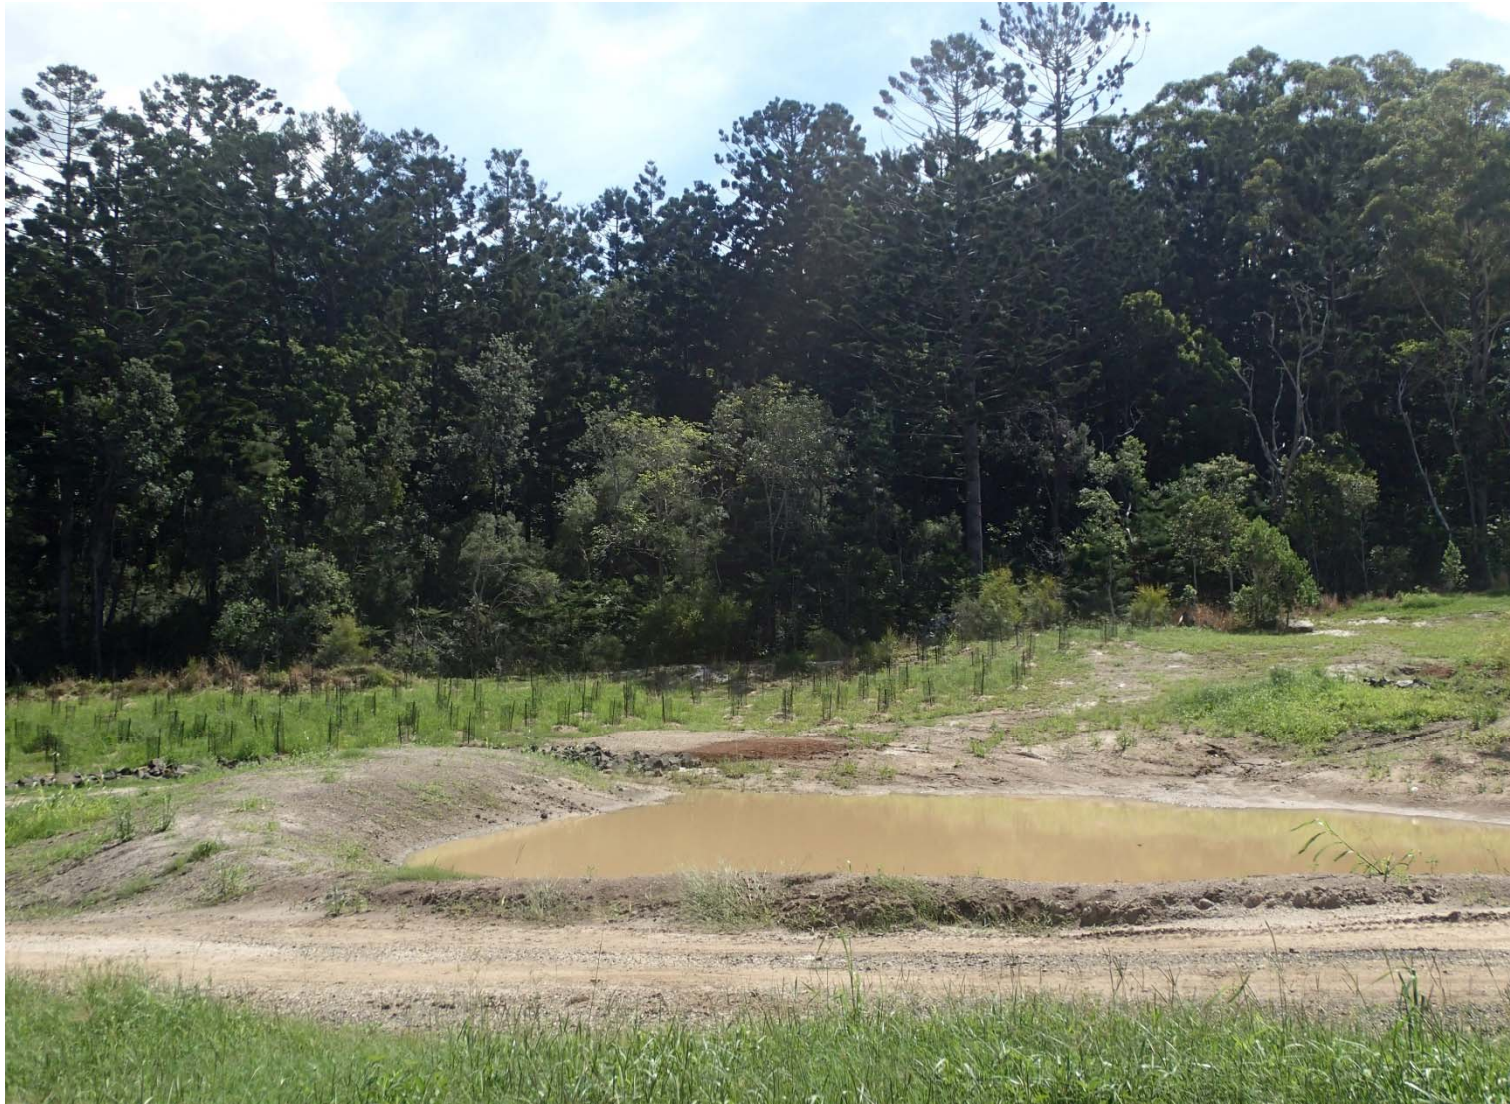
A soil bund was constructed on the area north of the rock-lined spillway of the wetland on PZW9 to finalise the retention structures so as to ensure overflowing water escapes down the rock-lined spillway.

**Figure 8 – New soil bund shown to right of spillway mouth, viewed from Central Dam wall looking northwest**

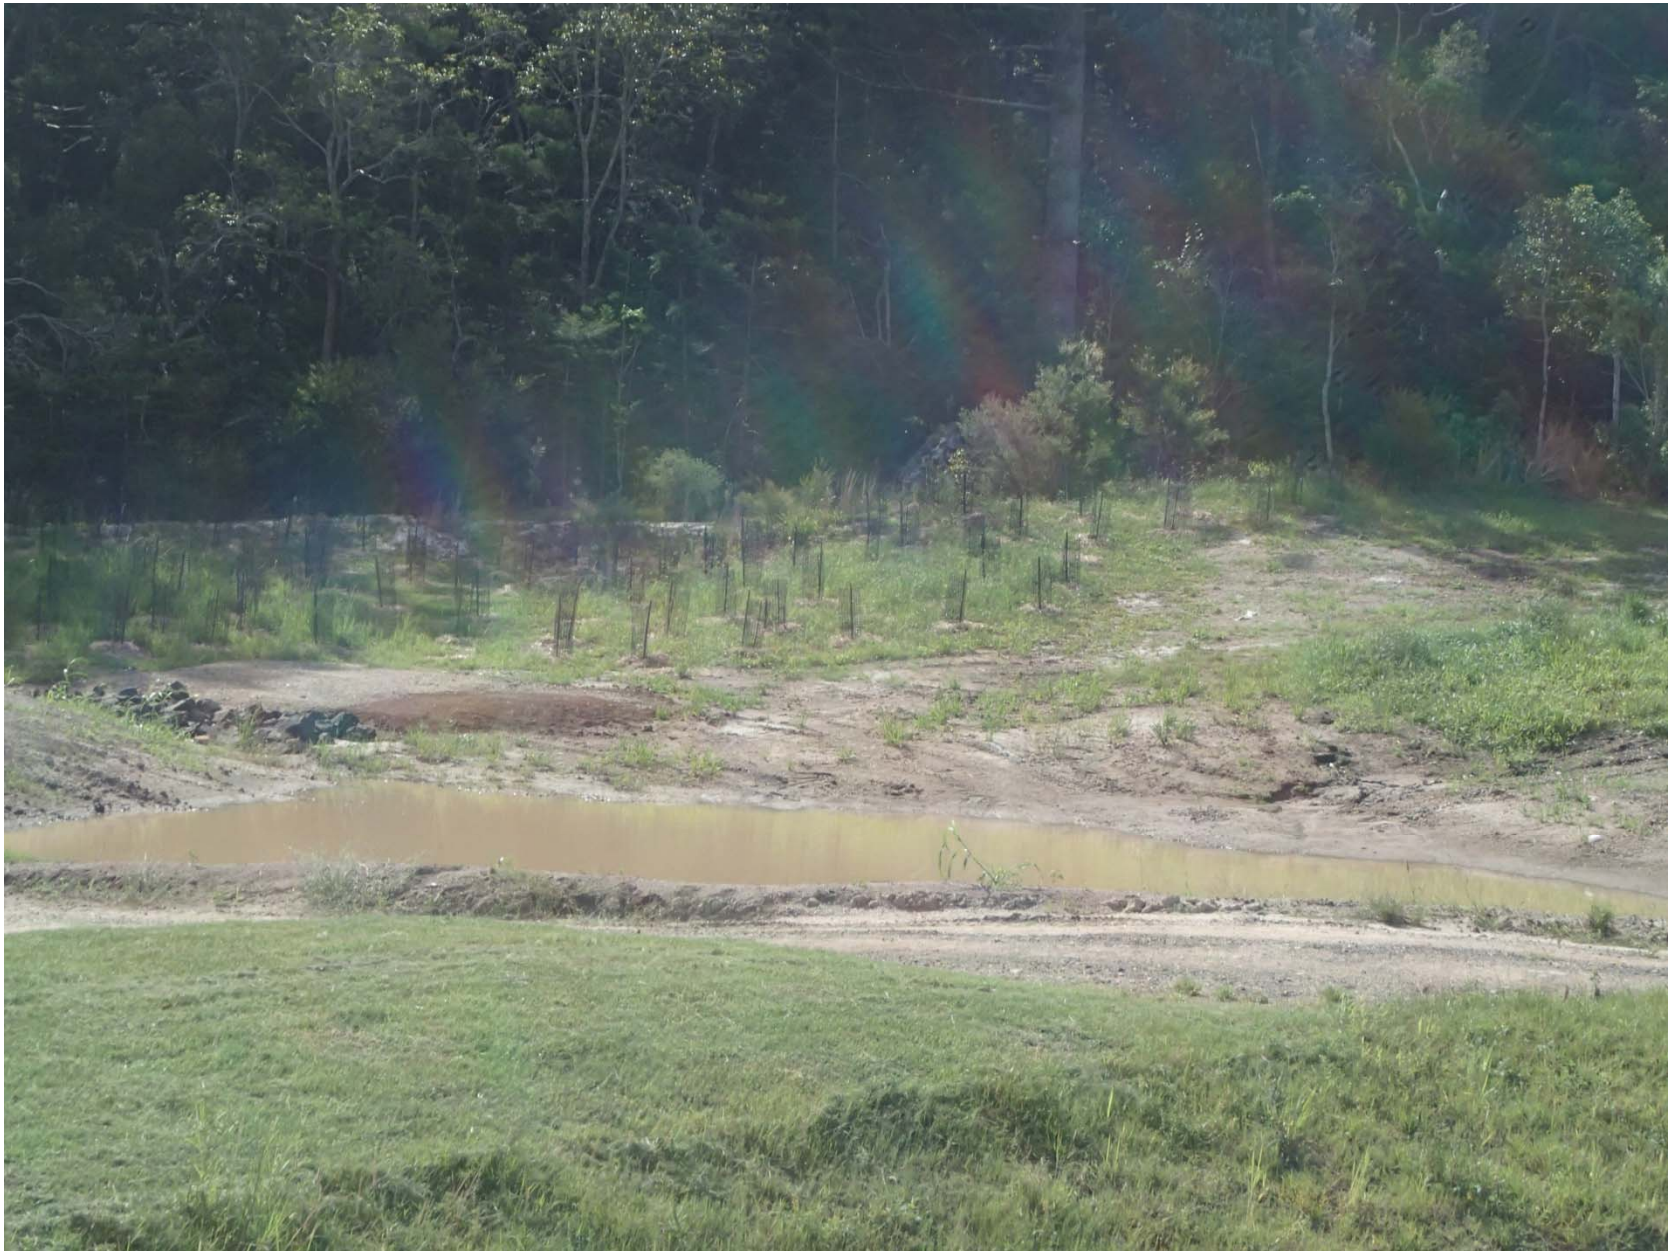
**Figure 9 – New soil bund shown to right of spillway mouth, viewed from Central Dam wall looking northwest**

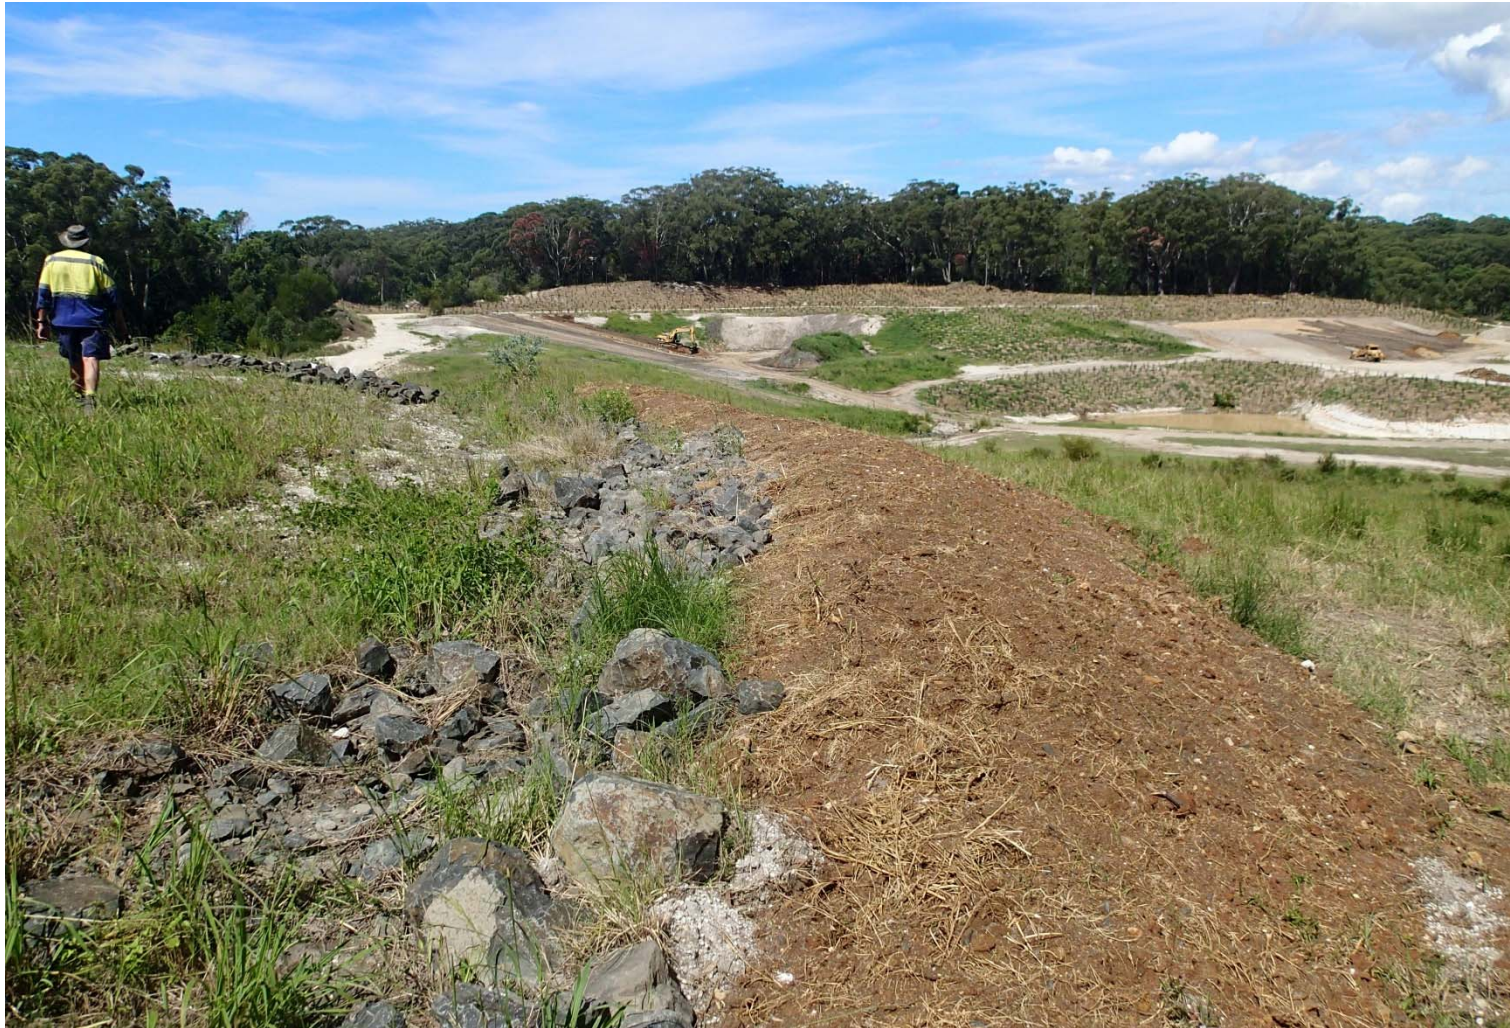
The performance of the crossflow drain in Area 6 in Annexure 1 of the Undertaking was observed during the 18 March 2019 rainfall event and it was observed that waterflows from PZW2 were overspilling the downstream edge of the drain in the vicinity of Area 6. A much larger bund was constructed shortly afterwards to prevent overspill from the drain, which is to be grassed in April 2019.

**Figure 10 – New bund looking south east**

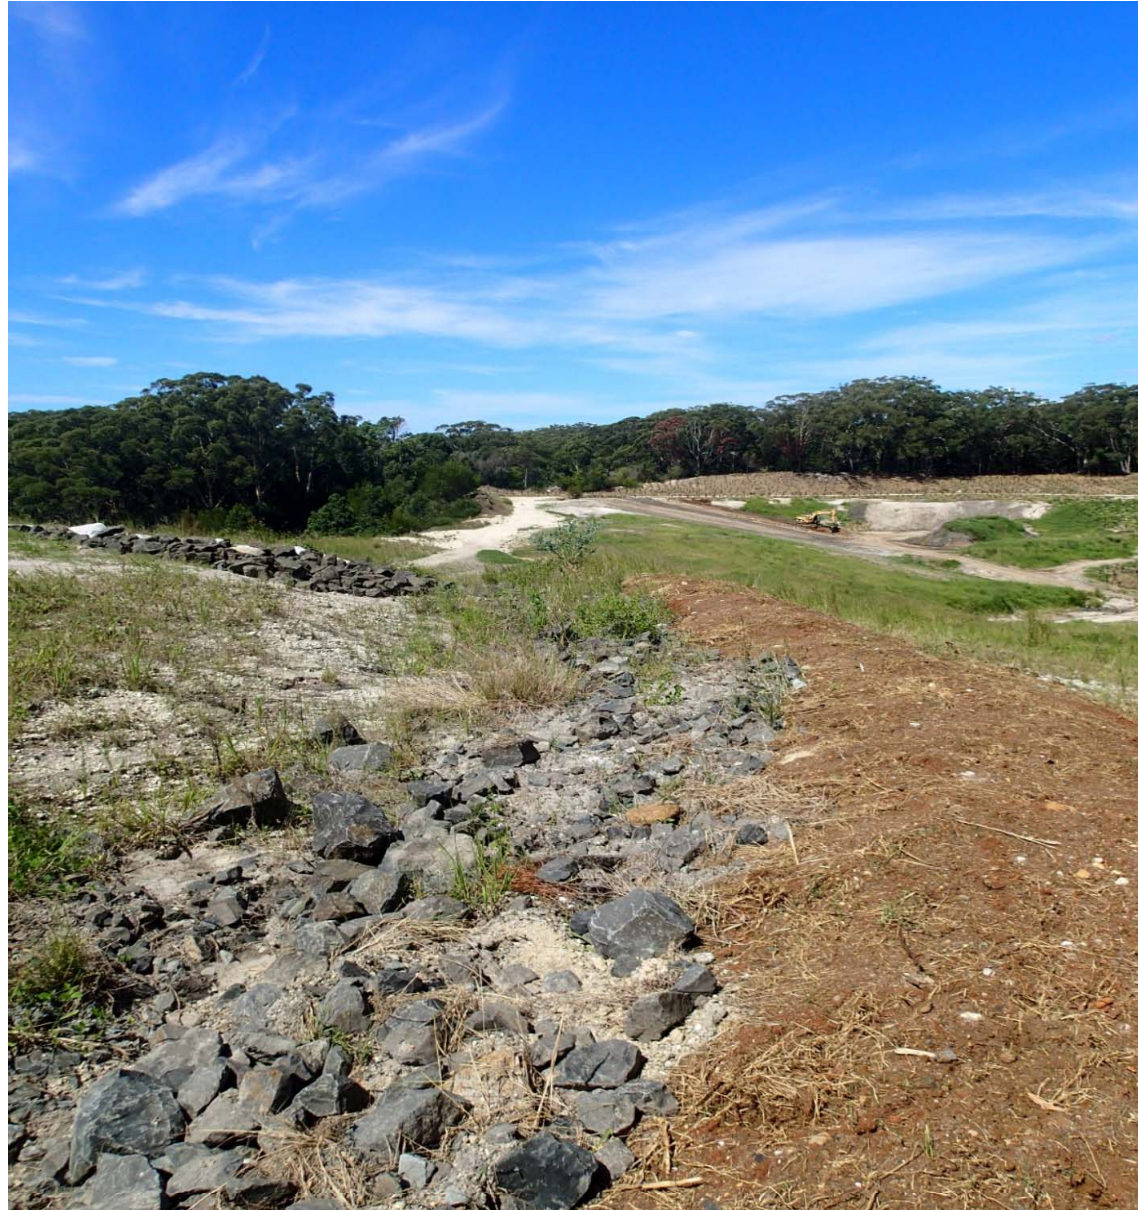
**Figure 11 – New bund looking south east**

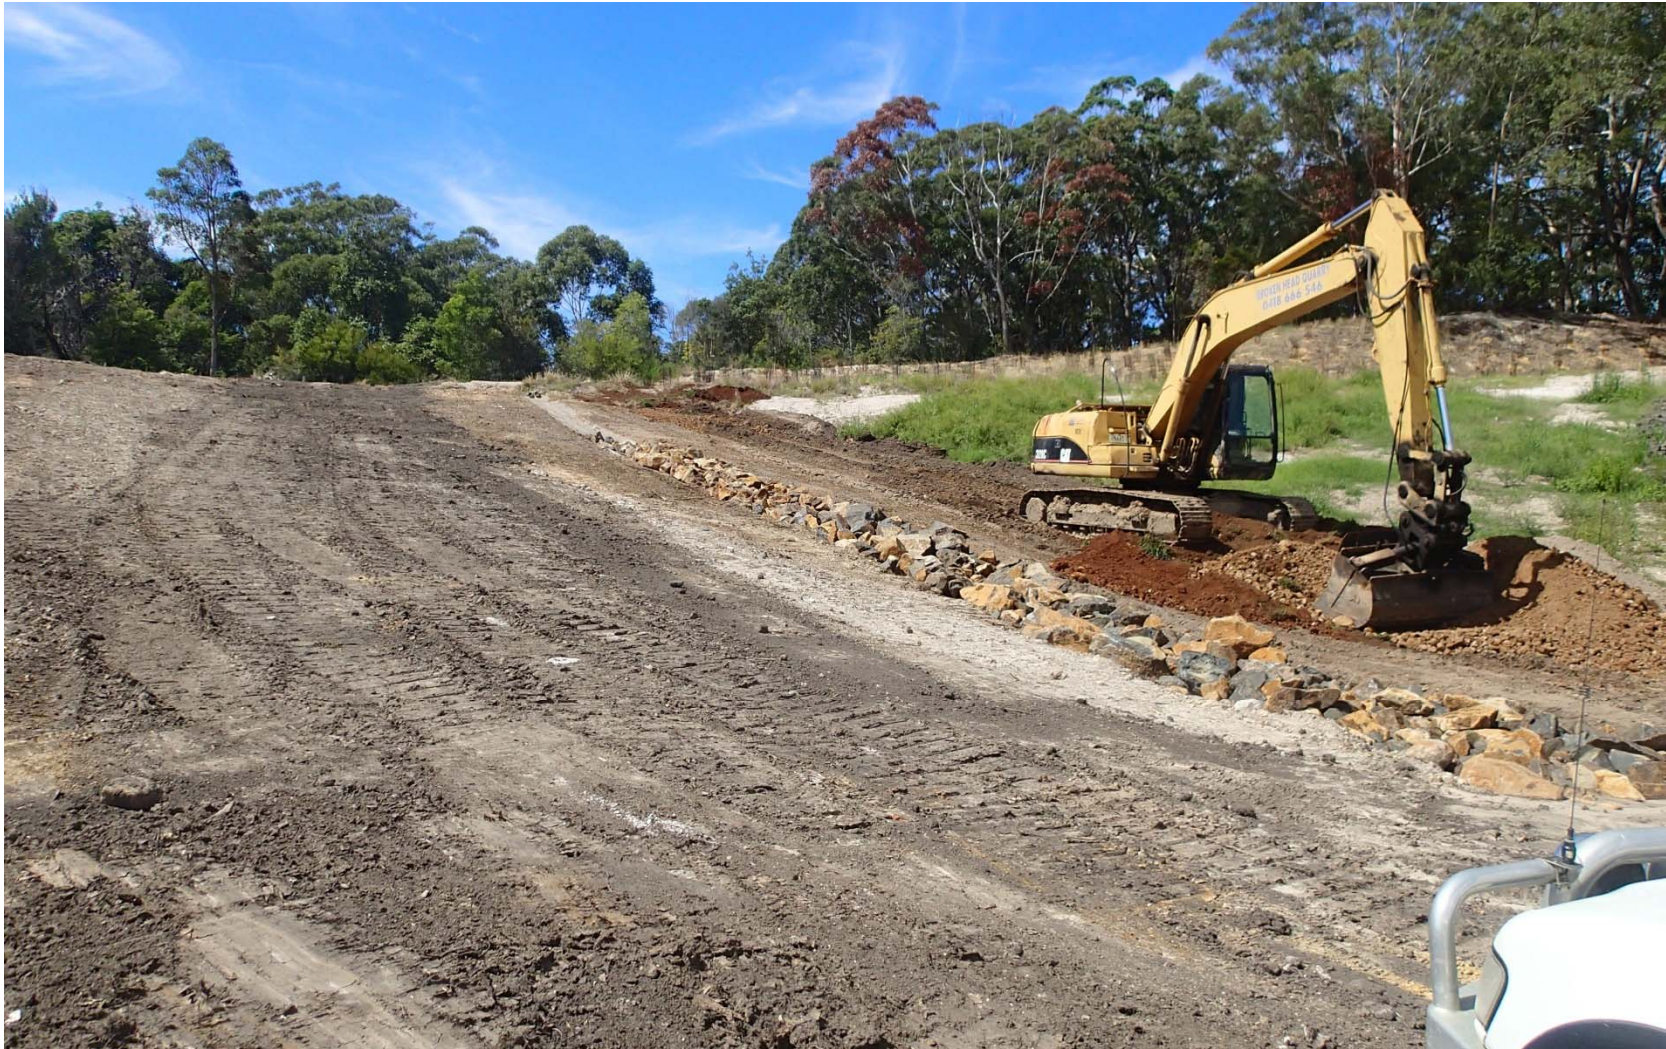
The final drain taking water from the upper access road on the Westside above PZW24 and waterflows from PWZ24 was constructed down PZW21 close to the boundary of PZW11 and PZW21. The upper portion is constructed in concrete canvas and the lower portion lined in geofabric and rock-lined.

Figure 12 – New PZW24 to PZW21 drain, viewed from PZW21 looking southeast

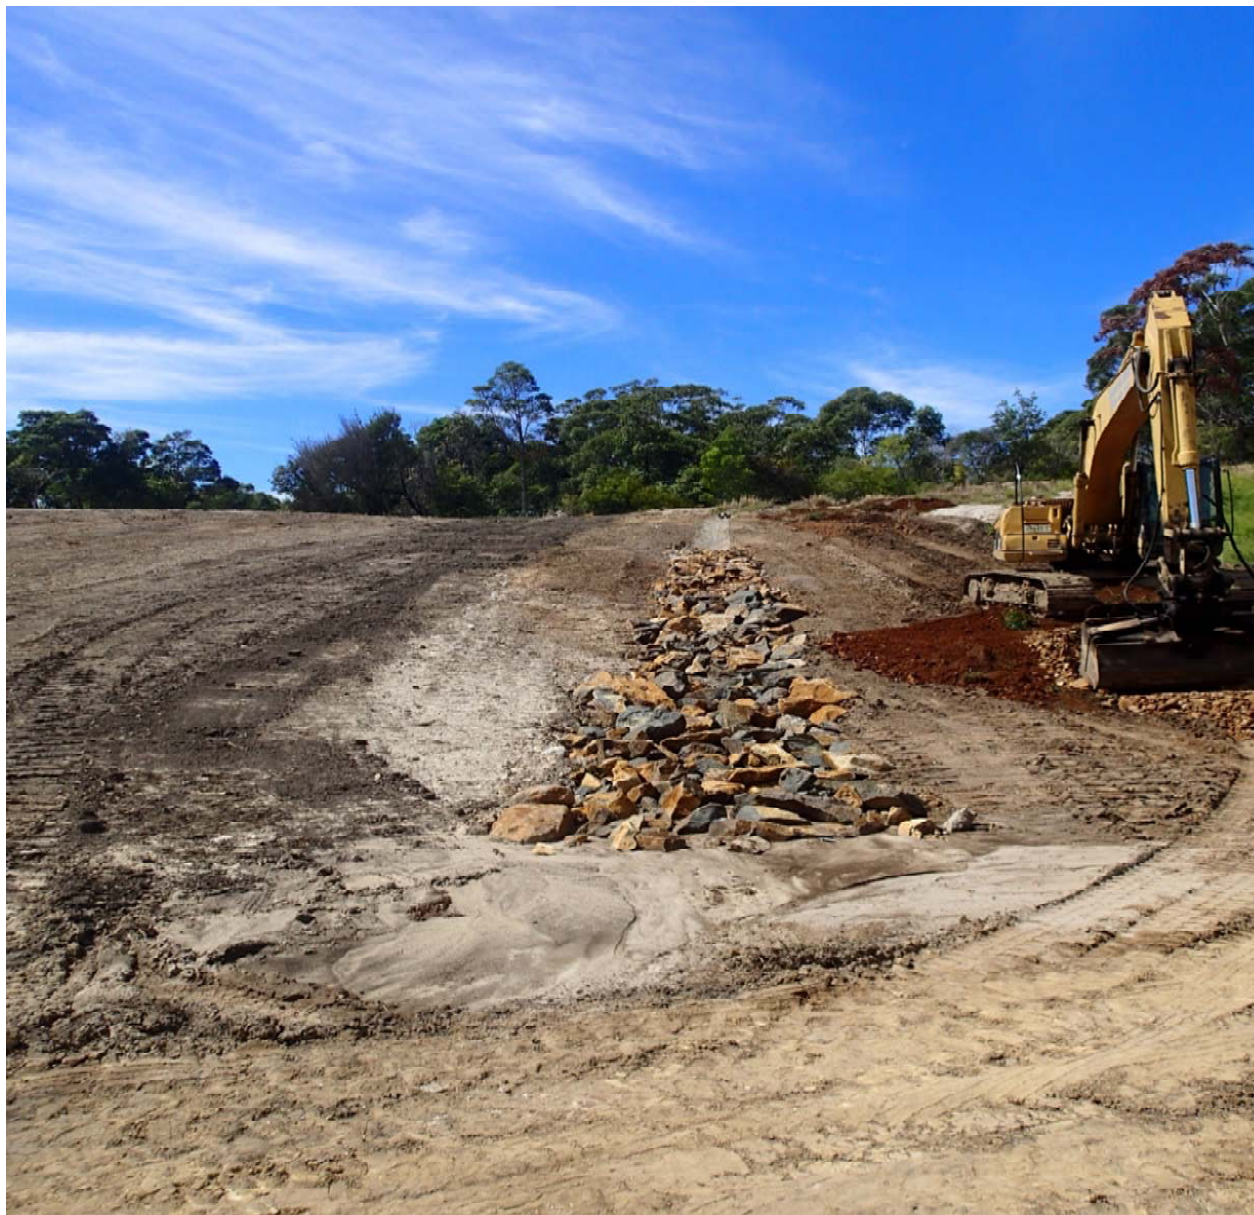
**Figure 13 – New PZW24 to PZW21 drain, viewed from foot of drain in PZW21 looking east**

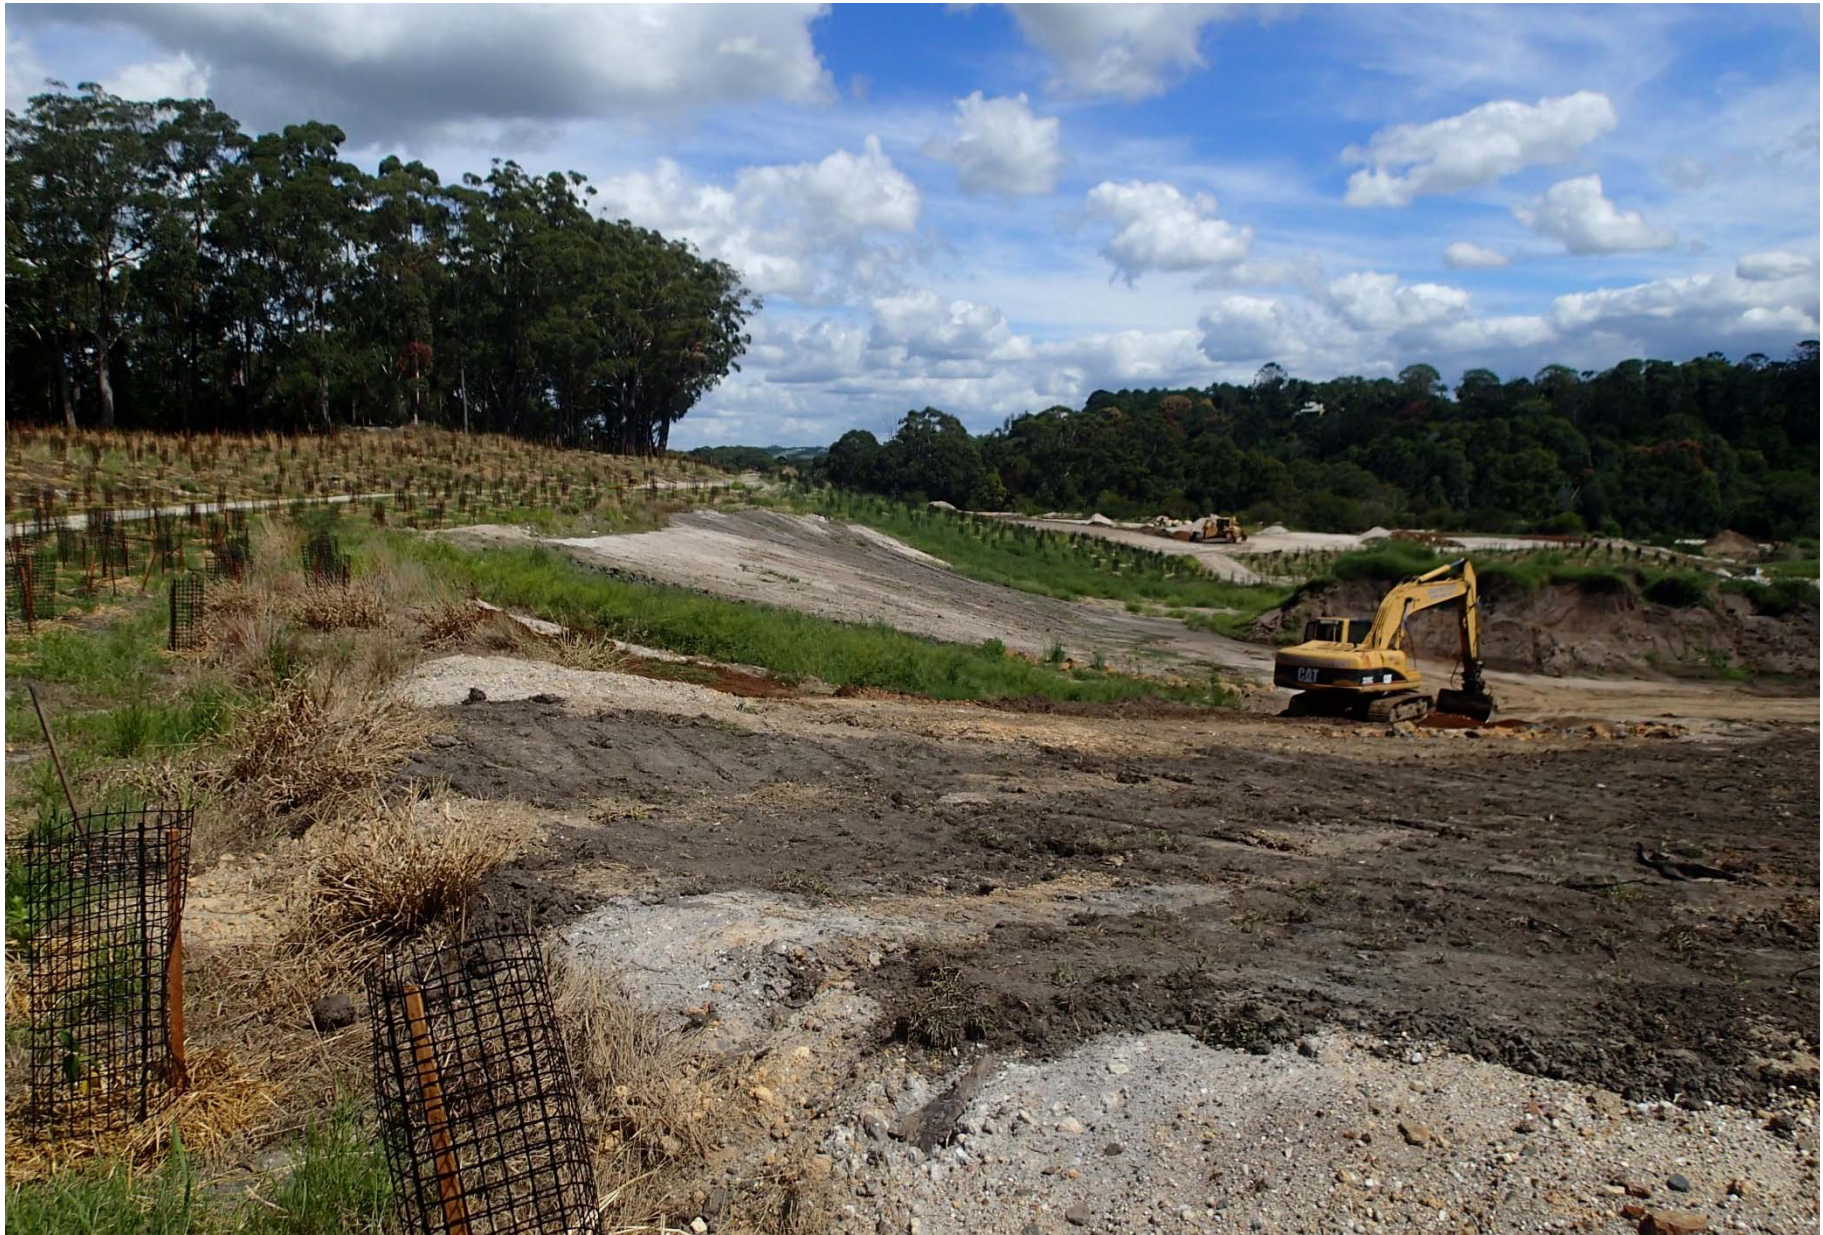
**Figure 14 – New PZW24 to PZW21 drain, viewed from PZW24 looking south**

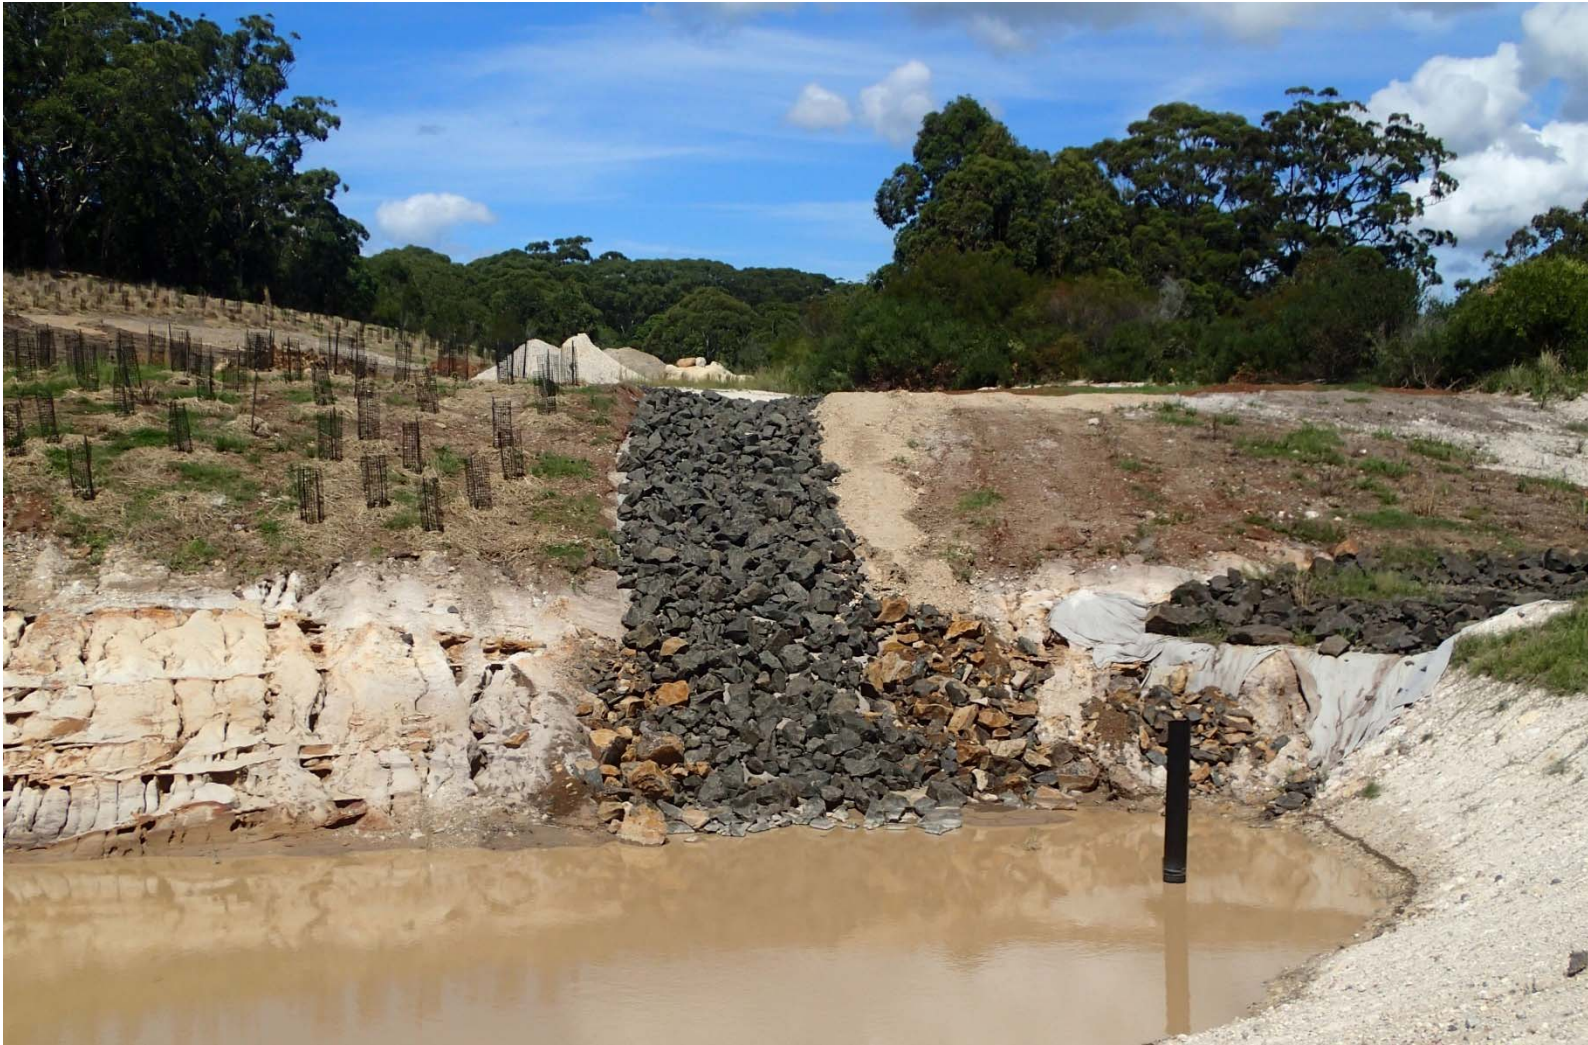
Following recommendations from Andrew Norris of Martens & Associates, drainage on the Blue Level (PZW22) and batters leading to the Blue Level (PZW21 and PZW23) was reorganised to prevent it spilling over the lower edge of PZW22 and instead ensuring it is redirected into the Central Dam. To achieve this, the drainage on the western edge of PZW22 near the Central Dam was reformed to push water flows from the existing drain away from the edge of PZW22 and collect it in an area that discharges to a new geofabric and rock-lined chute into the Central Dam.

**Figure 15 – Rock-lined chute to Central Dam viewed from Central Dam bypass road looking south**

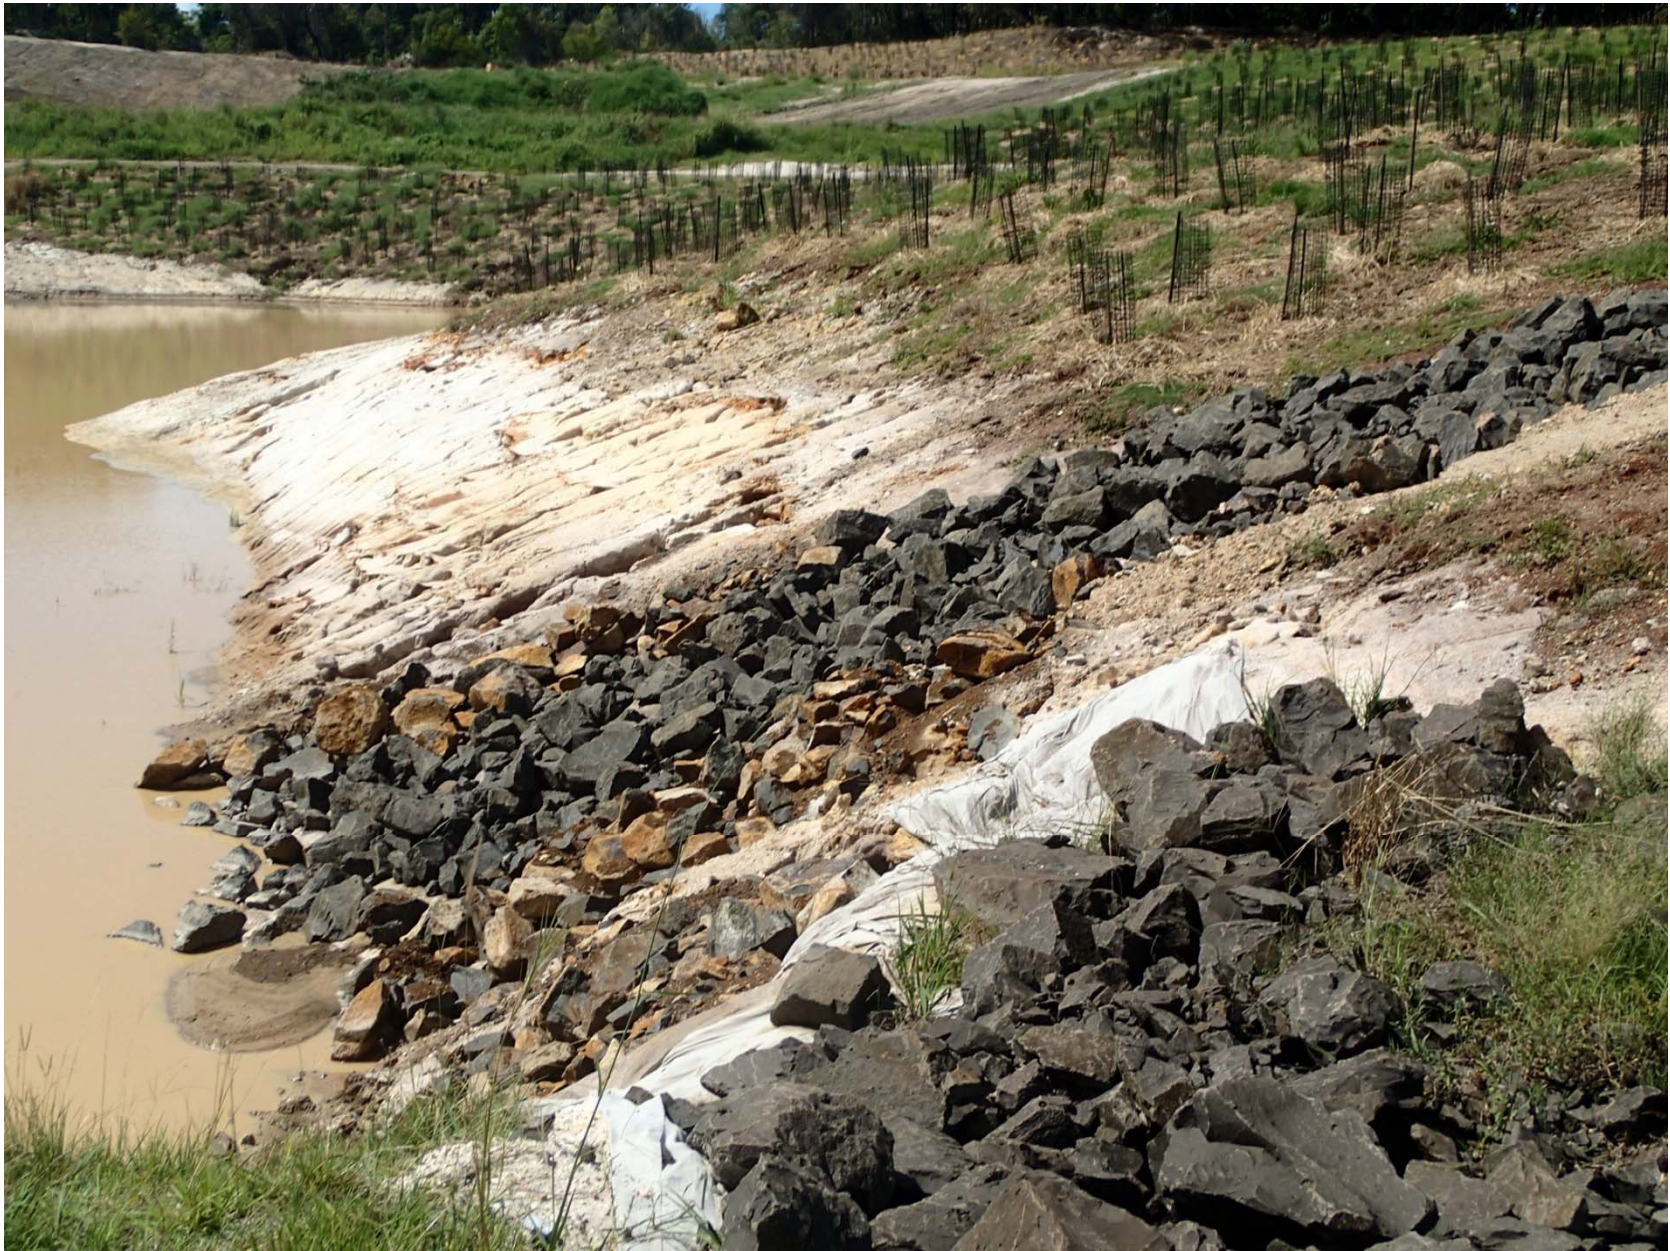
**Figure 16 – Rock-lined chute to Central Dam viewed from Central Dam spillway looking east**
