Broken Head Quarry

Enforceable Undertaking Progress Report

Report #8 – March 2019

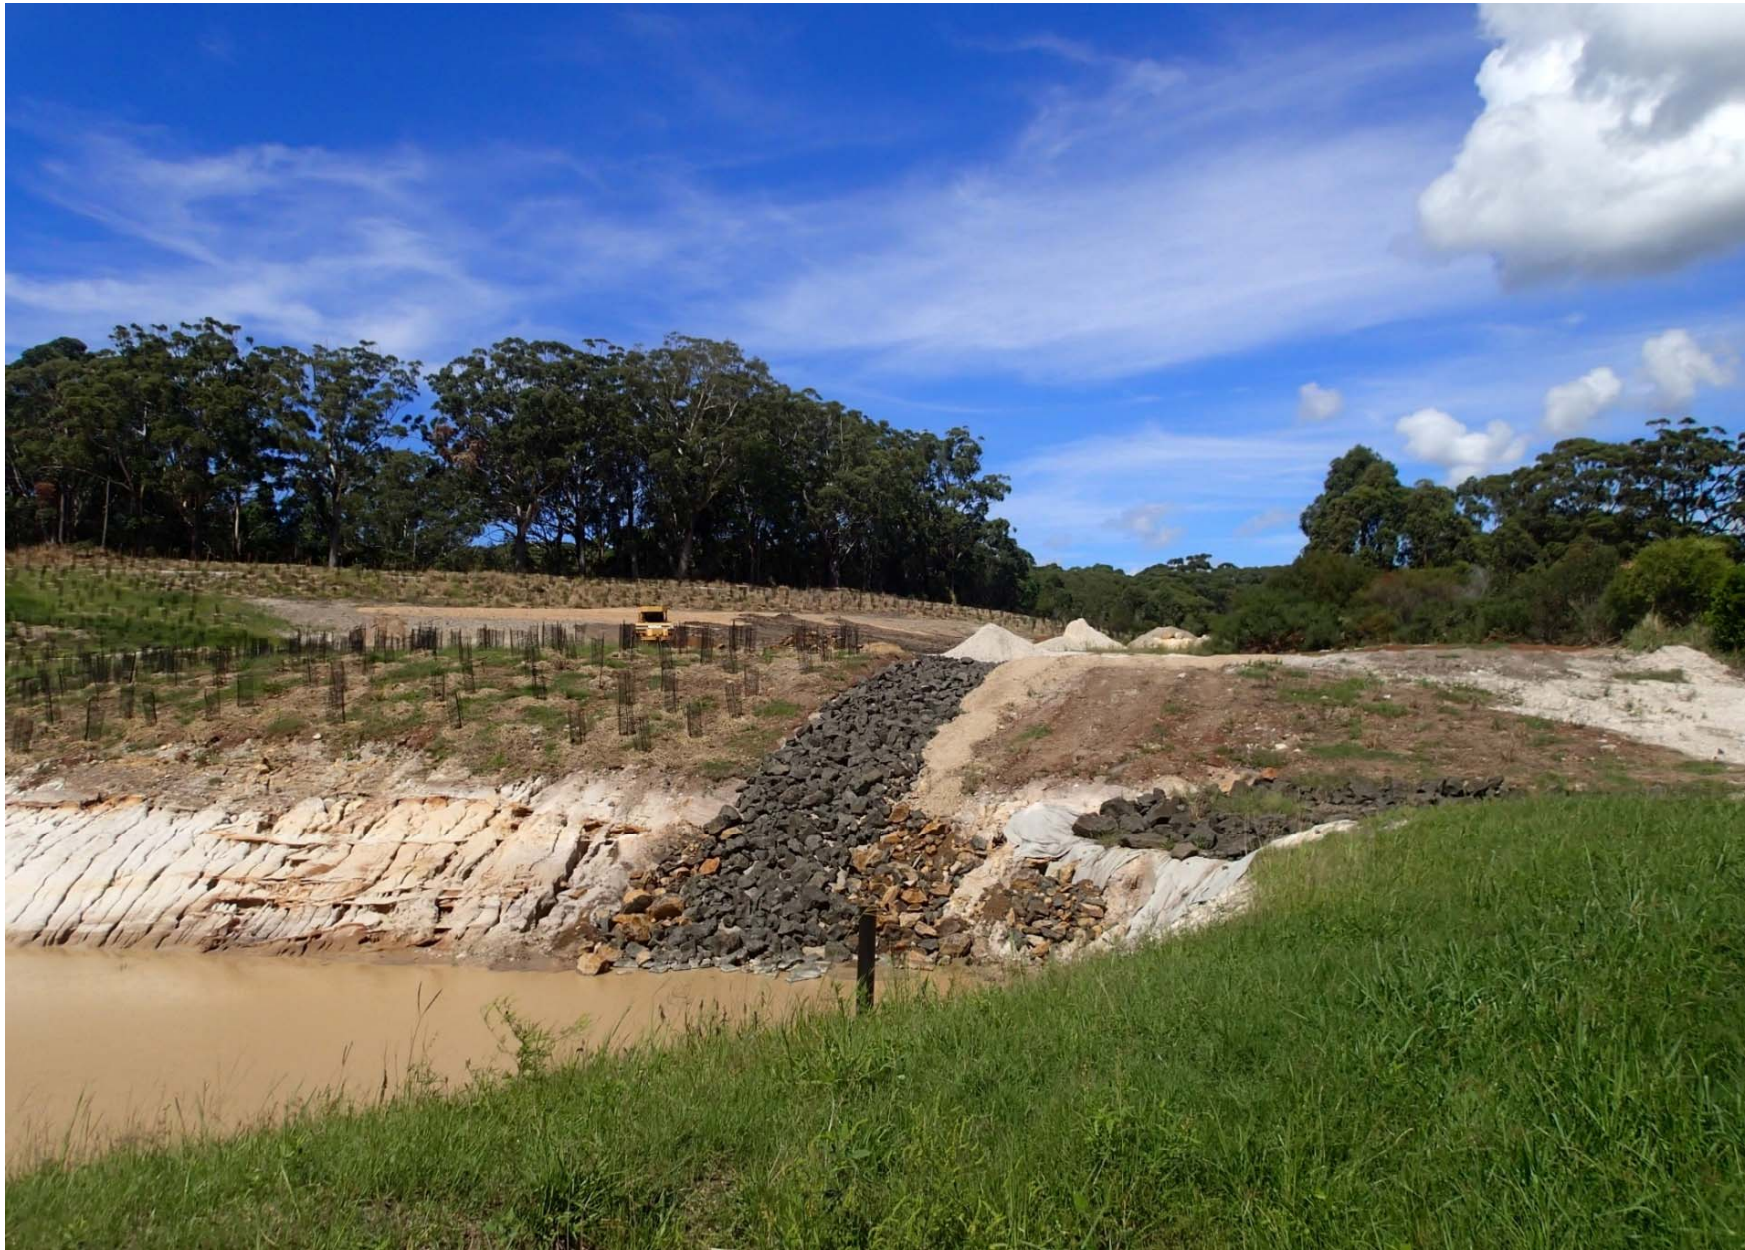
**Figure 17 – Rock-lined chute to Central Dam from Central Dam wall looking southeast**

The chute was constructed and was fully operational at the time when the 102mm rainfall event occurred on 18 March 2019, so its performance could be observed during this event. The chute performed well and drained its catchment effectively. Minor displacement of rock in the very lower portion of the chute occurred and this area was modified afterwards to widen out the chute at the bottom below the high-water mark for the Central Dam. These works are shown in **Figure 17** above, where different coloured rock was used in these repairs.

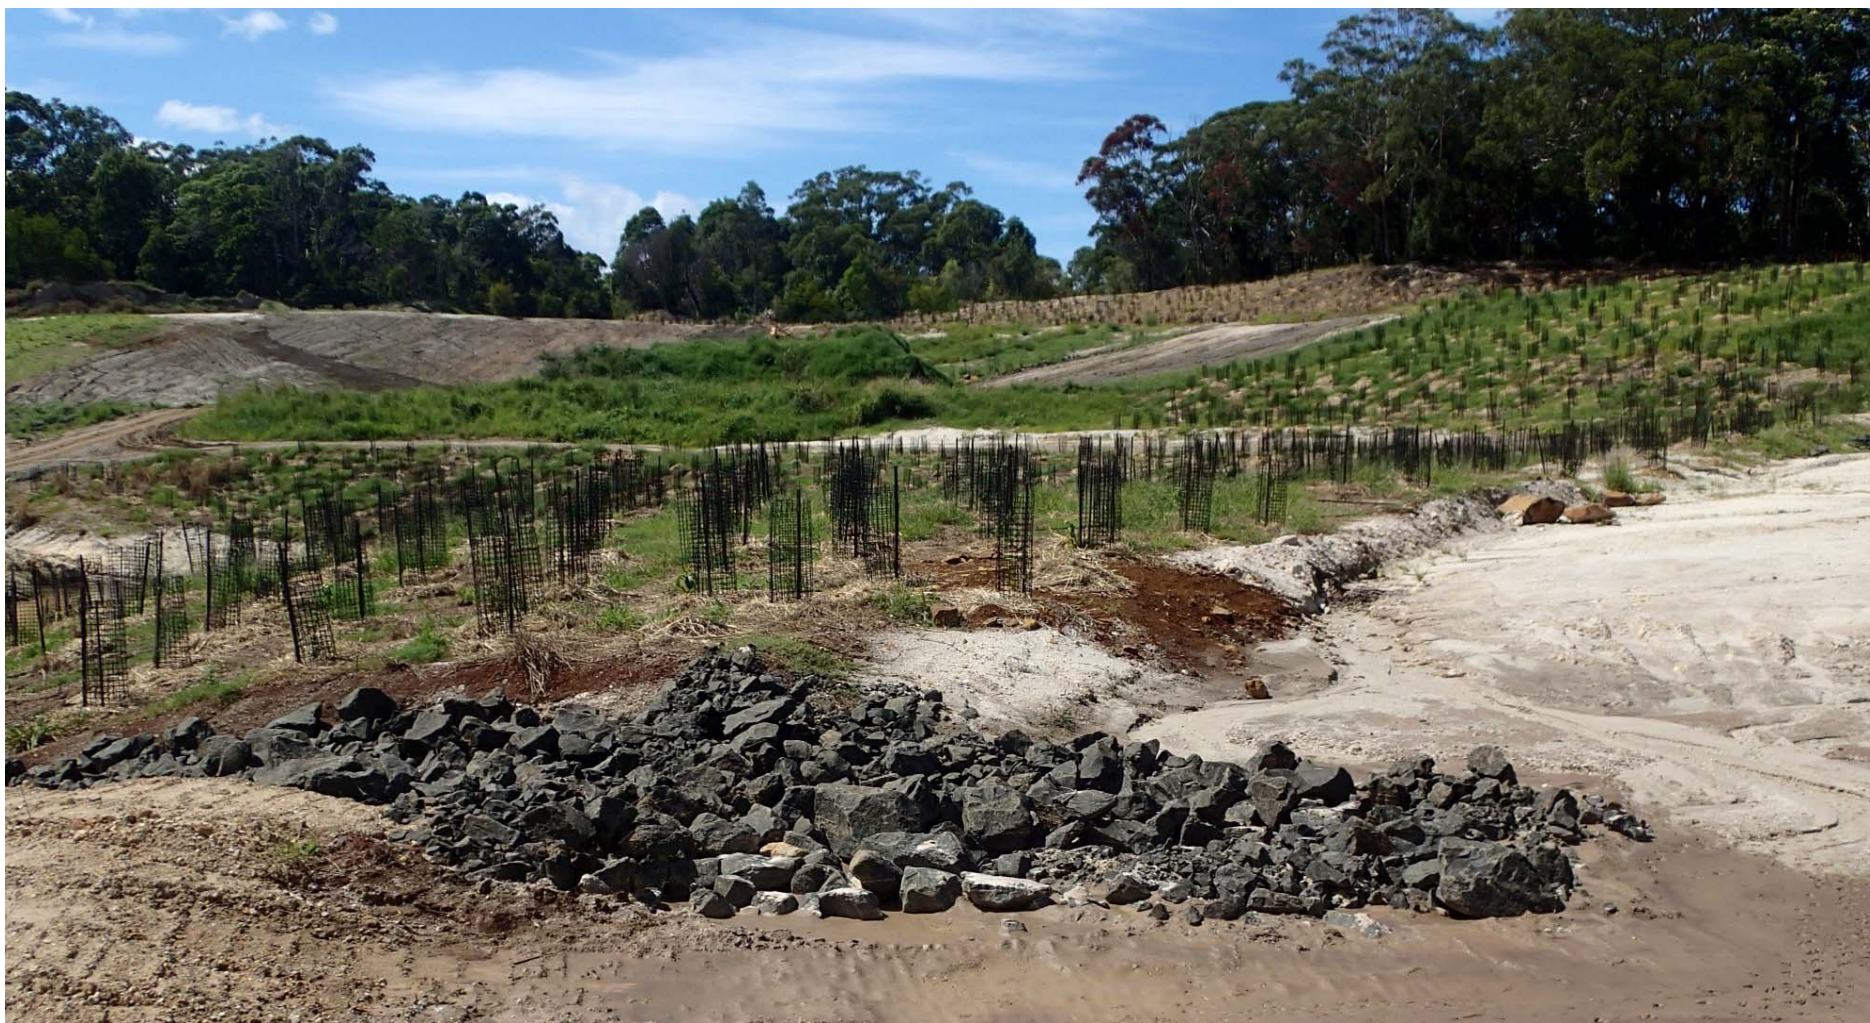
**Figure 18 – Top of rock-lined chute to Central Dam taken looking east**

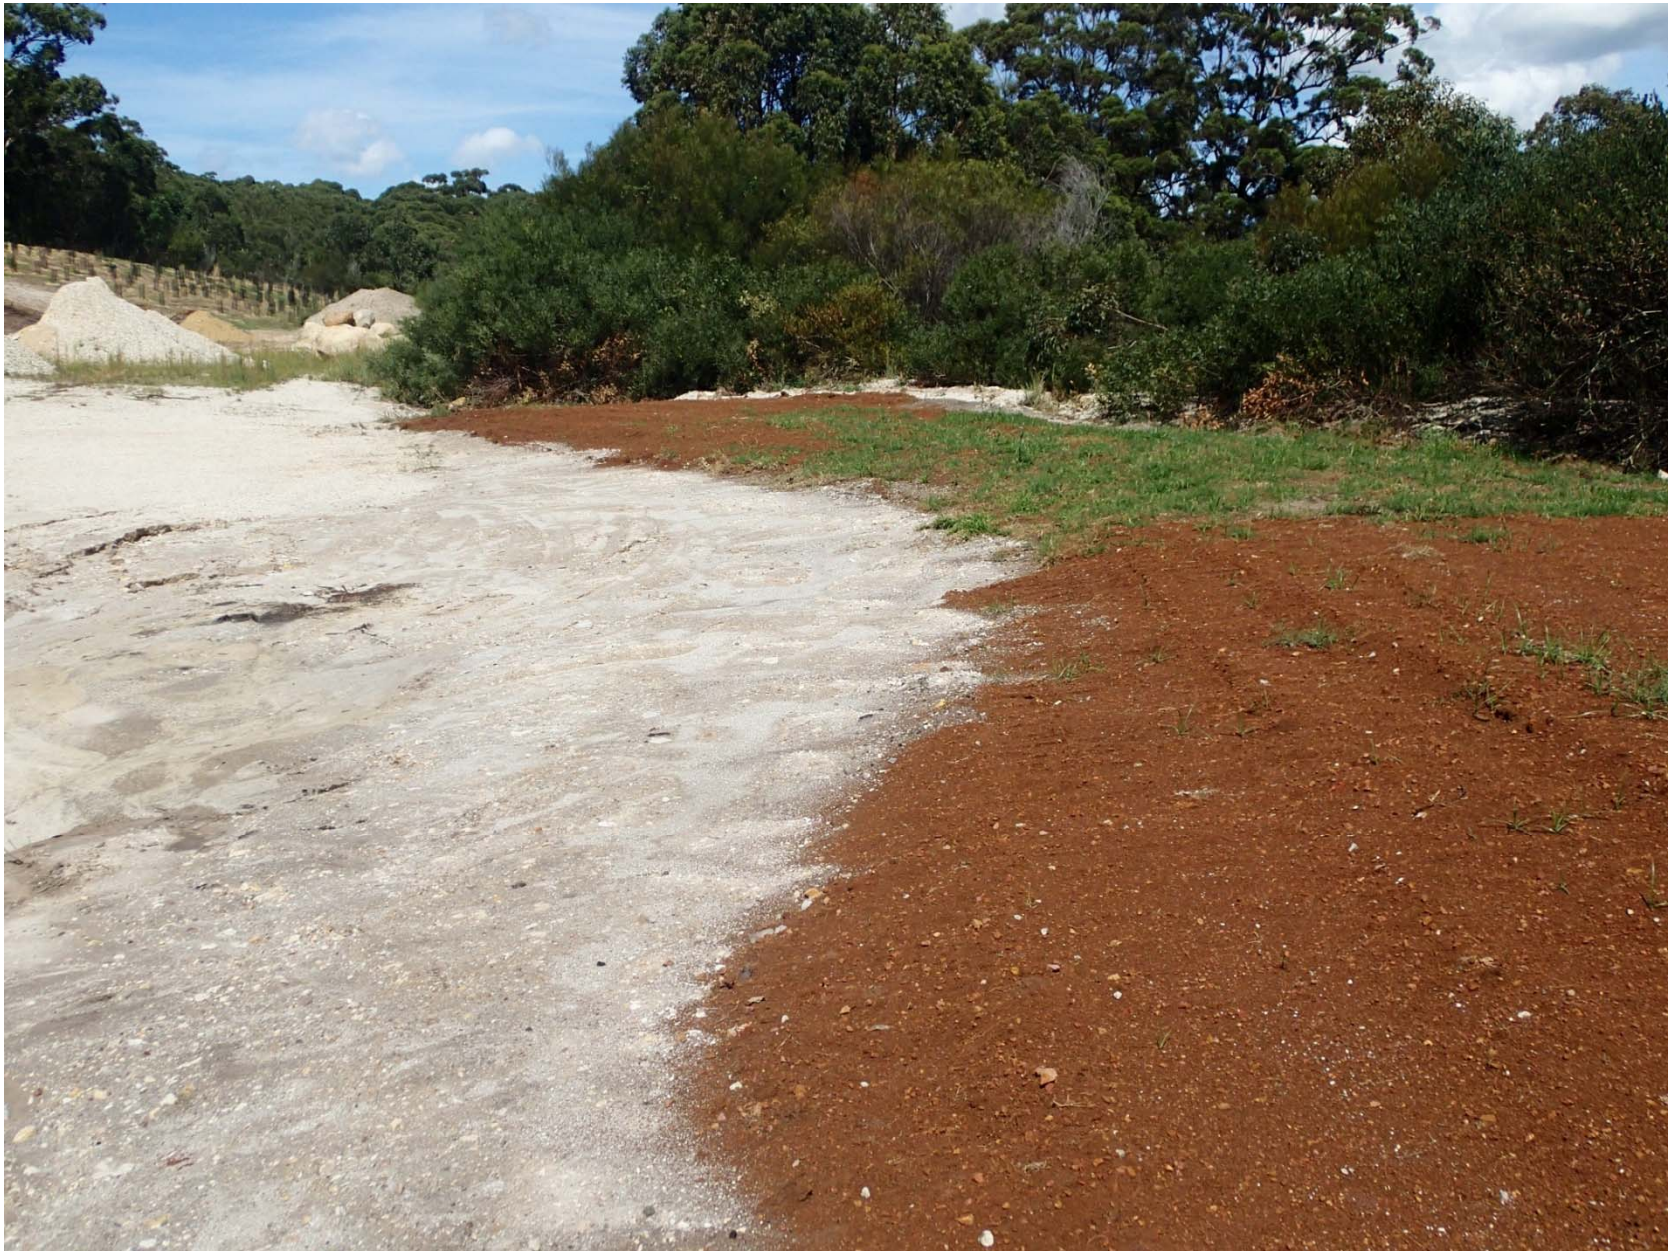
**Figure 19 – Former edge drain filled and diverted to terminate at new rock-lined chute head, viewed from head of rock-lined chute looking south**

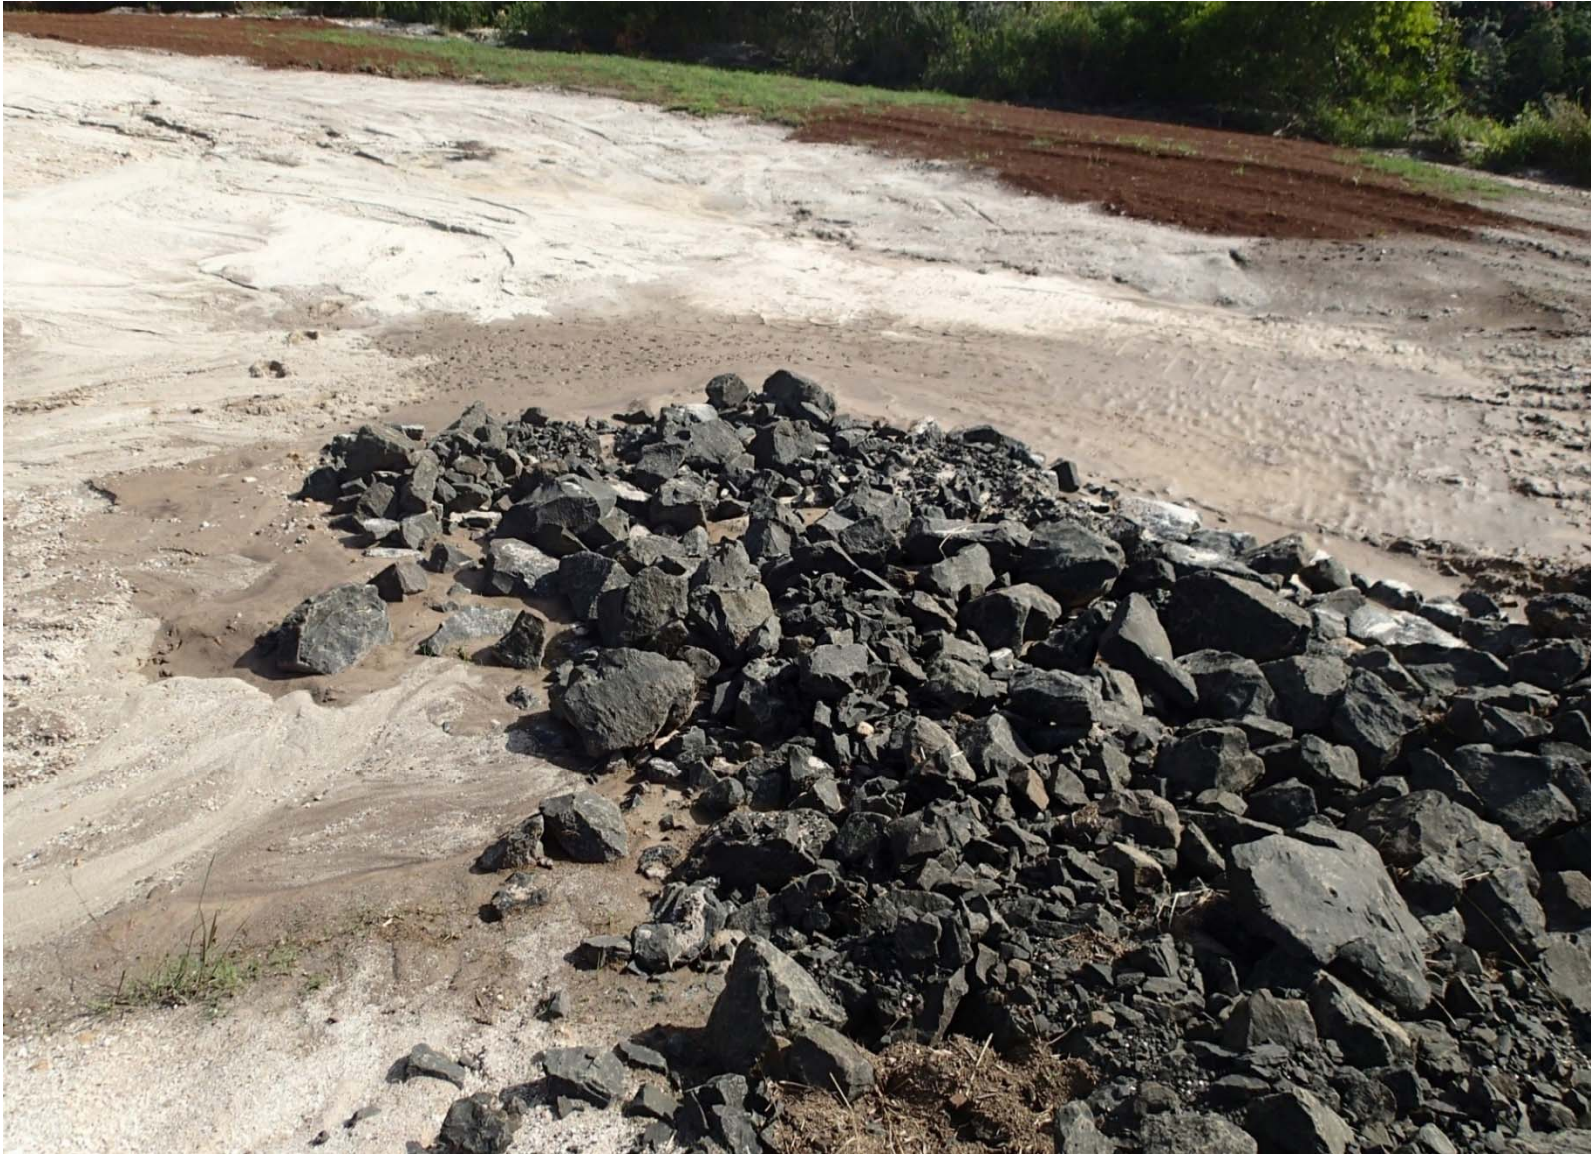
**Figure 20 – Top section of rock-lined chute looking west. Collection and drainage point for runoff from PZW22**

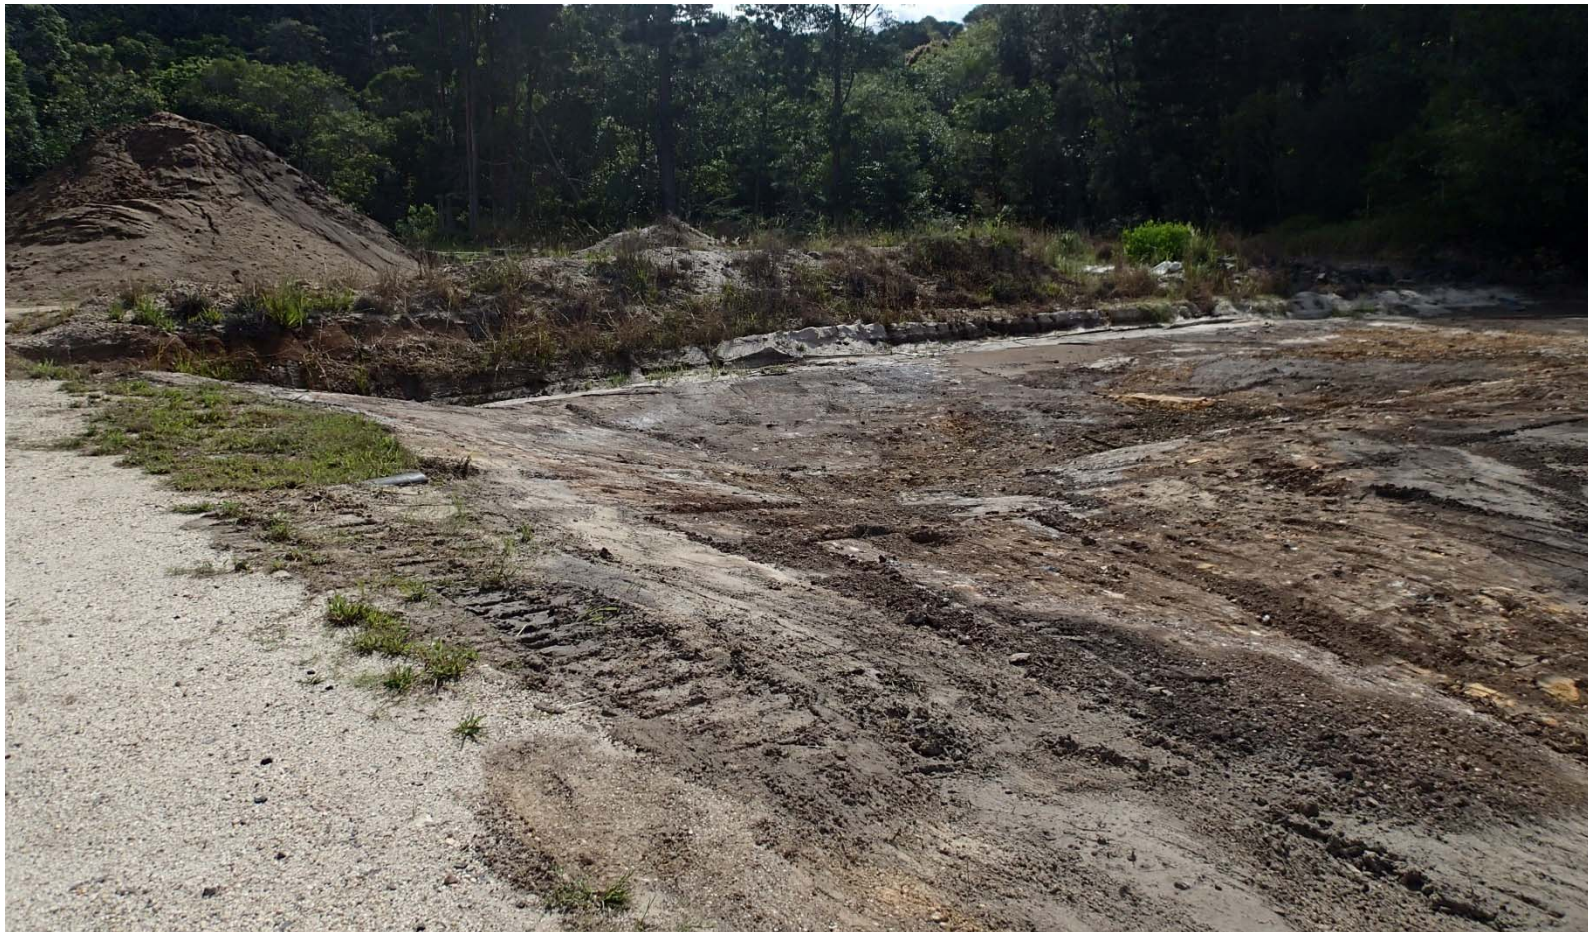
Topsoil for emplacement on top of the new fill on PZW22 and PZW23 has been progressively removed from the stockpile on the site of proposed wetland area in PZW16. The works to construct the depression for this wetland and its integration into the Cutoff Drain have commenced. These works will progress in parallel with the emplacement of topsoil on PZW22 and PZW23. Note these works are not the subject of the 31 March 2019 milestone.

**Figure 21 – PZW16 wetland partially constructed, viewed from access road to PZW15 looking northwest**

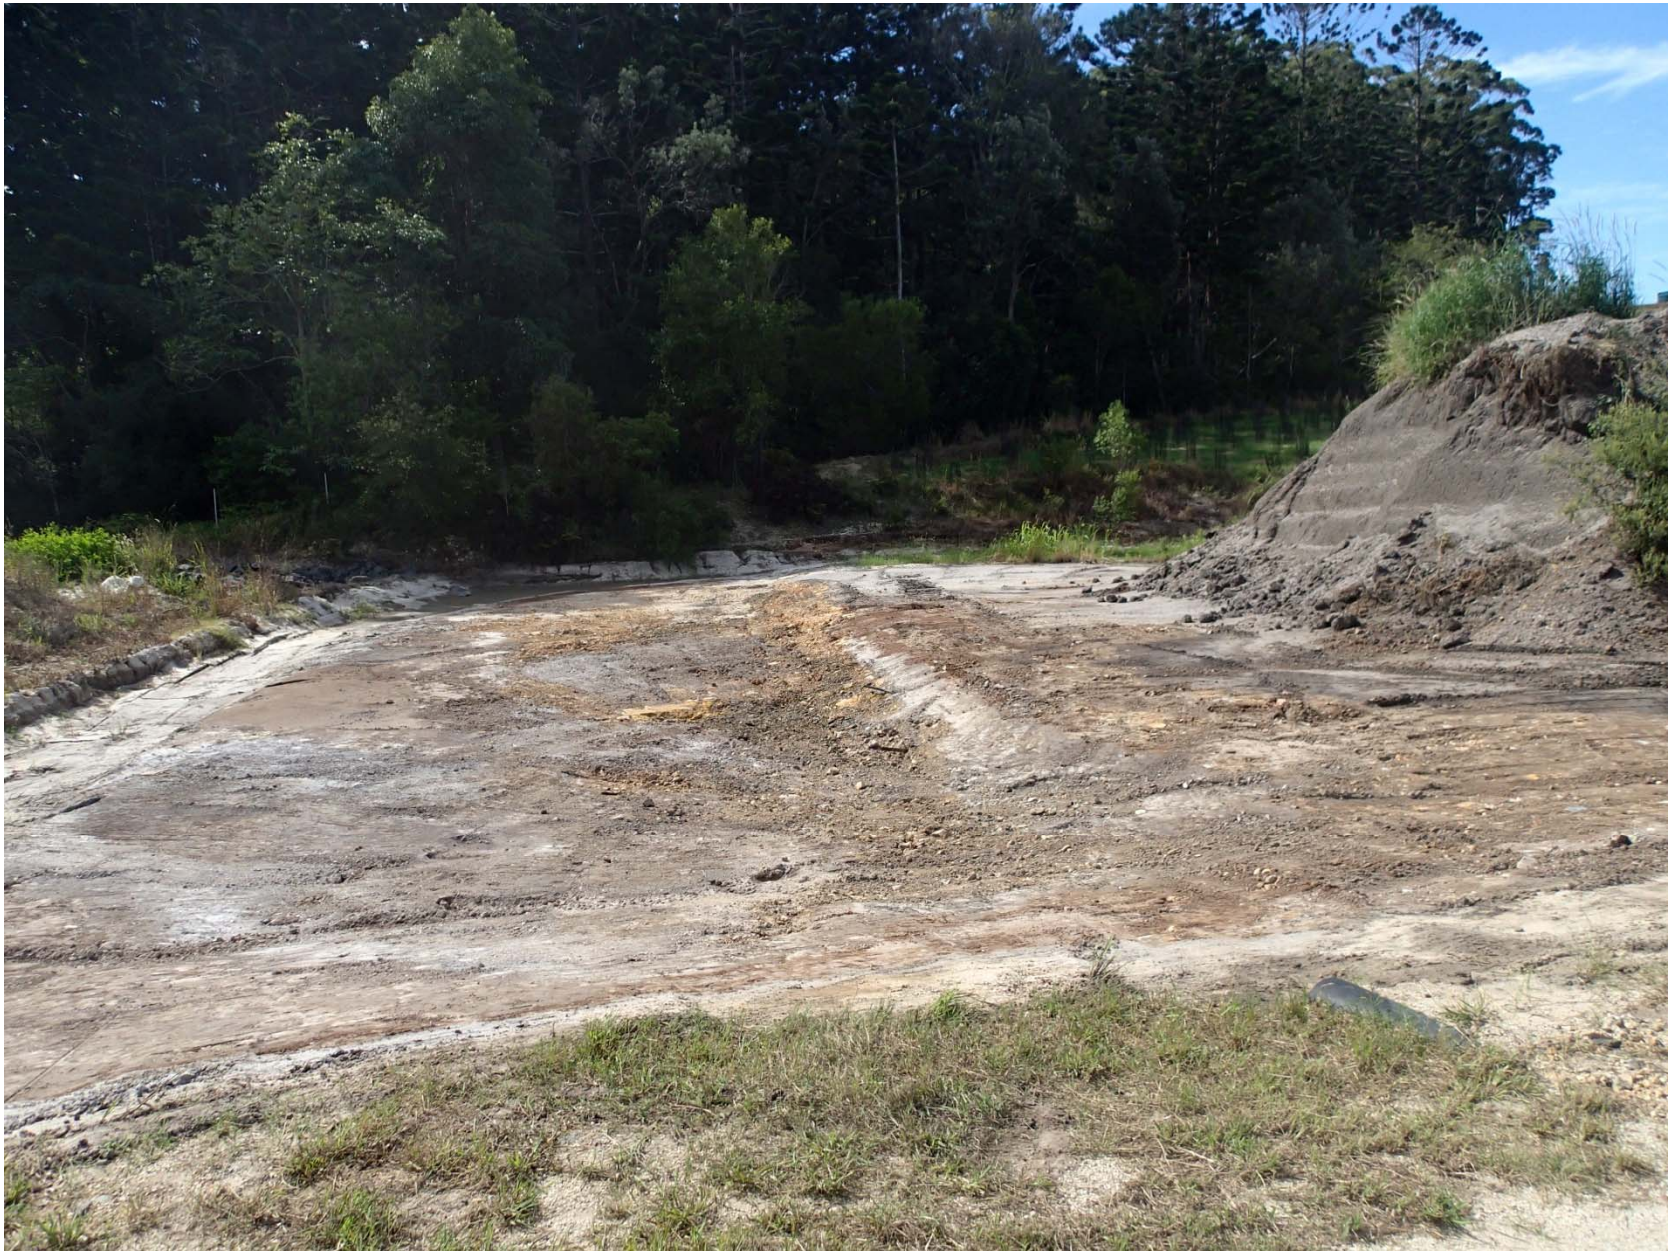
**Figure 22 – PZW16 wetland partially constructed, viewed from access road to PZW15 looking north**

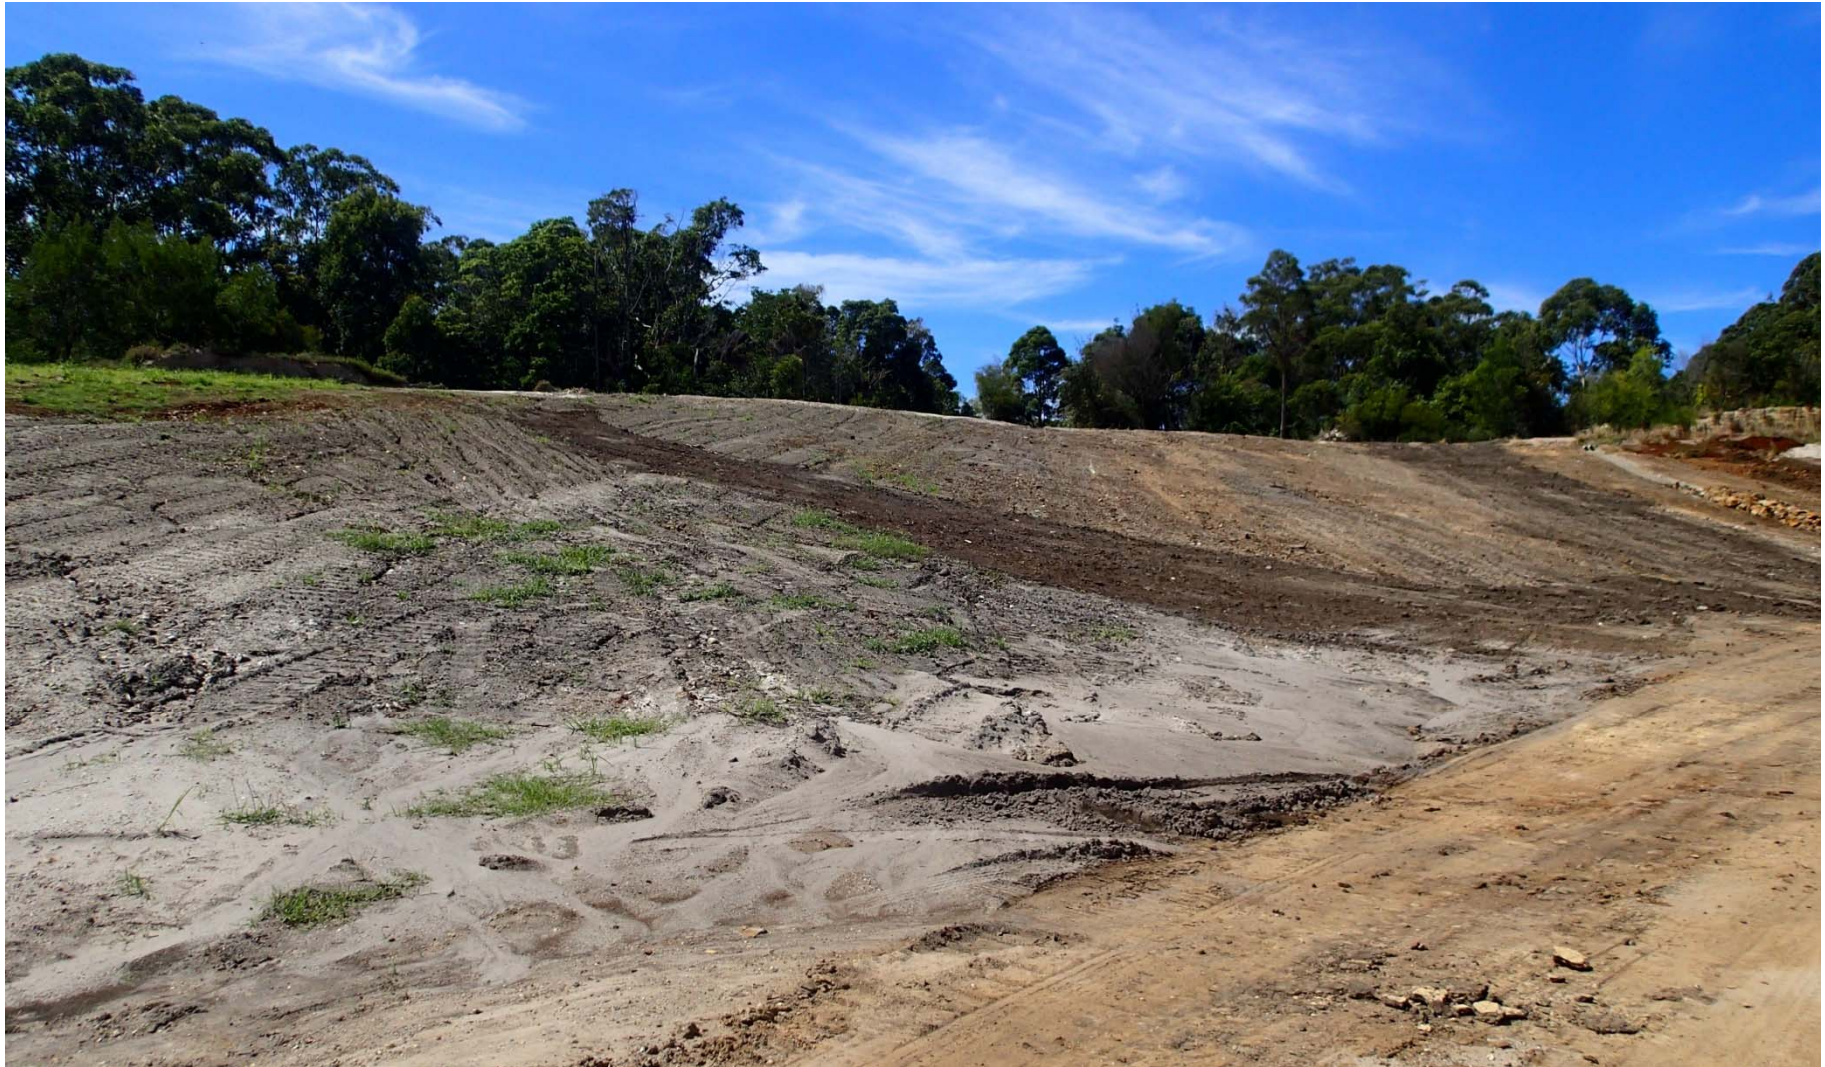
**Figure 23 – PZW21 area between PZW11 boundary and new drain, final landform and topsoil, looking southeast**

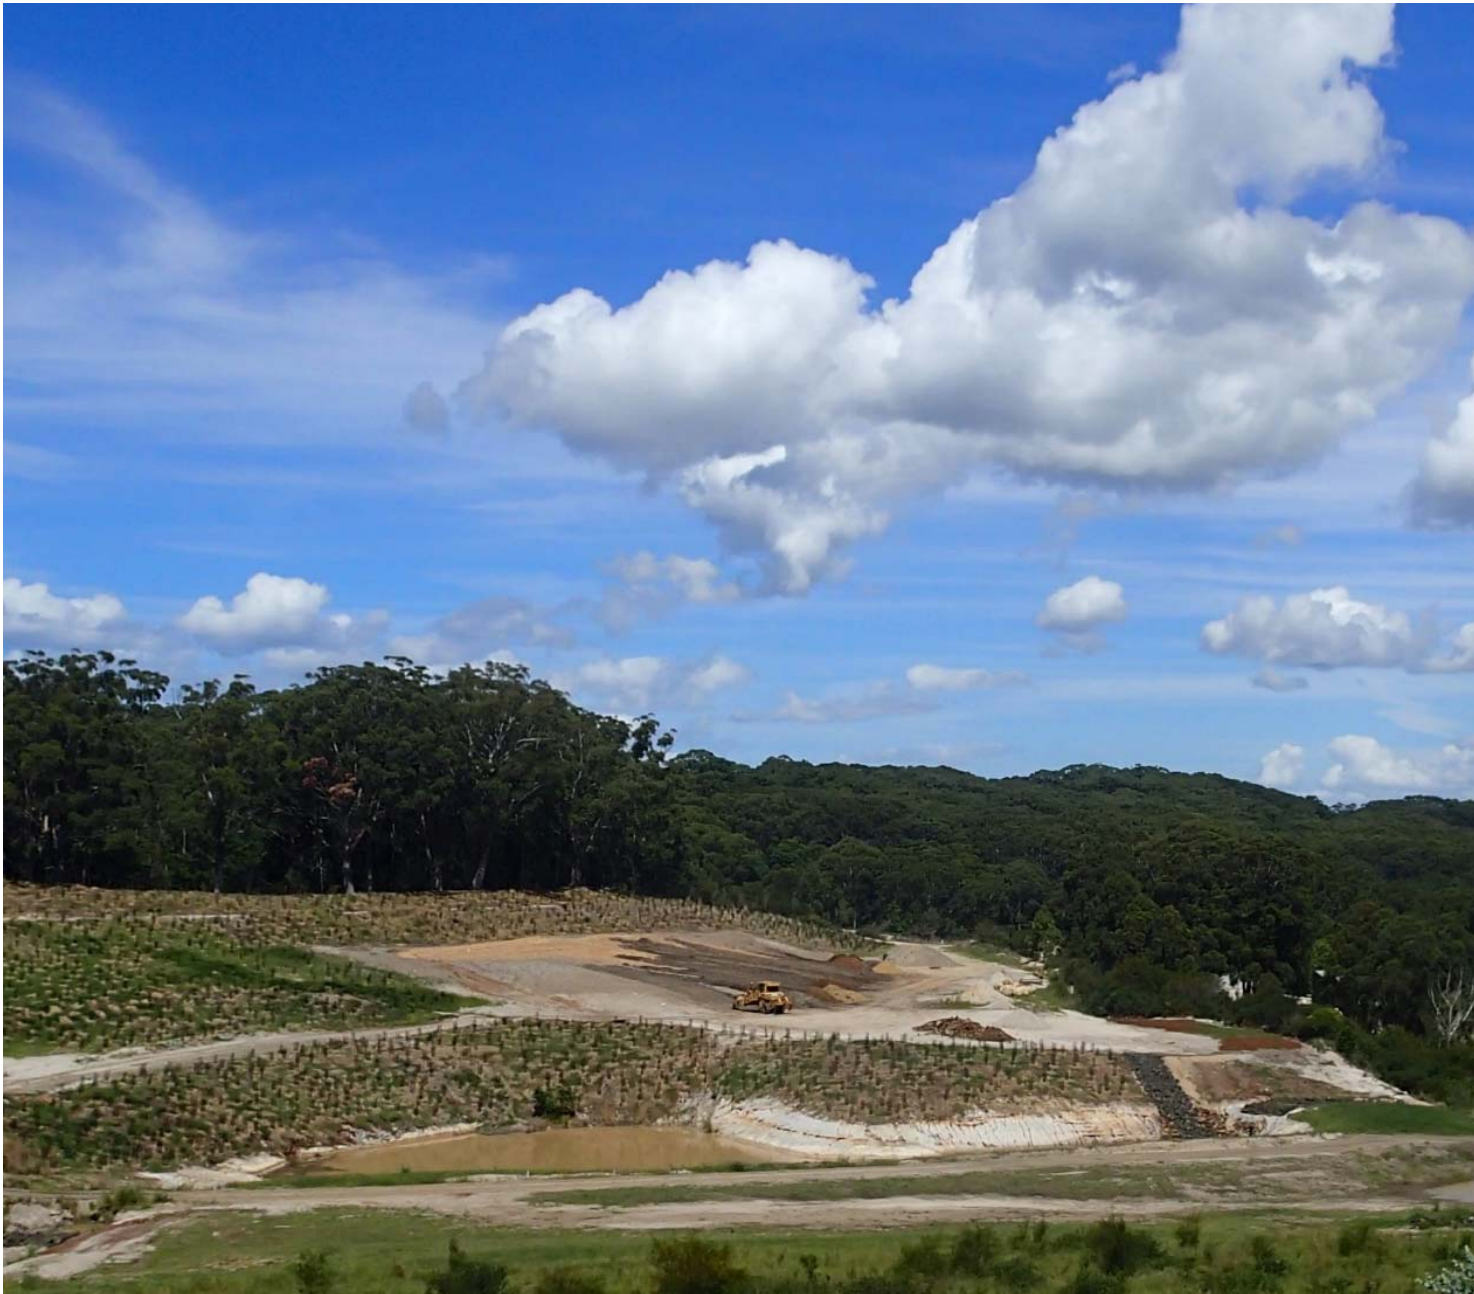
**Figure 24 – Fill emplacement area on PZW23 (centre picture) viewed from PZW2 looking south**

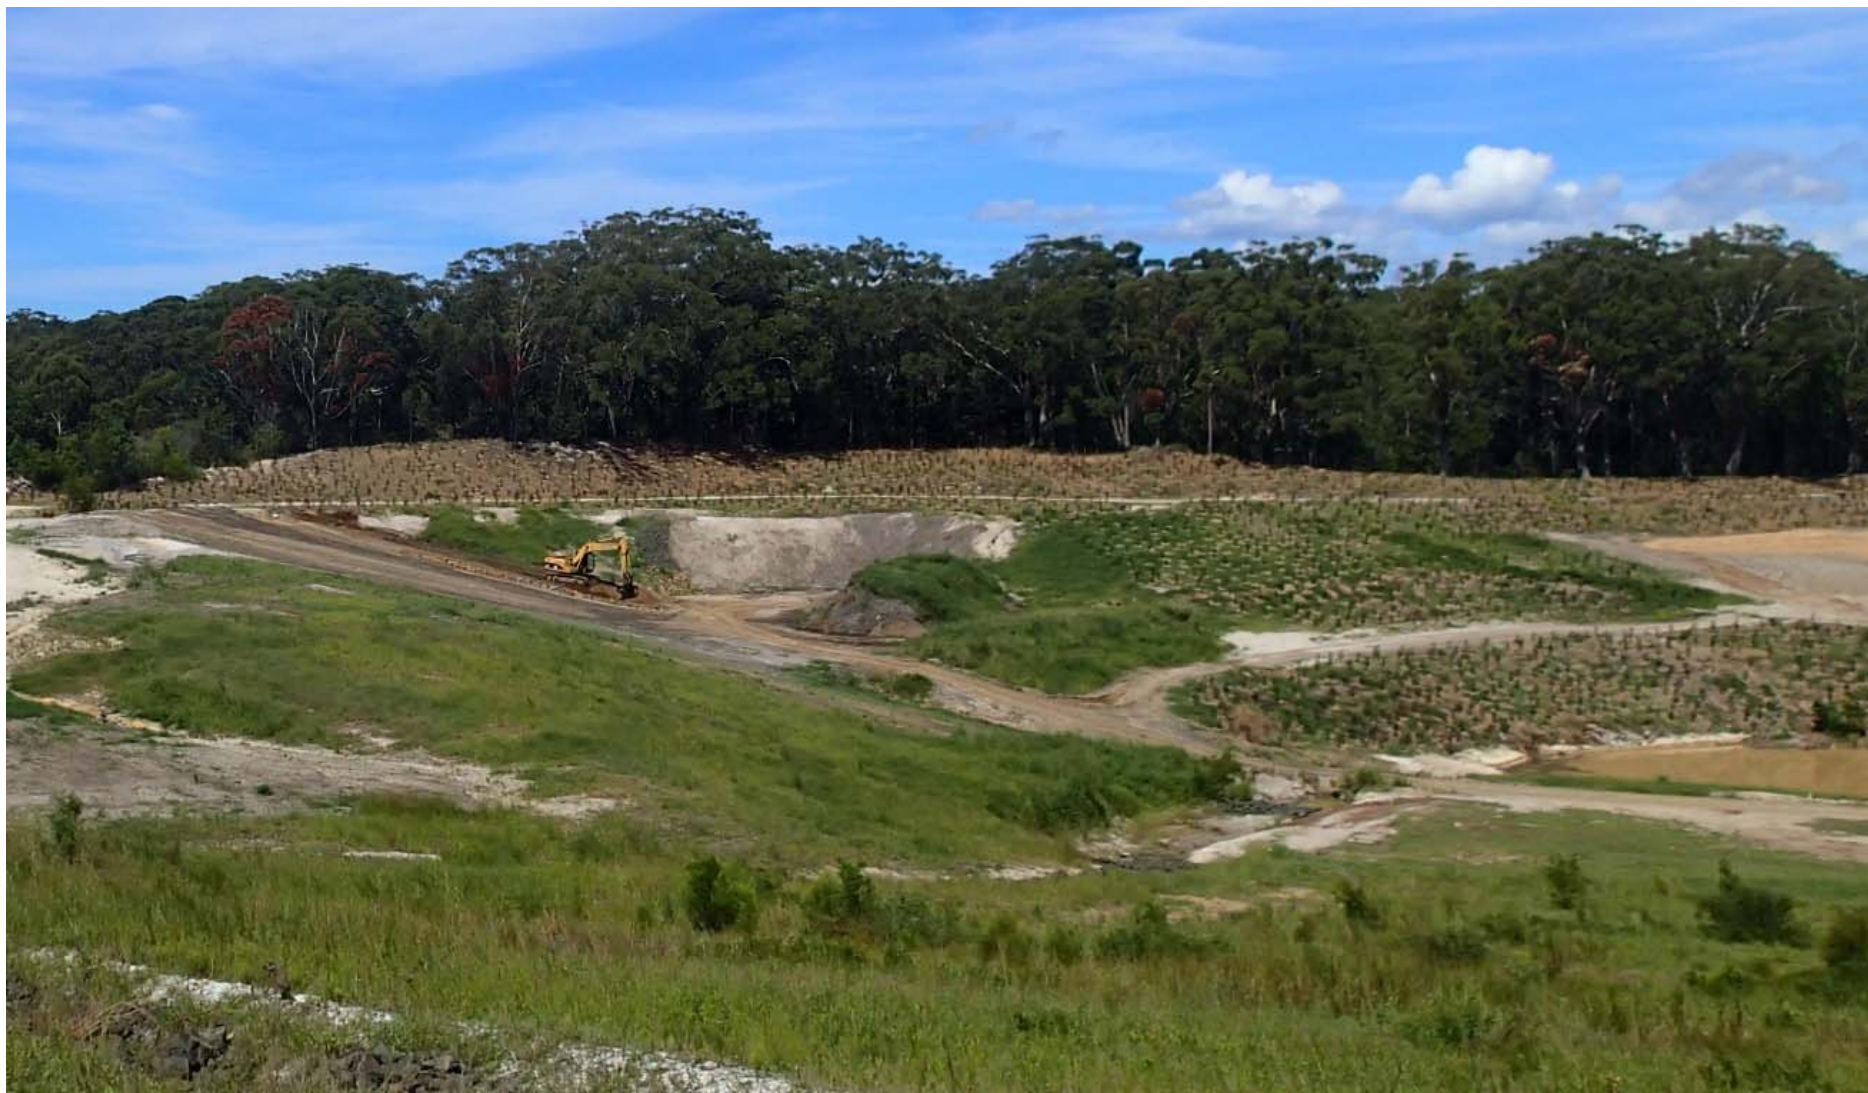
**Figure 25 – Fill emplacement area on PZW21 viewed from PZW2 looking south**

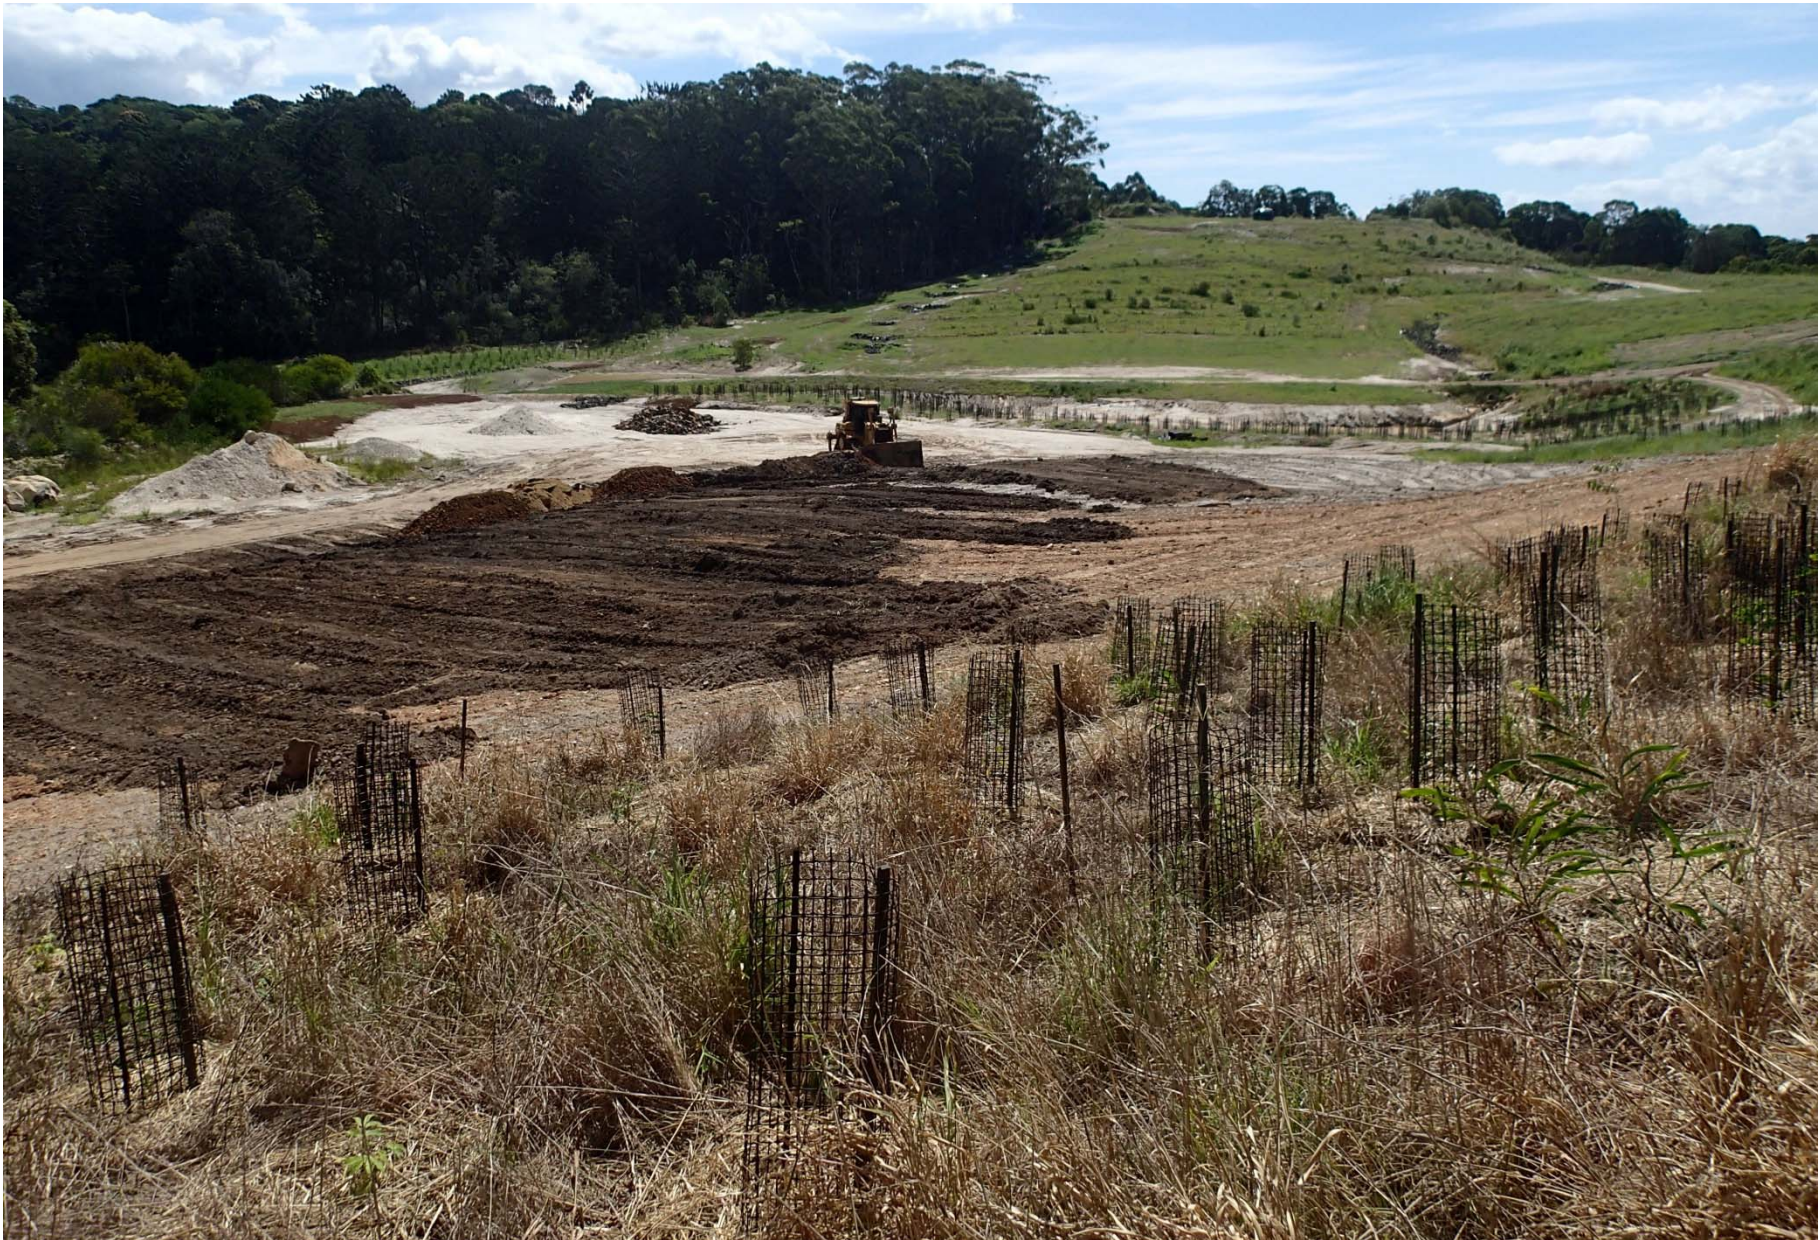
**Figure 26 – Fill emplacement area on PZW23 viewed from PZW24 looking north**

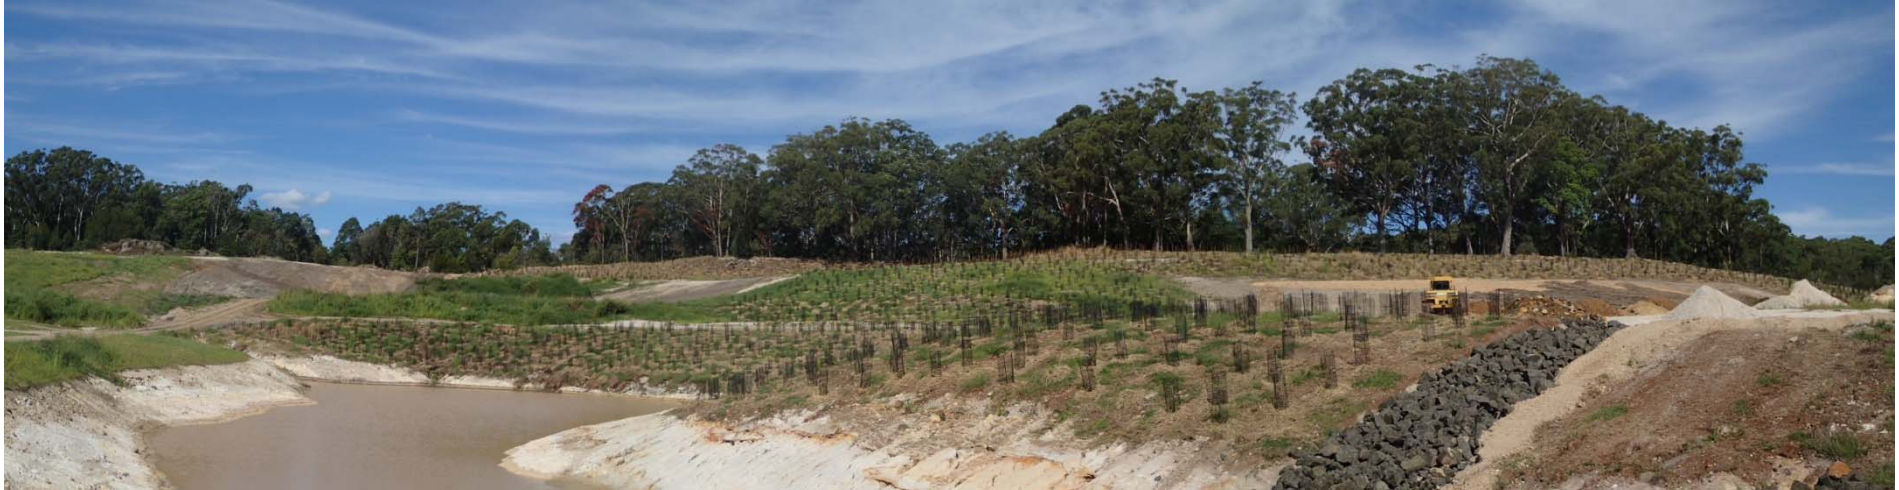
**Figure 27 – Panorama of PZW21 and PZW23 fill areas viewed from Central Dam wall looking east**

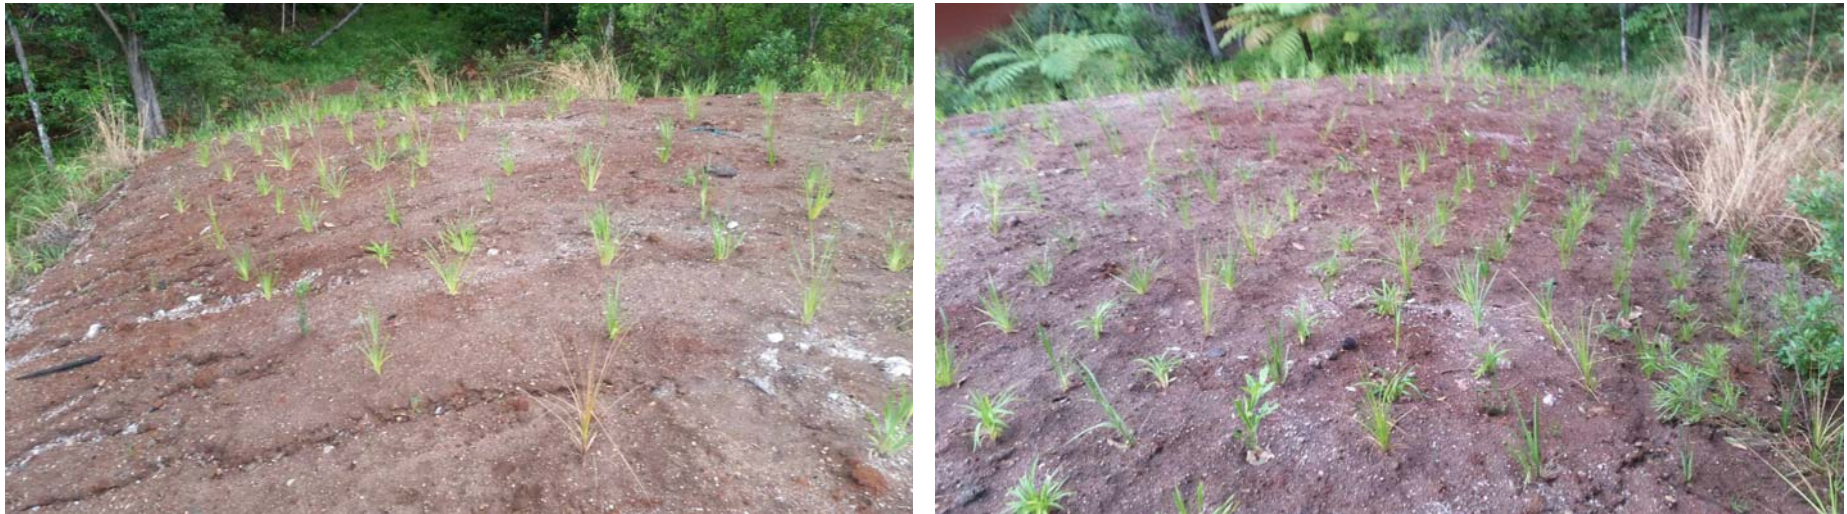
Areas in PZW13 had moderate erosion from the period before erection of the bund at the western edge of PZW15.

This area was rehabilitated with fill and topsoil and, together with the remainder of PZW13 and clear areas with PZW14, was planted with *Lomandra* and similar species.

Figure 30 and Figure 31 – New topsoil and erosion repair plus plantings on PZW12 near boundary with PZW13/PZW14, looking north
