# The Turbocharger Clamp A.D.:

*A Real Safety Improvement  
or FAA Over-reach?*

*By Mike Jones*

*Cessna Pilots Magazine, originally published: July 2023*

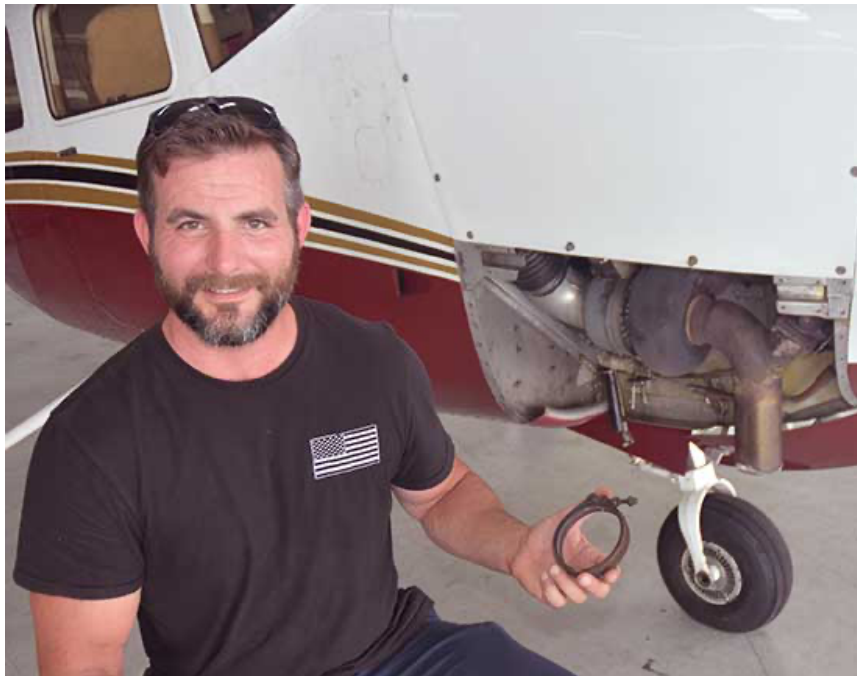
Unhappily, the bad news wasn’t over. The inspection of the exhaust V-band clamp discovered excessive wear, along with a tiny crack along one edge. Clearly, flying with a damaged exhaust system is a bad idea and the clamp needed replacement. But Smith’s favorite parts supplier was sold out: their waiting list had 107 airplanes ahead of me. It felt like a Lady Luck was planning a game of “whack a mole,” and I was the whackee.

*Brandon Smith is a brilliant A&P at Pinehurst Aviation Services at the Pinehurst (Moore County) Airport in North Carolina (KSOP). The V-band clamp in his hand just came off the turbocharger on my T210 behind him. Smith performed the seven inspections required by the new airworthiness directive and found the clamp failed three of the tests. This particular part may have had as many as 1,700 hours in service.*

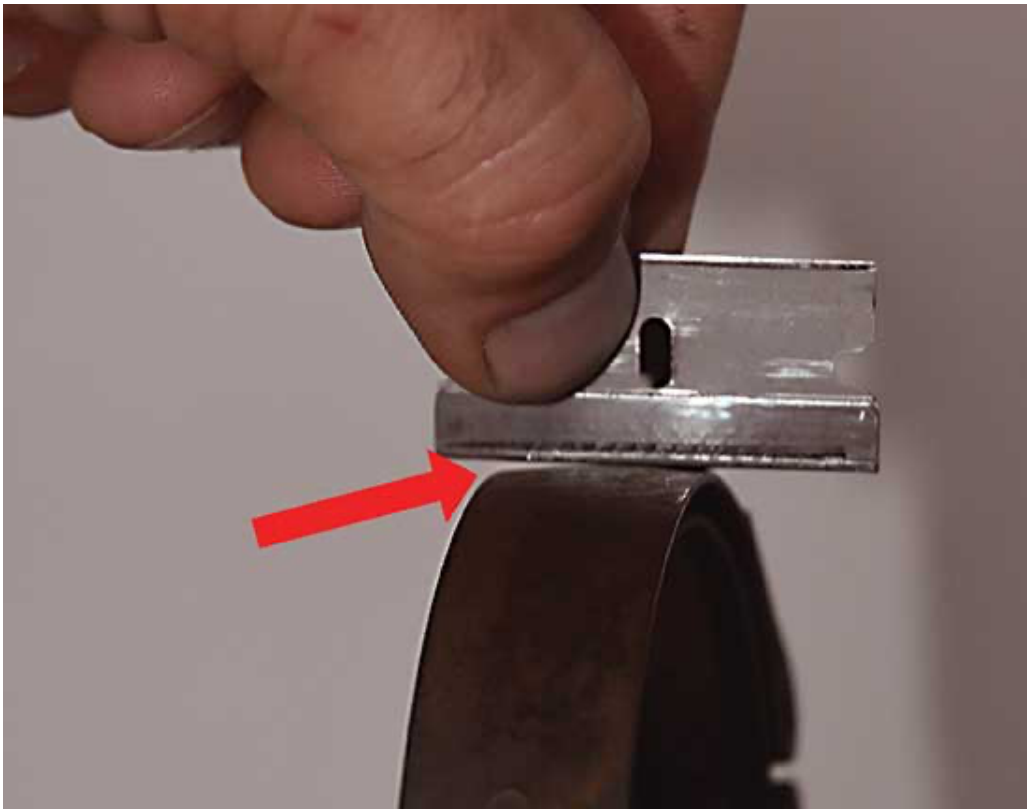
*The V-band clamp is supposed to be flat, but years of heat and vibration have warped this example. The red arrow is pointing at a gap between the flat straight-edge tool and the worn surface of the clamp. This failure was relatively easy to find, as was the second inspection, which was to test for corrosion.*

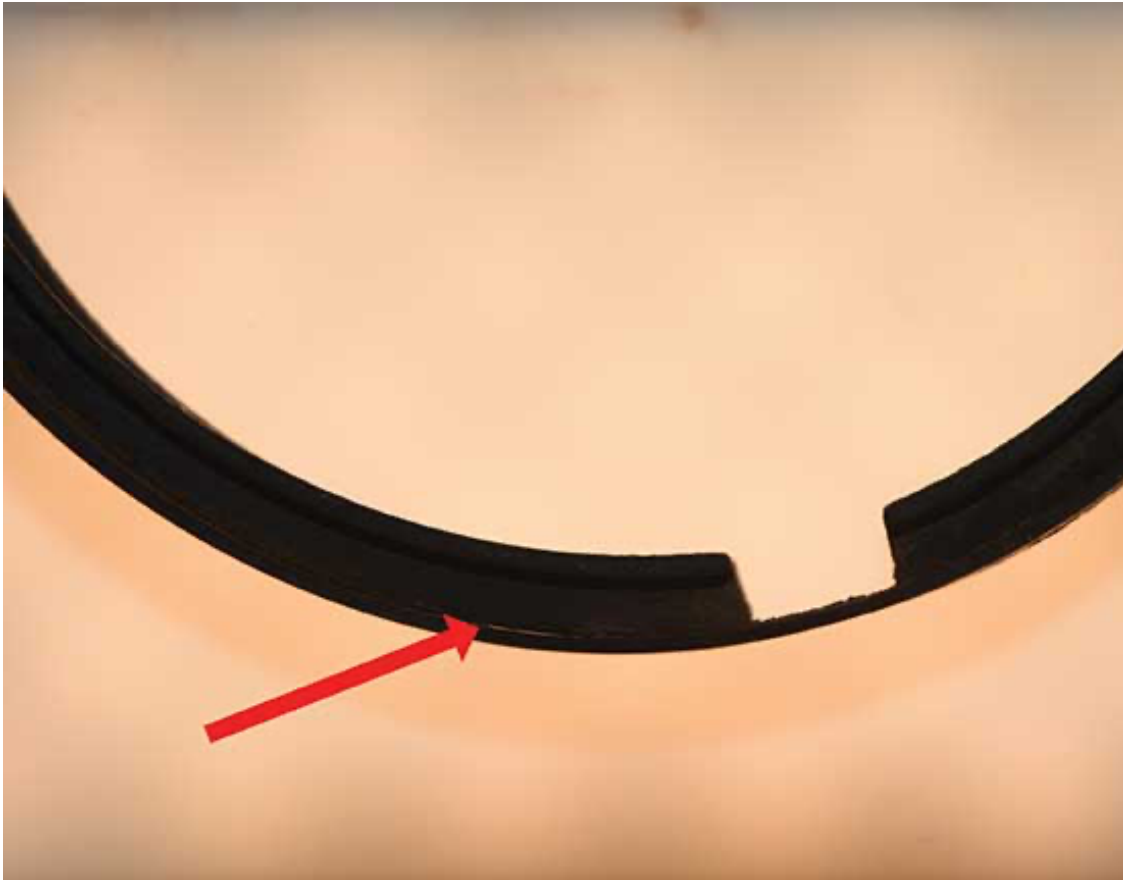
*This is the third test the V-band clamp failed; years of wear and tear have caused spot welds to weaken, allowing the inner band of the clamp to separate from the outer band. Although the gap is very small, it is visible by the red arrow and indicates the band has lost its structural integrity. Good catch, Brandon Smith!*

My experience supports Saxton’s position. It was impossible to find a replacement Cessna S1921-1 V-band clamp. As I mentioned earlier, my A&P called Textron (the owner of Cessna today) and other vendors and they were all out-of-stock. He found one vendor with a waiting list of 107 airplanes. I also spent hours on the phone, contacting at least ten shops.

I finally found help at Tornado Alley Turbo in Ada, Oklahoma. Their part, #11-1100035, was not made by Textron but is functionally equivalent, in-stock,
