December 7, 2021

**RE: Forensic Engineering Report – Wind Damage  
Newnan Presbyterian Church  
38 Greenville St. S  
Newnan, GA 30263**

Per your request, Shields Engineering Group, Inc. performed a forensic engineering inspection at the Newnan Presbyterian Church at the address above. The Church purportedly sustained damage as a direct result from high winds from a tornado that passed through Newnan on March 26, 2021. This investigation was conducted on November 9<sup>th</sup>, 2021, by Martin Shields, P.E. and Ava Shields of SEG.

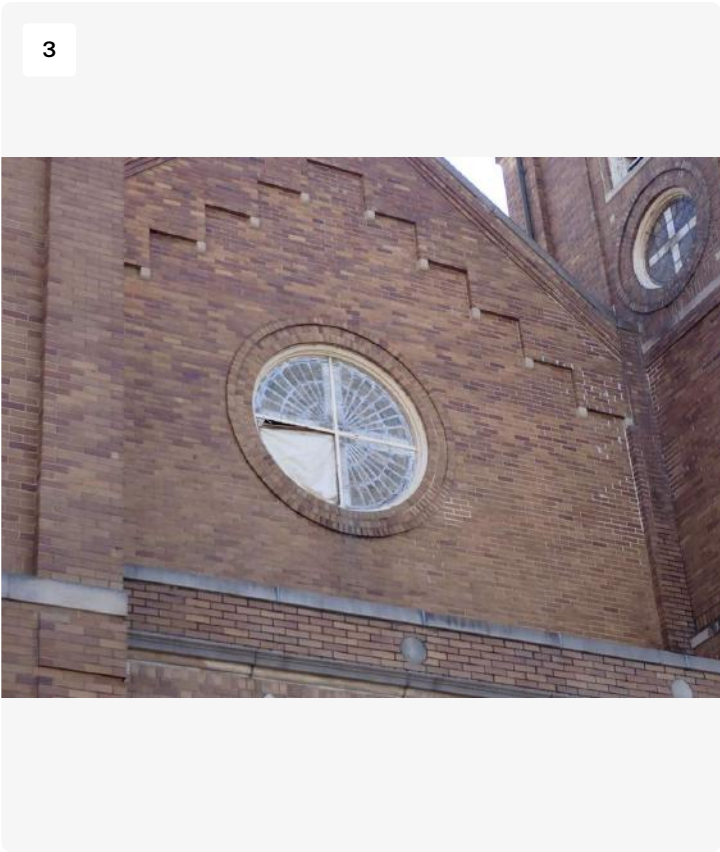
- A walk around of the Main Building was conducted. SEG noted a broken stained-glass window on the western elevation, above the main entrance due to the high winds and wind-borne debris. The stained-glass windows were found to have storm-protection plexiglass panels around them on the north and south elevations. The metal frames around these protection panels were observed to be displaced and uplifted due to the high winds. On the south elevation, a protective window was noted to have a crack. Other windows on the south elevation had displaced sealant strips (**Photographs 1—11**).
- A downspout on the south elevation was found to have a chalky substance on the wall due to discharge from an unknown supply line. It is unclear if the supply line was meant to connect to the downspout (**Photographs 12—15**).

Broken window

2. Remove and replace the damaged modified-bitumen flat roofing assembly on the west elevation.
3. Remove and repair the stained-glass window on the western elevation.

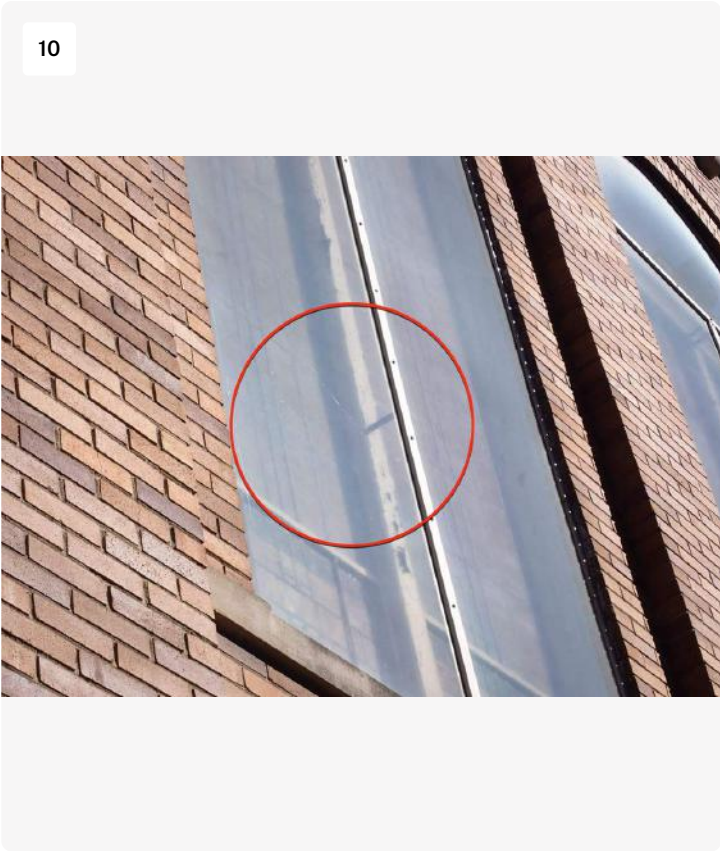
Broken window

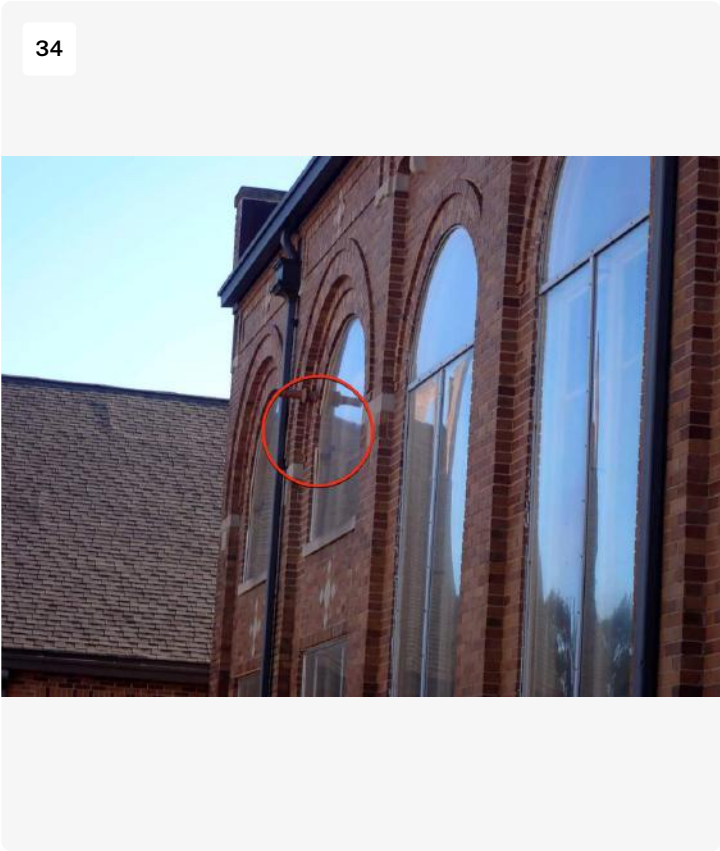
- The north elevation was observed to have a displaced vinyl awning due to the high winds. SEG found the plexiglass storm windows over the stained glass to be bowed on the north elevation. One of the panels was noted to have been displaced from the metal window frame and pushed inward. Other windows on the north were observed to have missing window seals and displaced metal window frames (**Photographs 16—38**).
- SEG observed broken, displaced and chipped slate tiles on the northern slope from the ground (**Photographs 39—42**).

Bowed window

4. Remove and replace all plexiglass storm-protection windows on the north and south elevations.
5. Remove and replace all damaged gutters and downspouts.

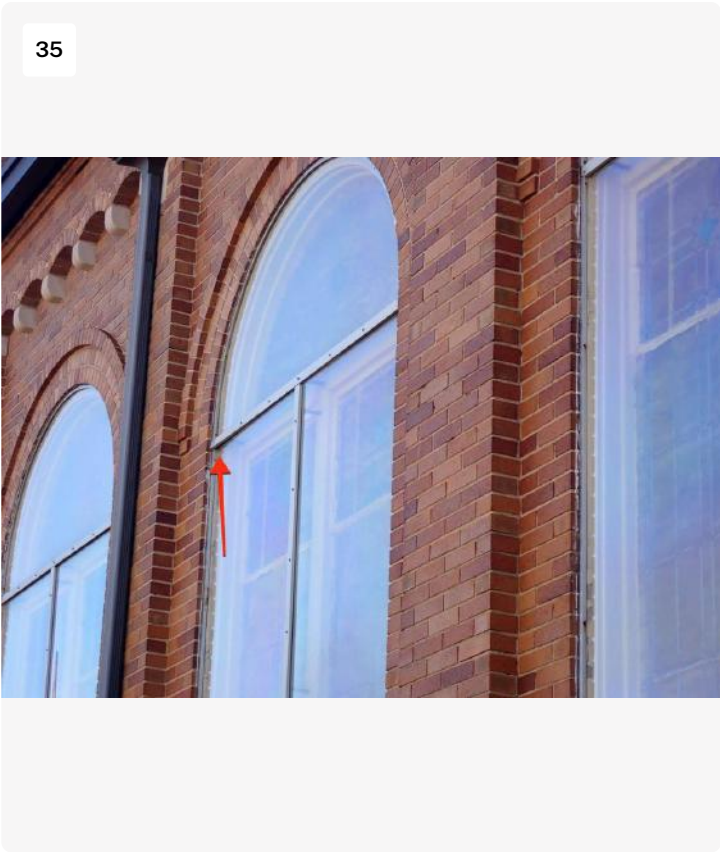
Broken window seal

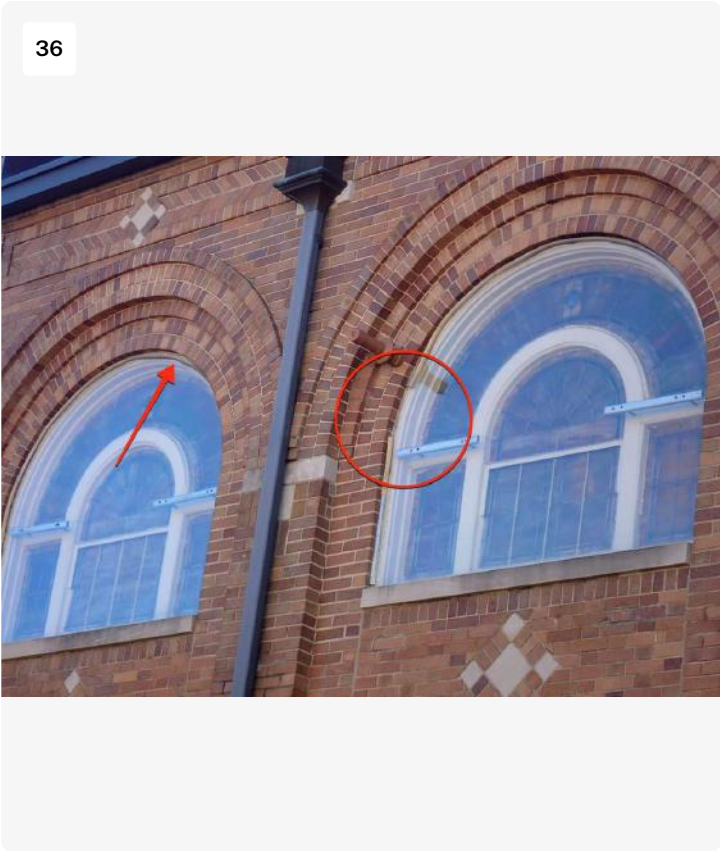
Displaced window frame

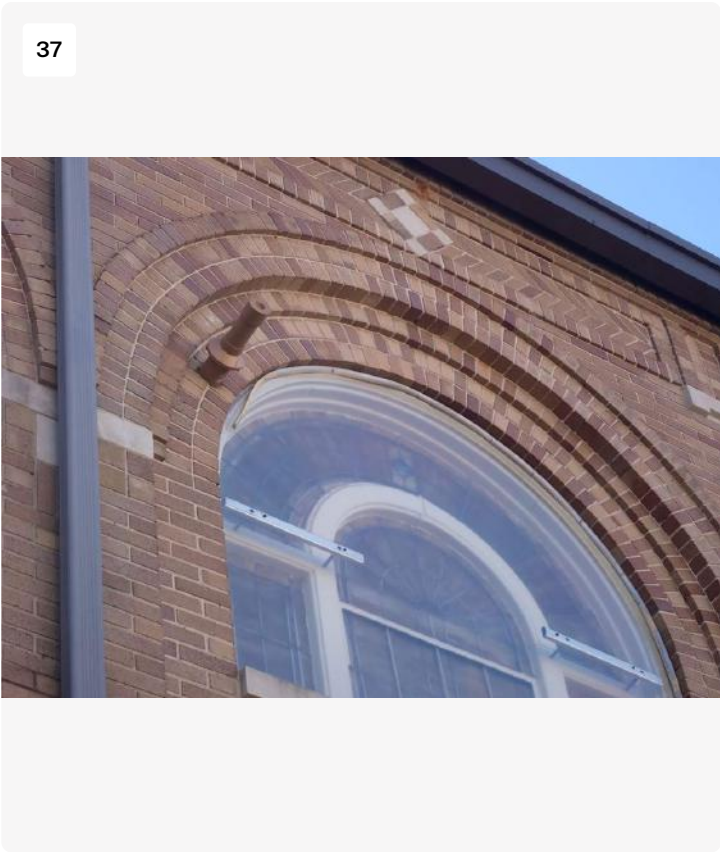
Damaged, missing window seal

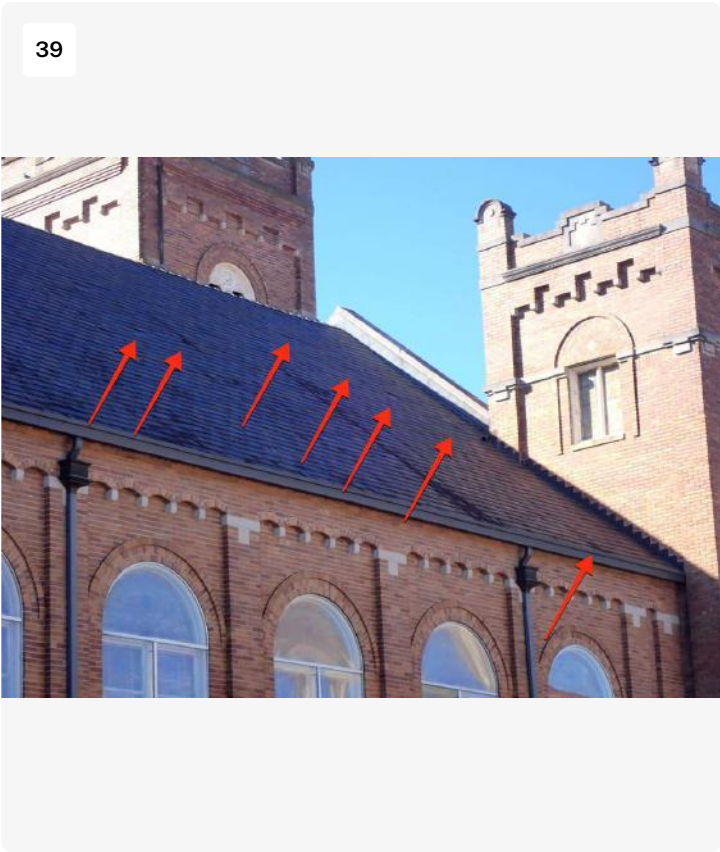
Displaced/missing tiles

1. The slate tiles should be removed and replaced on both the north and south slopes. If economically feasible and if replacement tiles are available to match, the intact tiles can be removed and re-attached, after the replacement of the old/damaged roofing felt. Several items to note if the intact tiles are going to be re-used: 1) A breakage factor must be included as approximately 10 to 15% of the intact tiles will be broken, and 2) many of the intact tiles are currently chipped and have small cracks – these tiles cannot be re-used per IBC codes.

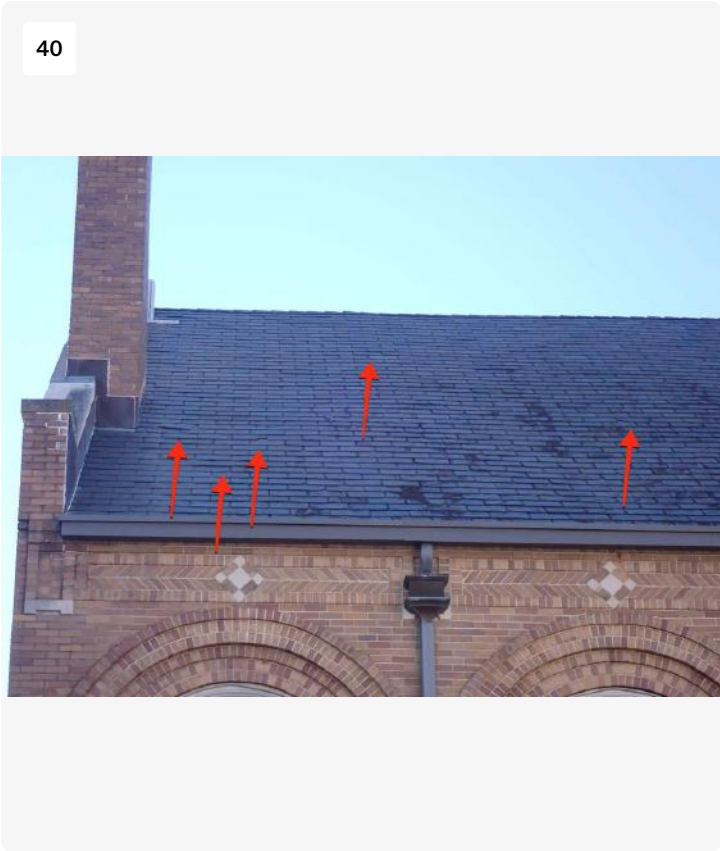
Displaced/broken tiles

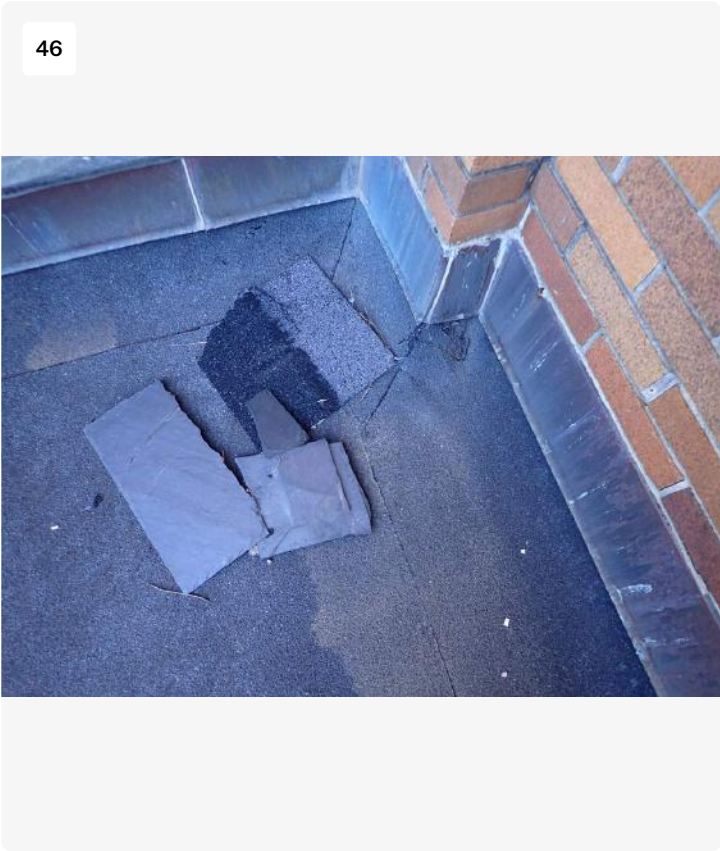
- The flat-lay modified bitumen roofing assembly was inspected for storm-related damages. SEG found several broken slate tiles on the roofing assembly that had fallen from the main roof above. Abrasions and scratches were noted throughout the roofing field due to the fallen tiles and wind-borne debris. Areas of the mod-bit lap seams were found to be unbonded and uplifted due to the high winds. Storm-related debris was noted underneath some of these lap seams, as well as throughout the roof (**Photographs 43—70**).
- Copper counter flashing was noted around the roofing assembly. A scratch was found on the copper from the adjacent broken slate tile that had fallen (**Photographs 71—73**).

Broken tiles and shingles that fell from the above roofing assembly

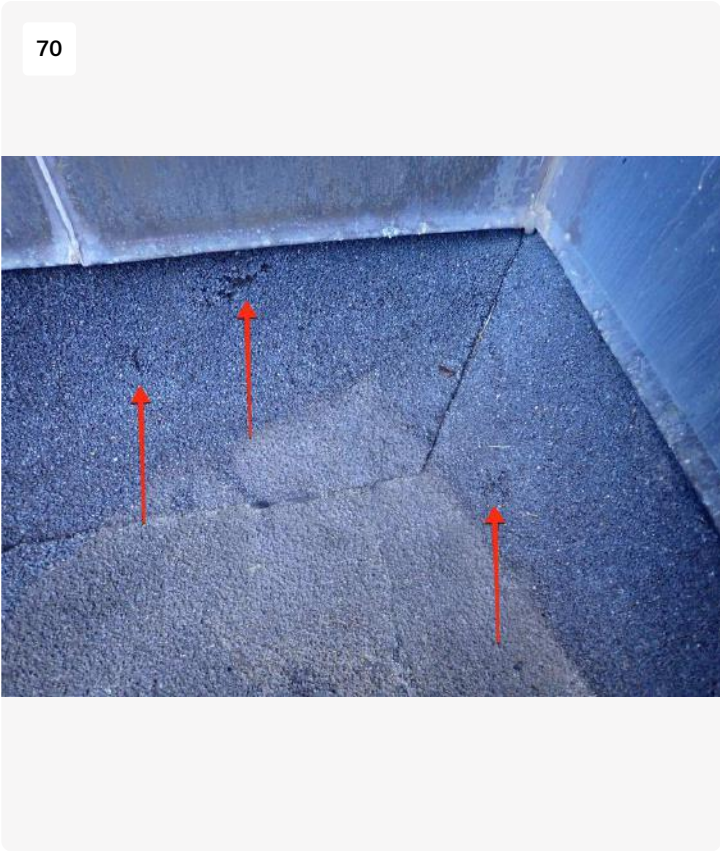
Damages to mod-bit from fallen tiles

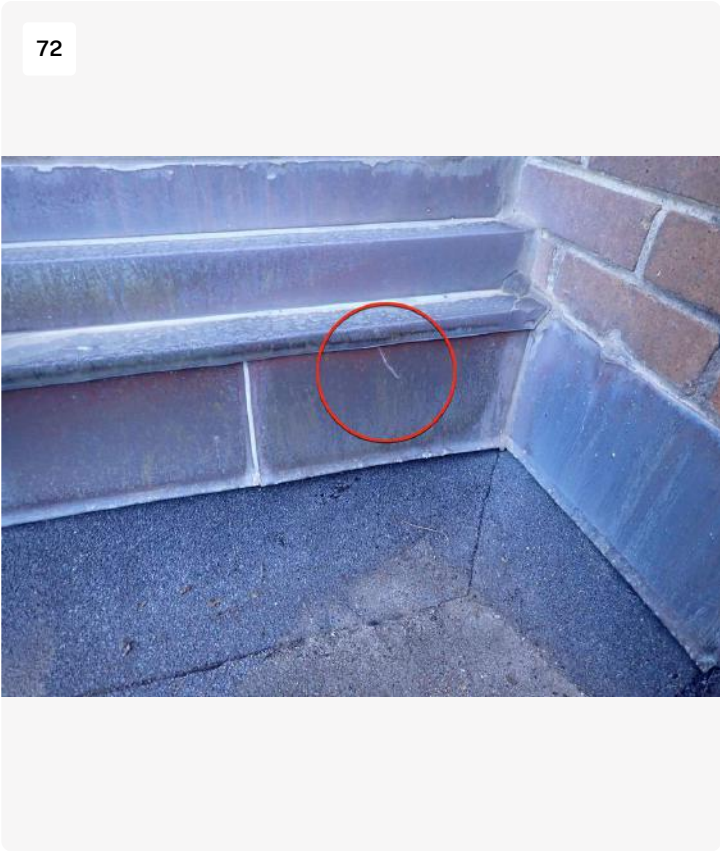
Damage to copper flashing from fallen tile

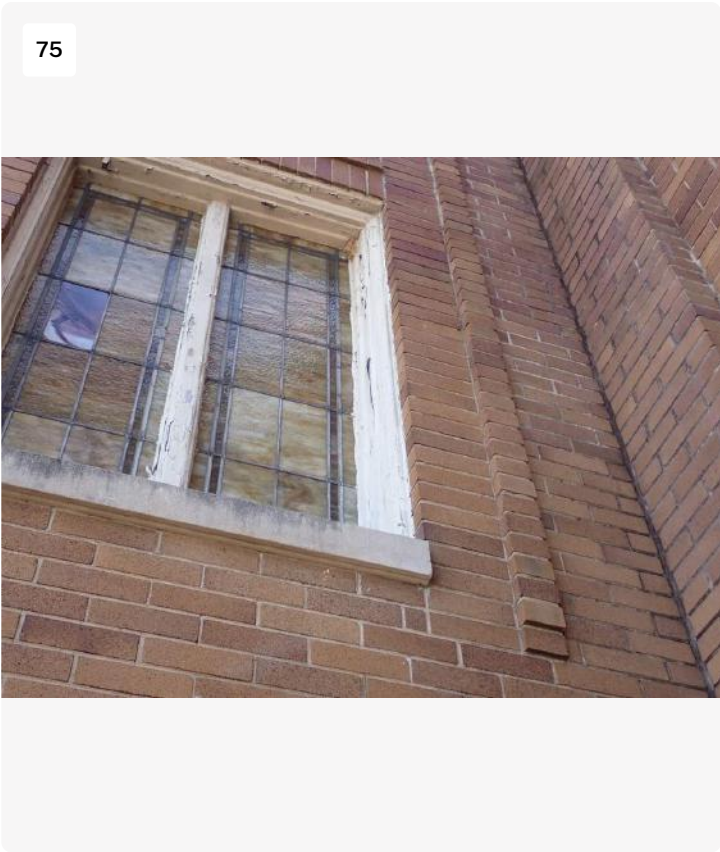
Damages to painted window frames due to high winds

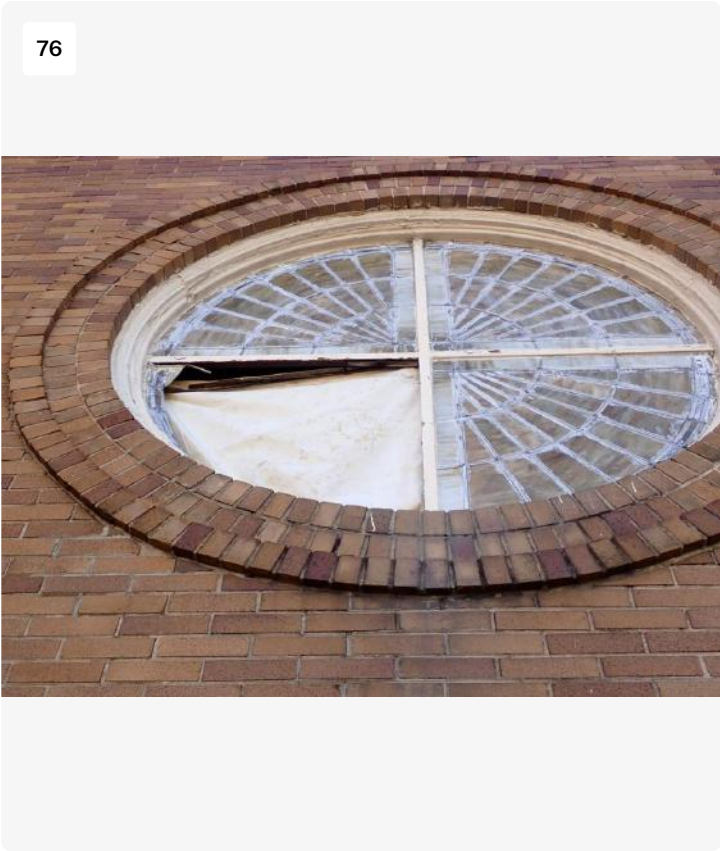
Broken mosaic window

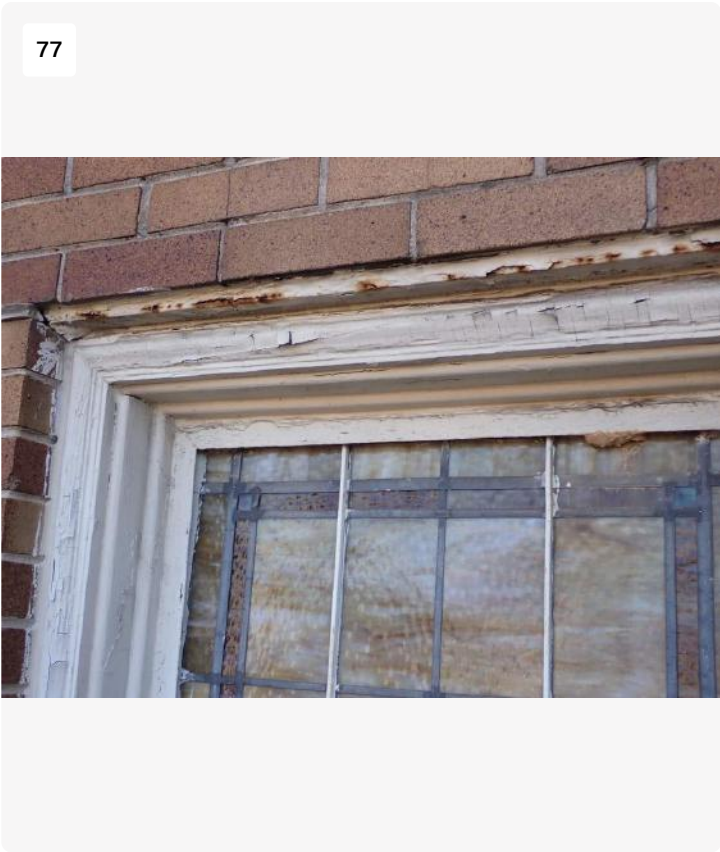
Paint ripped off due to high winds

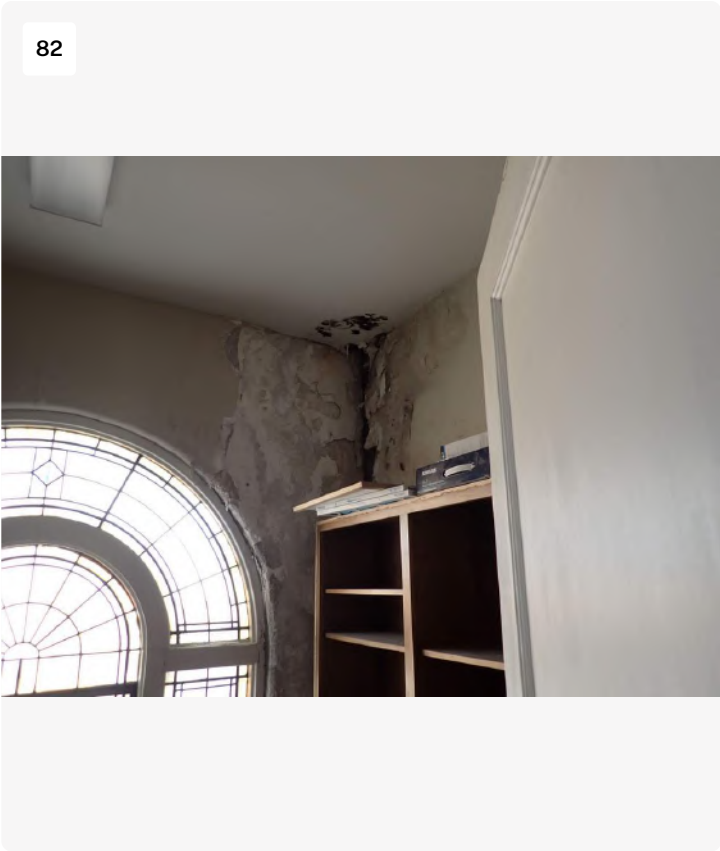
- SEG inspected the interiors for water intrusion and associated water-related damages. Significant water damage and mold was found on the upstairs walls and ceilings in the NE and SE multi-use rooms. Efflorescence was noted on the plaster walls throughout the upstairs - this is due to soluble salts dissolved by moisture that are drawn to the surface. The water stains were reported to be located near the chimneys where loose slate tiles were observed. Several cracks were noted on the walls and ceiling. Due to the age of the building, it is unknown how much displacement was present prior to the tornado (**Photographs 82—99**).
- The R.O. Jones Rooms was found to have moisture intrusion in the seagrass cloth wallpaper, with moisture bubbles. The wood flooring below the wallpaper had water damage along the edges. Again, efflorescence was noted around the

Water damage/mold  
Efflorescence

6. According to *The Institute of Inspection Cleaning and Restoration Certification Standard for Professional Water Damage Restoration* (IICRC S500), interior plaster, drywall, insulation and flooring that was impacted by the roof leaks, should all be removed. Hard surfaces should be mitigated using the IICRC S500 Standards, which includes anti-microbial spray and HEPA vacuuming to disinfect affected.

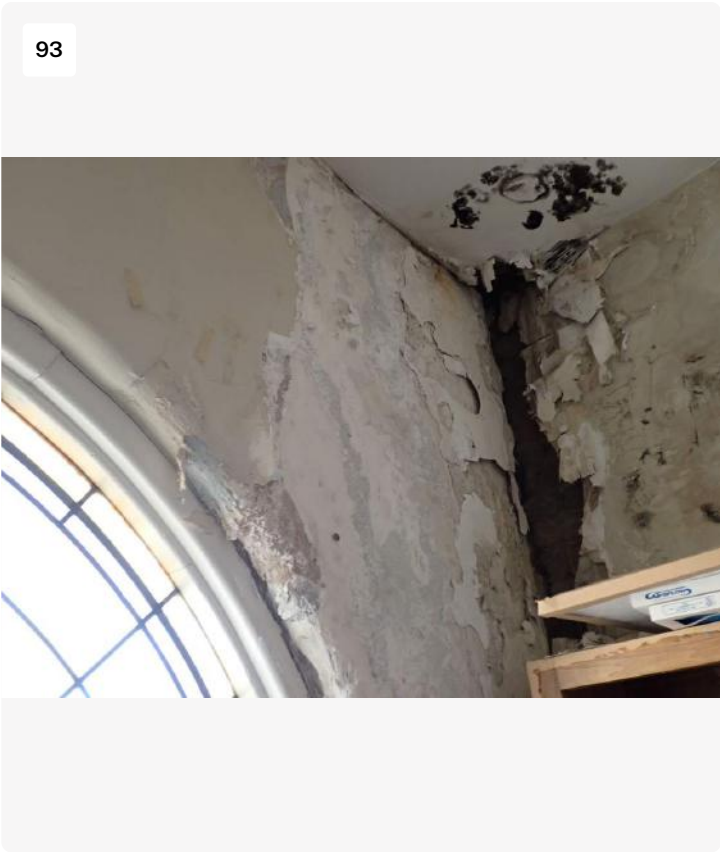
Water damage

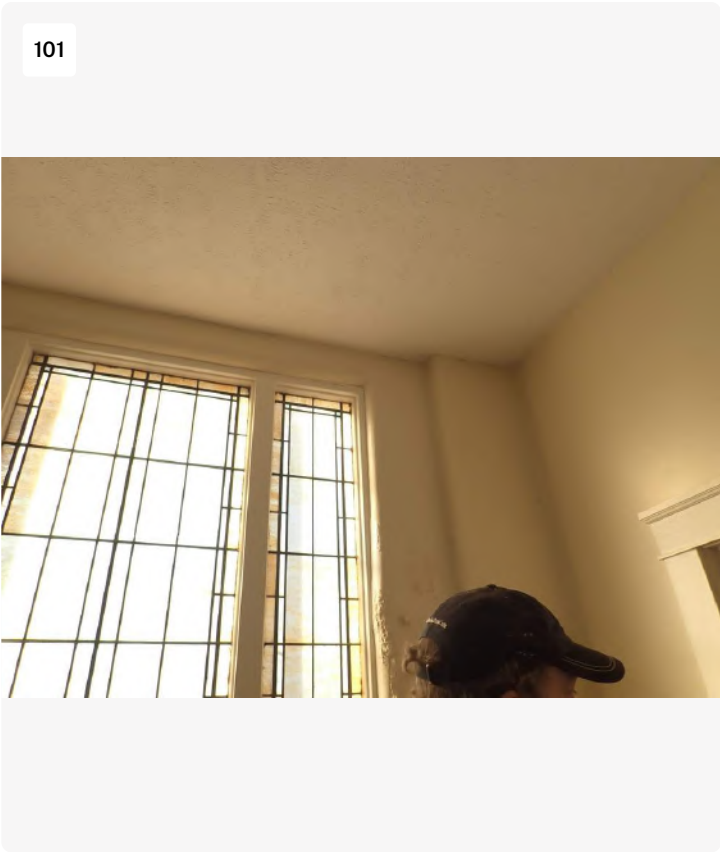
windows, with large cracks in the plaster. Water stains were seen on the ceiling, with minor displacement (**Photographs 100—113**).

Water damage

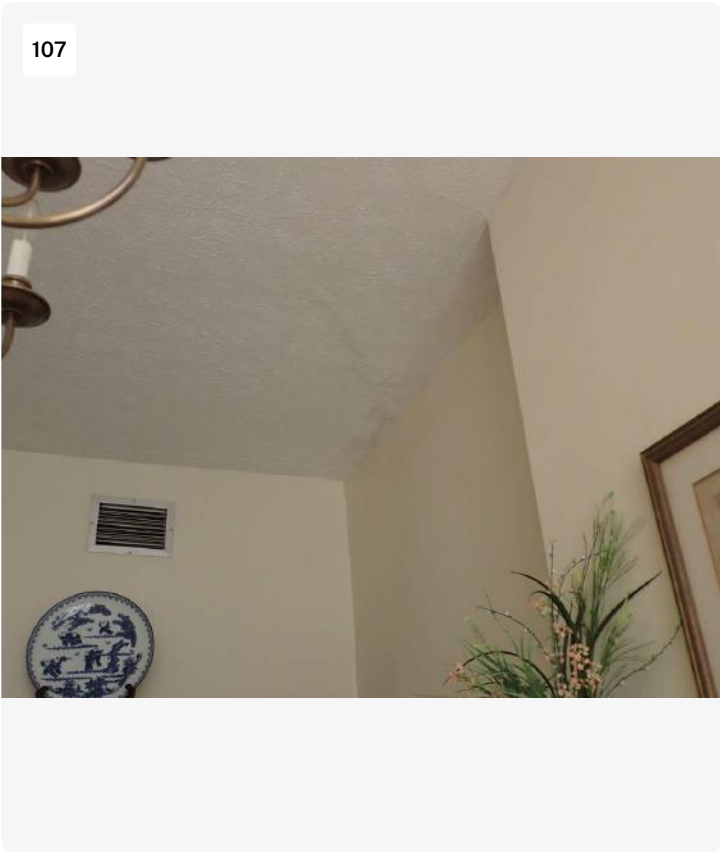
Water stains

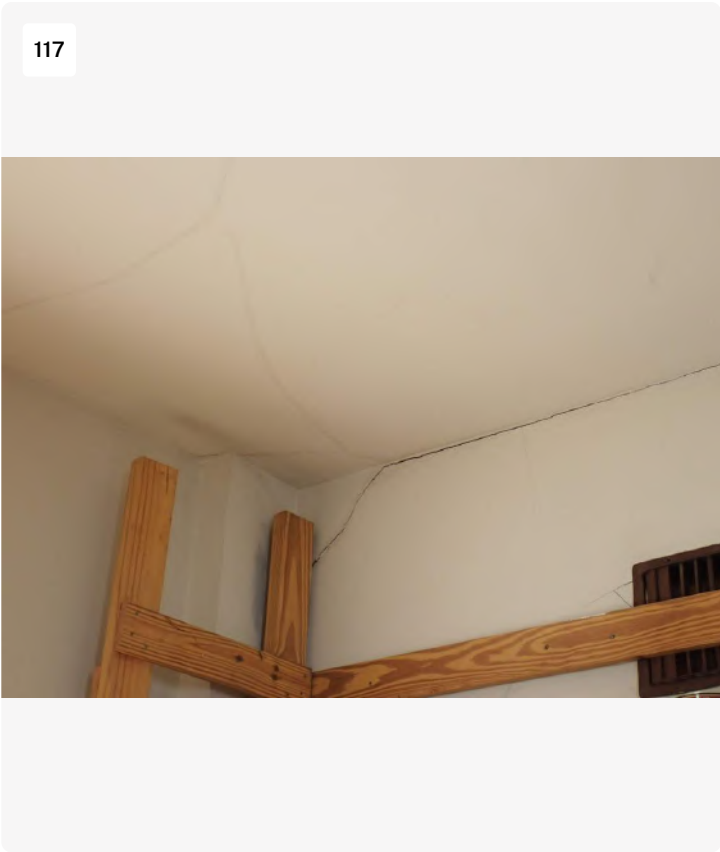
- The Session Room had similar displacement around the window frames, and large cracks noted above the windows and walls. Efflorescence was found on the corners of the walls and around the windows, with water stains on the ceiling (**Photographs 114—130**).

Water damage

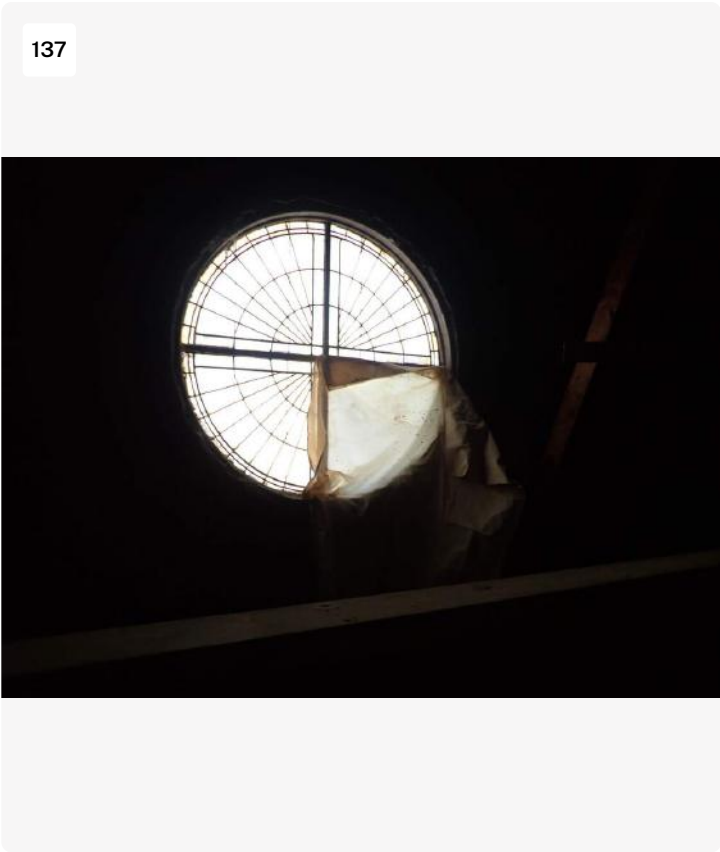
- Cracks were observed in the stain-glass windows on the second floor (**Photographs 141—143**).
- Water damage (efflorescence) was noted on the walls and ceilings of the NW stairway behind the Sanctuary, with chipping plaster and water stains (**Photographs 156—168**).

Broken window

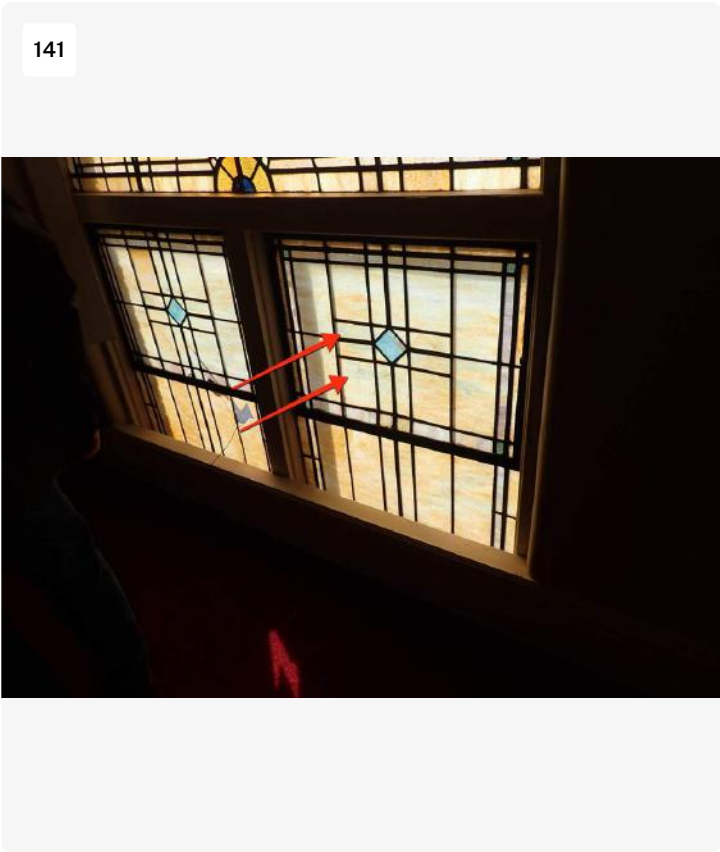
Cracked window

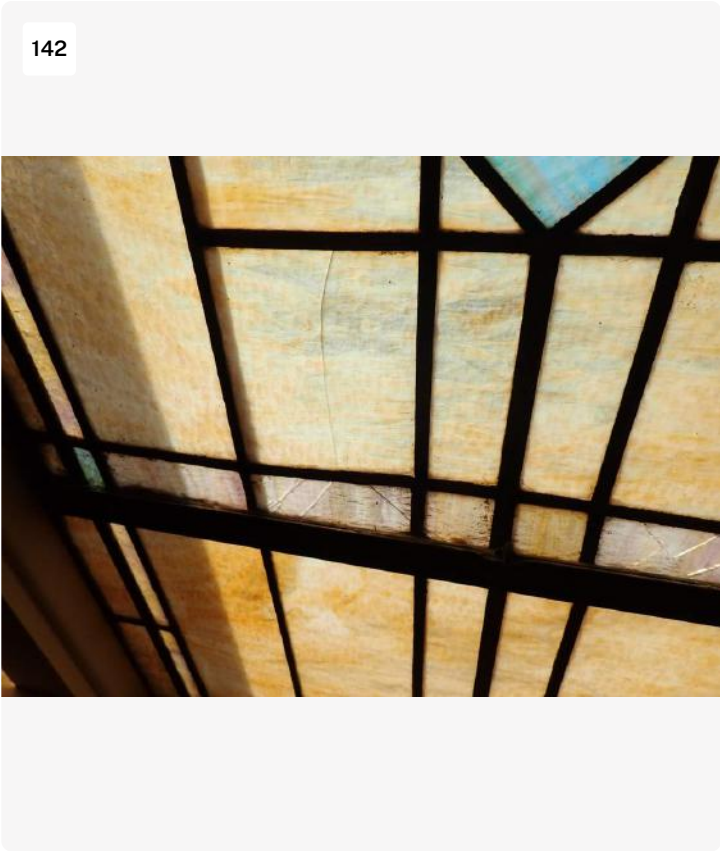
Cracked window

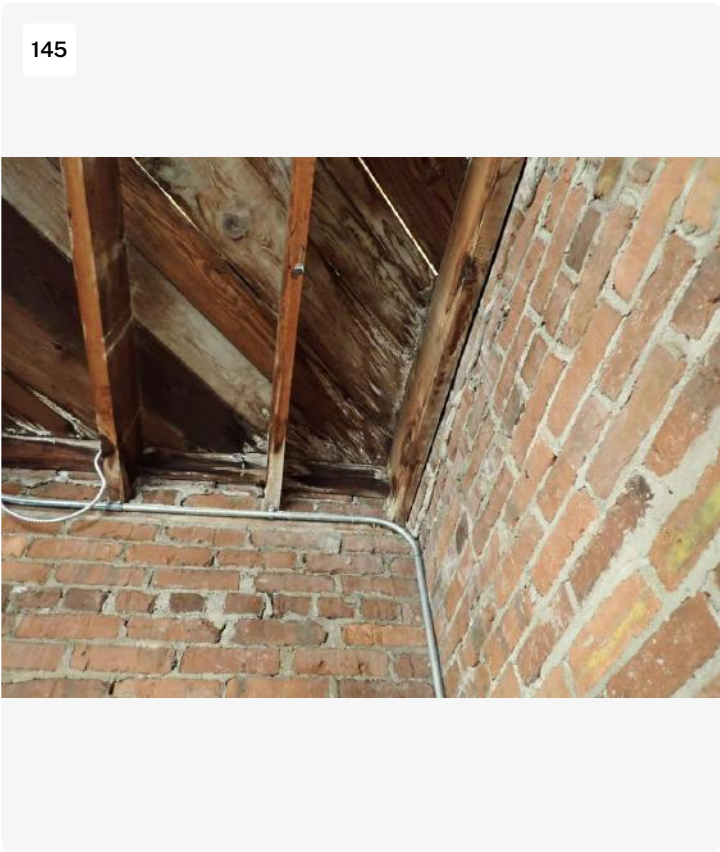
- SEG inspected the interior areas of the towers on the NW and SW corners of the Church. The exposed wooden floor joists were noted to have water stains throughout (**Photographs 131—137, 144—148**).

Water stains

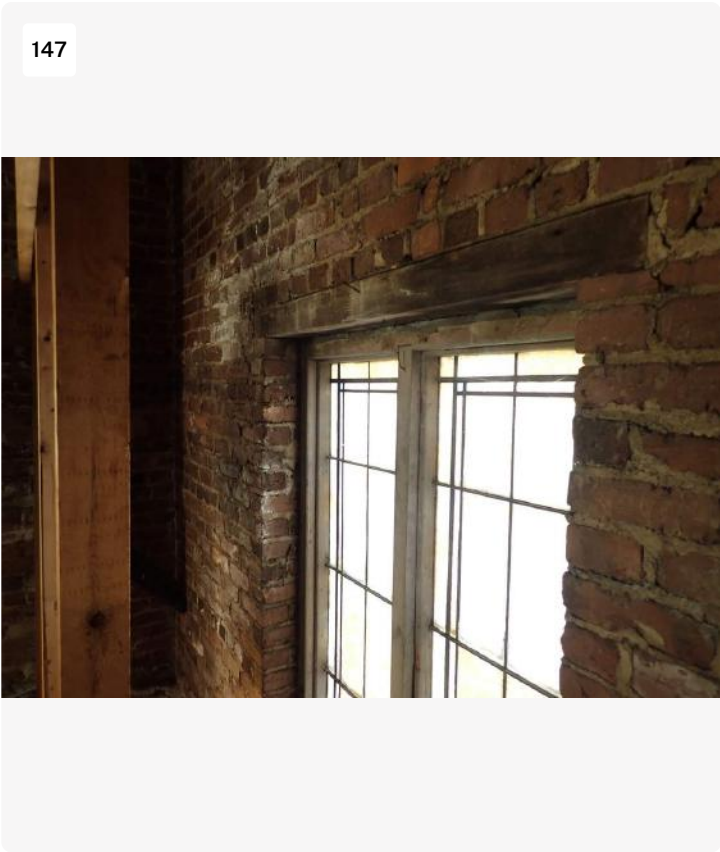
Water stains around windows

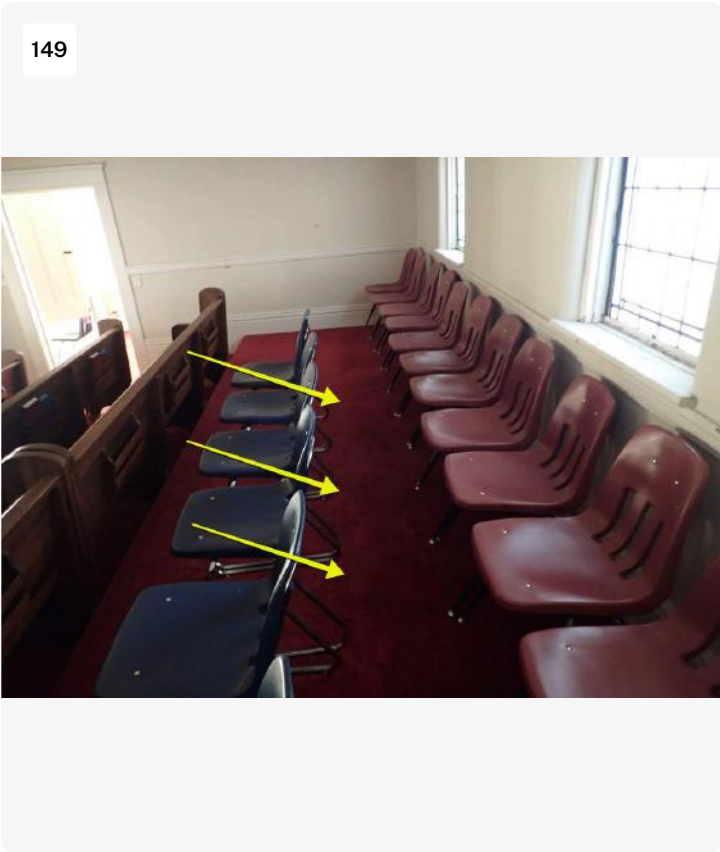
- The mezzanine above the sanctuary was found to have displacement around the windows and in the walls. Efflorescence was seen on the wall above the window with chipping plaster. Water stains were also noted on the carpet (**Photographs 138—140, 149—151**).

Water stains on carpet

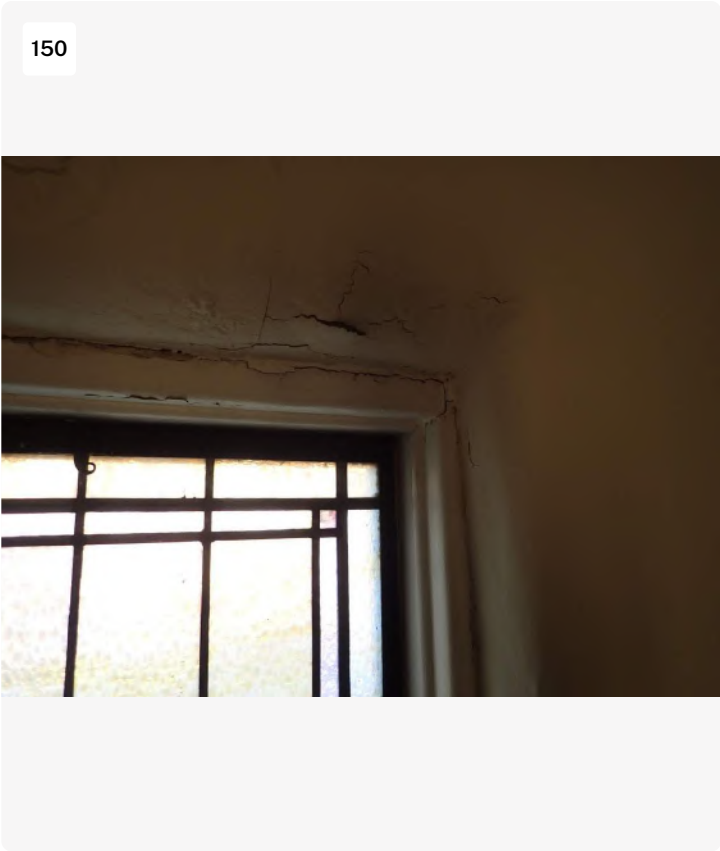
Water damage

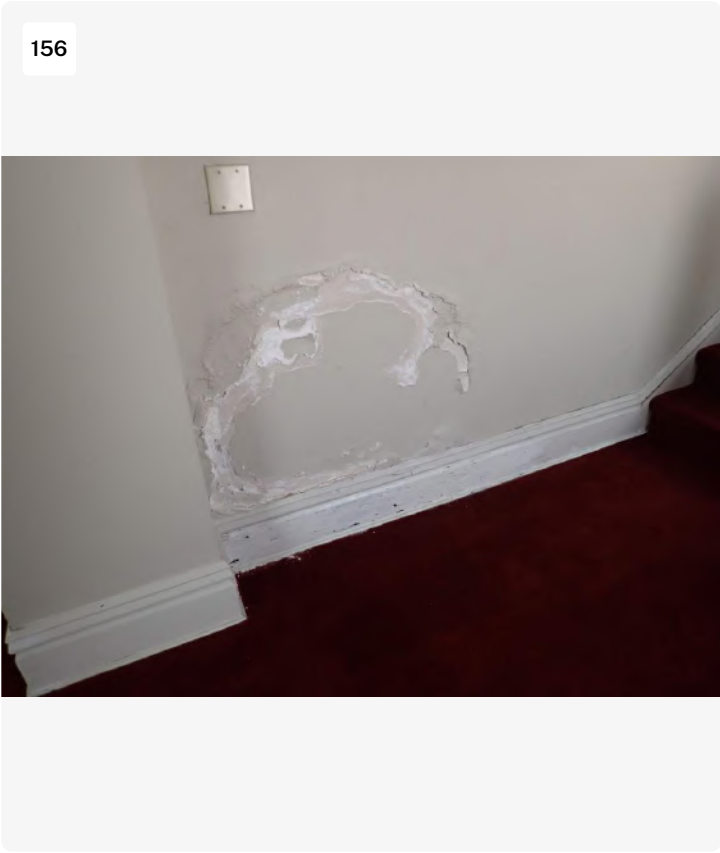
Water damage

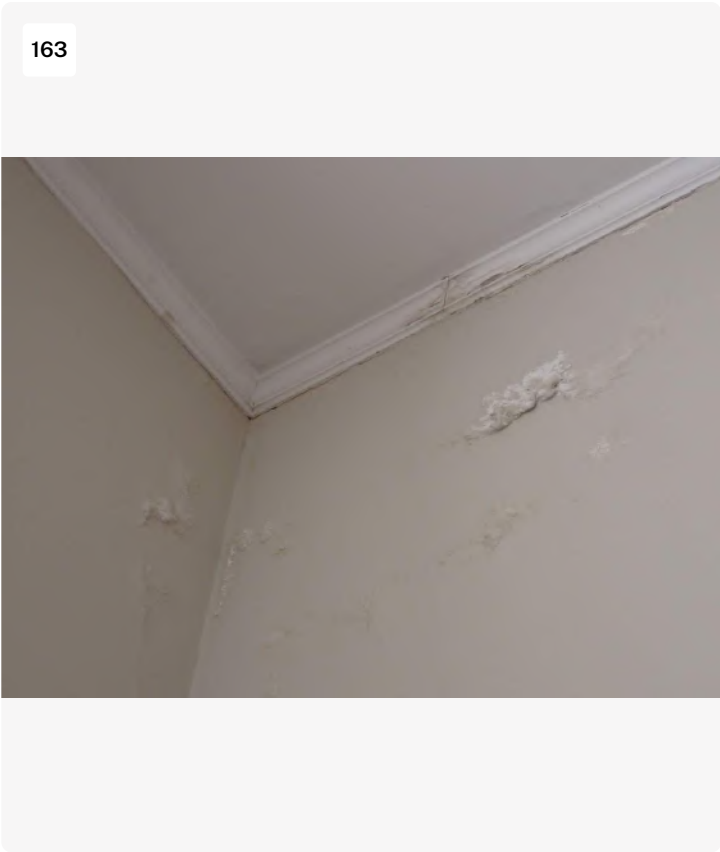
Water damage

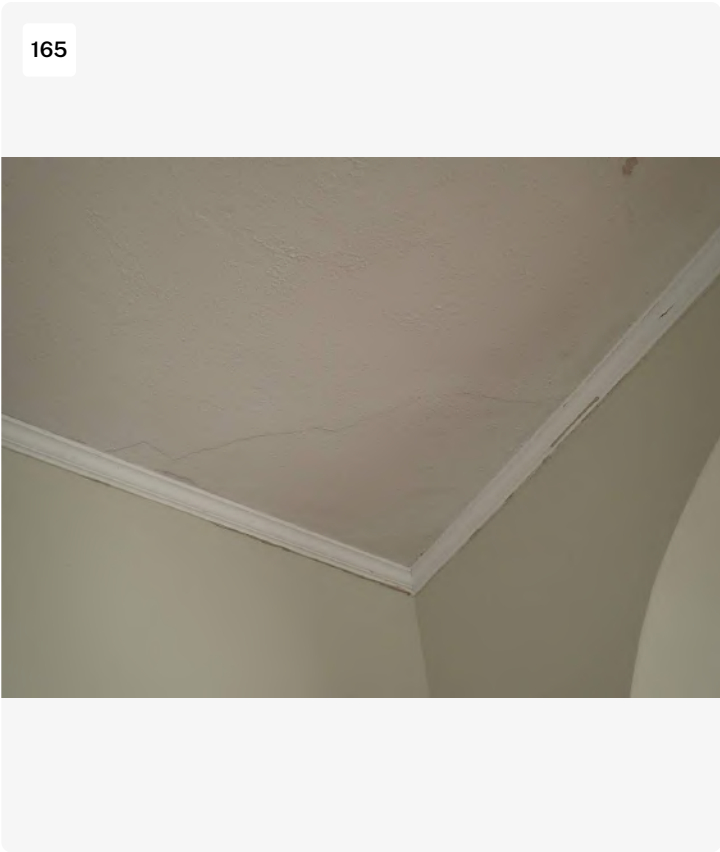
Water stains

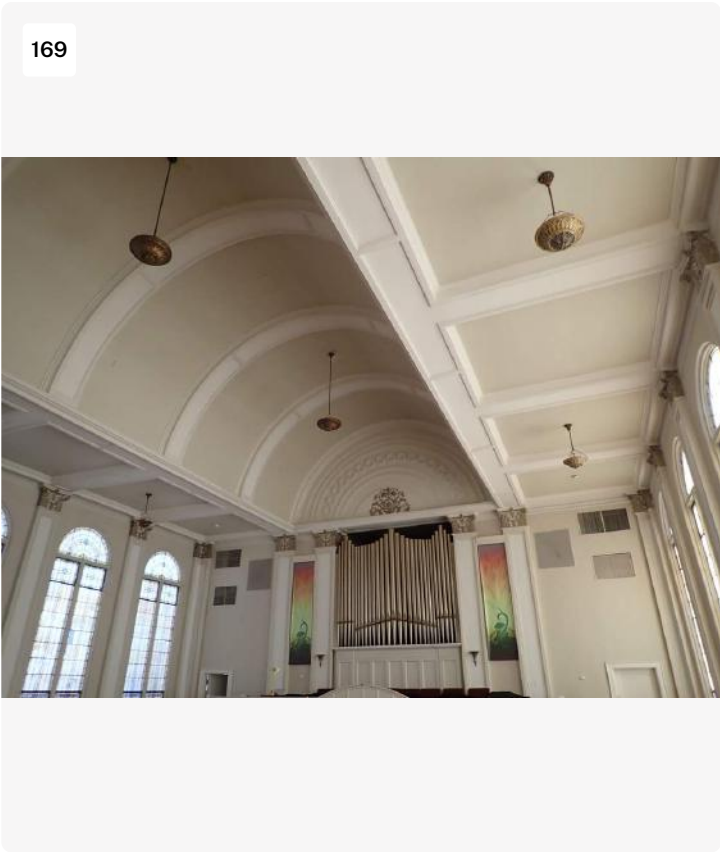
Water damage

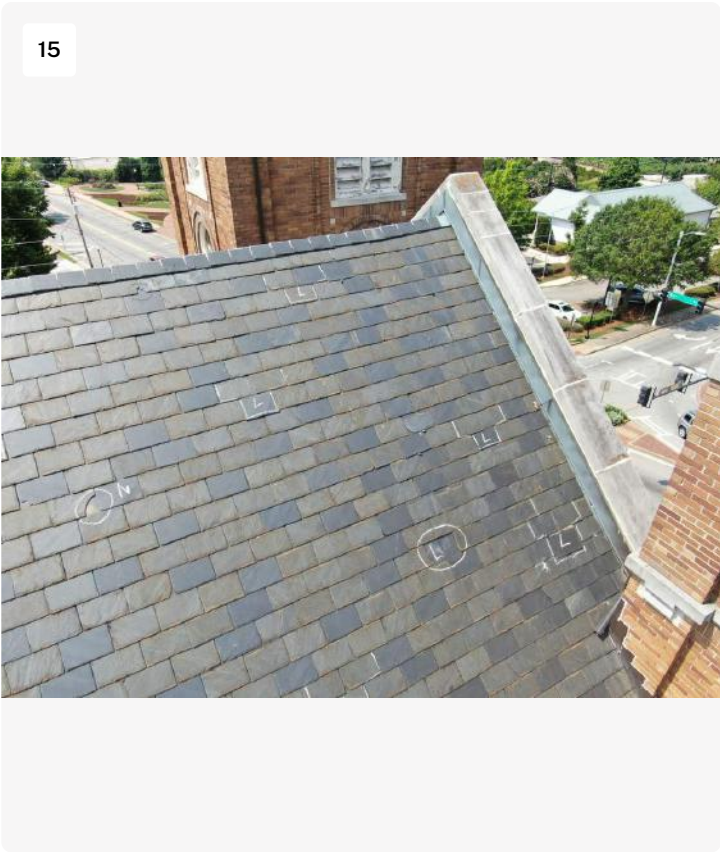
- Drone photographs revealed several broken, chipped, displaced and missing slate tiles on the north and south slopes.
- Old damage was pointed out to note the difference between the fresh cracks.

Missing, displaced and chipped tiles noted

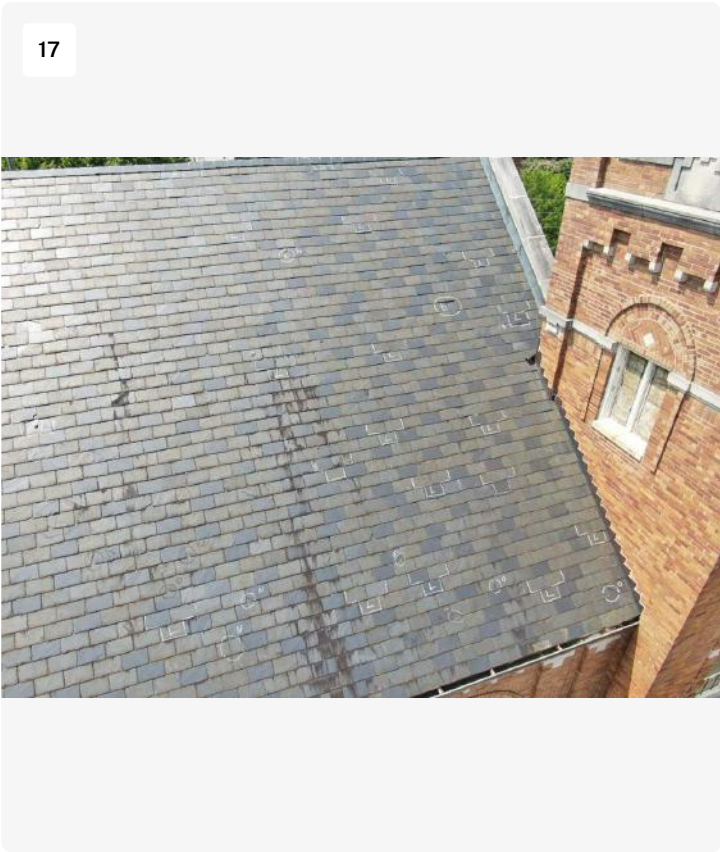
Cracked and displaced tiles

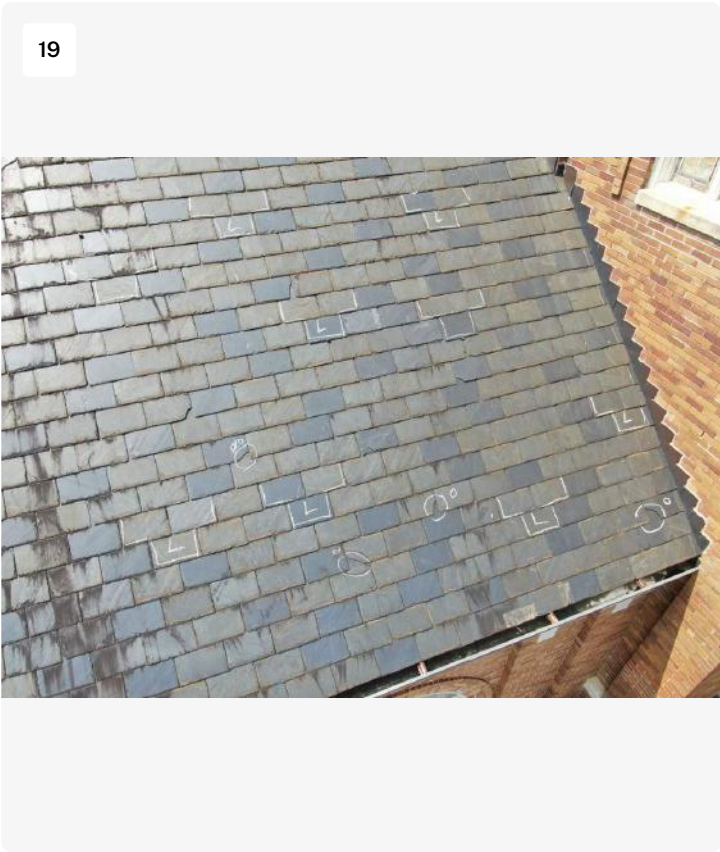
Missing, cracked and displaced tiles

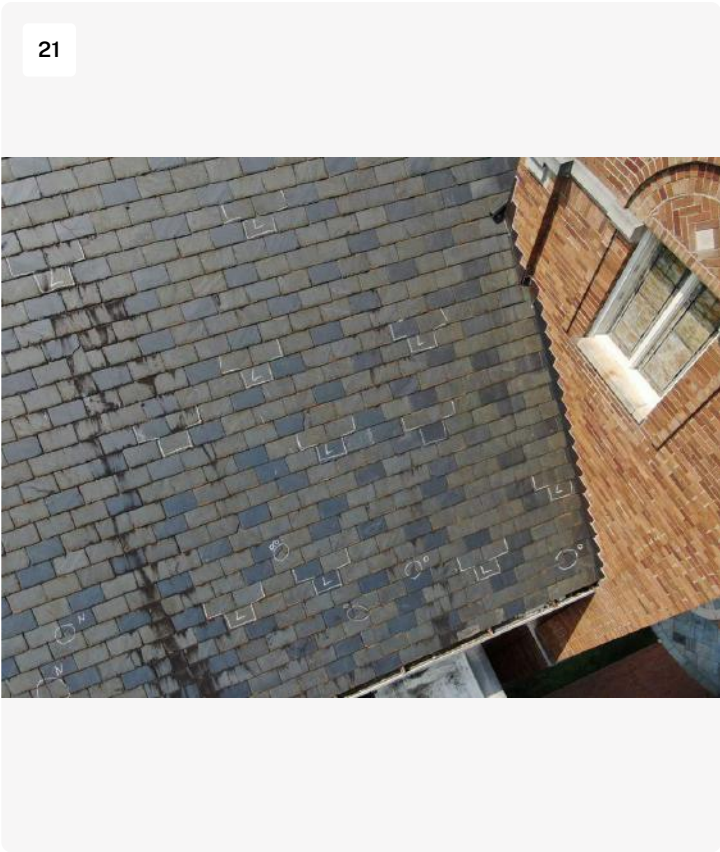
Old cracks were noted along with fresh cracks  
Displaced tiles
