December 7, 2021

**RE: Forensic Engineering Report – Wind Damage  
Newnan Presbyterian Church  
38 Greenville St. S  
Newnan, GA 30263**

Per your request, Shields Engineering Group, Inc. performed a forensic engineering inspection at the Newnan Presbyterian Church at the address above. The Church purportedly sustained damage as a direct result from high winds from a tornado that passed through Newnan on March 26, 2021. This investigation was conducted on November 9<sup>th</sup>, 2021, by Martin Shields, P.E. and Ava Shields of SEG.

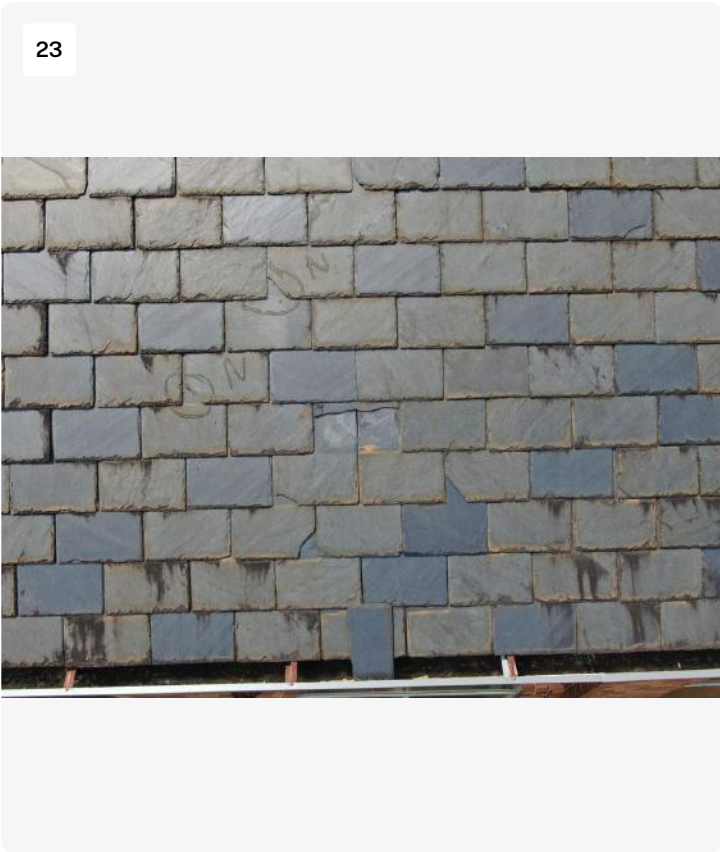
Broken and cracked tiles

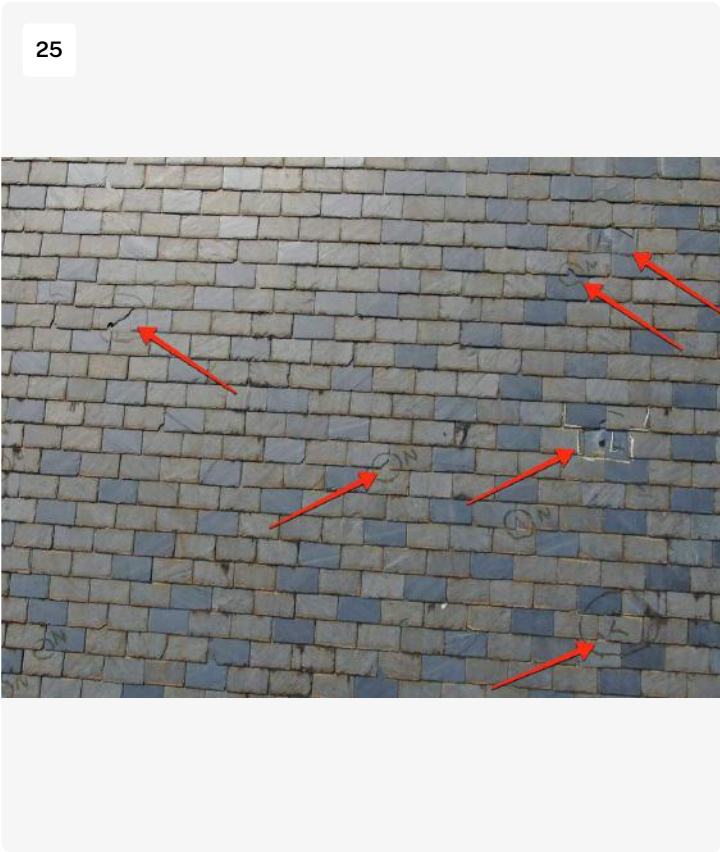
Broken, cracked and displaced tiles

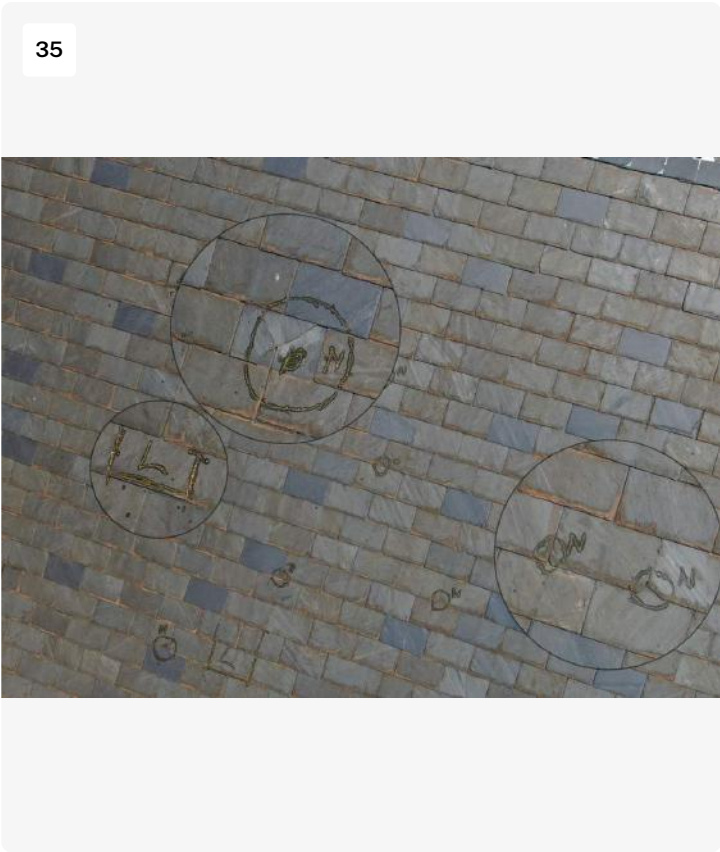
Broken and displaced tiles

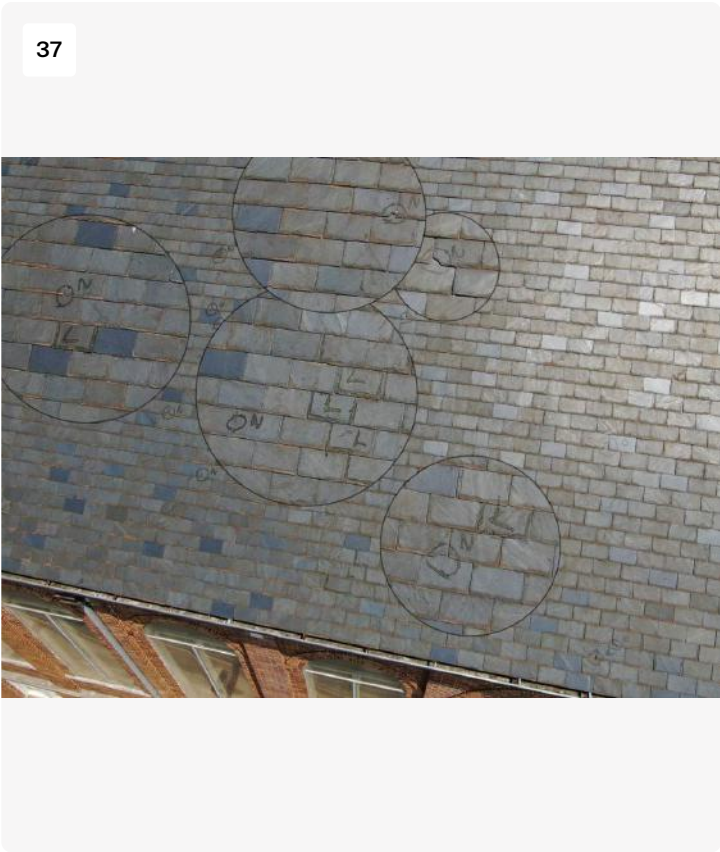
Displaced and broken tiles

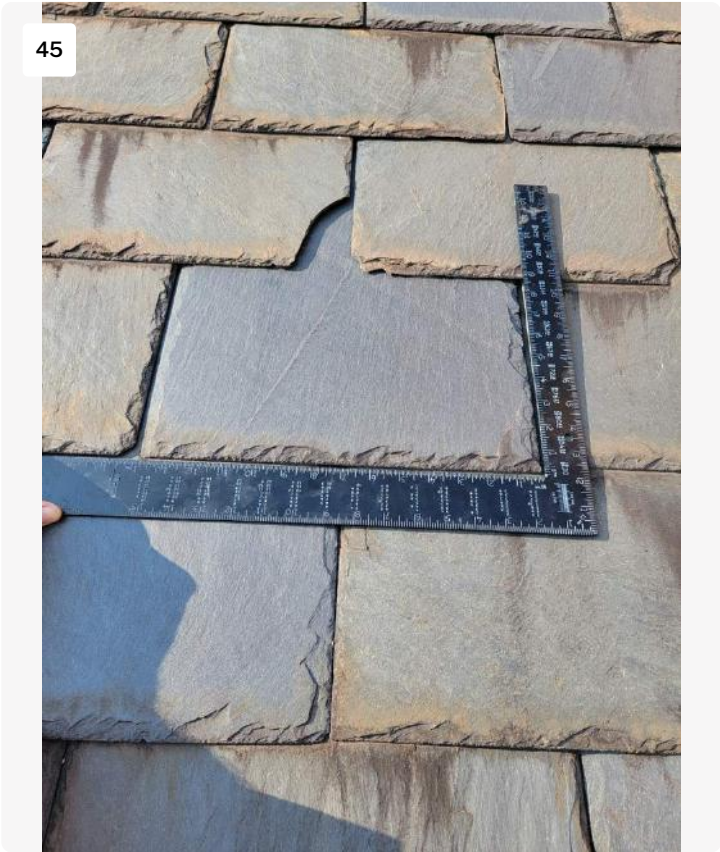
Cracked tile

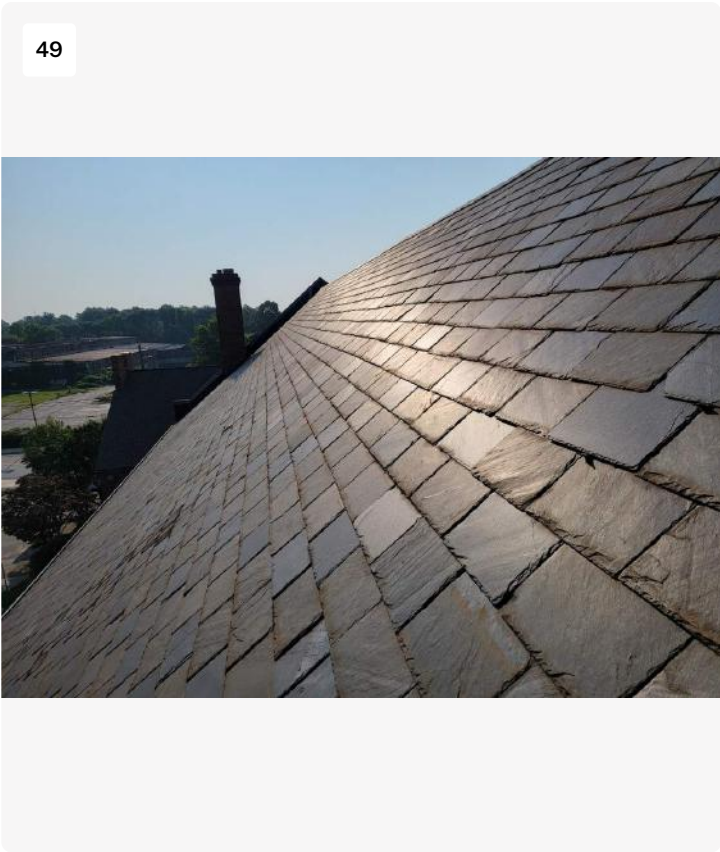
Missing tile

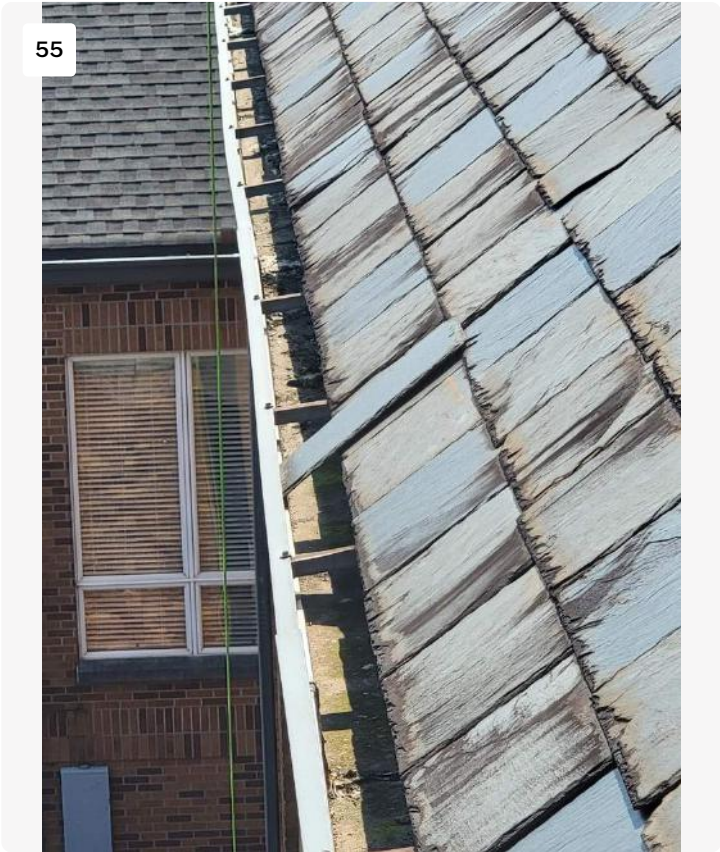
- Wind-borne debris impacted the tile roof resulting in several broken edges and chips in the slate.
- Several broken tiles were found to have fallen into the gutter of the roof resulting in damage to the metal gutters.
- Loose and displaced tiles were noted on both slopes, with some tiles missing completely.
- We estimate that 10 to 30% of the slopes were affected.

Broken tile in gutter

4. Remove and replace all plexiglass storm-protection windows on the north and south elevations.
5. Remove and replace all damaged gutters and downspouts.
