Ohio Asphalt Paving Conference

Local Government Strategies for Building and Maintaining Asphalt Pavement: A Case Study

February 1, 2023

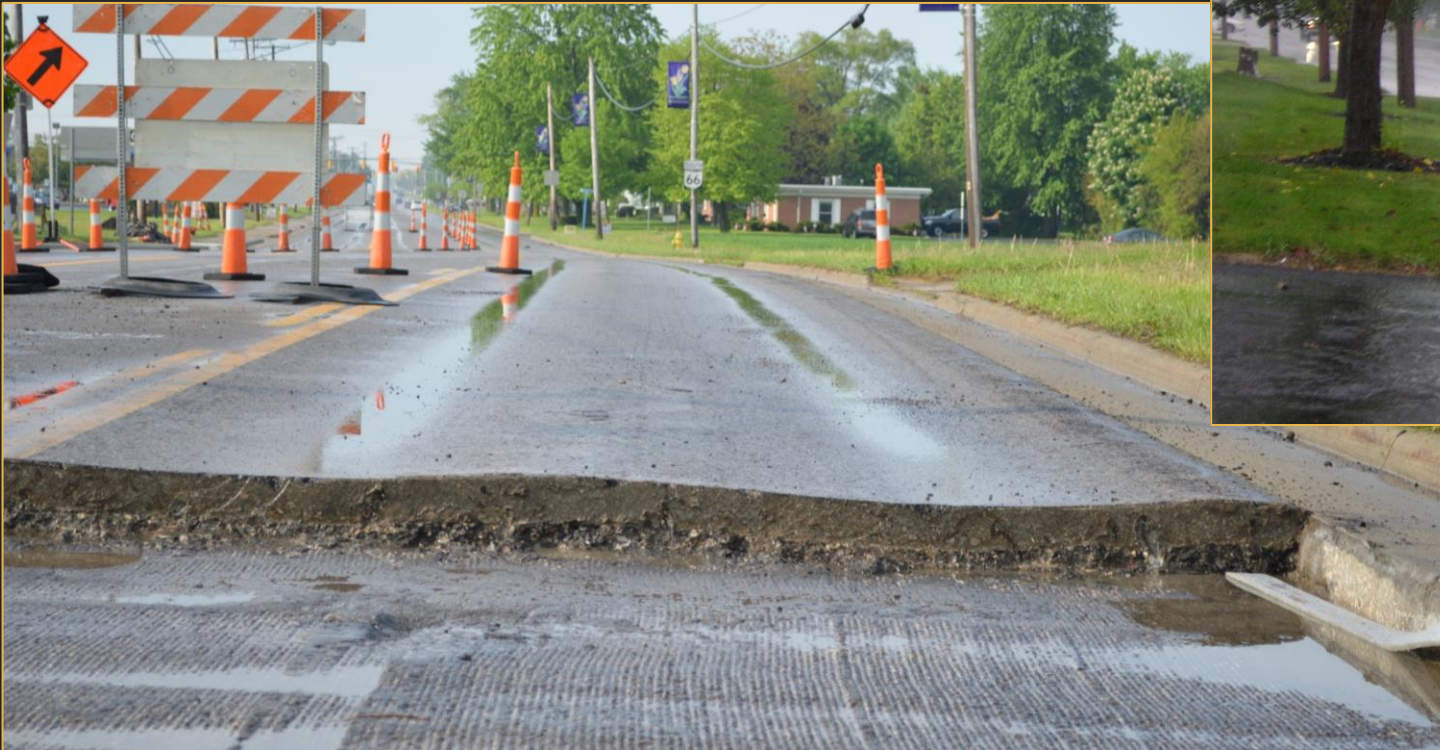
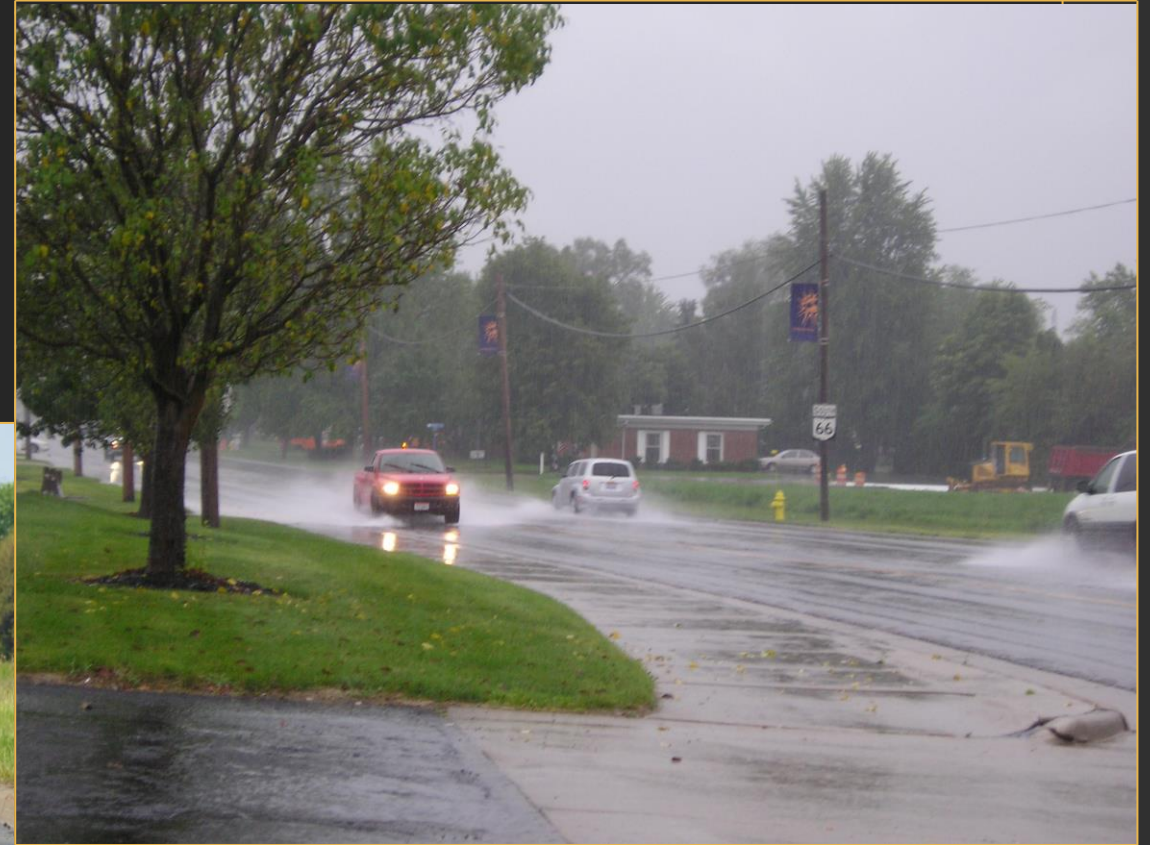
Fast-Forward 21 Years

- Moderate/Major Rutting

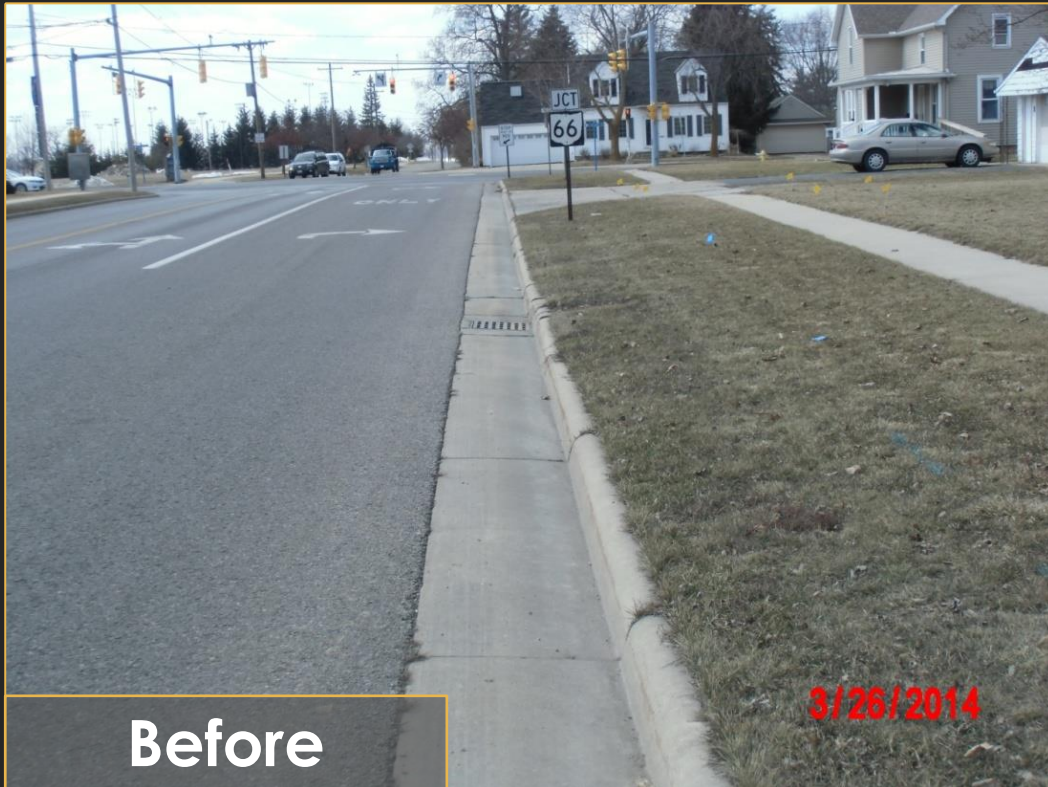
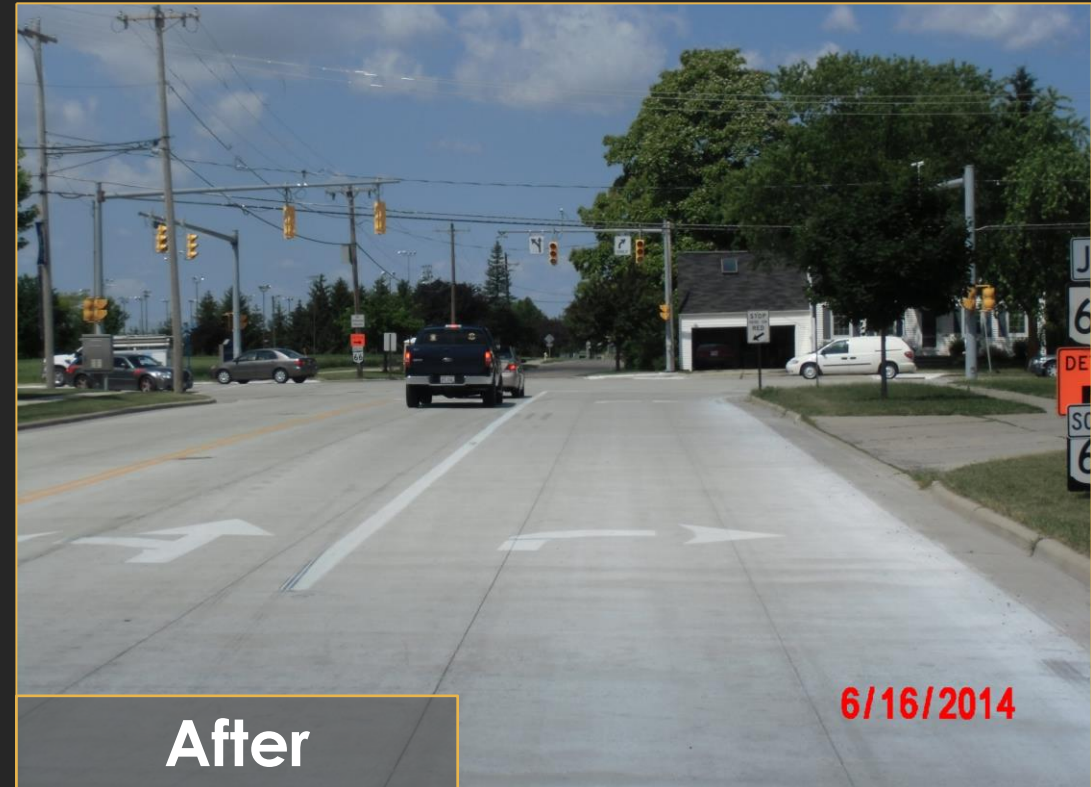
- Worked great to prevent rutting

Concrete Overlay - 2014

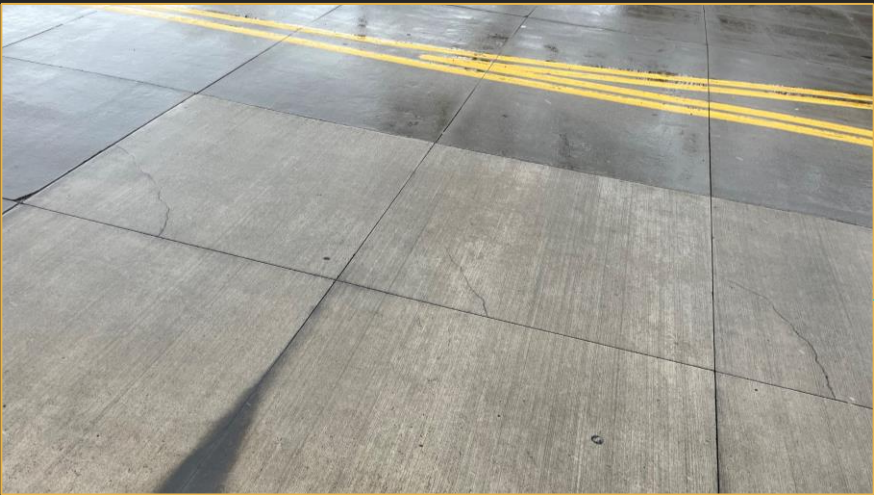
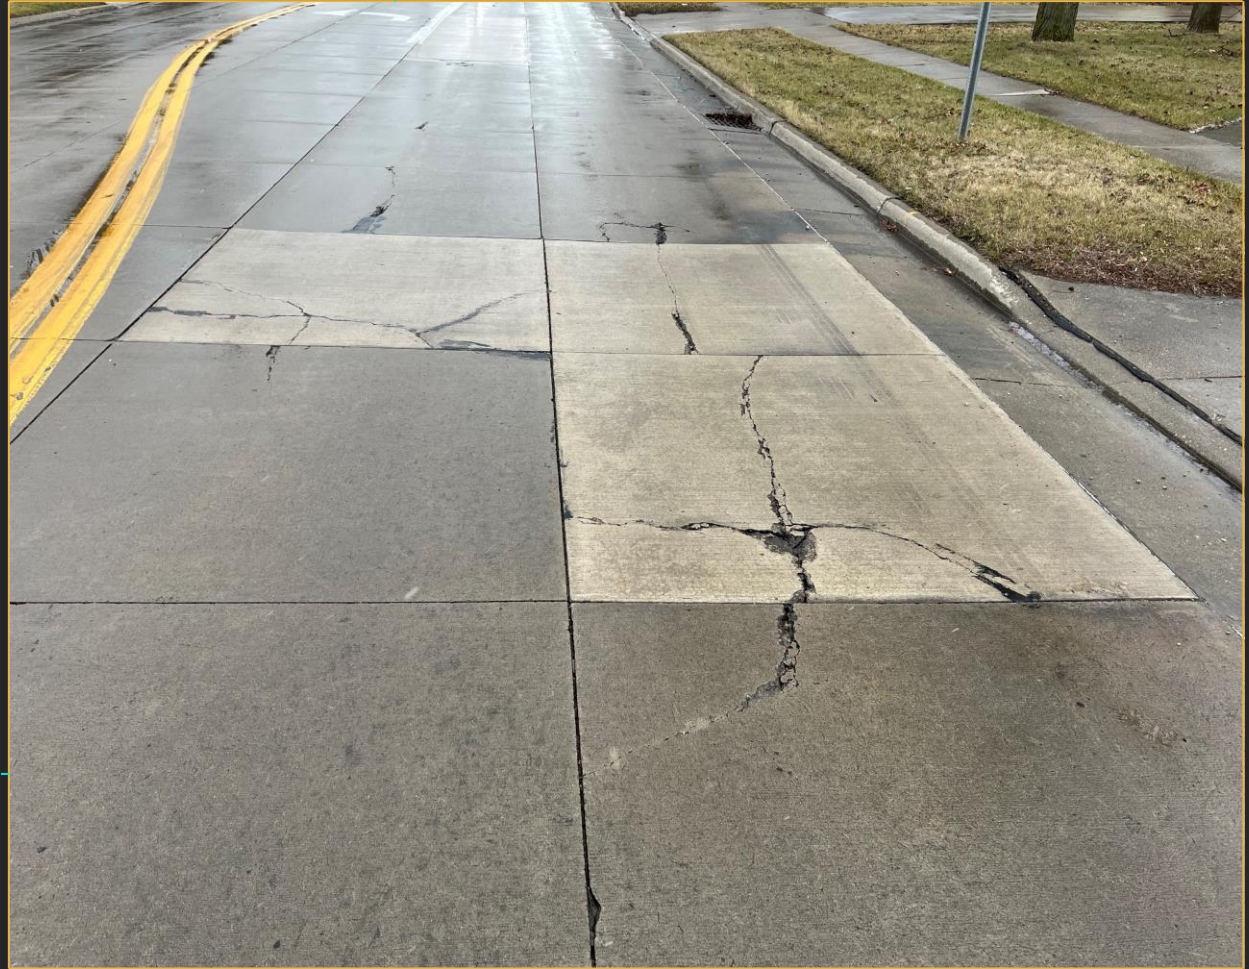
- Durability issues

Concrete Overlay - 2014

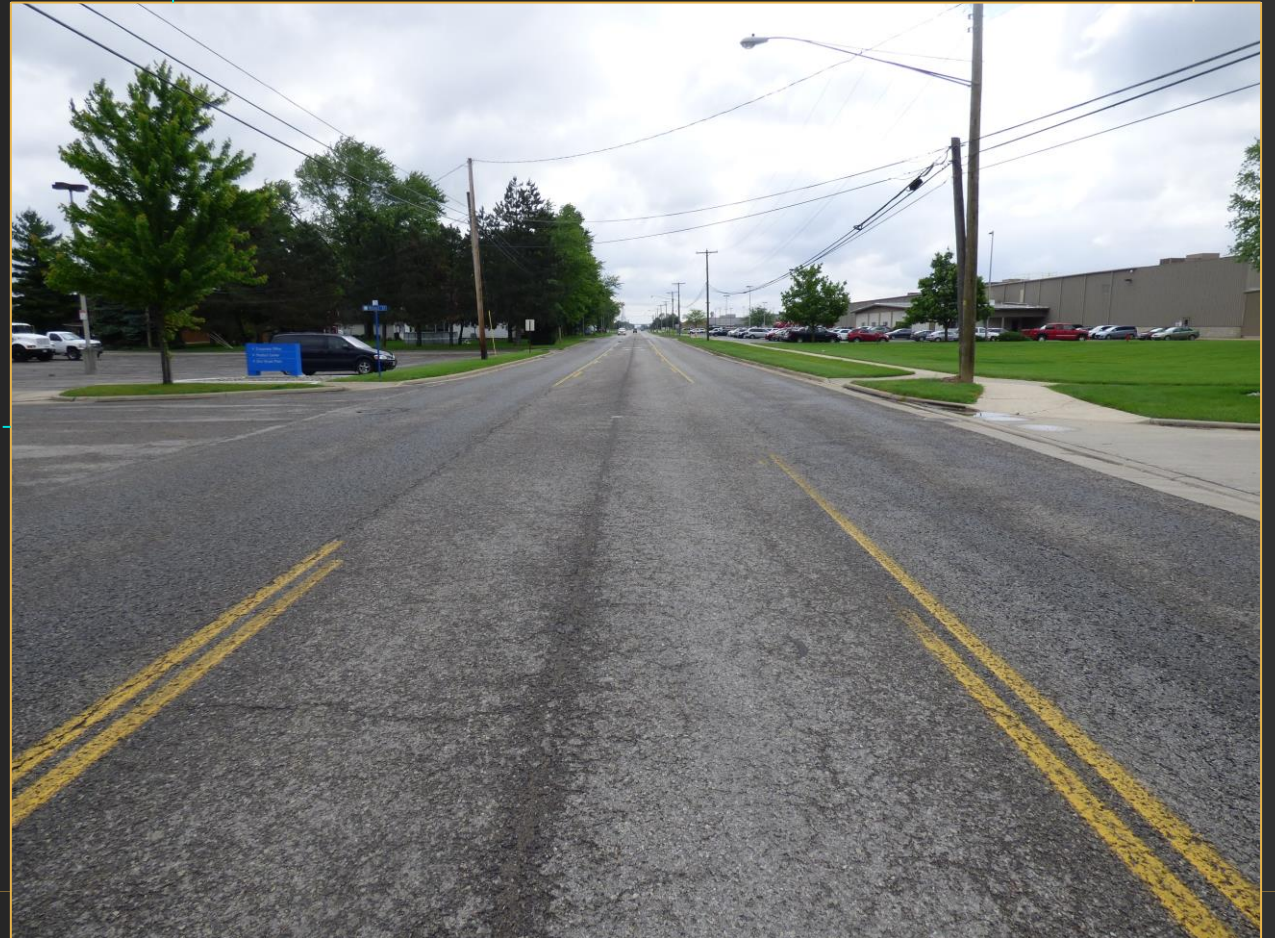
- Major Rutting at intersection
- Minor Rutting elsewhere
- **2006** – Resurfaced w/ SMA
 - Coarse-graded, raveling

2014 – Concrete Overlay just at Intersection

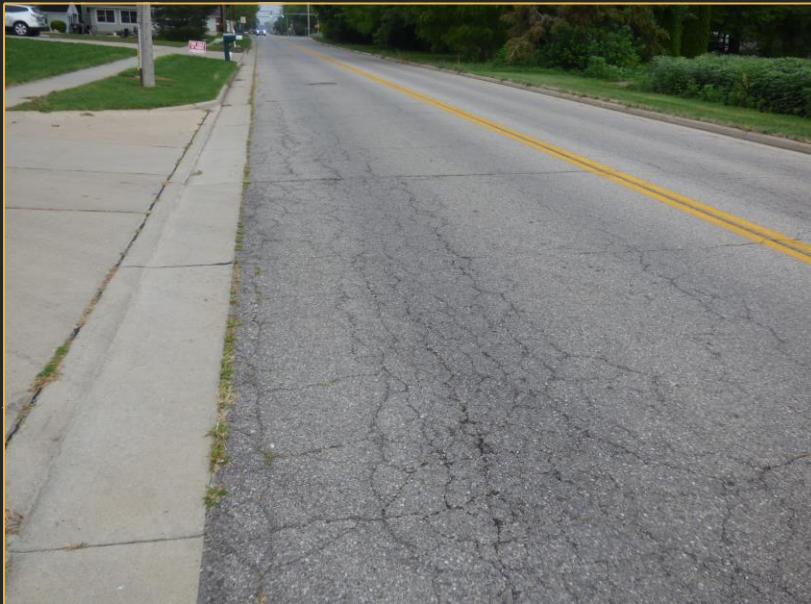
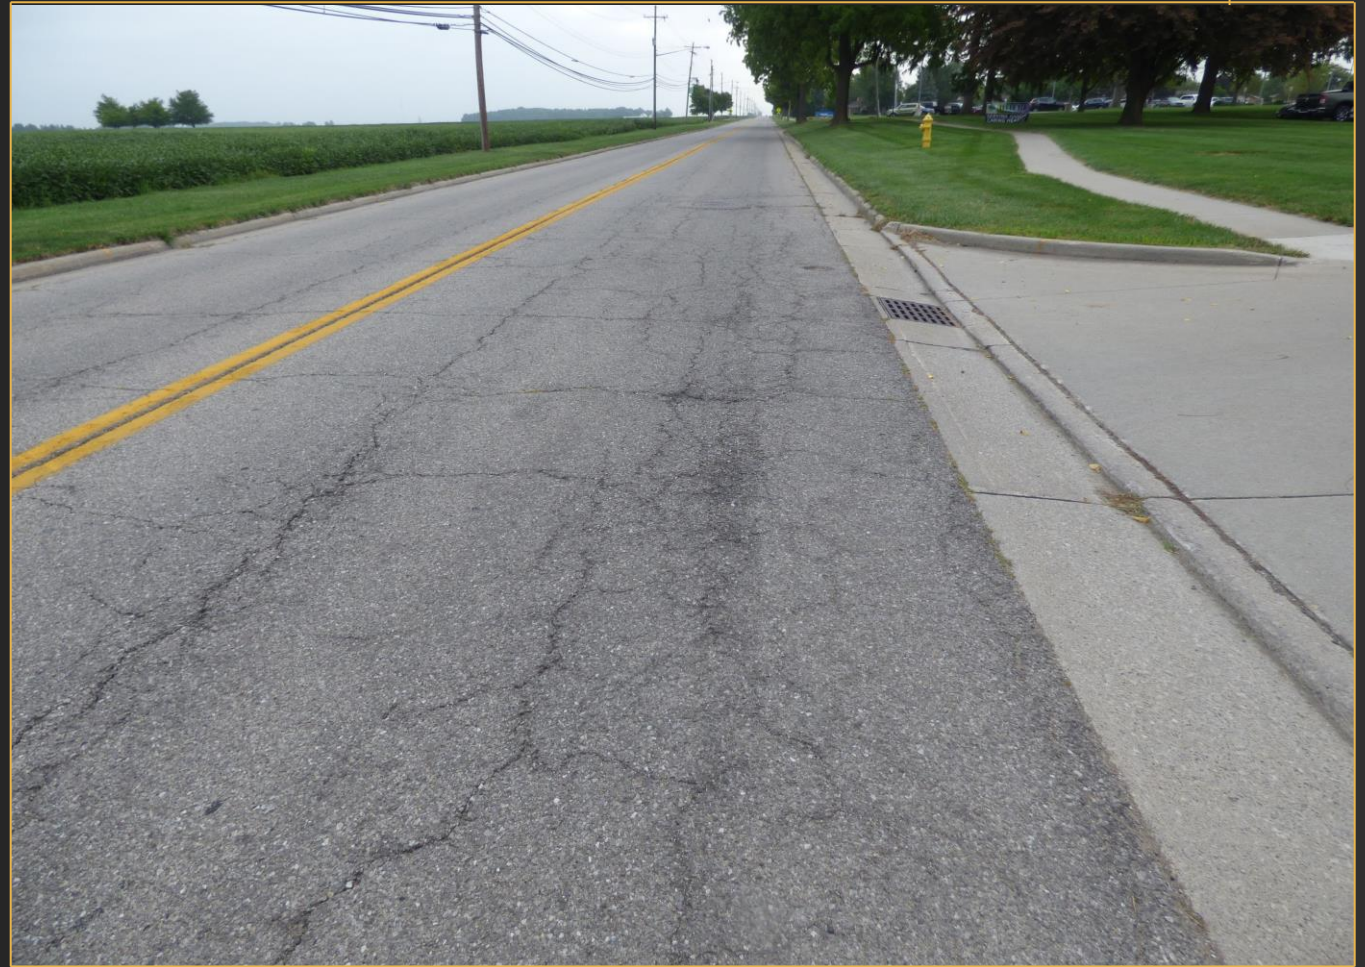
Longitudinal & Block Cracking

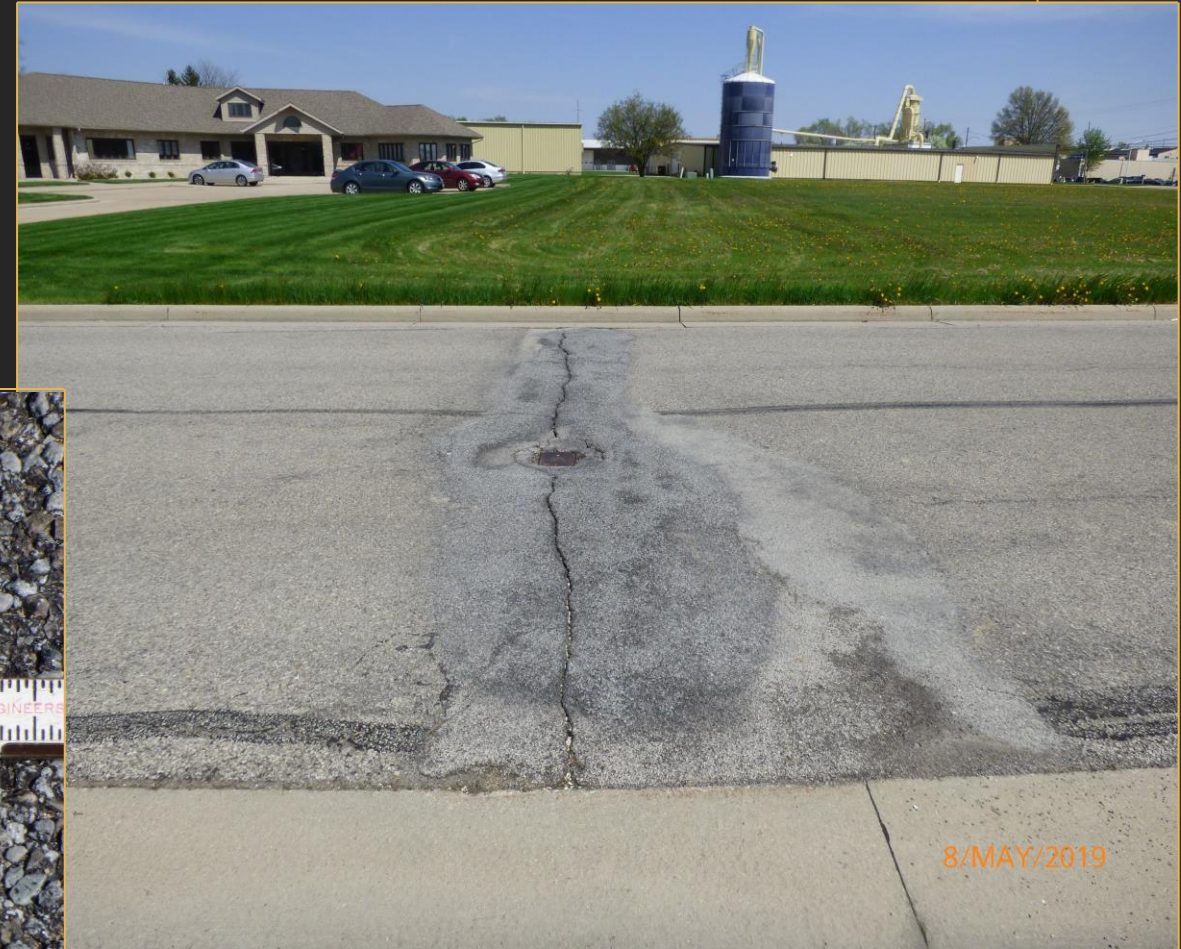
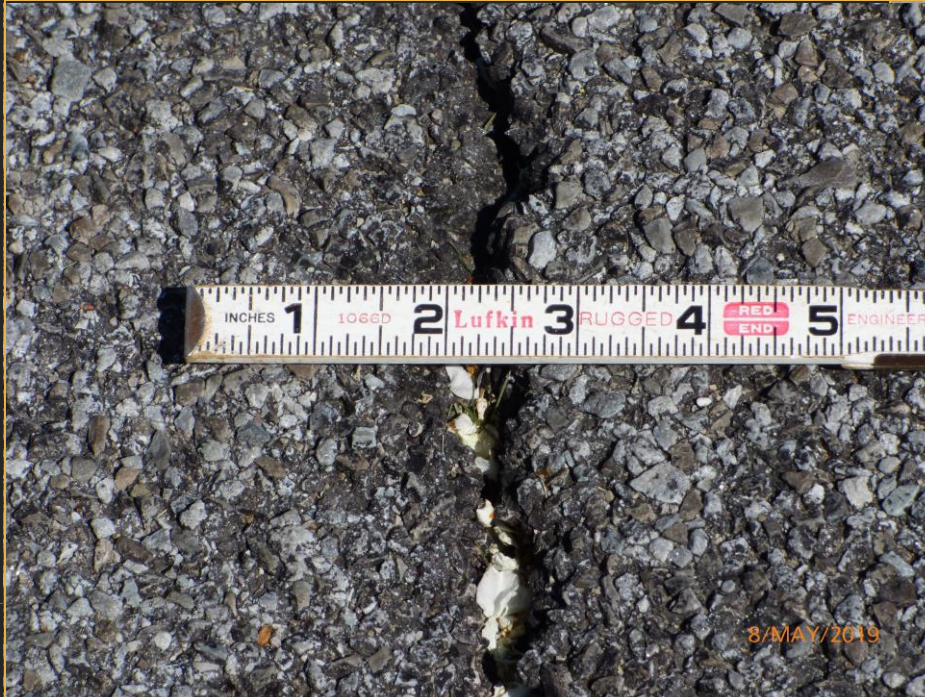
- Large Traverse Cracking w/ Settlement – 80' +/- Spacing
- Spray Patching performed to improve ride quality

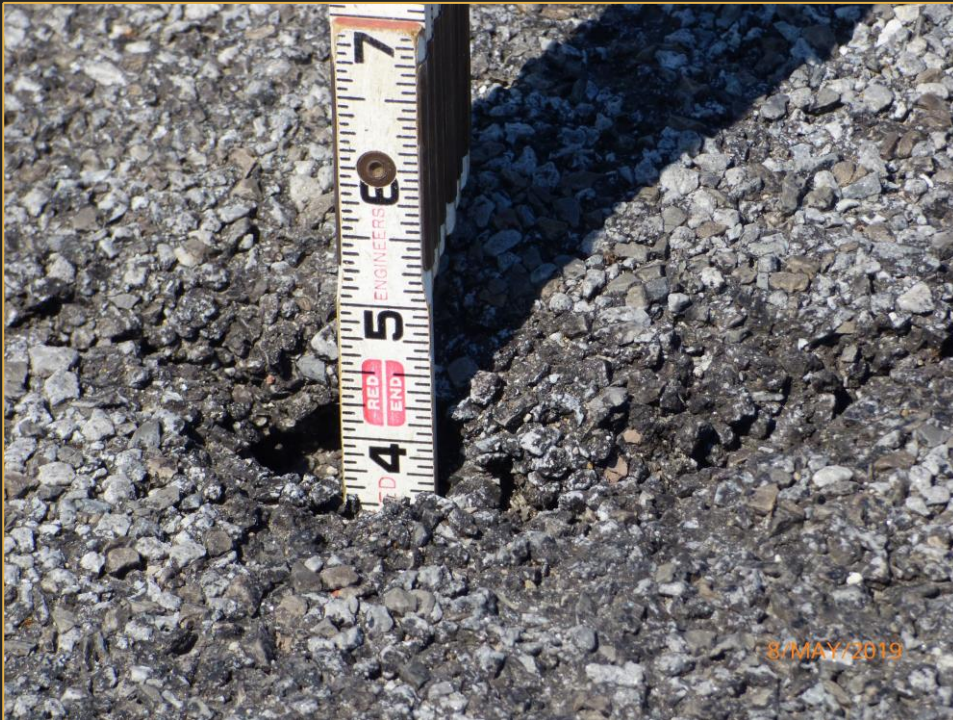
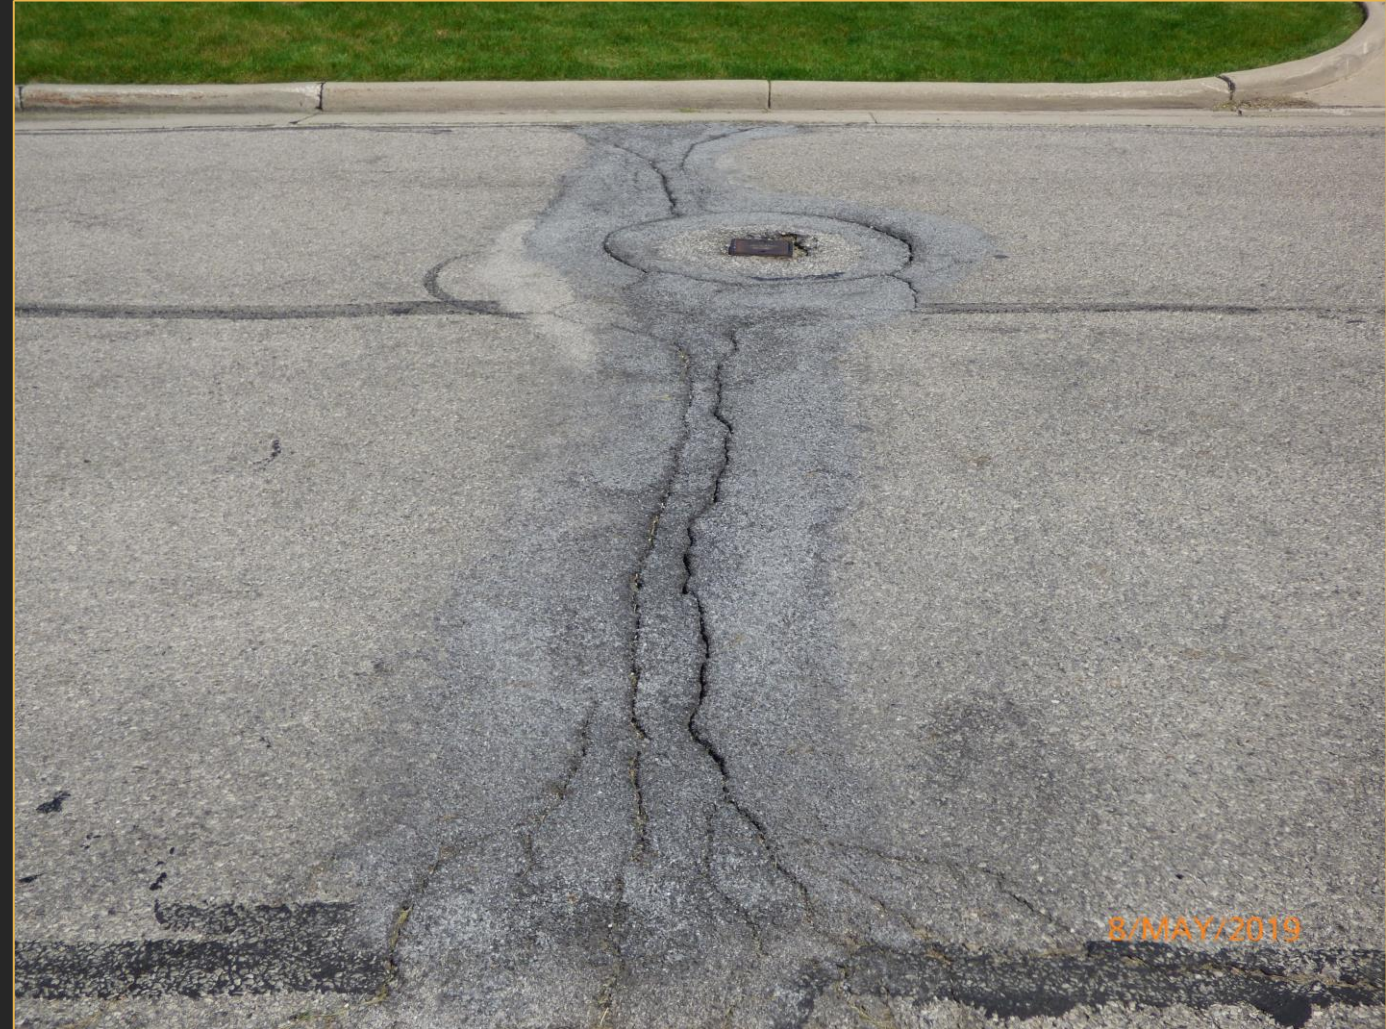
- Large Traverse Cracking w/
Settlement – 80'+/- Spacing

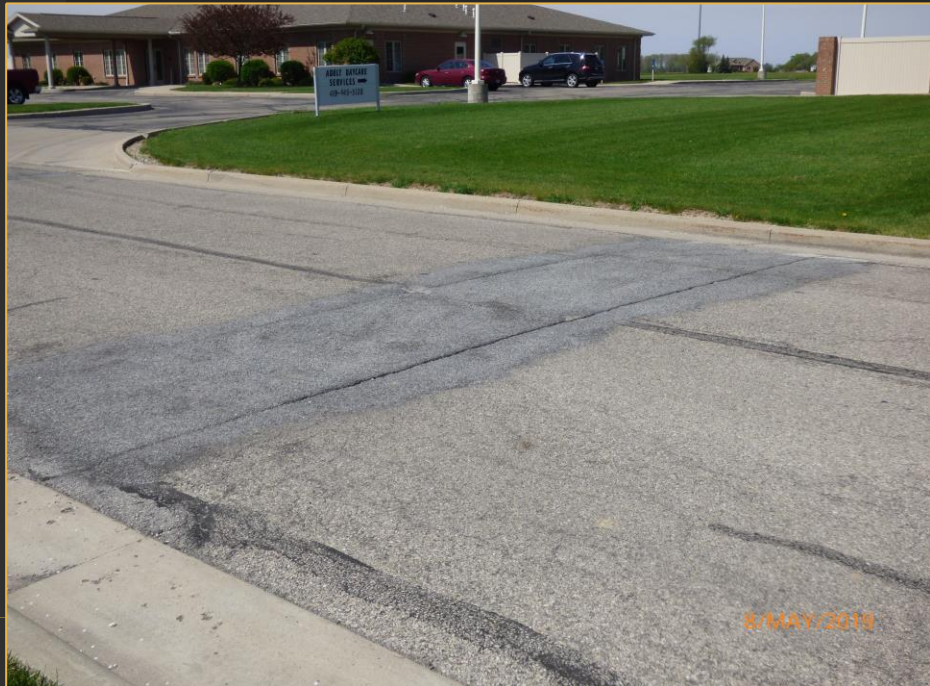
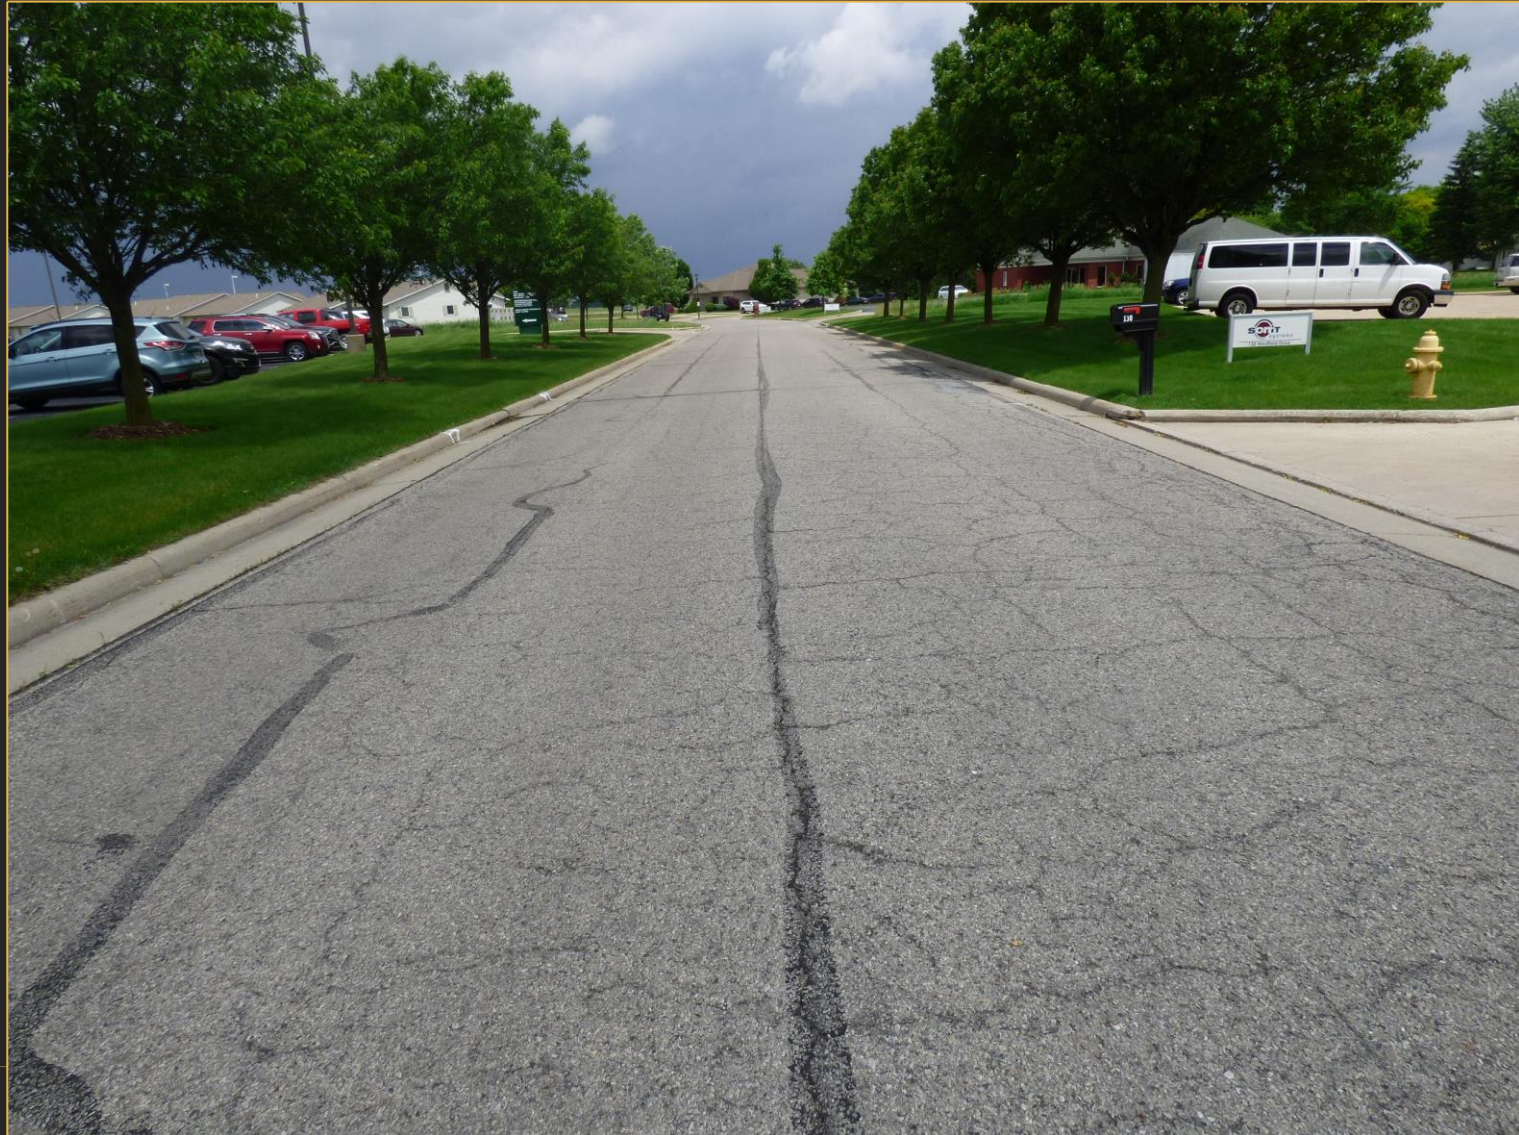
- Trench Patches
- Mod. Block Cracking

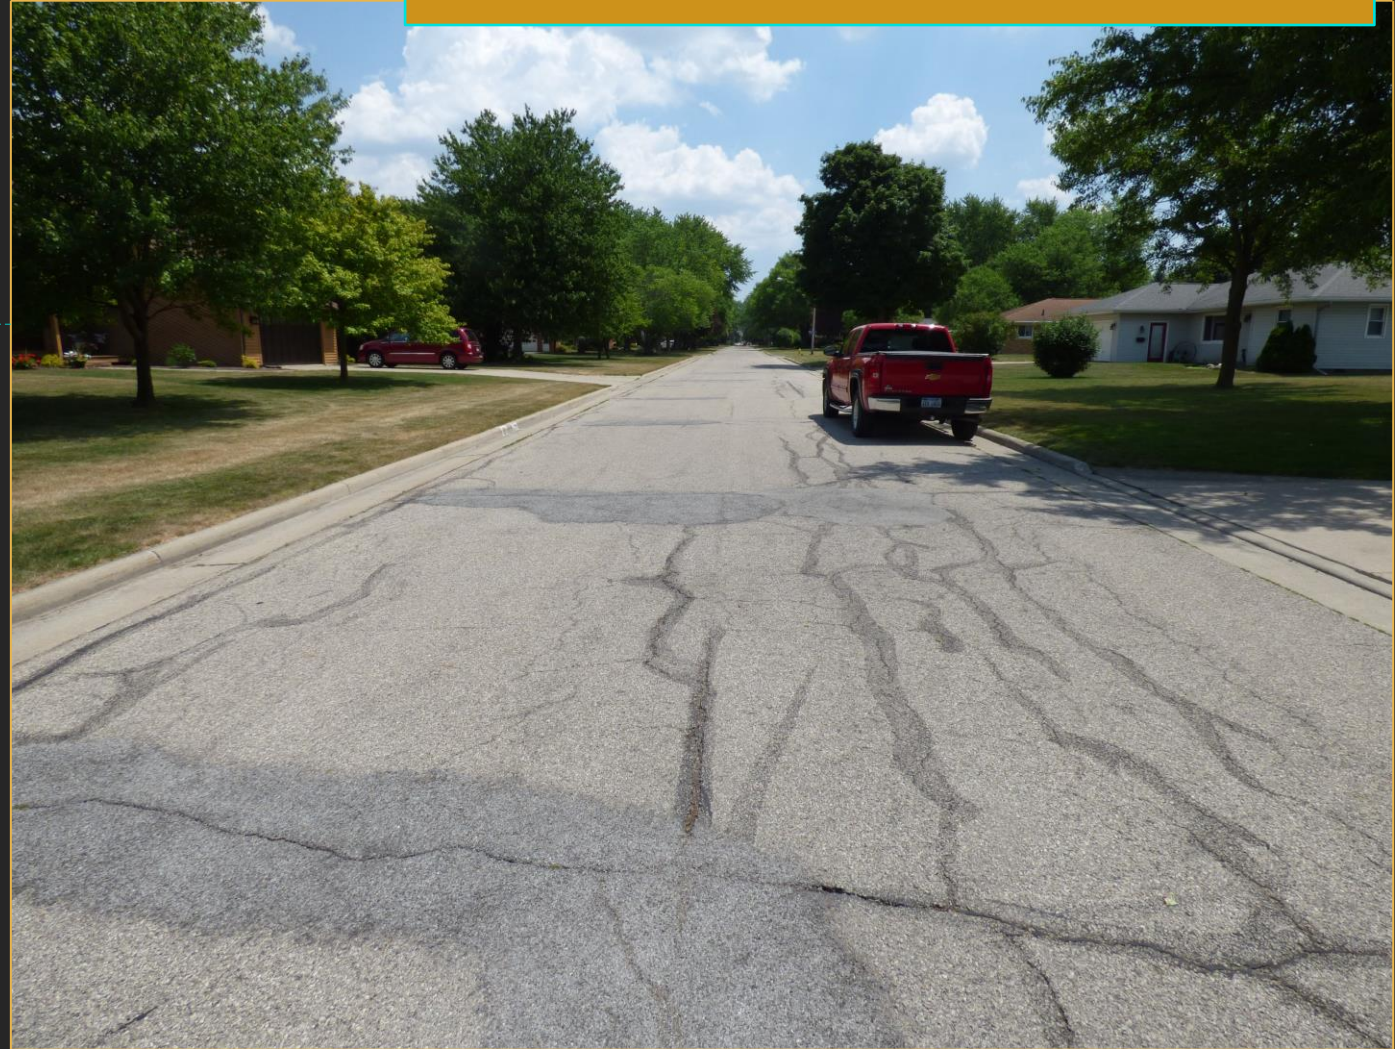
- Large Traverse Cracking w/ Settlement: 40'-60' Spacing
- Spray Patching performed to improve ride quality

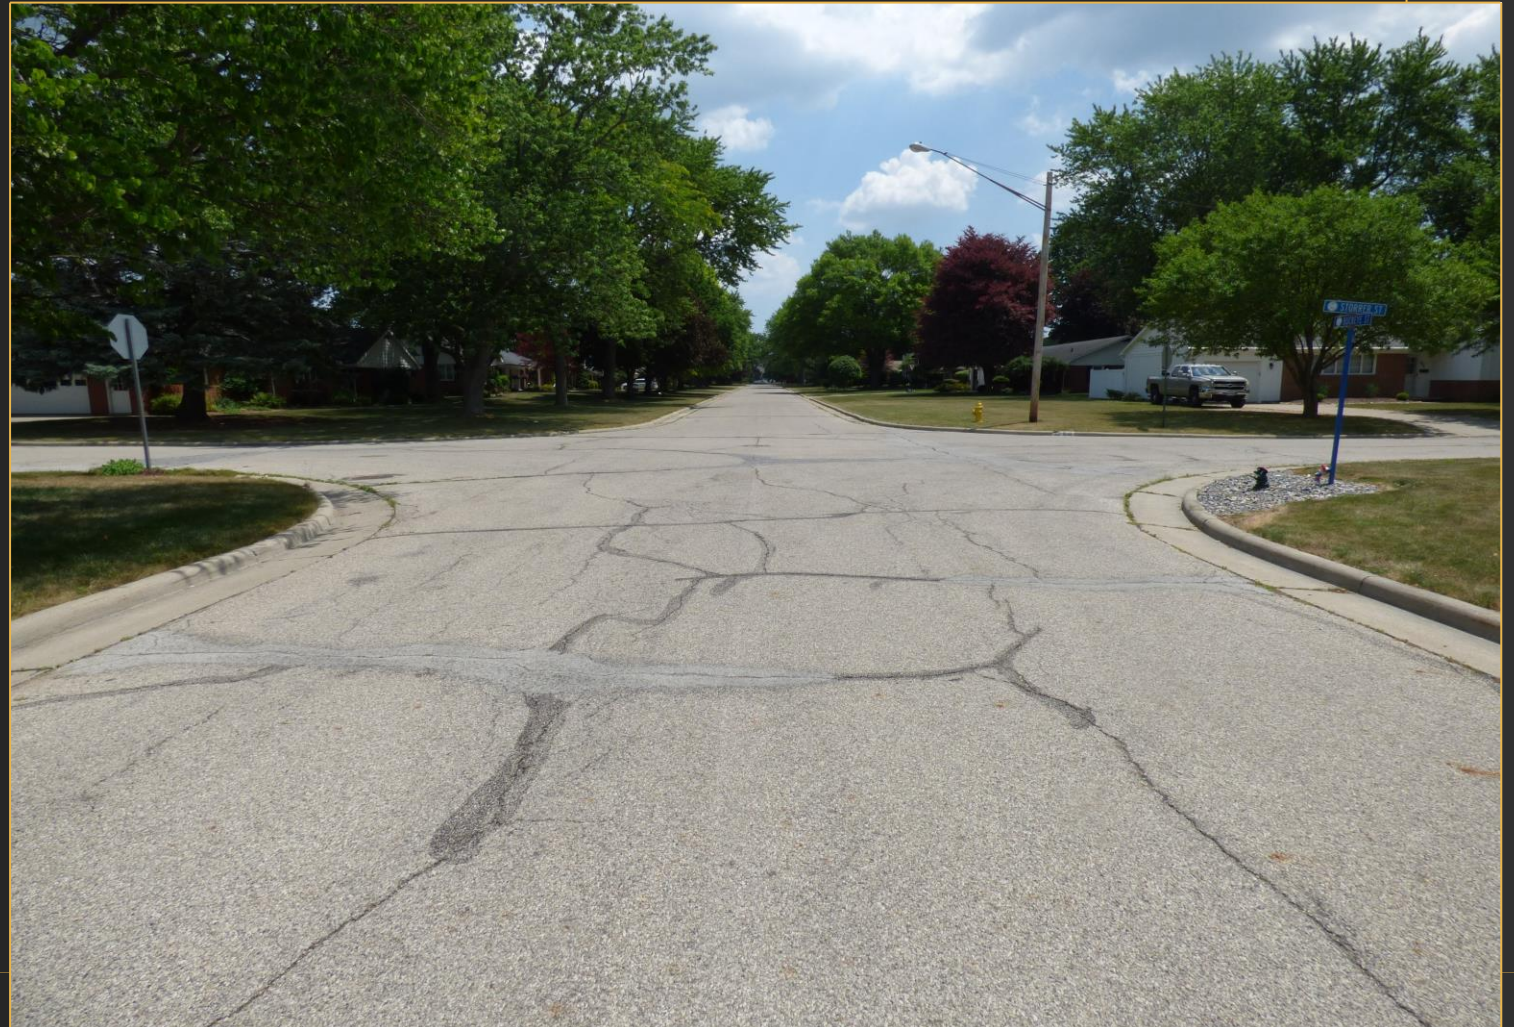
- Mod. Block Cracking

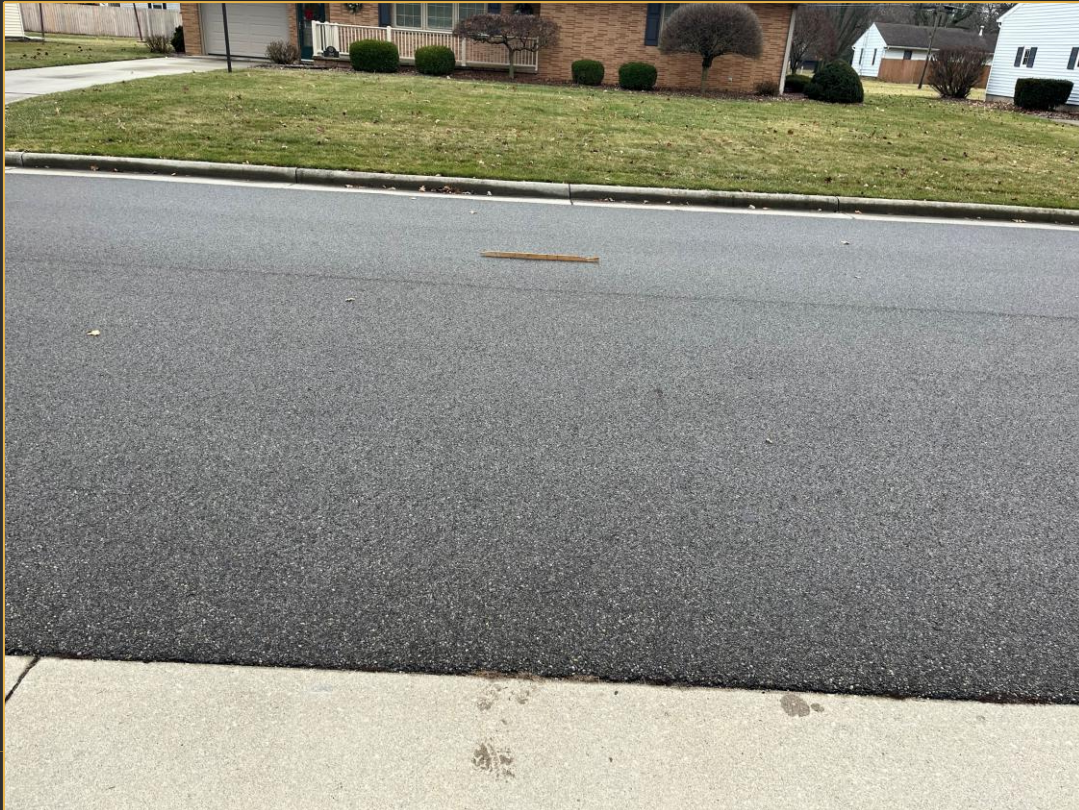
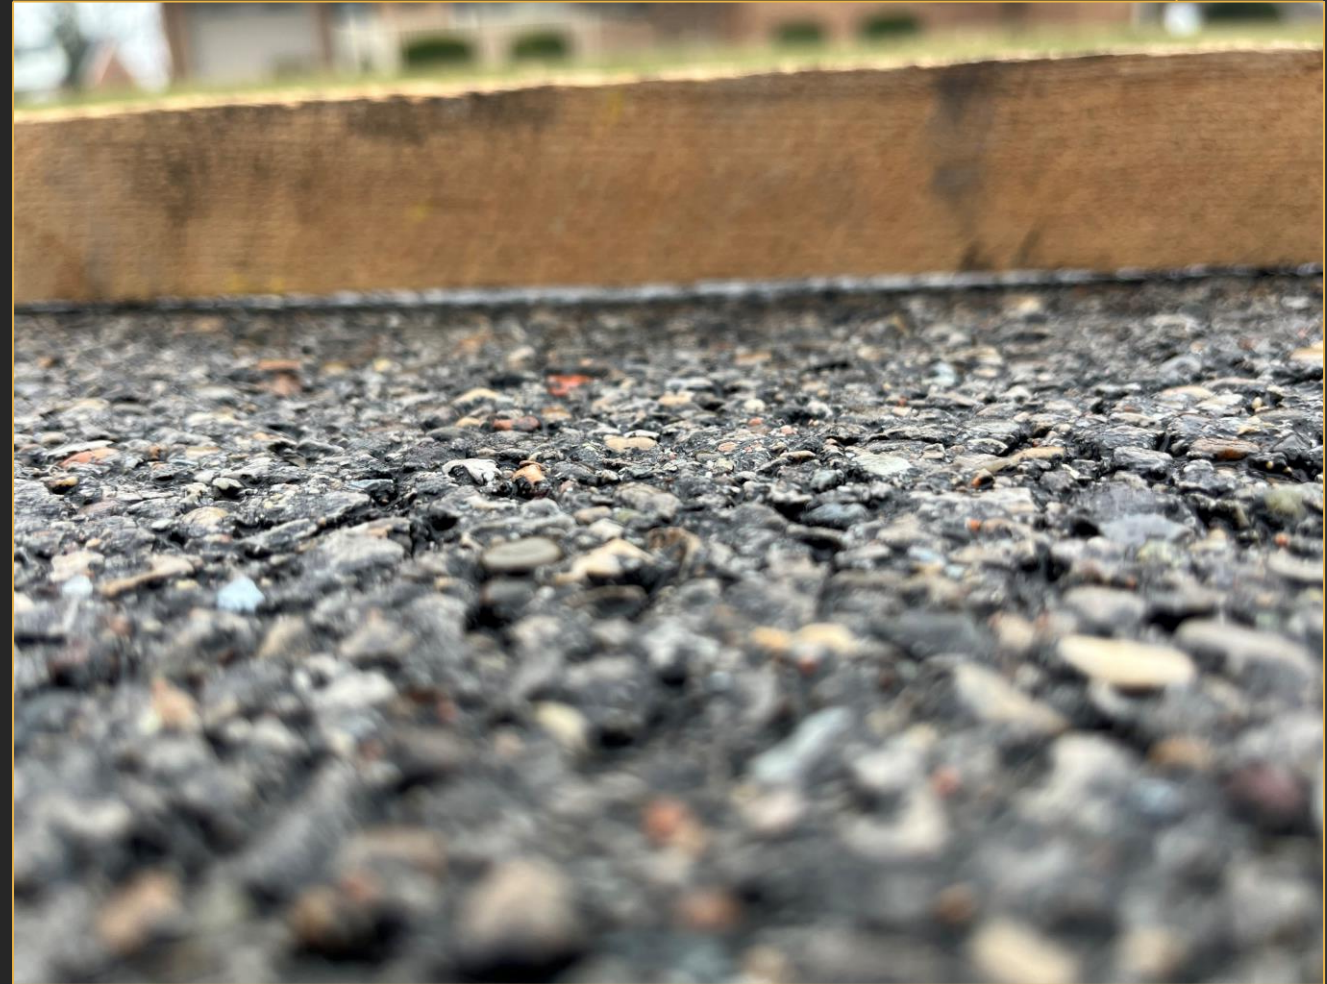
- Some issues with “Dips” at joints

Buckeye Street Resurface – 2020
