### ST. JAMES' CHURCH, CAMELEY

### CONSERVATION OF THE WALL PAINTINGS TREATMENT REPORT

August 2026

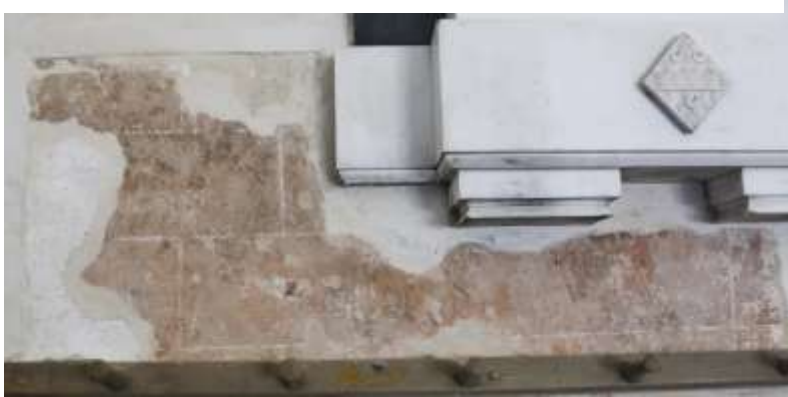
FIG 1.

In previous surveys it had been thought that the red curving lines within the fictive masonry were part of the design. However, on close examination these lines were found to cut through the masonry lines and appeared to have been applied with a coloured crayon rather than paint.

The fictive masonry design painted on the north wall. Thin white lines were applied to a polished terracotta coloured plaster.

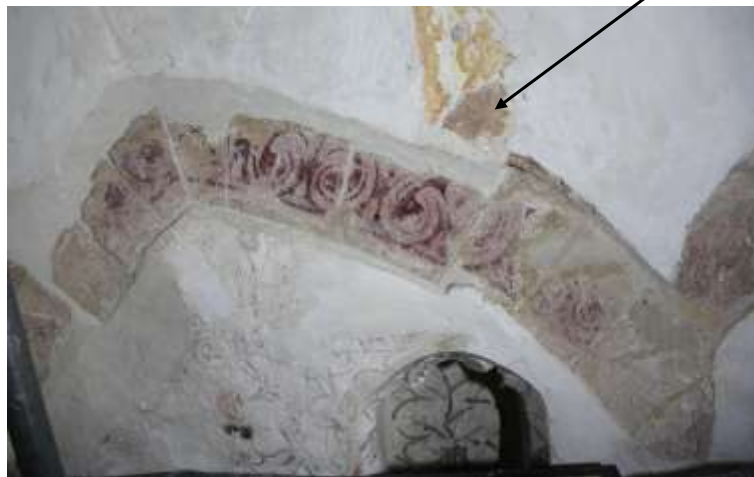
FIG 2.

Removal of previous repairs applied to cover imperfections in the shape of the arch revealed that the chancel arch and north side (blocked) arch had both suffered serious deformation in the structure and a number of the arch voussoirs had slipped after the painting of the earliest schemes - the scrolling trefoil leaf on the central arch and the palmette design on the north side arch. The north side arch that had appeared to be a gothic pointed arch was in fact a semi-circular Norman arch. Following this major movement in the late twelfth or early thirteenth century, the deformation in the arches was corrected with a terracotta-coloured plaster, very similar to that on the north wall. The plaster covered the earliest paint schemes. On the chancel arch the same pink plaster repairs were overpainted with the pink scheme decorated with black diagonal lines thought to date from the thirteenth century.

View showing the north side arch after the displacement of the stones had been revealed.

Area of the terracotta/pink plaster that was revealed that postdates the movement of the arch.

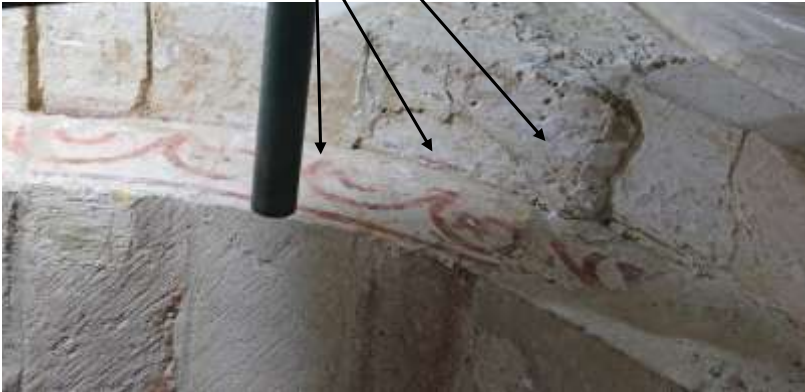
FIG 3.

View showing the soffit of the central arch after the more recent repairs had been removed.

Early repair with the terracotta/pink plaster. This repair supports the second early paint scheme on the soffit with diagonal bands.

The earliest scheme consists of the scrolling foliage with trefoil leaves and a red border line of the soffit.

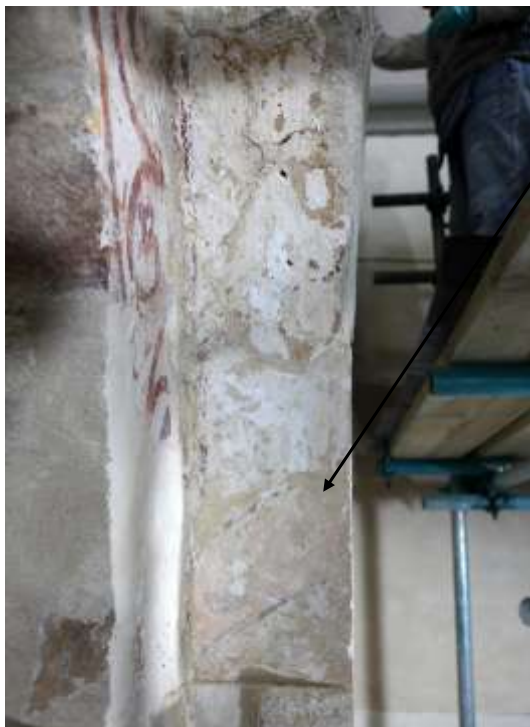
FIG 4.

Second scheme that is contemporary with the terracotta/pink plaster

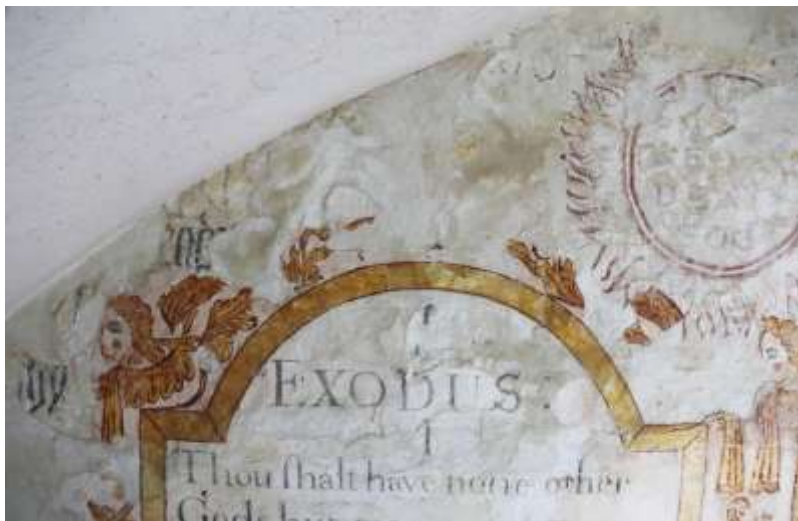
FIG 5.

A closer examination of this area revealed that the wall was replastered in the eighteenth century from a line just below the words EXODUS and CHAP:XX at the top of the panels. The areas of wall to the north and south of the central decalogue were also found to also retain some earlier fragments of plaster.

View of the upper north side of the east wall showing the palimpsest of different schemes.

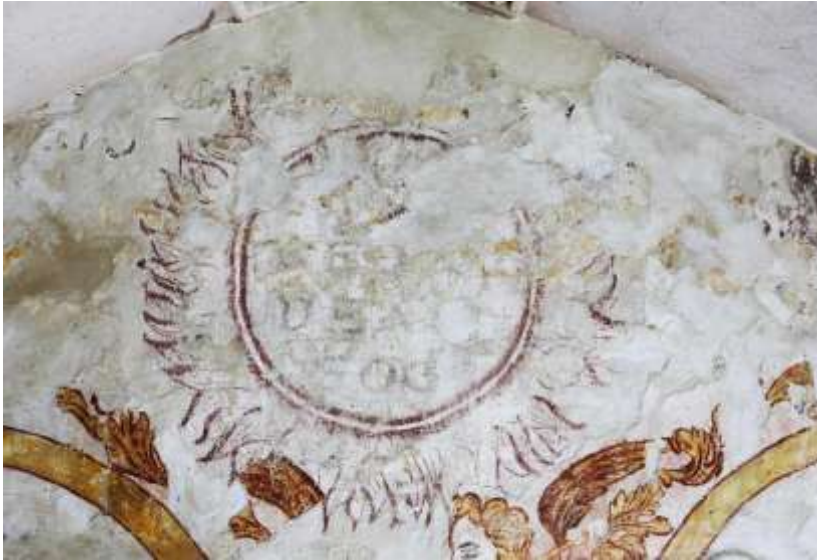
FIG 6

Detail showing the sun motif with lettering in the centre.

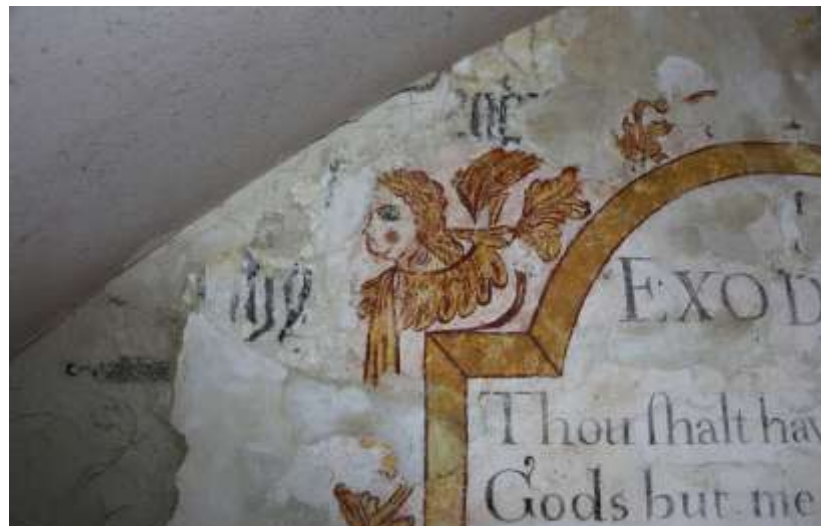
FIG 7.

Detail showing the earlier gothic script.

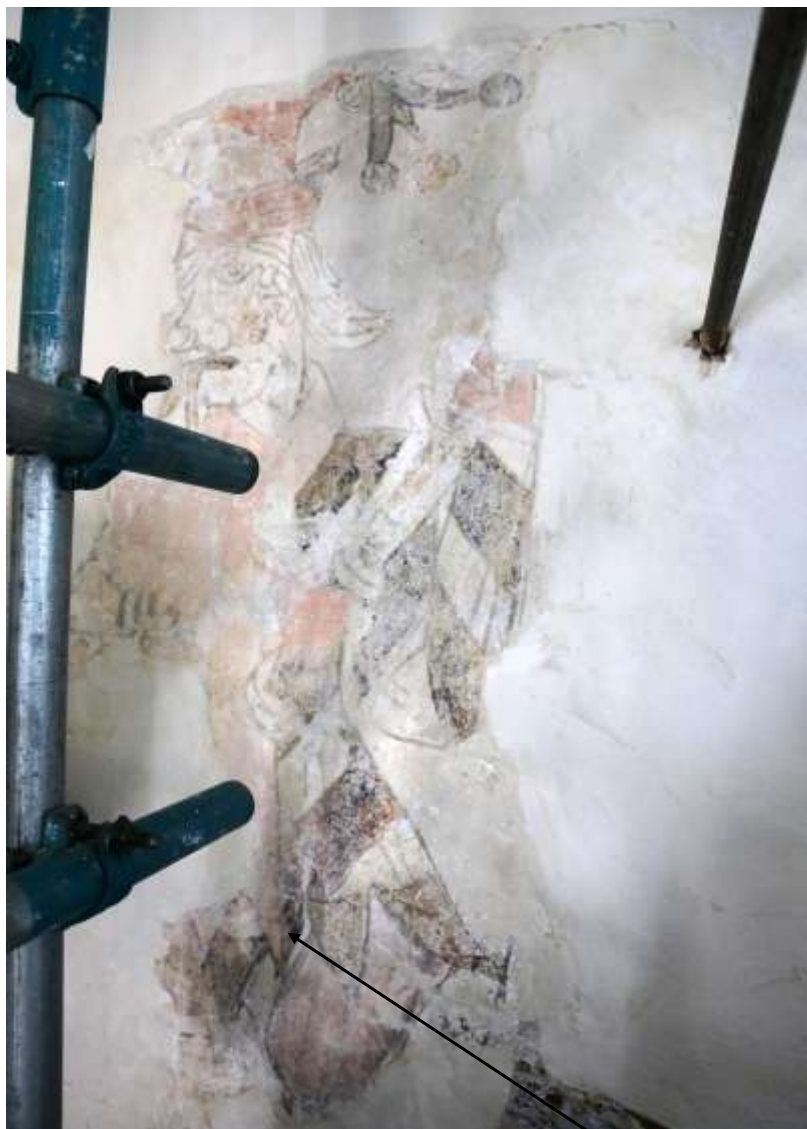
FIG. 8

View showing the Jester, taken from the scaffold.

It is thought that some of the black /brown bands may be a discoloured red and this will be confirmed by analysis.

Pink band similar to that coming from the mouth that is thought to represent blood from the sword wound.

The black/brown bands on the lower area of the jester's doublet may be a discoloured red such as vermilion or red lead and paint samples have been taken and sent for analysis to confirm whether this is the case (the results of the analysis will be sent in a later report).

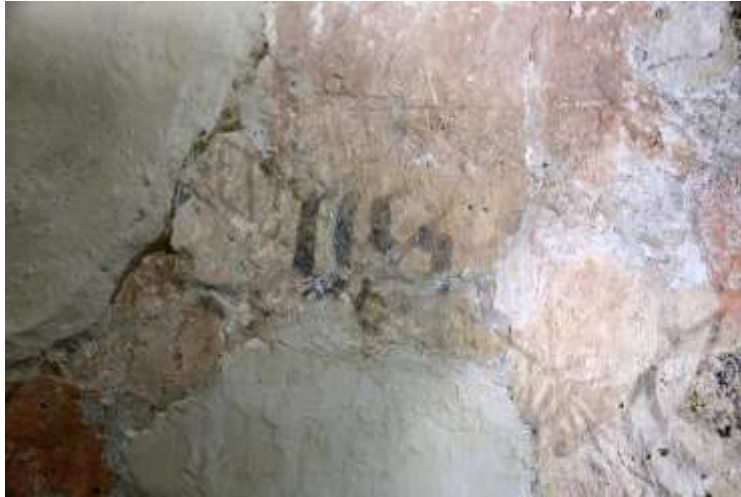
FIG. 9.

Detail showing the lettering. Beneath the lettering there appears to be a rope with a tassel painted in grey/black lines.

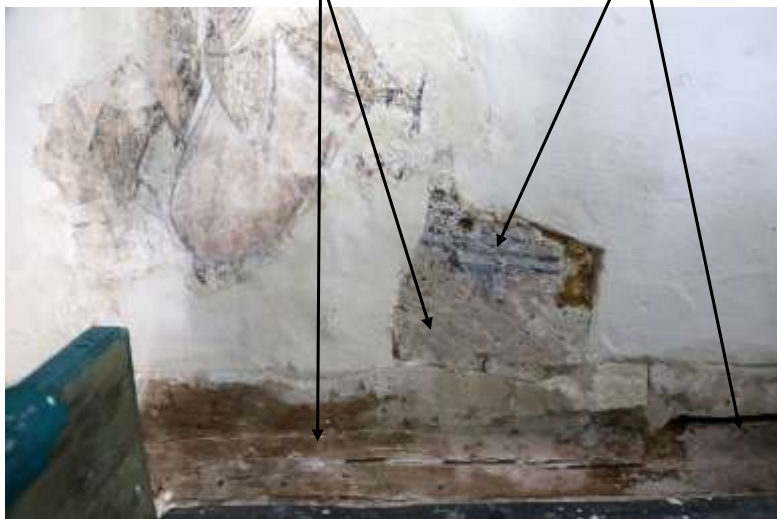
FIG 10.

Work on the lower wall revealed that the 'brocade' design found beneath the jester figure continued onto part of the horizontal timber beam/lintel above. Part of the timber is now unpainted but this area has sparrow pecks in the timber surface indicating that it had been plastered. It therefore seems likely that the painting continued in this area on a layer of plaster that has since been lost.

Detail showing the timber in the wall that is partially covered with the painting.  
Unpainted area of wood where the plaster and paint are missing.

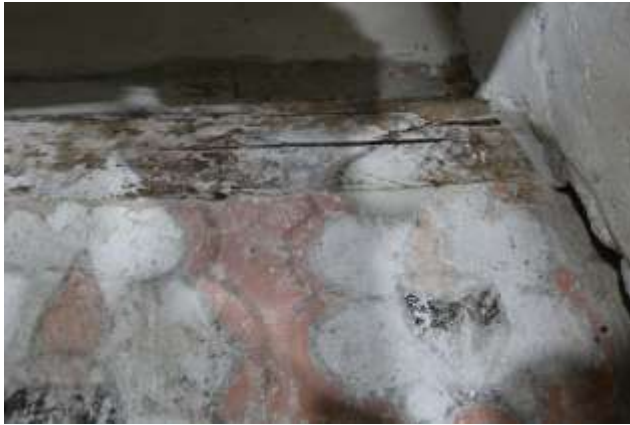
FIG. 11

Detail showing the brocade design on the lower wall that clearly also covers the timber in the wall.

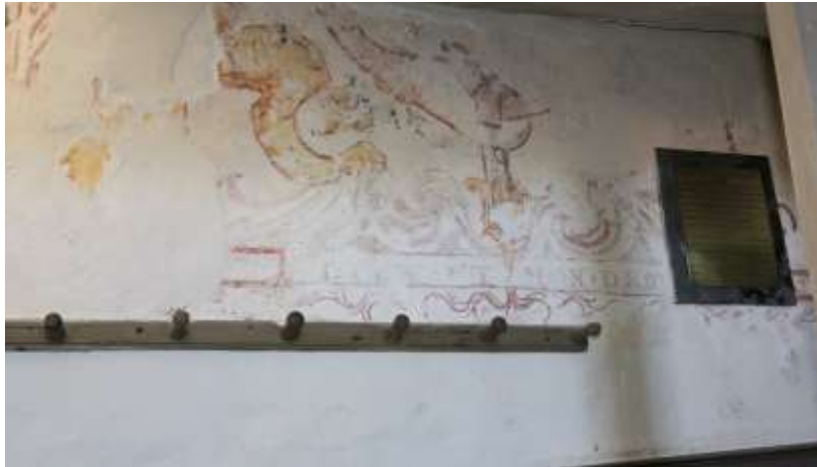
FIG 12.

View showing the extent of the Royal achievement visible on the south wall beneath the gallery.

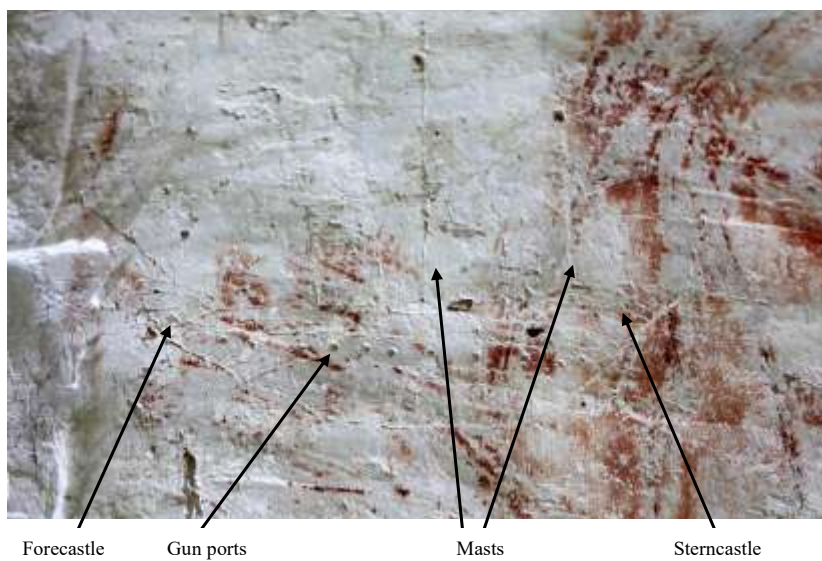
FIG. 13. View of the smaller incised image of a ship.

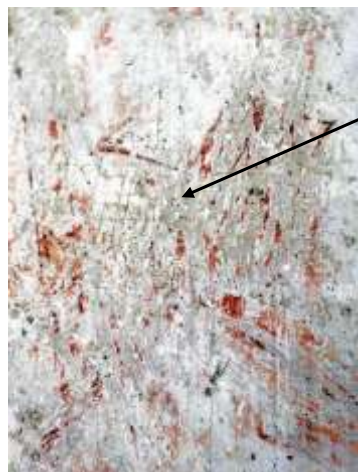
FIG. 14

Detail of the rigging on the larger ship.

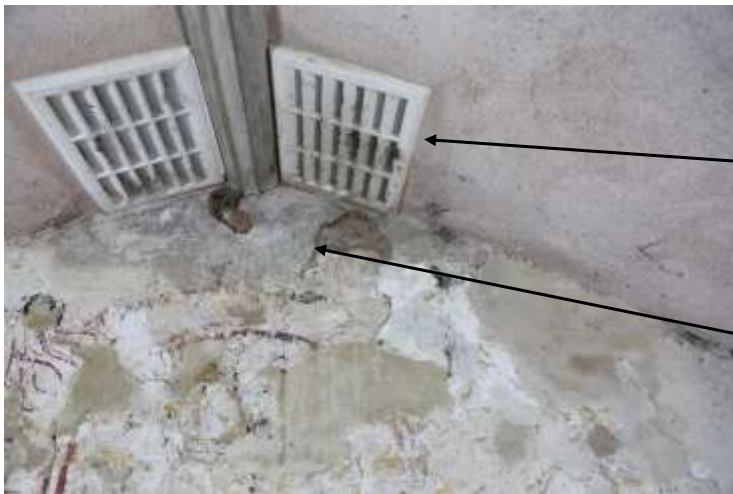
FIG. 15

The upper wall clearly retained a considerable amount of moisture in the internal structure and this unfortunately became more apparent once the hard cement and gypsum repairs were removed. The original mud plaster and pointing retained a significant amount of moisture. The ventilation grills on the ceiling above the east wall were found to be completely blocked with debris.

Detail showing the area at the top of the east wall. The ventilation grills were found to be completely blocked. Note the later hard cement fills at the top of the wall.

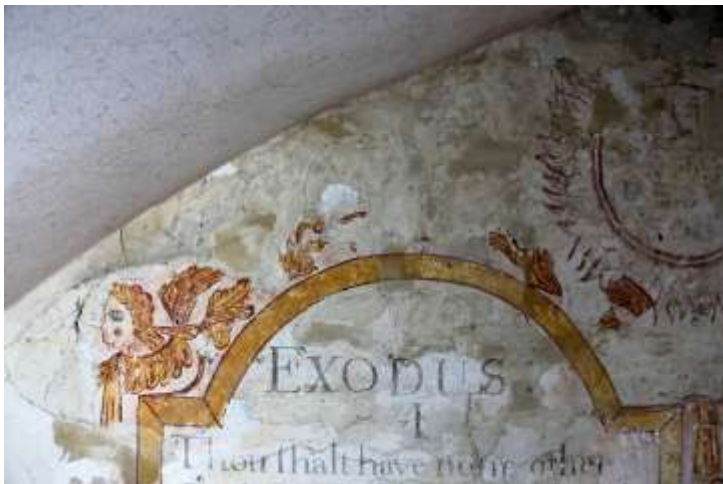
FIG 16.

View of the upper north side of the wall showing dark areas where later fills were retaining moisture

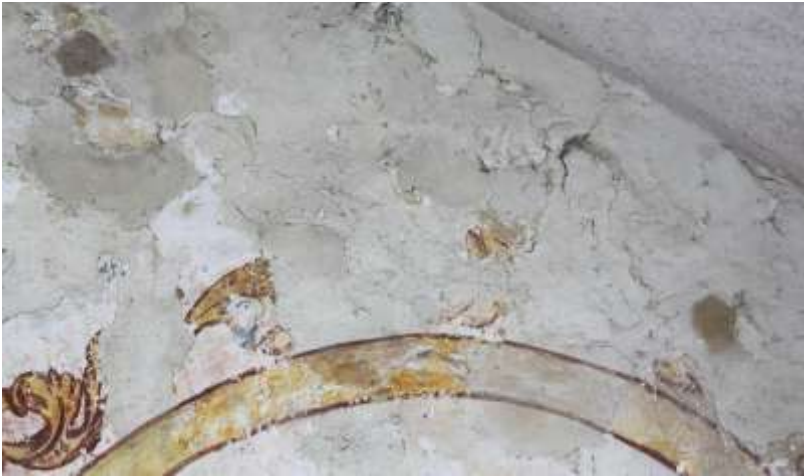
FIG. 17.

Detail showing the south side of the upper wall. Later limewash covers a number of inappropriate repairs that had already started to fail.

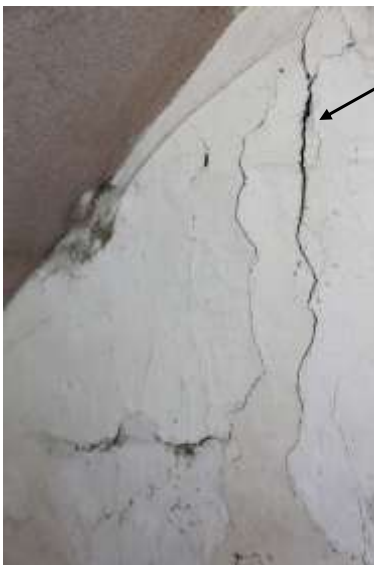
FIG 18. Left

Cracks and failing fills on the north side.

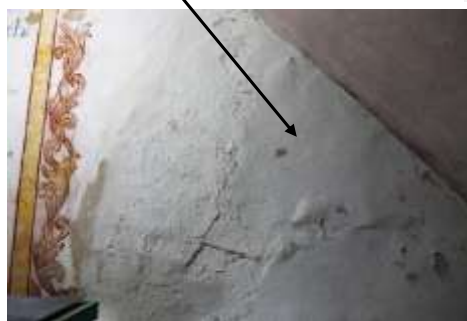
Fig 19

Later limewash covering a large cement and gypsum repair.

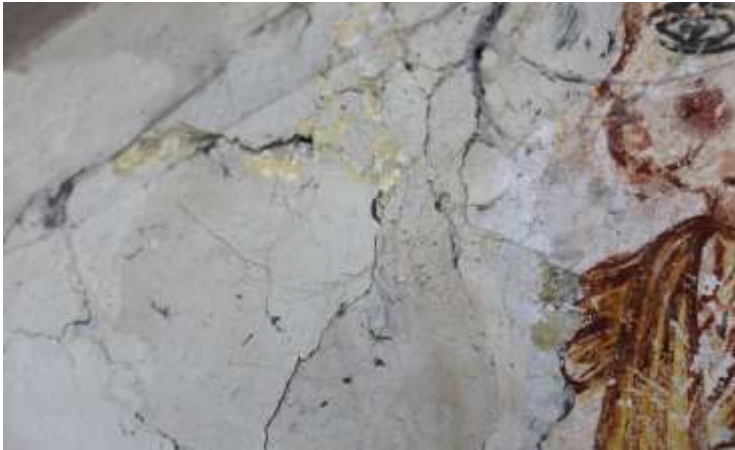
Fig.20

Detail showing failing original plaster covered with later limewash. Removal of the limewash to understand the extent of the original plaster revealed the gothic lettering.

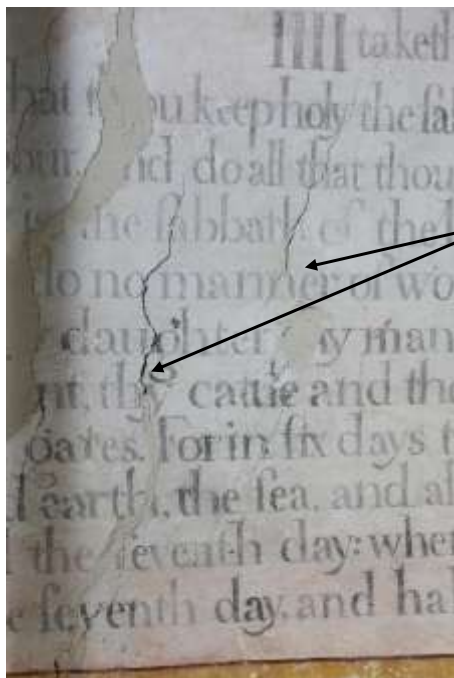
FIG 21

Detail of the central panel that was applied onto a later eighteenth-century plaster. A number of the previous repairs filling cracks had failed.

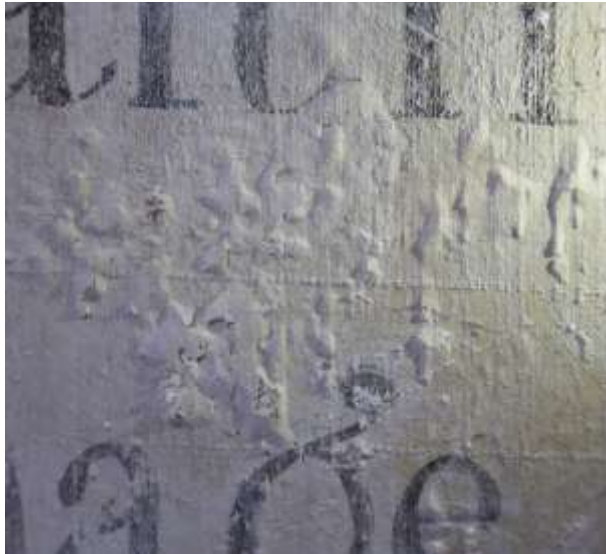
FIG. 22

Salts and blistering paint were visible on the painted surface of the Decalogue. These only occurred on the upper wall, just below the area where the wall had been damp for some time - clearly a result of the wetting and drying process leading to the crystallization of salts on, or just behind, the painted surface.

Detail showing blistering limewash layers caused by salt crystallisation occurring just behind the paint layers

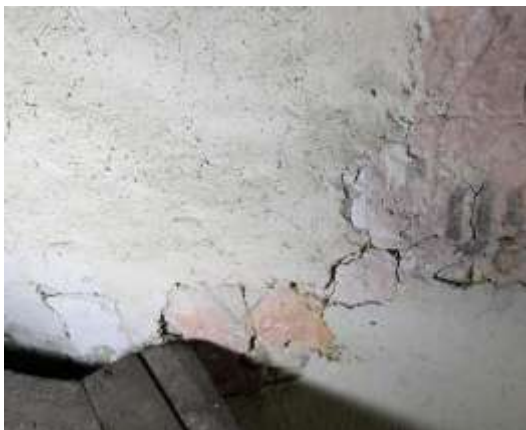
FIG 23.

The plaster was unstable at the bottom of the painting.

Detail showing detachment of the surviving fragments of plaster at the bottom of the wall painting.

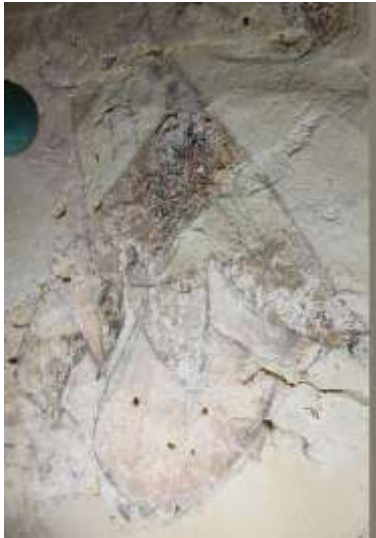
FIG 24. Left

Detail showing cracks and previous grouting holes that were left unfilled.

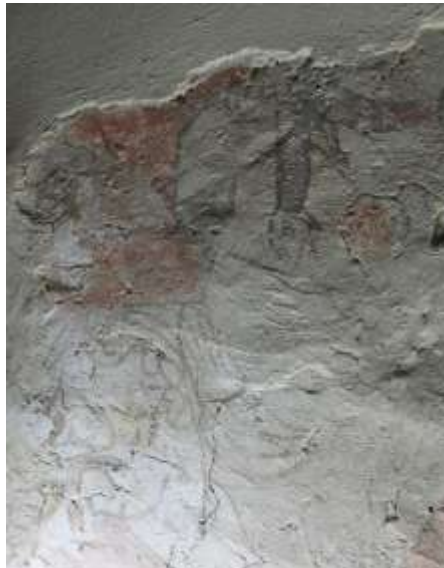
FIG 25 below

Detail of the jester's head showing cracks in the plaster.

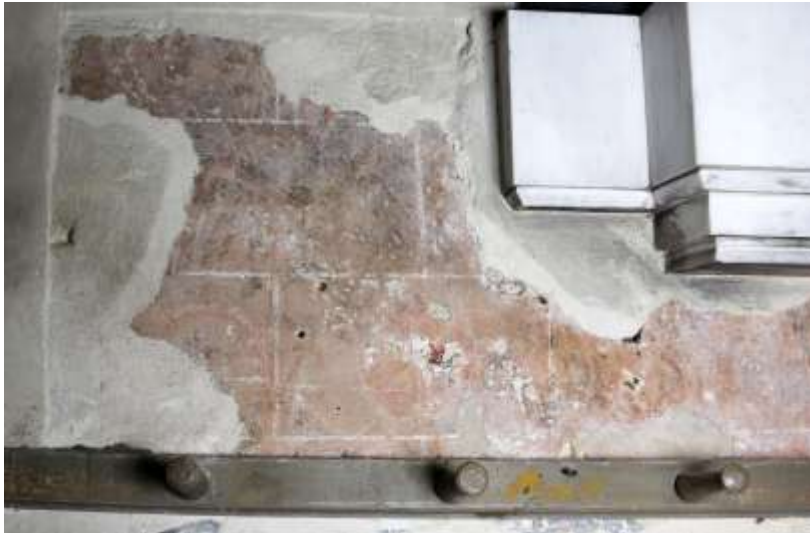
FIG 26

This area of wall was largely stable and there was clear evidence of previous grouting. However, there were still a number of lacunae with visible large voids behind the surface and areas of unstable plaster at the edge of the wall painting, adjacent to the later monument. Fine horizontal and vertical cracks were also recorded. In a number areas abrasion of the smooth plaster surface was recorded.

View showing the area of fictive masonry with visible lacunae and cracks at the edge of the plaster.

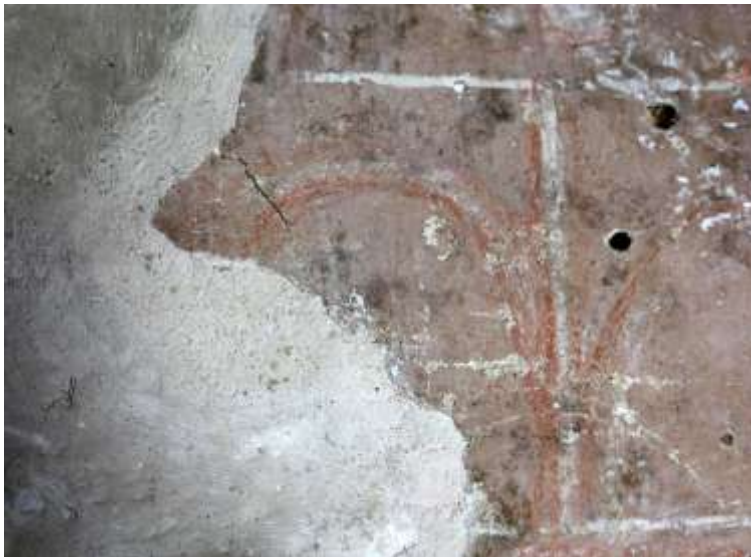
FIG 27

Detail showing abrasion and holes and the later sketch in red applied over the surface.

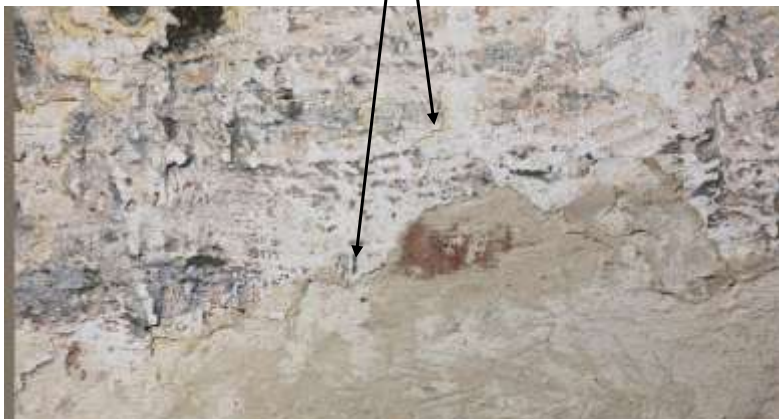
FIG 28

The St. Christopher painting was applied onto an extremely uneven, thin plaster layer that covered the fictive masonry design. Areas of detachment of the thin plaster and flaking paint were recorded.

Detail of the surface showing areas of lifting paint.

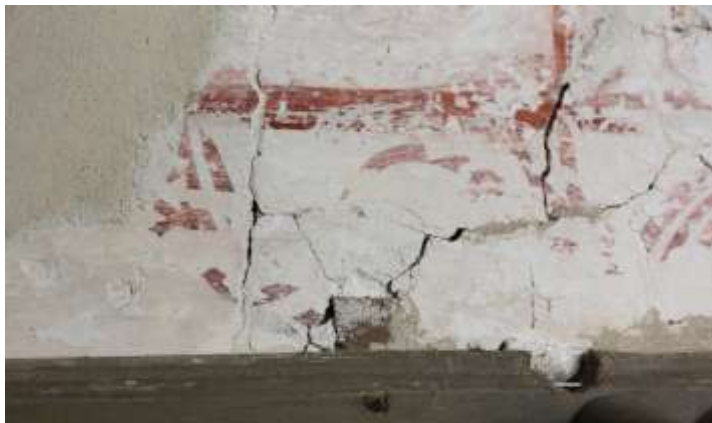
FIG 29

Extensive loss of adhesion of the plaster and limewash layers was recorded making some areas extremely fragile. There were also numerous cracks in the surface.

Detail showing numerous cracks in the surface.

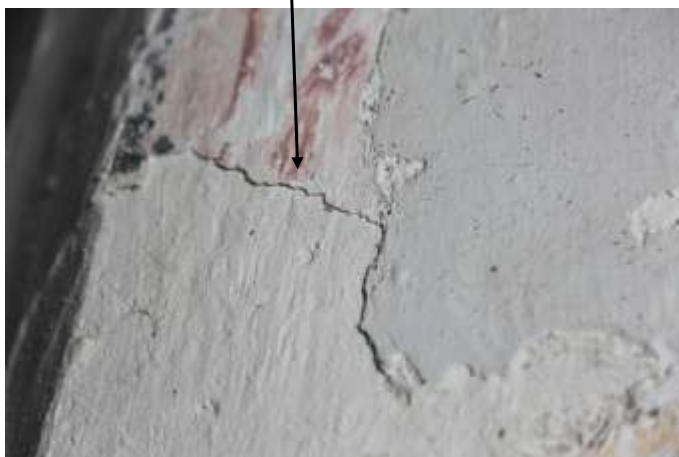
FIG 30

Lifting paint at the edge of the painting.

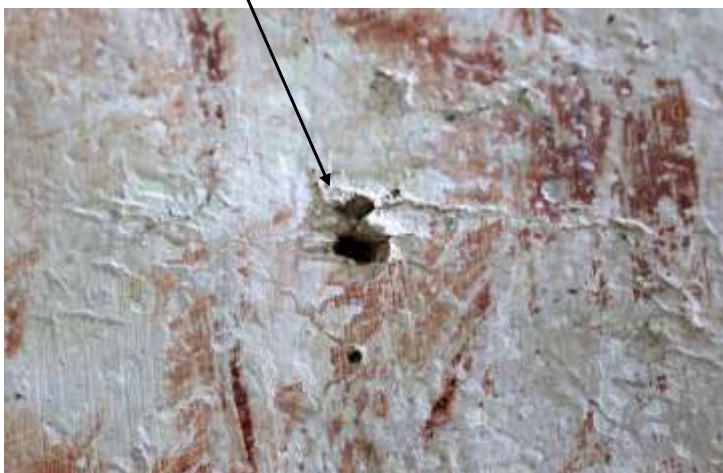
FIG. 31

A number of holes with deep voids were recorded and there was extensive detachment of the plaster on the north side of the area.

Lacunae in the plaster

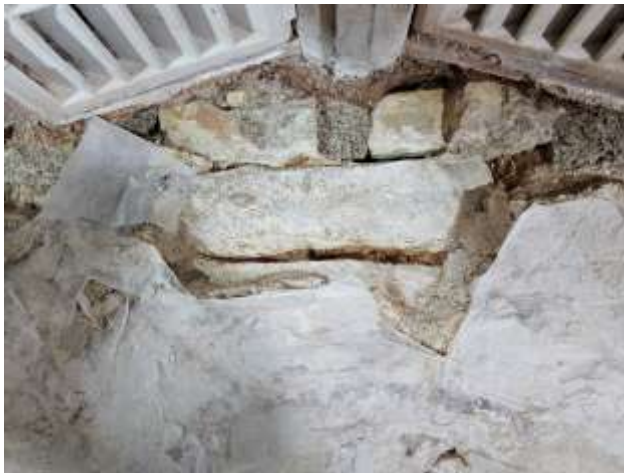
FIG 36

Detail showing the area at the top of the wall where the plaster has been removed. Much of the early mud-based pointing had been washed out of the joints by the continual moisture ingress.

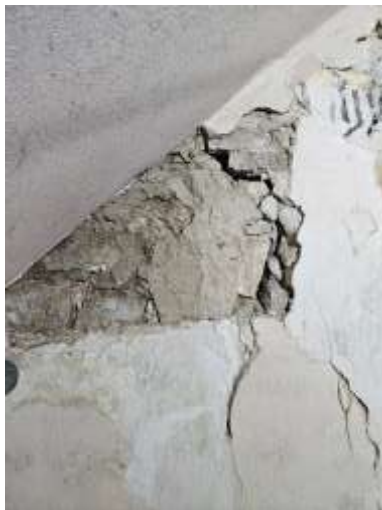
FIG.37

Gradual removal of later failed repairs revealing large open cracks in the structure beneath.

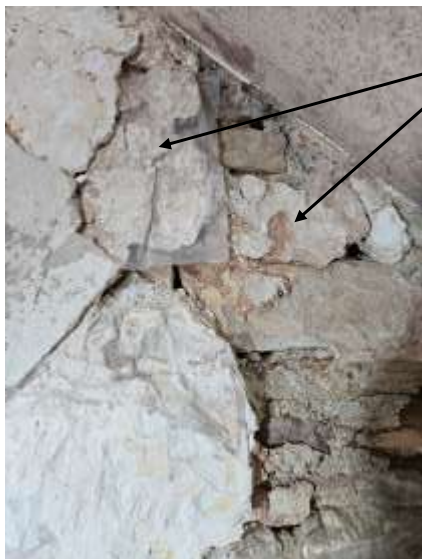
FIG. 38 left

Removal of later cement and gypsum revealed earlier plaster beneath that was very similar to the terracotta/ pink layer used for the fictive masonry.

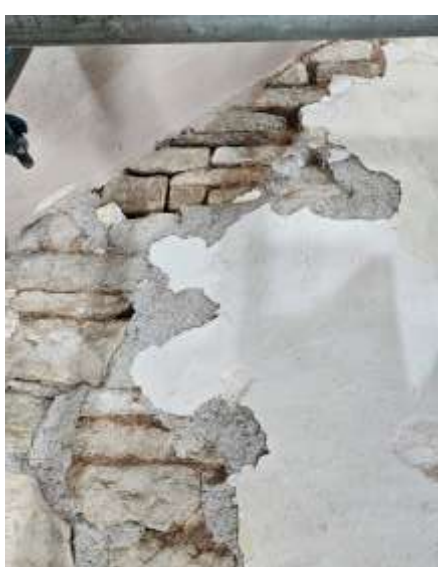
Fig 39 below

Wall on the north side of the east wall after removal of failed later plaster.

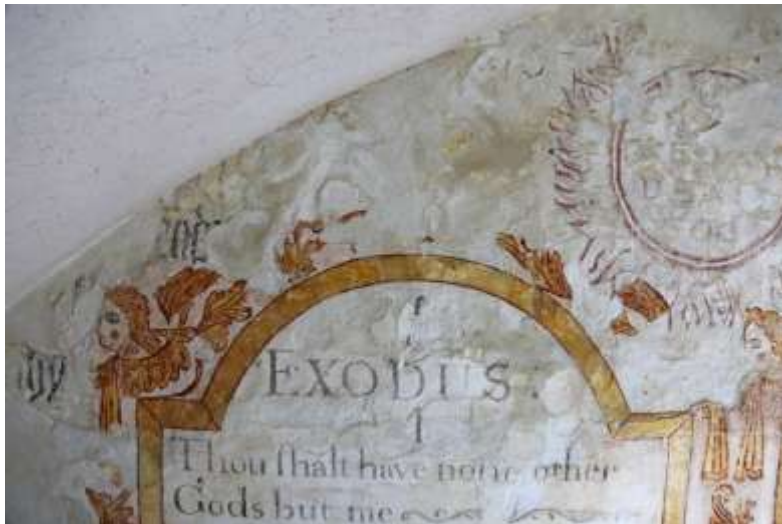
FIG. 55

East wall upper area. Some of the fills were still not completely dry at this point.

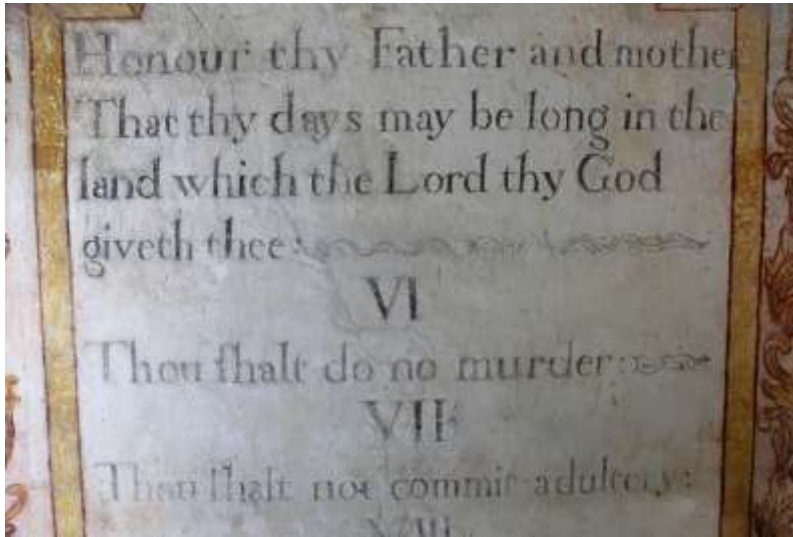
FIG. 56

Detail of the decalogue after treatment.
