PORT TOWNSEND REBUILD GROUP – Image Gallery (Sample)

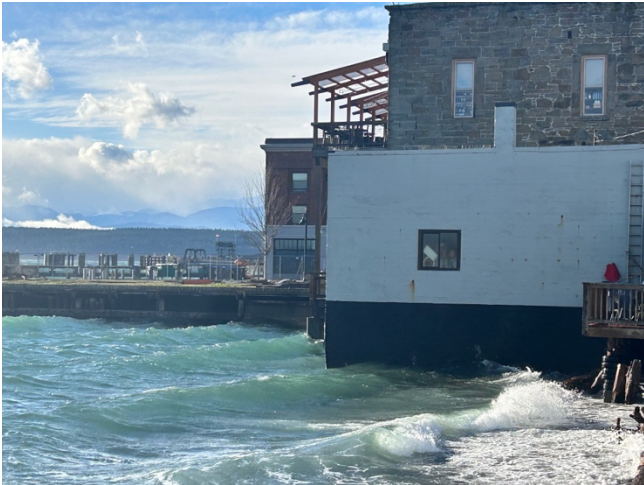
From top left to bottom right: (1) Waves battering the exterior of the Hastings Building; (2) Dilapidated dock adjoining the Hastings Building; (3) Flooding in the basement of the Customs House; (4) Exterior wall damage to the Customs House facing Port Townsend Bay; (5) Hastings Landing dock in unsafe and degraded condition; (5) Exterior wear and tear on the Uptown Theater.
