**COVER STORY** Old Mills Condominium's roof lives up to its name » p.2 Reserve funding strategies » p.C Funding your roof replacement » p.F

## Old Mill Condominiums,

located in Revere, MA, is a 100-year-old mill that was converted into condominiums.

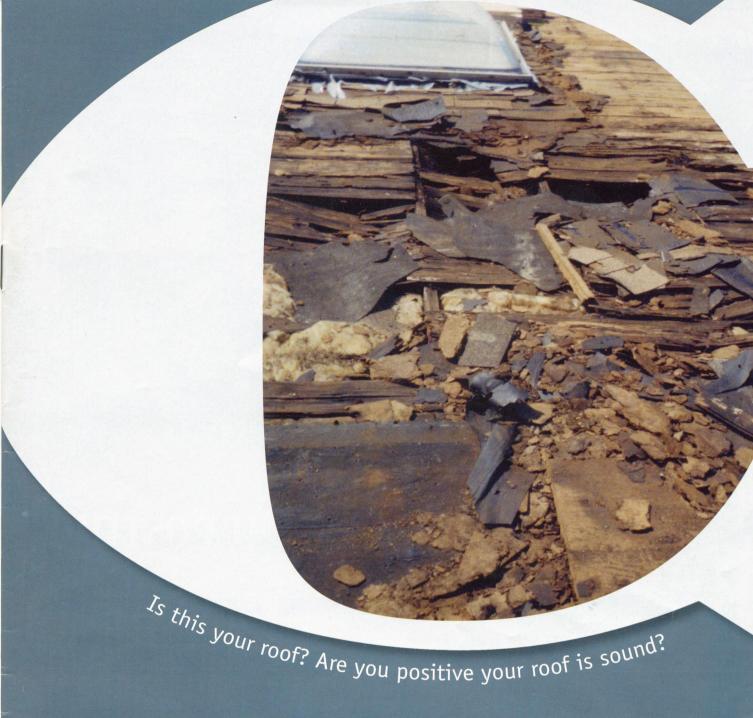
The roof system was 7 years old and was leaking badly with every rainstorm. At that time, the contractor never fully stripped the roof because of all the work that it would entail. Wooster Roofing was called in to diagnose the problem. After the initial inspection it was determined that most of the leaking was from the old dome-style skylights and a lack of proper ventilation.
