## Rapid Roof Services PTY LTD License No: 245603C

Roof Inspection Report

Roof Condition: Fair

Age of Roof: 35-40 Years

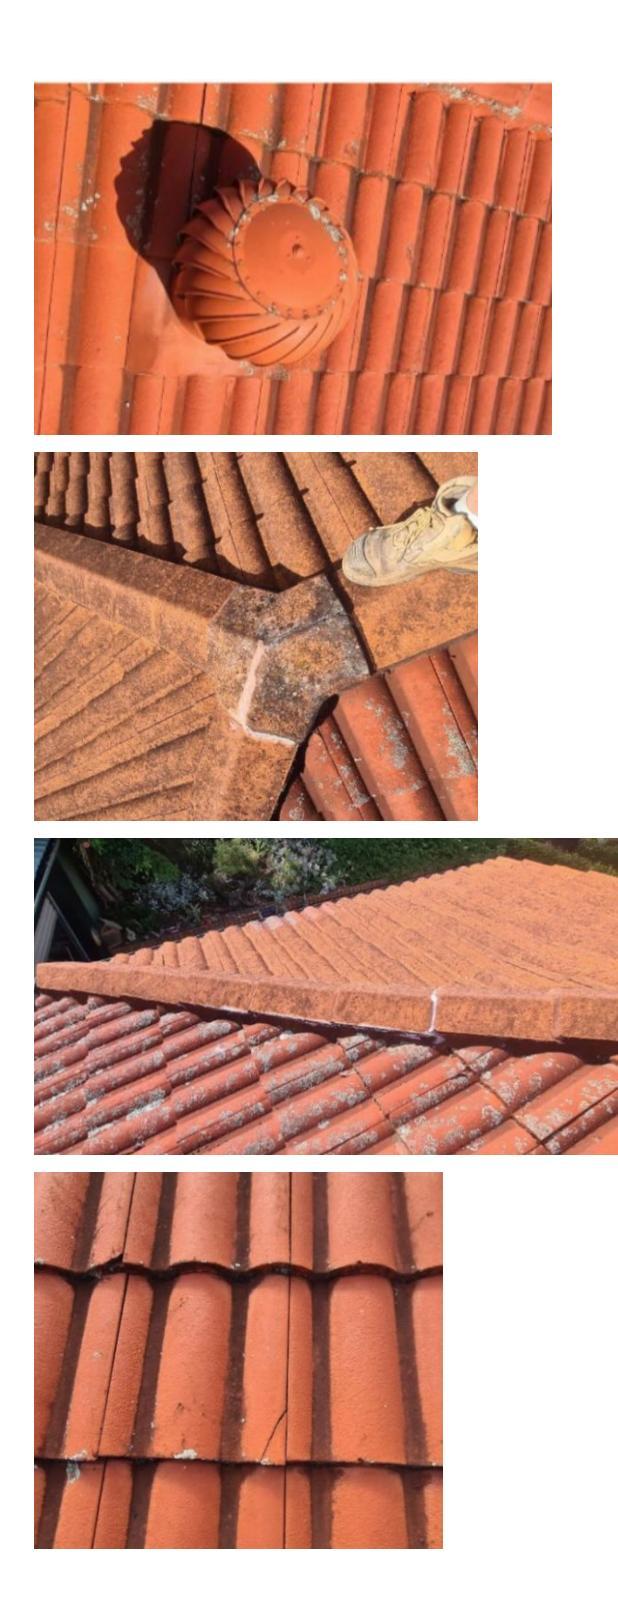
Photos:

-Stain and leaks to gyprock ceiling -Sections of ceiling taken out -Water running down brickwork

-Apex ridge (which is being repaired)

The severe storm in March pushed water back under the tiles. Due to the sheer influx of rainfall it resulted in leakage.

Recommendations: REPAIRS -Replace Apex ridge with new.
