Special Edition on Photographic Reconnaissance and Photographic Intelligence - March 1945

ISSUED BY AIR MINISTRY A.C.A.S.(I)

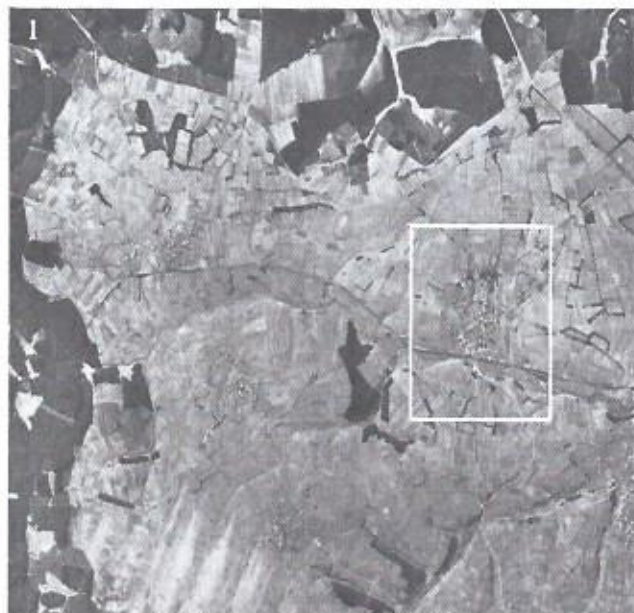
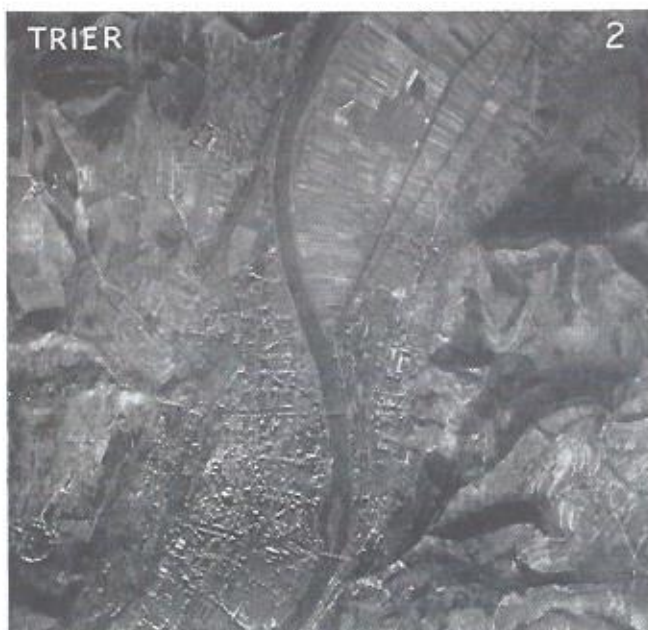
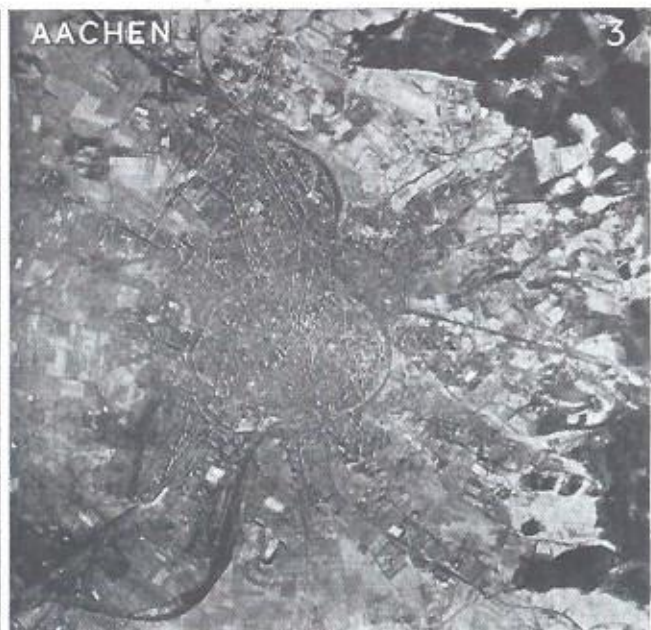
(Plate 1.) The first reconnaissance sortie of the "Heston Special Flight" was made on 18th November, 1939, the target intended to be covered was Aachen, but the anticipated difficulties of navigation proved well founded and the result of this first effort was some photographs south of Aachen on the Belgian side of the frontier. The contact print reproduced here is from this first sortie, it covers the village of Bullingen and was taken with an F.24 camera and 5 ins. lens from 33,000 ft. giving a scale of 1 : 79,200. (See also opposite page.)

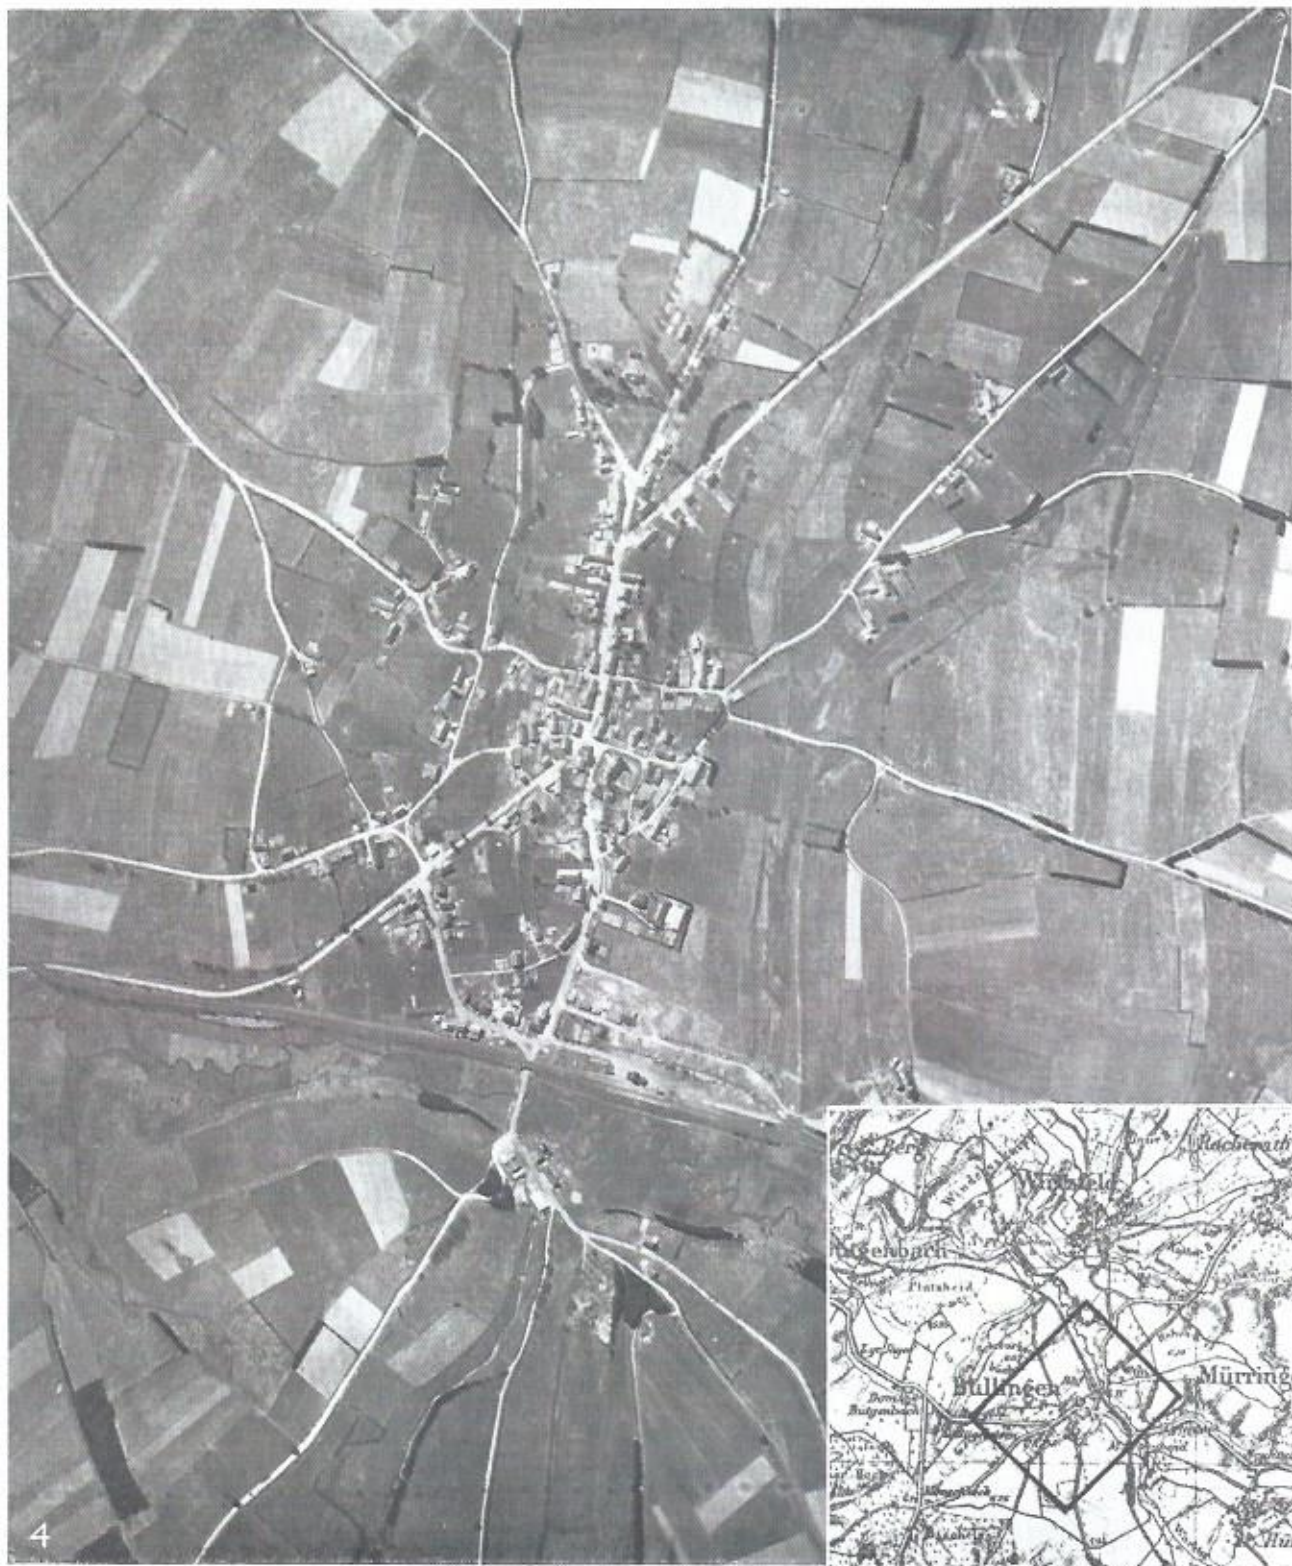
(Plate 4.) This is a contact print from a sortie flown in April, 1944 with an F.52 camera, and 36" lens from 34,000 ft. giving a scale of 1:11,300. It is of the same Belgian village outlined in Plate 1 opposite and shows clearly the advance in quality and scale of photographs due to the development of cameras and long focus lenses.

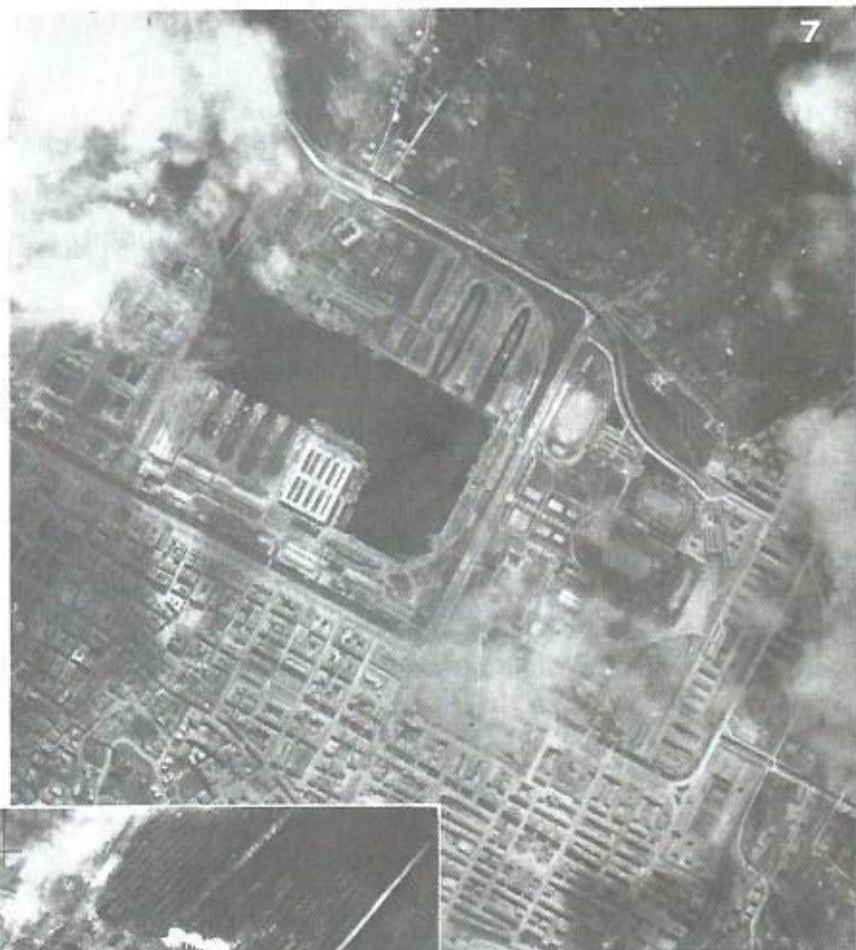
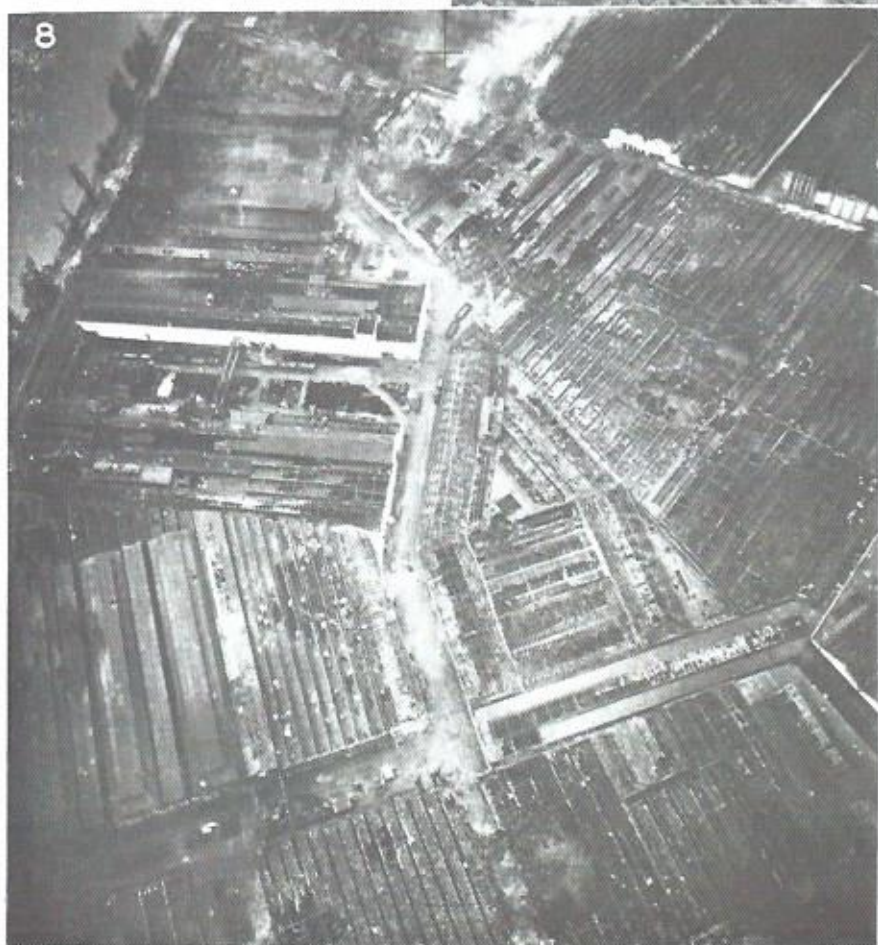
(Plate 8.) On the night of 3/4th March, 1942, BOMBER COMMAND aircraft attacked the Renault Works at Billancourt. The following day a P.R. aircraft took off in heavy rain and poor visibility to photograph the damage, flying by instruments in 10/10 cloud until breaking cloud near the target at 500 feet and proceeding to photograph the damage from as low as 400 feet. On the return journey he met with similar conditions, at one time being at 0 feet over the Channel. At 800 feet over land he was still in 10/10 but eventually landed safely. The illustration, left, shows one of the fine oblique photographs which were obtained and brought back in the face of such appalling conditions.

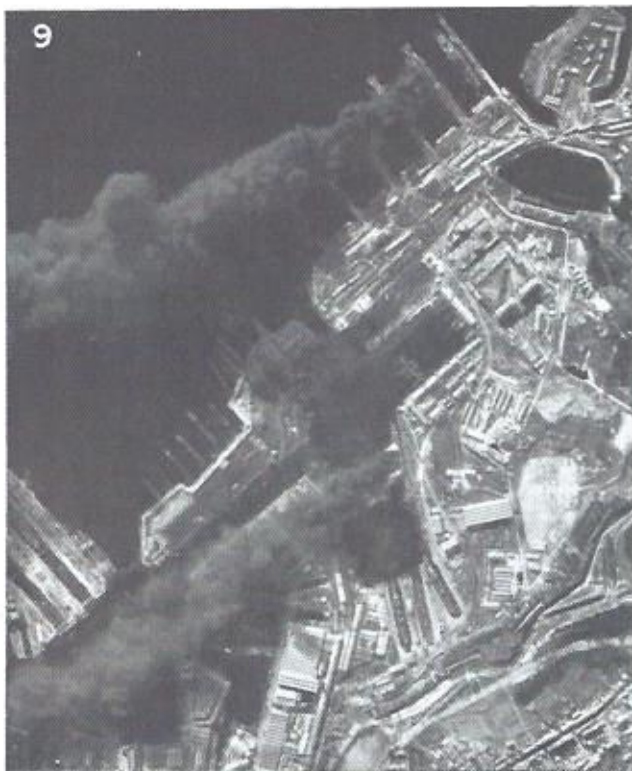
(Plate 9.) Many rumours were prevalent regarding the scuttling of the French Fleet before the question was finally settled by air photographs which revealed the destruction of the greater part of the Fleet in Toulon harbour on the 28th Nov., 1942.

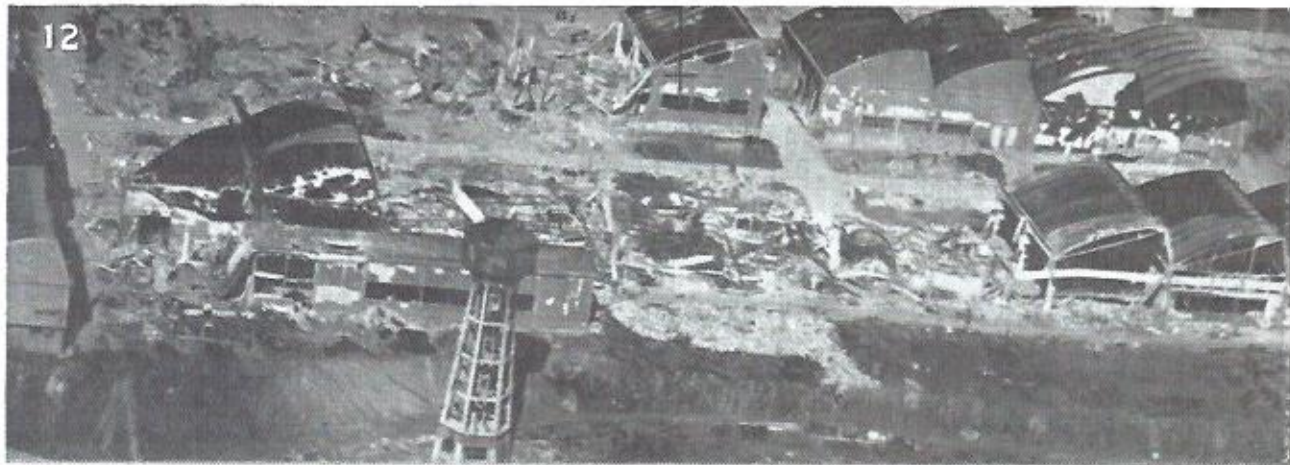
(Plate 12.) A fine low oblique shot, taken in March, 1944 by a P.R. Mosquito with side-facing oblique camera, showing the heavy damage caused by 12,000 lb. bombs to the Gnome and Rhone aero-engine works at Limoges.

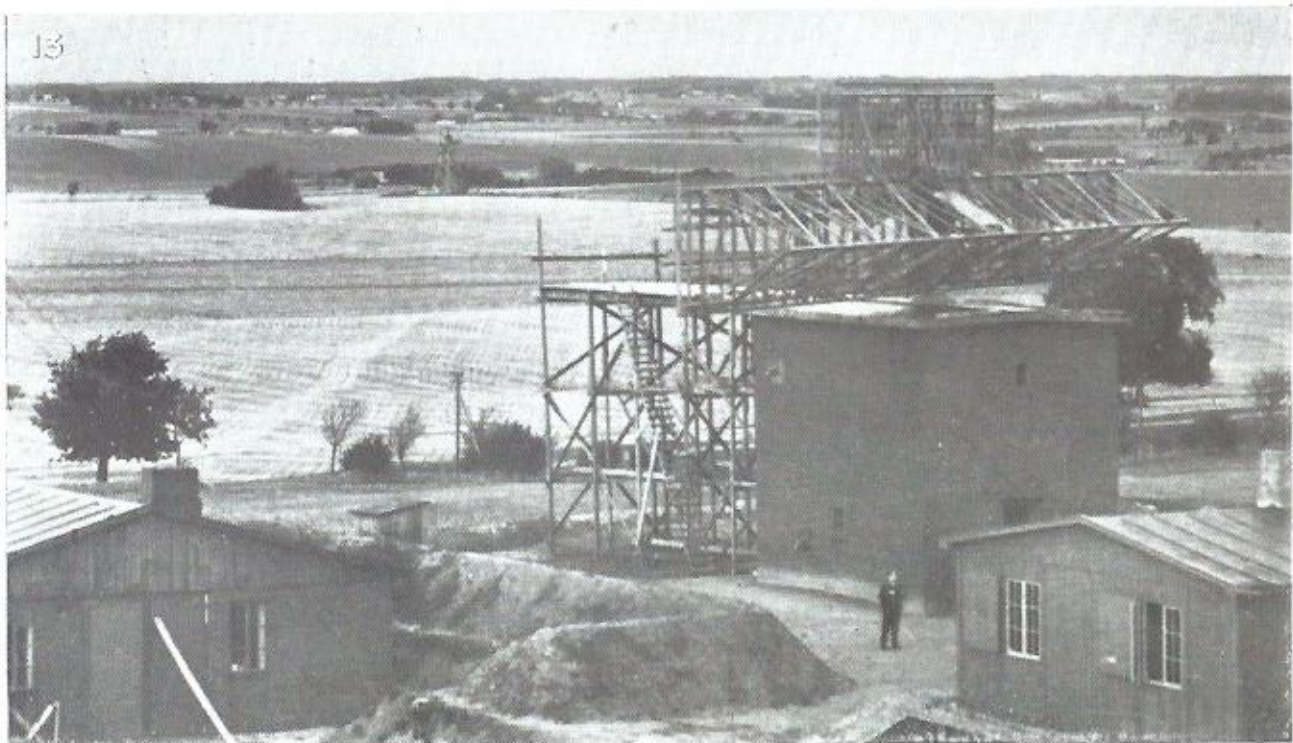
(Plate 14.) On the 12th July, 1944, a P.R. aircraft set out to find the ' Tirpitz '. Thick cloud predominated off the Norwegian coast, but there were some breaks at lower altitudes, and the pilot flew at varying levels until the ' Tirpitz ' and attendant ships were suddenly spotted obliquely from 15,000 feet. Down went the aircraft in an extremely steep dive, pulling out at 9,000 feet at cloud base, when the top escape hatch suddenly blew off and disappeared. Despite this calamity two runs were made over the target and oblique and vertical photographs obtained. On the return journey the crew almost froze because of the draught from the broken hatchway but got back safely after a round trip of over 2,300 miles. Below is one of the excellent vertical photographs which were obtained of this once formidable battleship.

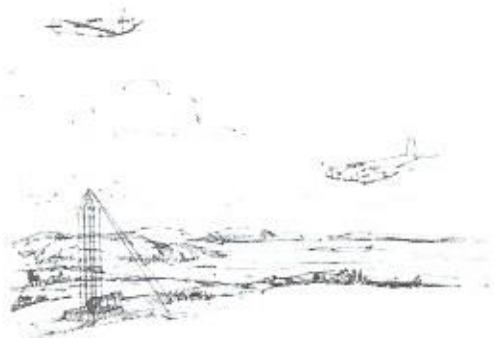
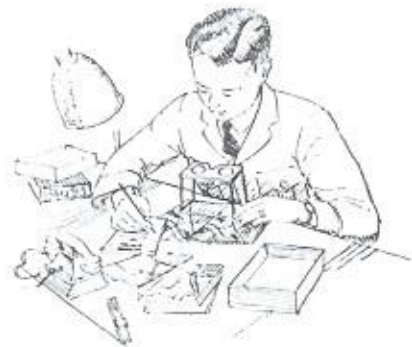
The next few pages are an attempt to describe in some detail a few of the actual results which have been achieved. They show that the subject is a varied one and covers a very wide and considerable field.

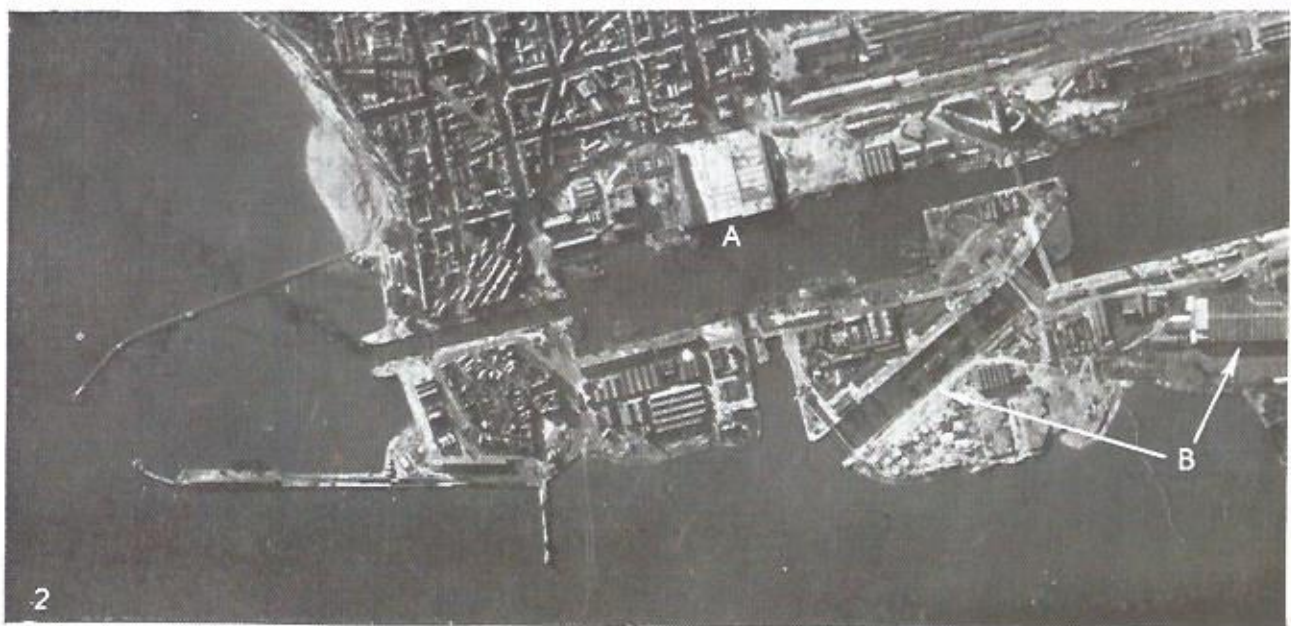
*A print from one of the sorties used for the construction of the model. Compare this with the Admiralty chart in Plate 1.*

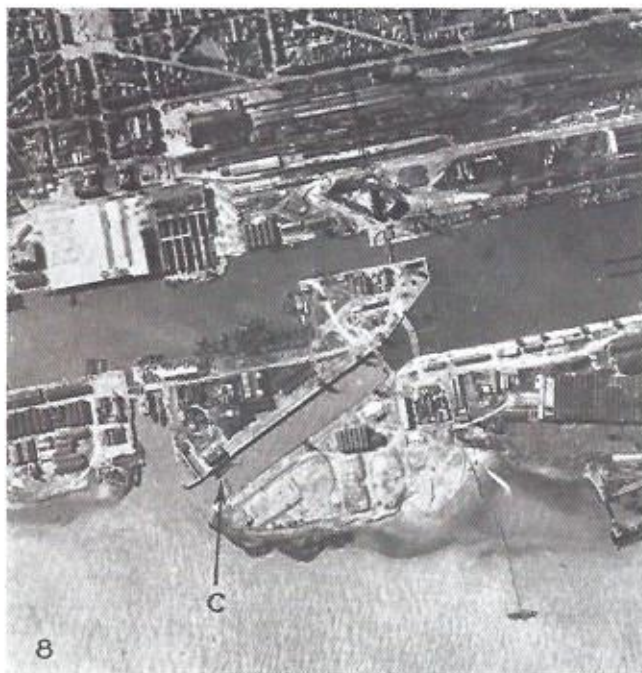
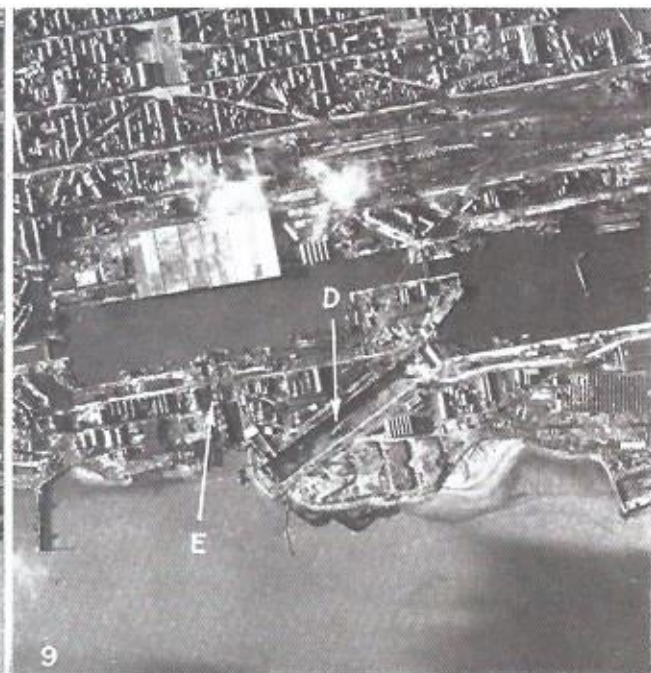
Final assessment from photographs taken after the action.  
Plate 8 : Taken a week after the attack shows the gate destroyed (C) and the lock flooded and unserviceable. The wreck of the 'Campbeltown' was not visible until the lock had been drained.  
Plate 9 : Taken several months later shows the lock drained and dammed up, with the wreck of the 'Campbeltown' (D) and construction of new locks (E).

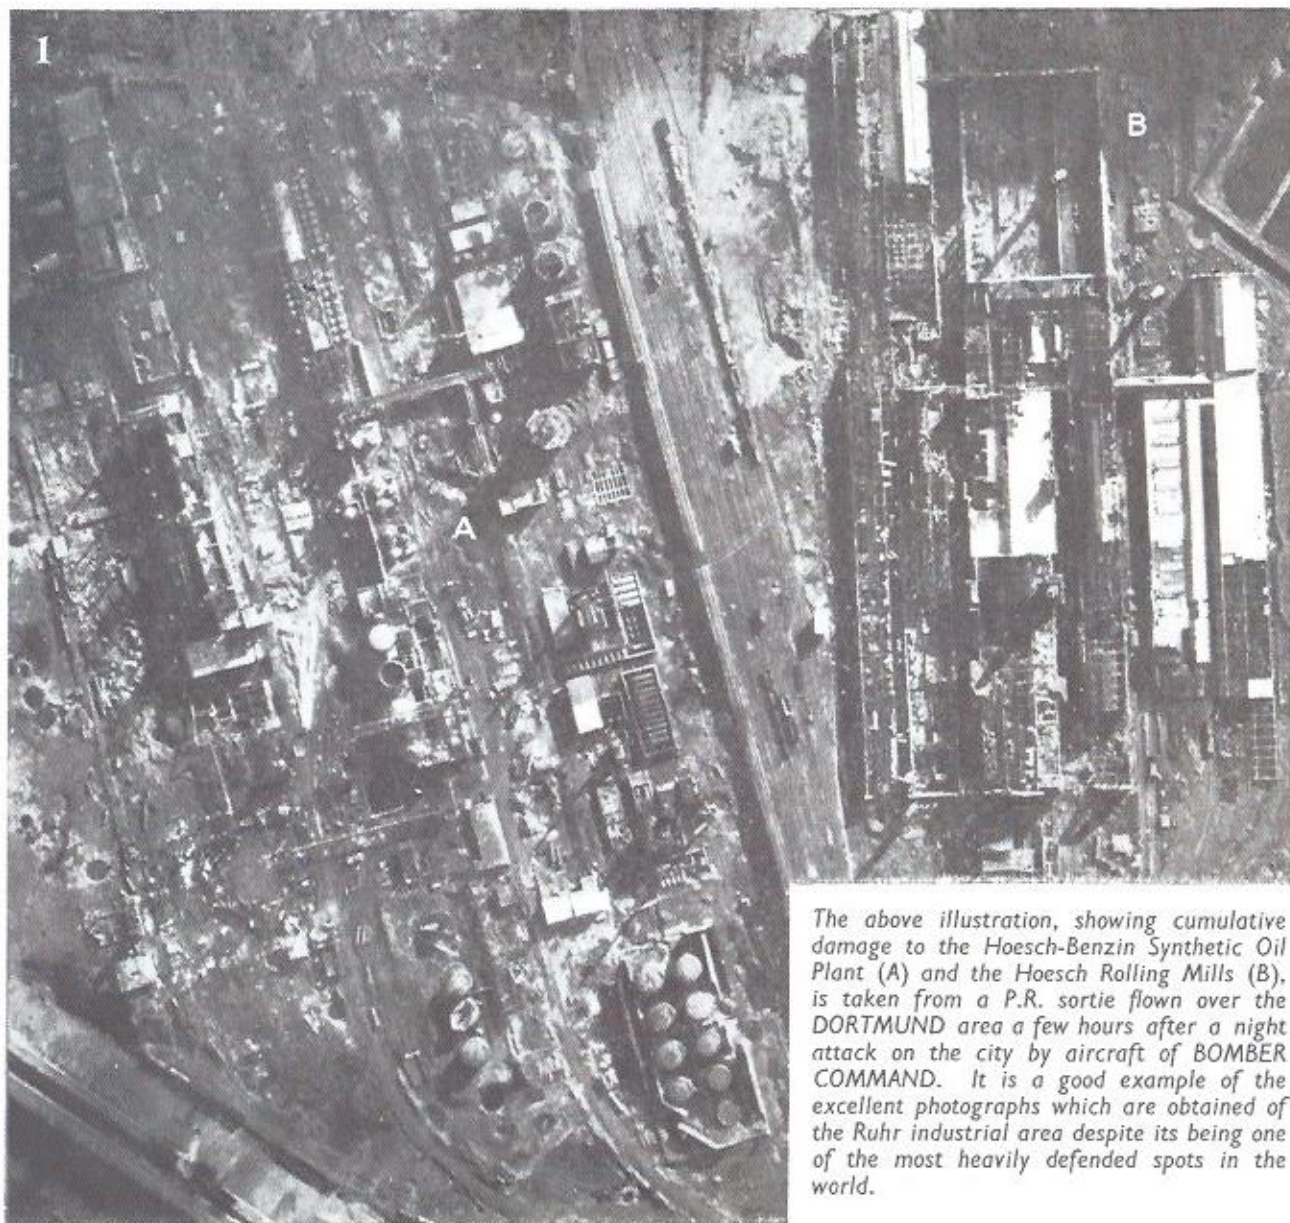
The above illustration, showing cumulative damage to the Hoesch-Benzin Synthetic Oil Plant (A) and the Hoesch Rolling Mills (B), is taken from a P.R. sortie flown over the DORTMUND area a few hours after a night attack on the city by aircraft of BOMBER COMMAND. It is a good example of the excellent photographs which are obtained of the Ruhr industrial area despite its being one of the most heavily defended spots in the world.

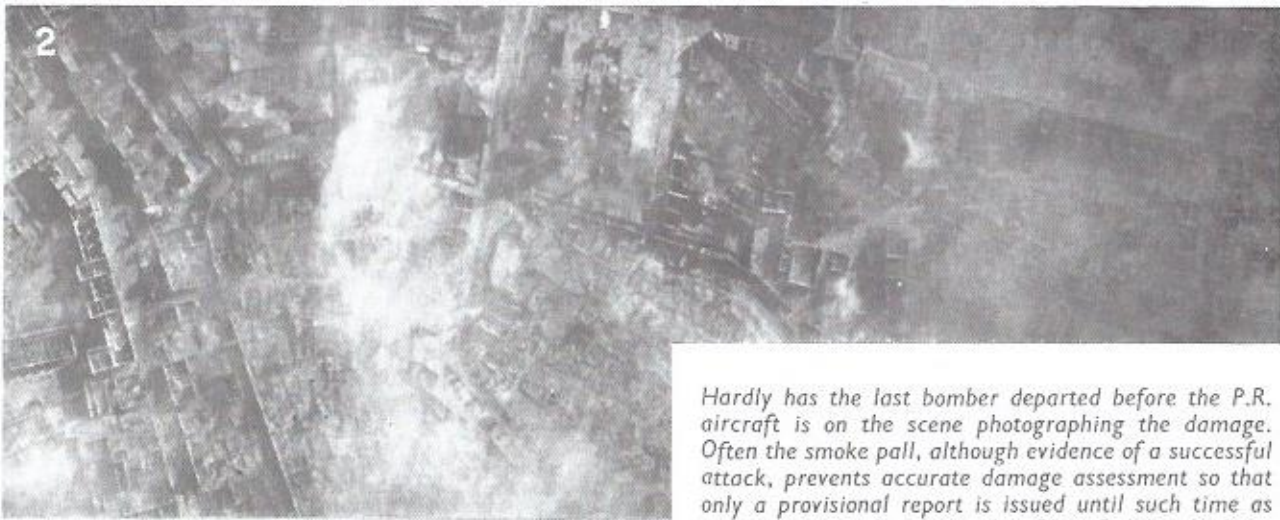
Hardly has the last bomber departed before the P.R. aircraft is on the scene photographing the damage. Often the smoke pall, although evidence of a successful attack, prevents accurate damage assessment so that only a provisional report is issued until such time as good cover can be obtained. Plate 2 (above) shows part of the burning town of Darmstadt after a night attack by BOMBER COMMAND. Plate 3 shows a part of the devastation by fire and H.E. and was taken a week after the assault was delivered on the city.

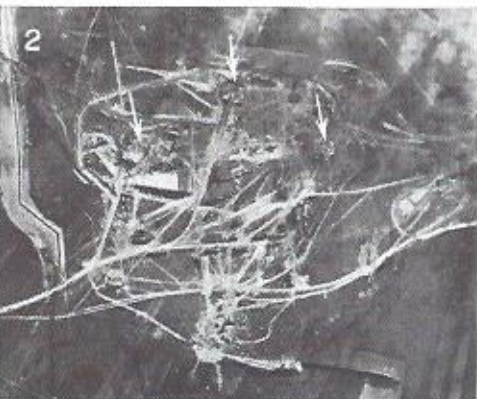
These three photographs cover a period of a year from 9.8.42 (Plate 1), 24.12.42 (Plate 2) to 23.9.43 (Plate 3) and show the early foundations and finally the completed casemates.

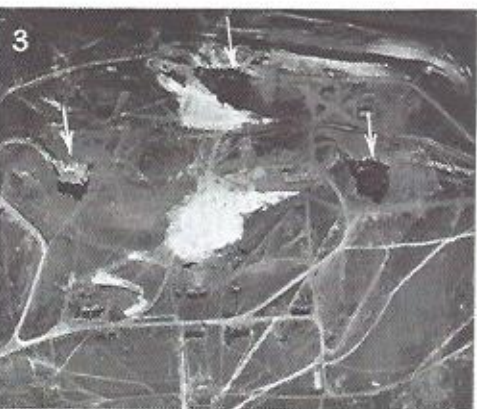
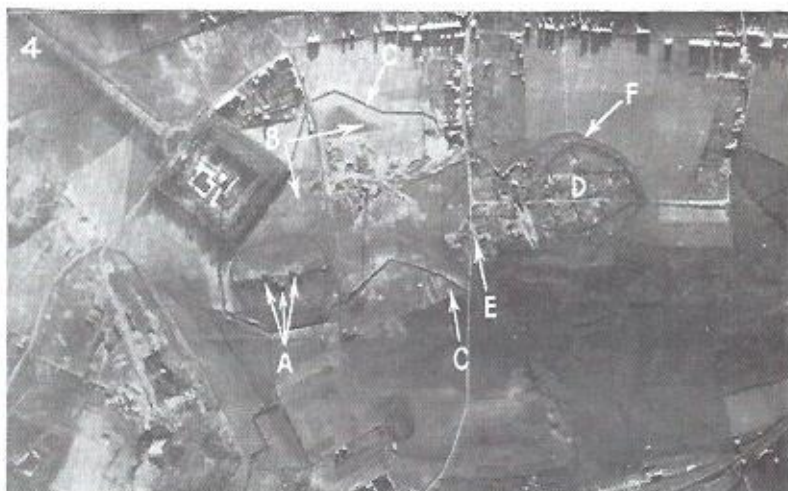
Plate 4 : Elaborate defences in the Boulogne area.

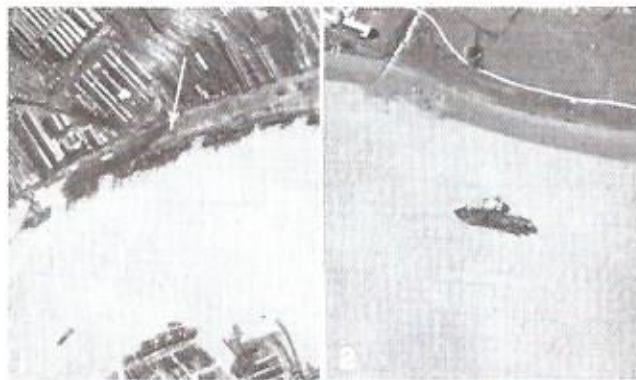
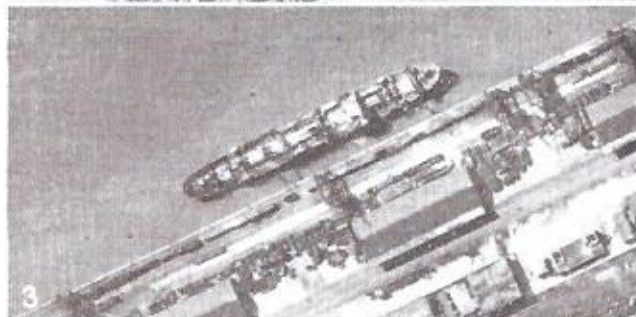
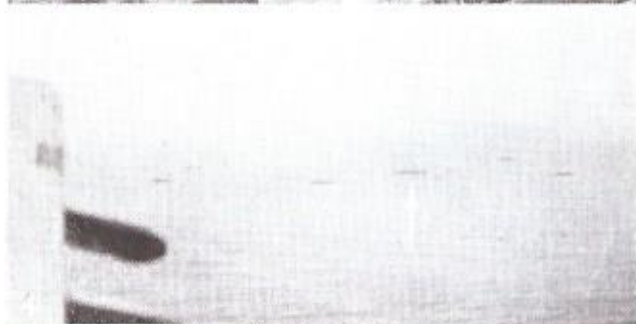
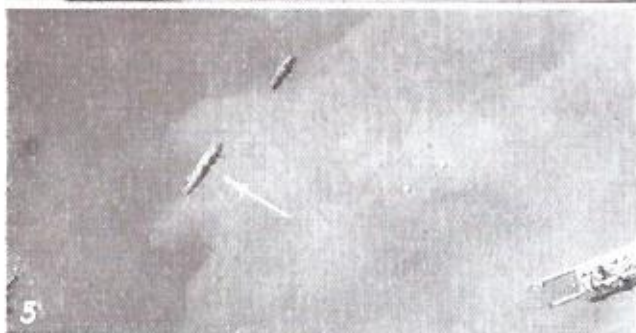
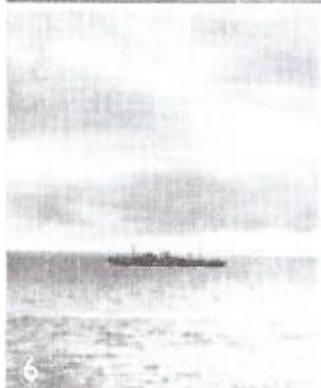
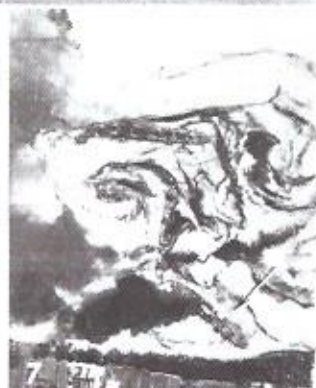
The German **MUNSTERLAND**, a vessel of 6,400 g.r.t. achieved some success on the route to the Far East. *Plate 1* shows her inward bound to Bordeaux during May, 1942. She is seen under attack by an anti U-boat aircraft of the R.A.A.F. operating with Coastal Command. Probably damaged, but able to continue, she reached Bordeaux and berthed at the Customs House Quays where she unloaded (*Plate 2*) and then moved up to the dockyard at Nantes where she underwent extensive refit—and no doubt repair (*Plate 3*). Later she duly moved to dock, using the large floating dock at Pauillac (*Plate 4*, 14.3.43) but she did not go back to the dockyard nor move to the customary loading berth. Instead she remained at Bordeaux for 5 months and then was once more docked. Meanwhile the losses amongst blockade runners on the

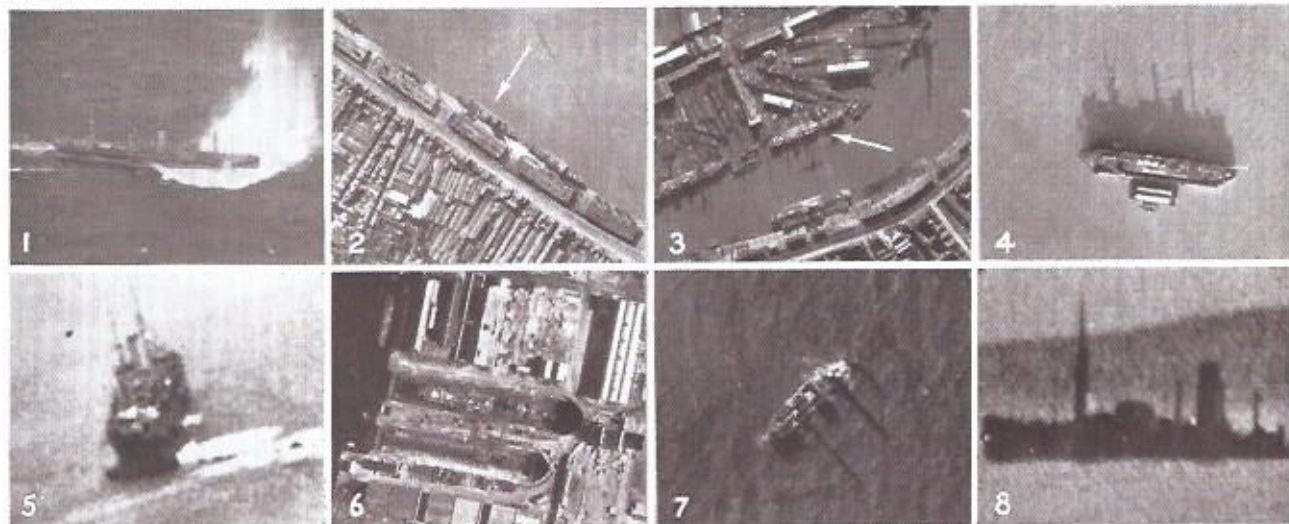
The **ALSTERUFER**, a modern German fruiter of only 2,729 g.r.t., was not regarded as a potential Blockade Runner when she lay inactive at Nantes until early in 1943 (*Plate 1*). When she moved to a dockyard berth in February (*Plate 2*), it was thought that she might be going to be commissioned as a Sperrbrecher, like others of her type and size. Almost immediately, however, she moved to the loading quay at **BORDEAUX** (*Plate 3*, 14.3.43) and suspicions were confirmed when she left the area, during a spell of cloudy weather at the end of March, in company with the **OSORNO** and the **PORTLAND**. The outward journey was successful for **ALSTERUFER** and **OSORNO** but the return to Europe of **ALSTER-**

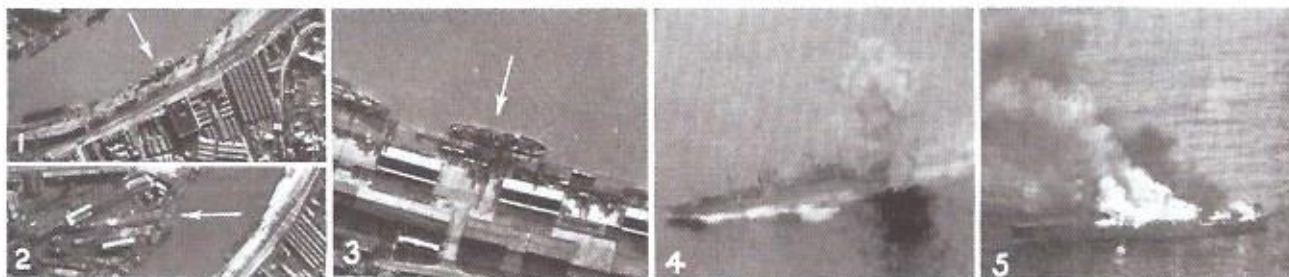
# RESEARCH ON ENEMY WARSHIPS

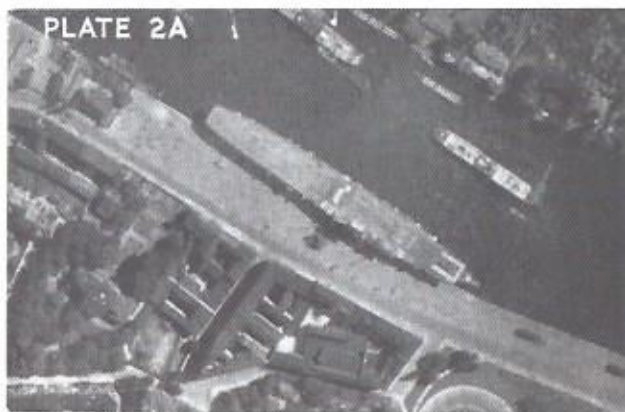
showed that the projected sister ships to the 'Tirpitz' and 'Graf Zeppelin' were not being proceeded with.

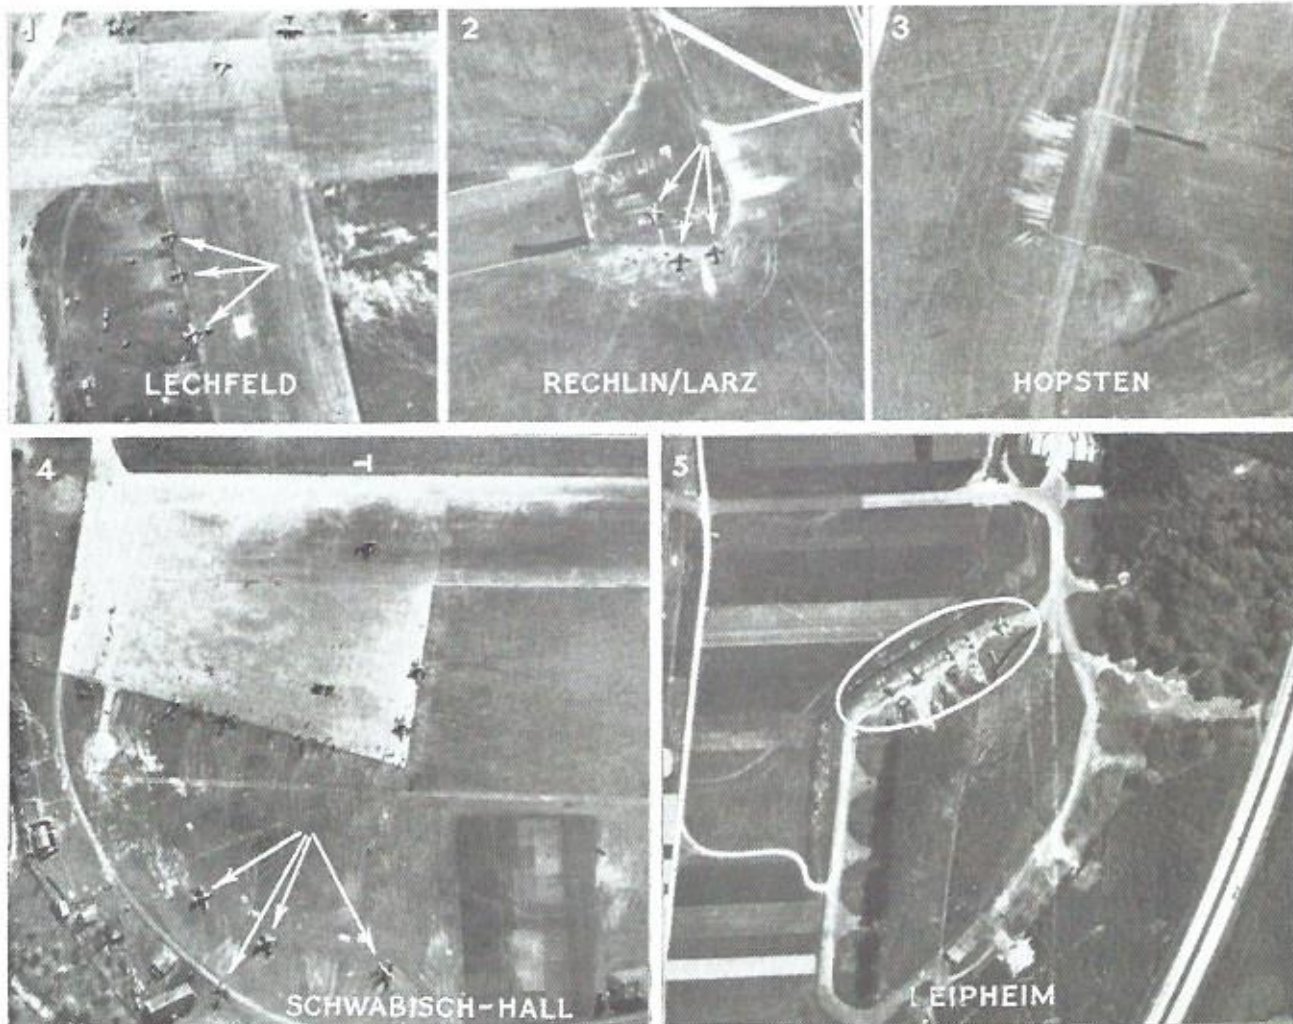
Factory dispersal following ceaseless attacks on the production centres led to the discovery of an improvised Me 262 assembly factory at LEIPHEIM A.F. (Plate 5), and a former shoe factory at WASSERBERG (Plate 6) nearby was found to have converted to Me 262 production. Photographic evidence also went towards confirming that the agricultural implement factory at BAUMENHEIM (Plate 7) had been similarly commandeered. Finally close scrutiny of activity reported in and around the road tunnels at ESCHENLOHE (Plate 8) in the Bavarian Alps revealed that Me 262 production had been eventually driven underground.

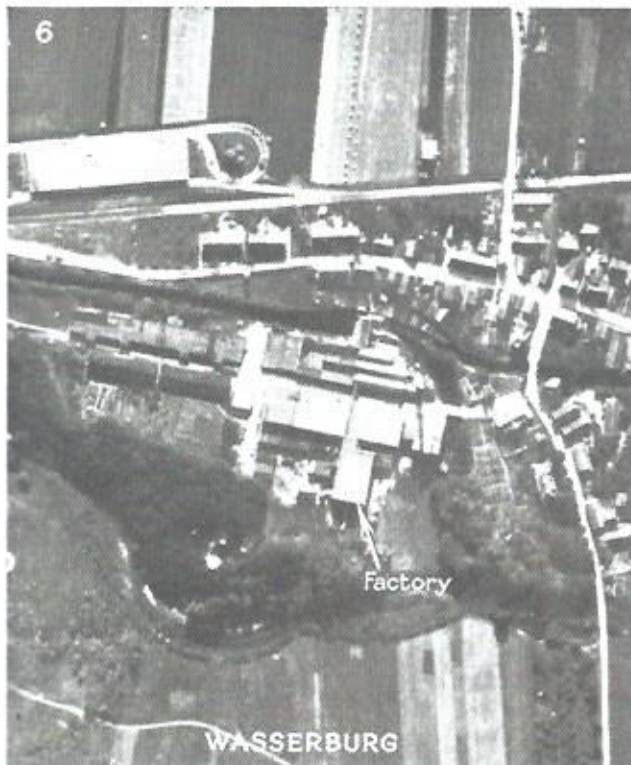
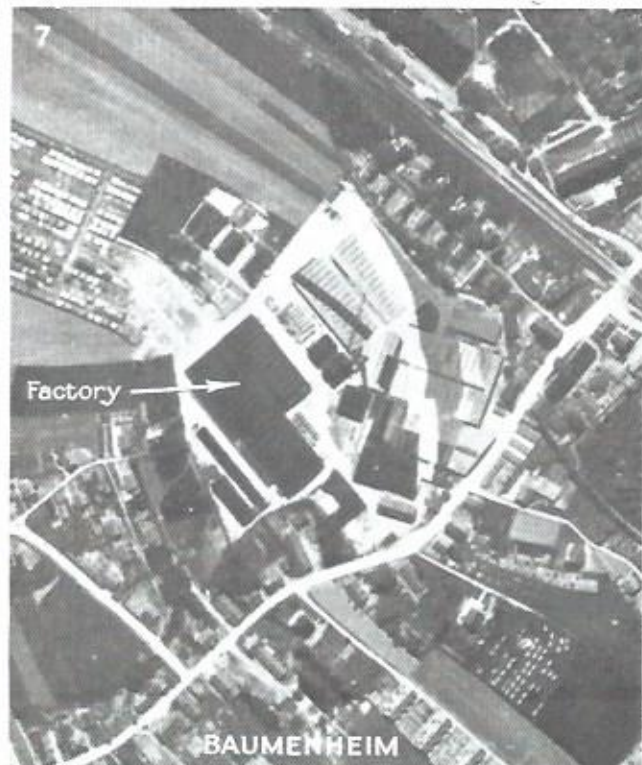
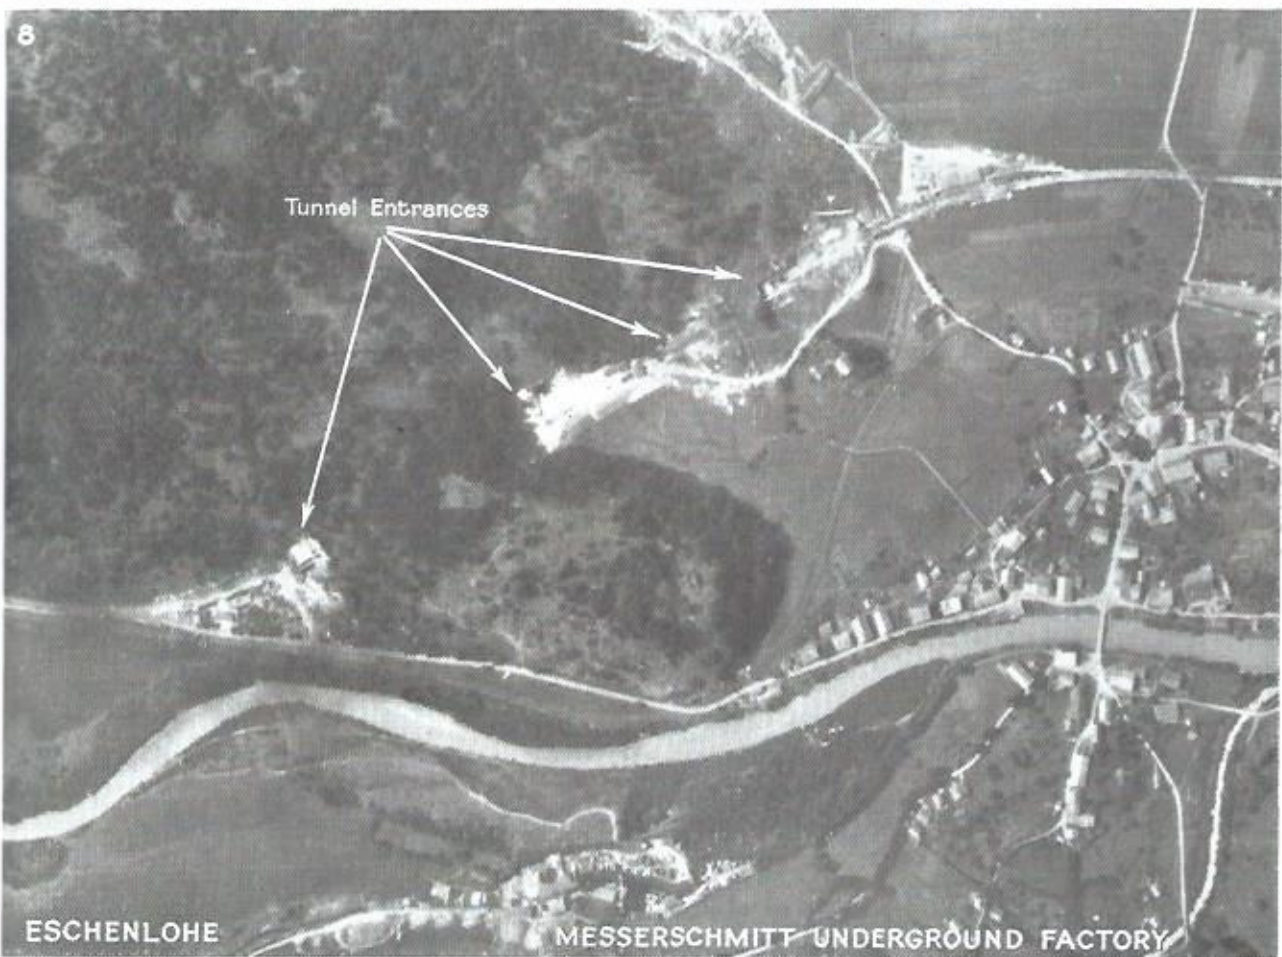
## WATCHING THE AIRFIELDS

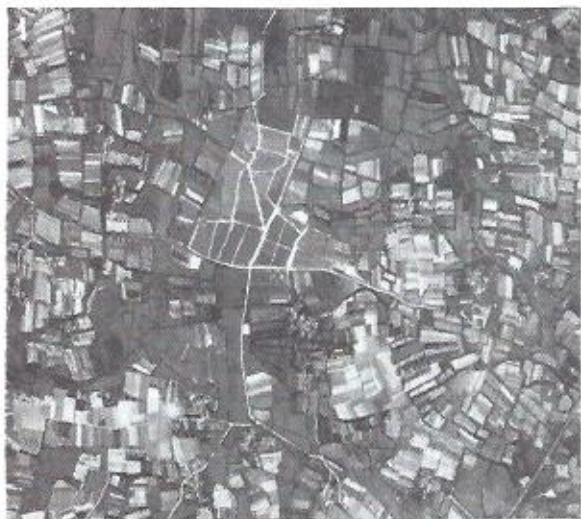
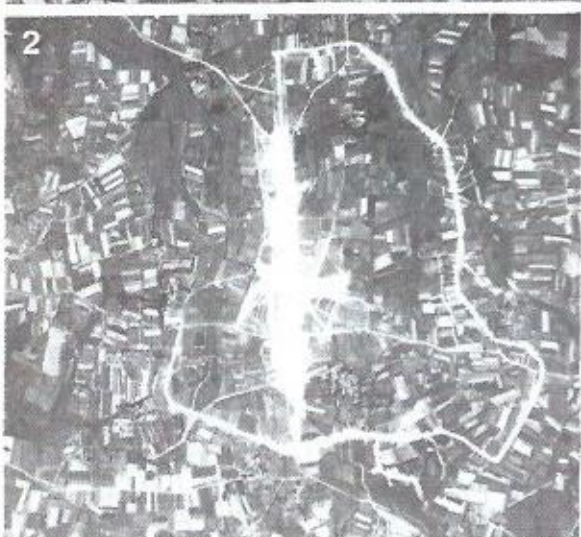
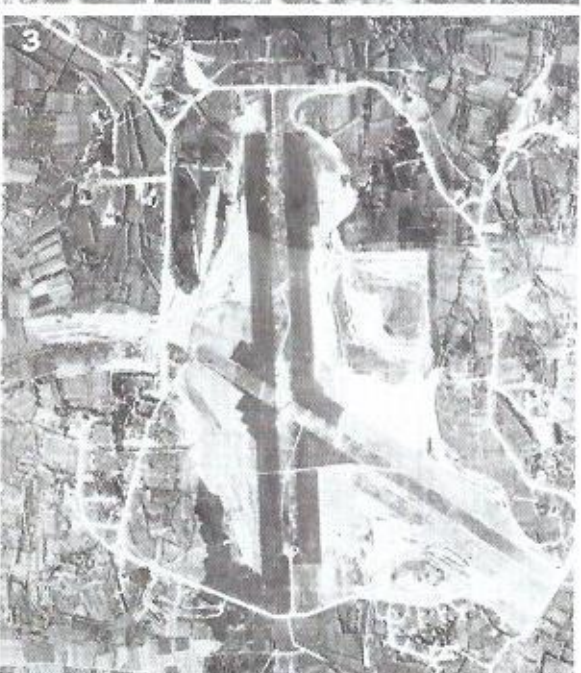
Sure sign that the saturation bombing of airfields was destroying far too many aircraft on the ground was vividly illustrated in 1943 by the photographic cover of numerous new dispersal areas covering extensive stretches of the surrounding countryside. Such photographic evidence is obviously, invaluable for briefing low flying 'strikes'. *Plate 7* shows the elaborate and extensive spread of taxi tracks (*arrows*) for aircraft dispersal away from the airfield (A) at Montelimar.

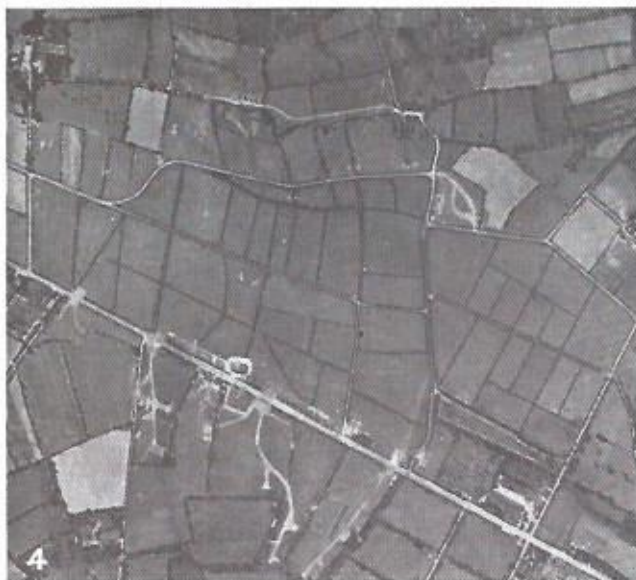
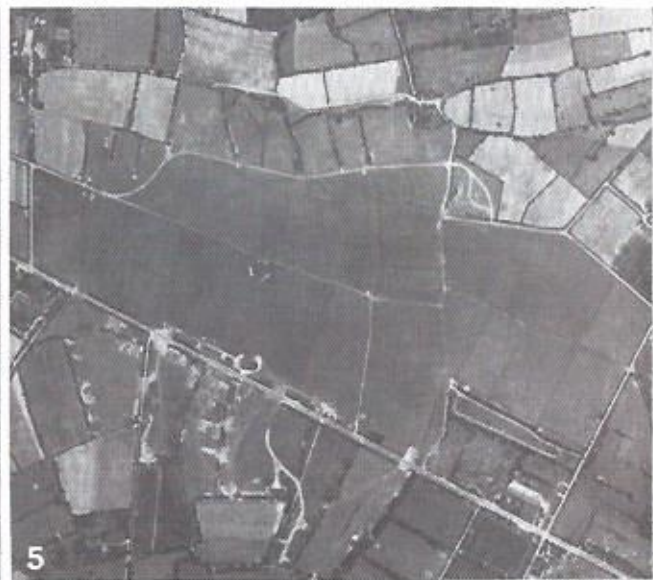
Plate 4 : The landing ground at Laval with a painted pattern of fields, hedges and bushes to merge in with the surrounding features. Compare this with a photograph taken a year later (Plate 5), the camouflage has worn off and the landing ground is clearly visible.

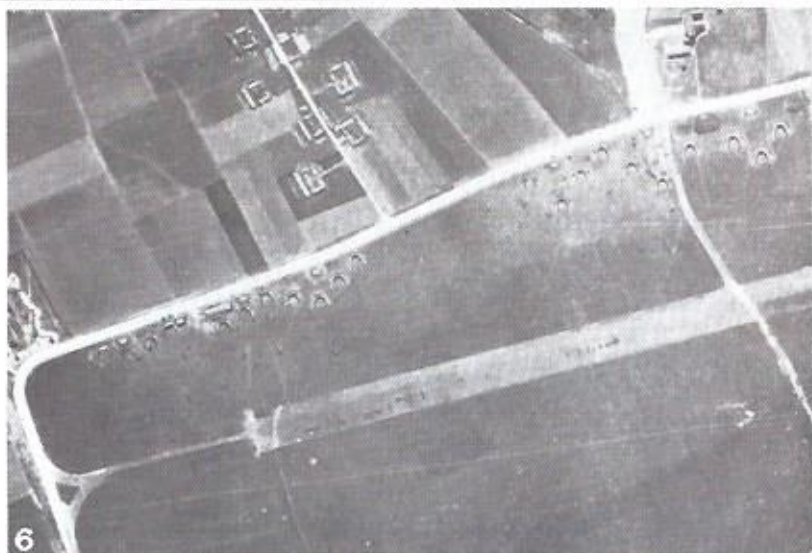
Plate 7 : Widespread dispersal (arrows) at Montelimar airfield (A), also a result of the ever increasing Allied bombing offensive and destruction of aircraft on airfields.
