Special Edition on Photographic Reconnaissance and Photographic Intelligence - March 1945

ISSUED BY AIR MINISTRY A.C.A.S.(I)

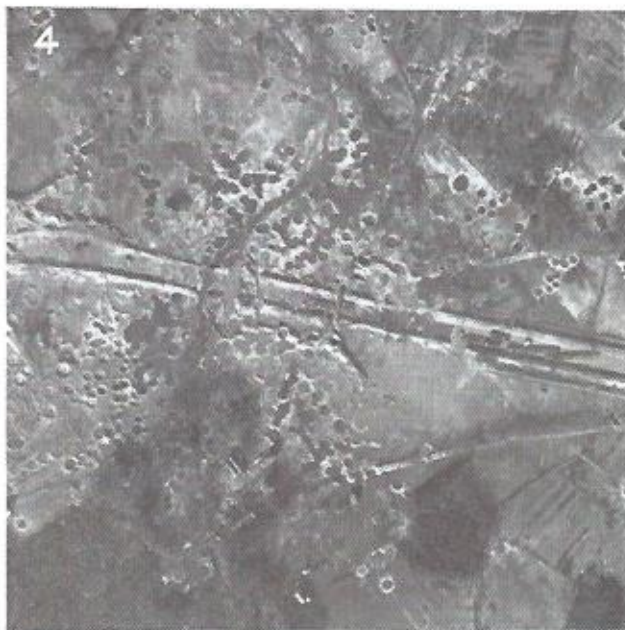
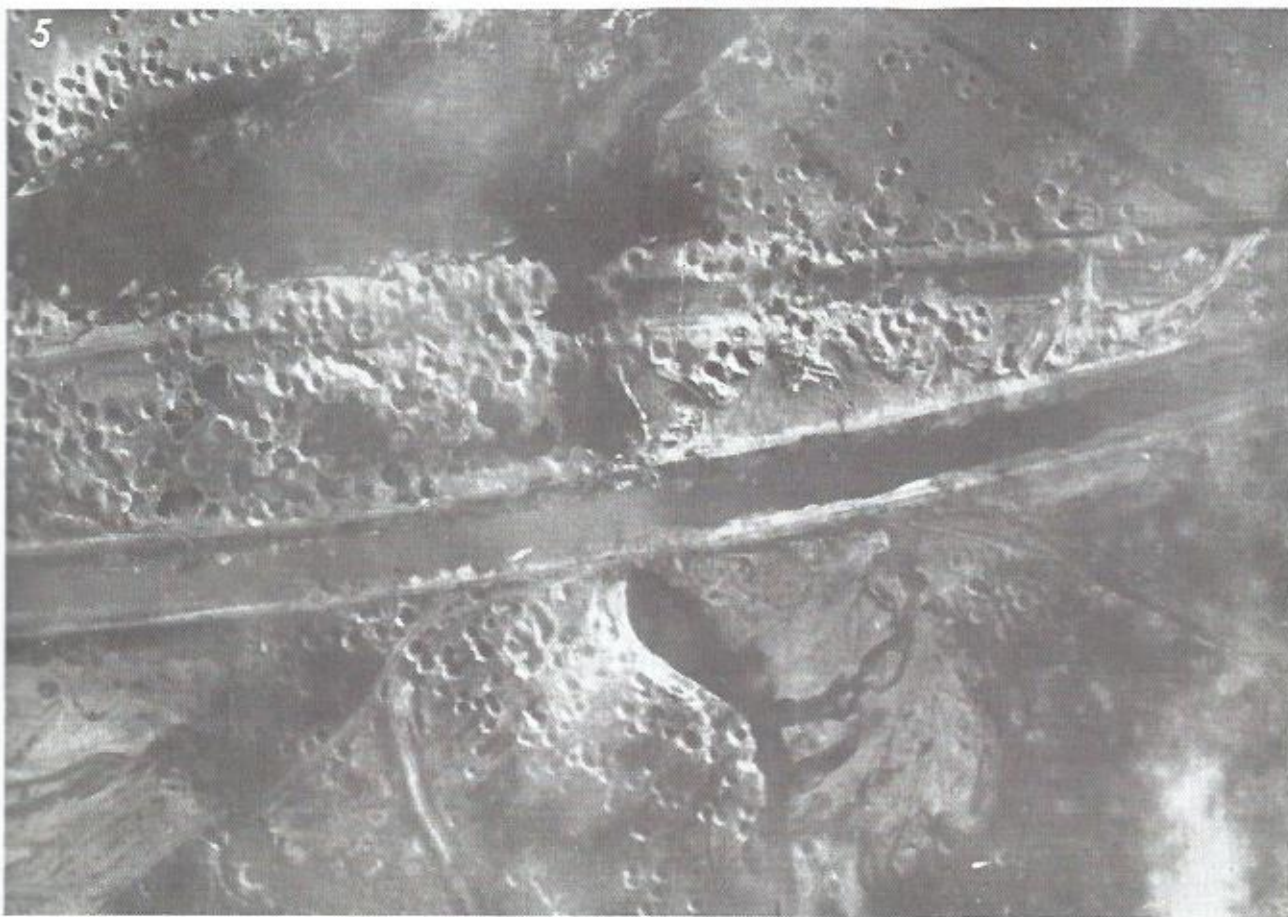
*Plate 4 : The embanked stretch of the Mittelland canal near Gravenhorst was chosen as a vulnerable point and has been successfully attacked. Reconstruction work is shown in progress following the last raid.*
