Homeowner’s Guide

The Life Cycle of Your Roof

What to Expect From Your CertainTeed Roof

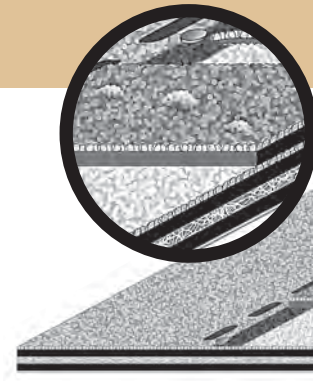
Blisters: During the course of natural weathering, small bubble-like raised areas known as blisters may appear on the surface of the shingles. The blisters may be small and pea-sized or as large as a quarter. The blisters may be open, exposing the asphalt, or closed. Blisters frequently result when minimum ventilation requirements are not met.

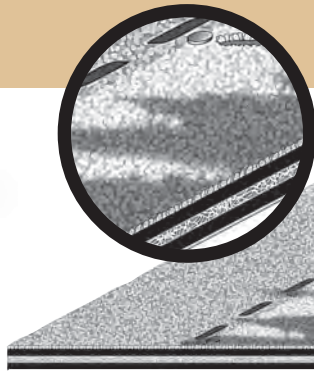
Algae Stains

Staining: Finally, over a period of time, shingles may develop dark brown or black streaks that are sometimes mistaken for soot, dirt, moss or tree droppings. In actuality, this discoloration may be caused by algae growth. Although most roofing systems are susceptible to algae discoloration, it is most readily visible on white or light-colored shingles.

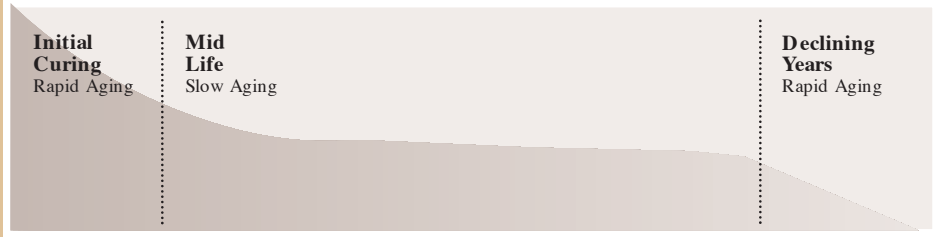
The Life Cycle of a Roofing Shingle

When your new roof was installed, friends and neighbors may have remarked how it enhanced the beauty of your home. However, research indicates that aging begins soon after the shingles are installed and progresses rapidly during the initial curing phase of its life cycle. During this stage, granule loss may occur, small blisters may develop, or the shingles may curl slightly at their edges. You may even notice that this curling is more pronounced during cold weather and the shingles may lie flat as temperatures rise. The good news, however, is that after this curing stage the shingles enter a long period of slow aging, which lasts for the major portion of the shingle’s natural life.

During the “mid-life” period, aging continues at a much slower rate. The cracking or granule loss still occurs but does not increase at a noticeable rate. Only after this long period of mid-life does the aging process begin to accelerate once again as the shingles enter their declining years. It’s during this period that homeowners normally think about replacing their roofs.
