# Rehydration supports floodplain restoration:

| production and biodiversity working together on Boodgheree Station, Thargomindah Queensland

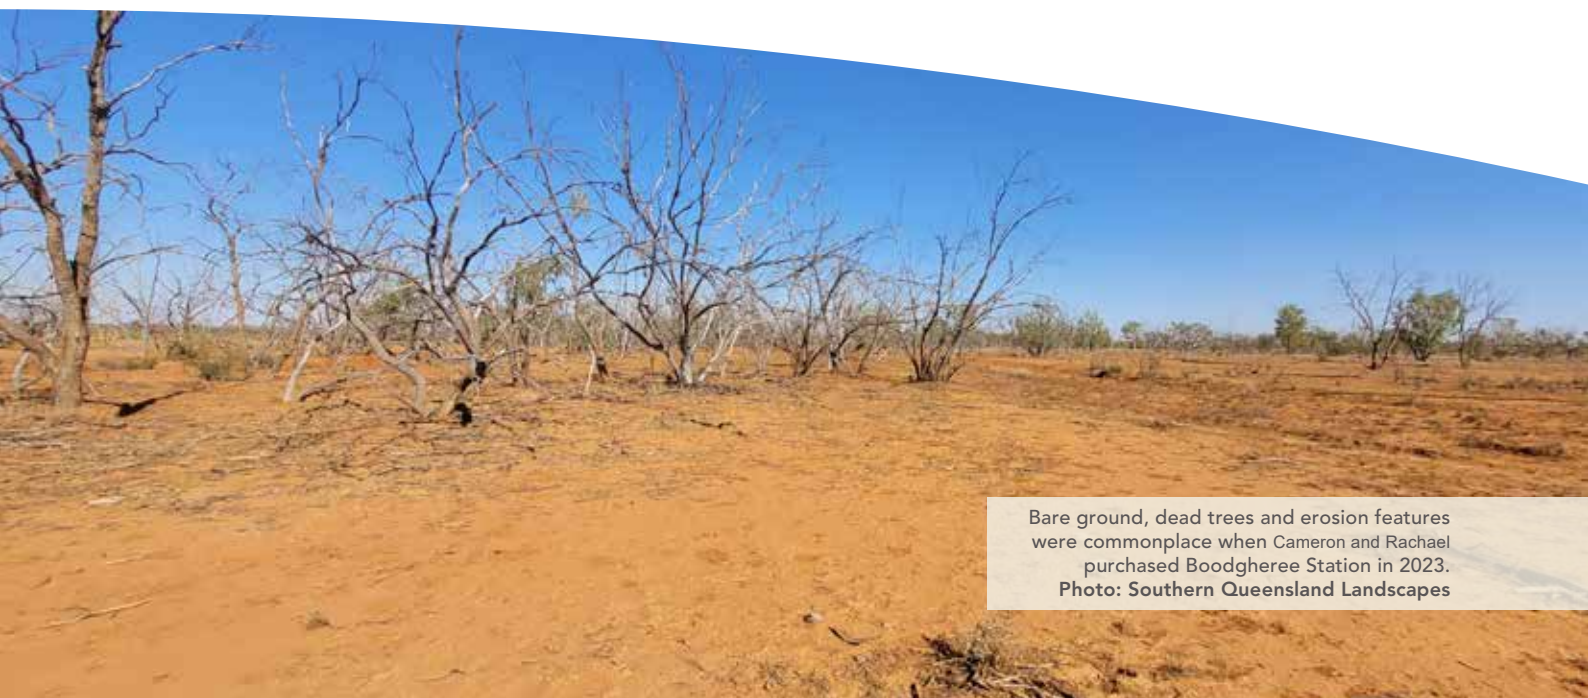
Bare ground, dead trees and erosion features were commonplace when Cameron and Rachael purchased Boodgheree Station in 2023.  
Photo: Southern Queensland Landscapes

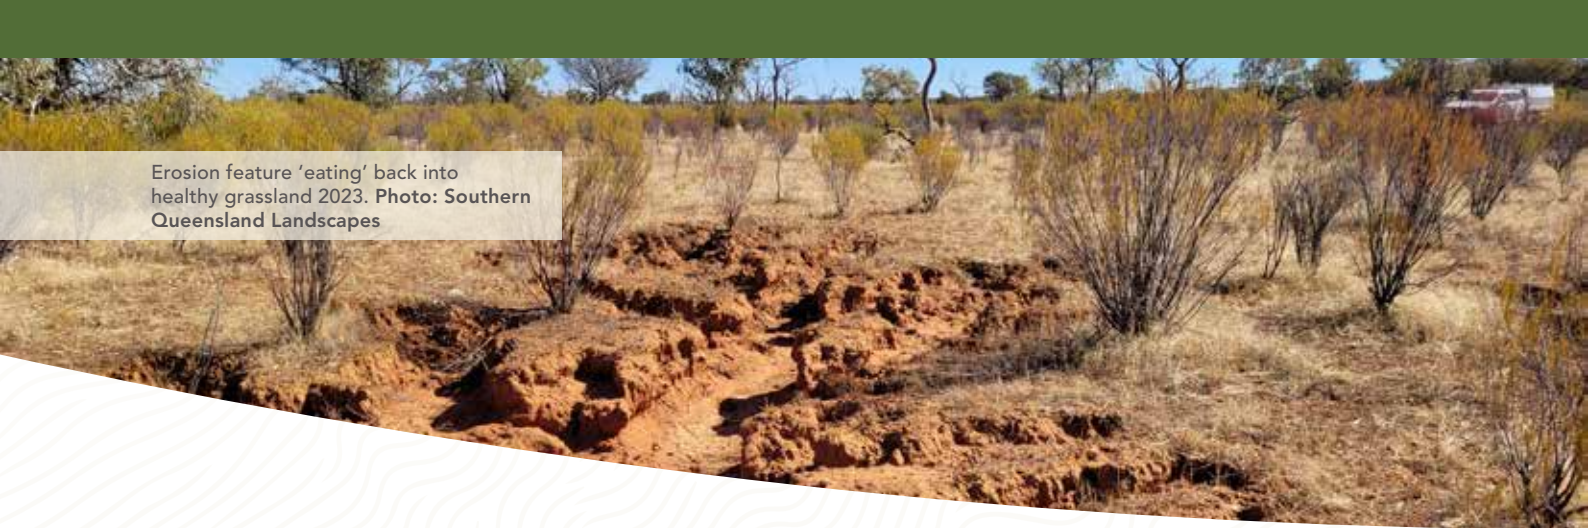
Erosion feature 'eating' back into healthy grassland 2023. Photo: Southern Queensland Landscapes

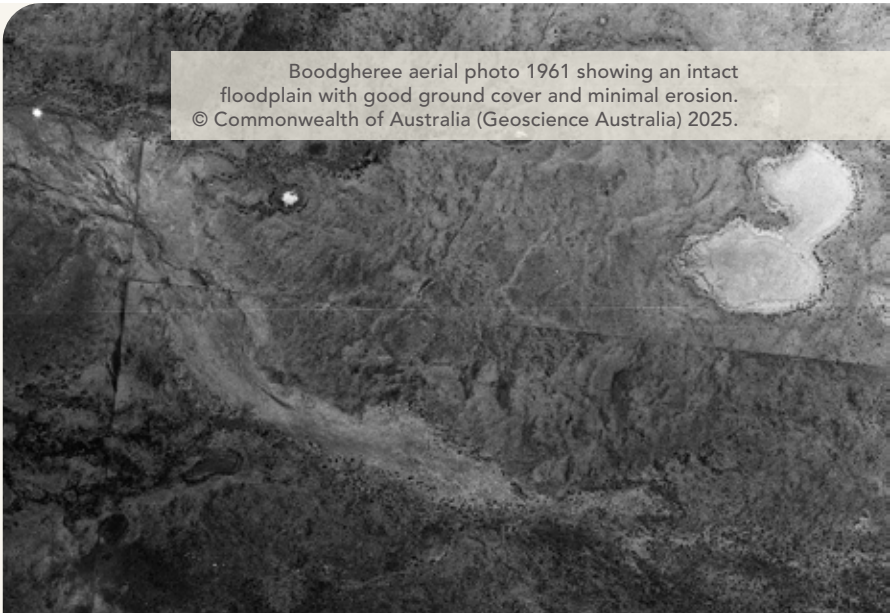
An aerial photograph taken during the drought of 1961, shows a relatively intact floodplain on Bodgheree (bottom half of the image) with good vegetative cover and little evidence of bare soil or erosion. In the top left corner of the image, the first signs of surface scalding and erosion are evident in higher reaches of the floodplain.

Boodgheree aerial photo 1961 showing an intact floodplain with good ground cover and minimal erosion. © Commonwealth of Australia (Geoscience Australia) 2025.

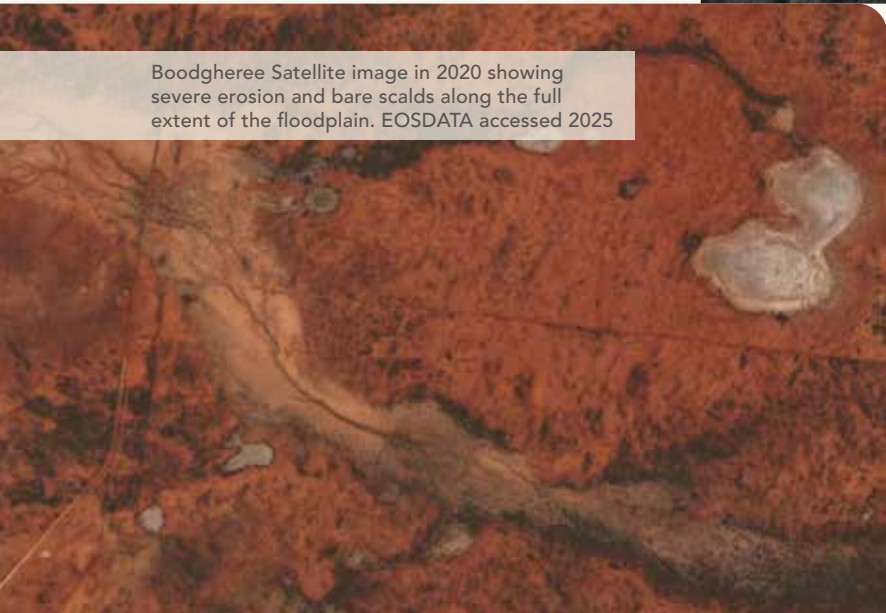
Boodgheree Satellite image in 2020 showing severe erosion and bare scalds along the full extent of the floodplain. EOSDATA accessed 2025

By the end of the extended drought in 2020, a satellite image shows large areas of scalded, bare ground and a clearly visible erosion feature draining the Bodgheree floodplain for almost its entire length.

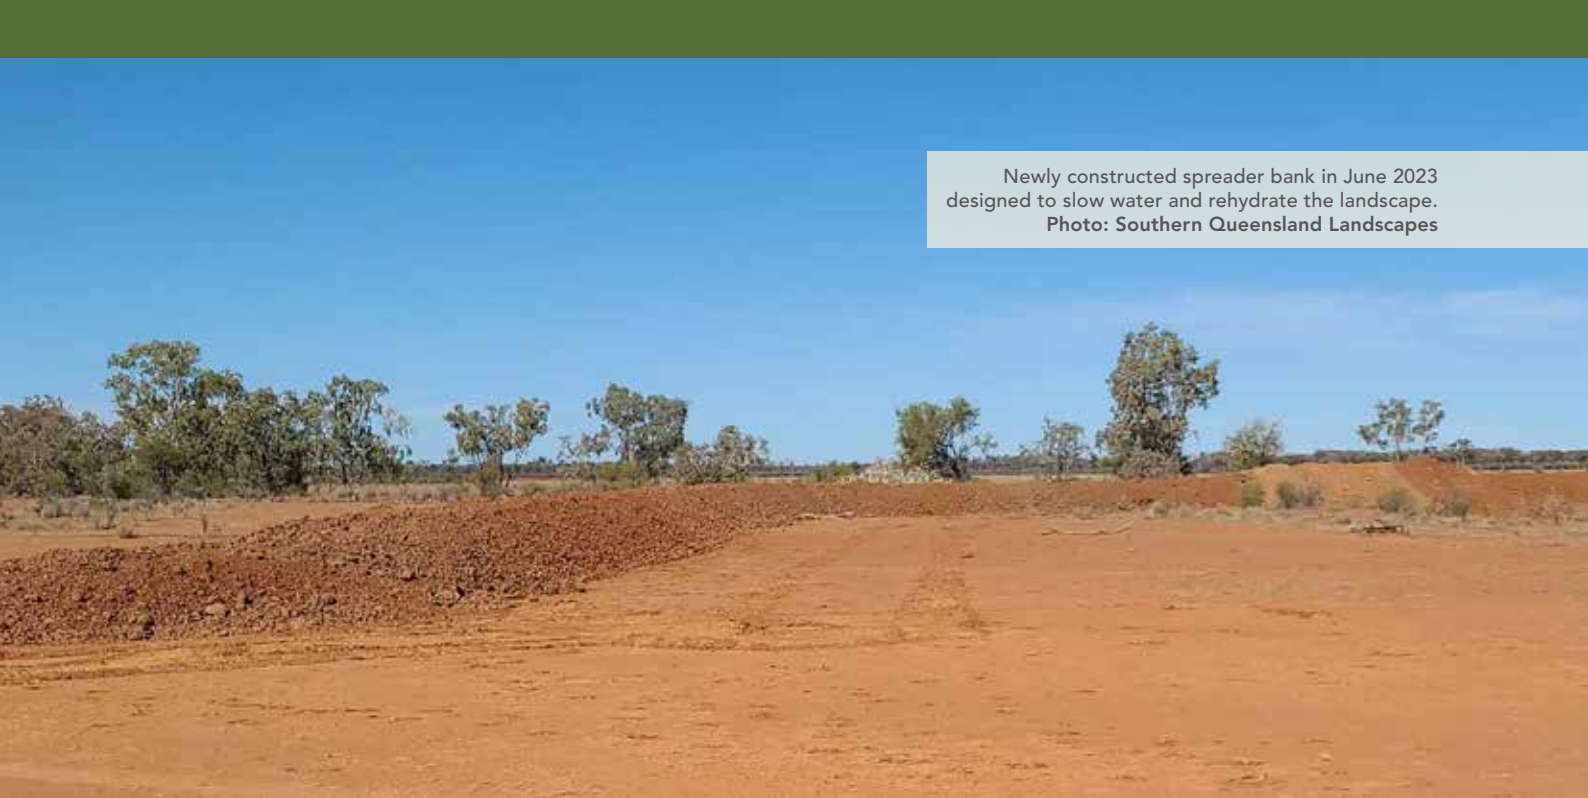
Newly constructed spreader bank in June 2023 designed to slow water and rehydrate the landscape.  
Photo: Southern Queensland Landscapes

Using a laser level to determine landscape rise and fall, and coordinating with the machine operator, Glenn marked out a series of strategic works to begin the process of restoring the landscape. The first step to addressing erosion was to 'put the plug back in' and start rehydrating the landscape. Using a combination of earth, rock, and timber bank constructions, perpendicular to the water flow, high velocity runoff was slowed, allowing the water to bank up and spread across the floodplain. In some situations water was directed into safe areas of vegetation, slowing it down, dropping sediment and healing erosion features before continuing down the flat. Every effort was made to avoid disturbing the fragile soil surface to minimise losses to wind and water.

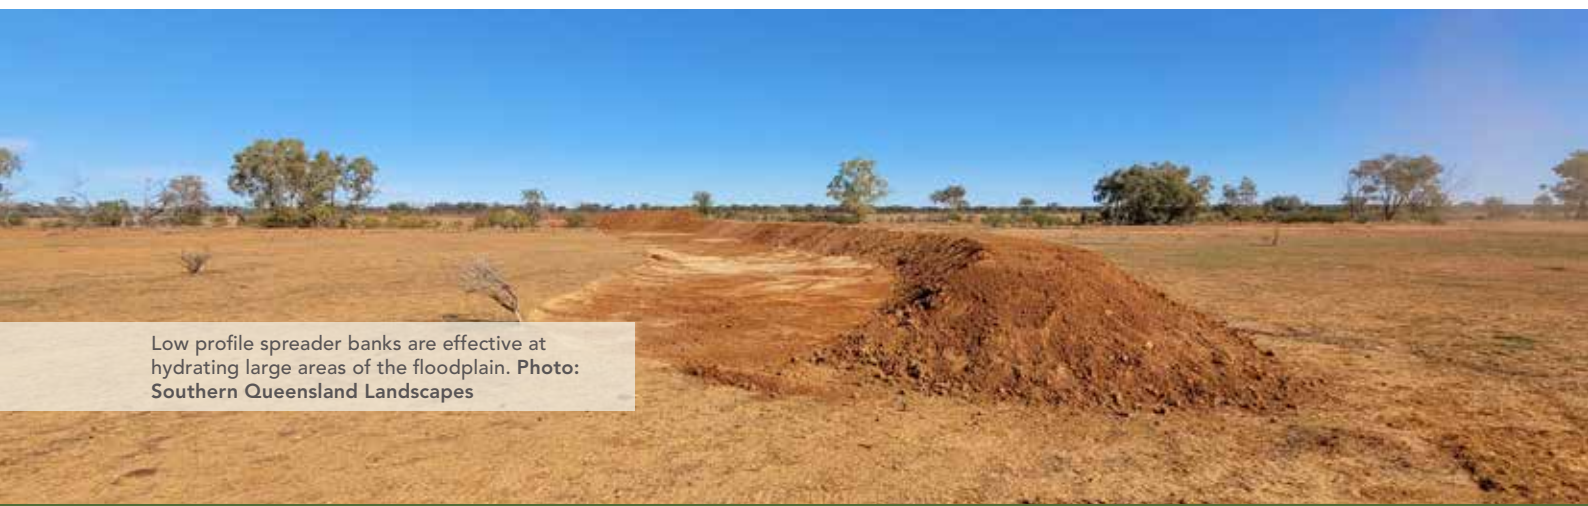
Low profile spreader banks are effective at hydrating large areas of the floodplain. Photo: Southern Queensland Landscapes

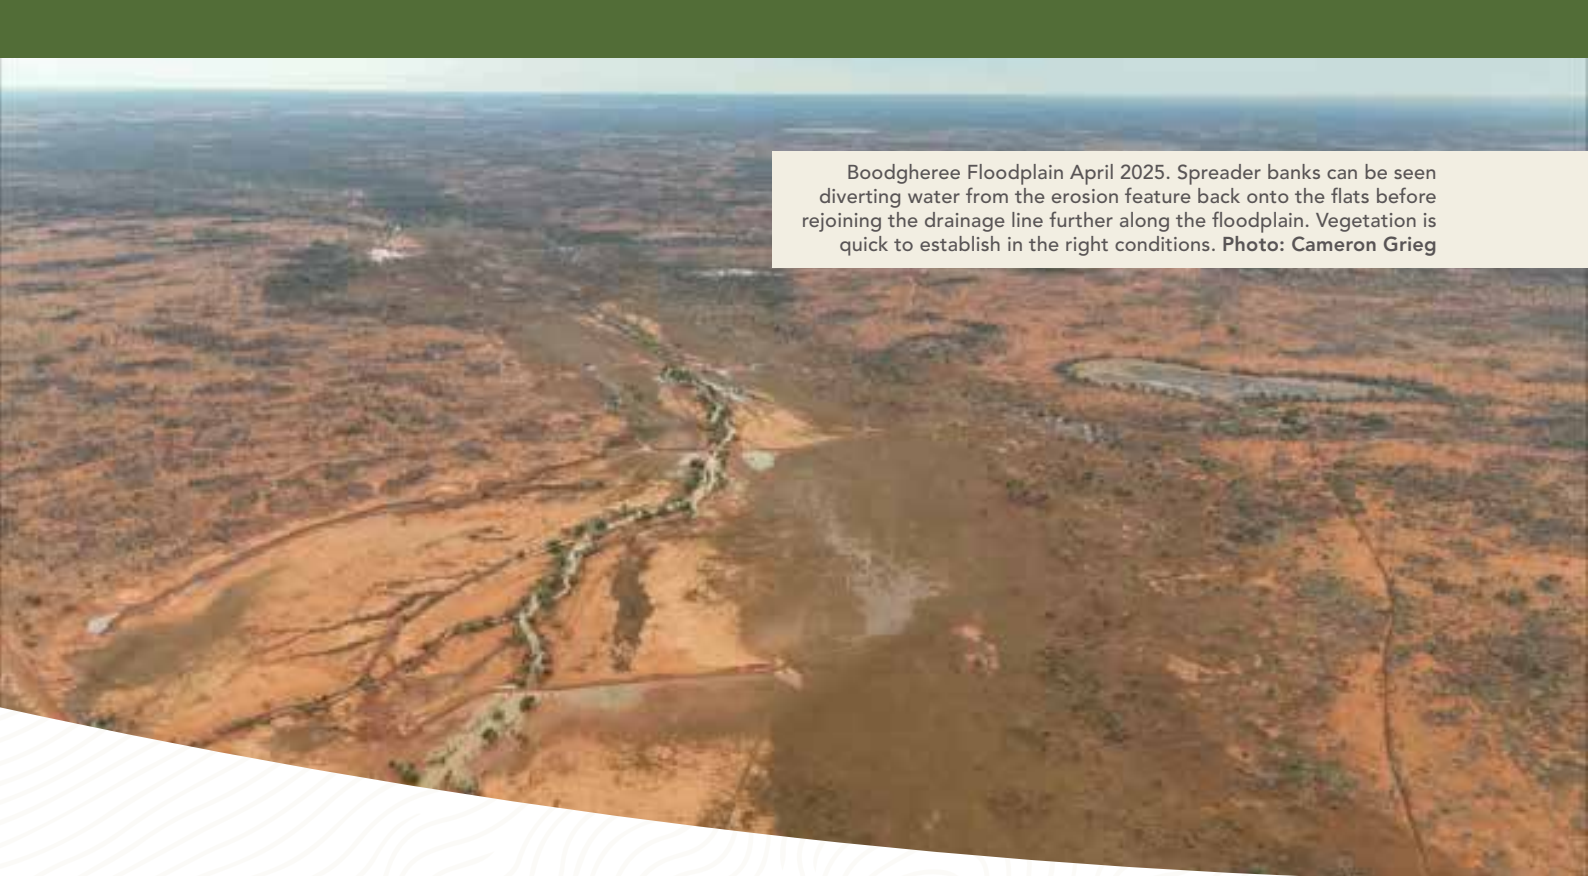
Boodgheree Floodplain April 2025. Spreader banks can be seen diverting water from the erosion feature back onto the flats before rejoining the drainage line further along the floodplain. Vegetation is quick to establish in the right conditions. Photo: Cameron Grieg

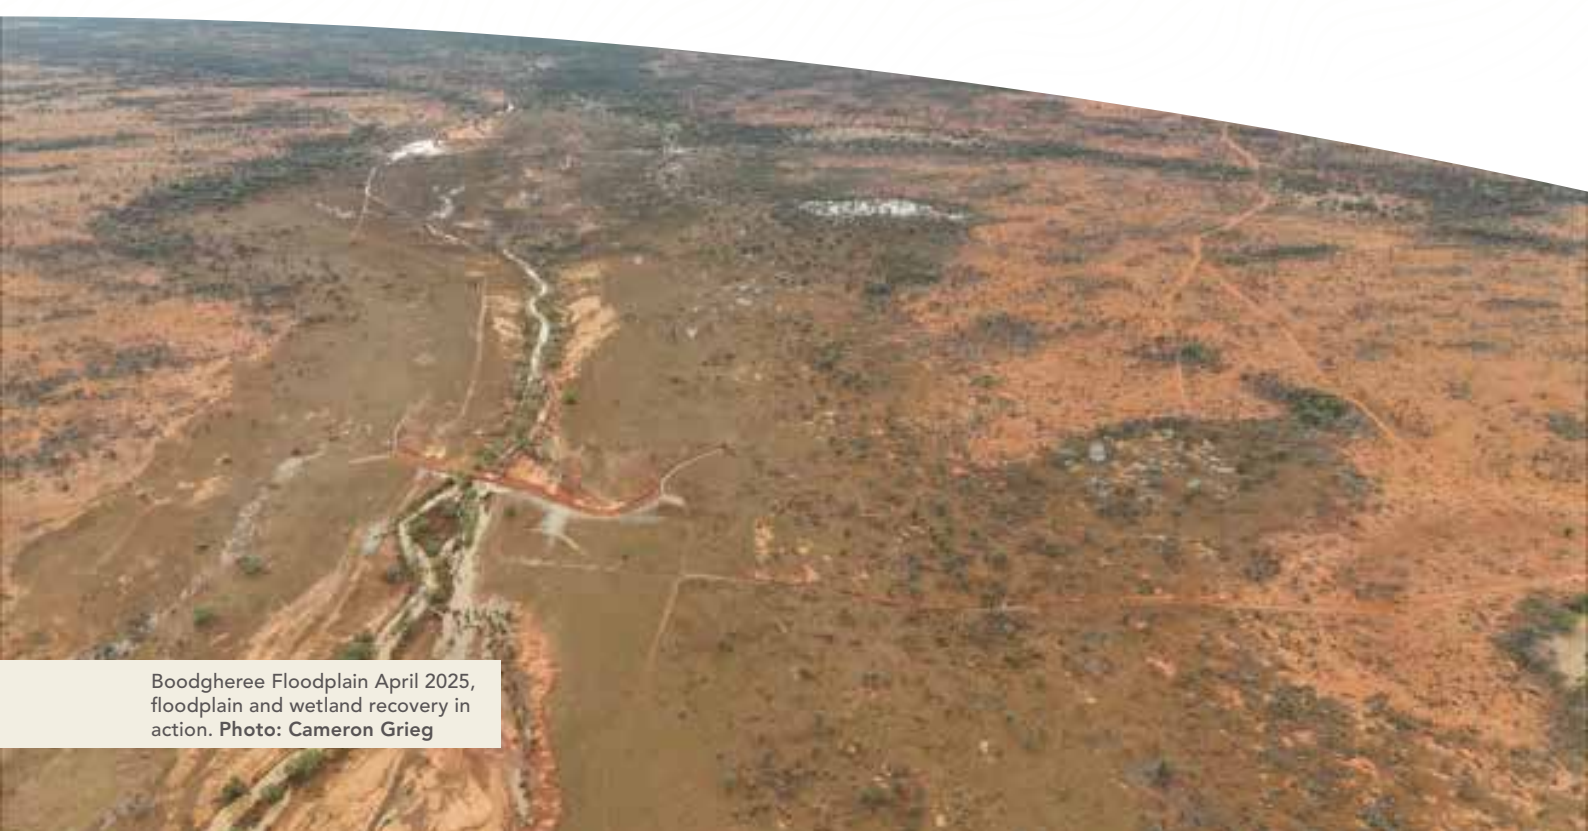
Boodgheree Floodplain April 2025, floodplain and wetland recovery in action. Photo: Cameron Grieg

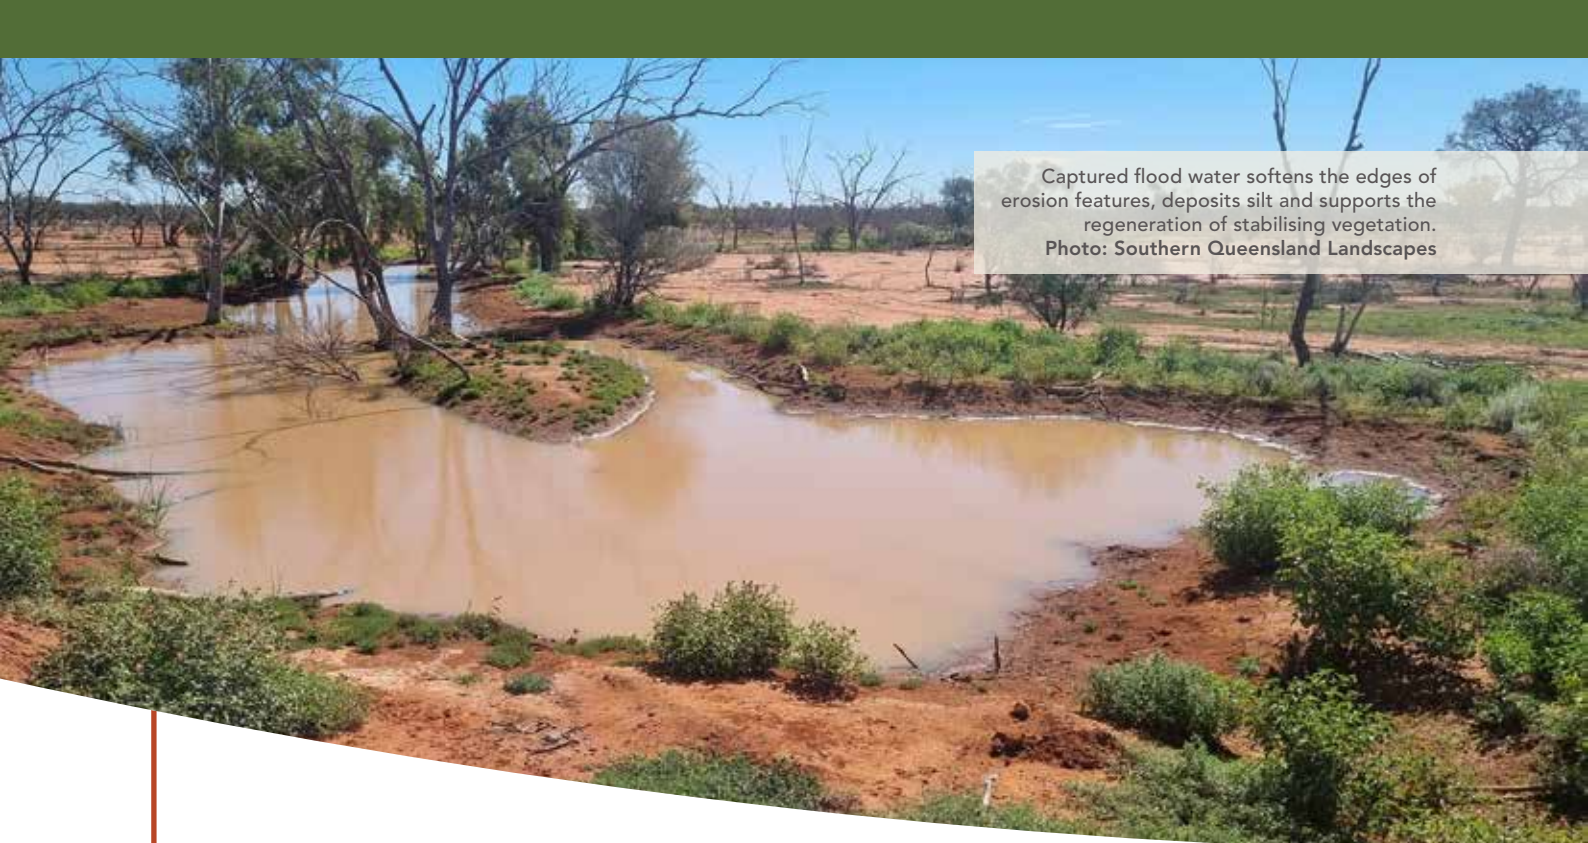
Captured flood water softens the edges of erosion features, deposits silt and supports the regeneration of stabilising vegetation.  
Photo: Southern Queensland Landscapes

George, Rachael and Cameron acknowledge that the timing of the 2025 flooding event in Western Queensland could not have been better for testing the effectiveness of the restoration work on Boodgheree. But they also agree that without their commitment to landscape renewal, the flood event could have been catastrophic. The timely implementation of carefully designed interventions meant water was slowed, limiting further erosion and areas that had been bare for so long, rehydrated and started to revegetate. Ponds retained water for longer, raising soil moisture levels, allowing trees to refresh and pastures to reestablish. The edges of erosion features, softened by captured water, supported the succession of stabilising vegetation.

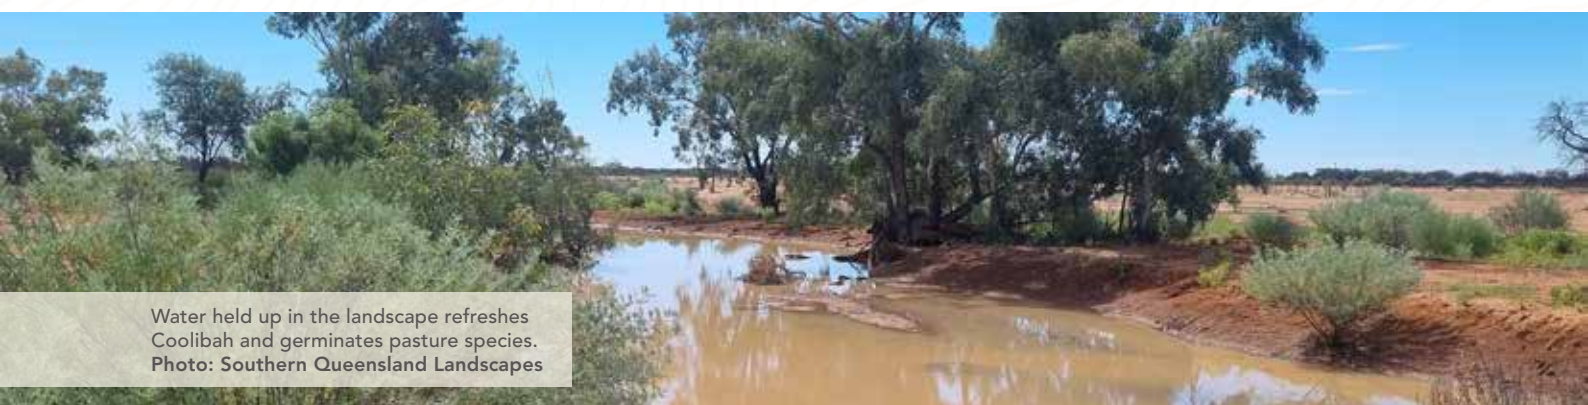
Water held up in the landscape refreshes Coolibah and germinates pasture species.  
Photo: Southern Queensland Landscapes
