## Story from Aileron Station on Practice Change

## Since the Practice Change Workshop

Practice Change Workshop – demonstration site - then versus now

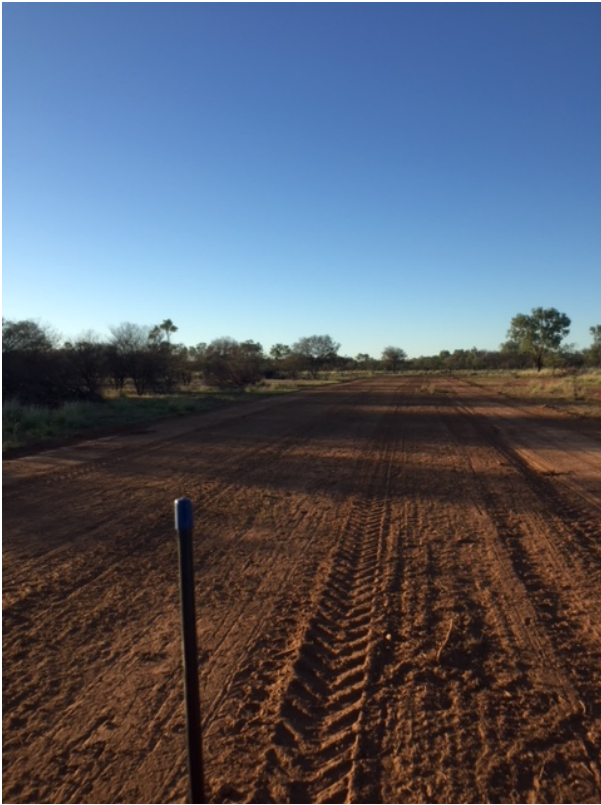
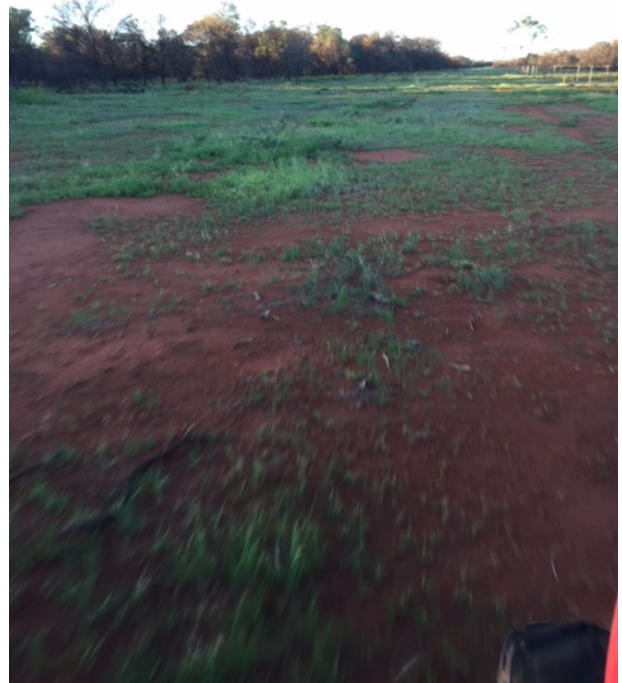
Fence lines and roads are now graded flat; we try to avoid creating rills or moving too much top soil.

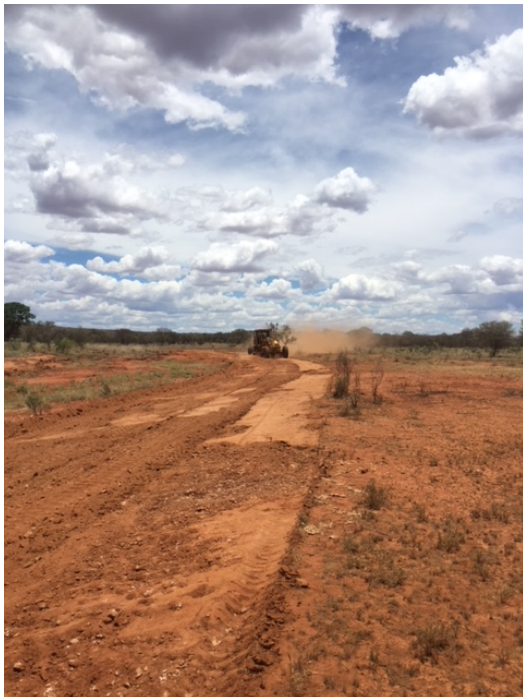
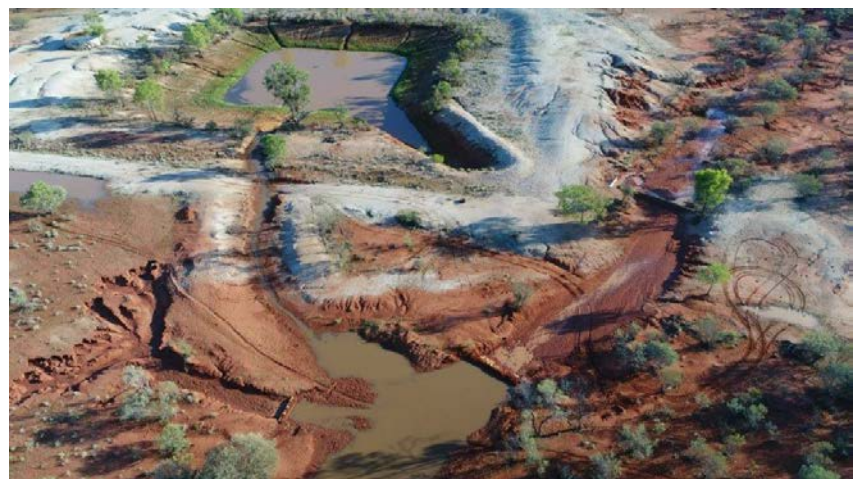
We are also battering the sides of eroded gully's, and we better understand where we should start repairing damage around dams, so they don't create erosion. As shown in the photo below (this dam problem is a longer term project, but I wanted to demonstrate how we are thinking about what we've learned and the level of change we are aiming for).

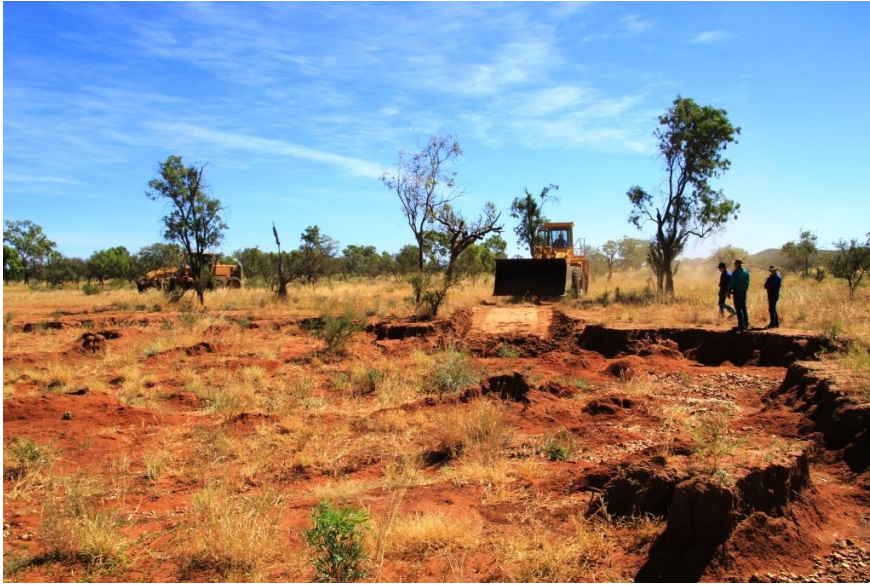
2017. Start of workshop.

Head of the erosion.

Road access on right side of photo; eroded gully's from the head to the left side

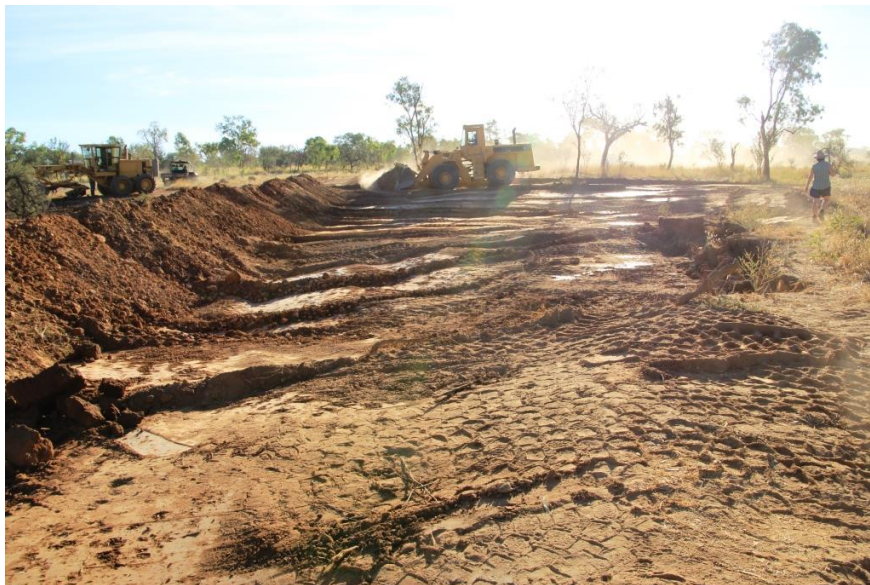
Head of the erosion being levelled, and wall being built

Sides of gully which flowed from the head of the erosion. Removing the sharp edges and battering them flat

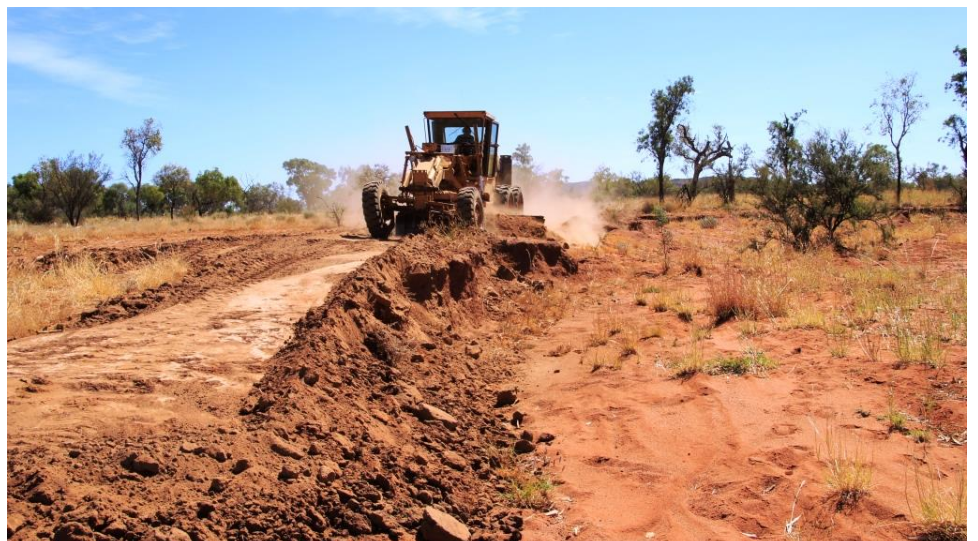
11/1/18. Area received heaviest rain in November 2017, smaller showers in December 2017 and January 2018. No signs of erosion since workshop.

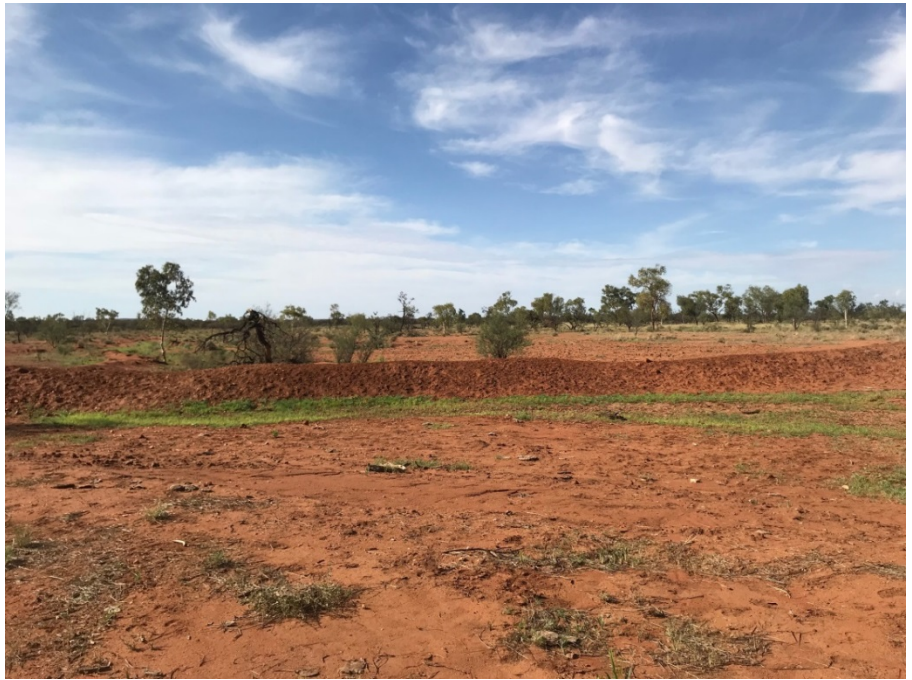
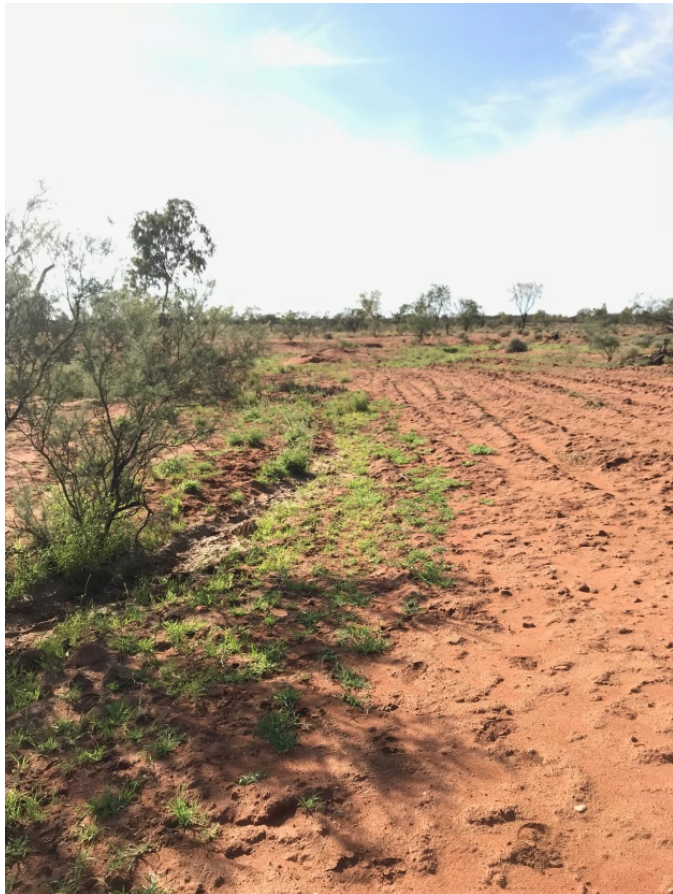
Sides of gully's. Water no long gushes through, vegetation has increased.

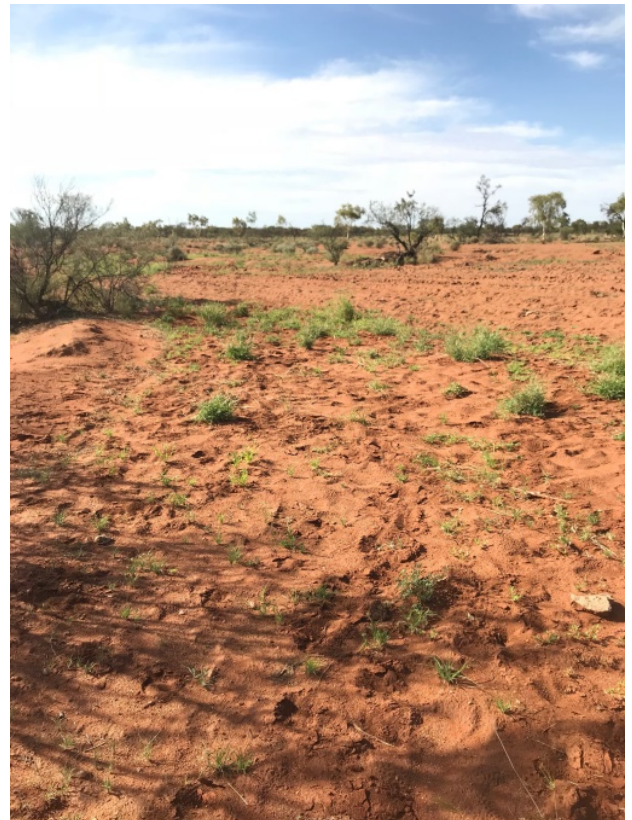
Inside gully, water used to gush from the head of erosion.

Vegetation has returned.

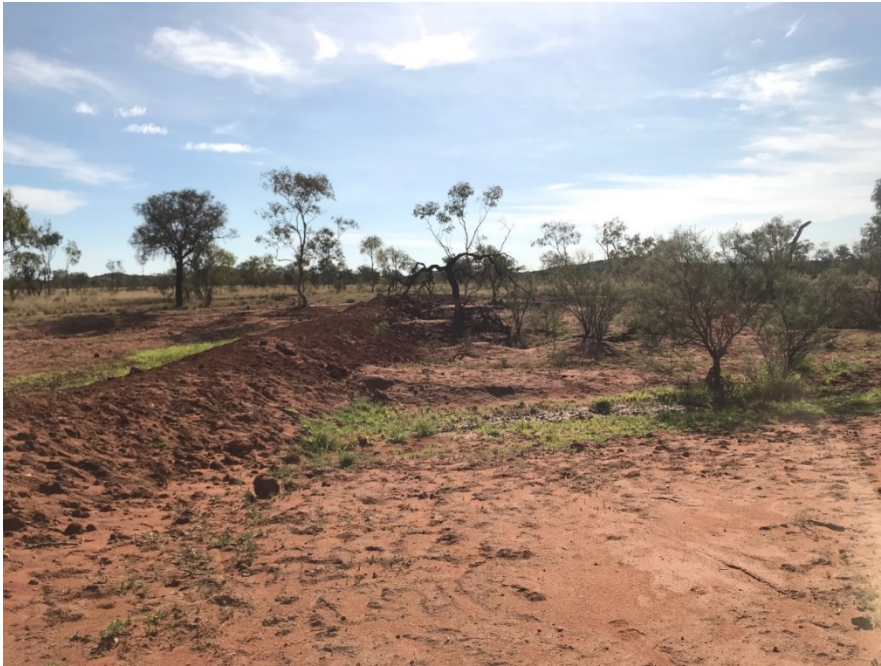
These two photos show the gully side of the wall built over the head of the erosion. No sign of soil movement since the work was completed (during the workshop)

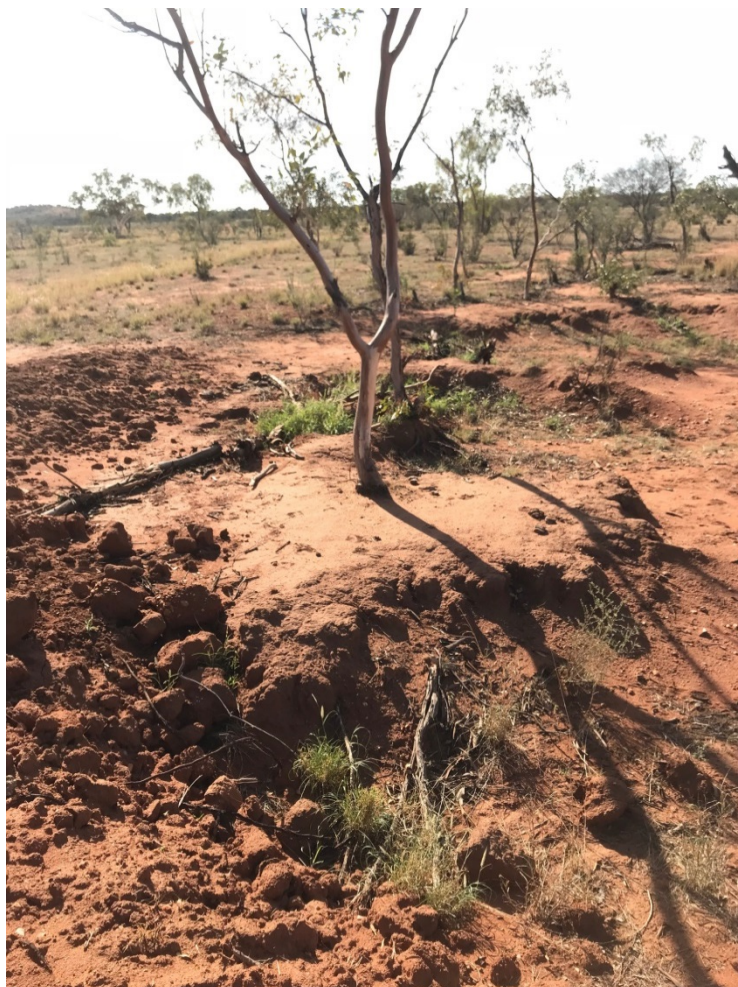
More of the battered sides.

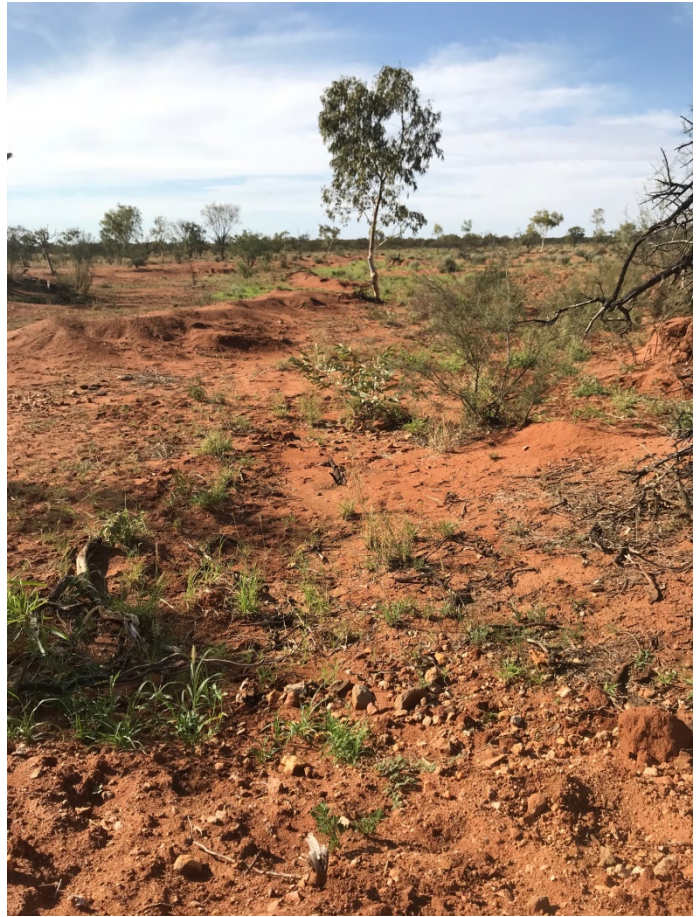
Vegetation has started to return.
