## TEST REPORT

No. : XMIN1907004595ML

Sample Name : STAINLESS STONE TIE  
Product Specification : 130×1.5 (with stainless bolt 6.5×60)  
Manufacturer : XIAMEN BANGMEI IMPORT AND EXPORT TRADE LTD.  
Buyer : STONECLAD LTD  
Material and Mark : STAINLESS STEEL 316  
Other Information : 25Mpa mortar with 28 days before testing ( the Rate of sand: cement ≈ 4:1 by volume)

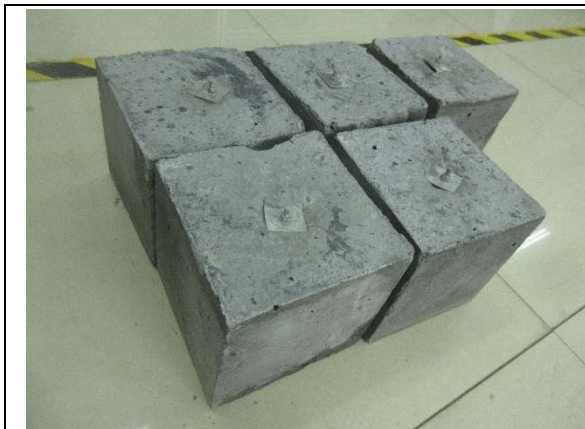
Photo 1: Sample

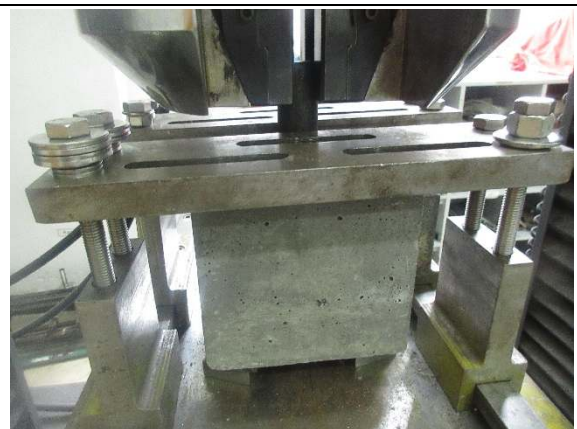
Photo 2: Before test

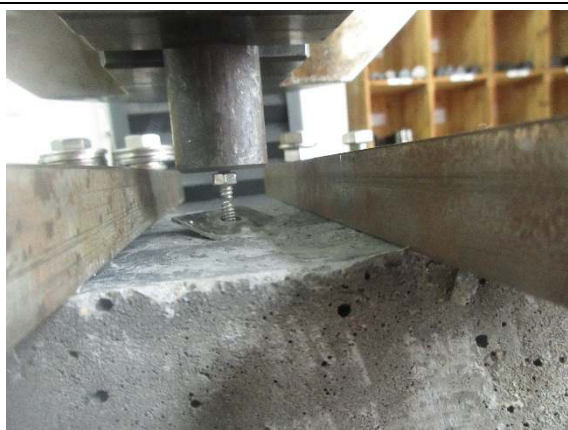
Test method: fix the sample on the test machine. Apply the pull force to STONE TIE embedded in mortar at a speed of 2mm/min until failure. Determine kilo newton strength of system.

Photo 3: During the test

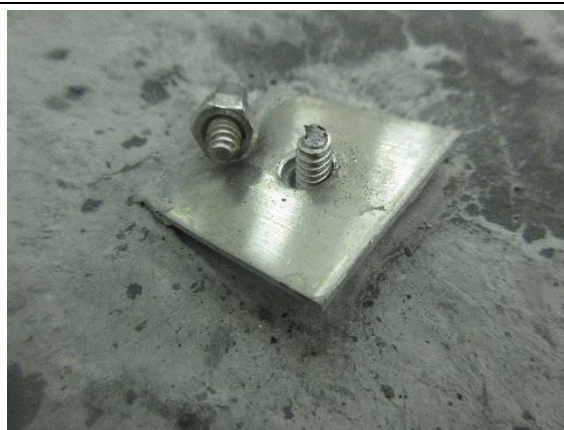
| Test item | Maximum force(N) |
|---|---|
| Pull Test (1#) | 10575 |

Photo 4: After test (1#)

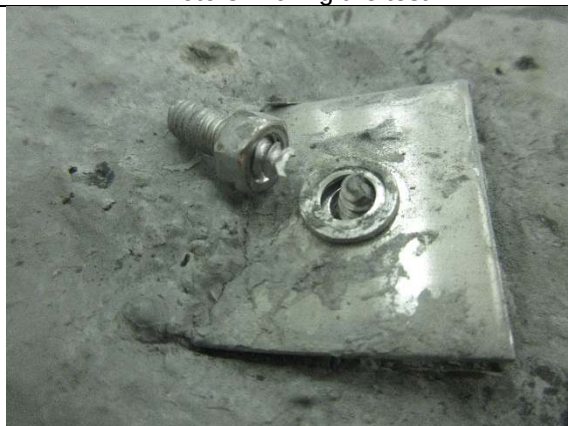
| Test item | Maximum force(N) |
|---|---|
| Pull Test (2#) | 10389 |

Photo 5: After test (2#)

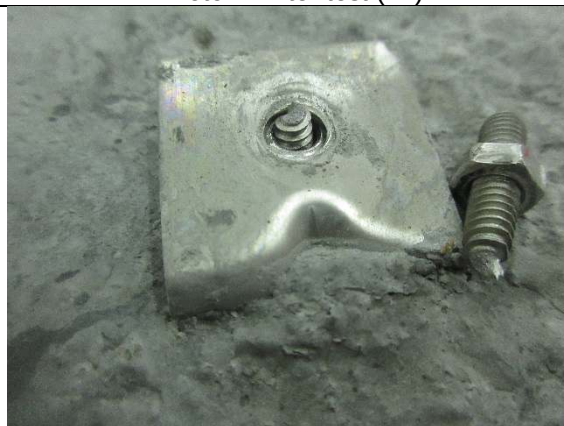
| Test item | Maximum force(N) |
|---|---|
| Pull Test (3#) | 10306 |

Photo 6: After test (3#)

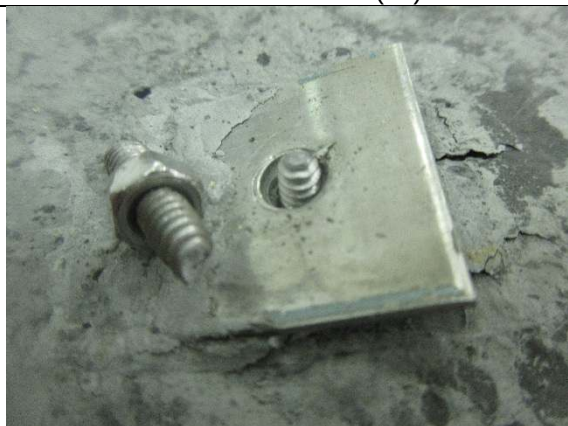
| Test item | Maximum force(N) |
|---|---|
| Pull Test (4#) | 10637 |

Photo 7: After test (4#)

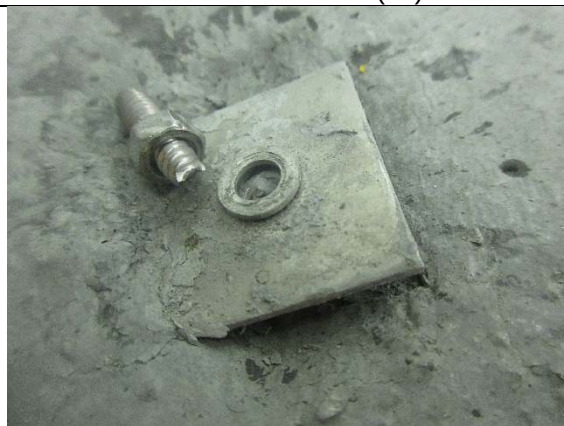
| Test item | Maximum force(N) |
|---|---|
| Pull Test (5#) | 10380 |

Photo 8: After test (5#)
