Bat Activity Survey and Roost Count St. James' Church, Wigmore, Herefordshire 13th August 2025

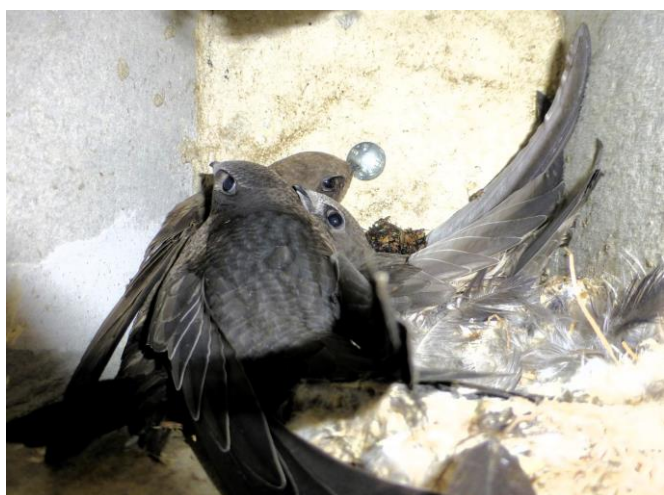
Figure 2: Adult with 2 juvenile swifts in a swift box installed at Wigmore Church

At the last box check in March 2024, all four swift boxes were used by swifts. This was confirmed by evidence of feeding remains and nesting materials. However, this year just two out of four boxes were in use by swifts. Overall the swift population has decreased compared to previous years and the number of nest sites, excluding the swift boxes once reached 11 but that number has declined. We were not able to carry out an accurate swift count at our August visit as many of the swifts leave for Africa in July. We were lucky to meet a local resident who has offered to carry out a swift nest count for us in 2026.

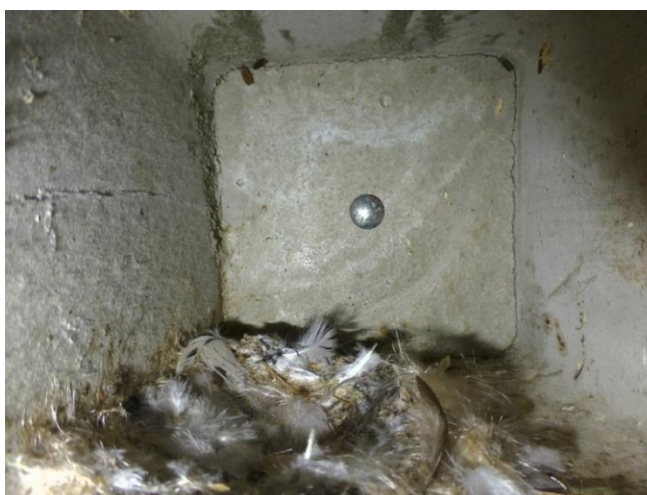
Figure 3: A swift was observed leaving this swift box when we arrived to monitor it.
