Re: Request for Superseding Order of Conditions (SOC)

41-119 Baxter Road, Nantucket, MA

DEP File No. SE48-3736

PROJECT AT A GLANCE: SE48-3736 SCONSET GEOTUBE EXPANSION

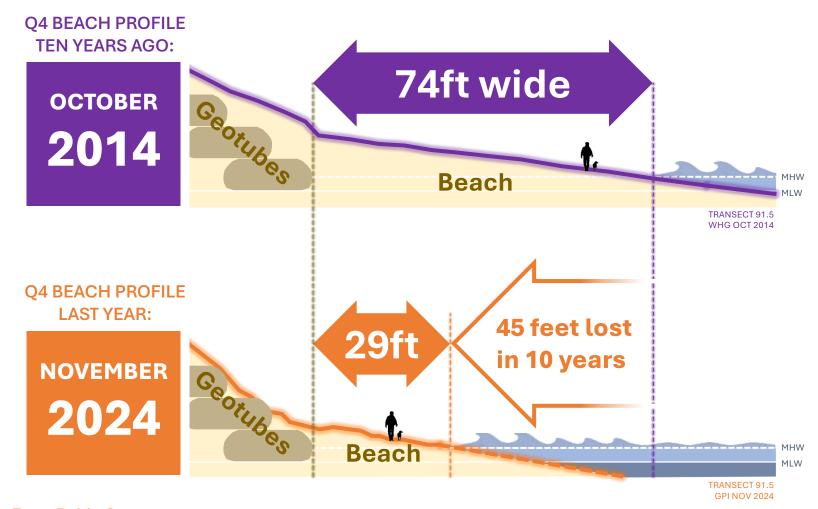
1. The beach fronting the existing geotubes has narrowed 45 feet in 10 years.

"The beach in front of the geotubes continues to narrow and steepen, with both horizontal retreat and vertical cutting ('passive erosion') typical of seawalls." - Dr. David Kriebel, PhD, PE, submitted 2/6/25

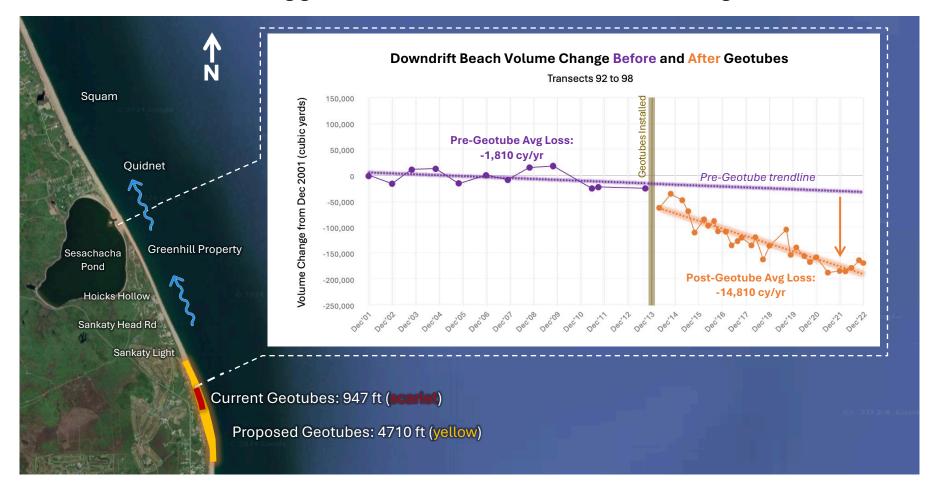
2. Downdrift of the existing geotubes, the erosion rate has accelerated eight-fold.

"Data indicate notable temporal changes to beach behavior before and after geotube installation, with dramatically increased erosion rates downdrift following geotube installation... Substantial changes have occurred that correlate both spatially and temporally to the geotubes. Erosion has worsened downdrift of the existing geotubes and this should give pause to the idea of expanding the geotubes and potentially further increasing these effects."

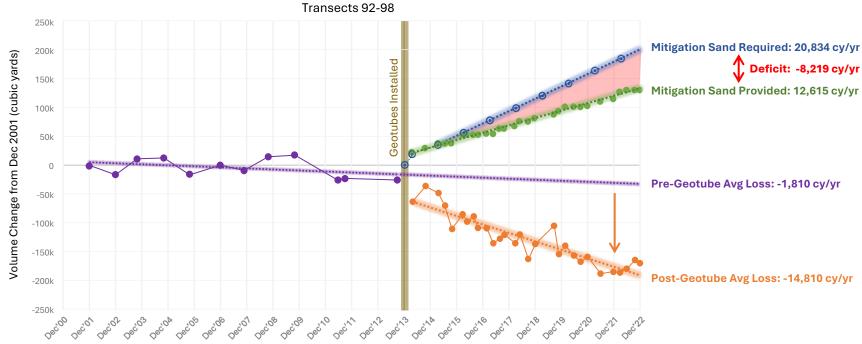
3. The mitigation sand deficit has likely contributed to downdrift volume loss.

Judging from Woods Hole Group survey data charted below, it is reasonable to postulate that:

- a) Were it not for the mitigation sand provided (green line), downdrift volume loss (orange line) would likely have been worse;
- b) By this same reasoning: had the full mitigation volume required in the permit (blue line) been provided, downdrift volume loss (orange line) would likely have been less severe;
- c) It follows that the sand deficit (red arrow) has likely contributed to downdrift volume loss (orange line):

• "This lack of mitigation sand provides an explanation for much of the -14,810 cy/yr loss of beach volume downdrift of the geotubes." – <u>Dr. David Kriebel, PhD, PE submitted 8/2/24</u>

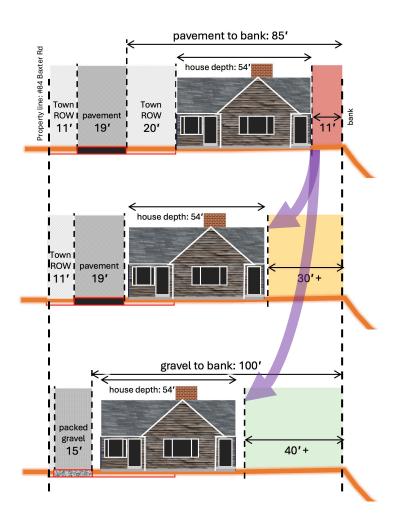
Example: #83 Baxter Rd

- #83 Baxter is an example of a structure at imminent risk, i.e.,
 "located less than 40' from the top of the eroding coastal bank without possibility of relocation [on-site]."1
- The Town has the ability to make more on-site relocations possible by granting easements into the road layout.

- The Town could immediately and at no cost to taxpayers grant bluff-side homeowners easements into the right of way up to the current pavement in exchange for equal square footage on the bank.
- There are two precedents of this strategy being used successfully, at #109 & #115/117 Baxter Rd.
- In the case of #83, it would allow the owners to move roughly 30' from the bank still within the imminent risk zone, but with an added degree of safety.

- Arcadis' Alternative Access & Utility Relocation Plan calls for conversion of northern Baxter Road from pavement to a narrower roadway of packed gravel. Narrowing of the road would expand easement opportunities for bluff-side homeowners.
- As part of the project, the Town could install the gravel roadway nearer the landward side of the Town ROW to further expand easement opportunities.

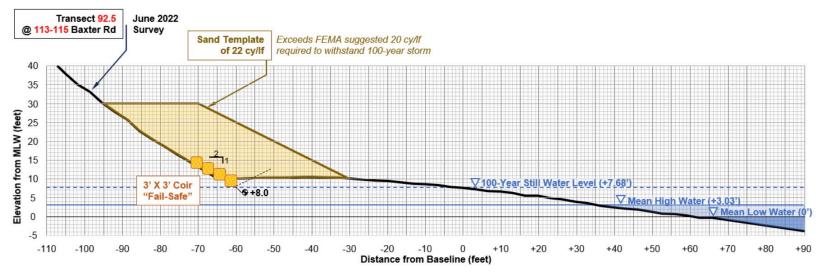
"FEMA has codified what coastal engineers call the '540 Rule', which states that a primary sand dune should have a cross-sectional area of ≥540 square feet – i.e., a volume per unit length of 20 cy/lf – to provide an effective storm barrier in a 100-year coastal storm. By this standard, if SBPF were to adaptively maintain 22 cy/lf of sand at the toe of the bluff as proposed, it would have the potential to provide protection to the bluff from erosion in a 100-year storm event without use of geotubes. Protection could be enhanced by a coir bag terrace system as a failsafe." The "Sand-Coir Berm" shown below is based on June 2022 beach profile for transect 92 (WHG data):

- 1. Satisfies the applicants' interest in protecting bluff from erosion in storms up to a 100-year return period.
- 2. Satisfies interests of downdrift property owners, as sand would be freely available to the littoral system.
- 3. Satisfies interests of community and environmental groups with a fully nature-based approach.
- 4. Consistent with WPA, a reasonable alternative to a mile-long coastal engineering structure.
- 5. Less costly and complex in terms of installation; would not require further engineering study.
- 6. Essentially self-removing: once adaptive mitigation is discontinued, the berm would naturally erode; the only required action would be removal of coir bags at the end of their service life.

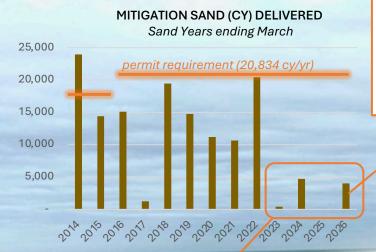
The delivery of ~4000 cubic yards of sand two weeks ago (6/6/25) is the first mitigation in more than a year, and represents **less than 4%** of the mitigation sand deficit.

Multiple tiers of geotubes have been continually exposed to direct wave energy for the past several years. This photo, taken on a typical September day last year, shows the narrowing and steepening effects of the current 947-foot-long geotube revetment.

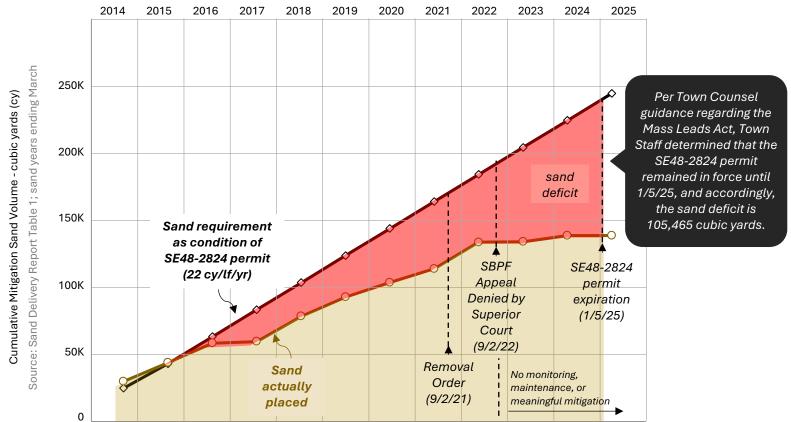
1. Quantifying the sand deficit is a matter of state law and arithmetic.

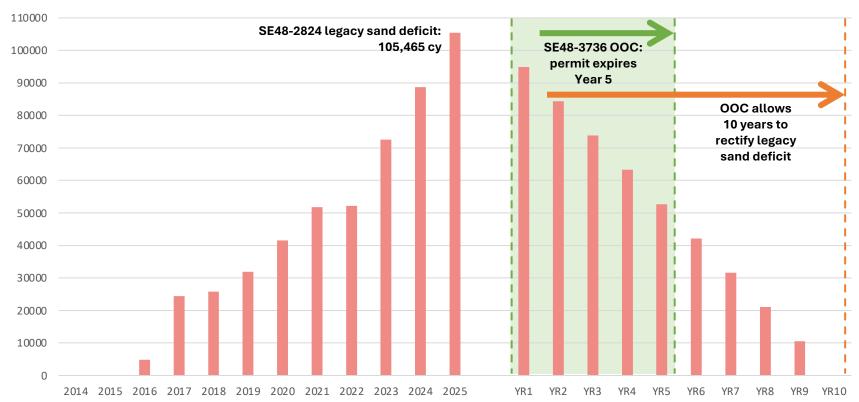
2. The OOC's 10-year allowance for rectifying the deficit is too lenient – twice the duration of the new permit – and without basis.

"Requiring the full volume of make up sand is vital to the neighboring resource area. Making up over ten years is too long and should be done over five years at most, i.e., within the life of the permit."

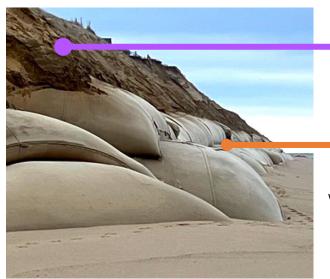
TOP OF TEMPLATE

By design, sand stockpiled here remains inaccessible to the littoral system during storm events, when it's really needed.

FACE OF TEMPLATE

If an insufficient sand supply is provided here, it is likely to be washed away in the early hours of a storm, exposing geotubes to direct wave action and depriving the littoral system of sediment.

This practice of applying minimal sand to the face of the template saves the applicants money, but defeats the purpose of mitigation, by artificially capping the volume of sand available to the littoral system. It also yields misleading data regarding how much sediment the system naturally demands each year (highlights added).
