HUNDRED OAKS CASTLE: ITS PAST,  
PROBLEMS, AND POTENTIAL  
Winchester, Tennessee

A Historic Structures Report

A Public Service Research Project of the  
Historic Preservation Program  
Department of History  
Middle Tennessee State University  
Murfreesboro, Tennessee

May, 1984

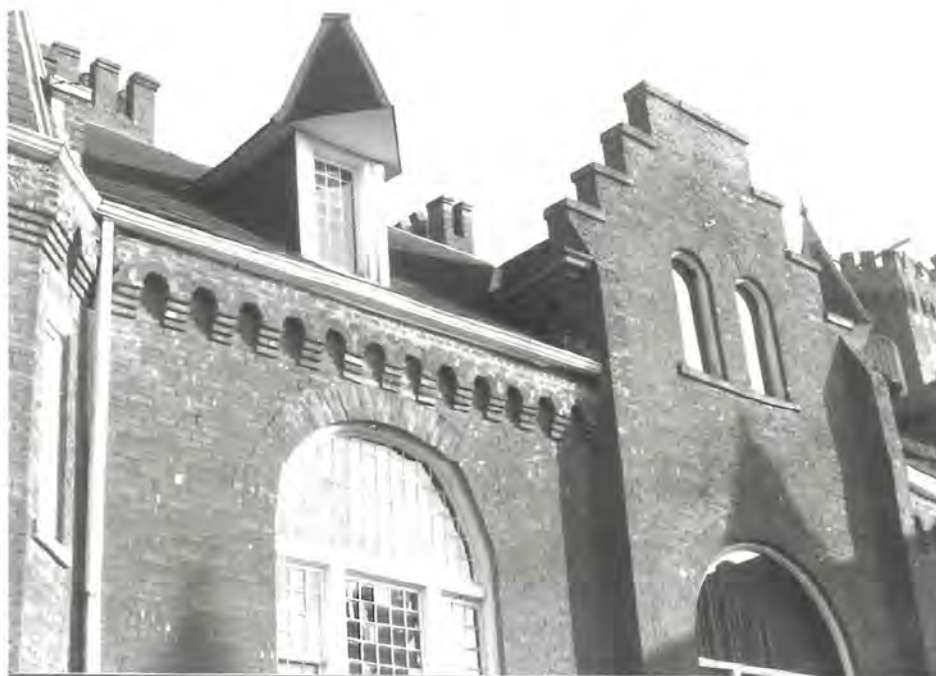
The brick three-story Romanesque castle which stands today was originally a four-over-four farmhouse with end chimneys. The lighter brick of this original structure can be detected upon close examination of the front (south) facade. The building was altered into an eleven-by-five bay European style castle featuring machicolation (fig. 1), a tower, turrets, and a bartizan (fig. 2).

Fig. 1. The castle features a machicolated cornice.

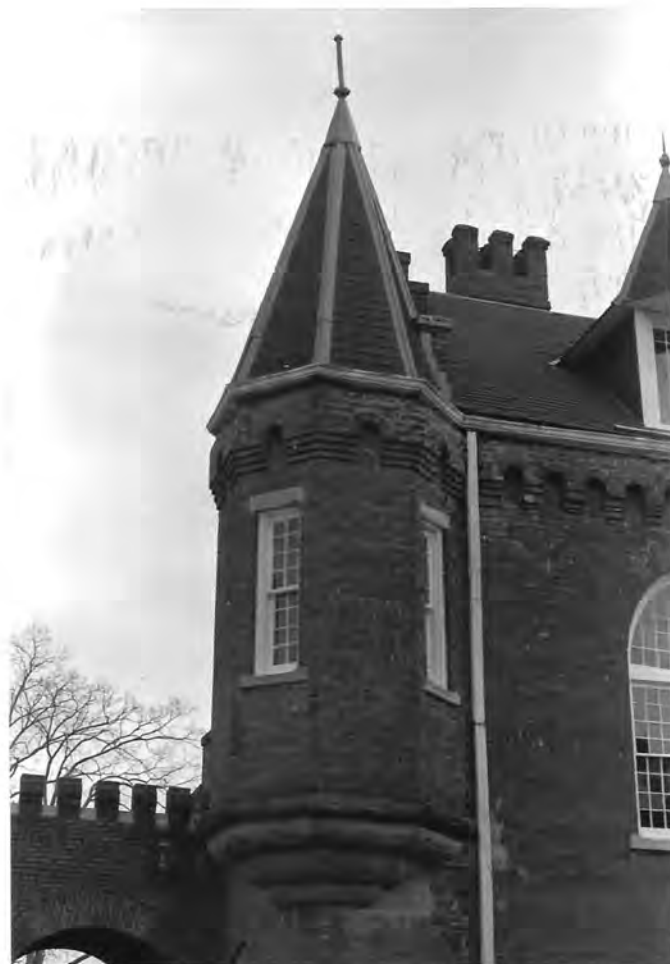
Fig. 2. A bartizan appears on the east facade.

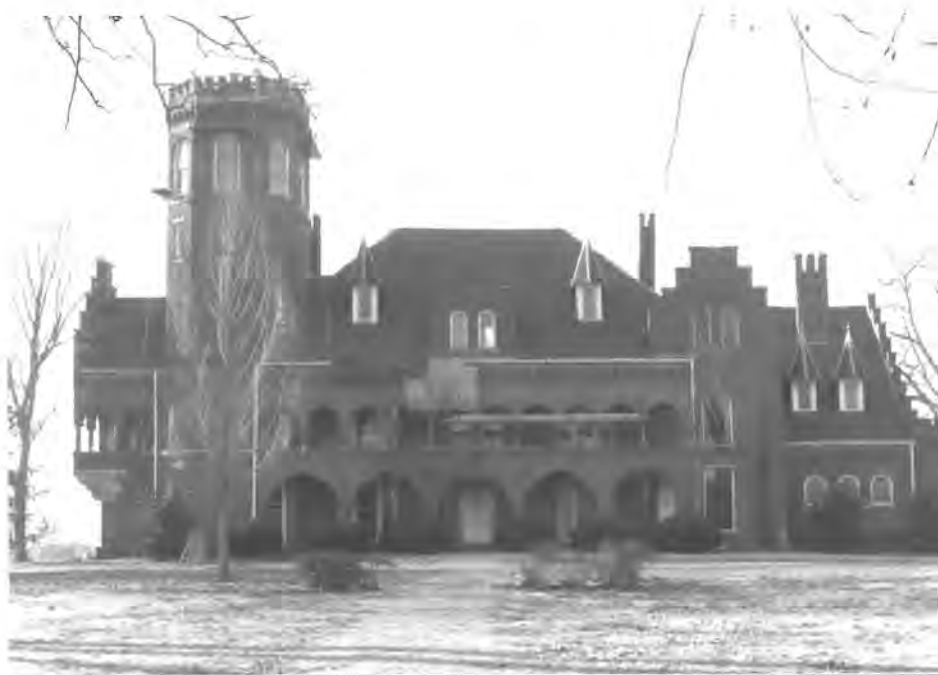
Fig. 3. Front facade

The front facade features this tower and a three-story Flemish gable joined with a two-story loggia (fig. 3).

The hexagonal tower is capped with crenellations and has six arched 30/30 windows on each face in the fifth story. Three narrow windows step down to the second and first stories each of which has two 30/30 windows. The three-story Flemish gable is supported by a modern brick buttress and has two

parallel arched 1/1 windows in the top story, one matching 1/1 second-story window and one square 1/1 window with a concrete lintel in the first story. The loggia is five bays wide on the first floor, joined by brick pillars, while the second story is in double rhythm joined by small brick columns. Machicolation forms a cornice across the front facade but does not appear on the front gables nor the tower. A corbelled belt course separates the first and second stories. A water table is made mostly of brick, but it has been capped with cement toward the west end of the castle.

The east wing has three arched 30/30 windows and is attached to an arched porte cochere which is capped with crenellations with two buttresses at each corner. The west wing consists of an arched cantilevered balcony with large concrete brackets underneath for support. The west facade (fig. 4) has a chateausque roof line dominated by the front tower, a Flemish gable, castellated chimneys, turrets, and attached turreted outbuildings. The three-story Flemish gable of the west wing has two arched 12/12 windows in the third story, the cantilevered balcony which shows on the front facade in the second story as well as one 20/20 arched window, and three windows on the first floor: two are arched 16/16 with the third being a flat 20/20 with concrete lintel appearing on the chamfered corner wall above an over-sailing course.

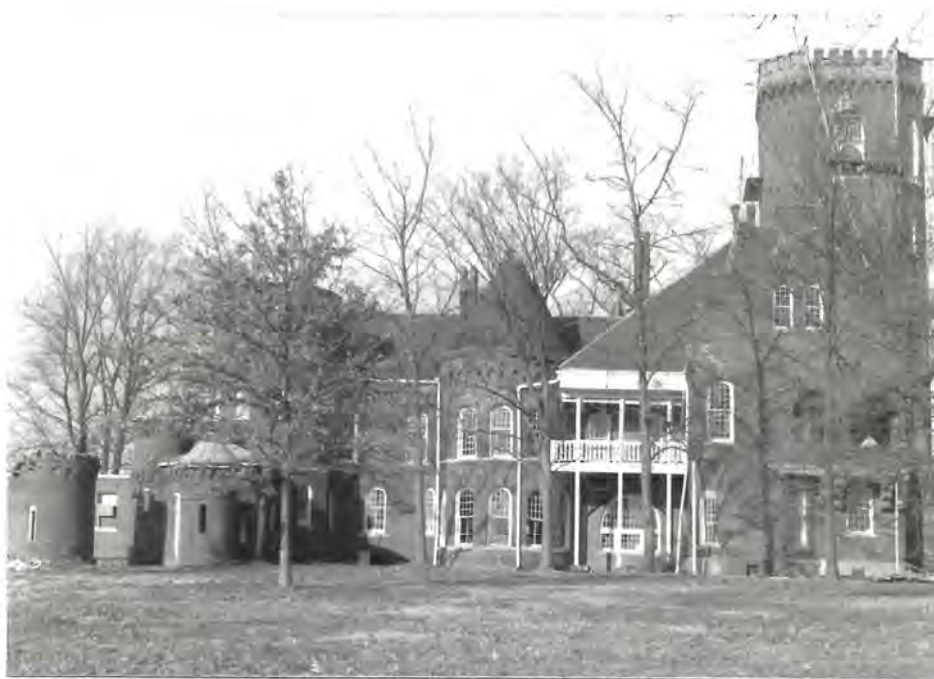
Fig. 4. West facade.

The back (north) wall of this west wing has a second-story large arched window--a stationary 64-light section over three casements sections of 12-20-12 lights. The first story has one arched 20/20 window and a doorway with an arched transom.

A cone roofed two-story turret with longer machicolation is centrally placed on the west facade. The second story has three arched 16/16 windows while the first story has five arched windows--two 8/4 flanking one 8/1. Between this central and an end turret appears a flat wall with machicolation, one second-story 16/16 window and two first-story 6/6 and 12/12 windows. Another second-story oriel window appears in the chamfered wall connecting the end turret. This window has an oversailing course beneath. Three round castellated outbuildings are attached to the turret with an arched passageway. There is also a fourth free-standing smaller turret.

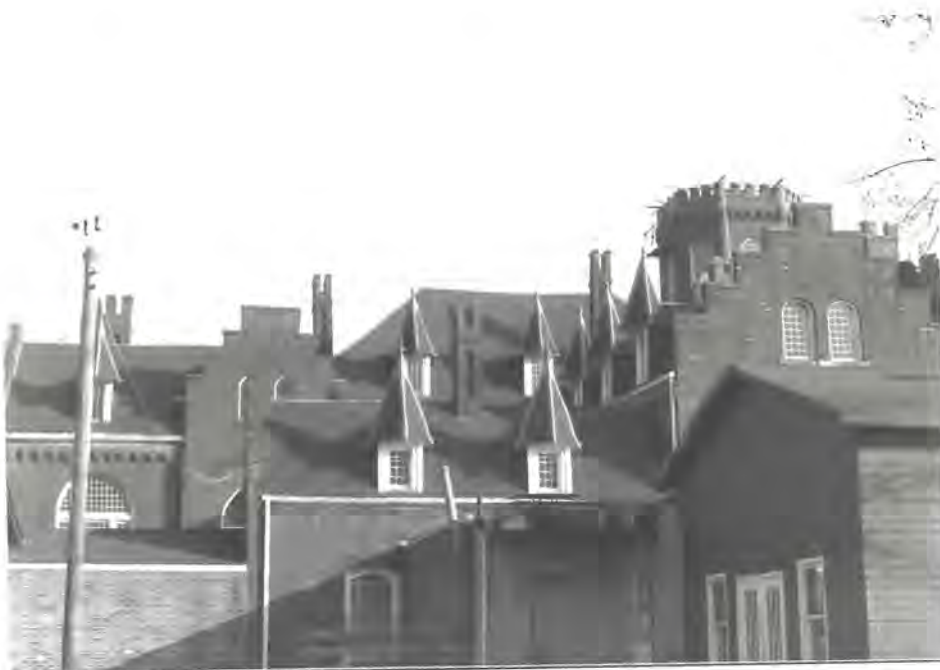
Fig. 5. North facade.

The rear (north) facade (fig. 5) has a three-story Flemish gable with two parallel arched 32-light windows in

the upper story. The second story has an oriel window consisting of three connecting 16/16 windows, flanked by an arched 12/12. Two modern additions, one of brick and one of wood, have been added to this facade.

The east wing of the north facade features two dunce cap dormers with fifteen-light windows in each, a castellated chimney and a 24/24 window on the first floor. There is no machicolation on this wing.

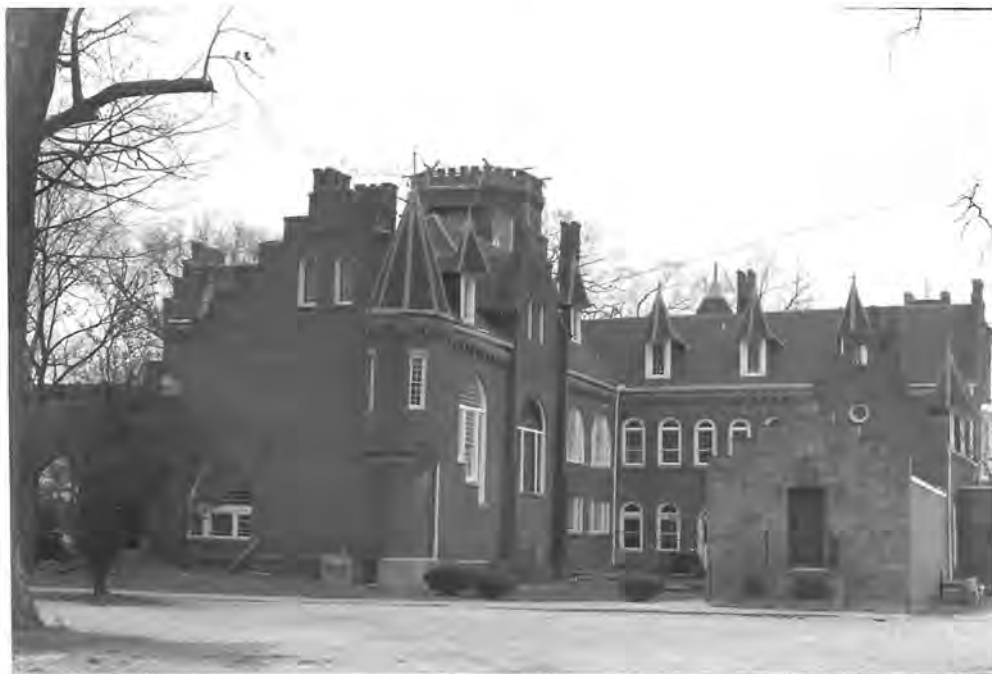
Fig. 6. East facade.

The east facade (fig. 6) boasts a roof line peppered with nine dunce cap dormers and a courtyard formed by the carriage house wing within a Flemish gable with an arched opening in the top step of the gable and a round nine-light

window and the main body of the castle. A modern extension has been added to the old carriage house in a similar Flemish gable form.

A three-story centrally placed Flemish gable has two single-pane third-floor arched windows and a large arched window (once containing stained glass). A large stepped arched window consisting of 198 lights appears in the wall which joins the bartizan at the corner. The bartizan has a dunce cap roof to match the dormers and three narrow 8/8 windows. Machicolation forms the cornice along the courtyard.

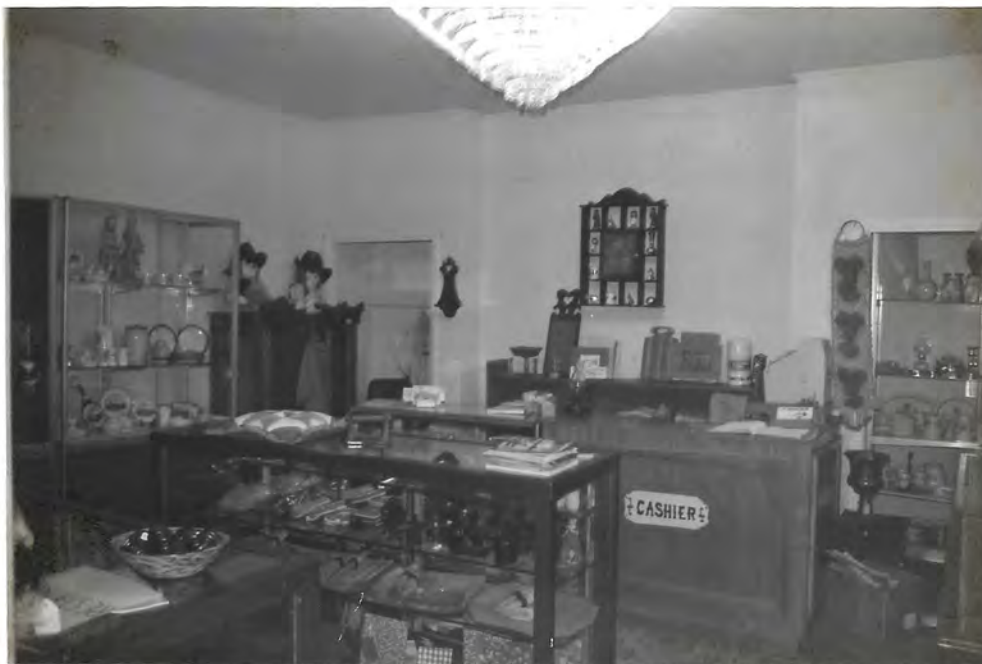
When Hundred Oaks was purchased by Marks, it was a four-over-four, possibly Greek Revival house (see history section) with a two-story ell (figs. 7, 8, 9). The two-story ell would have contained the Greek Revival entrance and central hall still used today (room 106).<sup>1</sup> Recessed chimneys in room 111, 105, 205, and 203 confirm the east and west walls of the original house. The fireplace in room 105 has been removed (fig. 10), but there is evidence of its previous existence in the recess found in the wall. The hearth may be seen in the house foundation; and, in the attic, original pencilled brickwork and ghosts of earlier flashing remain on the chimneys.

Fig. 10. One of the original end fireplaces was removed by Marks.

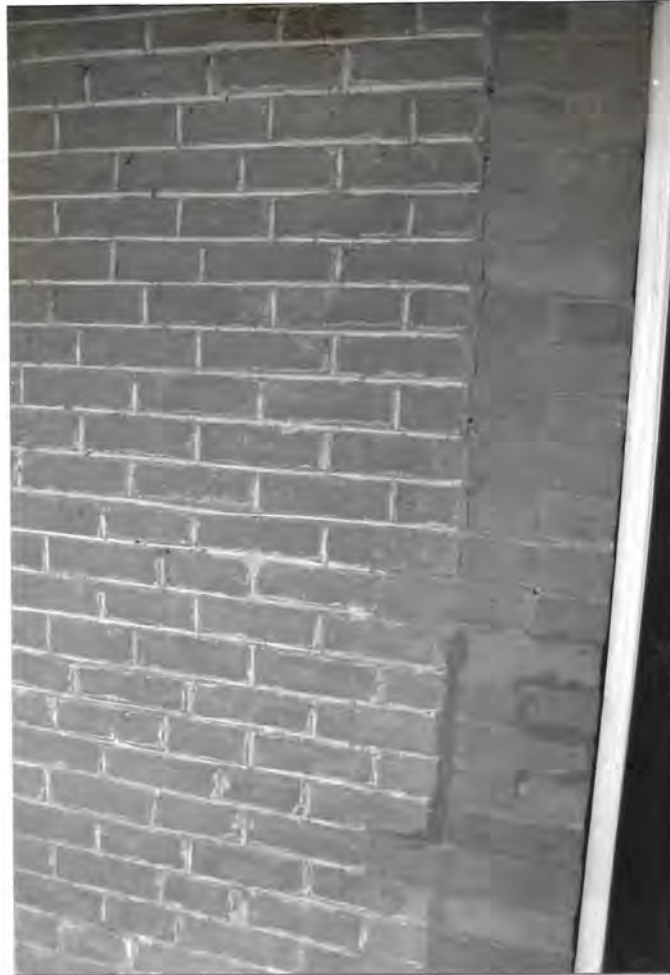
The north wall of the original house is identified by pencilling on the brick mortar. The pencilling comes to an abrupt end at the north exterior wall of room 112 (fig. 11). The existence of a wall dividing room 112 would substantiate the description of C. C. Estill, "the house had 8 rooms, four below and four above with hall below and above." This would also provide consistency between the first and second floor plans. Unfortunately, without disturbing the plaster of room 112, the wall's placement cannot be confirmed. The

Fig. 11. The pencilling of the brick mortar, loggia, by the end of room 112.

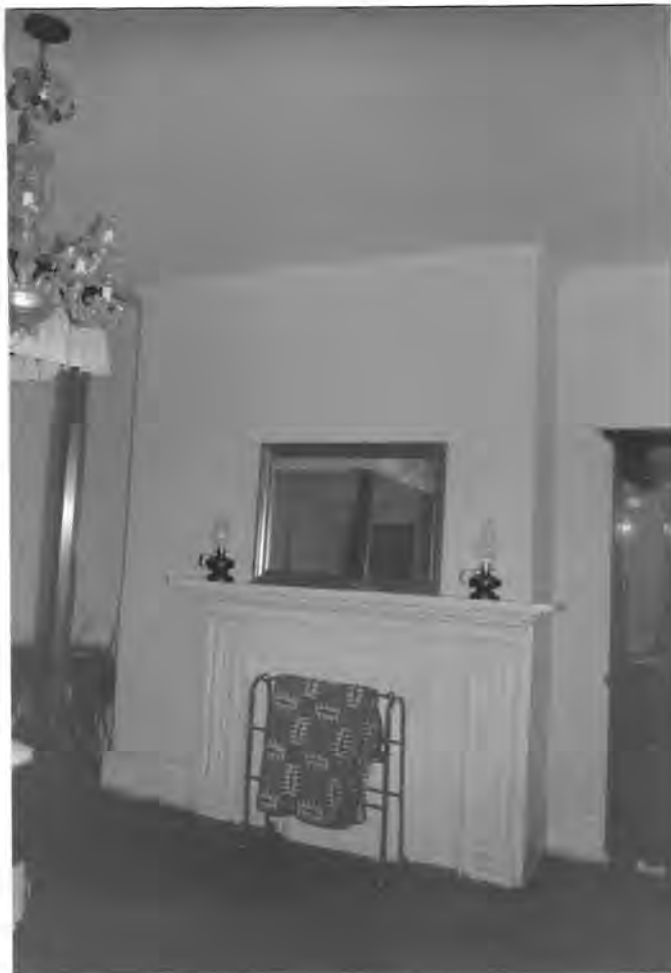
The second-floor room placement would have matched the first floor. Rooms 203 and 205 flanked the hall; rooms 206 and 210 formed the ell. The extra chimney flue of room 205 is unexplained, but may be evidence of an early heating system (fig. 12).

Fig. 12. One of the original chimneys; the extra flue is unexplained.

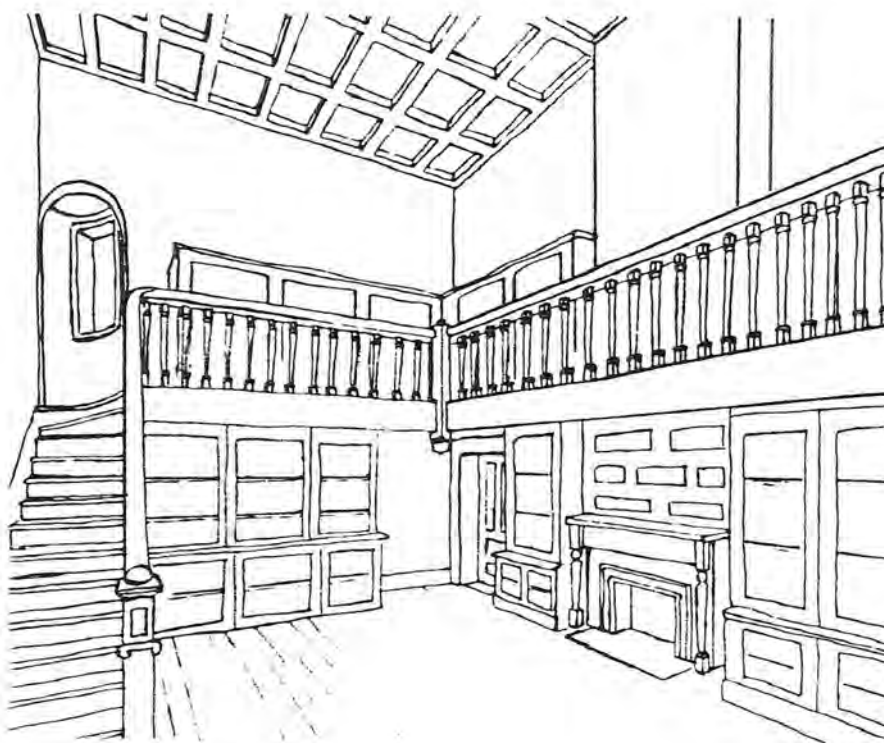
room 104. No controversy exists over the similarity of the library/studies themselves. Room plans are shown (fig. 13). Marks made a few changes. He raised the ceiling by three feet and did not arch the shelves openings. The speak-a-bit was moved to the head of the stairs (fig. 14). Descriptions of either house give no purpose to the speak-a-bit. Legend has said that Sir Walter Scott kept his private manuscripts in the room, but the proportions of a speak-a-bit makes this unlikely, and the theory gives no explanation of the room's name.<sup>9</sup> Despite changes made, the similarity of the room is undeniable.

Fig. 13. Floor plans of the study at Abbotsford and the library at Hundred Oaks.

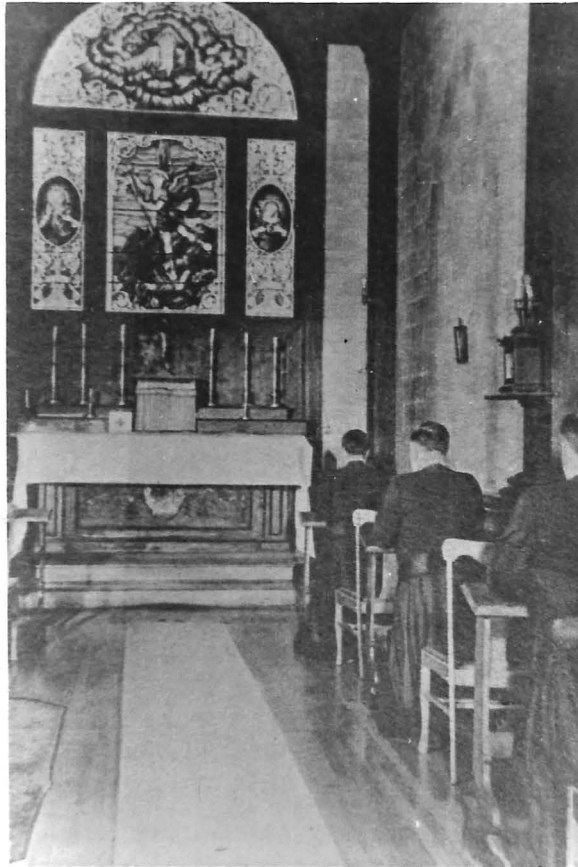
The most prominent change to Hundred Oaks when the Paulists moved their southern headquarters there in 1900 was the transformation of room 104 into a chapel. Stained glass windows were donated and an altar was placed at the north end wall.<sup>10</sup> The entrance from the chapel to the library was plastered over (fig. 15). A window from the north wall was reused to light the stairwell (fig. 16). A bathroom was added in room 204 with a concrete slab as a foundation for the utilities (fig. 17). The two-story loggia was enclosed (fig. 18).<sup>11</sup> Due to the expense of repairs and maintenance, the Paulist Fathers closed the "House of St. Francis de Sales" in 1955.

Fig. 15. Room 104, the chapel of  
St. Francis de Sales.

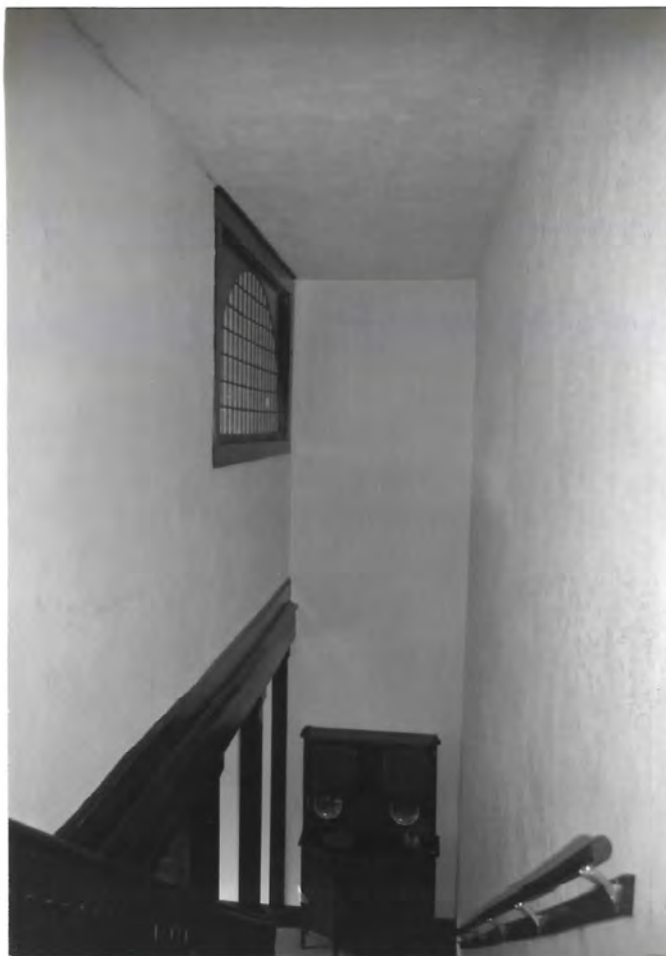
Fig. 16. The stairwell window, moved from room 104.

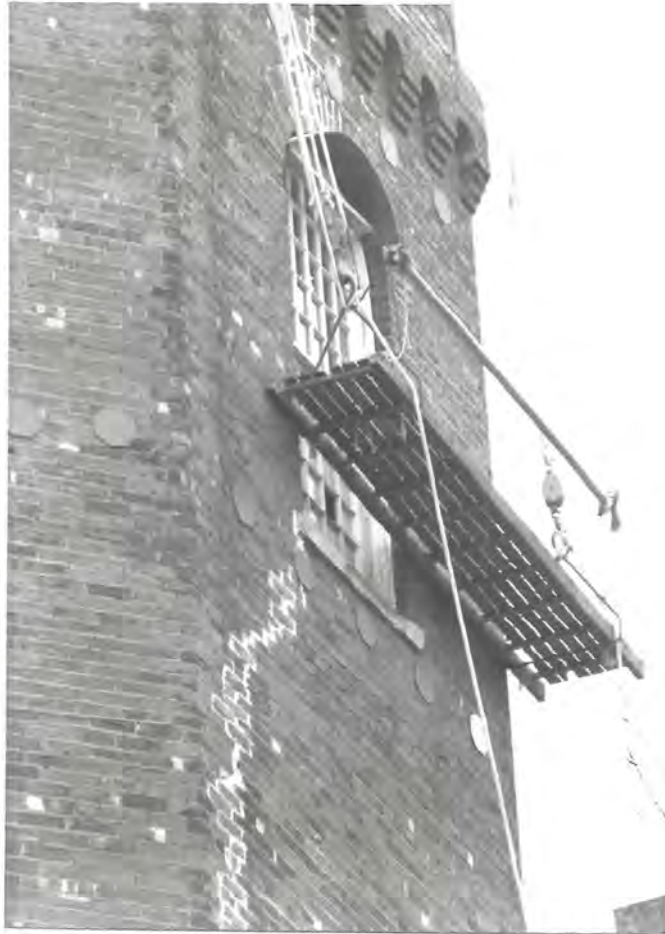
The major part of the first phase was to stabilize the main hexagonal tower which had several major cracks, causing window and door arches to fail. The movement of the failing walls has been corrected by a system of threaded rods, angles of steel, and fasteners. This process is now completed, and cracks have been reduced and properly repointed (fig. 19).

Fig. 19. Tower stabilization includes a system of threaded rods, angles, and fasteners, and remortaring of major cracks.

The first phase also included repointing and cleaning brick areas of the tower, front facade, and porte cochere. This cleaning and repair required the removal of inappropriate mortars, and replacement with new mortar matching the texture, color, and width of the original. The new mortar

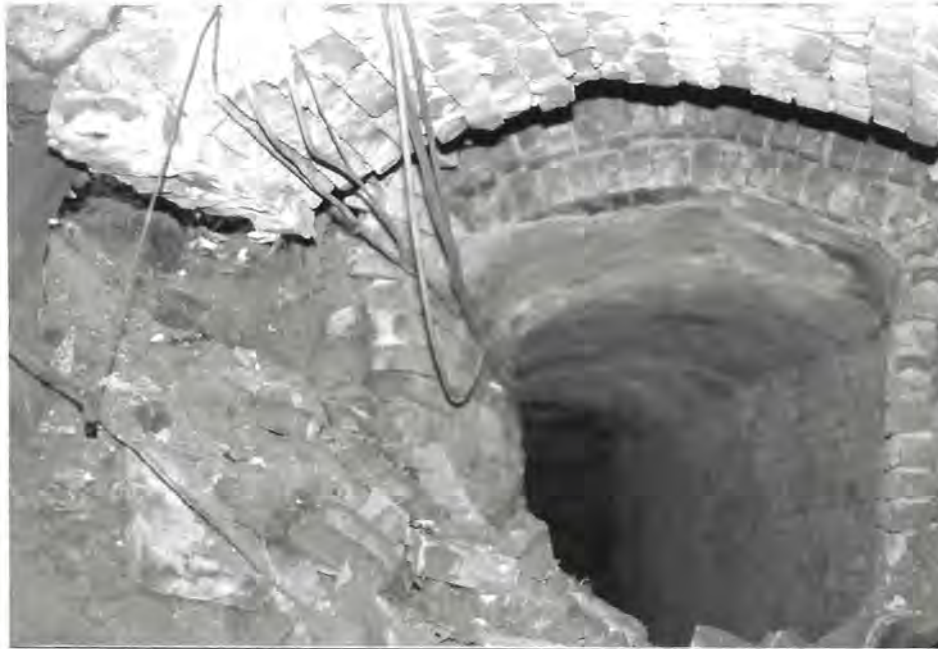
The most obvious and serious structural problem at the present time is the result of the collapsed tunnel wall which extends south from the castle cellar to the crawl space of the original house. At the present time the tunnel arch has collapsed below the north exterior wall of room 107, the hall connecting the gallery and the dining rooms (fig. 20). This collapsed tunnel has caused the walls of

Fig. 20. The tunnel below the courtyard shows arch failure.

If this problem is not corrected, the entire tunnel and the house could quickly collapse. The entire foundation could be in serious jeopardy if this tunnel wall and

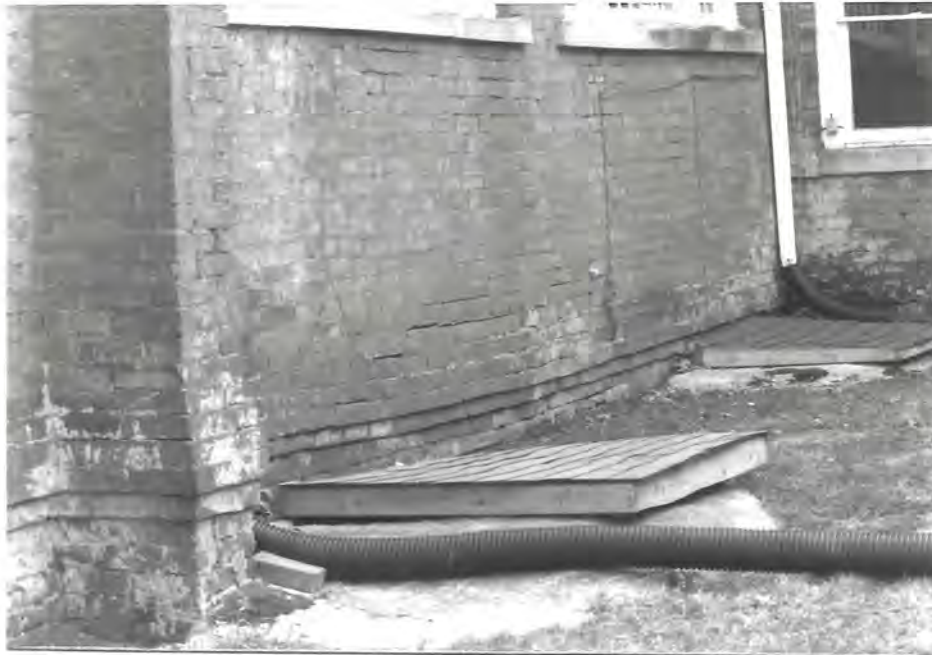
the first- and second-floor hallway to sag and crack. The bricks are rotating and buckling, causing stress in the exterior wall (fig. 21).

Fig. 21. Buckling and failing of east wall bordering the courtyard.

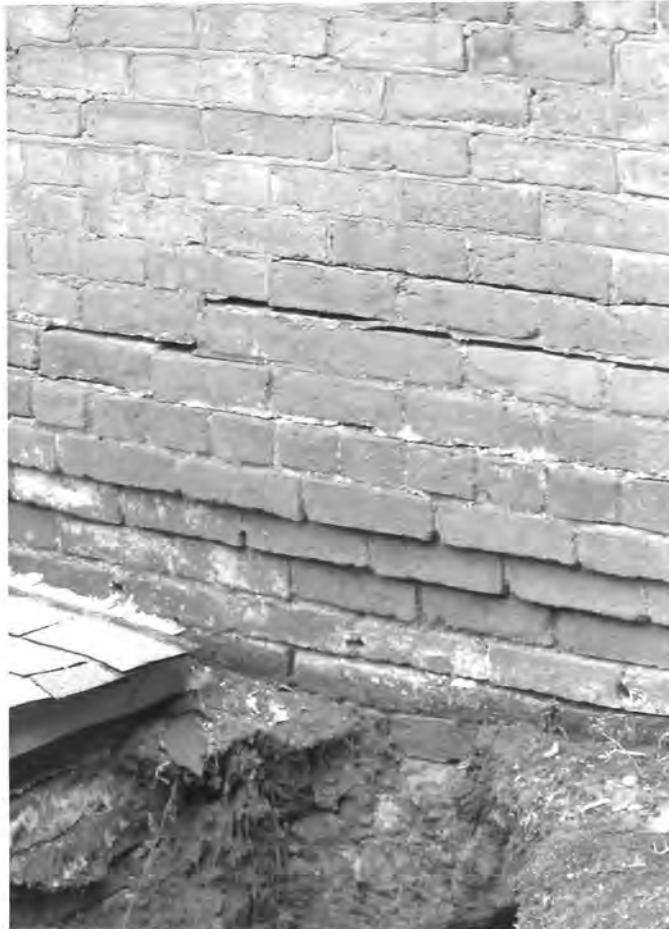
Fig. 22.  
The tunnel failure has created a hole in the courtyard.

Problems associated with the hole in the courtyard opening into the tunnel wall are: the buckling and rotation of the bricks in the exterior wall, failing window arches as seen in the gallery window, and interior walls separating from the ceiling (fig. 23). These problems could be reduced with the correction of the tunnel wall. However, repointing

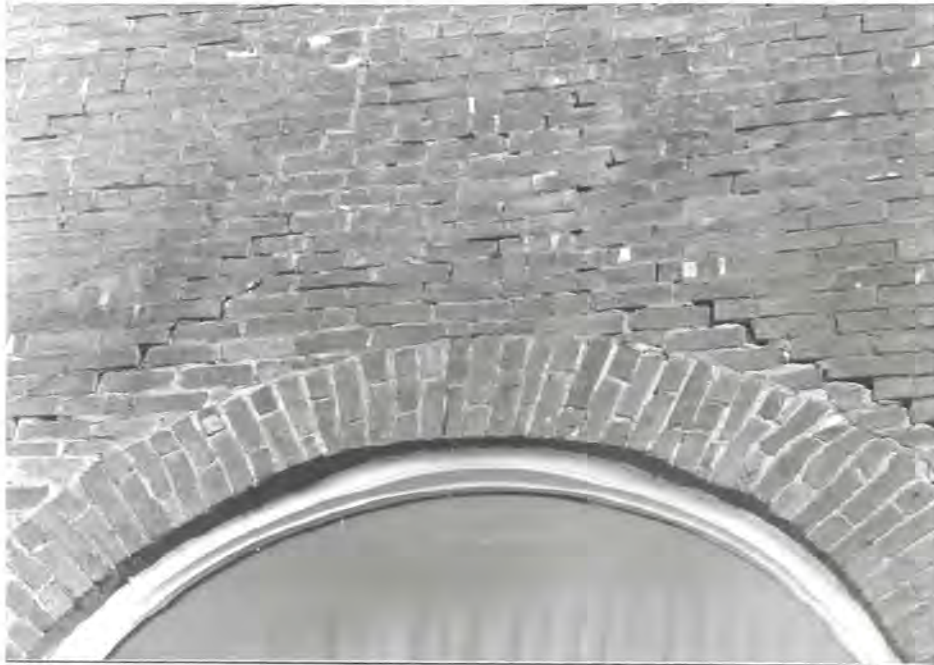
Fig. 23. Gallery window, close-up view of arch failure.

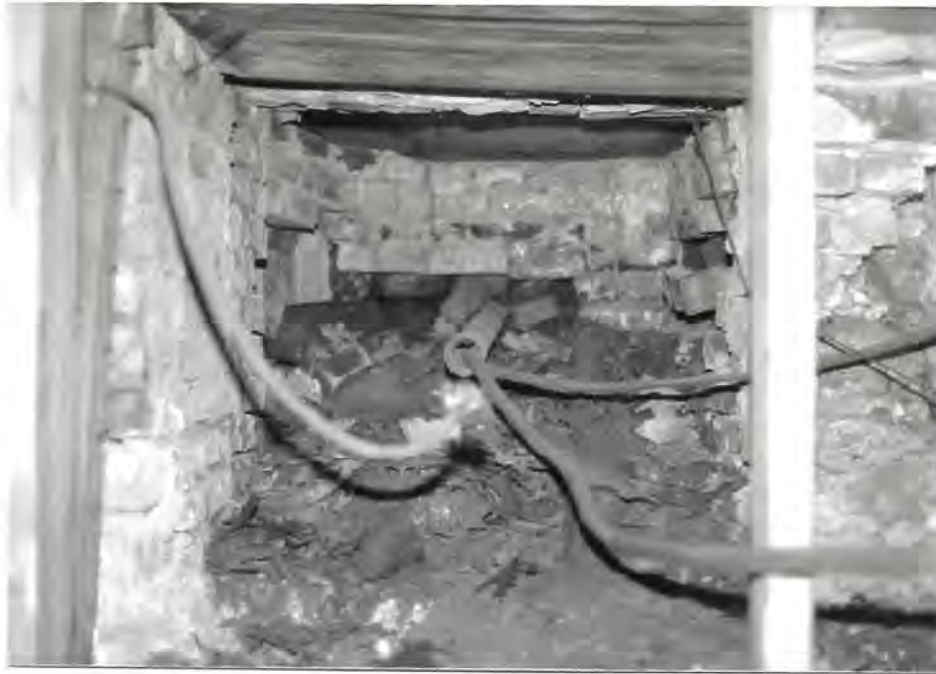
The overall foundation is apparently in good condition, but the sections which are on brick foundations need attention because the brick is losing its strength due to moisture within the cellars, crawl spaces, and tunnels. Most of the brick foundations show some damage resulting from water entering the area below the house through open vents or windows into the cellar areas. These vents are either open, covered with carpet, or covered with plywood (fig. 24); they need to be sealed if the foundation is to remain strong. The openings should be enclosed with a ventilation system which would allow for circulation of air to carry out any existing moisture.

Fig. 24. Leaves are evidence that this vent, now covered, was previously open.

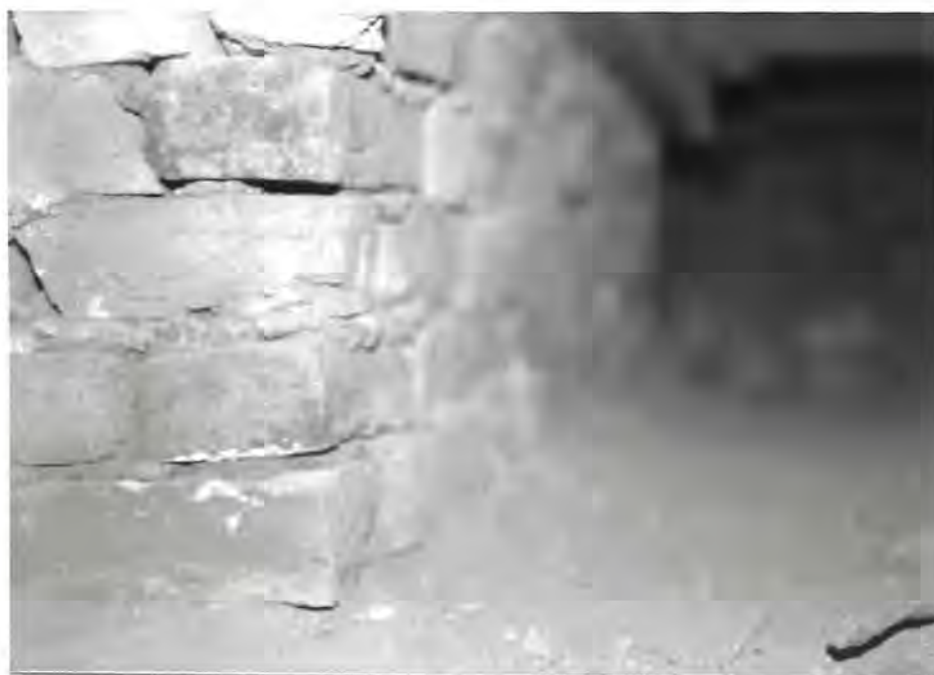
brick lintels may have to be installed in these areas. In addition, these settlement problems are keeping pocket doors in the dining room from operating properly. A final problem with this area of the foundation is that much of the original mortar has deteriorated and should be repointed (fig. 25).

Fig. 25. Deteriorated mortar of the original house foundation.

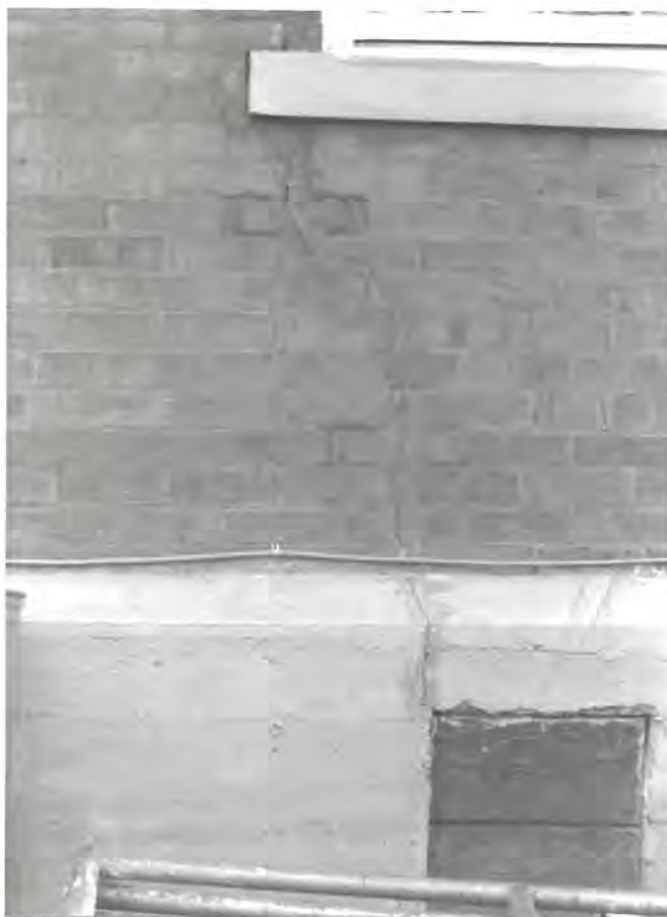
Another example of a continuous crack is to the north of the first crack. It begins at the foundation, continuing to the first-floor window and migrates to the flat

Fig. 26.  
Structural cracks  
begin at ground  
level.

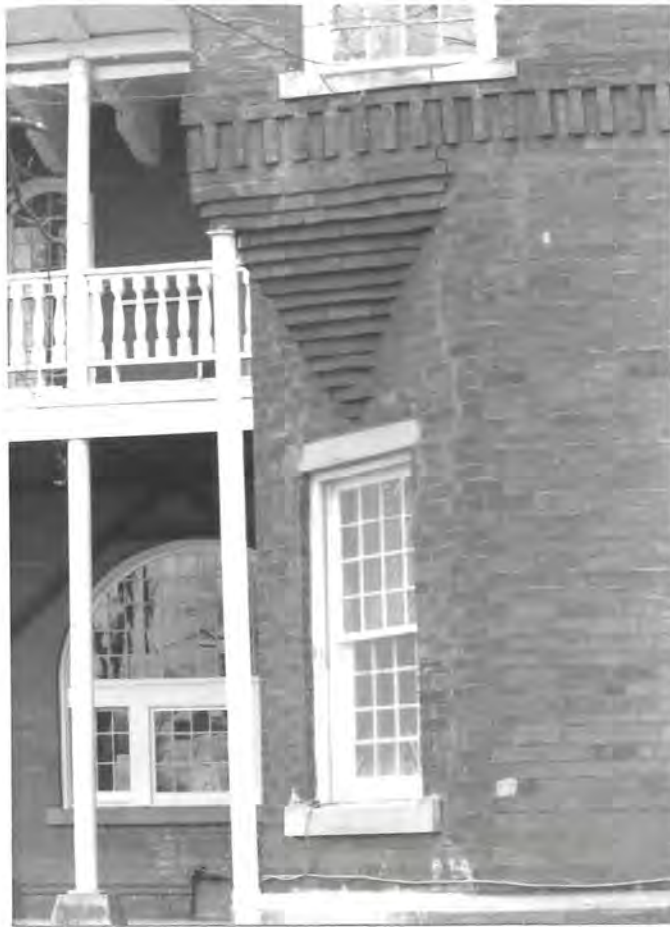
lintel. On this corner of the west facade wing is a cantilevered second-story overhang. This cantilevered corner gives the impression of being ready to fall off the corner of the house because the crack is in the joint of the extended area and the flat wall surface (fig. 27). Other examples of this problem can be seen on the outbuildings

Fig. 27.  
Crack extending  
from ground level  
to cantilevered  
corner.

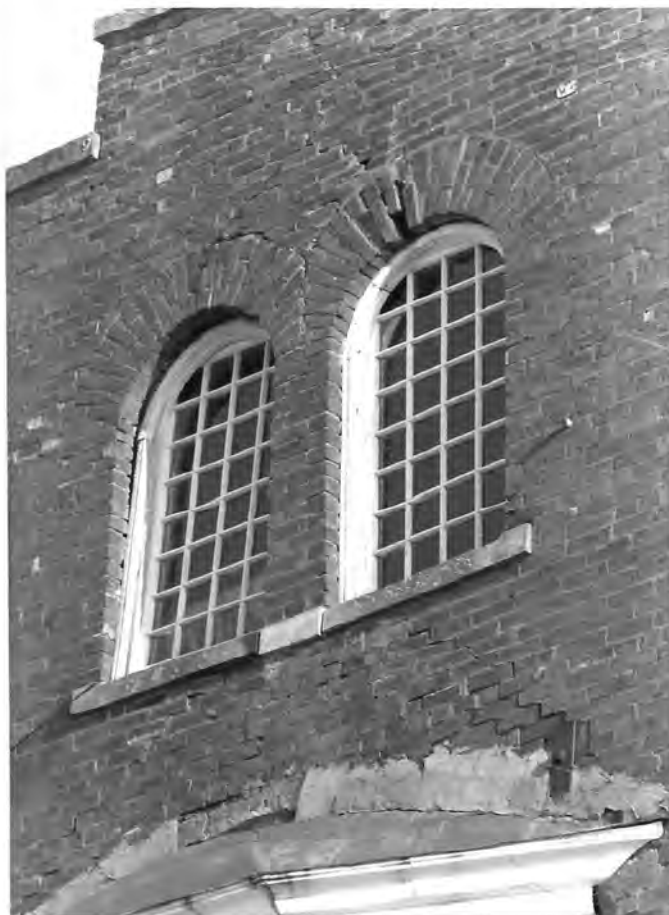
that are attached to the west facade of the cistern turret, the brick around the bay window on the north facade, and the arches of the pair of windows above the bay window. There are also several cracks on the exterior wall of the gallery, library, and hall (fig. 28).

Fig. 28.  
Evidence of cracks  
extending to the  
third floor above  
the bay window on  
the west facade.

Recommending that these cracks be repaired is almost useless until the problems of the foundation movement are first corrected. Previous attempts have been made to strengthen the foundation by pouring reinforcing walls in front of the base of the exterior walls. However, this has not helped because this reinforcement wall has cracked in the same areas as the original walls (fig. 29). These

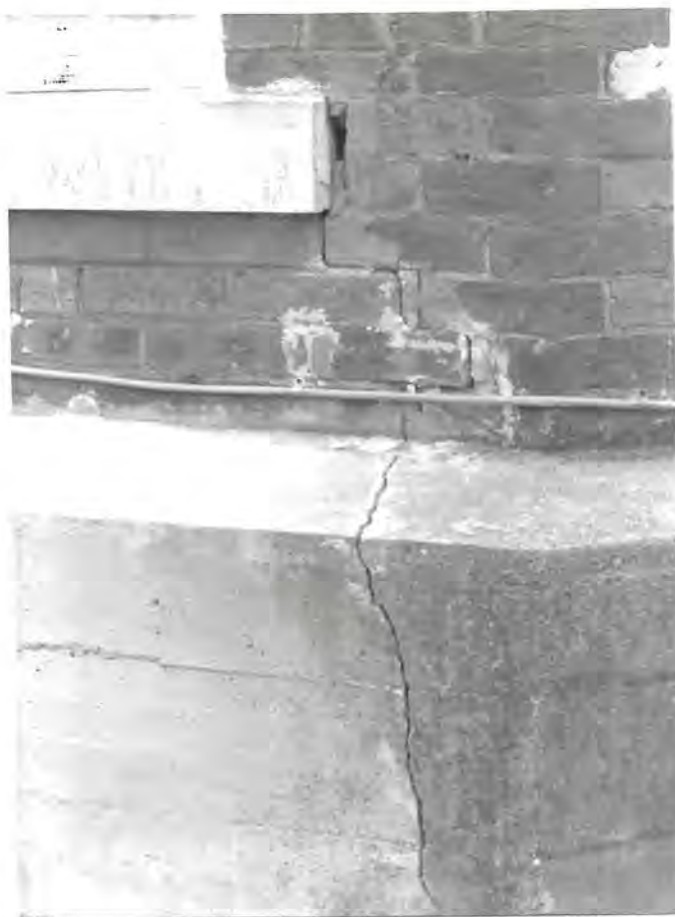
Fig. 29.  
Exterior reinforcement walls  
have cracked with  
the shifting of  
the house.

reinforcement walls can be seen on the west facade's south wing, and along the wall which connects the porte cochere on the east facade. When the foundation is repaired, these cracks can be repaired. Major brick failures not related to the foundation can be seen in the outbuildings, especially the wellhouse. These brick buildings are collapsing from the crenellations down (fig. 30) due to deterioration of the

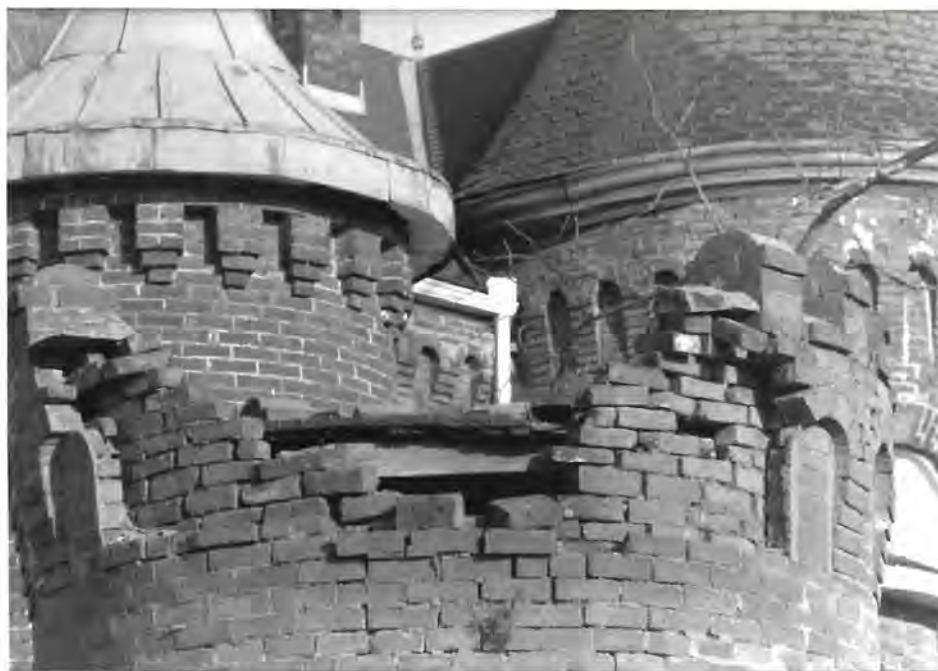
Fig. 30. Outbuildings are deteriorating from the foundations to the crenellations.

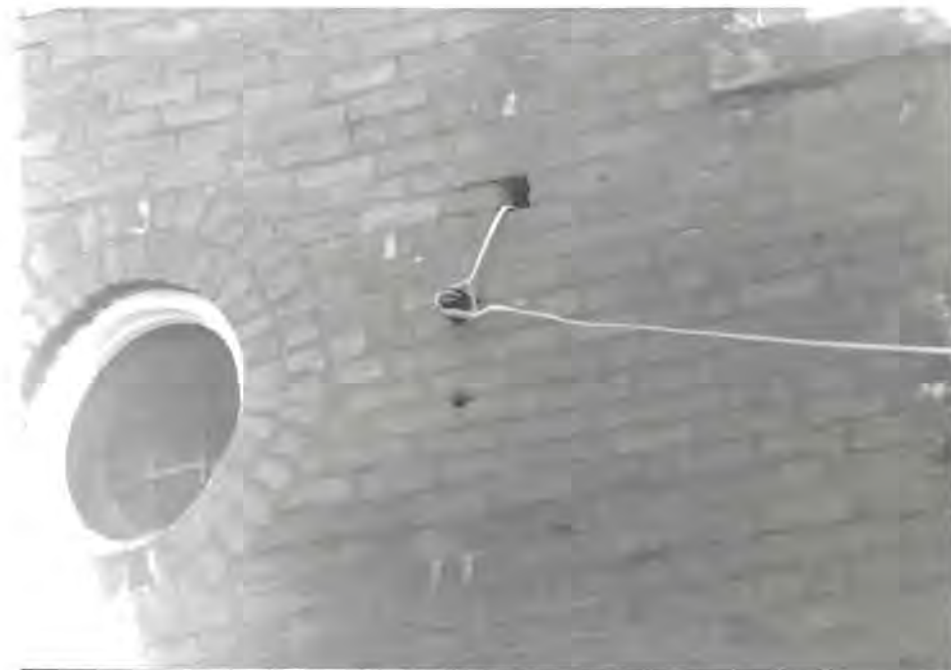
Finally, there are other minor structural problems which deserve mention. Several holes have been punched through the brick walls for installation of early electrical wiring (fig. 31). These holes should be closed, especially

Fig. 31. Holes have been punched in the brick for electrical wiring.

if they have no supporting lintels. A second problem is the large amount of moss growing in the connecting walkway of the back door of the cistern turret and the smokehouse, wellhouse, and storeroom. This growth is proof of water penetration from the deteriorated metal roof, and it is creating a serious problem because moss encourages the brick to retain moisture (fig. 32).

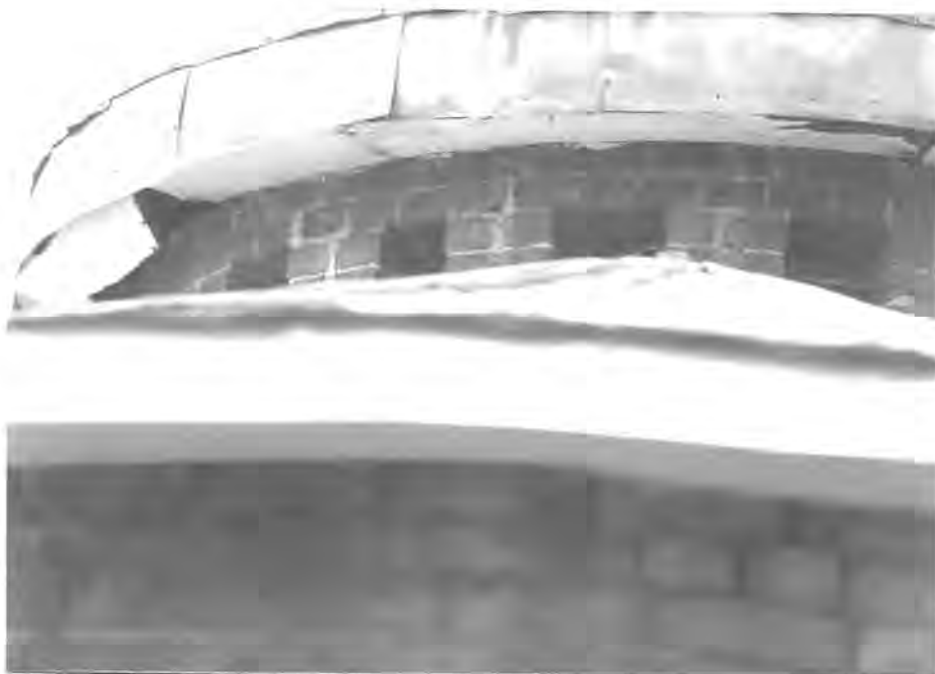
Fig. 32. The metal roof of the smokehouse is very deteriorated, allowing water penetration.

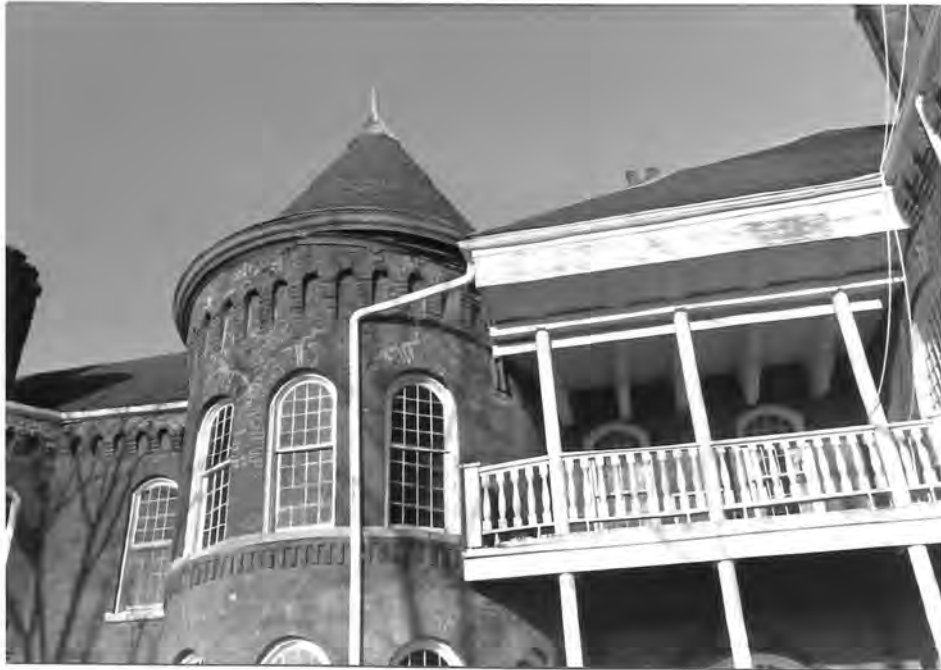
A final structural problem is the wooden balcony, on the west facade, which is supported with steel support beams. At this time the wood is beginning to rot away (fig. 33). The balcony is dangerous in its present condition. For it to be of any practical use, it probably should be rebuilt. An alternative which might be considered would be to remove the balcony completely. The balcony placement and access give no indication of being original to the structure. The other balconies and porches of the building have full length windows or doors and are constructed of

Fig. 33. Wooden porch on south facade shows deterioration of left corner.

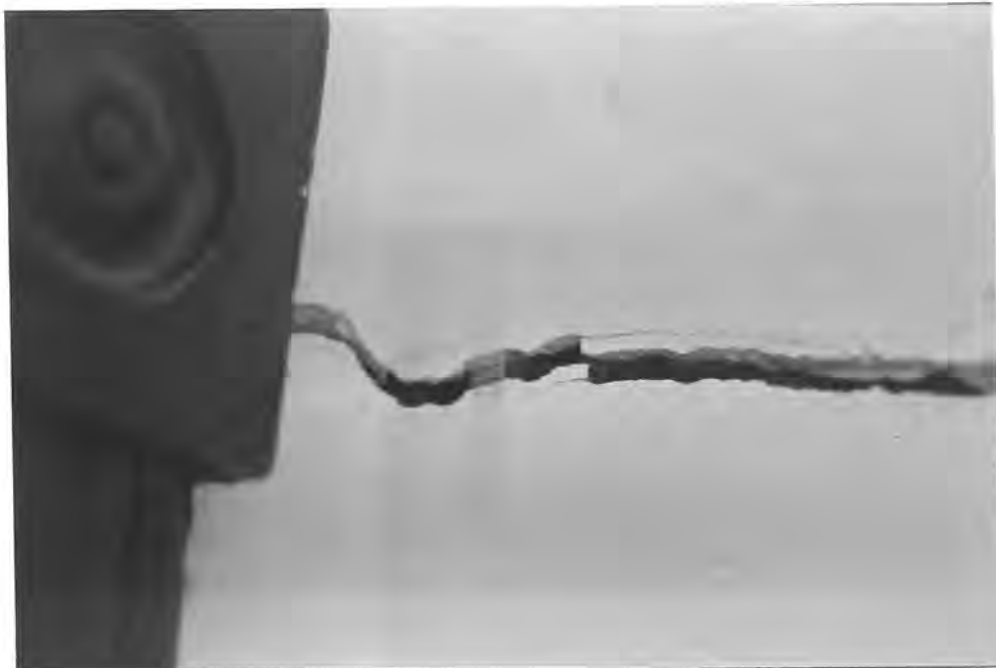
a crack detector was placed over one of the worst examples which appeared in the north wall of room 114. When checked again in March 1984, the indicator showed the crack had increased in width by one-quarter inch (fig. 34). Other

Fig. 34. The crack detector in room 114 shows one-quarter-inch movement from October 1983 to March 1984.

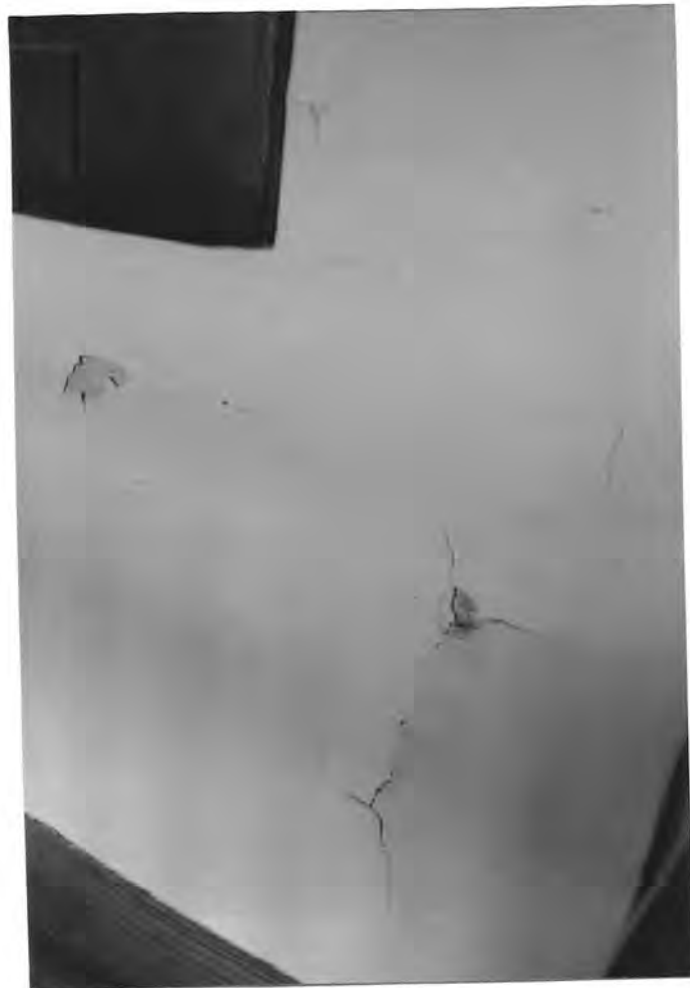
The crumbling plaster and peeling paint in the south wall of room 113 indicate the presence of moisture in the wall (fig. 37). "Rising damp" is caused when standing ground water is absorbed by the foundation and passed into

Fig. 37. Peeling paint and crumbling plaster in room 113 are due to rising damp.
