HUNDRED OAKS CASTLE: ITS PAST,  
PROBLEMS, AND POTENTIAL  
Winchester, Tennessee

A Historic Structures Report

A Public Service Research Project of the  
Historic Preservation Program  
Department of History  
Middle Tennessee State University  
Murfreesboro, Tennessee

May, 1984

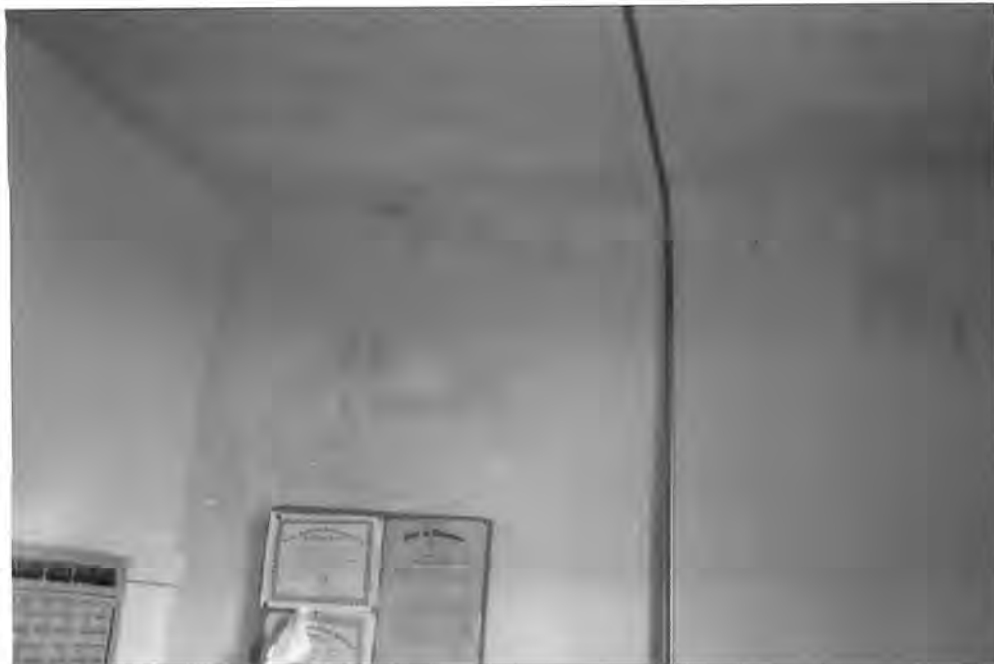
Another moisture problem resulting not only from rising damp but also from leaks in the roof and around structural openings is mildew (fig. 38). The final remedies for mildew

Fig. 38. The exterior walls in room 116 have mildewed.

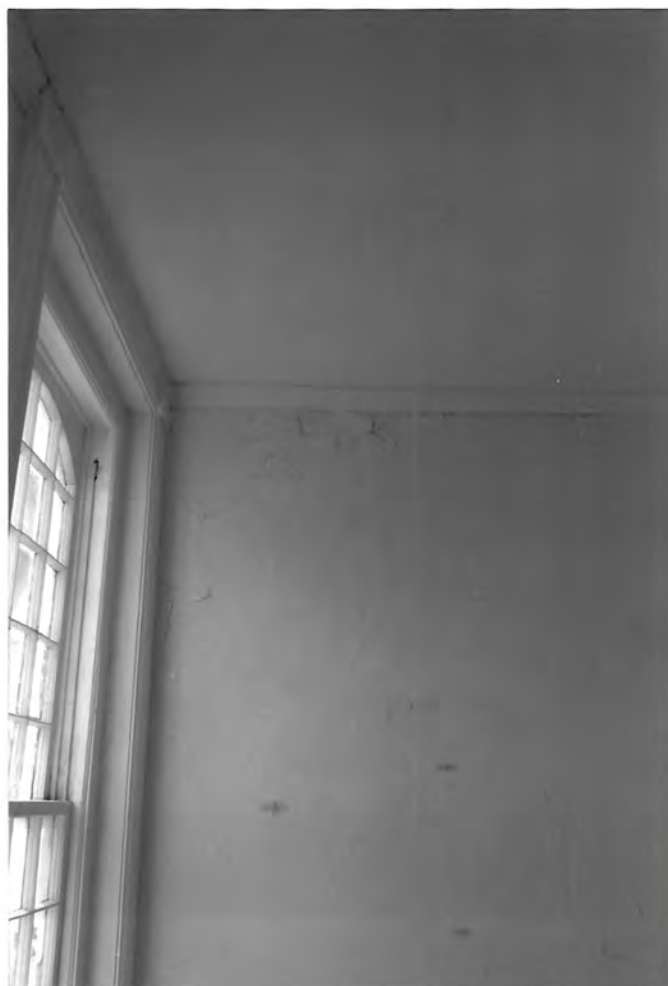
Fig. 39. Peeling paint, and ceiling and wall separation have occurred in room 209.

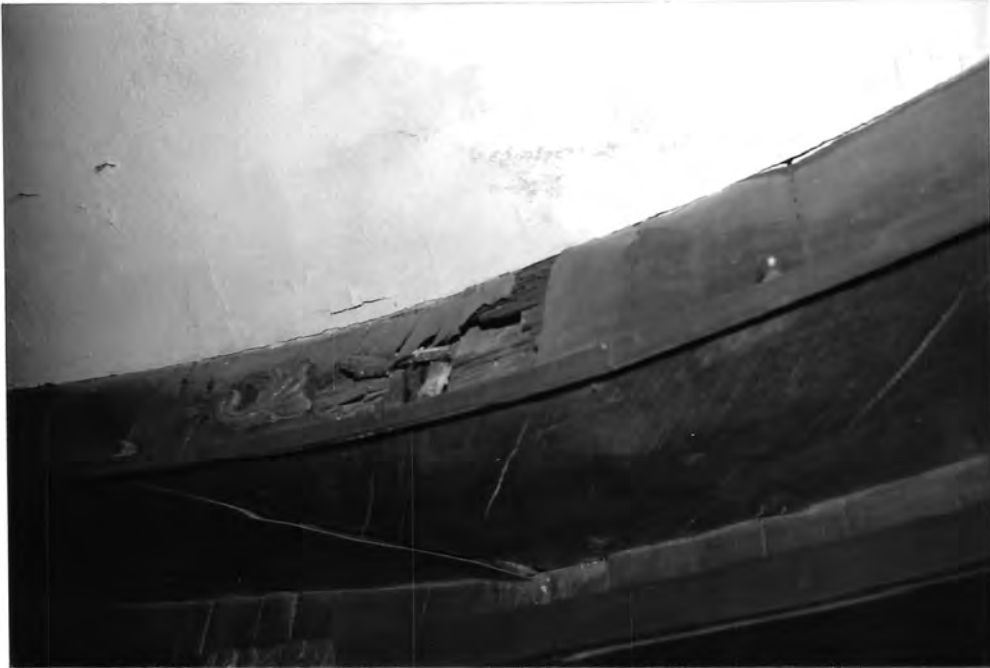
Fig. 40. Peeling paint and rotting molding  
in round turret kitchen.

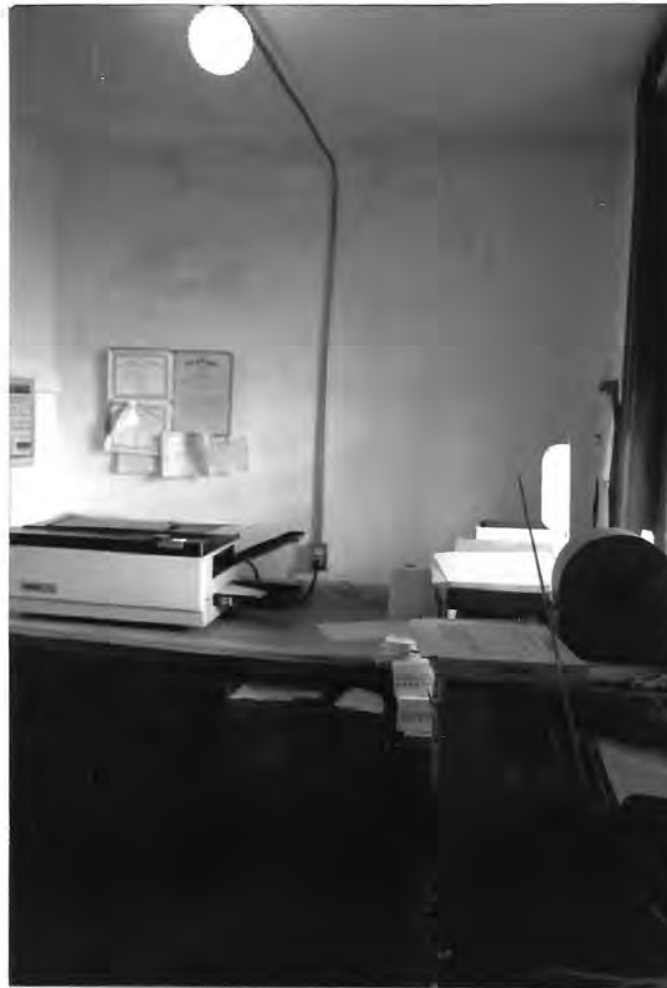
Relatively little work would need to be done to convert the rooms into dining areas. However, room 115 (fig. 45), would possibly benefit from some type of shelving in order to be maintained as a pantry or station.

Fig. 45. Room 115, now in use as clerical space.

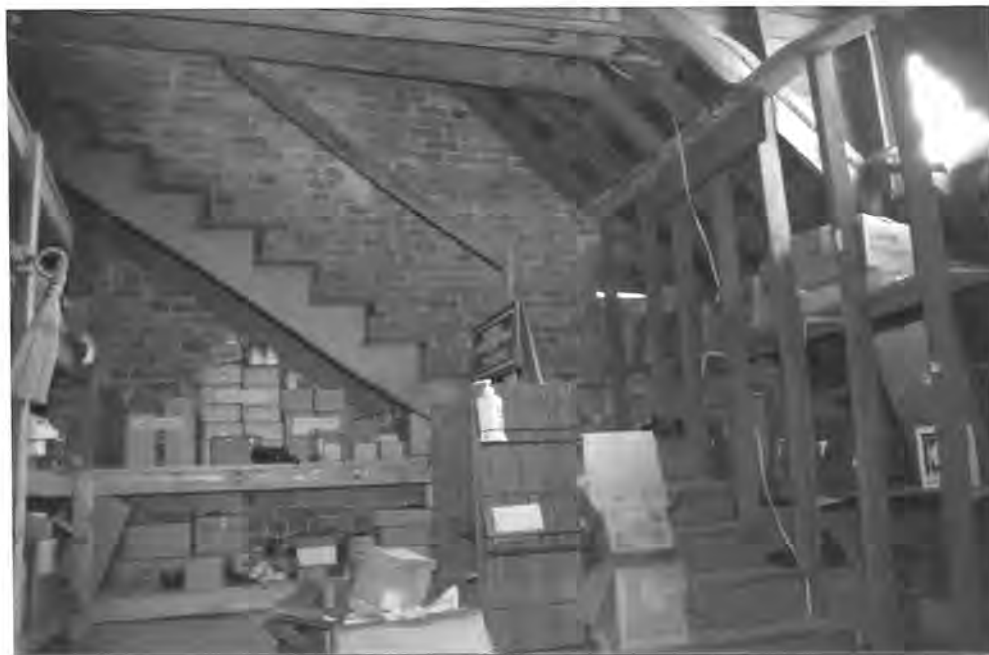
Thought will have to be given to the installation of electricity, heating, lighting, and phone service connections. Before drywall, trim, flooring, and painting is done, a qualified contractor should be consulted concerning local fire codes and building codes. The existing light filters through two clerestory dormer windows which are utilized in the loft section as well (fig. 46). Exposed rafters and beams would have to be covered and the ceiling area insulated. The present exposed brick wall on the west

Fig. 46. Room 201. Showing clerestory lighting and exposed rafters.

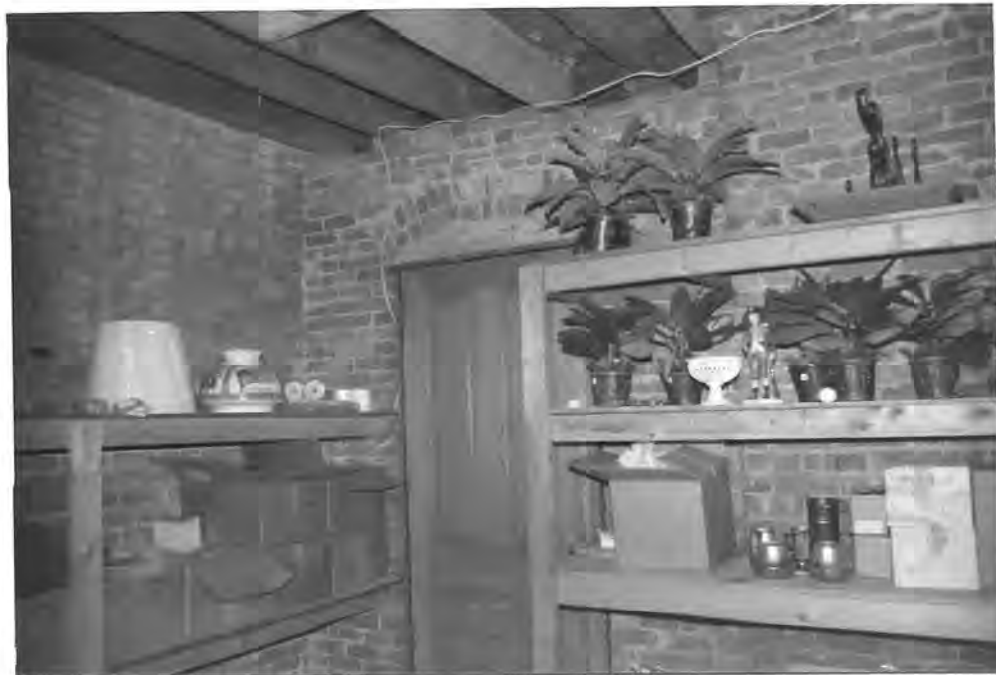
adjoining wall could be left exposed for aesthetic reasons (fig. 47). It is possible that heating and ventilation may be run through the fireplace flues to save space and conceal the ducts though lack of space is generally not a concern at

Fig. 47. Room 201. Exposed brick on west wall which could be kept for aesthetic reasons.

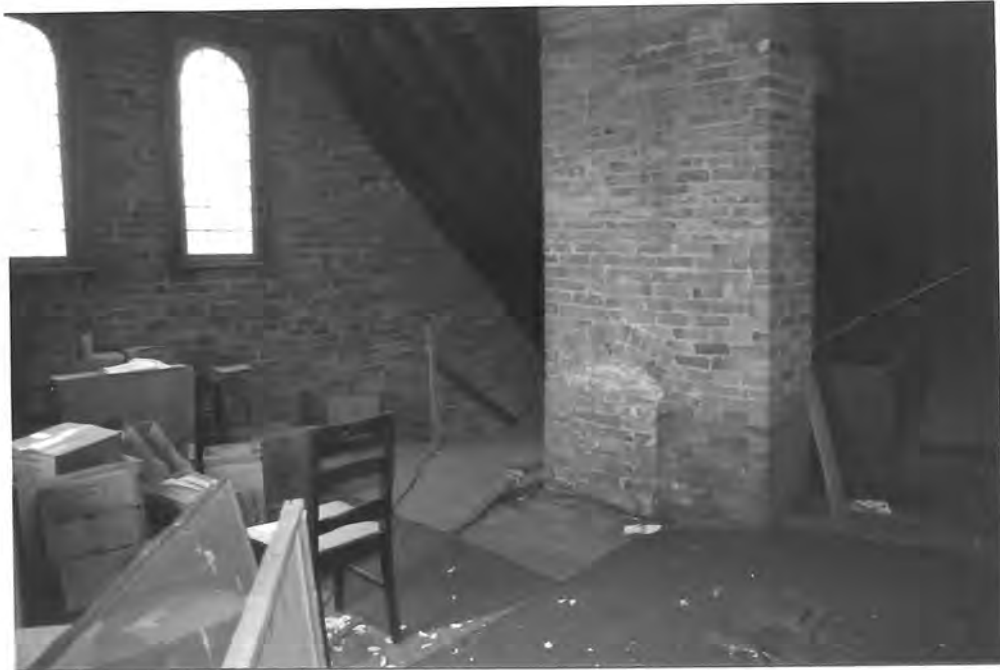
this property (fig. 48). The two floors could be divided, with the lower level serving as clerical offices and the upper level providing office space for the director.

Fig. 48. Room 202. Loft area showing chimney flue through which to run wiring, if not already utilized.

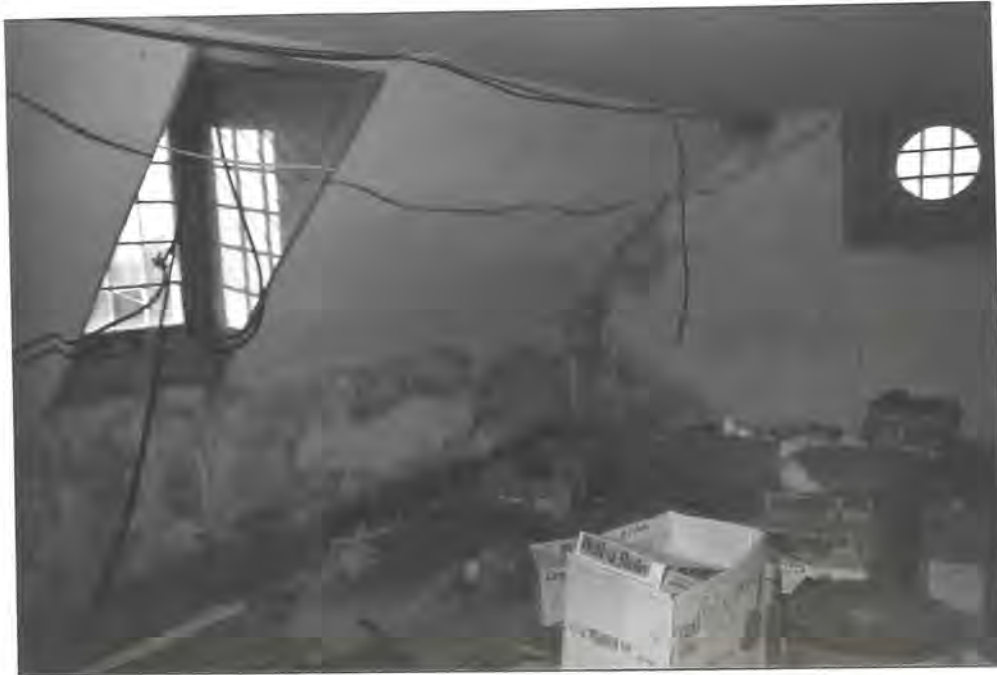
containing a bedroom and bathroom in room 211 (fig. 53), and a living room/kitchen space in room 212 (fig. 54). It has little remaining historical integrity in its interior spaces and frees other historically furnished and decorated spaces for bed-and-breakfast clients. A qualified architect should be consulted for the design and specifications.

Fig. 53. Room 211 would be rehabilitated as a caretaker's bedroom and bathroom.

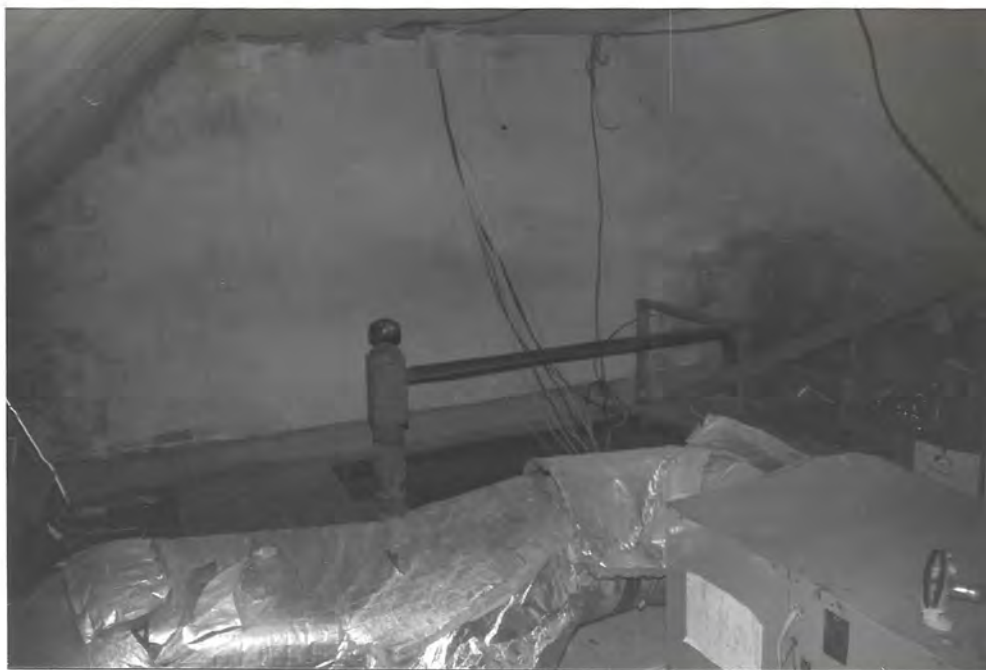
Fig. 54. A living room and kitchen space would be installed in room 212.

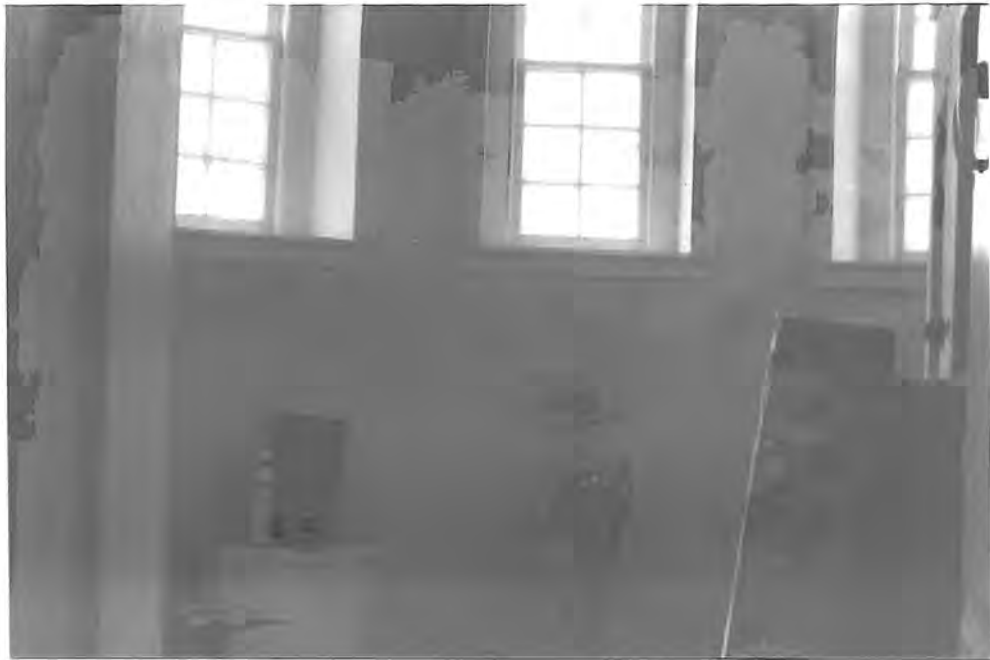
Fig. 55. The derelict bathroom space in room 218 should be repaired.

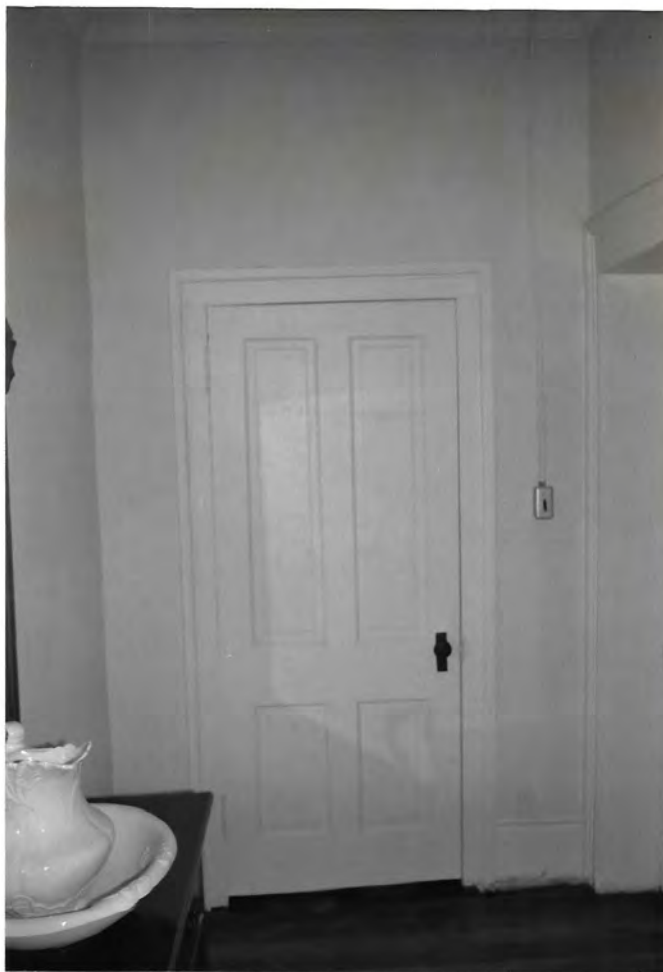
training would minimize strain on staff, and increased level of worker competence would allow for easier expansion. The final stage would consist of remodeling closets 203 A and B (fig. 62), and 205 A and B into private bathrooms, allowing a suite in rooms 207, 208, and 209 to be opened.

Fig. 62. This space could become a private bathroom for room 203.

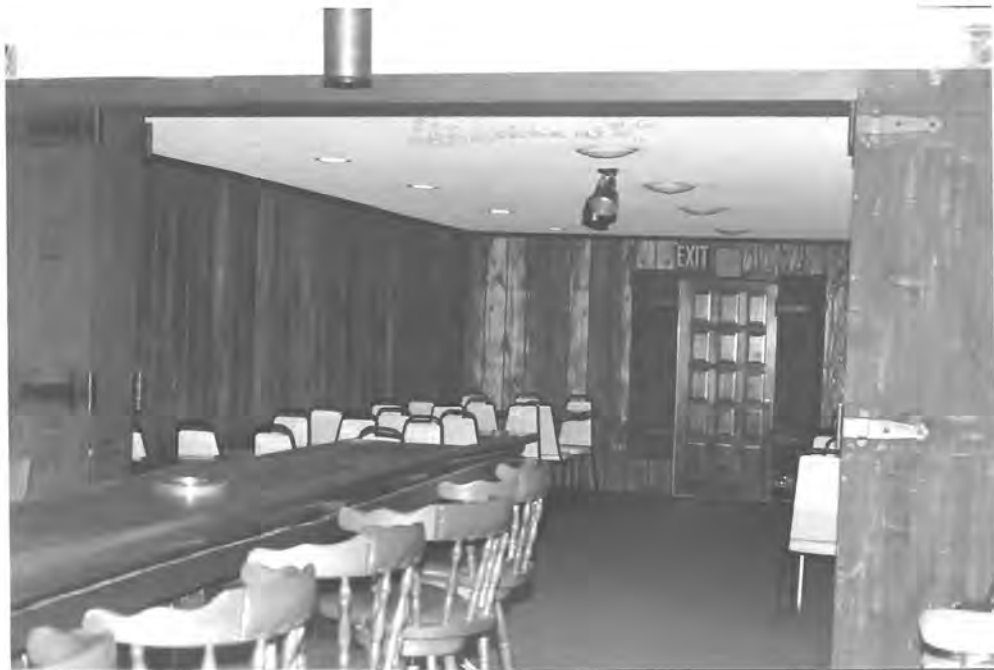
The present barroom located in room 109 (figs. 63 and 64) could be converted into a sitting lounge and furnished with television, tables, and lounge chairs. This would require additional lighting and electrical outlets; the area is presently much too dark. Removal of the existing bar will have to be considered, or possibly a new function as a

Fig. 64. The present barroom in 109 could be a sitting lounge and entrance for the bed and breakfast.

snack bar. This may require installation of new cooking and refrigeration facilities if the present kitchen does not suffice. The most feasible alternative would be the removal of the bar.

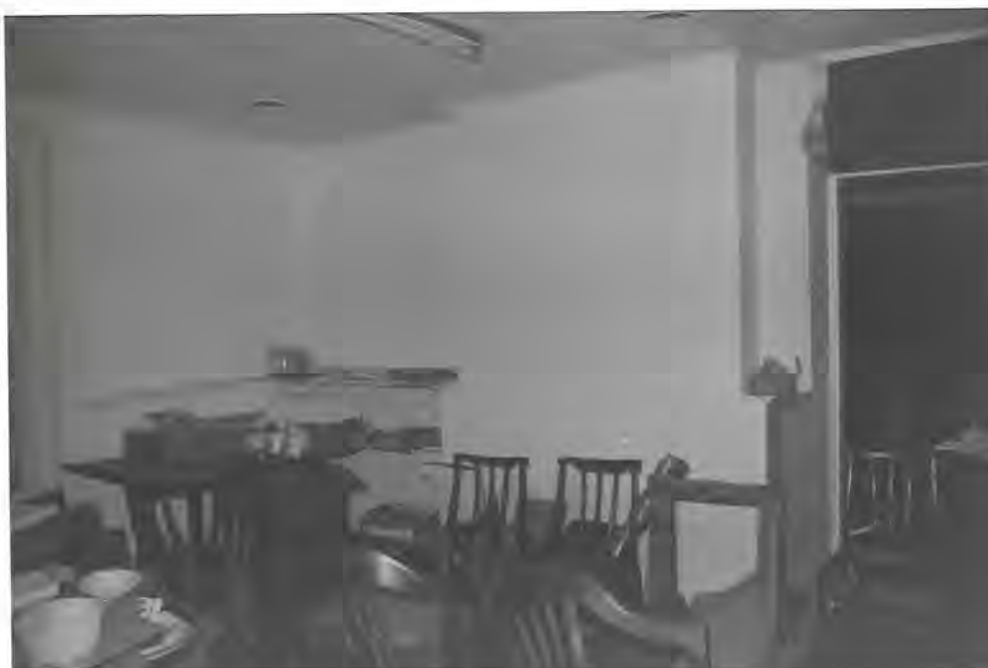
The adjoining room 110 (fig. 65) is recommended as the registration desk for the bed-and-breakfast. It has pleasant ambience with its wainscoted walls and is directly below the caretaker's apartment for convenience.

Fig. 65. This space would serve as entrance to the caretaker's apartment and registration desk.
