# Uniform Residential Appraisal Report

## SUMMARY

| Opinion of Market Value | \$518,000 | Market Value Condition | As Is |

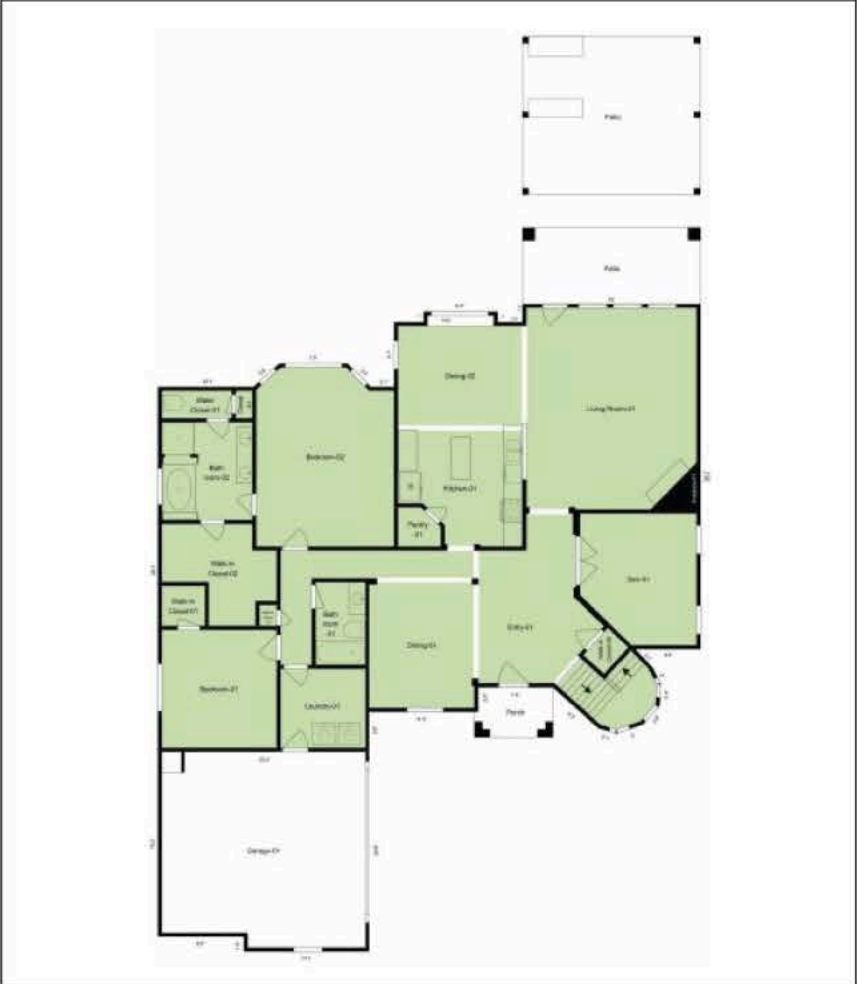
Dwelling 1 - Above Grade, Level 1

| Finished Area | 2,265 Sq. Ft. |
| Non-standard Finished Area | 0 Sq. Ft. |
| Unfinished Area | 0 Sq. Ft. |
| Garage | 453 Sq. Ft. |
| Total Area | 2,718 Sq. Ft. |

The Square Foot Calculations are consistent with the Square Footage-Method for Calculating: ANSI Z765-2021. Finished square footage calculations for this structure were made based on estimated dimensions only and may include unfinished areas, or openings in floors not associated with stairs, or openings in floors exceeding the area of associated stairs.

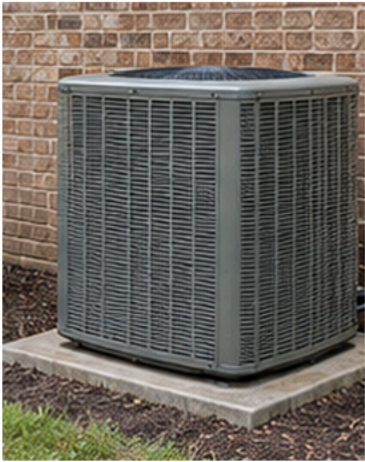
AC Unit

Quality rated Q3 based on two-story design with multiple gables/arched entry, mixed masonry exterior (brick with stone accent and stucco section), and a large covered rear patio with exposed wood framing and decorative braces. Condition rated C3 reflecting maintained exterior surfaces and site improvements with no visible deferred maintenance; only minor wear noted at HVAC condenser and typical garage floor staining.

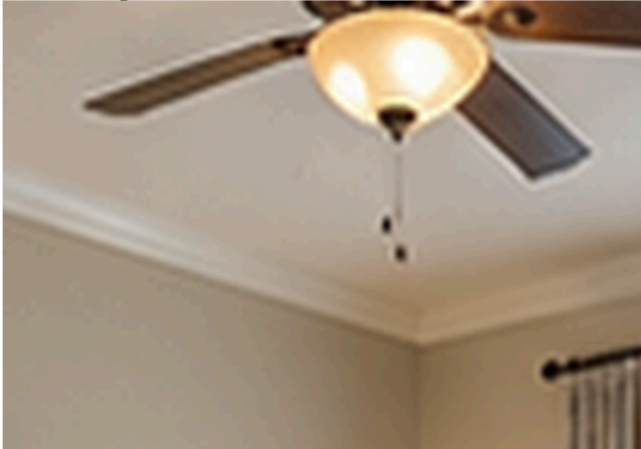
| <div>Level 1 - Bedroom</div> <div></div> <div>FICTIONAL EXAMPLE</div> | <div>Level 1 - Ceiling Detail 1</div> <div></div> <div>FICTIONAL EXAMPLE</div> |

| Feature | Location | Description | Affects Soundness or Structural Integrity | Recommended Action |
|---|---|---|---|---|
| Walls and Ceiling | Ceiling Detail 1 | Ceiling patching/discoloration at corner per the borrower the cause of the staining has been repaired. No further inspection is required. | No | None |

The cost to cure the single noted instance of deferred maintenance (damaged sheetrock ceiling) is estimated at less than \$500. Given the relatively minor nature of this item and the reasonable likelihood that the comparable sales utilized may have similar isolated instances of deferred maintenance, no adjustment was applied in the Sales Comparison Approach.

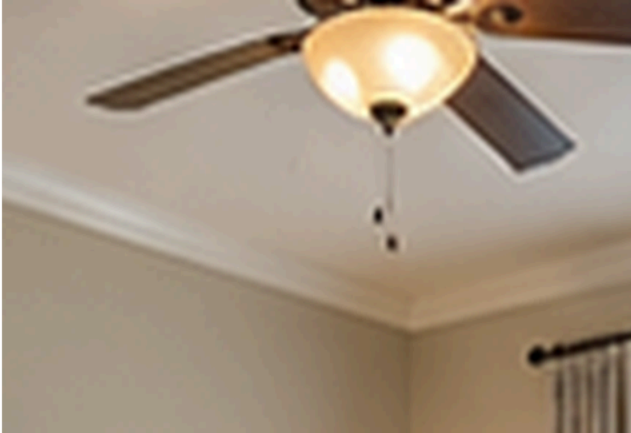
Apparent Defects, Damages, Deficiencies - Walls and Ceiling - Stained Ceiling

A close-up photograph of a ceiling fan and a light fixture, showing a dark stain on the white ceiling.

| Feature | Location | Description | Affects Soundness<br>or Structural Integrity | Recommended<br>Action |
|---|---|---|---|---|
| Walls and Ceiling | Ceiling Detail 1 | Ceiling patching/discoloration at corner per the borrower the cause of the staining has been repaired. No further inspection is required. | No | None |

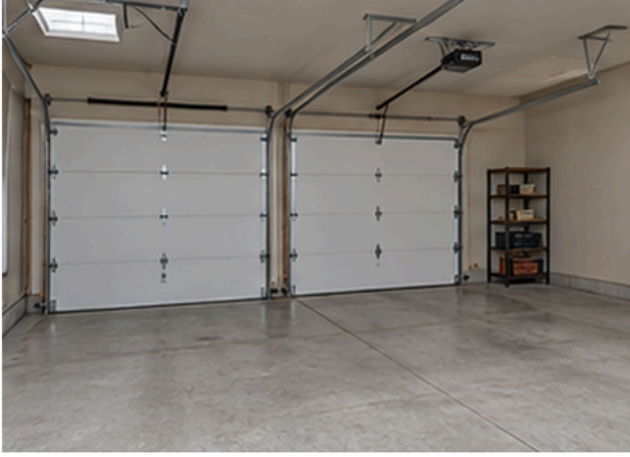
Apparent Defects, Damages, Deficiencies - Garage

| Feature | Location | Description | Affects Soundness or Structural Integrity | Recommended Action |
|---|---|---|---|---|
| Garage | Garage floor | Concrete floor staining/marks consistent with typical garage use. | No | None |

| Feature | Location | Description | Affects Soundness<br>or Structural Integrity | Recommended<br>Action |
|---|---|---|---|---|
| Garage | Garage floor | Concrete floor staining/marks consistent with typical garage use. | No | None |
