# The Evergreens Carriage House: A Case Study of Sustainable Reconstruction

Shantia Anderheggen

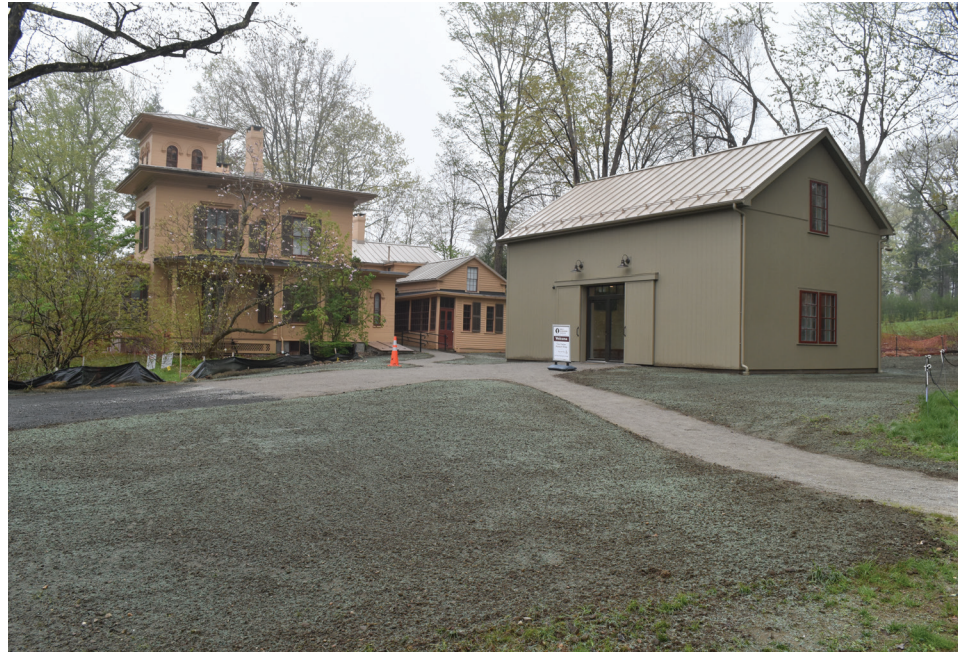
Fig. 1. The Evergreens, built ca. 1856, and its newly reconstructed carriage house, Emily Dickinson Museum, 280 Main Street, Amherst, Massachusetts. Photograph courtesy of Preservation Strategies, 2025.

In the world of historic preservation and cultural resource stewardship, routine maintenance and occasional capital projects are ongoing struggles for most historic building owners; undertaking a project to recreate a previously existing historic building is especially rare. The recent project that reconstructed a historic carriage barn at the Emily Dickinson Museum is a significant contribution to historic preservation and possibly a unique accomplishment: a reconstruction that meets *The Secretary of the Interior's Standards for the Treatment of Historic Properties* and certification by the Passive House Institute US (Phius), a US-based nonprofit organization “committed to decarbonizing the built environment” (Fig. 1).<sup>1</sup>

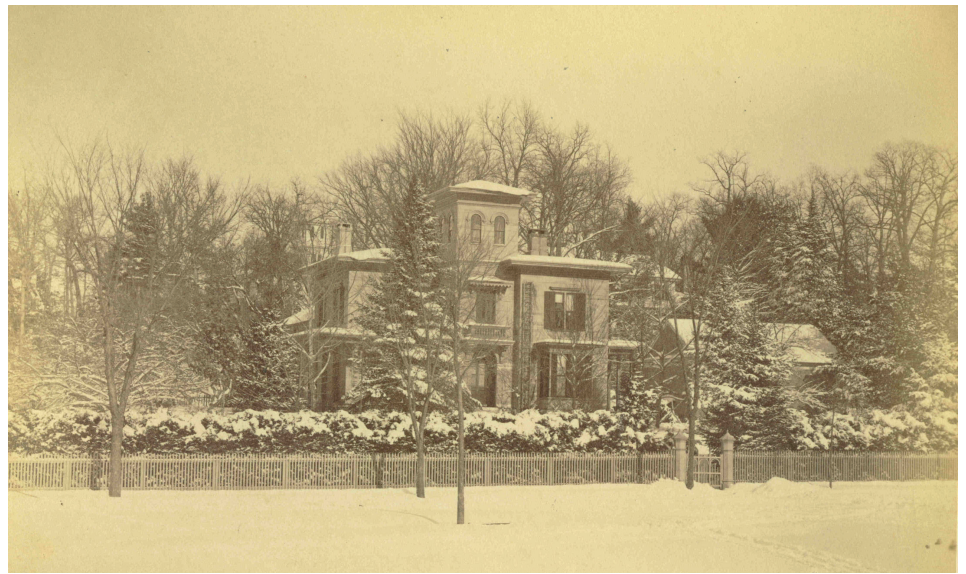
Fig. 3. The Evergreens, viewed from the south, with its original carriage house (right) by Charles Prouty, 1870. Photograph courtesy of the Jones Library, Inc., Amherst, Massachusetts.

From the mid-nineteenth century until the mid-twentieth century, the small outbuilding known as the Carriage House stood just east of The Evergreens, visible from Emily's second-story bedroom at the Homestead (Fig. 3). Demolished in the mid-1950s, this building's location and general appearance are known from documentary and archival evidence, as well as from scant physical evidence (e.g., several foundation stones and

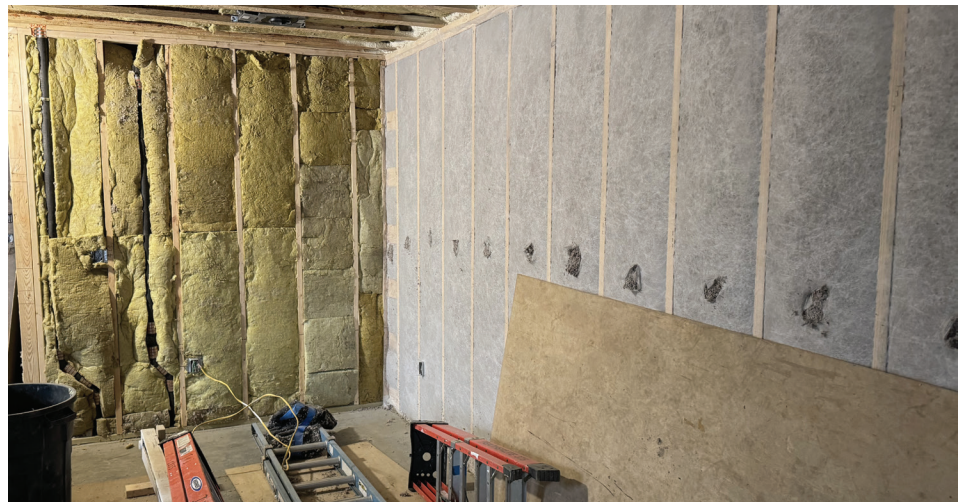
Fig. 4. The Carriage House, showing modern wood structural framing with cellulose insulation within the sidewalls. Photograph courtesy of Teagno Construction, Inc., 2025.

Like the roof, the building's sidewall cavities were infilled with cellulose insulation, an approach that made the walls exceedingly energy efficient while maintaining an exterior appearance consistent with photographic evidence and compatible with the surrounding historic buildings. The museum initially preferred a historically accurate and time-tested material such as wood for the exterior siding; however, a durable, inorganic modern material—combining polymers and fly ash and capable of effectively replicating the appearance of historic wood board siding with vertical nickel-gap shiplap—was ultimately chosen for the building's sidewalls

(Figs. 4 and 5). One small but critically important detail was added at the east and west gable-end walls: the siding was constructed to flare out slightly between the first and second stories to represent a clear distinction that is evident in one archival image of the historic building (Fig. 6). Finally, the flat-stock trim boards at the doors and windows were made from the same material as the siding. All exterior surfaces of the building were then primed and painted with acrylic-latex paint in a color determined through paint analysis of the historic fence (now reproduced) fronting the property on Main Street.

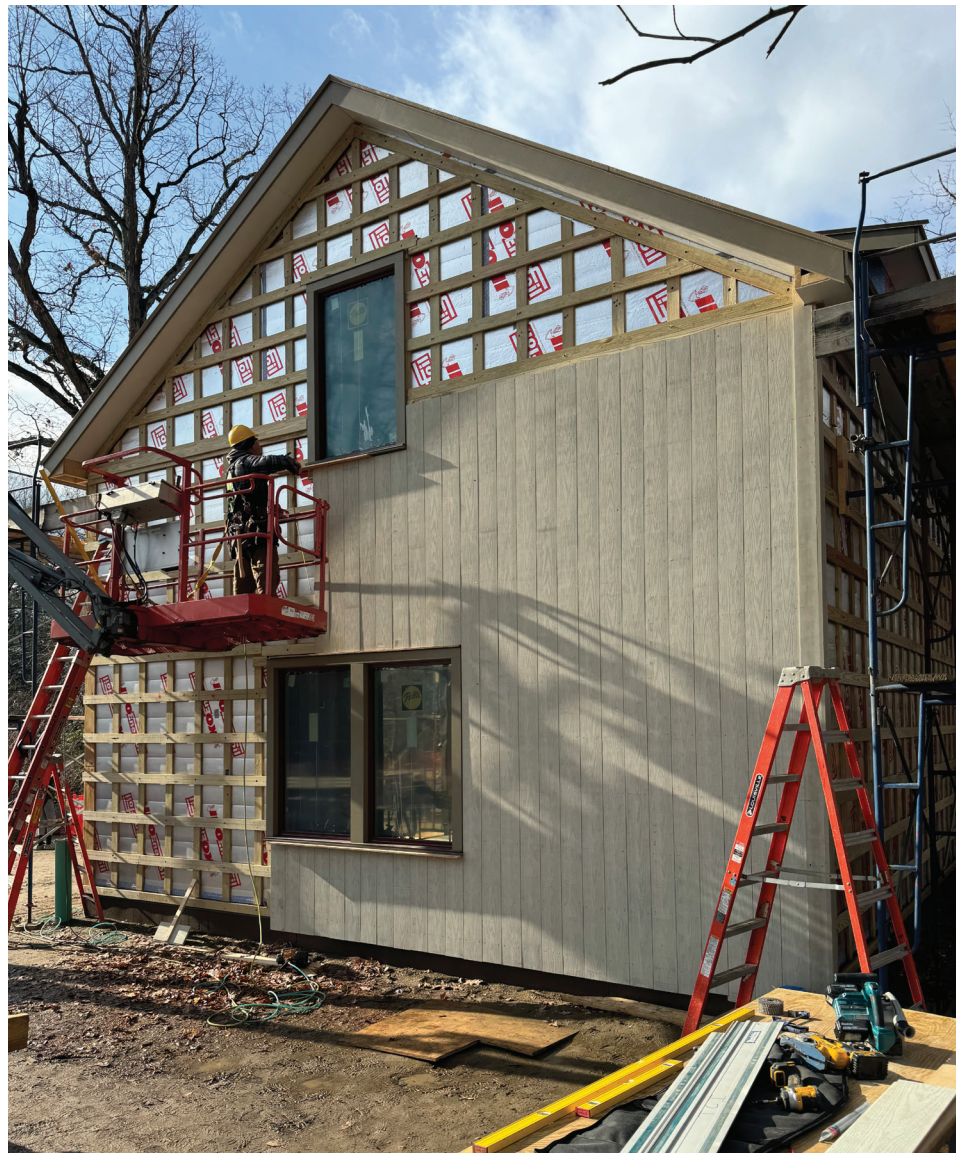
Fig. 5. The Carriage House, exterior walls, showing vertical nickel-gap shiplap siding made of polymers and fly ash, replicating the original building’s wood board siding. Photograph courtesy of Teagno Construction, Inc., 2025.

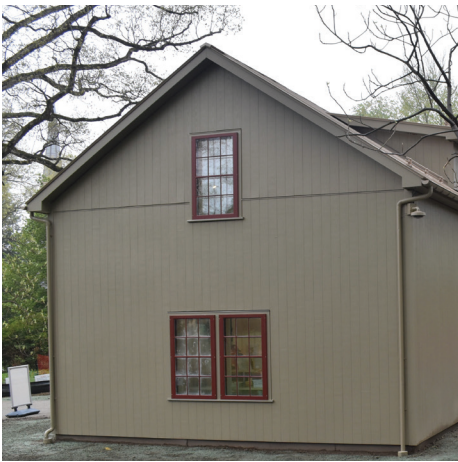
Fig. 6. The Carriage House, east sidewall, showing the juncture between the first and second stories of the gable-end walls that was subtly recreated. Photograph courtesy of Preservation Strategies, 2025.

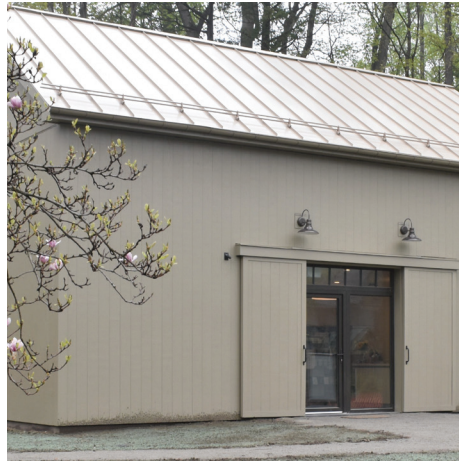
Fig. 7. The Carriage House, south façade, featuring a modern entry door system concealed by traditional sliding "barn" doors when not in use. Photograph courtesy of Preservation Strategies, 2025.

The choice of doors (a visitors' entry on the south façade and a staff entry at the west wall facing The Evergreens) was more challenging because of the need to balance historic compatibility with high energy efficiency. Documentation confirms that the historic building's south façade featured double barn doors. The problem of concealing the modern, energy-efficient, fiber-reinforced PVC door that was required to meet the Phius certification energy goals was solved by using a time-tested historic preservation approach: slightly recessing the modern glass door unit from the façade wall and installing a

set of sliding "barn doors" to cover the exterior face of the opening (Fig. 7), effectively reproducing a known historic appearance. At the west elevation, a single-entry door in a two-panel configuration, constructed with modern materials (polyurethane core encased in steel), leads to The Evergreens' east yard and rear shed.

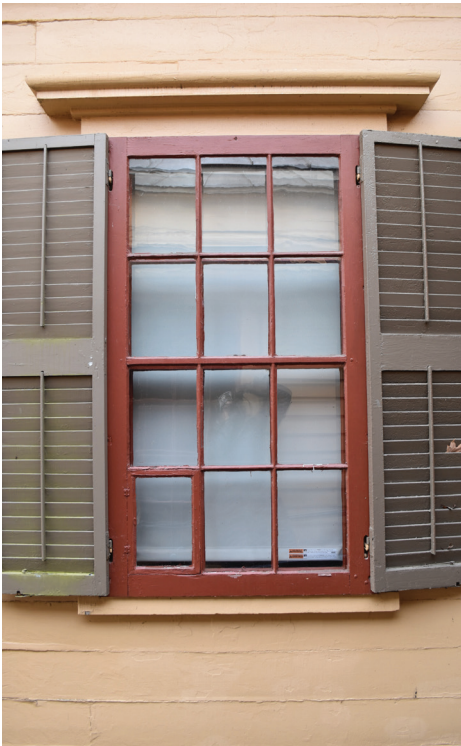
Fig. 9. The Evergreens, north elevation, showing a storm window treatment that served as the design basis for several window openings at the new carriage house. Photograph courtesy of Preservation Strategies, 2024.

light wood storm window, matching the historic storm windows found throughout The Evergreens, was mounted on the exterior of each plate-glass window. The installation of the wood storm windows at the exterior required careful attention because any punctures would compromise not only the ability of the plate-glass window to prevent air intrusion but would also void those windows' warranties (Figs. 8–10). Other design details included half-round metal gutters and downspouts installed at the south and north roof edges and, for heating and cooling, one exterior heat pump unit installed at the rear of the building.

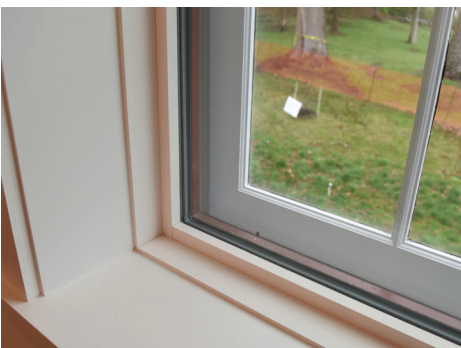
Fig. 10. The Carriage House, interior, showing Pella plate-glass windows used to meet the energy-efficiency requirements of Phius certification, with traditional wooden storm windows applied at the exterior. Photograph courtesy of Teagno Construction, Inc., 2025.

At the rear of the building, which is minimally visible for most of the year, fiberglass awning windows were chosen as a Phius-certified option for the second-story dormer windows. The east and west exterior sidewalls of the building, however, would both be highly visible from Main Street and surrounding parcels, as well as from The Evergreens and the Homestead. At these walls, the finished appearance of the carriage house needed to be more closely aligned with what likely existed on a mid-nineteenth-century building of this type and to be compatible with the historic windows found at the two historic buildings on the site. After months of investigation and deliberation—including consideration of traditional wood sash and storms, as well as both vinyl and fiberglass alternatives—the museum team landed on a creative solution for the four window openings at the east and west sidewalls. To achieve the airtightness required by Phius, a fixed plate-glass window (with a wood interior and aluminum-clad exterior) was installed. To ensure the historic appearance and compatibility with surrounding buildings, a custom-made twelve-
