- Tank Cleaning observations nearby or within MPA
- SCG Observations/Detections of Tank Cleaning Residues in Helcom & Bonn Areas
- Specific Tall Oil Observations

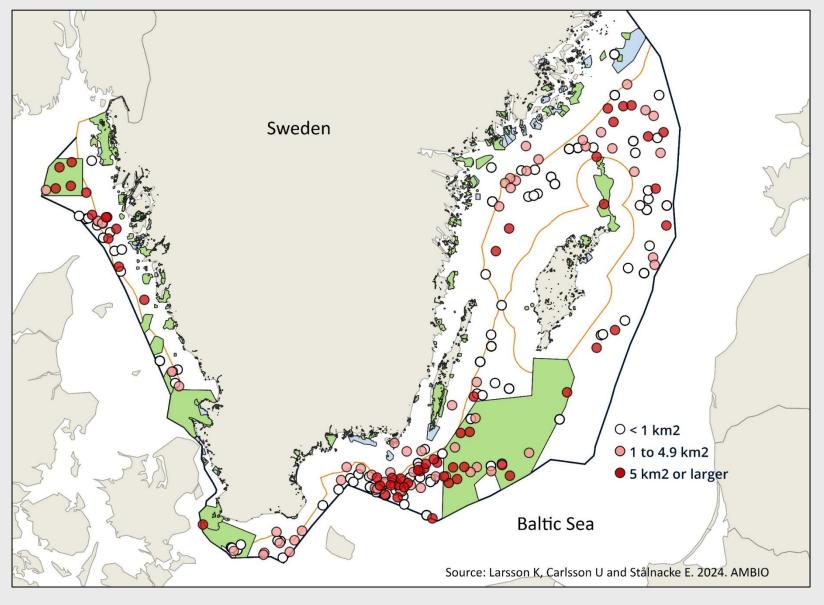
Location of detected discharges of non-petroleum substances in the southern part of the Swedish territorial sea and Swedish EEZ between 2020 and 2023. Size of discharges are indicated by the colour of dots. Green areas show coastal and marine Natura 2000 sites.

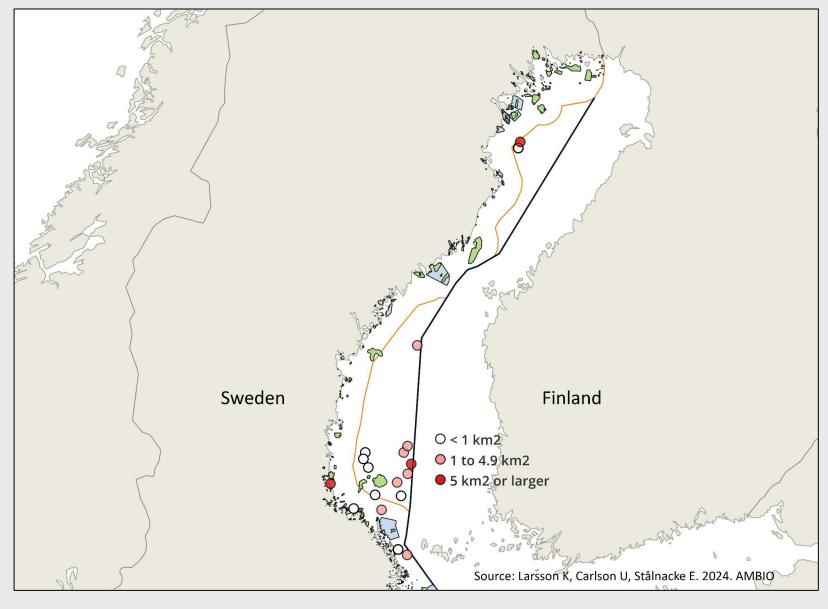
Location of detected discharges of non-petroleum substances in the northern part of the Swedish territorial sea and Swedish EEZ between 2020 and 2023. Size of discharges are indicated by the colour of dots. Green areas show coastal and marine Natura 2000 sites.

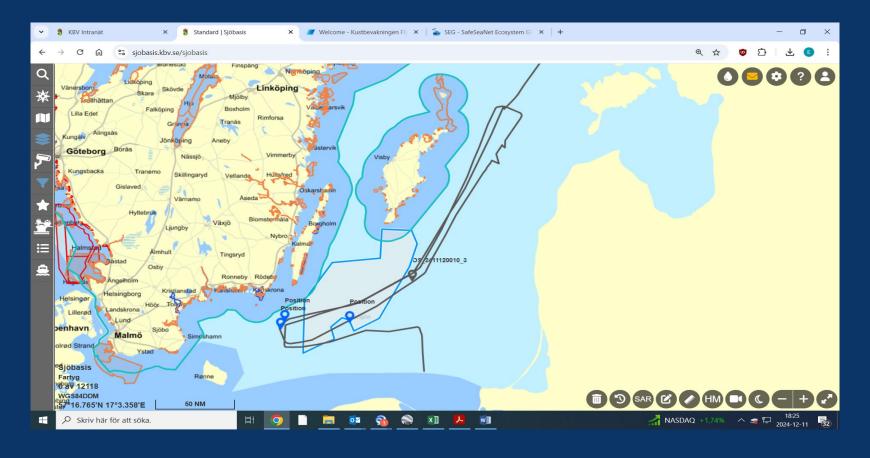
Chemical tanker route through the Baltic sea, tank cleaning, enroute from Gulf of Finland to Poland. Discharge residues of Tall Oil. Blue markers along the route shows EMSA satellite detections of slicks

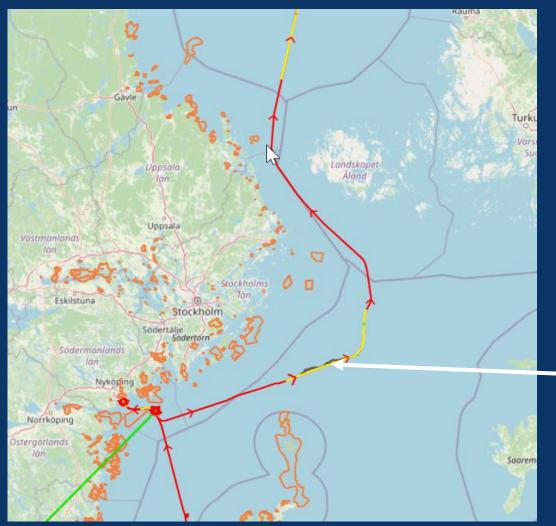
Tank cleaning residue A slick approx 90km long, 200 meters width. Tall Oil Crude & Pitch
