# City of McCammon Water Facilities Planning Study

November 2020

This chapter summarizes existing source, disinfection, storage, and distribution conditions for the City of McCammon's drinking water system. The City's water system, which is described in detail in the following sections, is comprised of one pressure zone, three ground water wells (two for domestic uses), and one water storage tank.

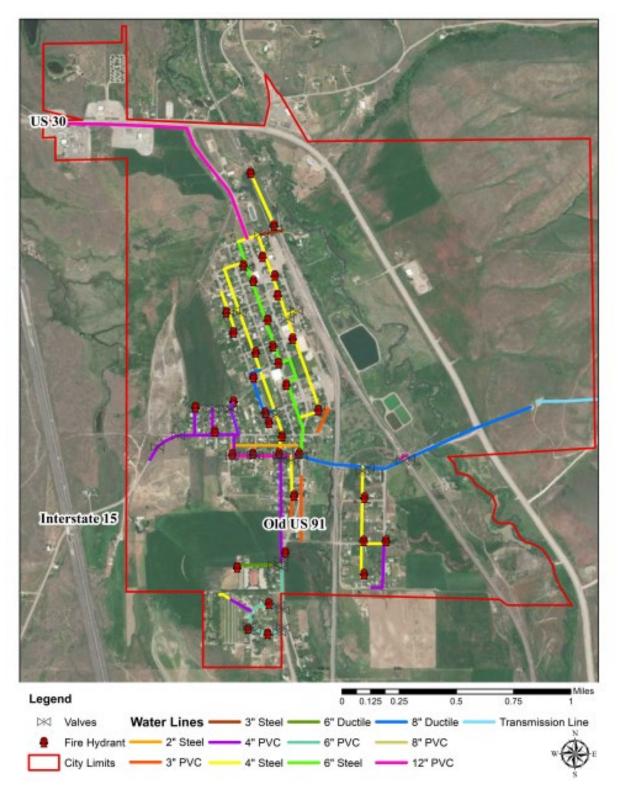
Figure 1-1 McCammon's Existing Water System

Residents within the City of McCammon receive culinary water from a community-wide water system. The City water system was installed following World War I. The original water supply source was Crystal Springs, a high mountain spring located several miles east of McCammon. Since then, three wells and a storage tank have been added to the system. The water supply and distribution system are currently owned and operated by the City of McCammon. The quality of the water is considered very good. However, the groundwater wells tend to produce fine sand and are high in dissolved iron. Currently, the system supplies water to 311 connections. A map of McCammon's water system is shown in Figure 1-1.

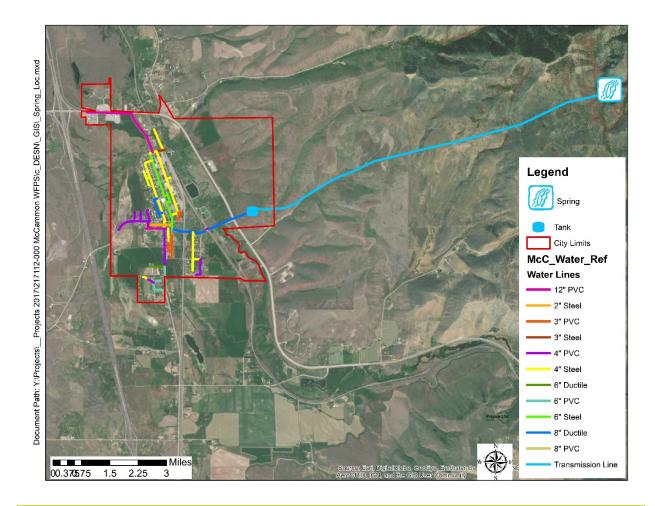
#### Figure 1-2 Crystal Springs

The main source of water for the City of McCammon is Crystal Springs, located approximately 3.5 miles east of the storage tank. The spring provides 540 gpm for the City based on the City's water right. The approximate alignment of the spring transmission line is represented on Figure 1-2. At the spring site, the City owns a 100-foot wide by 300-foot long piece of land. This land is fenced by five-foot high steel panels to keep out animals. A map with the location of Crystal Springs is shown in Figure 1-2.

At the spring, water is collected in two separate collection structures (north/left and south/right) consisting of buried corrugated pipe. Water from both collection structures flows into a large concrete bypass chamber equipped with an overlapping, locking, steel cover from which it flows to the 300,000-gallon water storage tank through a 6-inch cast iron discharge line. The concrete bypass chamber, flow metering manhole and associated piping were built as part of a 1998 construction project. The spring discharge line is equipped with a sample tap and air relief valve. The City holds easements for the spring transmission line allowing them access to the line for maintenance. In addition, the City owns the land where the storage reservoir sits.

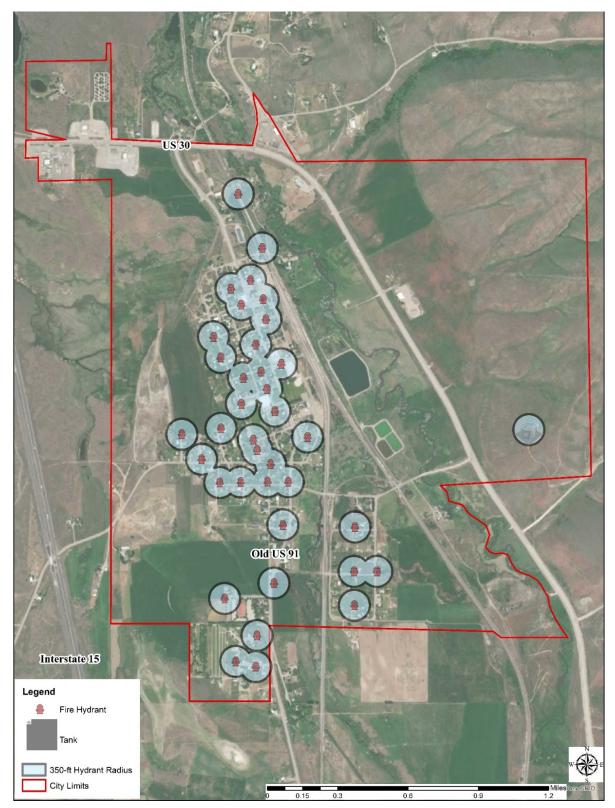
Figure 1-8 McCammon Hydrant Coverage

The system includes 37 fire hydrants and 35 known isolation valves. Of all the fire hydrants, 17 are connected to 6-inch pipe or larger. Most of the fire hydrants in the City of McCammon are older models, many of which are damaged or in poor condition. The isolation valves are in fair condition but are too few to adequately isolate the system. Some portions of the system cannot be isolated without shutting down up to one-third of the water system. The current distribution system also contains several dead-end lines that do not have hydrants or blow-offs for flushing. Dead ends limit water supply to these areas resulting in low pressure and potential stagnant water zones.

Hydrant coverage across the City was evaluated to identify gaps in access to fire hydrants during an emergency. Figure 1-8 shows hydrant coverage based on the location of hydrants with a service radius of 350-ft. The City currently does not have adequate hydrant coverage in some areas. The City should look to install additional hydrants to fill in the gaps shown in Figure 1-8.

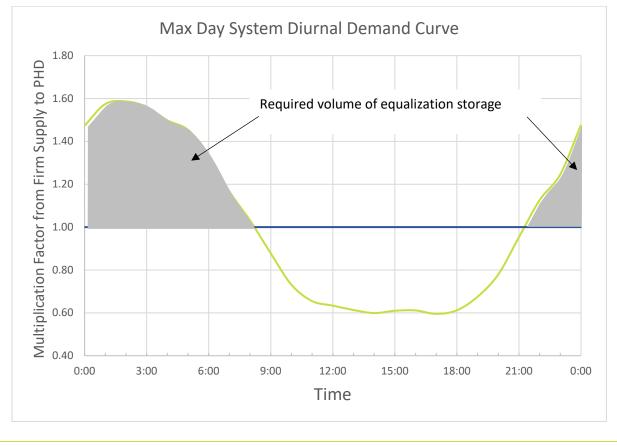
#### Figure 3-1 Typical Diurnal Curve

**Equalization storage** is quantified by the volume of water consumed by the City during high demand times of day that exceed the firm capacity of the system's sources. Equalization storage is a function of the City's diurnal demand pattern. The typical diurnal curve in Figure 3-1 illustrates how equalization storage makes up the difference between demand and firm supply.

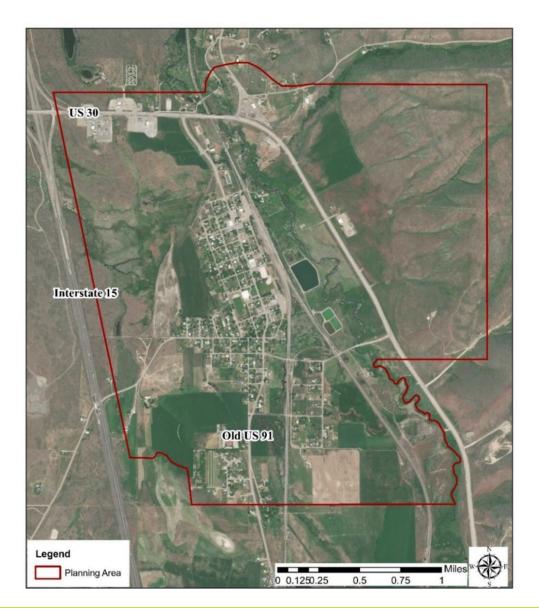
Figure 2-1: McCammon Planning Area

McCammon is situated on a small knoll bounded by the Portneuf River on the east, Interstate 15 on the west, and U.S. Highway 30 on the north. The Union Pacific Railroad runs between the river and the residential area of the City. The planning area of this study includes the area shown in Figure 2-1. This area includes City limits and surrounding areas where future residential, commercial, and industrial growth is likely to occur.

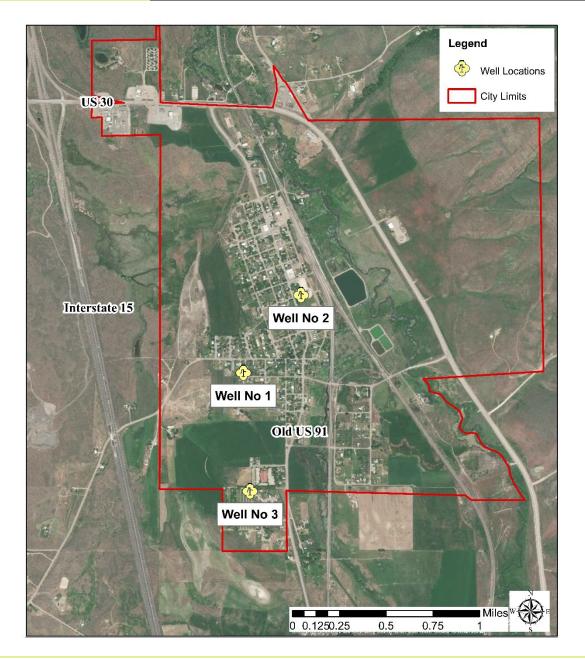
Figure 2-2 McCammon Well Locations

Groundwater levels in the area near the river have been recorded as shallow at 2 feet below ground to 6 to 8 feet below ground. West of the railroad, where ground elevations are 10 to 20 feet higher, groundwater is correspondingly deeper. The main City wells are located west of the Portneuf River as shown in Figure 2-2. A more detailed report of the area hydrology has been completed in the Preliminary Hydrogeologic Study for the Town of McCammon which was written by the Idaho Water Resource Research Institute. A copy of this report has been included in Appendix C.

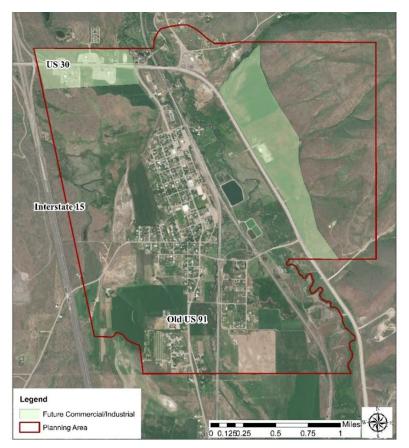
Figure 2-3 Commercial/Industrial Zoning

The land in the planning area is a mixture of developed and farmland. A portion on the north end and east side of town is zoned for commercial/Industrial use. These areas can be seen in Figure 2-3.

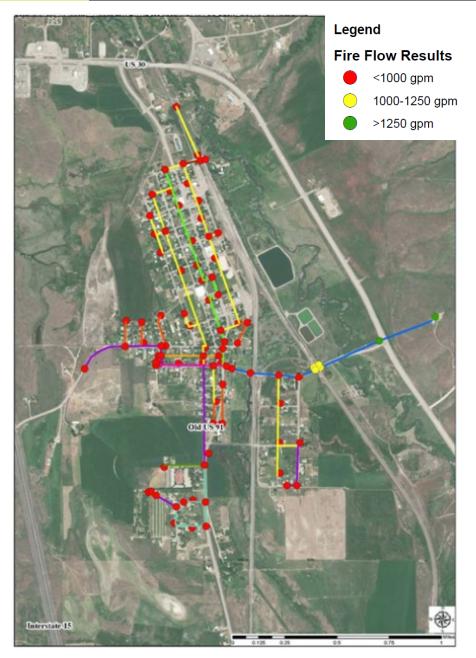
Figure 5-1 Maximum Day Plus Fire Flow Results

The recommended fire flow rates are discussed in Section 4.5 of this report. As shown in Figure 5-1, modeling results under fire flow with maximum day conditions show that only the junction nearest to the tank meets fire flow requirements currently. No hydrants currently meet fire flow requirements due to undersized pipes. The hydrant with the highest available fire flow had a flow of approximately 700 gpm. The average available fire flow for all the hydrants in the City was approximately 362 gpm. This is significantly lower than the base fire flow demand of 1,250 gpm, and the required fire flow at the church of 3,000 gpm and 4,000 gpm at the elementary school.

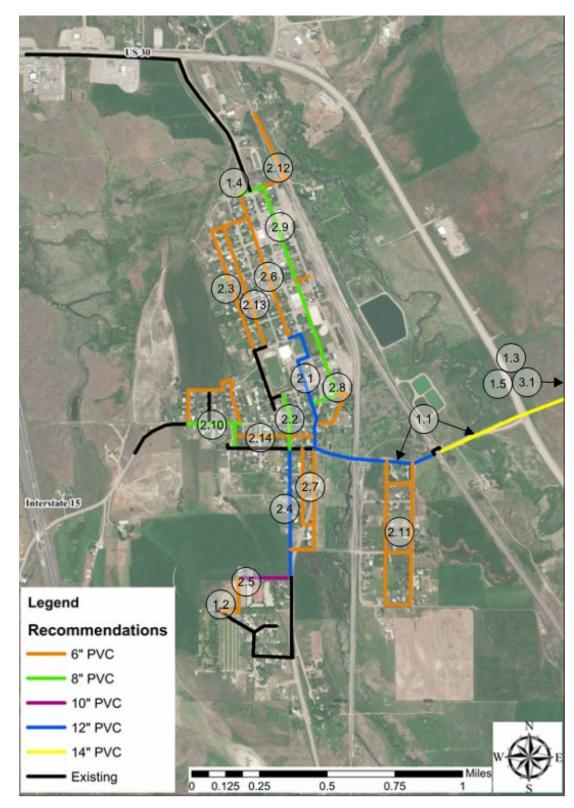
Figure 8-1 CIP Project Map

Figure 8-1 is a map showing the location of all of these improvements within the City.

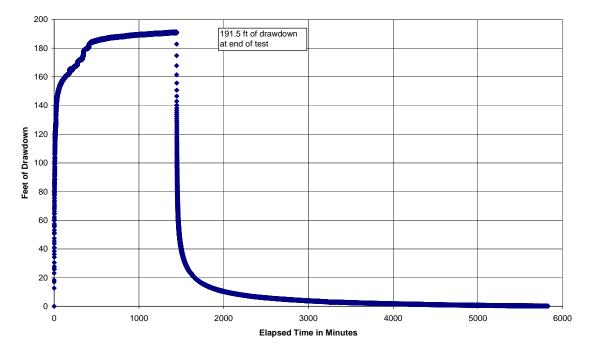
Pumping and recovery test for City of McCammon Bitton Well Average Pumping Rate 206 gpm, July 11-14, 2013

The well no longer produces sand but does produce rust-colored water for a few minutes after startup due to dissolved iron in the water. The well can produce a sustained 206 gallons per minute at 191 feet of drawdown based on the pumping test that was completed as part of the well improvements. The operator allows this well to pump to waste for a few minutes in the spring of the year before pumping into the system to allow the water to clear up. The well report that was submitted as part of this project is included in Appendix A.

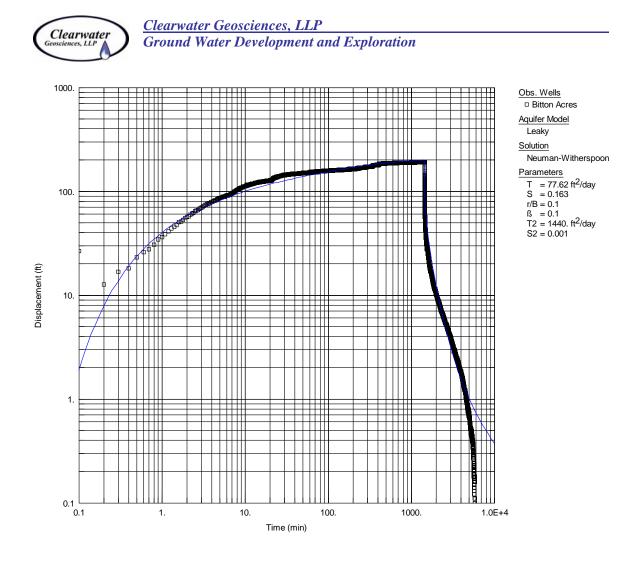
Preliminary Bitton Acres Well Test with no screen, June 11, 2013

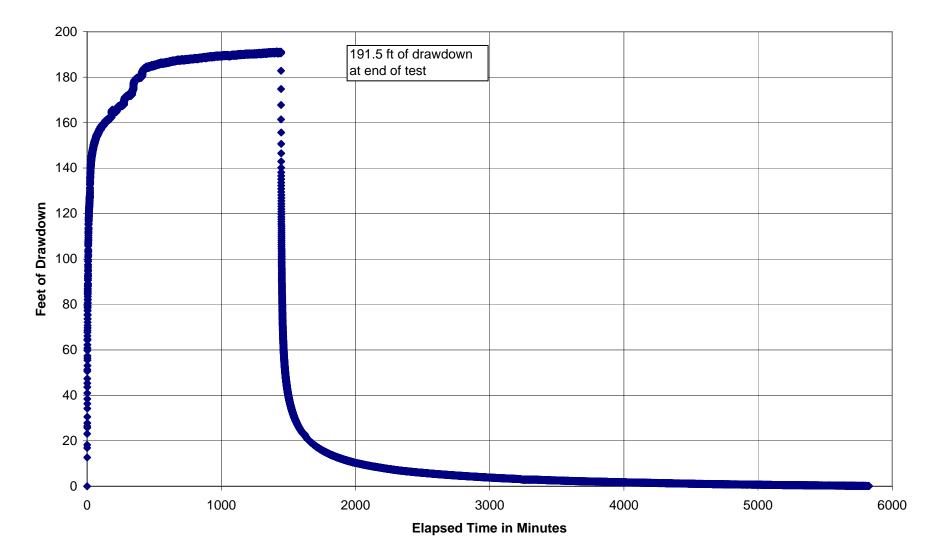
## Pumping and recovery test for City of McCammon Bitton Well Average Pumping Rate 206 gpm, July 11-14, 2013

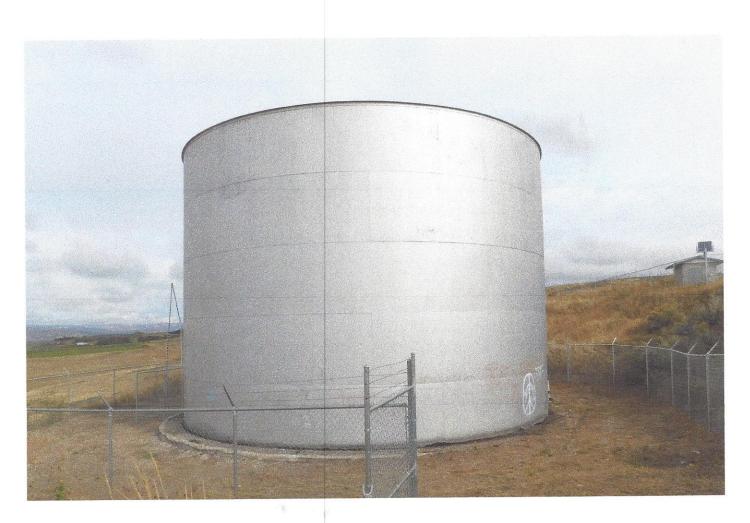
This report is a supplement to the visual and video inspection undertaken for the City of McCammon, McCammon, ID, by Liquid Engineering Corporation of Billings, MT. Tank 1 is an on grade water storage tank. The tank has a 300,000 gallon capacity, with an approximate height of 30' and an overall diameter of approximately 41'.

The tank was last inspected in 2019. The report from this inspection can be found in Appendix A. This inspection included recommendations for helping the tank meet OSHA, EPA, NFPA, and AWWA requirements. These recommendations include:

- Installing a davit arm on the primary shell manway and installing a second shell manway
- Installing anti-skid rung covers and a cable safety device on ladders
- Installing a handrail system on the tank roof with a toe board and swing gate
- Installing a second access hatch and an OSHA compliant interior access ladder
- Clearing around the concrete foundation ring down to a depth of 6"
- Installing proper signage
- Replacing the overflow system
- Replacing the liquid level indicator
- Replacing the roof vent
- Grouting and sealing the tank
- Installing a drain valve
- Pressure washing, scrubbing, spot priming, and painting the tank
- Reinforcing the support column baseplate
- Installing a mixing system
- Cleaning the tank interior
- Re-evaluating the tank interior condition at the next inspection.

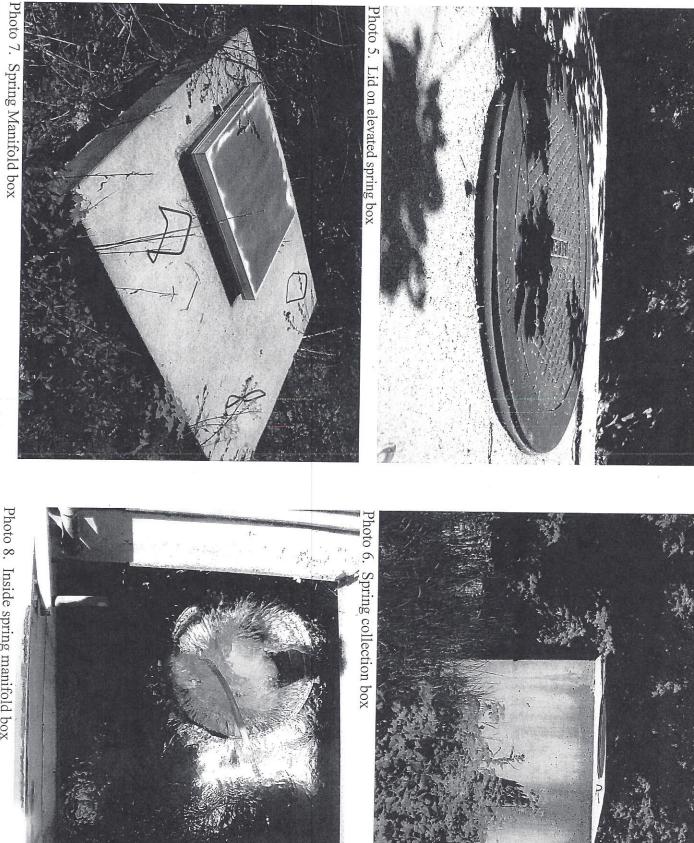
Photo 8. Inside spring manifold box

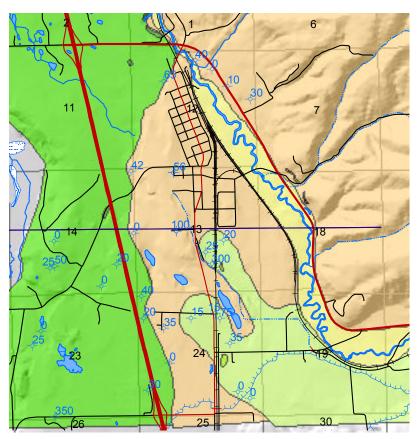
Logs from wells near McCammon indicate that several gravel aquifers are available for ground water development. Most of the domestic wells in this area penetrate a gravel aquifer approximately 80 to 100 ft below land surface (Figure 3). These wells yield an average of less than 50 gallons per minute (gpm). There is one anomalous well estimated at 300 gpm, however this well was not pump tested. The Portneuf River recharges the gravels below the Portneuf River basalts while Marsh Creek recharges the gravels underlying the Marsh Creek basalts.

Figure 3 – Well yield data in gpm for the McCammon area.

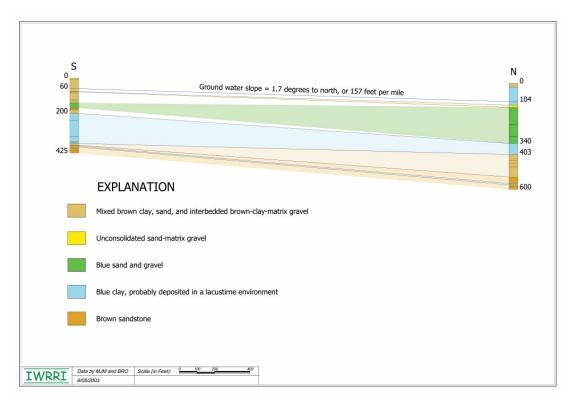
Figure 4 - Geologic correlation and water table for the two town wells.

The New well log shows a completion date of 21 September 2000. Information on file with IDEQ indicates an intention to conduct a sieve analysis and install an engineered well screen. The sieve analysis is dated 7 November 2000 suggesting the driller completed the New well without a screen. Rather than installing a screen the driller completed the well by filling it below 385 ft with washed gravels. The old well log also indicates it was completed without a screen. Well logs and sand analysis data are found in the appendices.
