# **RURAL TRAFFIC SAFETY PROGRAM**

## **ROAD SAFETY ASSESMENTS**

# **LYON COUNTY**

## 2025 High Five Program Road Safety Assessments

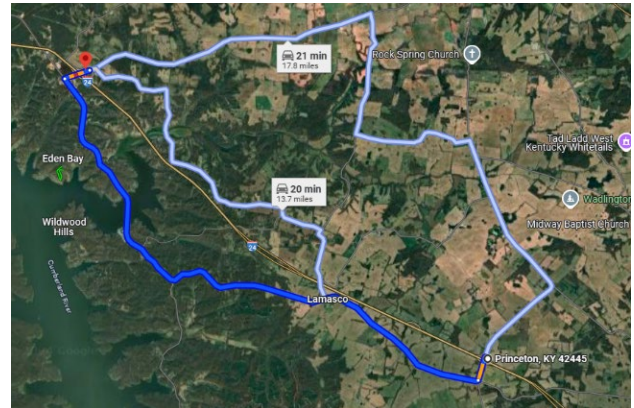
**Figure 3: I-24 Detour via KY 93**

The High Five program focuses on rural roads, and all county-maintained roads and low-priority state roads were included in the initial crash analysis<sup>3</sup>. KY 93 was also included in the analysis for Lyon County due to detour traffic when I-24 is closed (**Figure 3**). Routes inside the municipal boundaries of Eddyville and Kuttawa were removed from consideration, as the focus is on rural roads.

The top 27 ranked routes were presented to the project team and county stakeholders, which included the Lyon County Sheriff's Office and Kentucky State Police, at a Pre-Field Visit Meeting held virtually on January 16, 2025. The Lyon County Sheriff's Office cross referenced feedback received from a social media campaign for the High Five rural highway safety campaign with the top ranked EPDO routes. From there, the project team decided to conduct RSAs on the selected roads because of the high EPDO values **and** local priority. Most of the selected roadways are state maintained because local law enforcement considers these roads to be rural. As noted previously, KY 93 was specifically included due to it being a common detour route when I-24 is closed for crash incidents or maintenance (**Figure 3**).

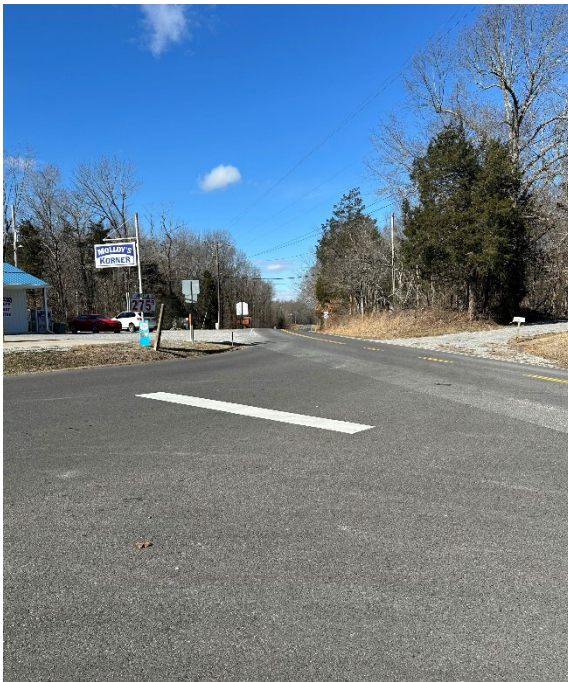
*Figure 11: View from KY 274, facing north*

Local participants noted difficult visibility near the intersection of KY 93 and KY 274. Vehicles driving southbound on KY 93 S are not visible to vehicles turning from KY 274 due to a sag in the road (**Figure 10**). Junction signs are present in both directions to note the upcoming junction. Intersection warning signs are not present. There are also no curve advisory speed signs or curve chevrons. A recently striped stop bar is present on KY 274 (**Figure 11**). It is angled to the left – the primary direction of travel – and does not span the entire lane width.

- Restripe the stop bar on KY 274 to be perpendicular to KY 93 and extend the bar across the entire land width for right-turning traffic.
- Install Combination Horizontal Alignment/Intersection warning signs (W1-10) on KY 93 S
- Install Chevron Alignment signs (W1-8).

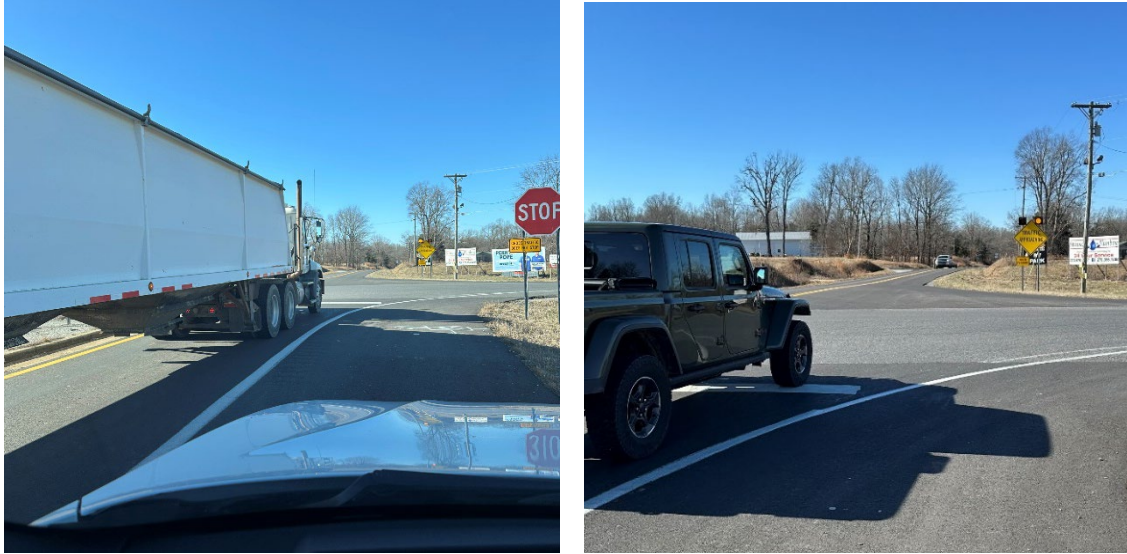
**Figure 15: Advanced Warning System**

An Advanced Warning System was installed around 2015. The system alerts drivers on the side roads—KY 293 and KY 1055—with a flashing light when vehicles are approaching in either direction on KY 93 (**Figure 15**). This aims to assist motorists with limited sight distance due to the road's sag in both directions. There are transverse rumble strips on KY 293 approaching the intersection and stop sign ahead signs (W3-1), all of which are in good condition.

The RSA team observed the flashing light warning system and the amount of time vehicles turning onto KY 93 had to react appeared adequate. Local participants noted that longer timing is potentially needed with the number of large trucks and vehicles pulling trailers traveling through the intersection. The team did not witness any near misses or queuing on KY 293, but street-view imagery reviewed later shows a queue of eight vehicles, including two pulling trailers (e.g. camper and a boat).

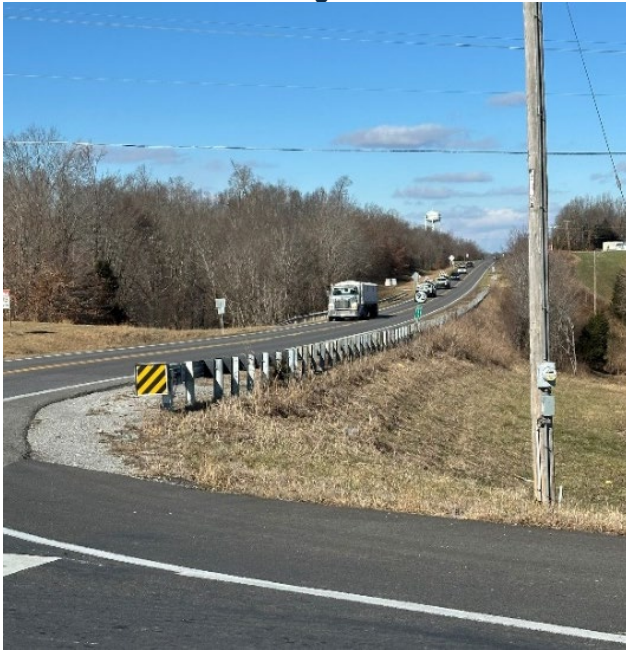
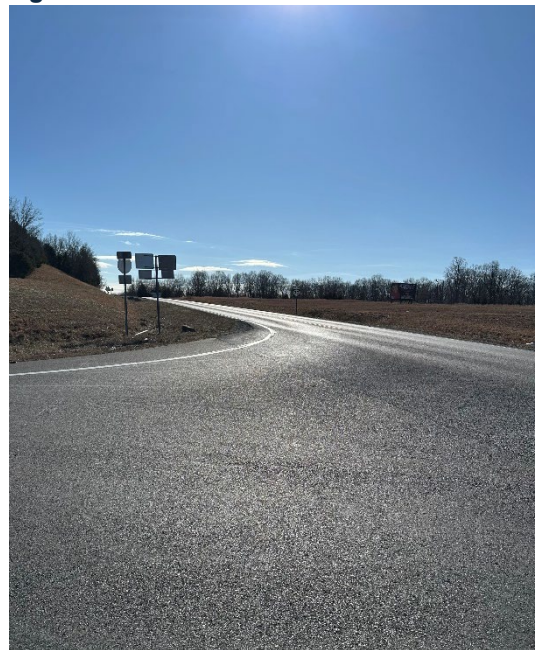
**Figure 16: View from left and right on KY 293**

As noted in the Intersection section, the road sags in both directions, limiting sight distance for motorists (**Figure 16**).

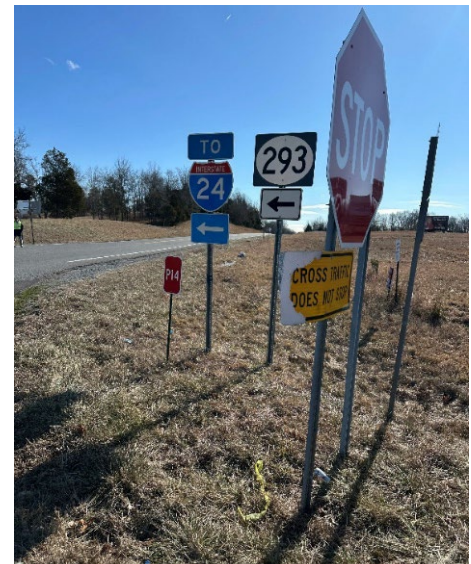
**Figure 17: Signage at KY 93 and KY 1055 Intersection**

There is a cluster of signs on the right-hand side of the approach on KY 1055 that blocks the driver's view of northbound KY 93 traffic (**Figure 17**).

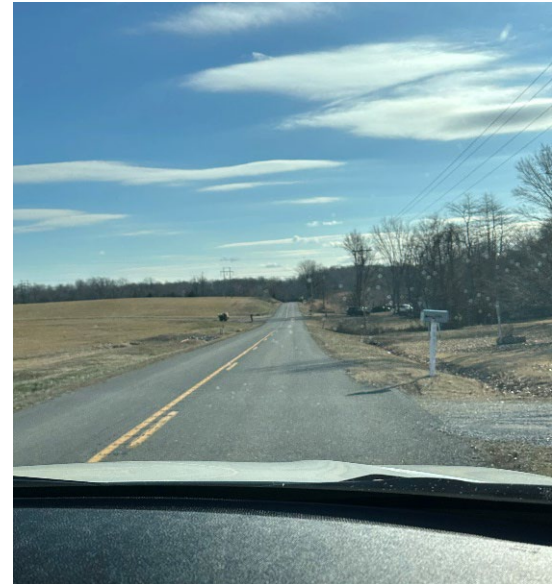
**Figure 22: Straight segment on KY 93 N**

Heading northwest from US 62, KY 93 N transitions into a straight segment after KY 819 (**Figure 22**). The team observed vehicles that appeared to be exceeding the speed limit. As this section of KY 93 N concludes at the Cumberland River, it is primarily utilized by residents who are acquainted with the road.

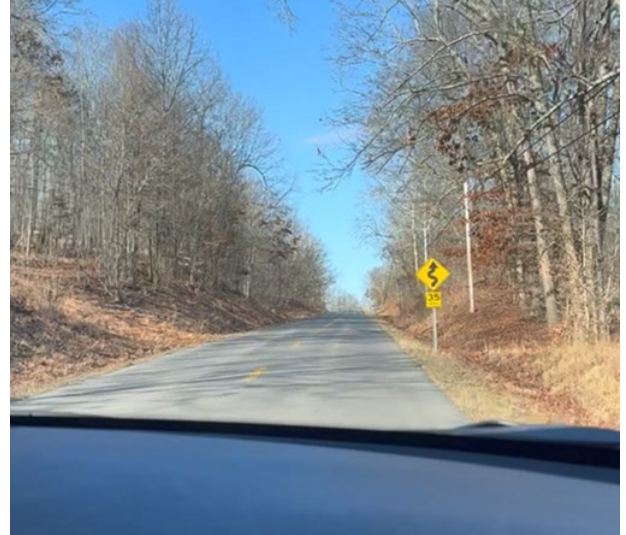
**Figure 27: Curve Advisory Speed Sign on KY 810**

KY 810 lacks speed limit signage. There are two sections with advisory speeds of 35 mph, and these are signed (**Figure 27**). Speeds over 55 mph were not observed. In the summer, local law enforcement noted that there are more vehicles with trailers traveling on the road, and they have a difficult time getting up to speed and navigating the curves.

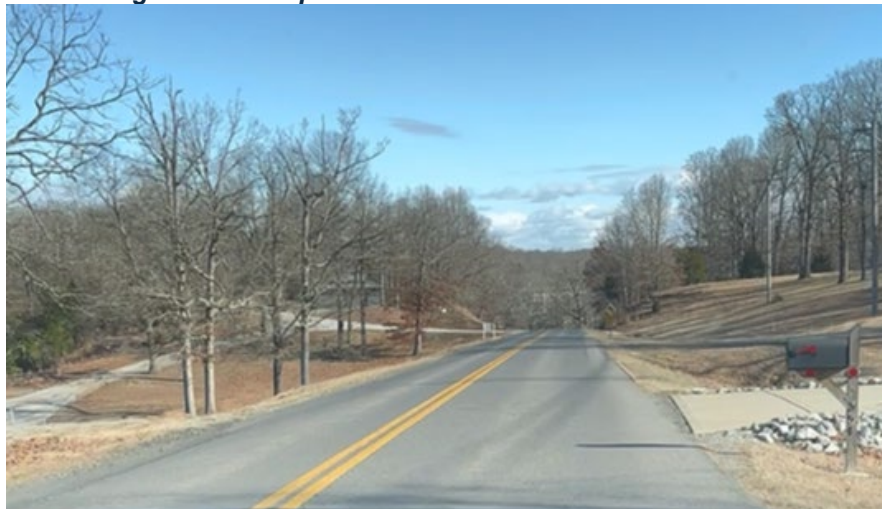
**Figure 28: Steep embankment on west side of road**

A steep embankment is on the west side of the road between mile points 4.134 and 4.209 (**Figure 28**).

- Investigate installing guardrails. Add the areas with significant elevation changes between mile points 4.134 and 4.209 to the competitive guardrail program.
- Vegetation control on US 62 at the railroad bridge near mile point 3.682.

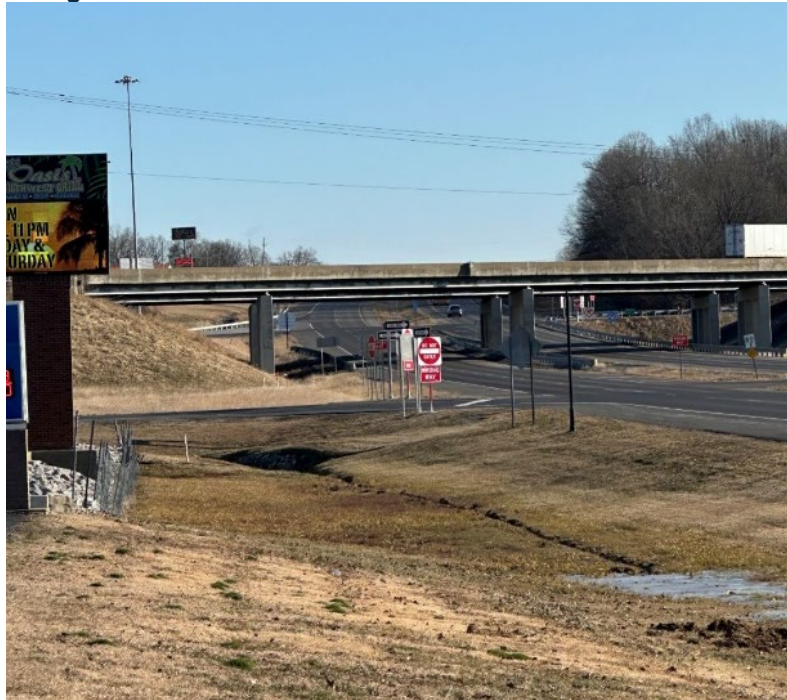
*Figure 33: View of US 62 northwest from the intersection*

While observing the intersection, local participants on the RSA team noted that the I-24 overpass to the northeast blocked the view of the traffic signal at Days Inn Drive for oncoming vehicles (**Figure 33**). When reviewing the sight distance after the field visit, it meets standards. However, as noted in the **Speed** section, higher travel speeds of vehicles exiting the I-24 off ramp and traveling west on US 62 were observed.

- Consider advanced signal/flashing warning lights on US 62 southwest bound.
- Utilize Intersection Control Evaluation Phase 1 to identify intersection control improvements (e.g. roundabouts through the interchange).
- Stripe a centerline the entire length of Days Inn Drive.

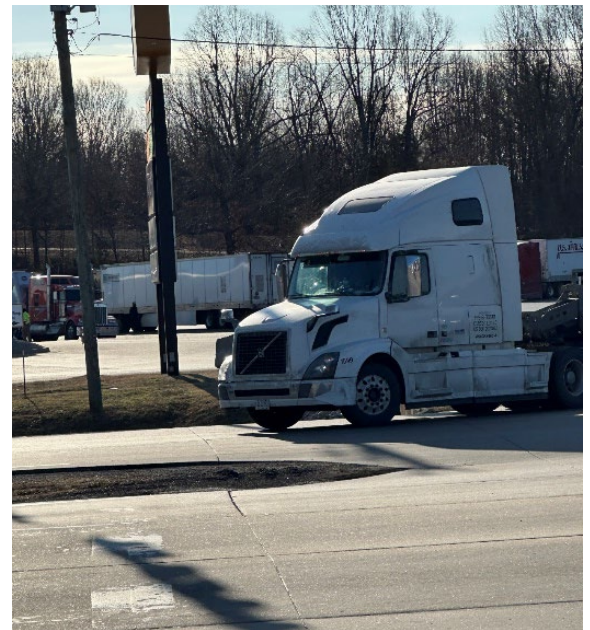
**Figure 34: Truck turning right onto US 62 from Huck's gas station, across from Days Inn Drive**

The RSA team observed heavy truck traffic in the intersection, particularly turning in and out of the Huck's entrance (**Figure 34**).

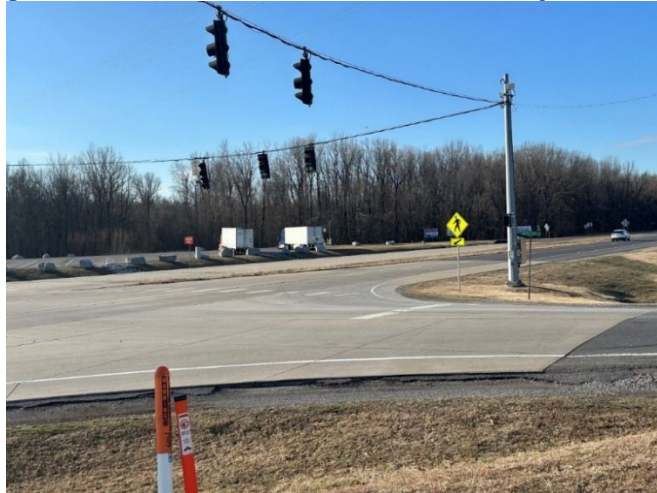
**Figure 35: Pedestrian Infrastructure near Days Inn Drive**

The markings at the intersection, both on Days Inn Drive and US 62, are faded. Local law enforcement also noted that several wrong way driving incidents have occurred due to vehicles turning left out of Days Inn Drive into oncoming US 62 traffic. The grassy median on US 62 may be difficult to see, especially at night. Additionally, there are no lane or stop bar markings at the Huck's entrance, which is heavily used by trucks. There is also a 115-foot continental striped pedestrian crosswalk.

- Add sidewalks within three feet of the pedestrian push button and curb ramps at the intersection of Days Inn Drive and US 62 to comply with ADA standards.
- Construct a pedestrian refuge island in the existing grass median on US 62 to reduce crossing length.

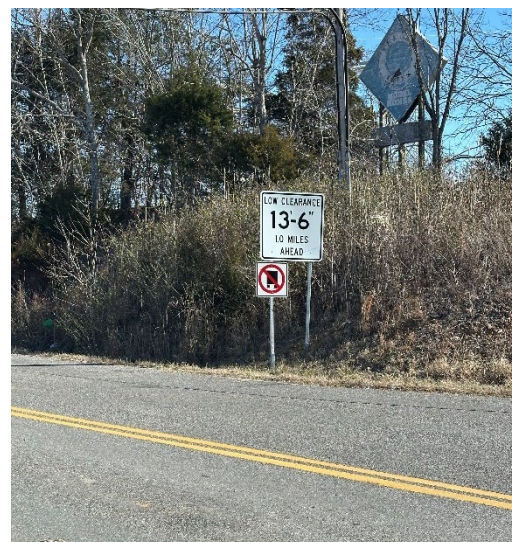
**Figure 40: Low clearance and restricted truck signage**

Low clearance signage is present at the intersections of KY 93 S and US 62 (**Figure 40**), referring to the I-69 tunnel further discussed in the **Roadside Conditions** section.

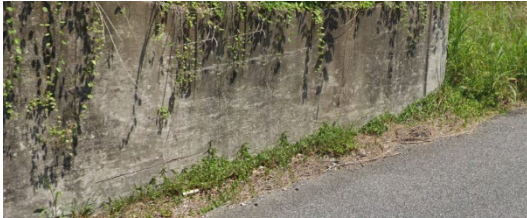
**Figure 41: Vehicle scrapes on tunnel wall**

A tunnel under I-69 is located at mile point 0.94 (**Figure 42**). The tunnel height is low – only 13 feet 6 inches, and the route is signed with truck restrictions. The tunnel has flat concrete abutments adjacent to the narrow road with no shoulder, and the speed limit is 55 mph. There are object marker signs. There is evidence that multiple vehicles have scraped the walls (**Figure 41**).

- Install crash cushions at each corner with barrier wall transitions at the tunnel under I-69
- Cut back the hillsides to improve line of sight.

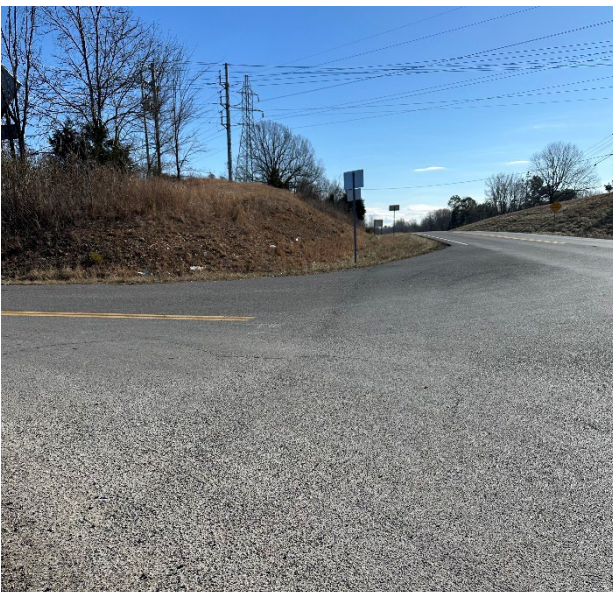
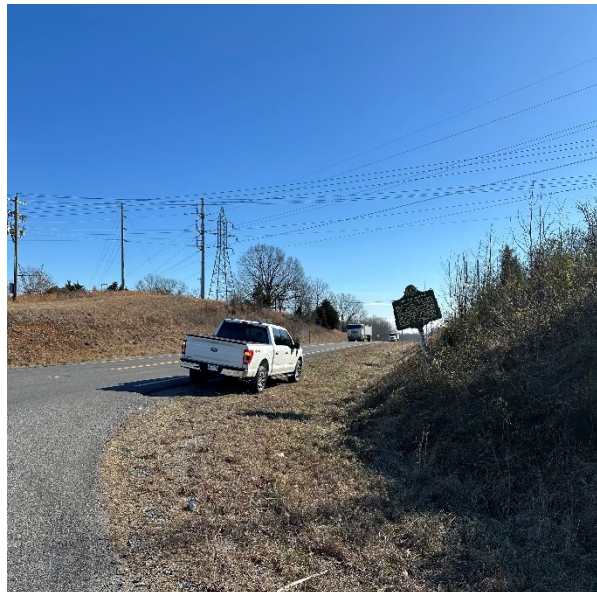
**Figure 43: Hillsides on the KY 3305 and Gregory Road approaches**

At the intersection with KY 93 S, there are hillsides close to the approach that limit the view for motorists turning from KY 3305 or Gregory Road (**Figure 43**).
