# *An Evaluation of a Crosswalk Warning System Utilizing In-Pavement Flashing Lights*

Funding by  
**State of California**  
**Office of Traffic Safety**  
and  
**Federal Highway Administration**  
**University of North Carolina Highway Safety Research Center**

April 1998

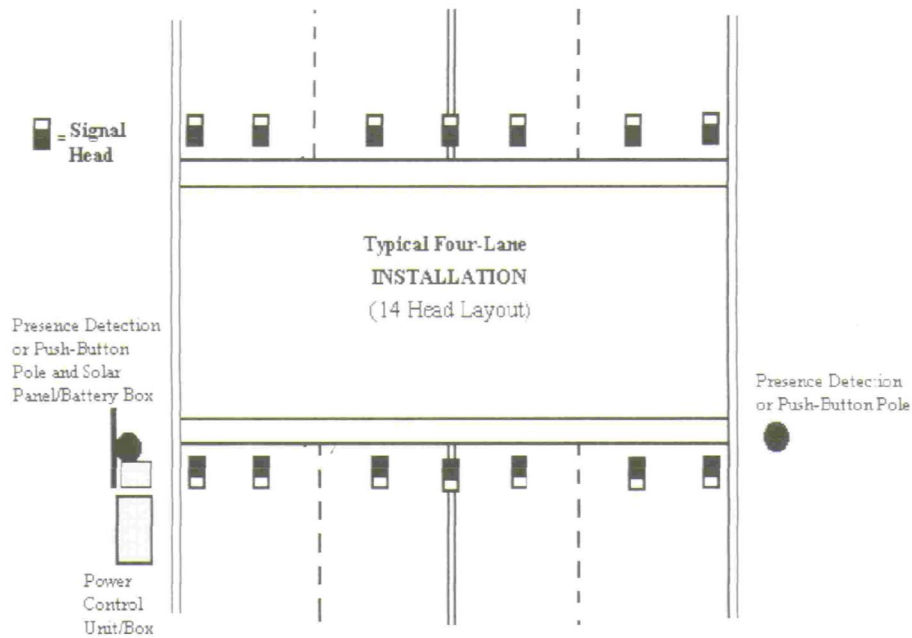
Experimental System Installation Pattern

Device Design

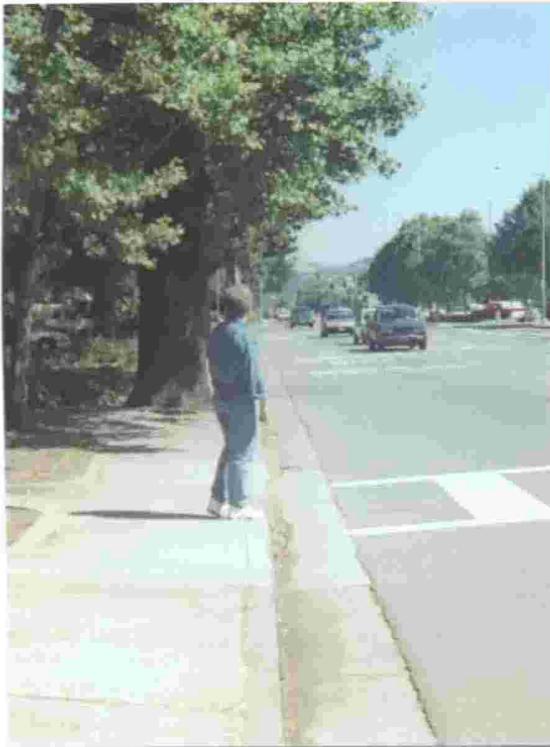
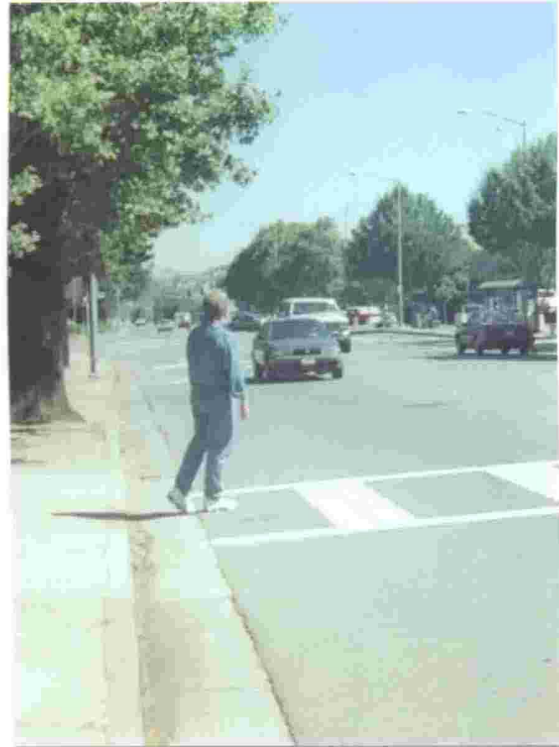
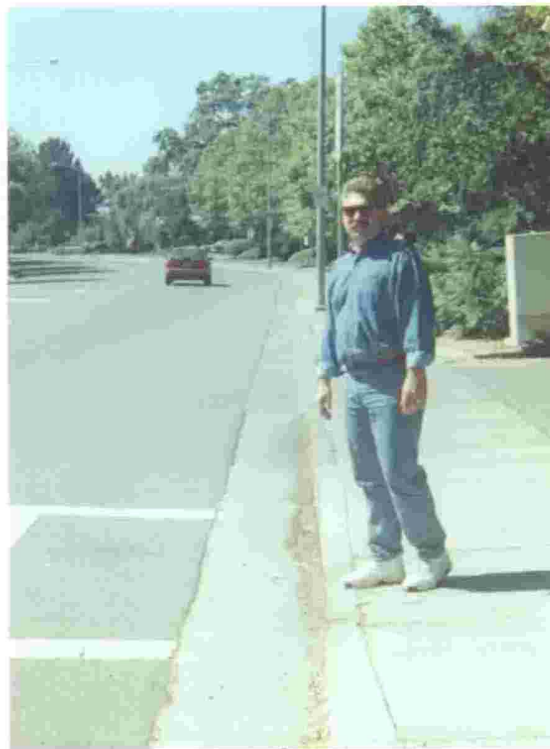
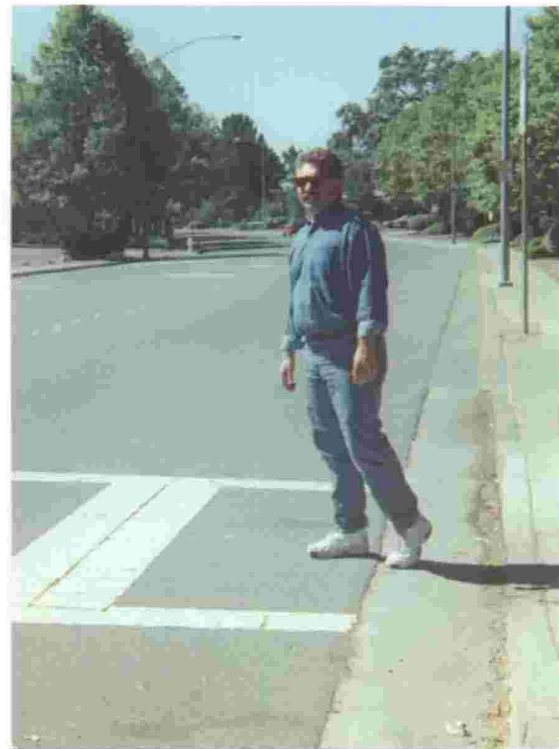
The reaction of the driver was measured under two conditions; (1) staged pedestrian looking at oncoming traffic, and (2) staged pedestrian stepping out into the travelway. The following information was collected:

- approach speed (from 500 to 300 feet in advance of the crosswalk)
- travel time and deceleration (from 500 to 100 feet in advance of the crosswalk)
- braking distance (distance away from the crosswalk that vehicles begin to brake)
- driver reaction (yielded to the pedestrian, reacted but did not yield, and did not yield to the pedestrian)

To ensure consistent data collection procedures and because the majority of the sites did not have a continuous pedestrian flow, all of the driver reaction surveys and interviews were conducted using a “staged” pedestrian as part of the data collection crew. Driver reaction was collected under conditions with the staged pedestrian “looking” to cross from the sidewalk and with the staged pedestrian “stepping” into the roadway.

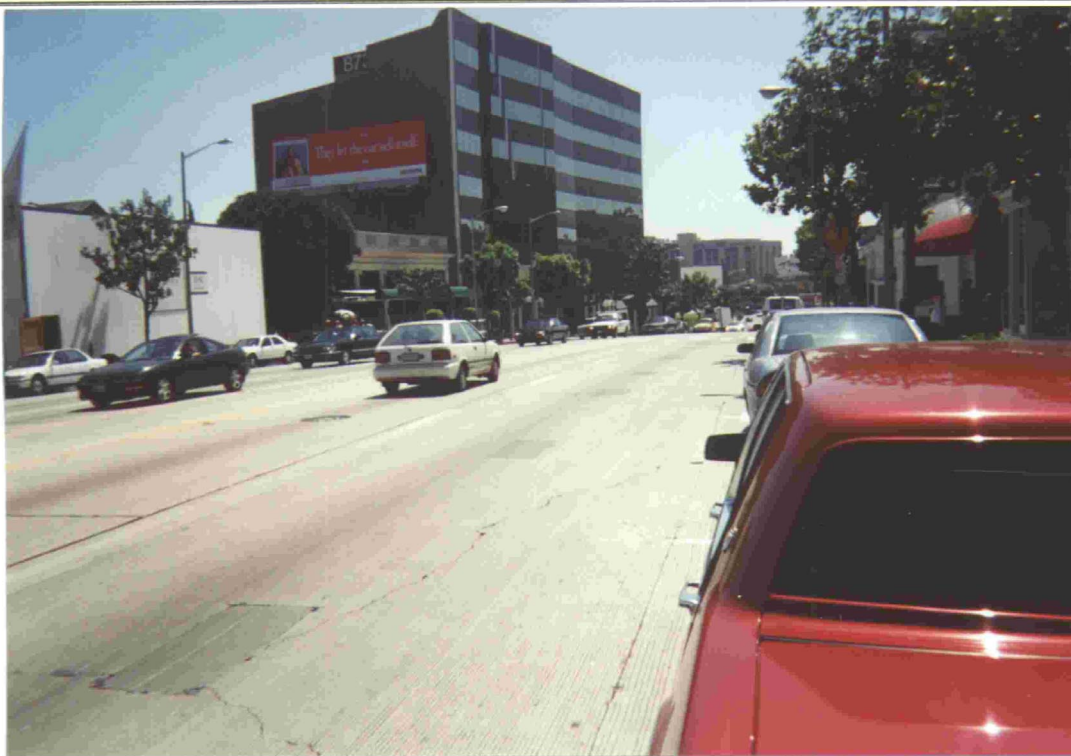
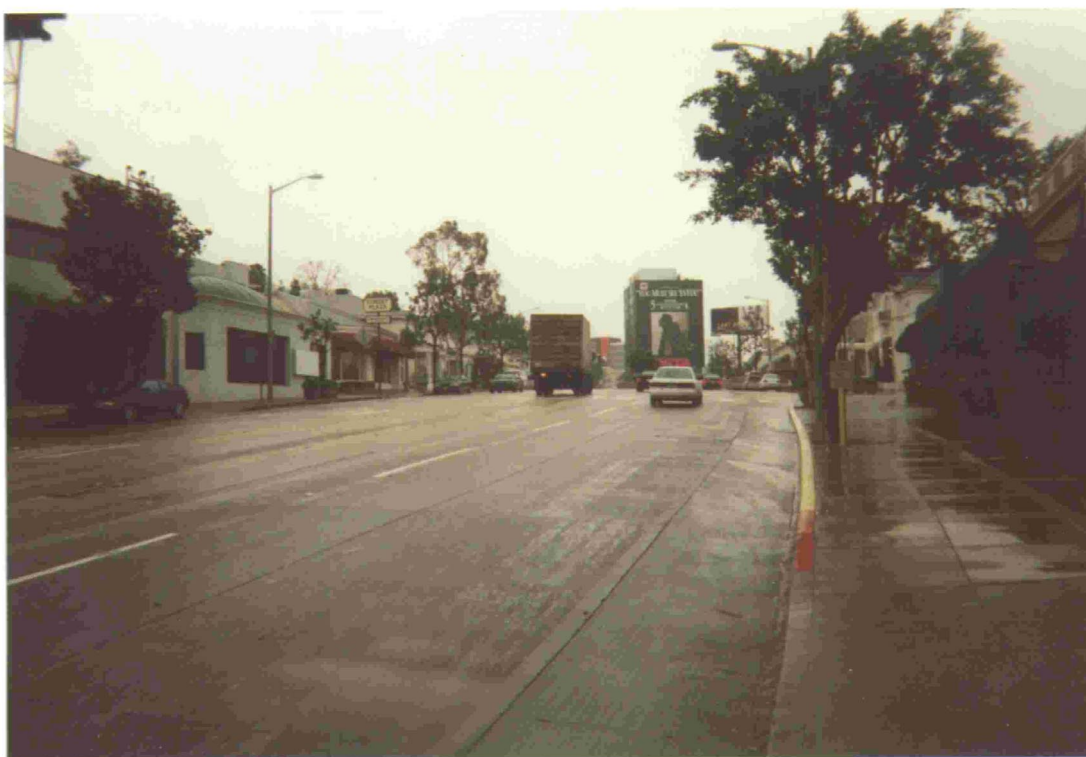
**Figure 8** **Sunset Boulevard/Sunset Plaza**  
*In-Pavement Flashing Lights Crosswalk Warning System Evaluation*  
 Whitlock & Weinberger Transportation Inc. City of West Hollywood

Sunset Boulevard/Sunset Plaza in West Hollywood, is a mid-block crosswalk which provides access across Sunset Boulevard in shopping and restaurant district. Sunset Boulevard is four lanes with average speeds near 30 to 35 mph and an average daily volume of 55,000. There is parking on both sides of the street and a horizontal and vertical curve just west of the crosswalk which impacts view of the crosswalk in the eastbound direction. Photos of the site are shown in Figure 8.

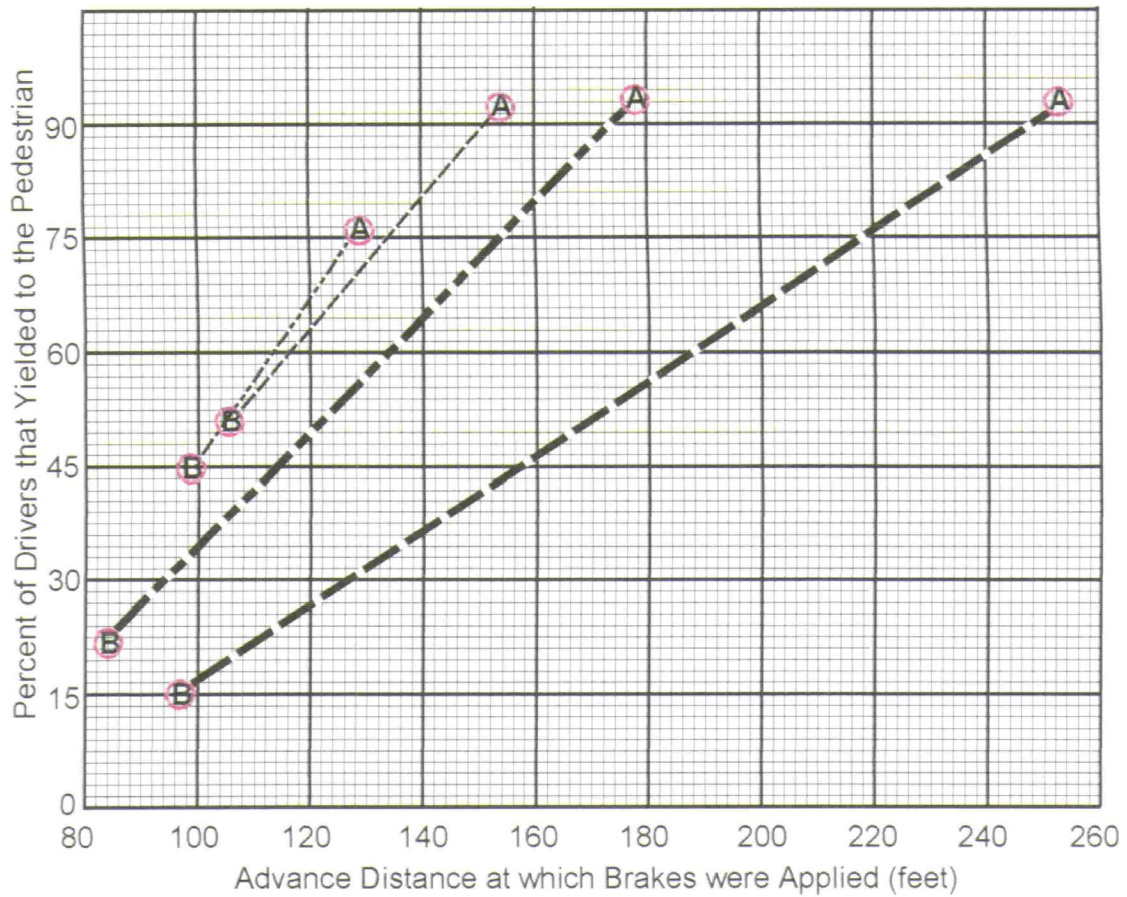
Figure 14 Data Comparison - Main Street/Laurel Street  
*In-Pavement Flashing Lights Crosswalk Warning System Evaluation*  
 Whitlock & Weinberger Transportation Inc. City of Fort Bragg

Existing pedestrian crossing conditions were initially less than desirable with less than 50 percent of the drivers during the day and less than 20 percent of the drivers during the evening yielding to the pedestrian at the four-way intersection on State Highway 1 in the City of Fort Bragg. As shown by Figure 14 and Table 3, the addition of the crosswalk warning system has consistently enhanced the driver's awareness of pedestrians and has modified driving habits to be more favorable for pedestrians. In both directions under both daytime and evening conditions, the distance at which brakes were applied has increased and the percentage of drivers that yielded to the pedestrian has increased to a level near 90 percent. The most dramatic changes occurred in the evening, with an increase of drivers yielding to the pedestrian from 20 percent to 90 percent and braking distance increasing from 90 feet to 250 feet from the crosswalk.

There were no significant changes in approach speeds at the intersection. Before the device was installed, average speeds were near 25 mph for both daytime and nighttime conditions. After the warning system was installed, speeds were near 24 mph for both daytime and nighttime conditions. There were slight changes in travel time between 500 and 100 feet in advance of the crosswalk ( less distance for northbound ) which was measured as an indication of the deceleration changes of the approaching vehicles. Before the device was installed, travel time averaged 9.7 seconds for daytime and 8.2 seconds for nighttime conditions. After the warning system was installed, travel time increased to 11.3 seconds for both daytime and nighttime conditions. Both of these speed and deceleration factors indicate that the warning system has had a positive effect in gaining the attention of drivers.

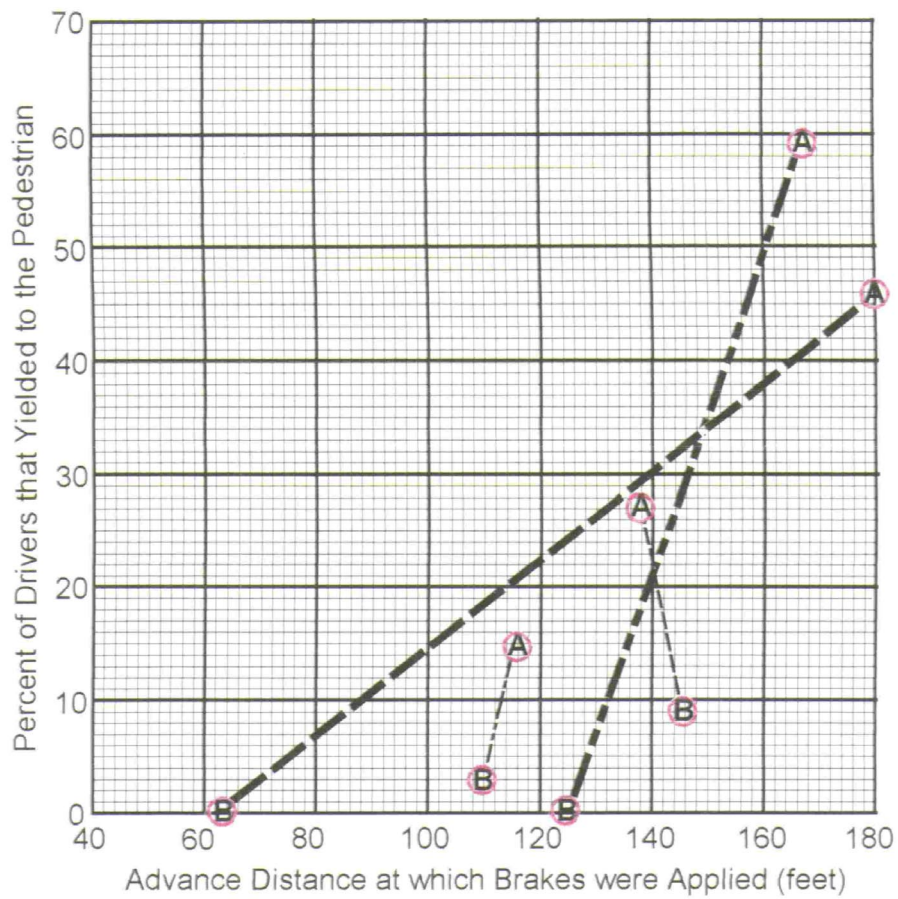
The midblock crosswalk of a four-lane arterial street in front of the Lafayette Park Hotel in the City of Lafayette started as a very poor pedestrian crossing location with almost no drivers yielding to the pedestrian. As shown by Figure 15 and Table 3, the addition of the crosswalk warning system has increased the drivers' awareness of the crosswalk and pedestrians and has modified driving habits to be more favorable to pedestrians. In both directions under both evening and daytime conditions, the percentage of drivers that yielded to the pedestrian has increased. However, with less than 30 percent of the drivers now yielding to the pedestrians during the day, this location continues to have very poor crossing conditions for the pedestrian even with the addition of the lights. This situation is generally caused by the speed of traffic, which exceeds the posted 35 mph limit and the presence of the freeway right of way on one side of the street, which leads to the driver not expecting a pedestrian crossing.

There were no significant changes in approach speeds at the intersection. Before the device was installed, average speeds were near 38 mph for daytime and 37 mph for nighttime conditions. After the warning system was installed, average speeds were virtually unchanged for both daytime and nighttime conditions. Travel

time between 500 and 100 feet in advance of the crosswalk also did not change significantly. Before the device was installed, travel time averaged 7.3 seconds for daytime and 7.5 seconds for nighttime conditions. After the warning system was installed, travel time averaged near 7.4 seconds for both daytime and nighttime conditions.

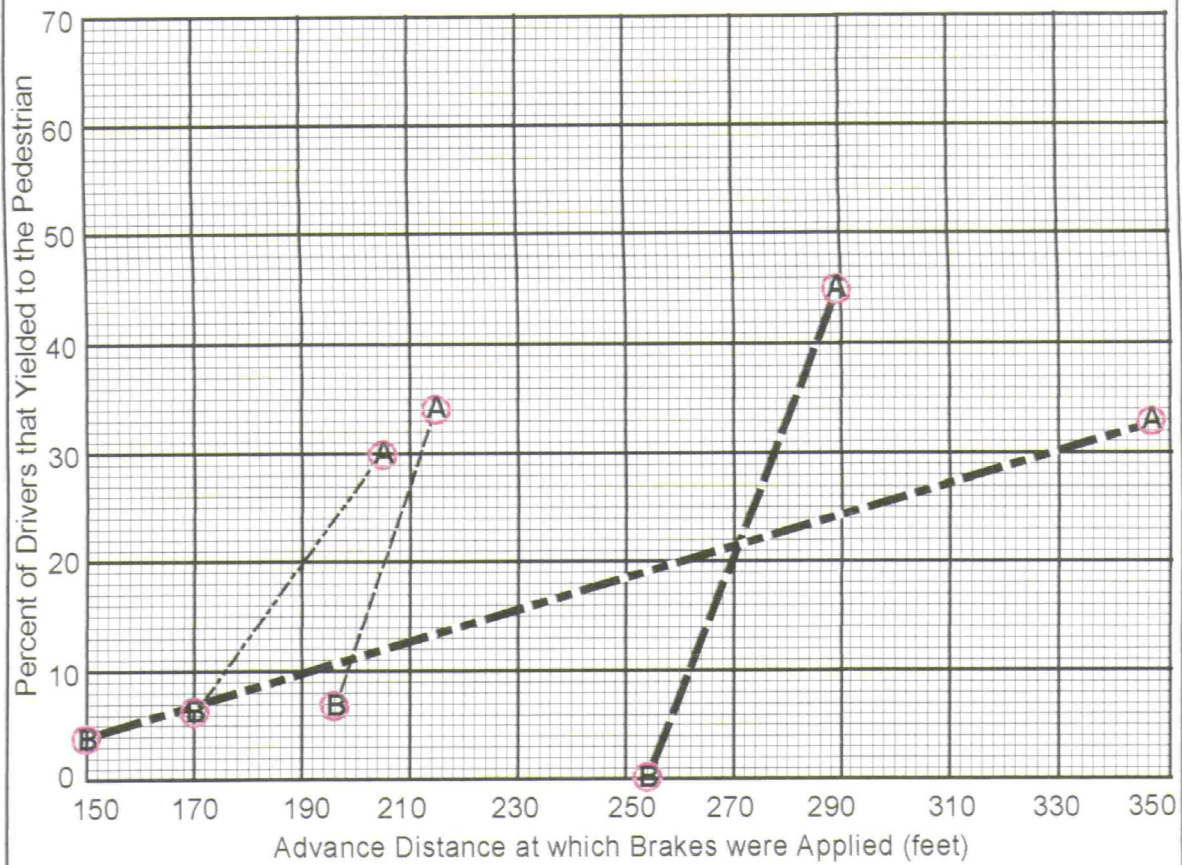
Figure 16 Data Comparison - Pleasant Hill Road/Condit Road  
In-Pavement Flashing Lights Crosswalk Warning System Evaluation  
Whitlock & Weinberger Transportation Inc. City of Lafayette

As shown by Figure 16 and Table 3, for this crosswalk of a four-lane 45 mph suburban arterial at a T intersection in the City of Lafayette, the addition of the experimental system has increased the drivers' awareness of the crosswalk and pedestrians. In both directions under both daytime and evening conditions, the distance at which brakes were applied has increased and the percentage of drivers that yielded to the pedestrian has increased. Before the installation, almost no drivers yielded to the pedestrian. The percentage of drivers yielding to the pedestrians has generally increased to almost 40 percent, but this level is still not desirable for comfortable pedestrian crossing conditions. This situation is caused by the general inability of the driver to stop safely for the pedestrian due to high speeds and platooning of vehicles, the community's attitude toward pedestrians, and the general absence of pedestrians during most of the day and night. The inability of drivers to stop safely is particularly a problem in the southbound direction where there is a vertical curve which limits the distance at which the driver can see the crosswalk.

There was a slight decrease in nighttime approach speeds at the intersection. Before the device was installed, average speeds were near 44 mph for daytime and 48 mph for nighttime conditions. After the warning system was installed, average speeds were virtually unchanged for daytime conditions and decreased to approximately 44 mph for nighttime conditions. Travel time between 500 and 100 feet in advance of the crosswalk also did not change significantly. Before the device was installed, travel time averaged 6.4 seconds for daytime and 6.0 seconds for nighttime conditions. After the warning system was installed, travel time averaged near 6.5 seconds for daytime conditions and 6.9 for nighttime conditions.

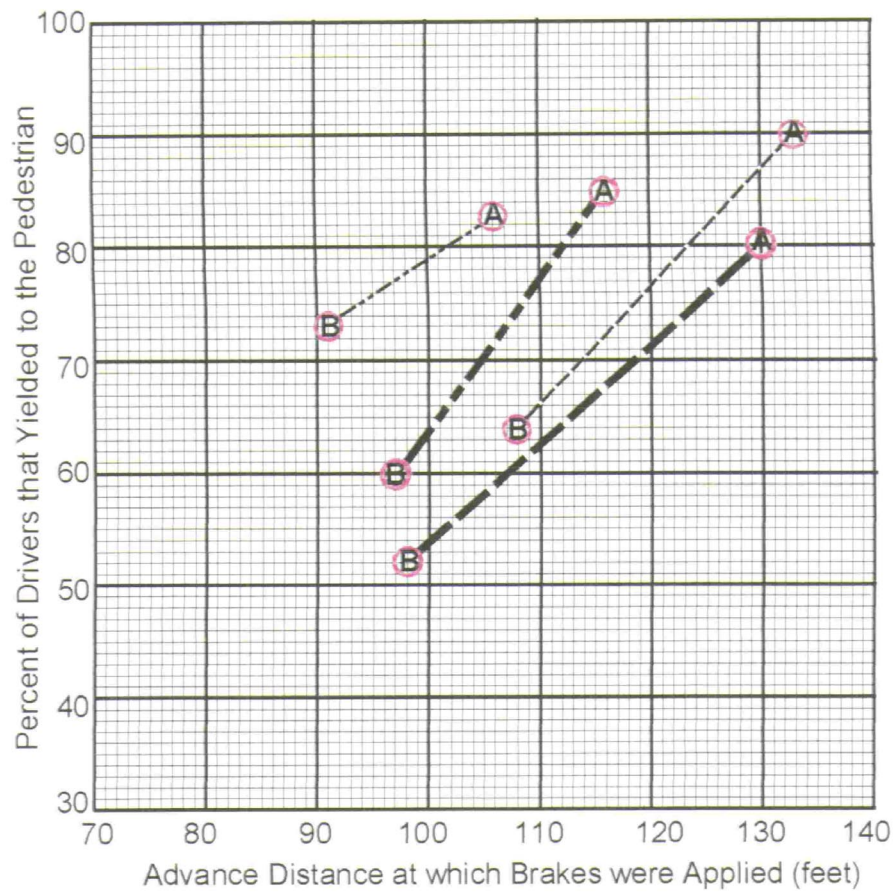
Figure 17 Data Comparison - Petaluma Blvd South/Putnam Plaza  
*In-Pavement Flashing Lights Crosswalk Warning System Evaluation*  
 Whitlock & Weinberger Transportation Inc. City of Petaluma

This midblock crosswalk of a four-lane arterial street in the historic downtown setting in the City of Petaluma started with 60 to 70 percent of the drivers yielding to the pedestrian, which is a minimal desirable level. As shown by Figure 17 and Table 3, the addition of the crosswalk warning system has increased the drivers' awareness of the crosswalk and pedestrians. In both directions under both daytime and evening conditions, the distance at which brakes were applied has increased and the percentage of drivers that yielded to the pedestrian has increased to a level between 80 and 90 percent. This location seems to be a prototypical site for use of the experimental system. Drivers are traveling at a speed which allows them to stop safely and they expect the presence of pedestrians since this is a downtown setting.

There were no significant changes in approach speeds at the intersection. Before the device was installed, speeds averaged about 22 mph for both daytime and nighttime conditions. After the warning system was installed, speeds remained near 22 mph for both daytime and nighttime conditions. There were no significant changes in travel time between 250 and 50 feet in advance to the crosswalk. Before the device was installed, travel time averaged 7.2 seconds for daytime and nighttime conditions. After the warning system was installed, average travel time remained near 7.1 seconds for both daytime and nighttime conditions.

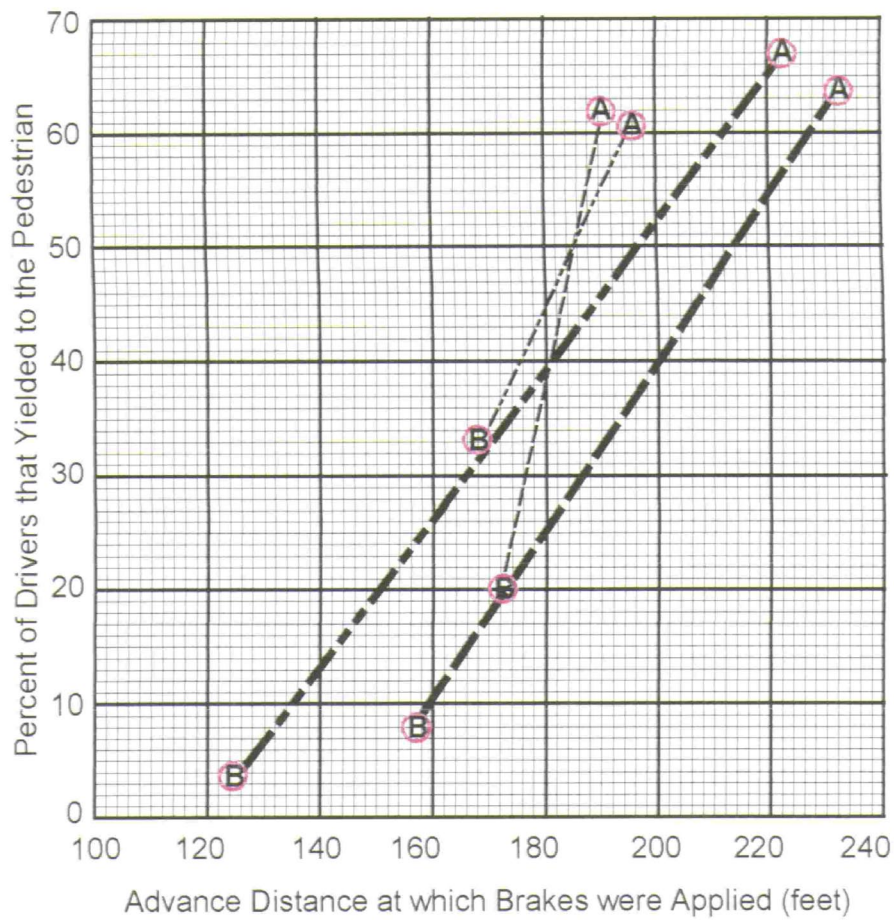
Figure 18 Data Comparison - Main Street/Hazel Street  
In-Pavement Flashing Lights Crosswalk Warning System Evaluation

Pedestrian crossing conditions were initially generally poor with less than 40 percent of the drivers yielding to the pedestrian at the four lane crossing at a T intersection on a State Highway in the City of Willits. As shown by Figure 18 and Table 3, the addition of the crosswalk warning system has consistently enhanced the awareness drivers have of pedestrians and has modified driving habits to be more favorable for pedestrian crossing conditions. In both directions under both daytime and evening conditions, the distance at which brakes were applied has increased and the percentage of drivers that yielded to the pedestrian has increased to a level near 65 percent, which is a minimal desirable level for the pedestrian. Even though the speed limit of 35 mph was the same as at Mt. Diablo Boulevard/Lafayette Park Hotel in Lafayette, this location seems to be a much more appropriate installation site due to the adjacent land use pattern which leads to drivers expecting pedestrian crossings and their ability to safely stop for the pedestrian.

There was a slight decrease in nighttime approach speeds at the intersection. Before the device was installed, average speeds were near 35 mph for daytime and 34 mph for nighttime conditions. After the warning system was installed, average speeds were virtually unchanged for daytime conditions and decreased slightly to approximately 32 mph for nighttime conditions. Travel time between 500 and 100 feet in advance of the crosswalk also did not change significantly. Before the device was installed, travel time averaged 8.1 seconds for daytime and nighttime conditions. After the warning system was installed, travel time averaged near 8.4 seconds for daytime conditions and 9.1 for nighttime conditions.

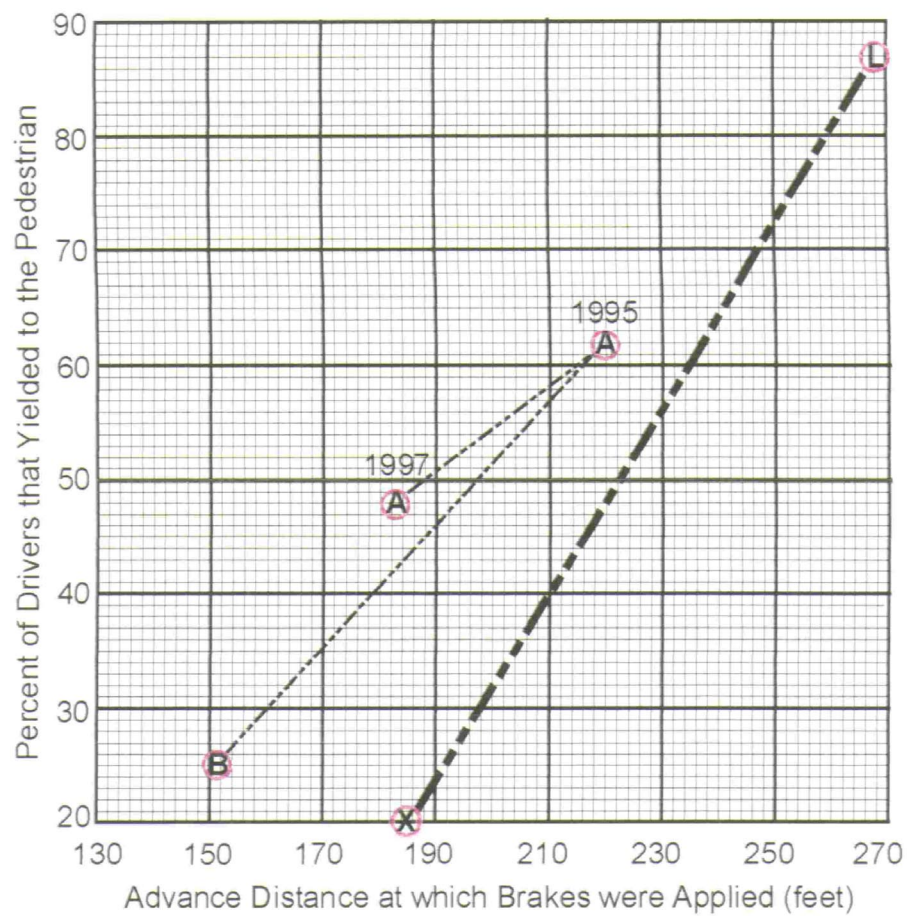
Figure 19 Data Comparison - Summerfield Road/Howarth Park  
In-Pavement Flashing Lights Crosswalk Warning System Evaluation

As shown in Figure 19, the daytime vehicle reaction characteristics have improved over conditions before the device was installed, but have degraded slightly from when the data was collected within one month of the device installation. This decrease in reaction characteristics may be attributed to the following issues:

- The brightness of the initial prototype units, which was of a different construction method than the current prototype, has degraded over the last two years.
- Drivers may have become more accustomed to the presence of the lights.
- The staged pedestrian's actions during the data collection process have been modified since the initial testing. In order to address the safety of the staged pedestrian, their actions are now less obtrusive on the approaching vehicle than in 1995.

The nighttime data shown in Figure 19 displays that the device is still extremely effective in enhancing the drivers' awareness of the presence of a pedestrian during evening hours. It should be noted that even though

the brightness of the initial prototype units has degraded, they are still very visible at night.

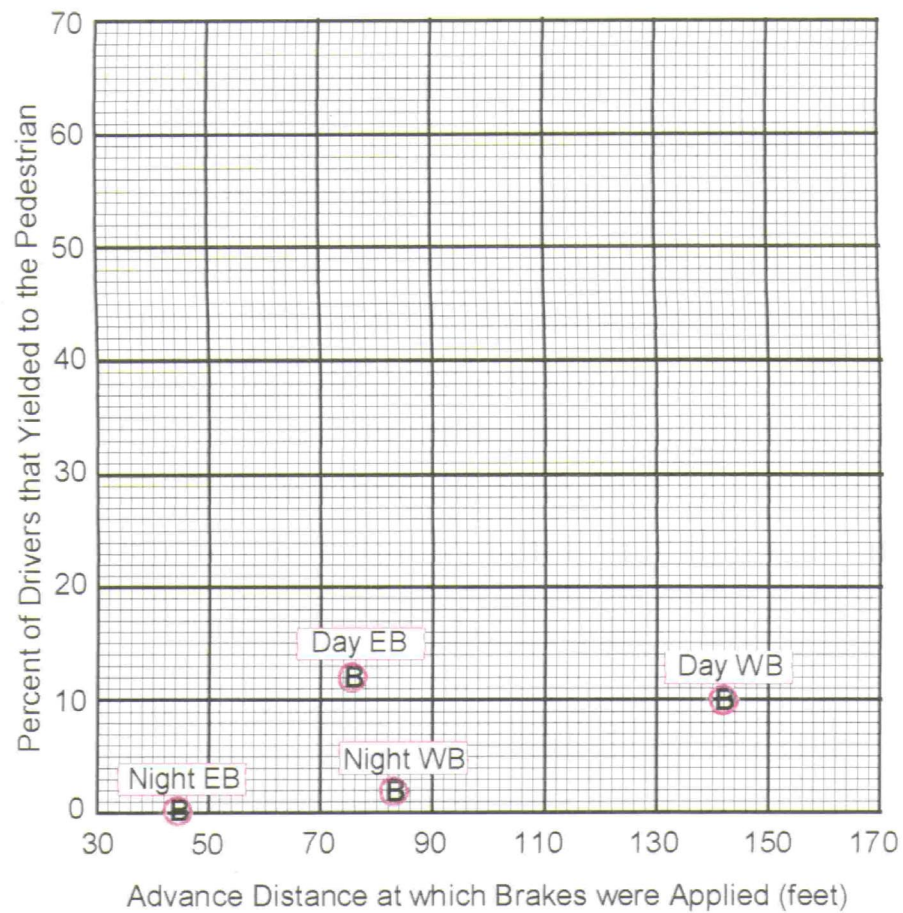
Figure 20 Existing Conditions - Sunset Boulevard/Sunset Plaza  
In-Pavement Flashing Lights Crosswalk Warning System Evaluation

As shown by Figure 20, the midblock crosswalk of Sunset Boulevard at Sunset Plaza has very poor pedestrian crossing conditions. Approximately ten percent of the drivers yield to pedestrians during the day and almost no pedestrian yield at night. The system is expected to be installed during Summer 1998. Comparison with after conditions will follow on the next update of the report.

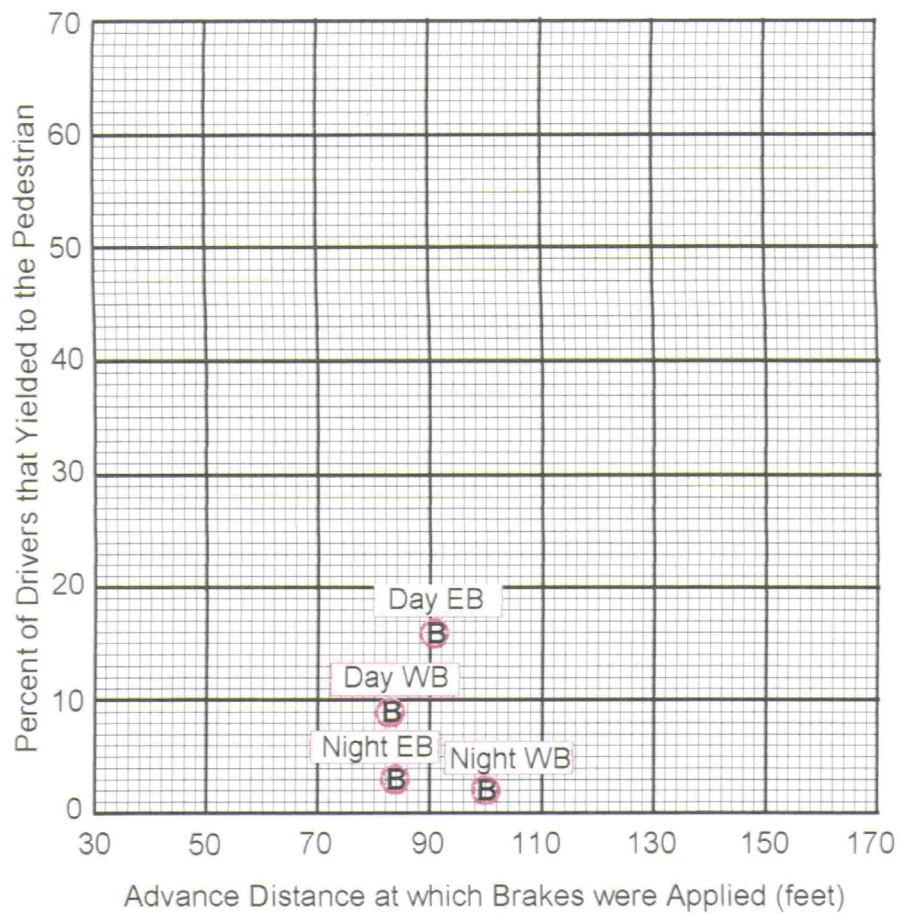
**Figure 21** Existing Conditions - Sunset Boulevard/Wetherly  
*In-Pavement Flashing Lights Crosswalk Warning System Evaluation*

As shown by Figure 21, the T intersection at Sunset Boulevard/Wetherly has very poor pedestrian crossing conditions. Approximately ten to fifteen percent of the drivers yield to pedestrians during the day and almost no pedestrian yield at night. The system is expected to be installed during Summer 1998. Comparison with after conditions will follow on the next update of the report.

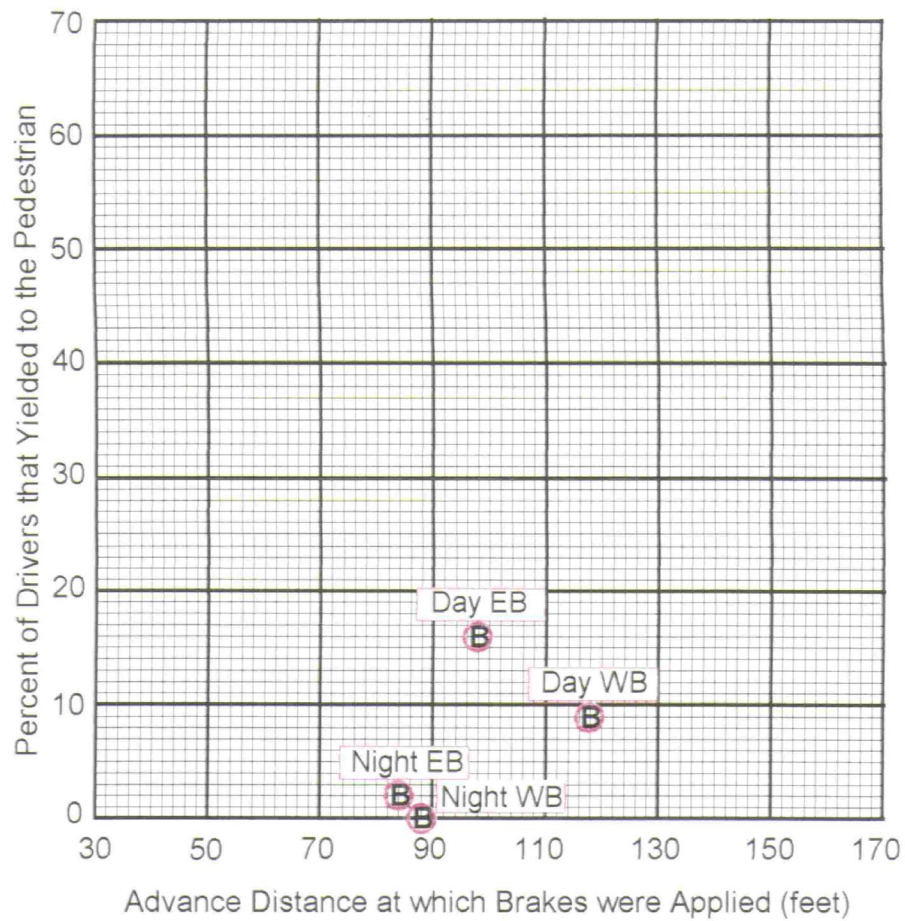
Figure 22 Existing Conditions - Sunset Boulevard/Alta Loma  
*In-Pavement Flashing Lights Crosswalk Warning System Evaluation*  
 Whitlock & Weinberger Transportation Inc. City of West Hollywood

As shown by Figure 22, the T intersection at Sunset Boulevard/Alta Loma has very poor pedestrian crossing conditions. Approximately ten to fifteen percent of the drivers yield to pedestrians during the day and almost no pedestrian yield at night. The system is expected to be installed during Summer 1998. Comparison with after conditions will follow on the next update of the report.

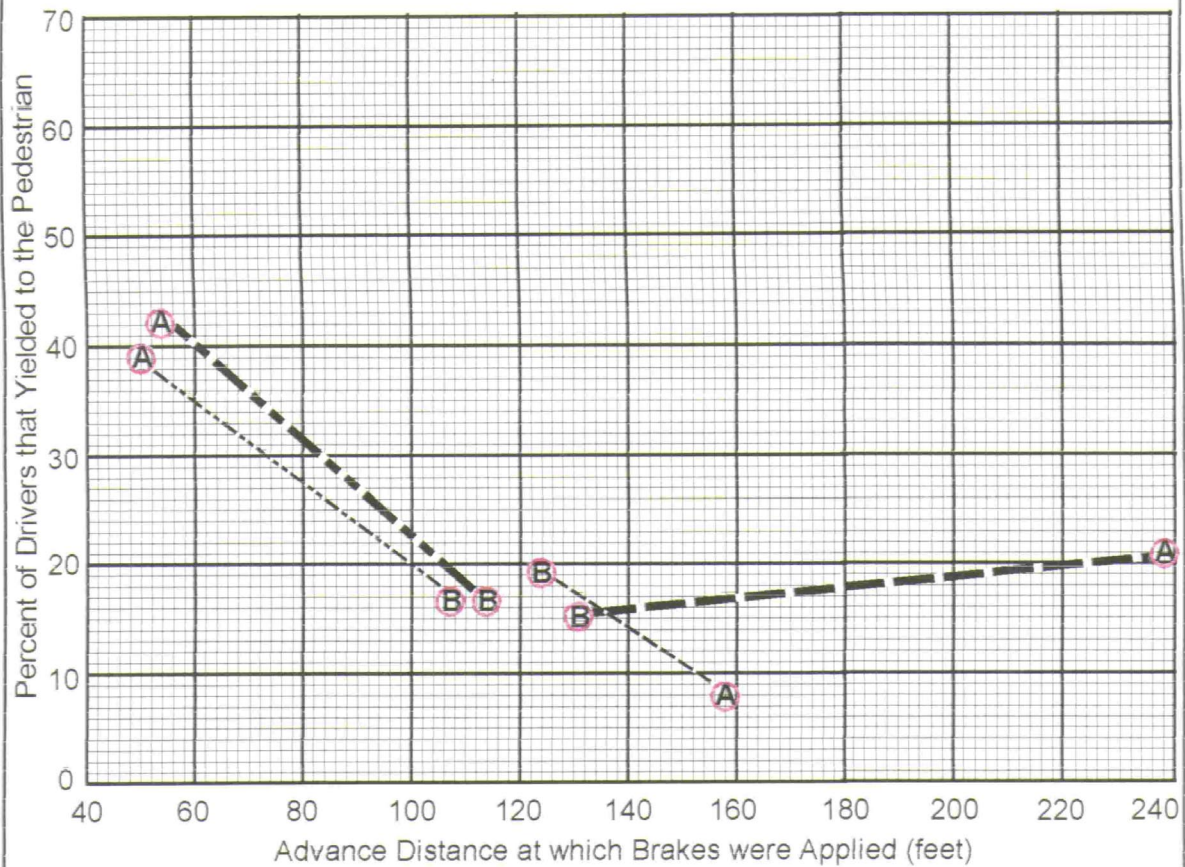
Before the warning system was installed, approximately 15 to 20 percent of all drivers yielded to the pedestrian. This is a level that is generally not desirable for comfortable pedestrian crossing conditions. As shown in Figure 23, after the system was installed, during the day, the percentage of drivers yielding to the pedestrian increased from 16 to 38 percent in the eastbound direction (uphill) while the downhill westbound direction decreased from 19 to 7 percent. During dusk conditions, the percentage of drivers yielding to the pedestrian increased from 16 to 42 percent in the eastbound direction and 15 to 21 percent in the westbound direction. Braking distance increased slightly in the westbound direction under both day and dusk lighting conditions while decreasing slightly in the eastbound direction (uphill)

There was no substantial change to either the approach speed or travel time measurements. The results at this site were the least consistent of all the other sites. This may be due to the grade on the street which results in restricted sight distance of the crosswalk in the uphill eastbound direction and faster speeds not conducive to abrupt stops in the downhill westbound direction. Many drivers in the downhill direction who did not stop were observed acknowledging the presence of the staged pedestrian either through a nod, smile or wave of the hand. The volume of traffic is only about 8,000 vehicles per day, which allows for many acceptable gaps for the pedestrian, and may have resulted in an understanding that it's too difficult for downhill drivers to come to an abrupt stop.

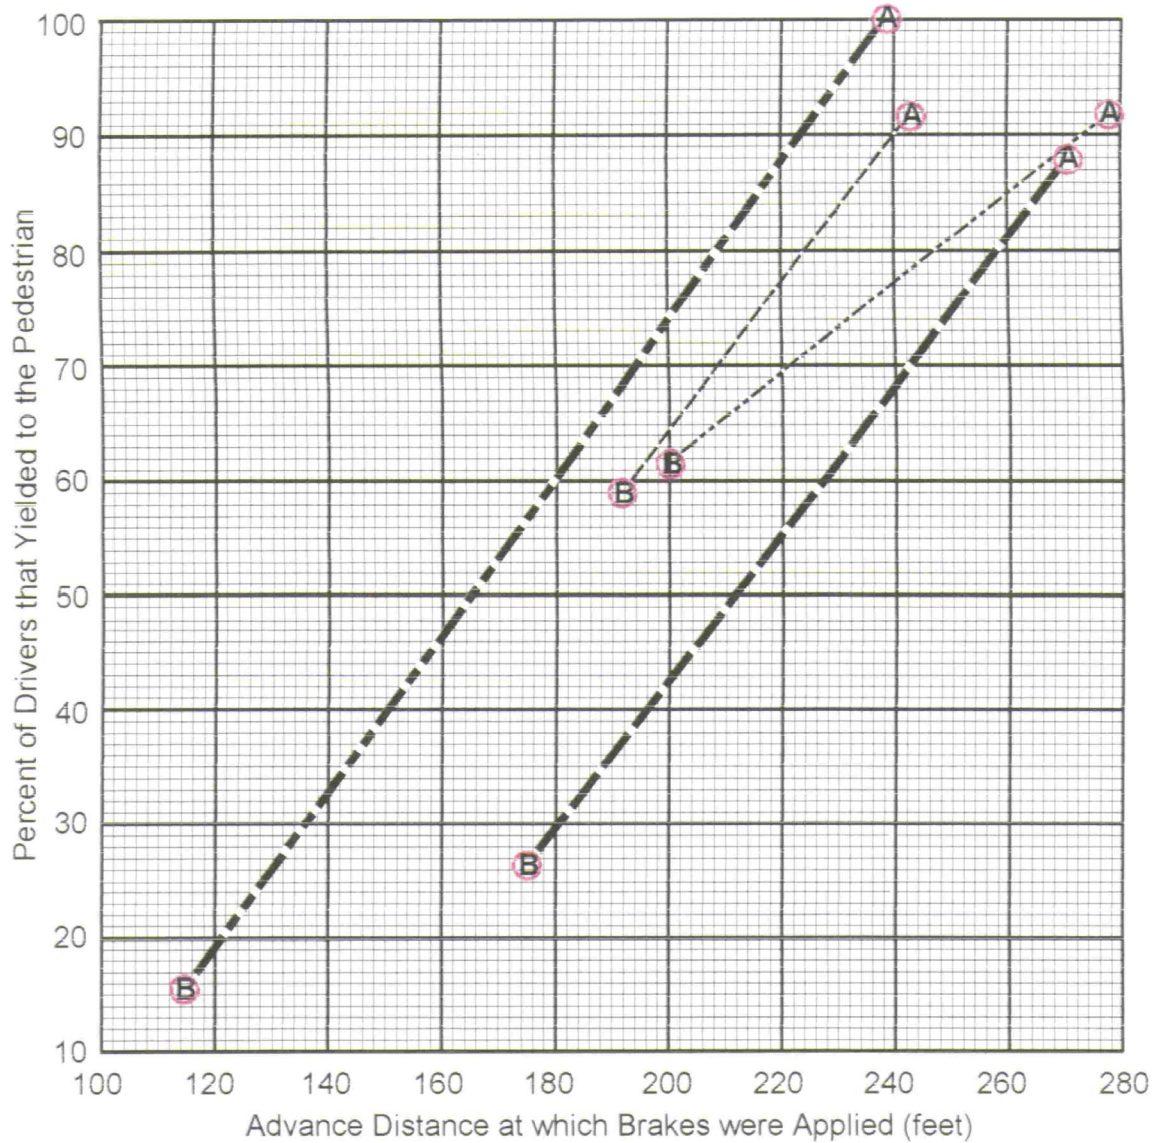
Figure 24 Data Comparison - Central Way/3rd Avenue  
*In-Pavement Flashing Lights Crosswalk Warning System Evaluation*  
 Whitlock & Weinberger Transportation Inc. City of Kirkland

In the "before" analysis, approximately 60 percent of the drivers were yielding to the pedestrian during the day, which is a minimal desirable level. In the evenings, pedestrian crossing conditions were less than desirable with approximately 15 to 25 percent of the drivers yielding to the pedestrian. As shown by Figure

24, the addition of the crosswalk warning system has increased the drivers' awareness of the crosswalk and pedestrians. In both directions, under both daytime and evening conditions, the distance at which brakes were applied has increased and the percentage of drivers that yielded to the pedestrian has increased to a level over 90 percent. The most dramatic changes occurred in the evening, with an increase of drivers yielding to the pedestrian from 20 percent to 95 percent and braking distance increasing from 145 feet to 250 feet from the crosswalk.

There were no significant changes in daytime approach speeds at the intersection. Before the device was installed, average speeds averaged 35 mph. After the warning system was installed, approach speeds decreased to 32 mph. During nighttime conditions, there was an increase in approach speeds recorded from 31.5 mph, before the system was installed, to 37.1 mph, after installation. However, total travel time in the study zone remained about the same even with the increase in approach speeds. In general, both the speed and deceleration factors indicate that the warning system has had a positive effect in gaining the attention of drivers.

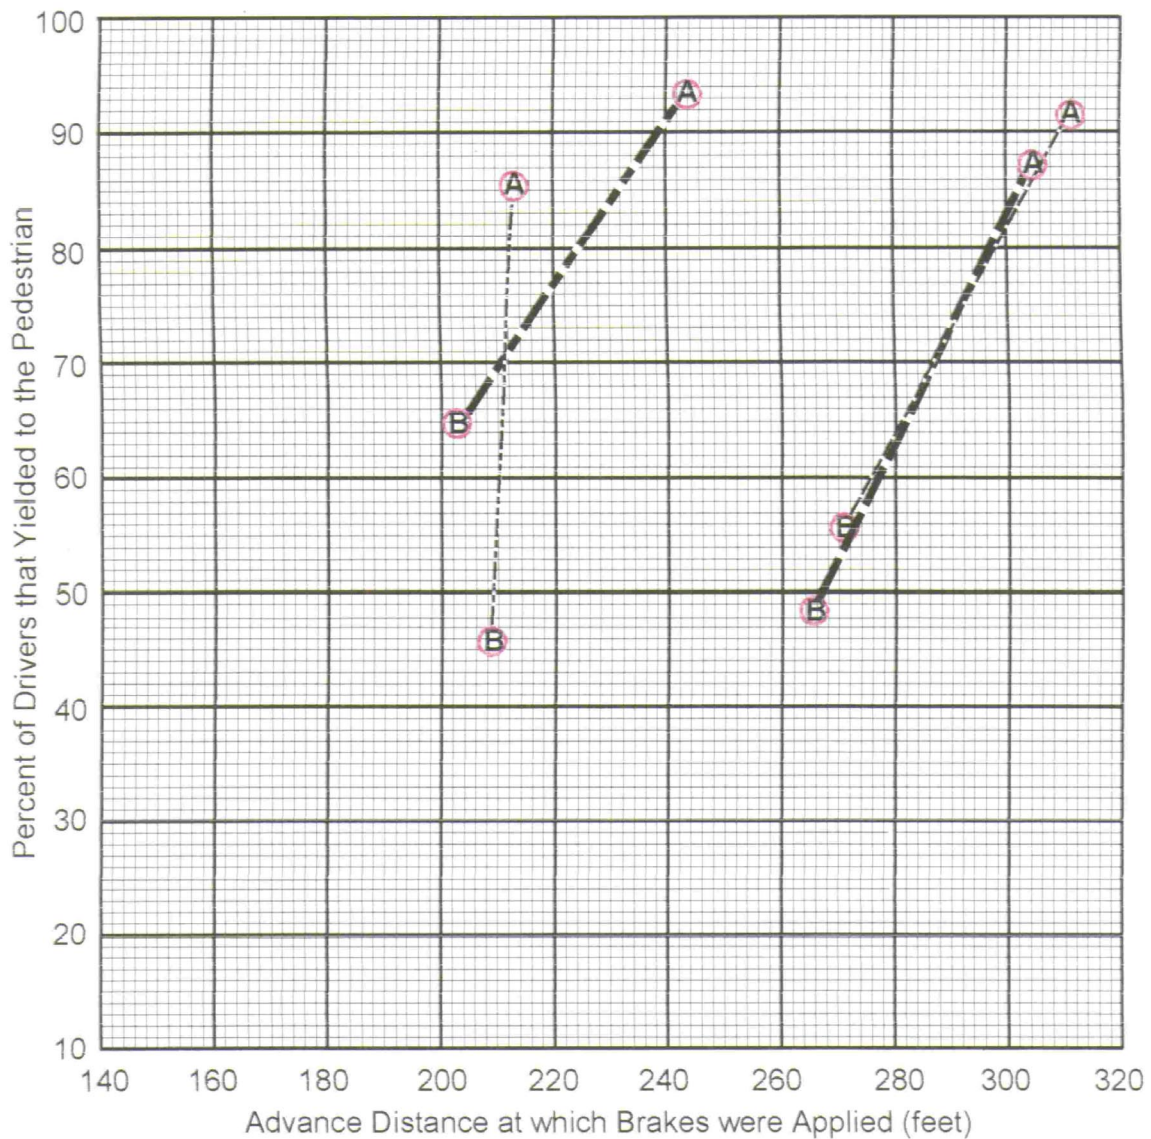
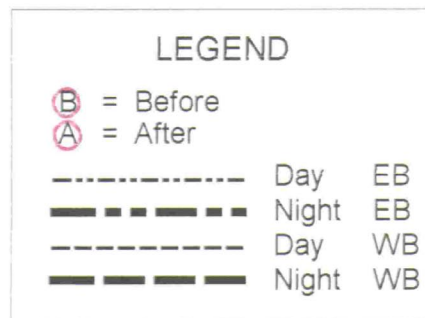
Figure 25 Data Comparison - Northeast 124th Street  
*In-Pavement Flashing Lights Crosswalk Warning System Evaluation*  
 Whitlock & Weinberger Transportation Inc. City of Kirkland

Existing pedestrian crossing conditions were initially at a minimal desirable level with approximately 50 percent of the drivers during the day and 60 percent of the drivers during the evening yielding to the pedestrian at the midblock crosswalk near the community center. As shown by Figure 25, the addition of the crosswalk warning system enhanced the driver's awareness of pedestrians and has modified driving habits to be more favorable for pedestrians. In both directions under both daytime and evening conditions, the distance at which brakes were applied has increased and the percentage of drivers that yielded to the pedestrian has increased to a level near 90 percent. At other locations, the change during the evening has typically been more dramatic than during the day. However, at this location, the change was similar to the daytime conditions. This may be due to the fact that this pedestrian crossing area on Northeast 124th Street had better lighting conditions than any other site evaluated.

There were both increases and decreases in vehicle approach speeds recorded at the site following installation of the warning system. There were very slight increases in travel time between 500 and 100 feet in advance of the crosswalk, which was measured as an indication of the deceleration changes of the approaching vehicles. Both of these speed and deceleration factors do not necessarily indicate any particular change in driving habits with the addition of the warning system. However, the reactions and braking distance have indicated that the system has had a positive effect in gaining the attention of drivers.
