## INSPECTION REPORT BY FIRELINE HOME INSPECTIONS

4501 Brandie Glen Rd  
Charlotte, NC 28269

04/19/2025

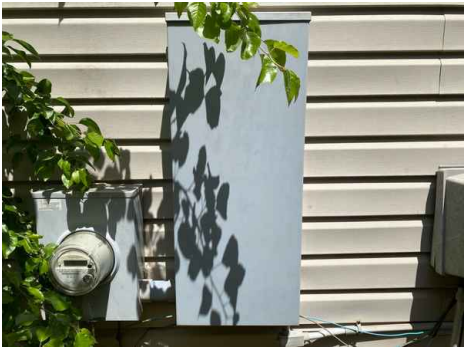
| <b>General Inspection Info: Weather Conditions</b><br>Sunny, Warm | <b>General Inspection Info: Type of Building</b><br>Single Family | <b>General Inspection Info: Electrical Panel Location(s)</b><br>Left Side Exterior<br><br>The electrical panel is referenced in the photo(s). |

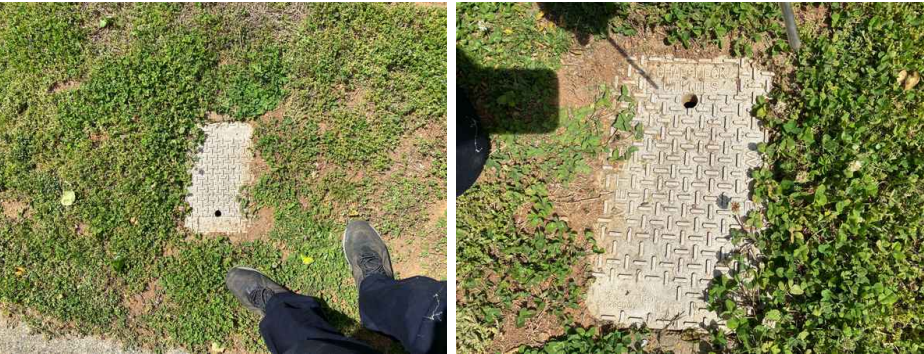
**General Inspection Info: Main Water Shut-Off Location**

Front Yard by Sidewalk

The main water shut-off location is referenced in this photo. It was difficult to open but inside will be the meter and shut off to the main water line going into the house.

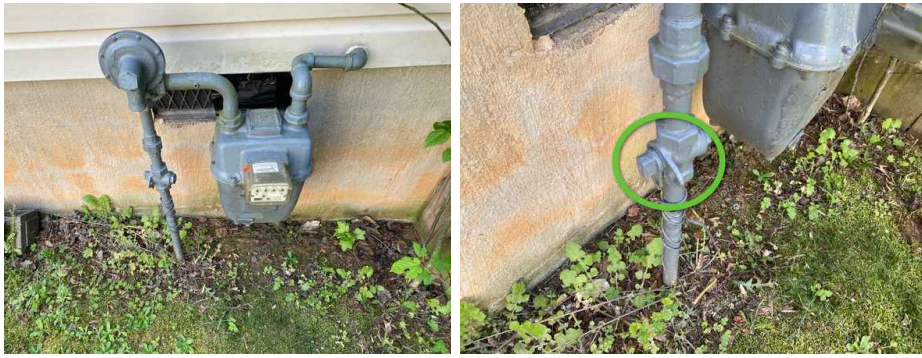
## General Inspection Info: Gas Appliances & Main Shut Off

### Right Side

The main shut off to the gas is referenced in the photo.

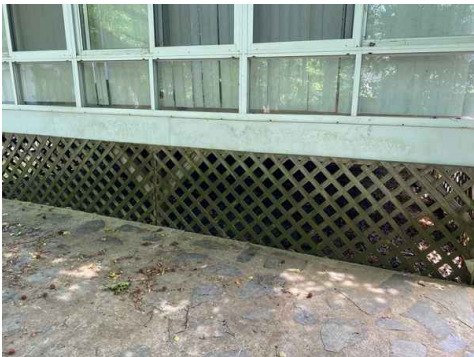
ATTACHMENT: UNABLE TO VIEW, DISCLAIMER

Due to height limitations or barrier installation, the deck means of attachment to the home was not readily visible and the inspection company disclaims responsibility for its inspection.

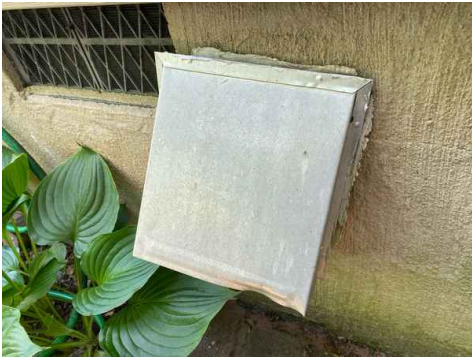
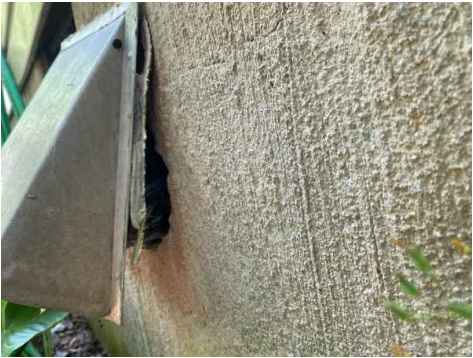
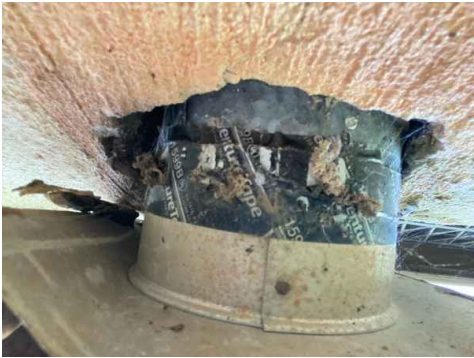
2.2.1 Wall Exteriors

DRYER EXHAUST DUCT: LOOSE, NO LONGER IN USE IN CRAWLSPACE

The old dryer exhaust duct was not loose from the crawlspace exterior at the rear of the home. This condition may allow pests to enter the opening around the vent. Recommend removal or securing of the duct to prevent easy access for water and/or pests.

Contact a qualified professional.

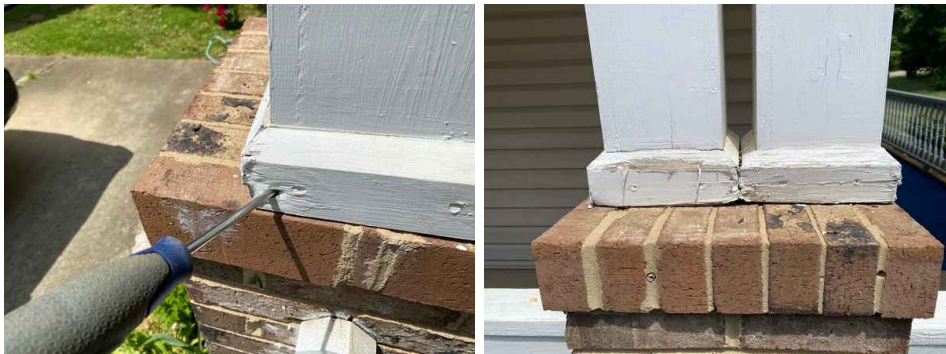
## 2.2.3 Wall Exteriors

**POST WITH WOOD ROT AT BASE**

An exterior post had wood rot around the base of the post. This should be corrected.

Contact a qualified handyman.

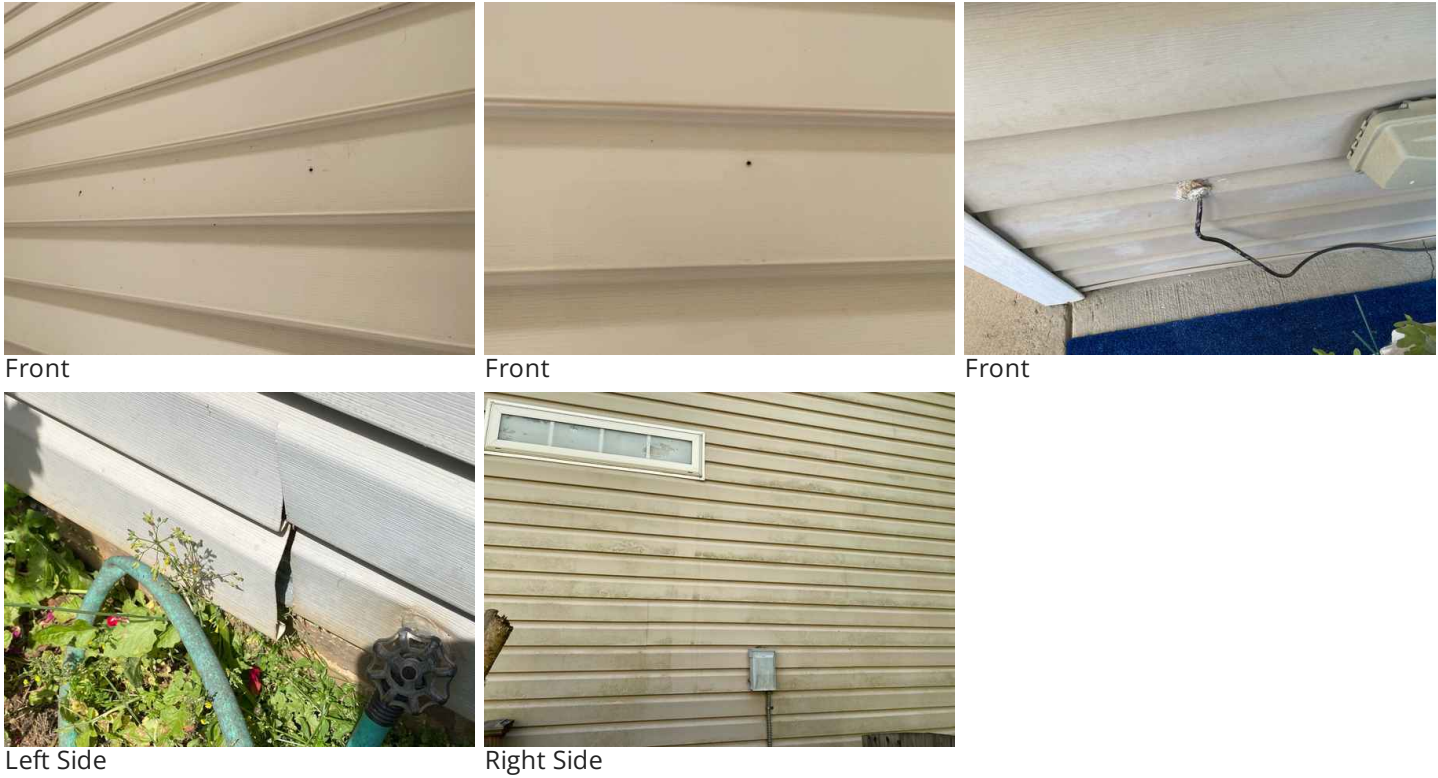
## 2.2.4 Wall Exteriors

The exterior walls exhibited weathering, wear, and deterioration commensurate with the age of the home. Continue to clean, repair, and monitor the exterior siding throughout the course of homeownership

Contact a qualified professional.

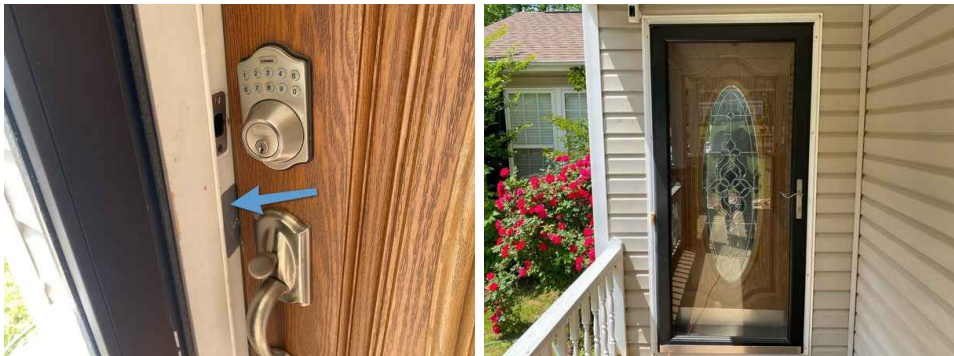
2.4.1 Door/Window Exteriors

**DOORS: HARDWARE MISSING**

The front door was missing necessary hardware. This should be installed to ensure that the door operates properly. Use photos as reference.

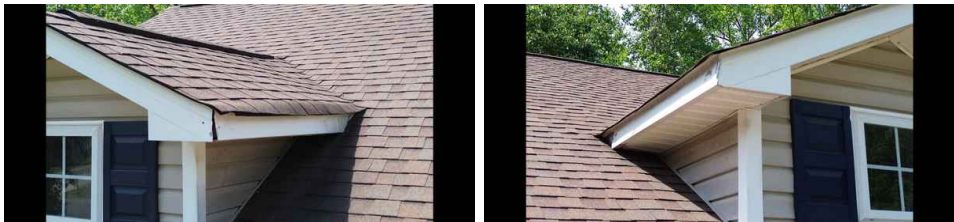
2.6.1 Eaves, Soffits & Fascia

**DAMAGE OBSERVED AT FASCIA**

I observed indications that one or more areas of the fascia were damaged.  
Correction and further evaluation is recommended.

Recommendation  
Contact a qualified general contractor.

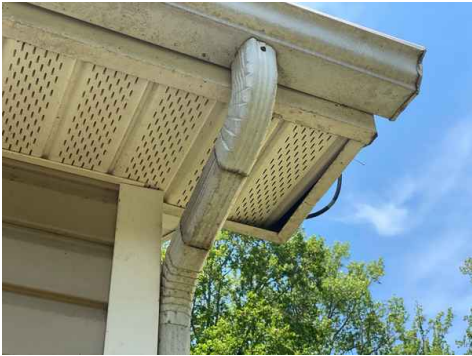
**DAMAGE OBSERVED AT SOFFIT**

I observed indications that one or more areas of the soffit were damaged.  
Correction and further evaluation is recommended.

Recommendation  
Contact a qualified roofing professional.

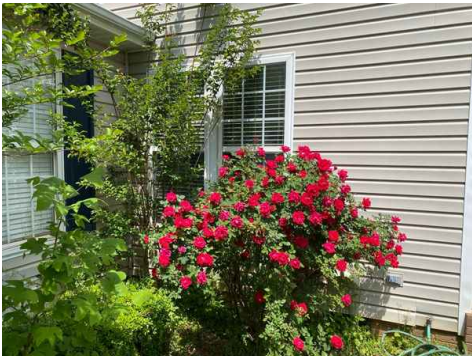
I observed dense vegetation around the house in areas. Dense vegetation and landscaping up against or near the house foundation and exterior walls may be prone to water penetration and insect infestation. At the front left side of the house, hydrostatic pressure has forced moisture through the crawlspace wall. This is evident by the heavy efflorescence deposits. Efflorescence is the grey, powdery deposit left by water permeating through the CMU block. It is recommended to remove the trees from this area to prolong the crawlspace.

Trimming, pruning and some landscaping is recommended in other areas.

Recommended DIY Project

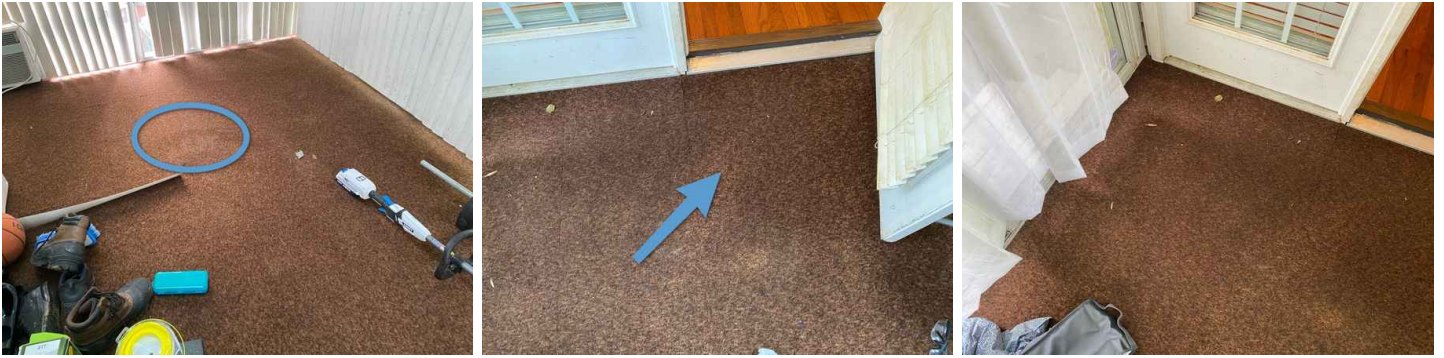
#### **WEATHERING: EVIDENCE OF PRIOR MOISTURE**

At the time of the inspection, there was evidence of prior leaks in the sunroom. While not wet during the inspection, it may or may not be actively leaking from the skylight windows. Monitor for leaks and moisture.

Contact a qualified professional.

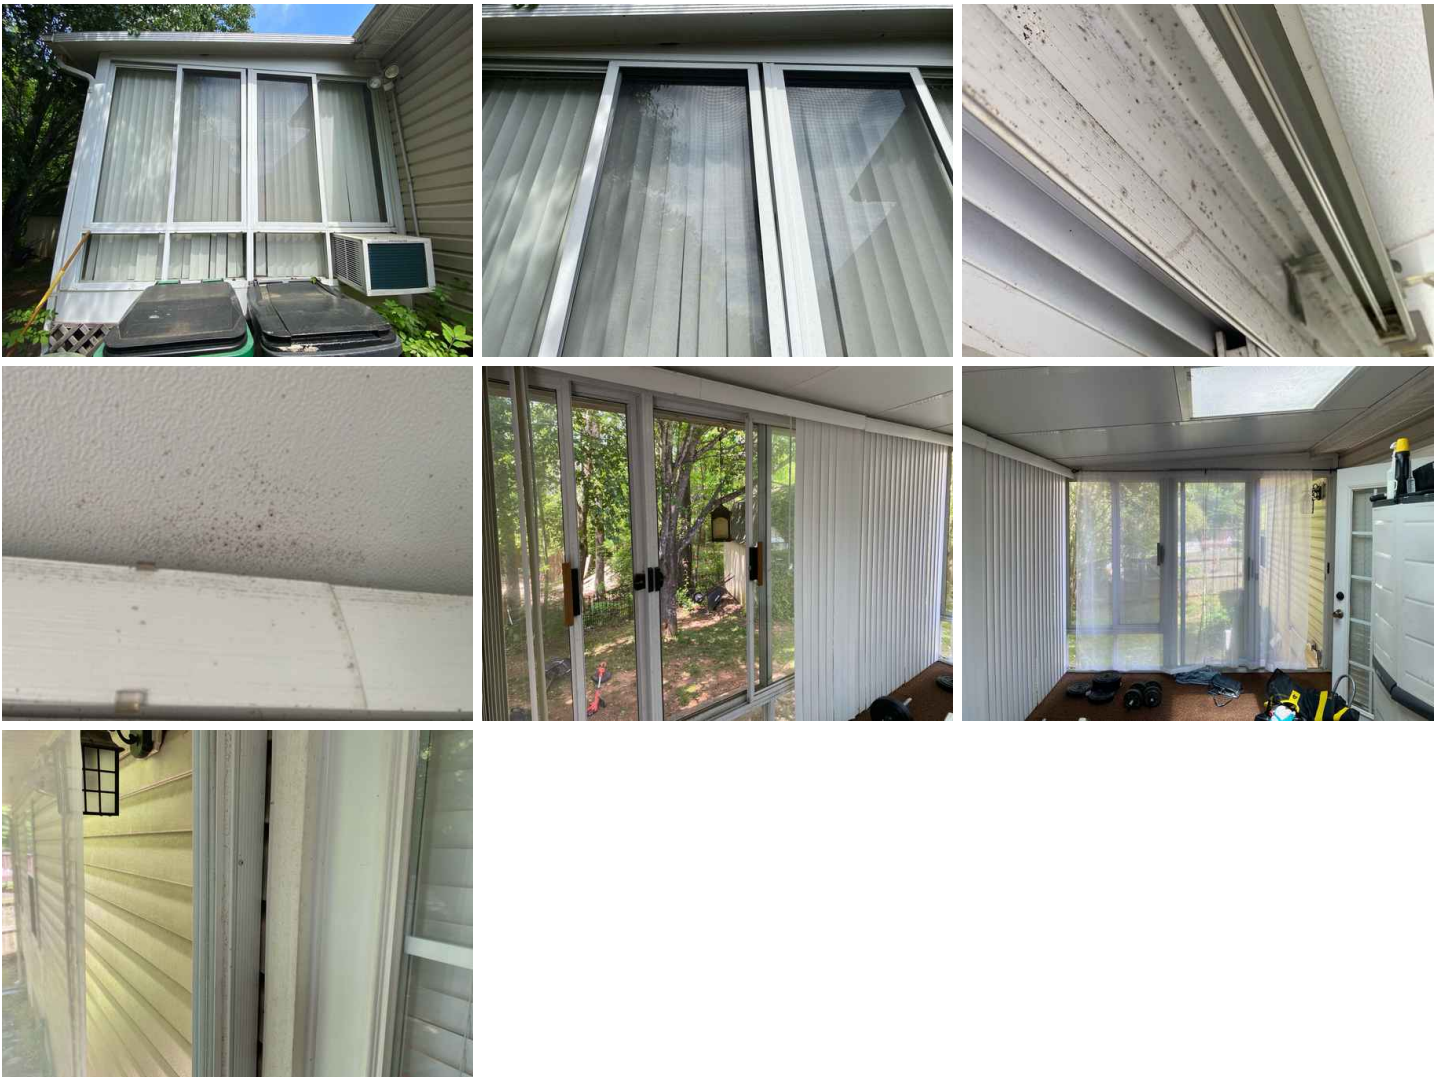
## 2.11.2 Sunroom

The sunroom exhibited moderate weathering and deterioration. There was evidence of fungal growth around the sliding window doors. Regular & routine maintenance will be necessary to prolong its lifespan. Recommend finding the permit for work performed on this sunroom to ensure proper construction. I was unable to closely examine the joists and ledger under the sunroom. An evaluation should be performed by a qualified contractor to provide an estimate for repairs as necessary.

Contact a qualified professional.

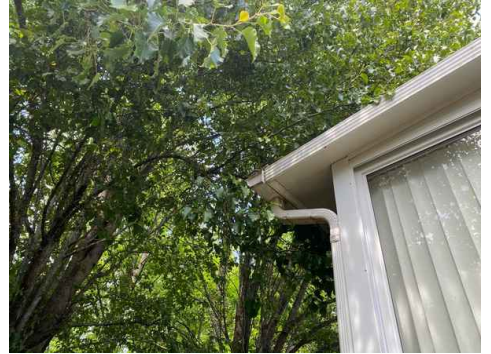
## 3.1.2 Roof Covering

**TREE TOO CLOSE**

I observed indications that a tree and or tree branch where overhanging the roof and maybe in contact with it.

Contact a qualified tree service company.

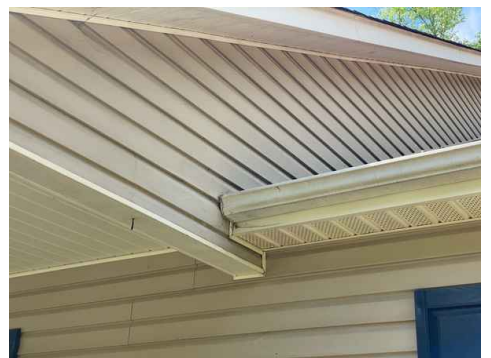
## 3.3.1 Flashing

**MISSING KICKOUT FLASHING**

I observed a defect that the flashing known as a "kickout" is missing. "Kickout" flashing "kicks" the roof water away from the house structure and diverts it into a gutter. This missing flashing could lead to hidden moisture intrusion and water damage issues that I would not be able to observe during a visual-only home inspection. A roofing professional is needed to further evaluate and make necessary corrections.

Contact a qualified roofing professional.

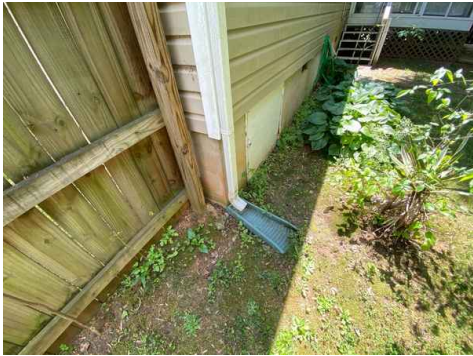
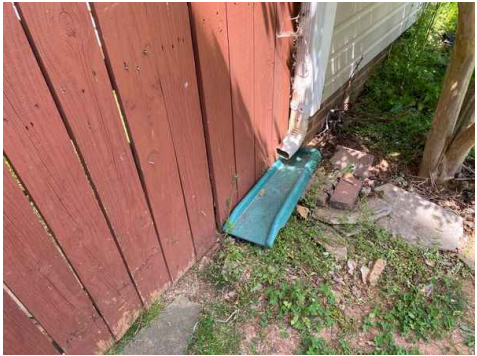
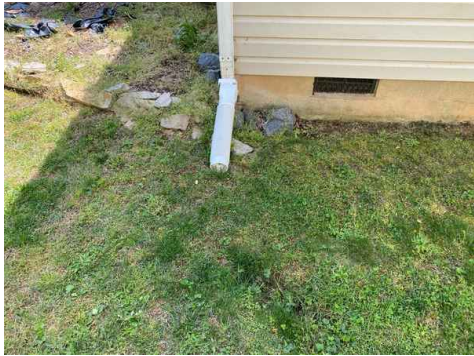
## 3.5.1 Gutters &amp; Downspouts

**DOWNSPOUTS DRAIN NEAR HOUSE**

One or more downspouts drain too close to the home's foundation. This can result in excessive moisture in the soil at the foundation, which can lead to foundation/structural movement. Recommend a qualified contractor adjust downspout extensions to drain at least 6 feet from the foundation. A handy homeowner should be able to do this project.

Recommended DIY Project

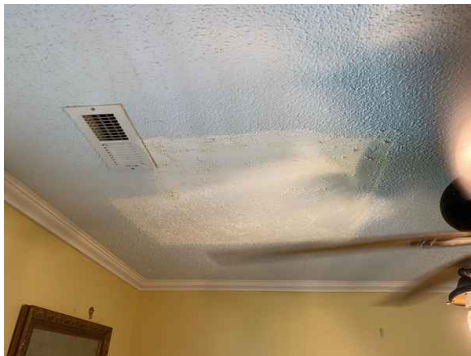
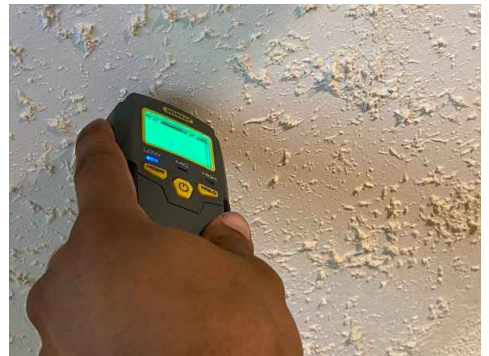
Drywall patching was visible in the ceiling of the front guest bedroom. Upon investigation with a moisture probe, there was no evidence of an active moisture problem. The patchwork could be improved upon by a qualified contractor.

Contact a qualified professional.

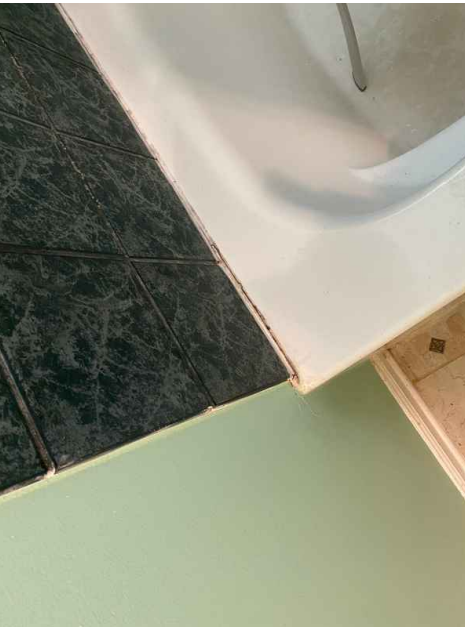
5.9.2 Bathrooms

BATHTUB: SEALANT, CAULK LINE FAILING

Sealant around areas where the tub meets the wall was old and had sections of cracked or missing sealant that may allow damage from moisture intrusion of the wall assembly. Maintenance should be performed by qualified personnel.

Recommendation  
Contact a qualified handyman.

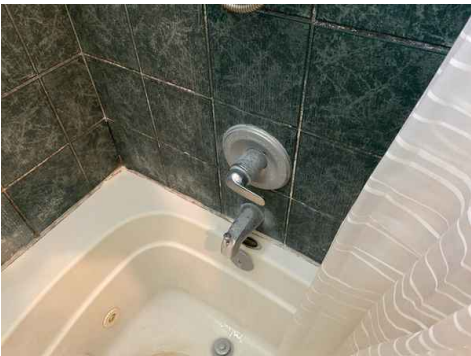
**SHOWER: HANDLES LOOSE WHEN OPERATED**

In the bathroom, valve handles were very loose when operated and should be tightened to prevent damage.

Recommendation  
Contact a qualified handyman.

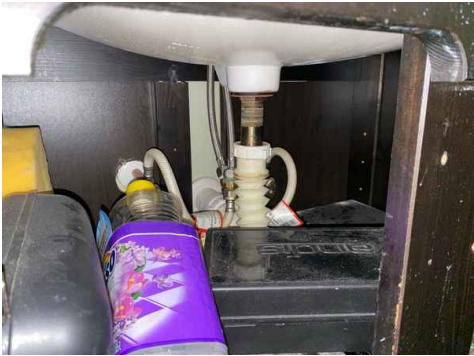
5.9.4 Bathrooms

**SINK: FAUCET INOPERABLE**

The hot water faucet of this bathroom sink was inoperable. It is recommended that it be serviced by a qualified plumbing contractor.

Bathroom (both water lines appear connected)

Recommendation  
Contact a qualified plumbing contractor.

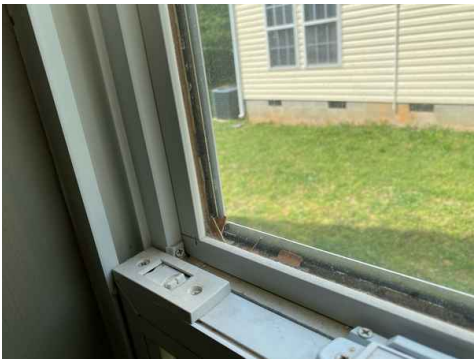
5.10.1 Windows

**DETERIORATION: MINOR, COMMENSURATE**

Windows in the home exhibited minor deterioration commensurate with the age of the home.

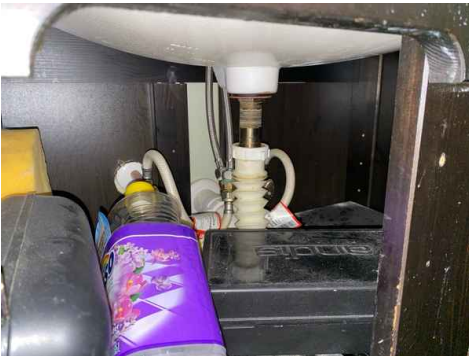
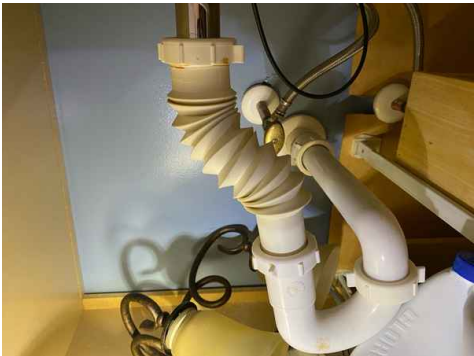
I observed indications of a defect at the sink drain trap. Flexible traps were installed, which is not recommended. Traps are installed to prevent toxic sewer gas from entering the living space. The existing trap should be replaced with an approved P-trap by a qualified plumbing contractor. One of the current traps leaked at the time of the inspection.

Recommendation  
Recommended DIY Project

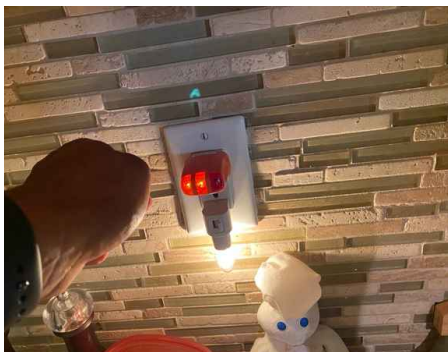
Kitchen

I observed ground fault circuit interrupter (GFCI) protection in the kitchen.

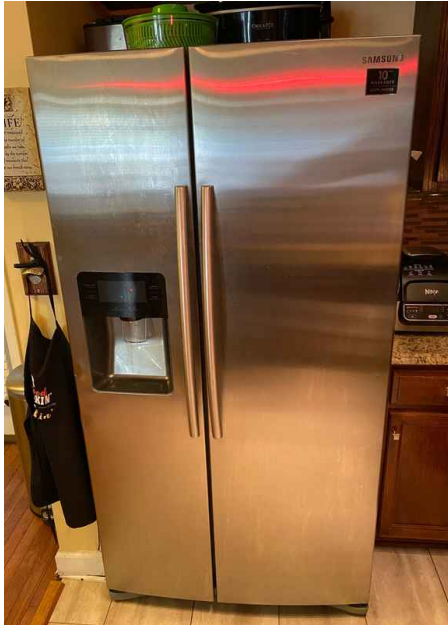
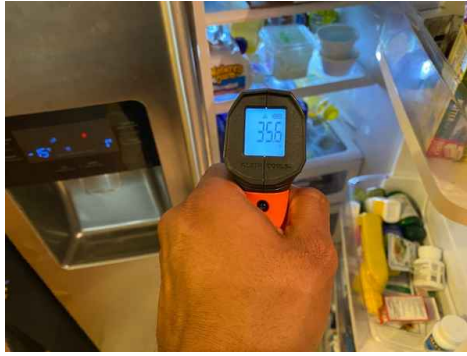
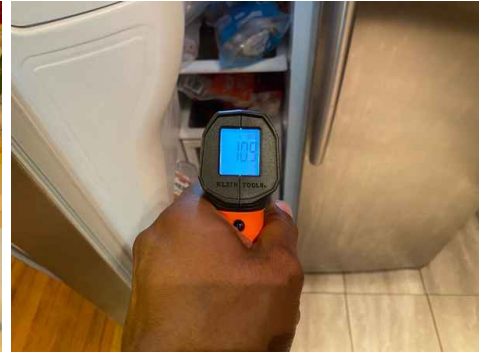
## Refrigerator: Refrigerator Brand: Samsung

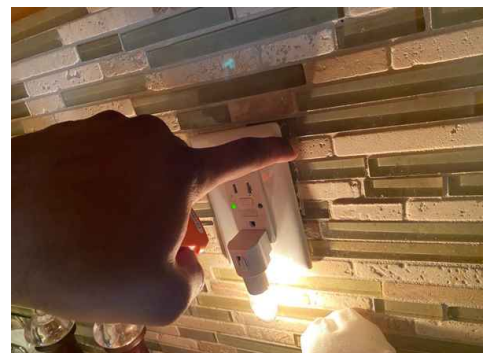
### 6.2.2 GFCI

#### RECEPTACLE: LOOSE

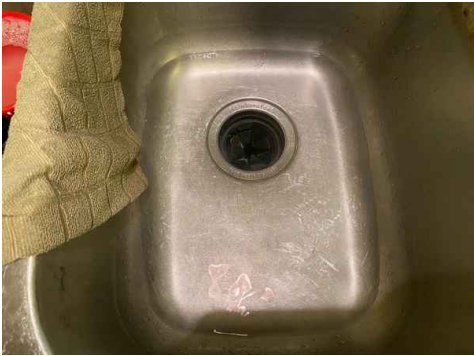
### 6.3.1 Kitchen Sink

#### DRAINAGE SLOW

Recommendation  
Contact a qualified plumbing contractor.

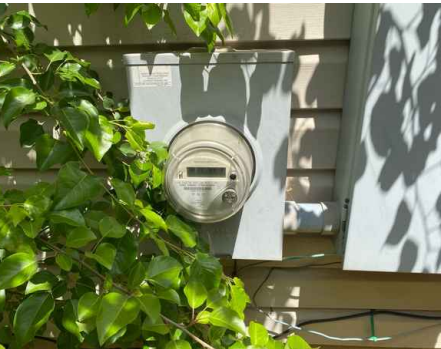
Left side

Electric Meter & Base: Electric meter location

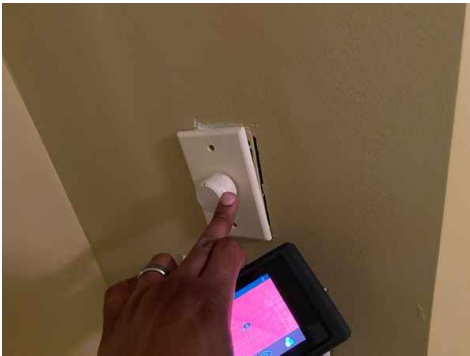
Multiple electrical receptacles were loose and moved when a plug was inserted, a potential fire/electrical shock hazard. Correction should be made as necessary by a qualified electrical contractor.

Contact a qualified electrical contractor.

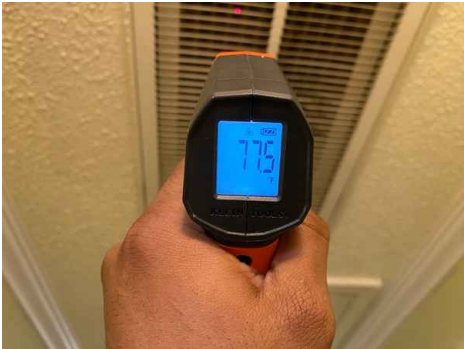
**Heating System Information:**  
**Return Air Temperature**  
77.5 Degrees Fahrenheit  
Room temperature air which is returning to the HVAC unit.

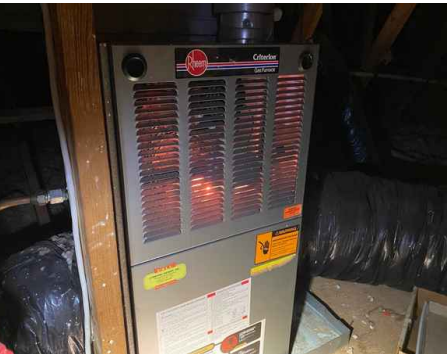
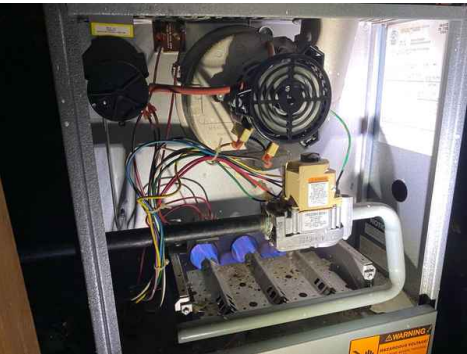
**Heating System Information: Energy Source**  
Gas

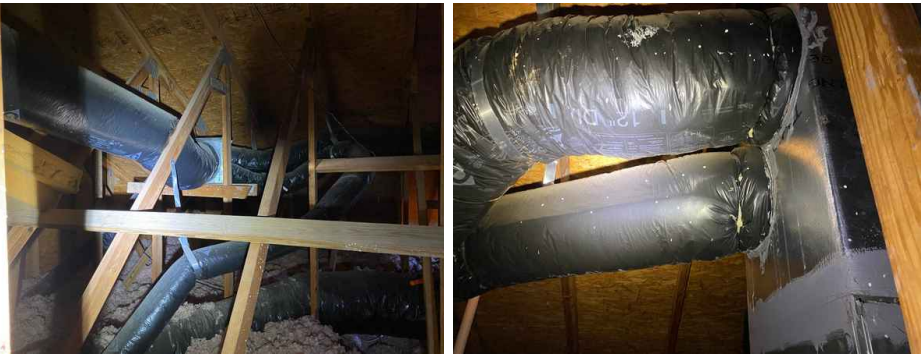
Insulated

I observed ductwork in the house. Warm-air heating systems, including heat pump systems, use ductwork to distribute the warm air throughout the house. I will attempt to determine if the each room has a heat source, but I may not be able to find every duct register.

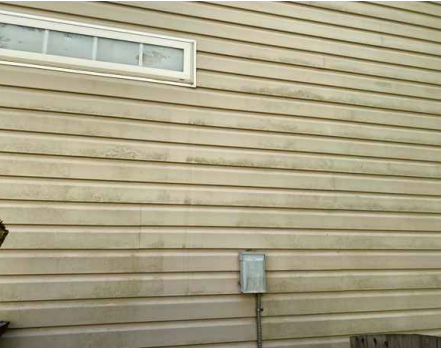
I observed a service disconnect within sight of the cooling system.

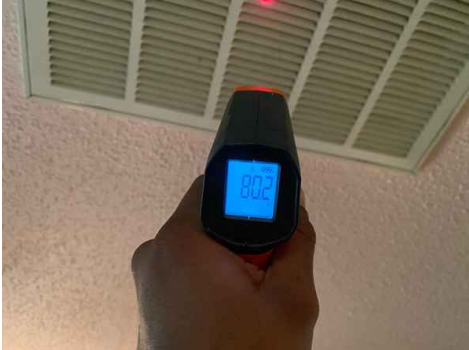
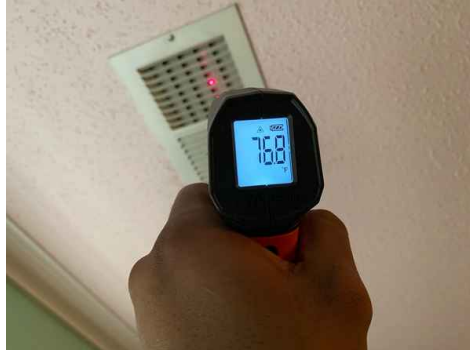
### 9.1.2 Cooling System Information

I observed that the heating system did not operate effectively. While testing the system, the temperature was set to 70 degrees. The A/C system ran for 30 minutes, but the temperature never got below 75 degrees in the house. An operating A/C system will have between a 14-22 degree difference between the supply air and return air temperature. While testing the system, the differential was just 3 degrees.

Correction and further evaluation is recommended by a licensed HVAC contractor.

Contact a qualified HVAC professional.

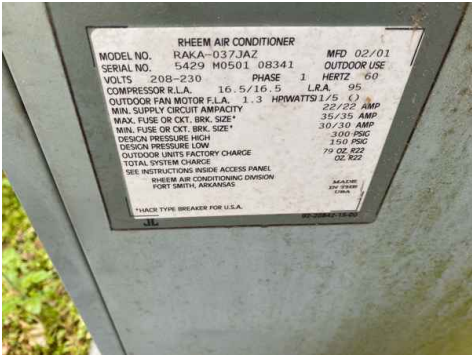
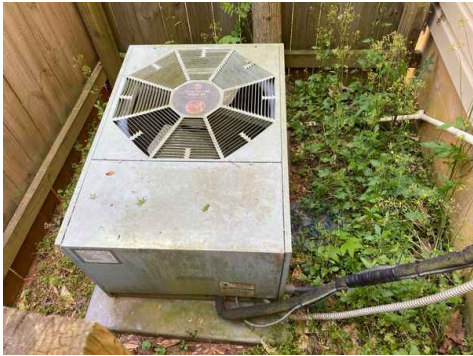
I observed during my inspection that the system appeared to be very old and at the end of its service life. It is not reliable. Ask the homeowner or occupant about its recent performance. Regular maintenance and monitoring of its condition is recommended. Budgeting for repairs and future replacement is recommended. [InterNACHI's Standard Estimate Life Expectancy Chart for Homes](#)

Recommend monitoring.

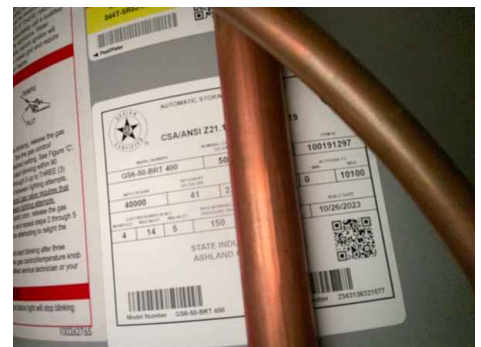
The photo shows the data plate of this water heater.

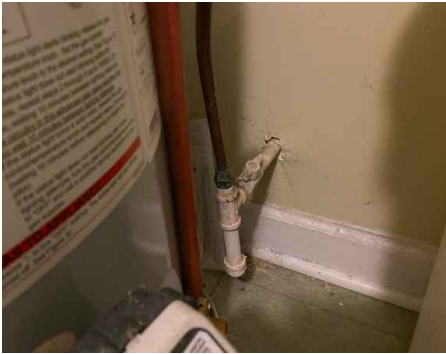
The photo shows the location of the shut-off valve for gas at the water heater.

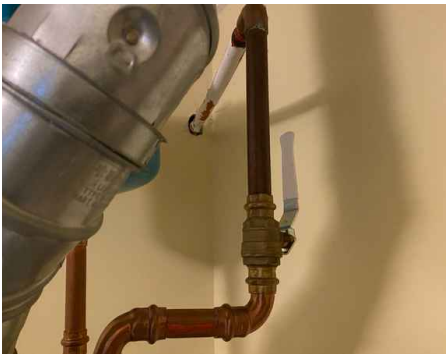
The photo shows the locations of shut-off valve for water at the water heater.

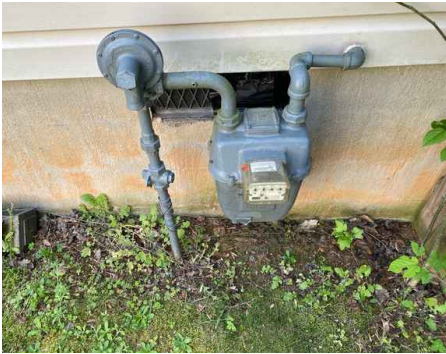
The photo shows the gas pressure regulator that controls the pressure under which gas is supplied to the home. Gas regulators leak small amounts of gas occasionally. If gas smell is strong and persists, contact your local gas utility provider.

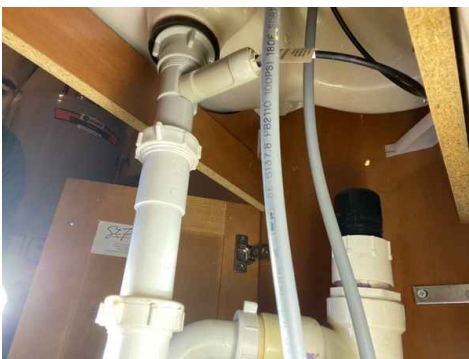
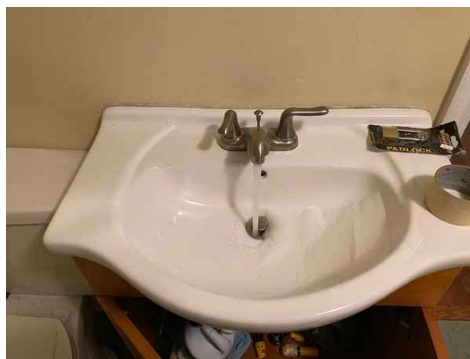
PB 2110

### **WATER DISTRIBUTION PIPES: POLYBUTYLENE, REPLACE**

Some of the distribution pipes in the rear bathroom sink was polybutylene. Certain polybutylene water distribution pipe installed between January 1, 1978 through July 31, 1995 has been identified as deficient. Pipes may become weak and fail without warning, resulting in flood damage. You should consult with a qualified plumbing contractor to discuss the necessity, options, and costs for replacement of all polybutylene pipe.

Contact a qualified plumbing contractor.

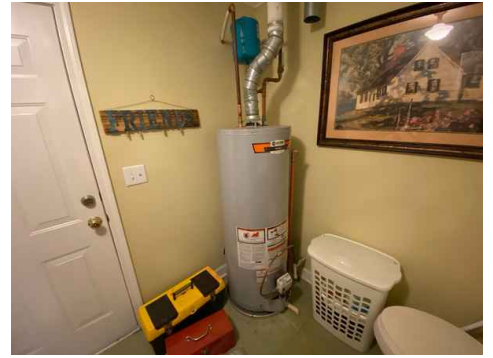
### 10.2.1 Water Heater

### **COMBUSTION AIR: INSUFFICIENT**

The water heater appeared to have insufficient combustion air. It is not standard for gas water heaters to be located in the bathroom. Inadequate combustion air can result in improper fuel combustion and the release into indoor air of excessive amounts of carbon monoxide, an invisible, odorless, toxic gas. An evaluation and work as necessary should be performed by a qualified plumbing contractor.

Contact a qualified plumbing contractor.

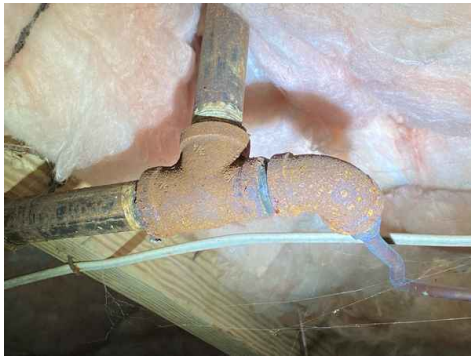
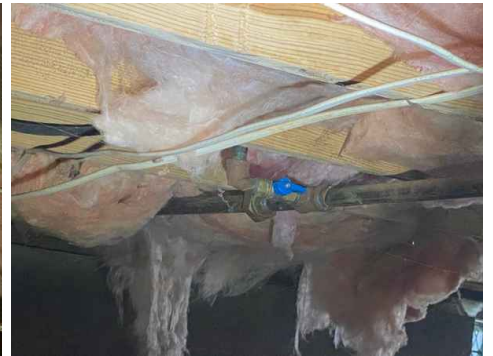
10.4.1 Gas System

**GAS PIPES: CORROSION, MODERATE**

Contact a qualified plumbing contractor.

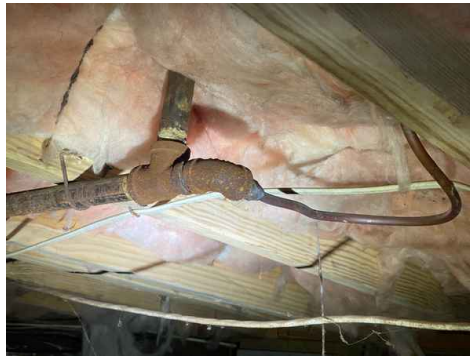
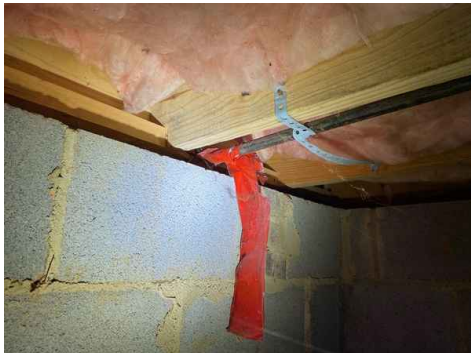
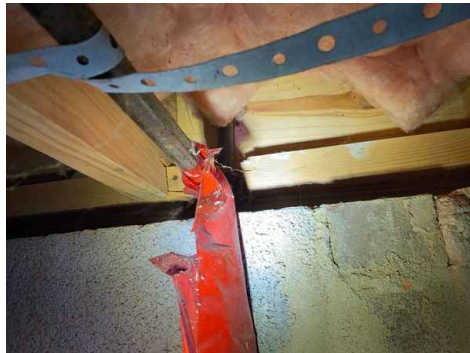
Gas pipes in the crawlspace of the home exhibited moderate general corrosion. If this condition continues it may eventually cause gas pipes to leak, introducing toxic gas into indoor air. The source of moisture causing this corrosion should be identified and corrected by a qualified contractor.

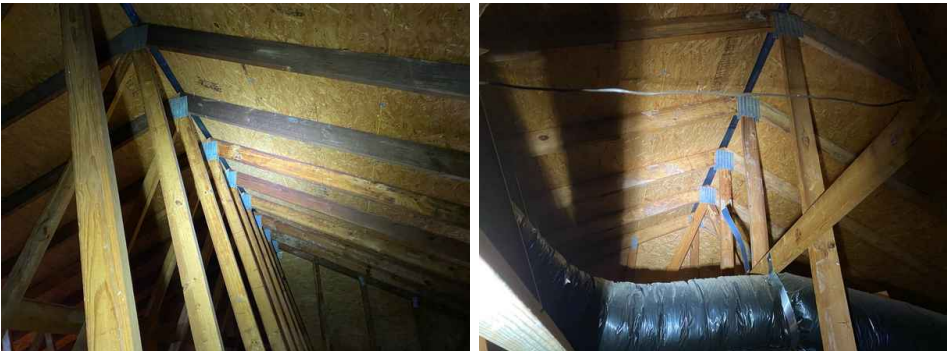
Roof Trusses: Truss roof

The roof was framed using manufactured roof trusses. Roof trusses should never be cut or structurally altered in any way. Using the truss interior attic area for storage may place improper structural loads on parts of the trusses not designed to support those loads and should be avoided.

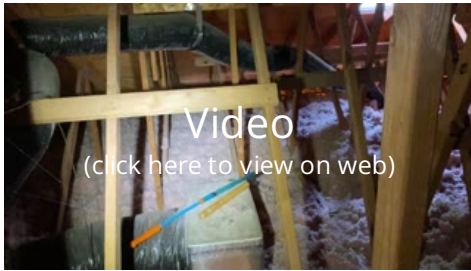
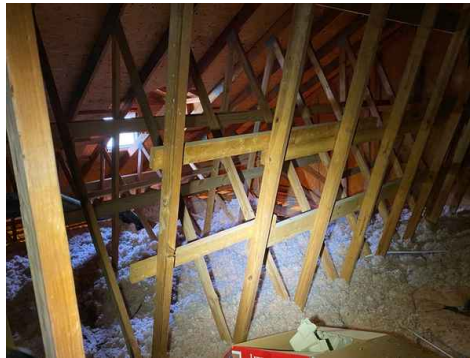
11.4.1 Thermal Insulation

Thermal insulation in the attic was poorly-installed and had significant gaps that will result in unwanted heat gain or loss. This condition will increase heating and cooling costs and reduce comfort levels and may contribute to ice damming of the roof during the winter. Insulation should be properly distributed to cover all portions of the attic located above the home living space.

Contact a qualified insulation contractor.

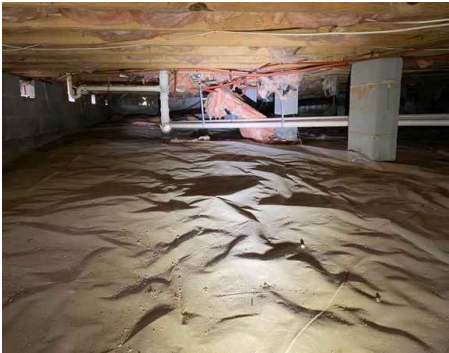
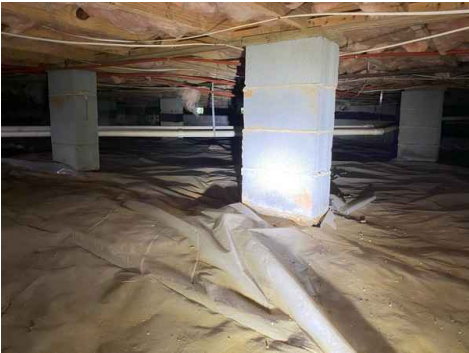
**Crawlspace: Crawlspace floor material**  
Dirt w/soil cover (plastic)

The floor of the crawlspace was covered with a plastic soil cover that consisted of sheet plastic. Soil covers are installed to help minimize moisture evaporation and soil gas movement into crawlspace air from the soil. Edges were sealed at overlaps and at the perimeter, which is also typically done to help lower radon levels.

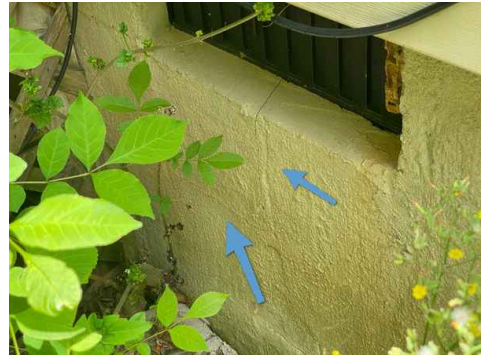
## 12.1.1 Foundation

**CMU FOUNDATION WALLS: CRACKING , MINOR**

Concrete masonry unit (CMU) foundation walls had minor cracking. Cracking did not appear to be continuous through the wall. Determining the cause of cracking can only be determined by a structural engineer or foundation expert. Continue to monitor.

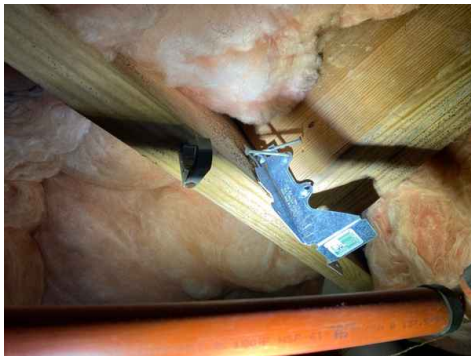
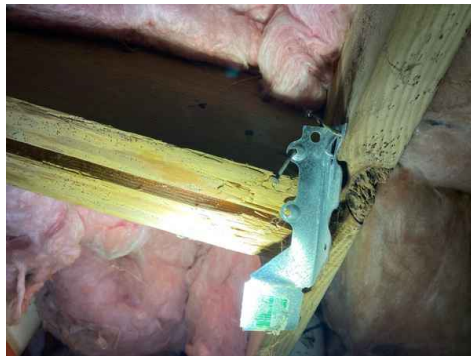
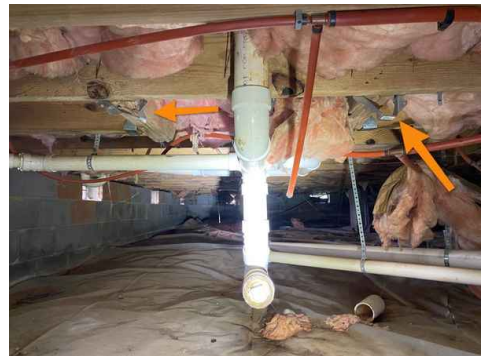
## 12.2.1 Crawlspace

**CRAWLSPACE: FLOOR FRAMING, INADEQUATE SUPPORT**

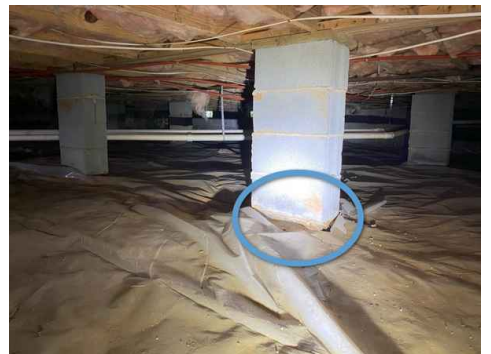
The floor of the crawlspace was covered with a plastic soil cover that consisted of sheet plastic. Soil covers are installed to help minimize moisture evaporation into crawlspace air from the soil. Edges at overlaps and the crawlspace perimeter were not sealed. This will reduce the effectiveness of the cover.

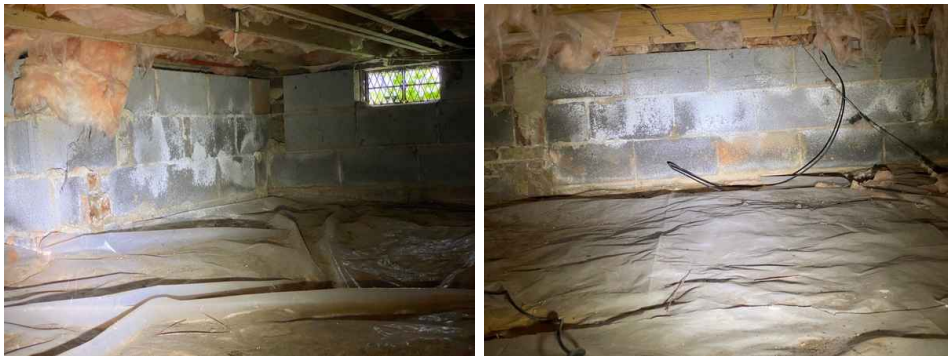
In the crawlspace, moderate amounts of efflorescence was visible at some of the interior surfaces of the foundation walls. Efflorescence is a white powdery mineral residue deposited by water seeping through porous concrete or masonry and evaporating when it reaches the surface. To avoid potential material damage, the source of moisture should be identified and corrected.

## Recommendation

Contact a qualified professional.

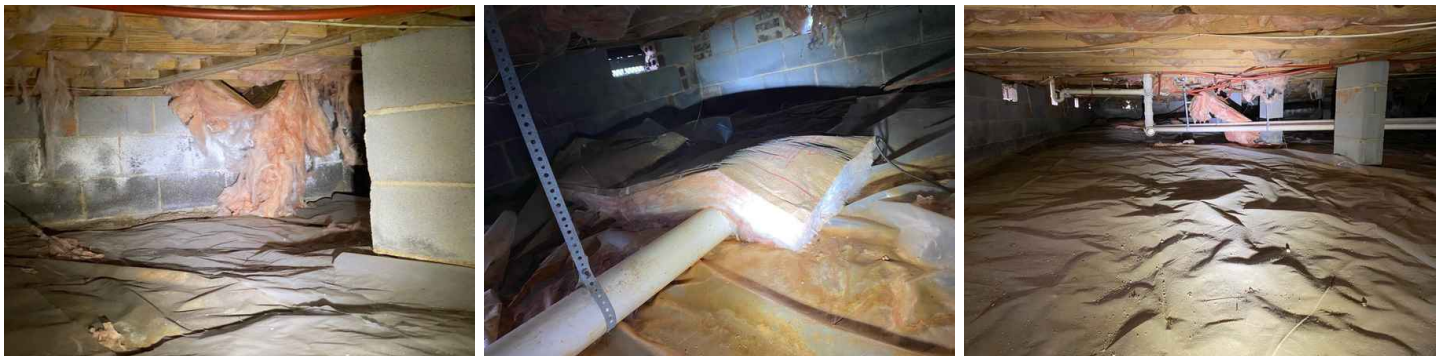
## 12.2.5 Crawlspace

**INSULATION: LOOSE, MISSING INSULATION**

Contact a qualified professional.

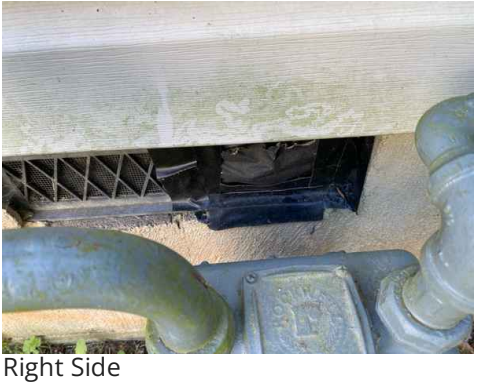
12.2.7 Crawlspace

**CRAWLSPACE VENT COVER  
DAMAGED**

The Crawlspace vent cover was damaged at the time of the inspection. Recommend replacing the vent to prevent moisture and pests from gaining entry into the Crawlspace.
