**Analysis of the November 26,  
1971 Loss of Owl 08 (REFNO 1781)  
Report Date: November 11, 2022**

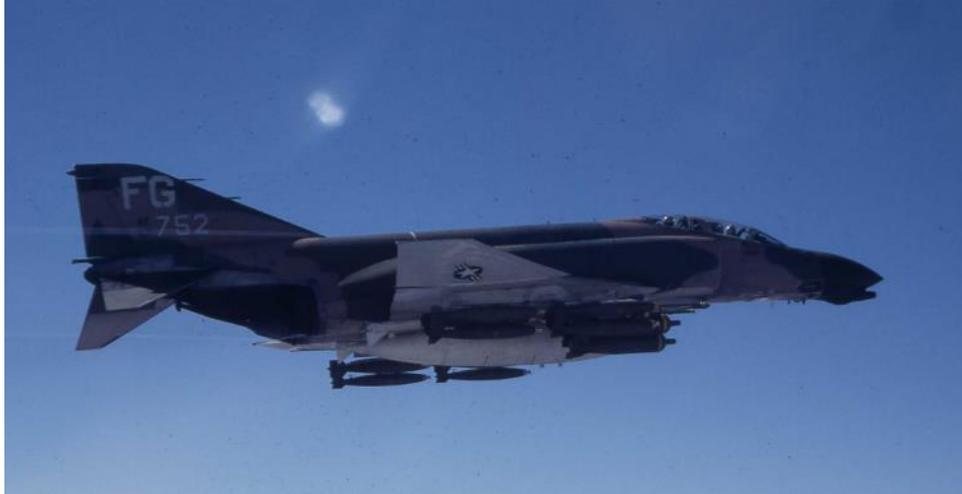
Figure 1: F-4D 66-7752 circa 1969 Source: Wendell Keller

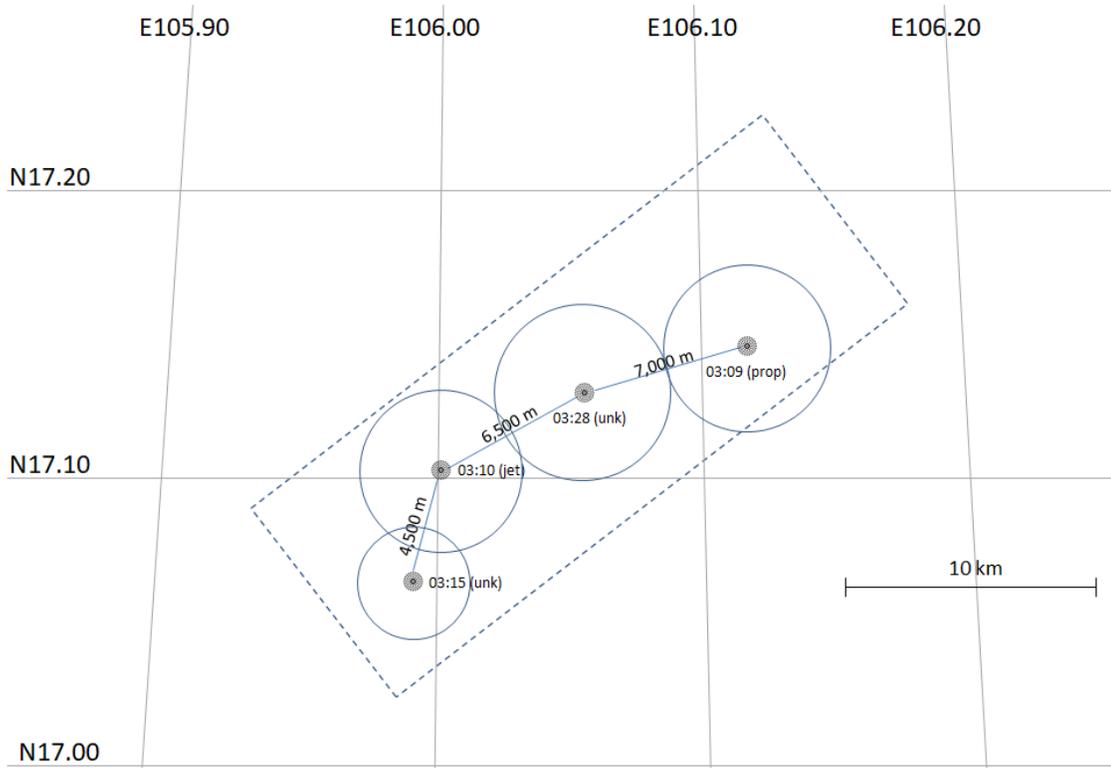
Figure 7: Sensor Activations on November 26, 1971

Interestingly, at 3:10 AM an acoustic sensor registered a "jet" aircraft approximately 4 miles southwest of D52, about 40 seconds away at F-4 speeds. While we can't prove the aircraft detected was Owl 08, given no other aircraft was assigned to this target area at that time this is very strong circumstantial evidence the crew reached their assigned target area about 75 miles northeast of their last-known radar position crossing into Laos (Record Loss Location). Additionally, at 3:09 AM a "prop" aircraft was detected and at 3:15 AM and 3:28 AM an aircraft was detected but both were classified as "unknown". The ground distance between sensors is also listed, which will become important when creating a sensor detection model later in this section.

However, this profile needs to be tempered by the fact ground distances between the four sensors activated varied from 4,500-7,000 m (from Figure 7) and multiple sensors were not activated at the same time, which means the average maximum ground distance at which an aircraft could be detected that night must be  $\leq \frac{1}{2}$  the distance between sensors or 2,250-3,750 m. Using 7,750 m as the maximum x-distance and a  $\theta$  range from  $10^\circ$  (a guess) to  $50^\circ$  above the horizon, this dramatically decreases the detection capabilities, resulting in a "doughnut" that was likely much closer to Figure 8. This puts the effective maximum detection zone between 0-3,750 m across the ground and 0-4,500 m above the ground assuming that vegetation and atmospheric conditions (temperature, pressure, clouds, and relative humidity) were the same at all four sensor locations, which was highly-unlikely.

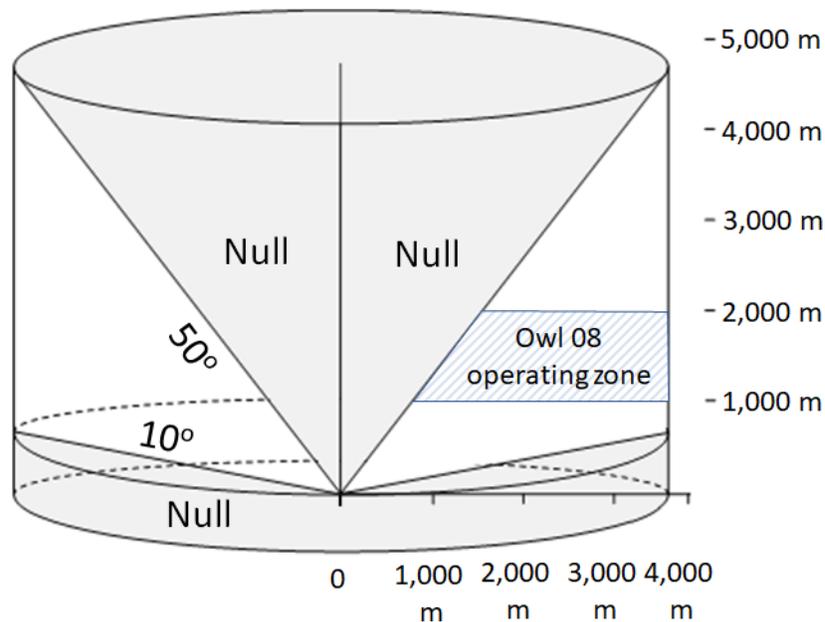
Figure 8: Igloo White Expected Aircraft Detection Zones

Acoustic sensors had a "doughnut" pattern (null zone) but they were not uniform due to vegetation, terrain, and weather conditions, making plotting a standard pattern impossible. Mr. Serstad said that during Operational Testing and Evaluation of the sensors prior to combat deployment, "Vegetation raised hell with the acoustics." (Serstad) However, according to him, detection angle ( $\theta$ ) was as high as  $50^\circ$  above the horizon but detection range dropped dramatically as the angle approached the horizon (i.e., aircraft flying at higher altitudes would be detected sooner). He estimated aircraft detection ranges (x-component) varied from 1,600-3,200 meters (m) to as much as 8,000-11,000 m under ideal conditions. Additionally, operational evidence showed that EC-121 aircraft (used as airborne relays between sensors and a central computer at Nakom Phanom Airbase in Thailand) sometimes received sensor data triggered by their own aircraft flying overhead. Since they operated in the 16,000-18,000 foot/4,800-5,500 m Above Ground Level (AGL) range, this should be considered the maximum detection altitude (y-component). (Project Checo 1970-1971)

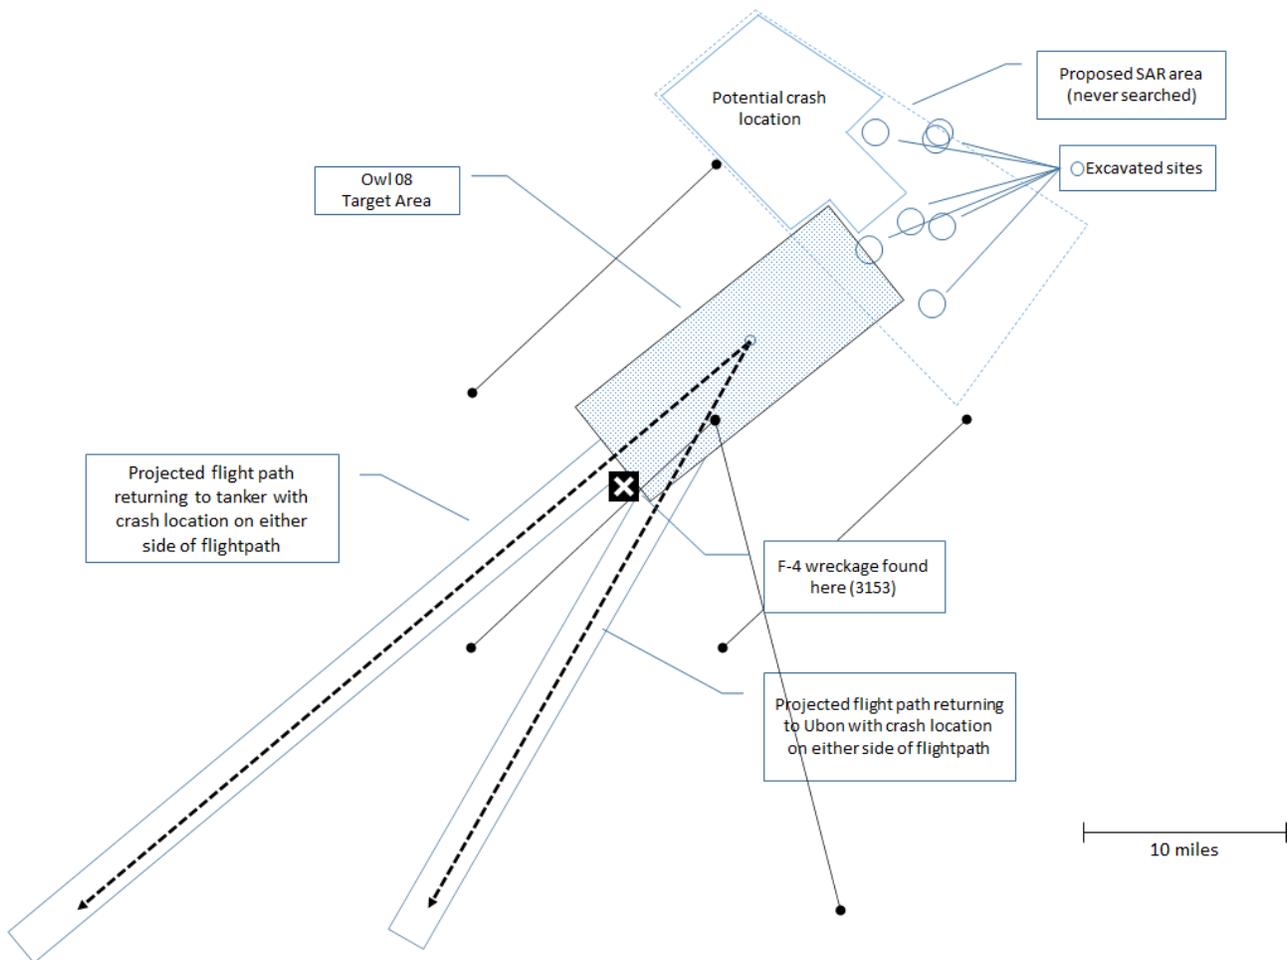
Figure 12: Possible crash locations for Owl 08 vs. areas already searched and UNC 3153's location

To sum up this section and looking at Figure 12 below, the Team believes the missing aircraft may have crashed either along the projected flightpaths from the target to the tanker or from the target to Ubon (outside the areas already searched) or in the northern corner of the proposed SAR area (labeled "Potential crash location"). It's important to note how close 3153 is to both projected flightpaths. Likewise, SAR Area 19 (searched 11/26/71 to 12/3/71) goes almost exactly over 3153. If 3153 is actually 1781, *then this is strong evidence the aircraft broke up inflight* because a new crash site crater would likely have been seen from the air.

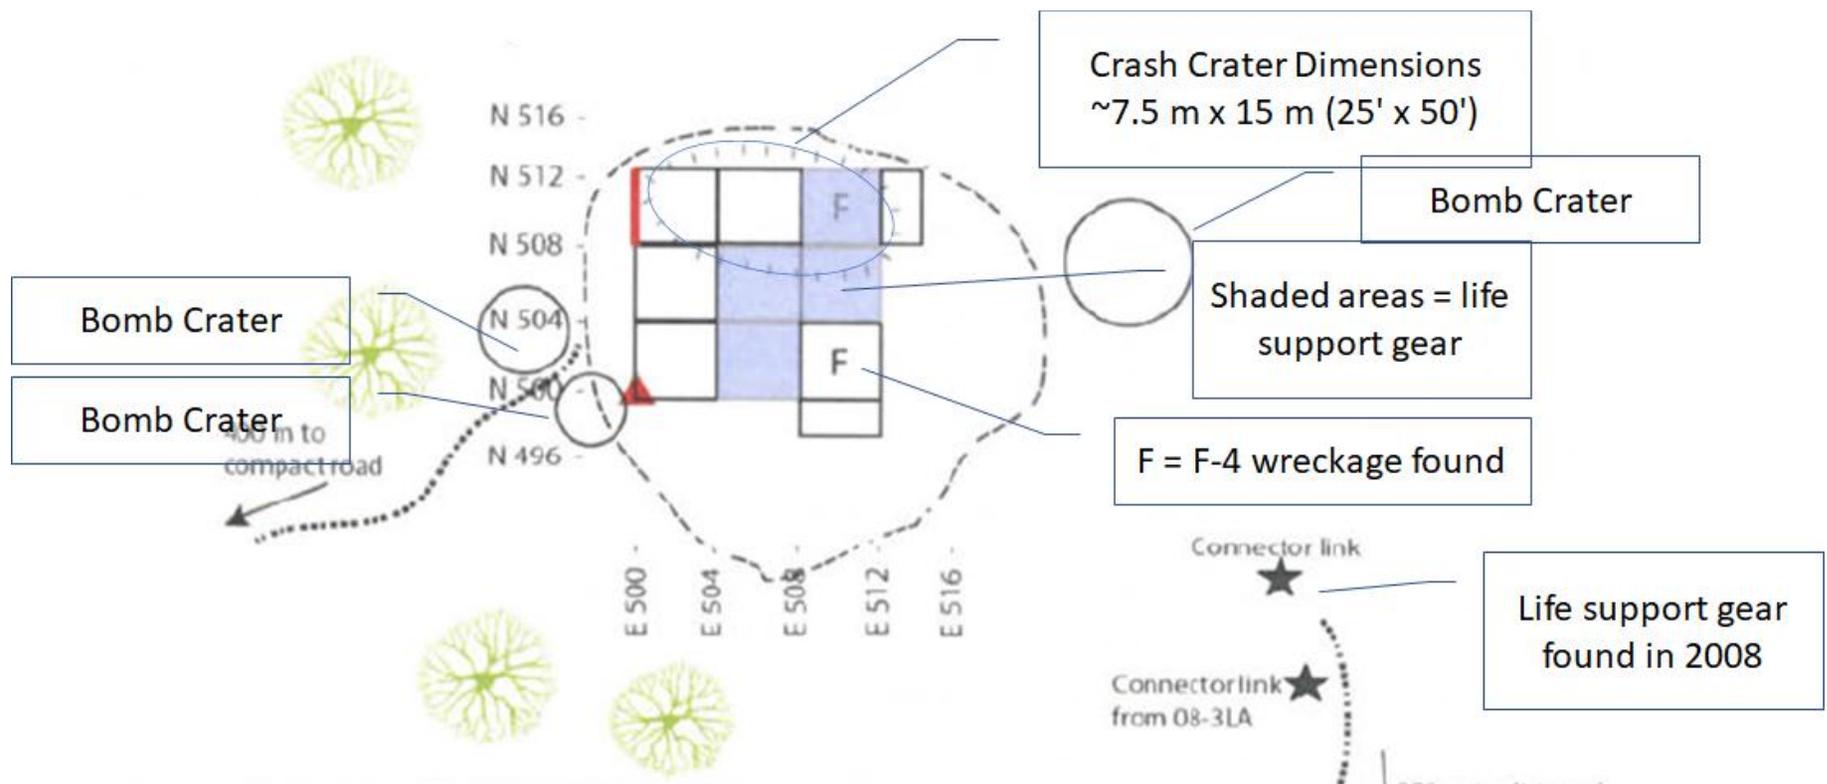
Figure 14: 3153 Excavation Area Source: Interim Search and Recovery Report CIL 2013-095-R

During the April 2008 site survey of the suspected crash site of REFNO 0572 (1Lt Ray Krogman, USAF, shot down on 1/17/1967 in an [O-1 Bird Dog](#)), a parachute connector link not from an O-1 was found but no association to a case could be made. Then while excavating 0572 in May 2013 (JFA 13-4LA), several pieces of diagnostic F-4 wreckage (data plates) were found as well as possible Life Support. Site LA-00527 site was then designated Uncorrelated 3153. The proximity of 3153 to the edge of the 1781 target area led to 3153 being excavated twice as possibly associated with 1781. The first excavation (May-June 2019) turned up more F-4 wreckage and possible Life Support equipment. The second excavation (October-November 2019) turned up more F-4 wreckage, possible Life Support, and possible osseous (bony) remains, after which the site was closed, meaning the anthropologist assessed that no further possible evidence could be recovered.

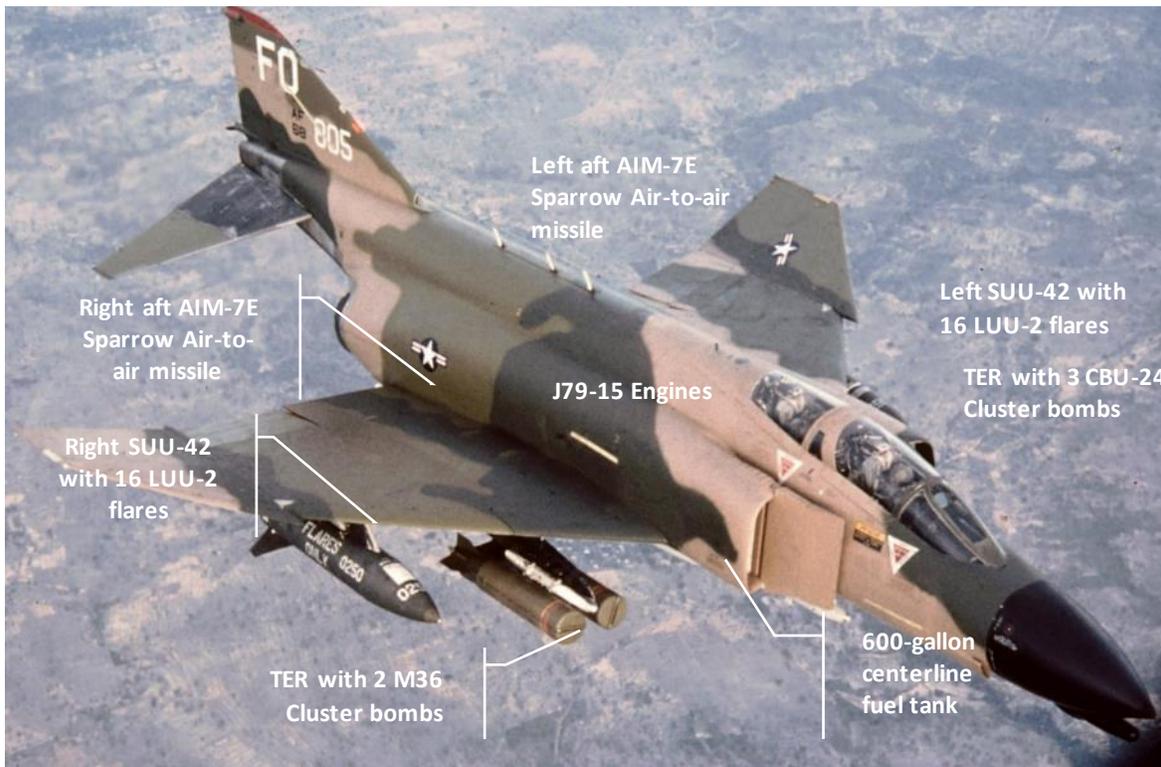
Figure 15: F-4D-66-8805, 435th TFS out of Ubon on Cherry tanker (January 1971) Source: Don Jay

While this image shows F-4D 66-8805, it was very similar to 66-7725 (being only 143 units later on the production line). The missing aircraft would have looked nearly-identical to what's shown here, the main difference would have been a black underside instead of white.

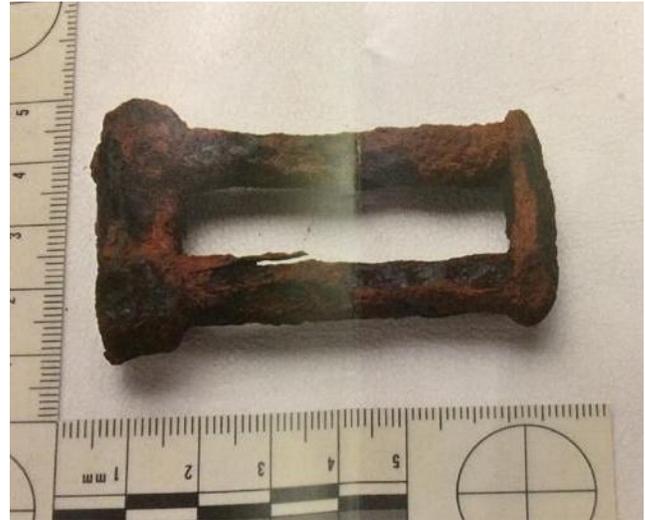
Figure 16: Parachute Connector Source: DPAA during 2019 League Meeting

The parachute connector (a piece of metal that connected a person or object to parachute risers) shown here was found during the May-June 2019 excavation of 3153. DPAA initially assessed it as coming from a personnel (pilot's) parachute but later said it could also be from an aircraft deceleration (drag) chute since both parachutes had similar components. While Life Support analysis is beyond-the-scope of the Team's abilities, this struck us as odd seeing as the parachutes in question had different functions, materials (drag chutes were designed to be reusable; pilot's parachutes were not), and diameters. The table below shows there was a total of 39 parachutes of differing diameters aboard the aircraft. It seems unlikely both the pilots' and aircraft's parachutes had the exact same connectors.

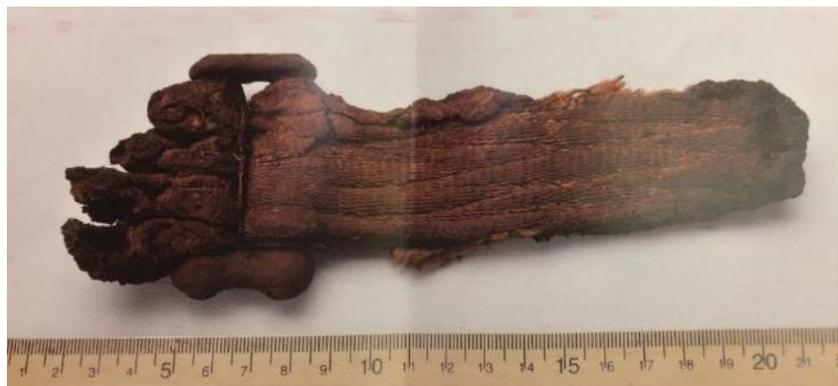
Figure 17: F-4 Drag Chute View Source: DPAA during 2019 League Meeting

A badly-burned F-4 drag chute piece was found. While on rare occasions such chutes were deployed in flight and released, it's likely that in such situations they made it to the ground intact. Since such items would have been in serviceable condition, they would have been useful to local ground forces so the Team suspects this one was aboard an F-4 at the time of impact, rather than being burned up later.

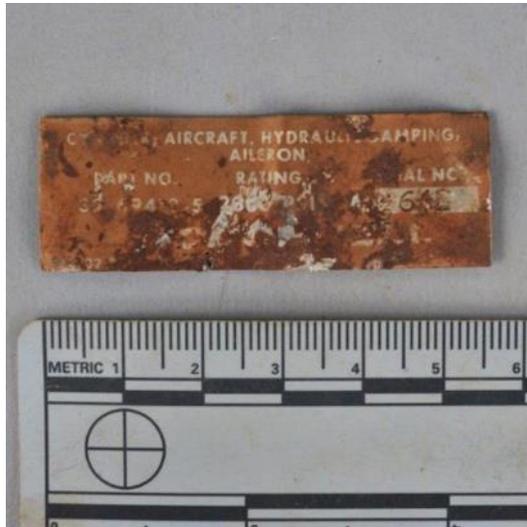
A data plate with Part Number 32-69413-5 was found, which DPAA assessed to be from an F-4 Left Aileron Hydraulic Damping Cylinder and was generic to most models of the F-4 Phantom. The aileron was a flight control surface use to control roll in conjunction with a corresponding spoiler on the opposite wing.

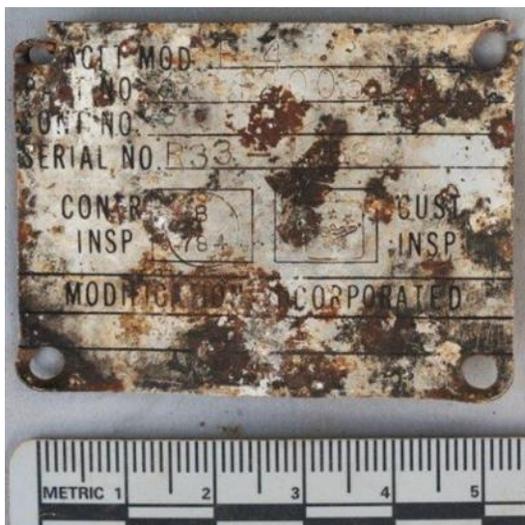
A data plate with Part Number 32-12003-307 was found, which DPAA assessed to be from an F-4 Left Spoiler Assembly and was generic to most models of the Phantom. The spoiler was a flight control surface use to control roll in conjunction with a corresponding aileron on the opposite wing.

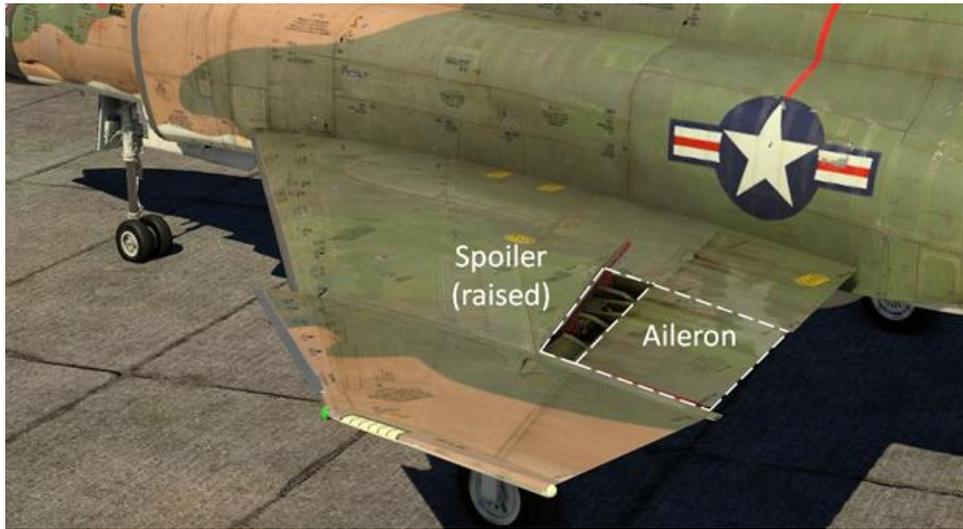
Figure 20: F-4 left spoiler and aileron locations Source: War Thunder 1

The image below indicates the spoiler and aileron locations. The spoiler is shown here in the raised position.

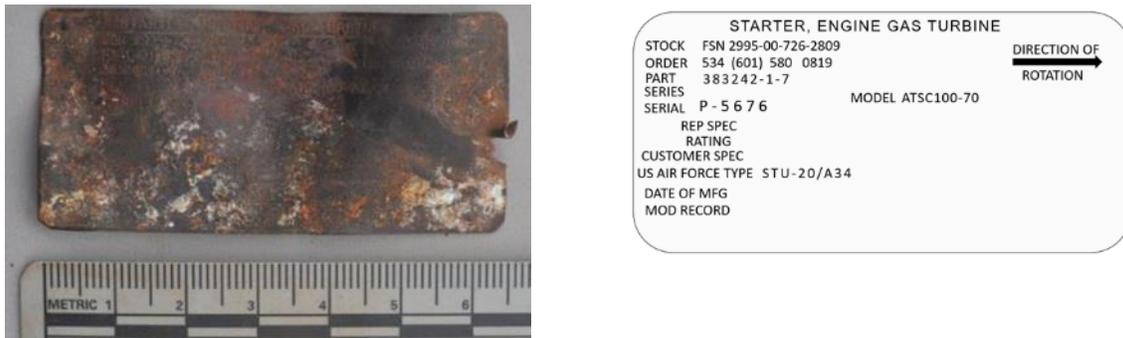
Figure 21: STU-20/A34 Starter Data Plate Sources: DPAA and 1F-4C-10

A badly-burned data plate found by DPAA was subject to further analysis by the Team and determined to be from a STU-20/A34, which was the starter unit for the General Electric J79-15 Engine Series. This is an important assessment because it narrows down the type of aircraft from which it could have come.

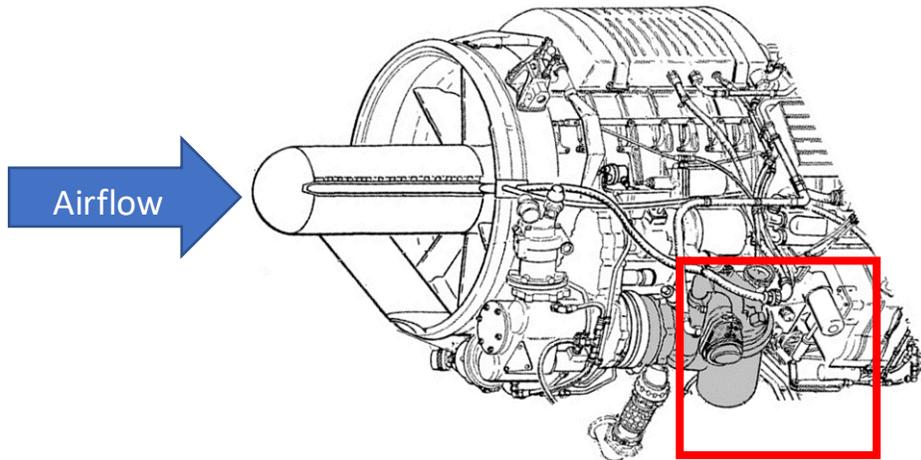
Figure 22: STU-20 Starter location Source: 1F-4C-10 J79-15 Series Engines, Power Package Build-up

The image below shows the location of the STU-20/A34 starter on the underside of the J79-15 engine.

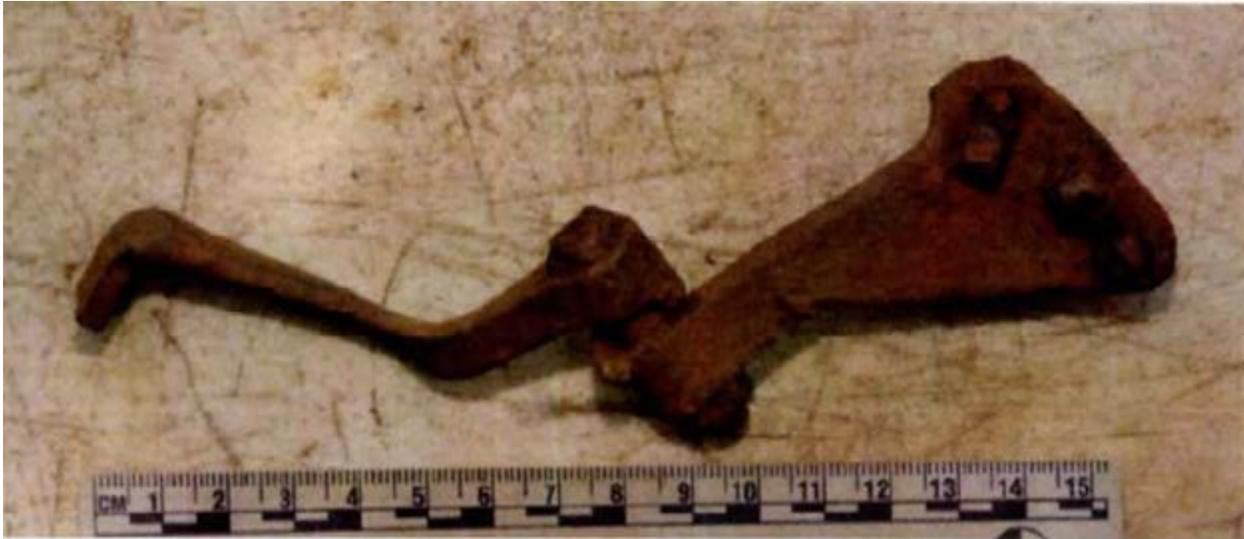
Figure 23: AERO-7A Assembly Source: Interim Search and Recover Report CIL 2019-225-R UNC 3153

The May-June 2019 excavation of 3153 also found the AERO-7A Missile Timer Arm and Foot shown below. This was part of the AIM-7 Sparrow air-to-air missile launcher on the Phantom and the "foot" was used to eject the missile from the aircraft upon launch.

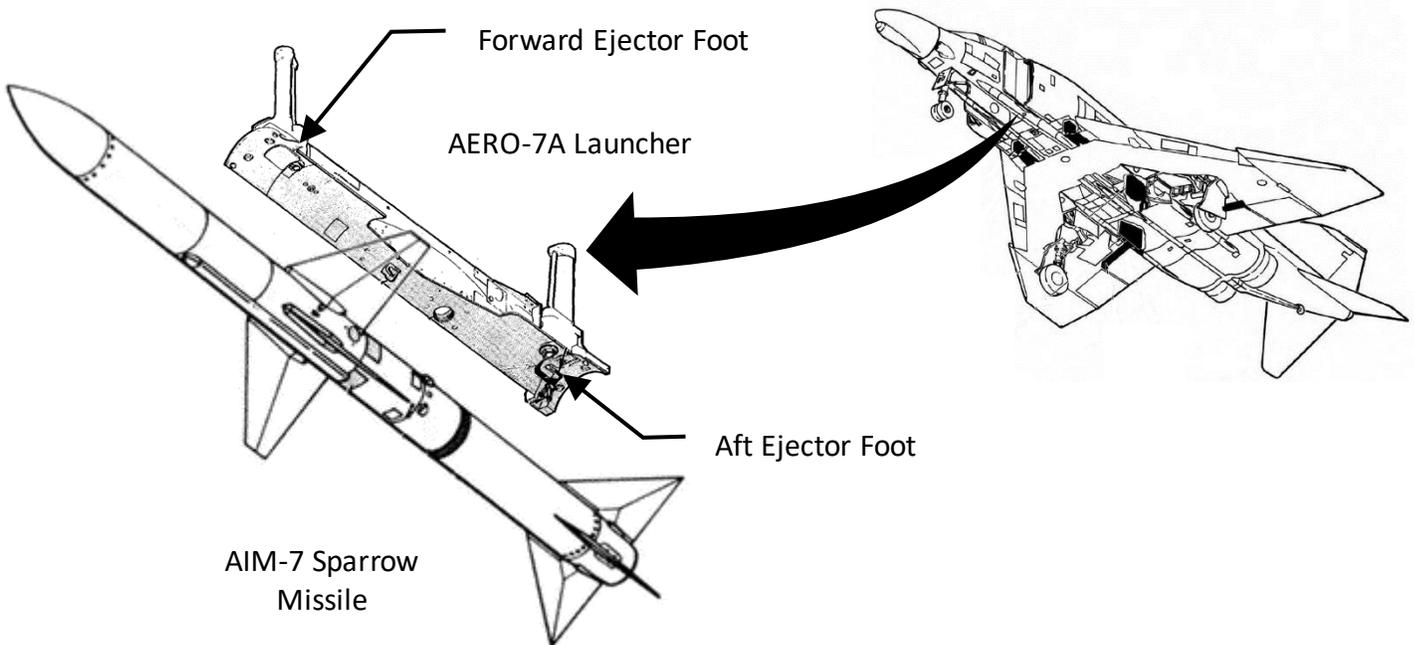
Figure 24: AERO-7A Missile Assembly location Sources: NAVAIR 01-245FDB-2-1.2 F-4B Aircraft Operating Procedures and T.O. 1F-4E-34-1-1 Aircrew Weapons Delivery Manual (Nonnuclear) USAF Series F-4E Aircraft

Figure 24 below shows the AERO-7A Missile Launcher Assembly position on the belly of the F-4 (there were a total of 4 such launchers) and the locations of the two feet that ejected the missile upon firing. This piece of evidence is important because since RF-4Cs did not have Sparrow Missile launchers we can rule out 3153 as being an RF-4C, so *it must be an F-4C or F-4D.*

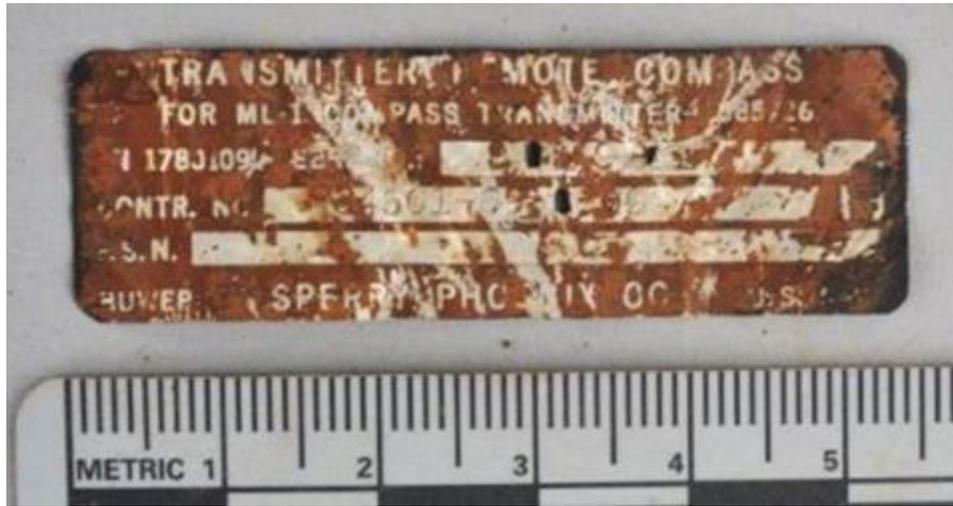
Figure 25: Remote Compass Transmitter Data Plate Source: Interim Search and Recovery Report CIL 2013-095R

Another data plate DPAA found came from a Remote Compass Transmitter (not the compass instrument in the cockpit but the actual magnetic sensing unit). This data plate was consistent with all F-4 models and was used in other aircraft.

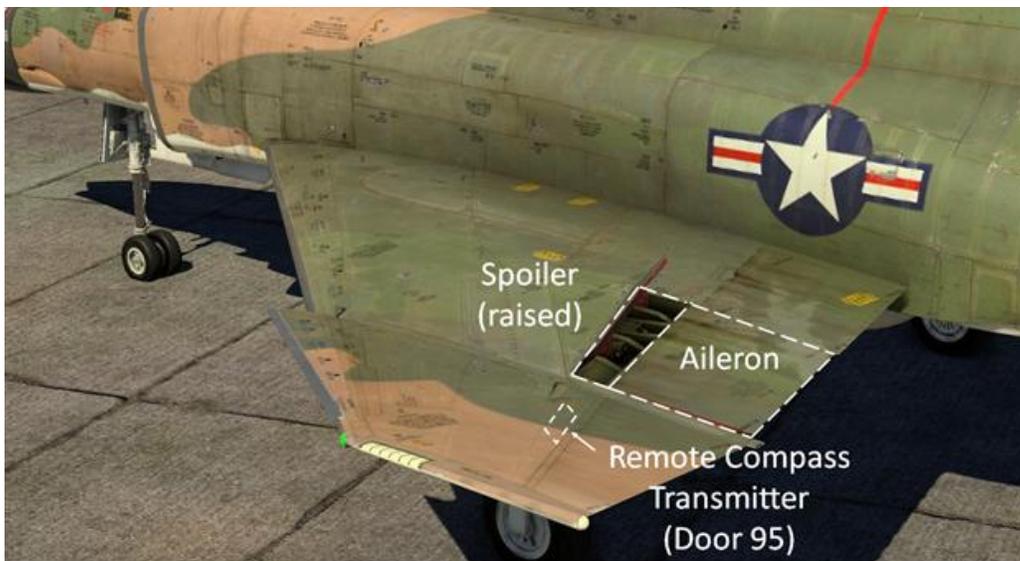
Figure 26: Remote Compass Transmitter Data Plate location at Door 95 Source: War Thunder 1

However, it's interesting to note that in the F-4, the Remote Compass Transmitter was found under Door 95, an access panel in the left wing very close to the spoiler and aileron assemblies.

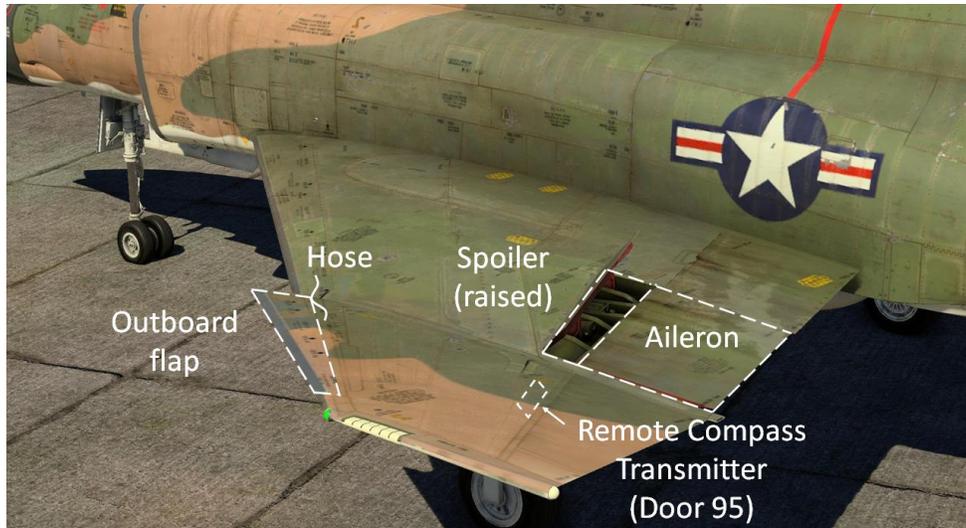
Figure 29: F-4 Outboard flap emergency down line location on wing Source: War Thunder 1

After the starter plate, the next most-important artifact DPAA found was a Hose Tag Part # 656200-3-0190. The Team determined this to be an F-4 Outboard flap emergency down line, part of the

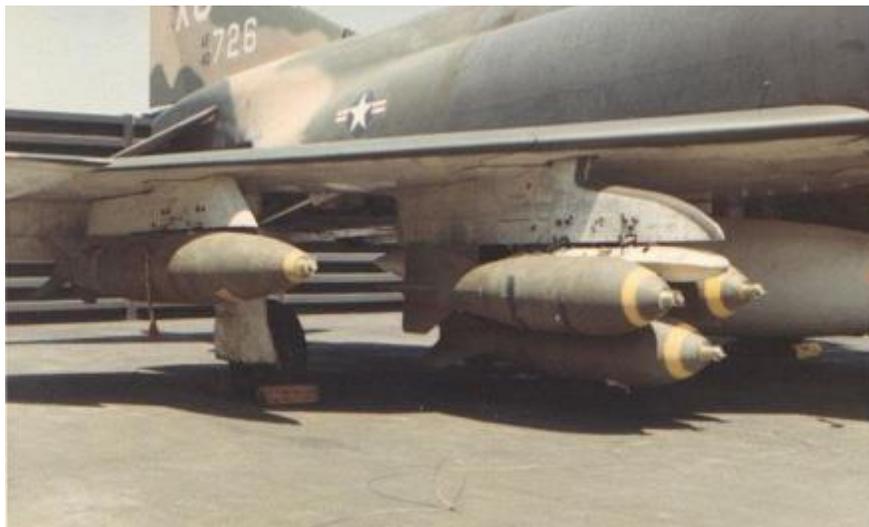
A Triple Ejector Rack (TER) enabled an aircraft carry up to 3 bombs on a single weapons station as shown below.

Figure 30: Triple Ejector Rack (TER) on an F-4 Source: Modelwork

The view of the TER found at 3153 (below) shows the sway braces used to secure bombs to the rack and prevent side-to-side movement. Since TERs were jettisonable and carried by multiple types of aircraft, it's possible this one is coincidental to 3153. However, the TER was a very strong piece of equipment – stressed to carry thousands of pounds of ordnance at up to several times the force of gravity – so the fact this one is fractured leads the Team to suspect it was attached to the 3153 aircraft when it hit the ground rather than being coincidental. However, nothing conclusive can be taken here.

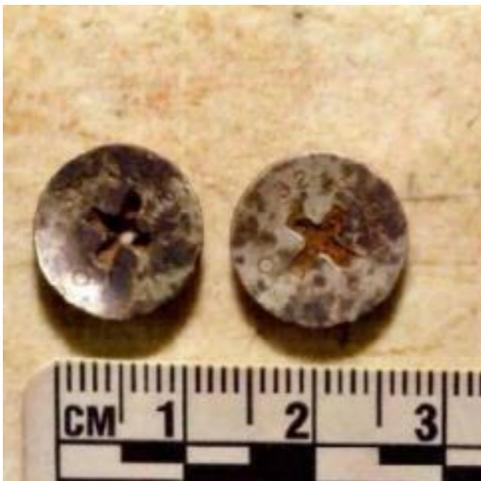
Figure 32: Screws Source: Interim Search and Recover Report CIL 2019-225-R UNC 3153

Several screws with Part Number 32-33027-47 were found. DPAA assessed them to be large head screws used to attach the titanium panels to the aircraft near the engine afterburner exhausts; they were generic to all F-4 models.

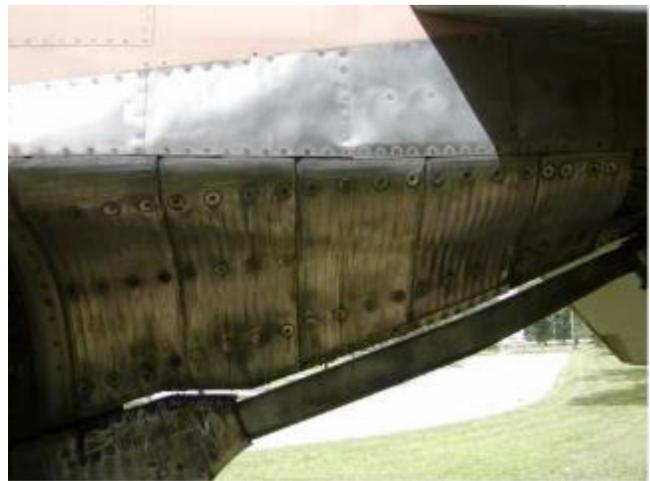
Figure 33: Titanium screws behind port engine exhaust section Source: Flickr

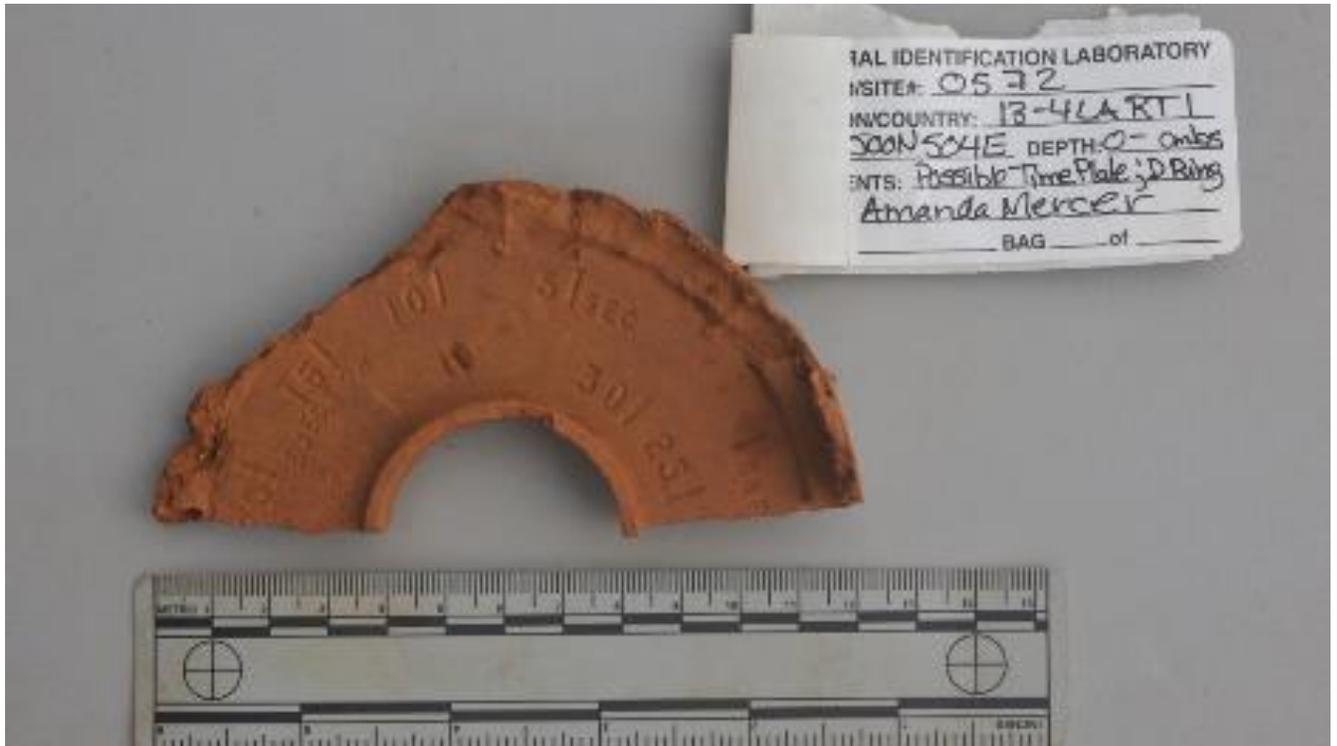
Figure 35: Suspected Flare Timer Plate Source: DPAA during 2019 League Meeting

An object suspected of being an illumination flare timer plate was also found. This could be related to 1781 because the aircraft was carrying 32 LUU-2 flares.

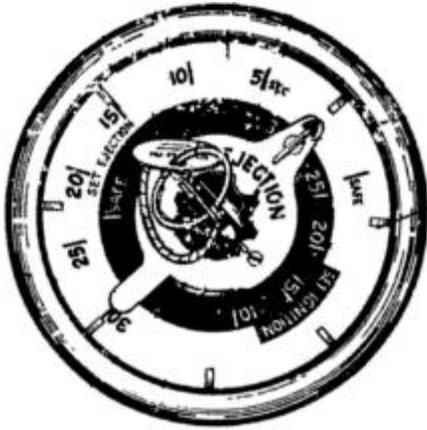
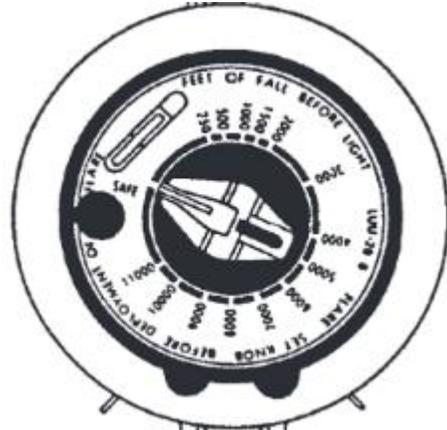
MK-24 Flare Timer (uses seconds)

LUU-2 Flare Setting (uses feet)

Figure 36: Comparison of Mk-24 and LUU-24 Settings

accept Mk-24s, it is definitely not from this aircraft and since many thousands of Mk-24s were dropped during the course of the war, it was likely coincidental to 3153.

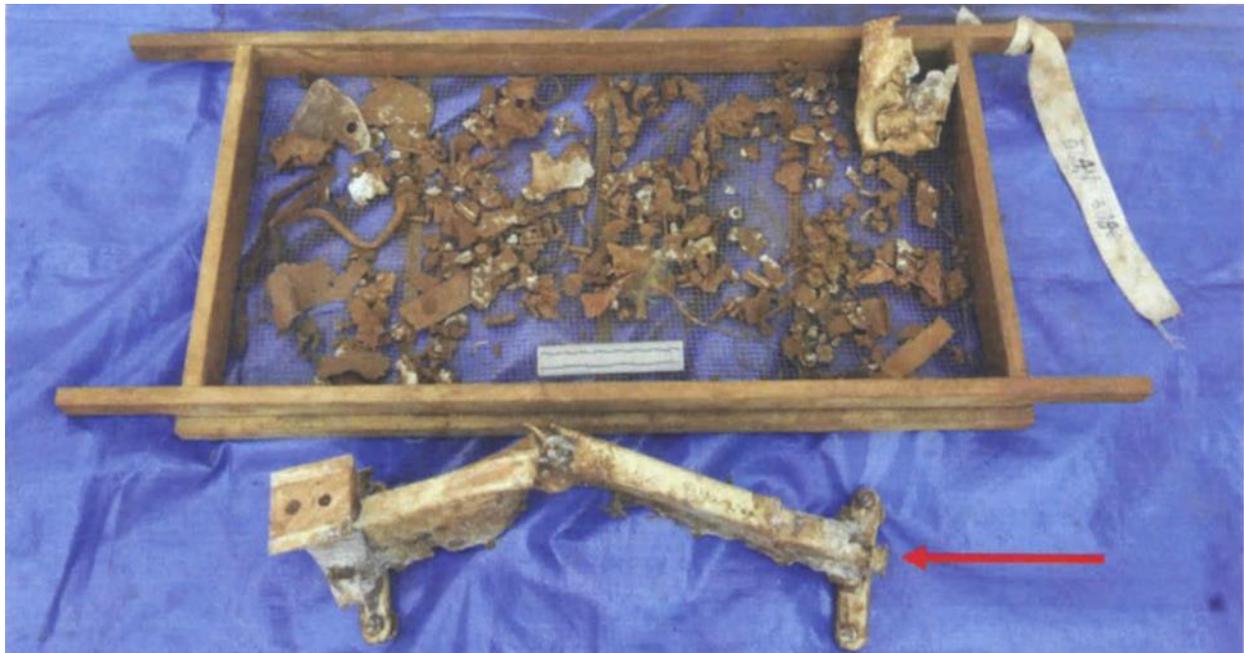
Figure 37: Ancillary Wreckage and TER Source: Interim Search and Recovery Report CIL 2013-095R

The image below shows ancillary wreckage DPAA found at 3153 as well as the TER. To give an idea of scale, the F-4 was about the same length and weight as an 18-wheel tractor-trailer so seeing how little wreckage was found, you can assess the difficulties DPAA had in drawing conclusions from it.

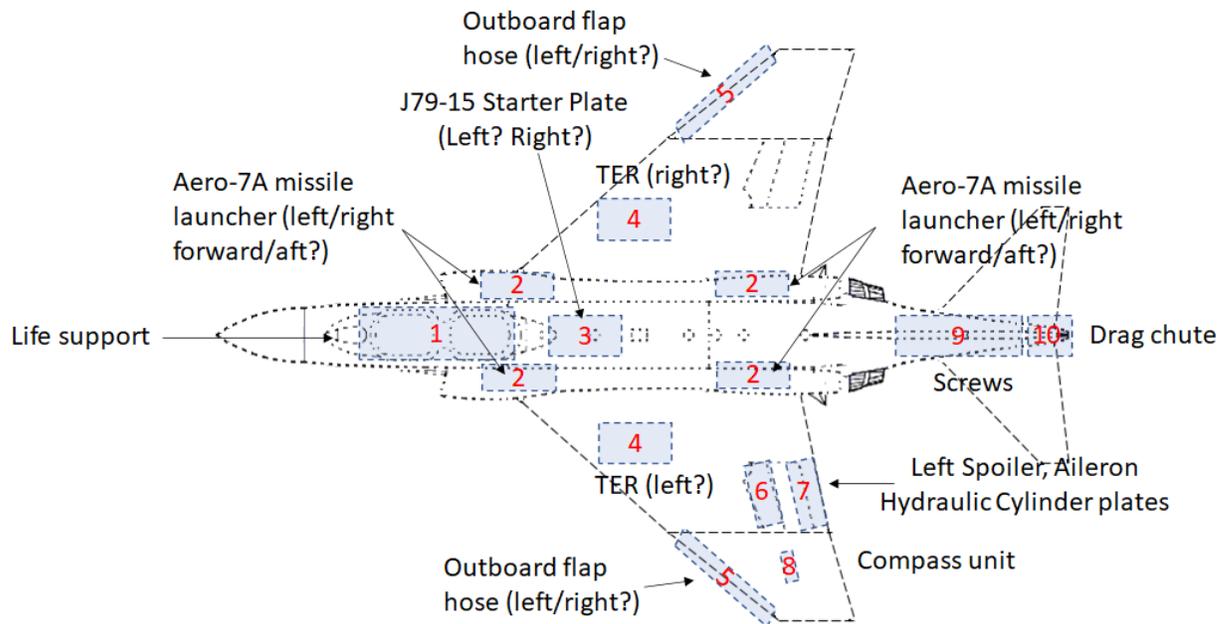
Figure 38: F-4D plan view with wreckage locations superimposed

However, if we superimpose the wreckage to where they were located on the F-4 (plan view below), it's interesting to note that at least three pieces of wreckage – Items #6, 7, and 8 – (and possibly four more: #2, 3, 4, and 5) came from the *left* side of the aircraft.

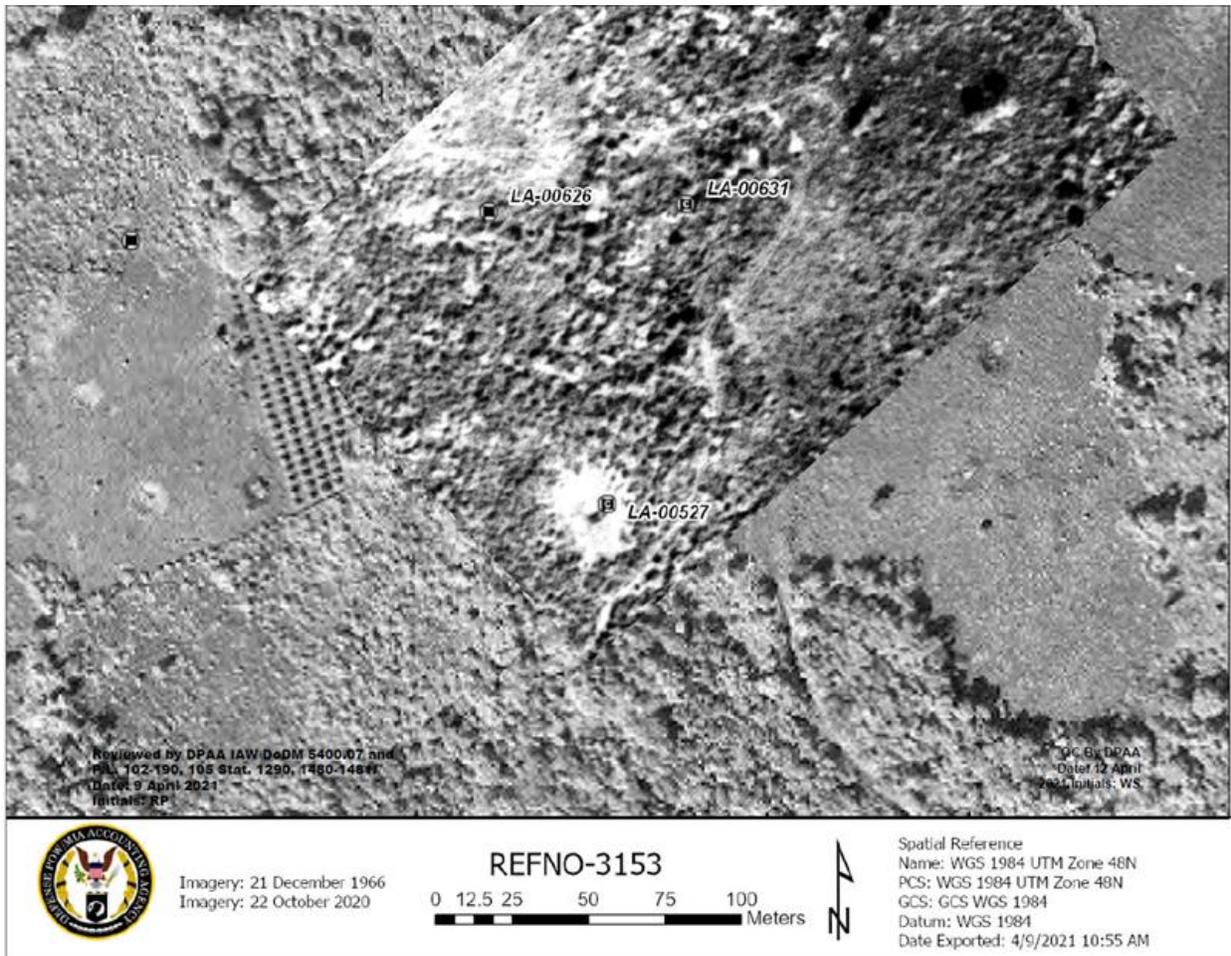
Figure 41: December 21, 1966 reconnaissance aircraft image; LA-00527 is REFNO 3153 and LA-00626 is REFNO 0572 Source: REFNO 3153 Imagery Release, 9 April 2021

Figure 41 shows December 21, 1966 imagery from a reconnaissance aircraft (most-likely a U-2). LA-00626 (later exclusively-correlated to REFNO 0572) and LA-00527 (later identified as REFNO 3153) are visible as is LA-00631 (the Team is unsure to which case this location is referenced). LA-00527 is circular and no wreckage is present.

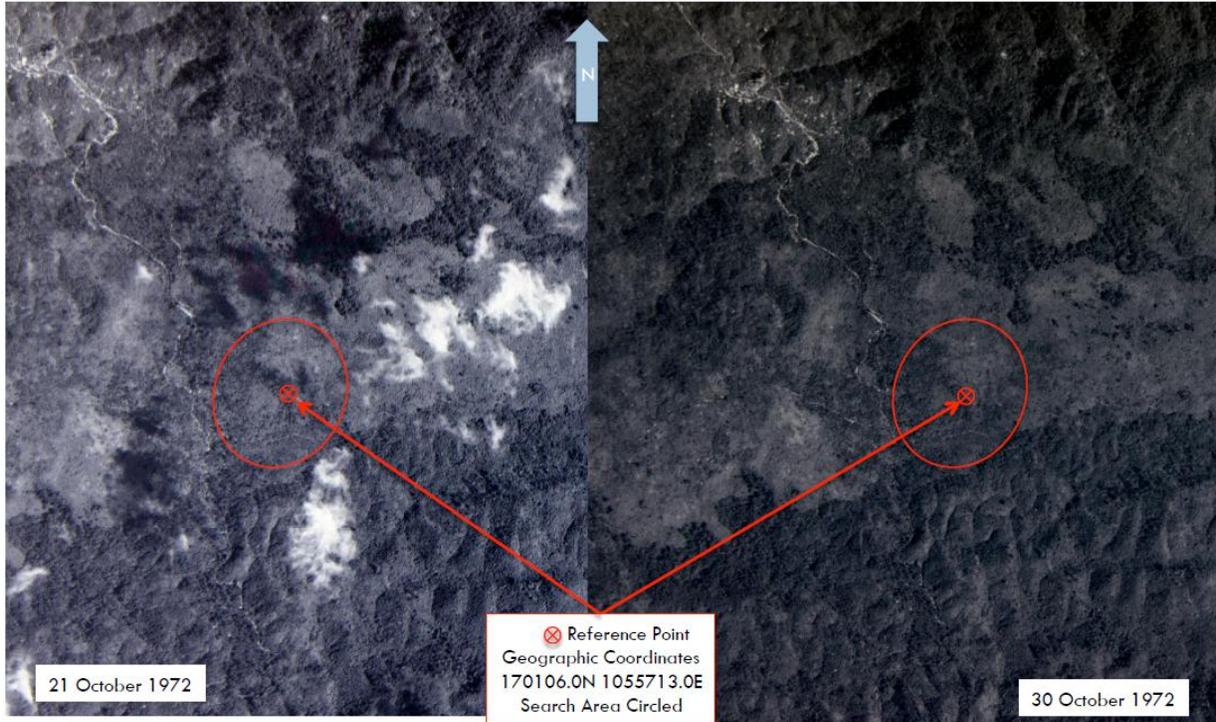
Figure 43: Possible crash site at the 3153 coordinates Sources: ARC Imagery Analysis, Google Earth, NARA, 1204-1/2, October 21/30 1972

Figure 43 shows declassified satellite imagery from late October 1972 (approximately one year after Owl 08 went missing).

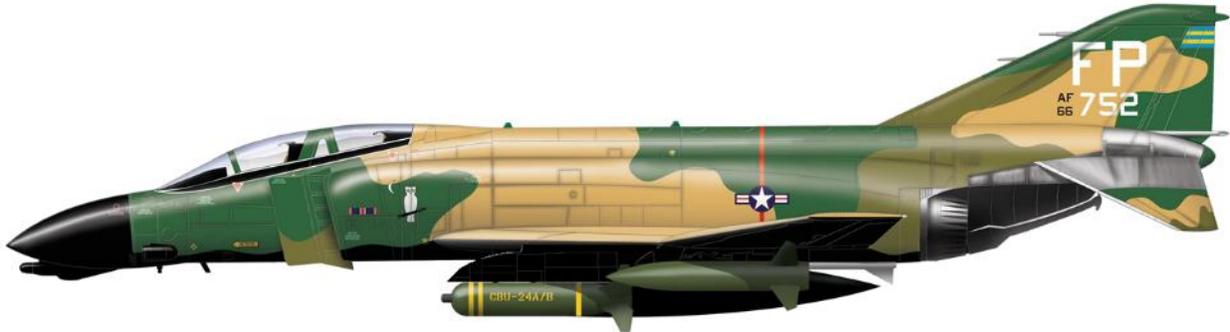
The purpose of this section is to provide details on the ordnance carried by the missing aircraft. As was stated in the Case Overview and Research Methodology section, the aircraft was configured with the following external stores and looked as shown below.

- 1 600-gallon centerline tank (about 4,000 pounds of fuel)
- 3 CBU-24 800-lb. cluster bombs with 665 BLU-26 or BLU-36 bomblets each
- 2 M36 690-lb. incendiary cluster bombs
- 2 SUU-42 flare dispensers with 16 LUU-2 illumination flares each (821 pounds total each)
- 2 AIM-7E Sparrow air-to-air missiles (435 pounds each)

Figure 50: F-4D 66-7752 "Owl 08" as seen on November 26, 1971 Source: Mads Bangsø

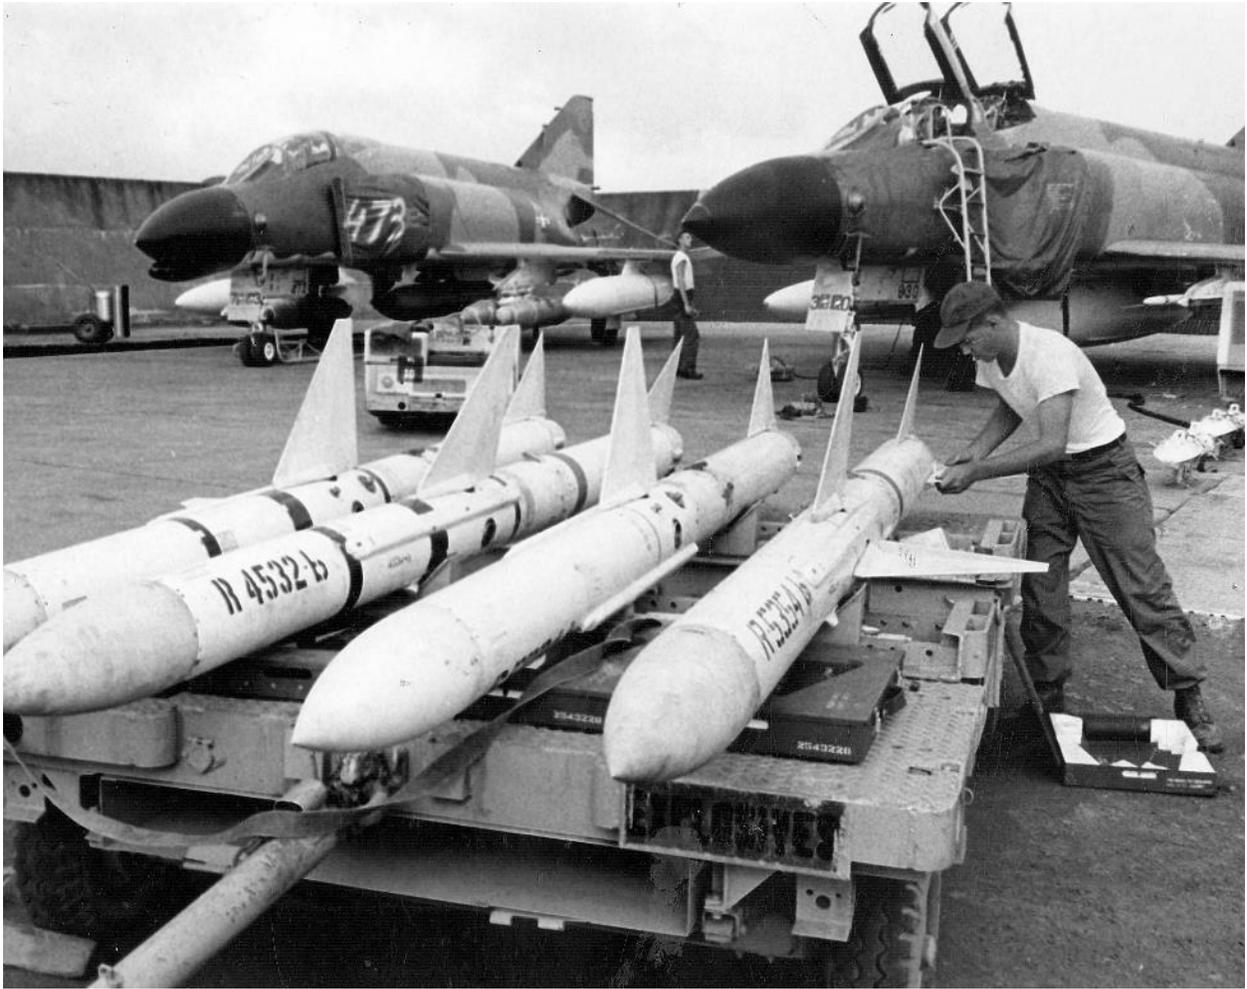
For many air-to-ground missions, F-4s carried two AIM-7s in the rear missile bays for self-defense. In the following image, AIM-7E missiles are being readied to load onto the F-4s in the background. You can see the missile second from the left has the serial number 'R 4532 b'. The bottom fins were installed when the missile was loaded on the aircraft using a hydraulic lift known as a "jammer".

Figure 61: AIM-7E Missiles awaiting loading aboard F-4s Source: War Thunder 2
