Windstorm Mitigation Report (OIR-B1-1802)

Inverness Condominium II Association, Inc.

Building 2, 2581 Countryside Blvd, Units 2101-2212, 2301-2313

As of 04-23-2025 | FPAT File# MUD2524157

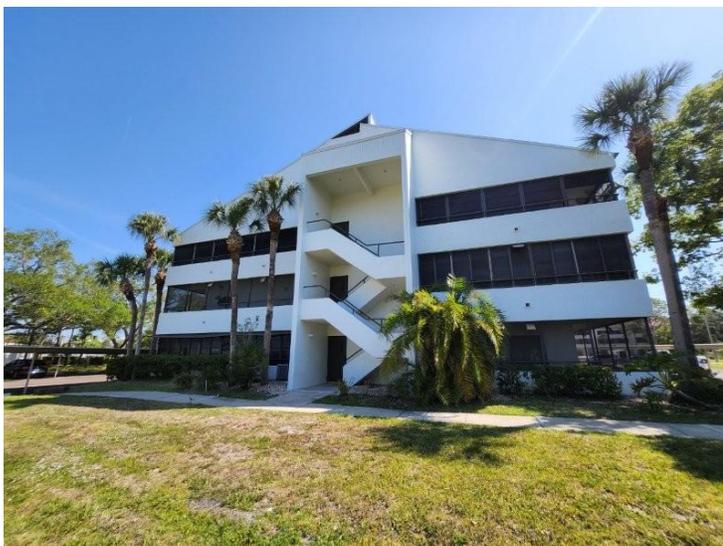
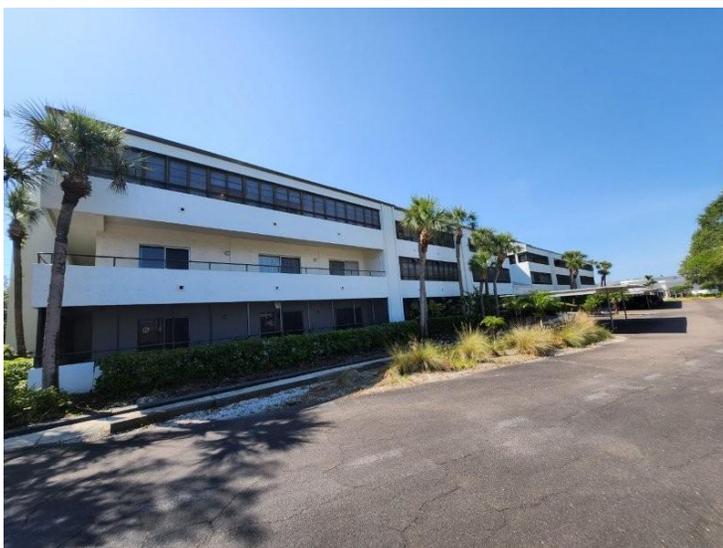
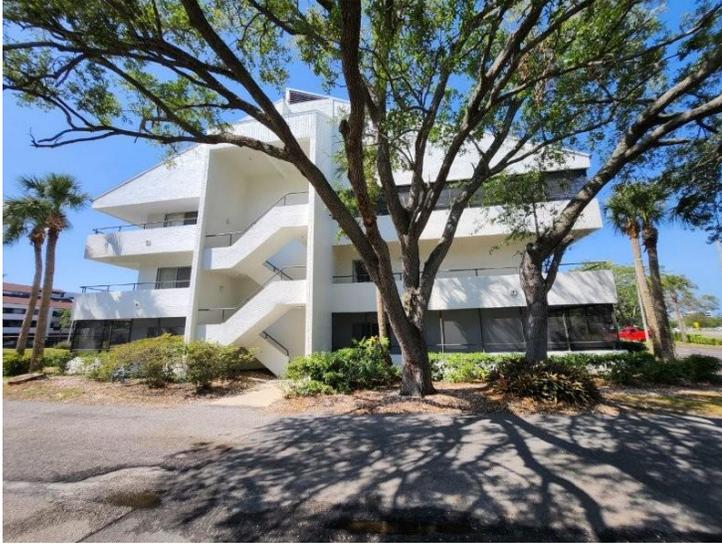
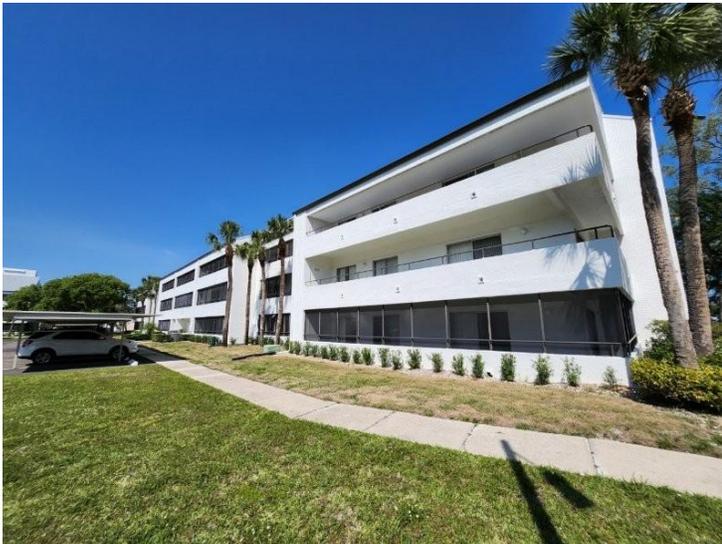
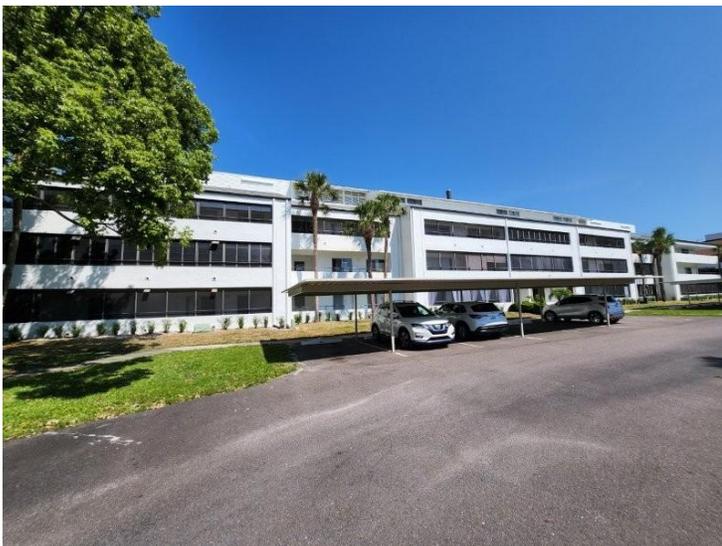
Comments: | Other Roof
Inspection verified a gable roof shape. |

Exterior Elevation

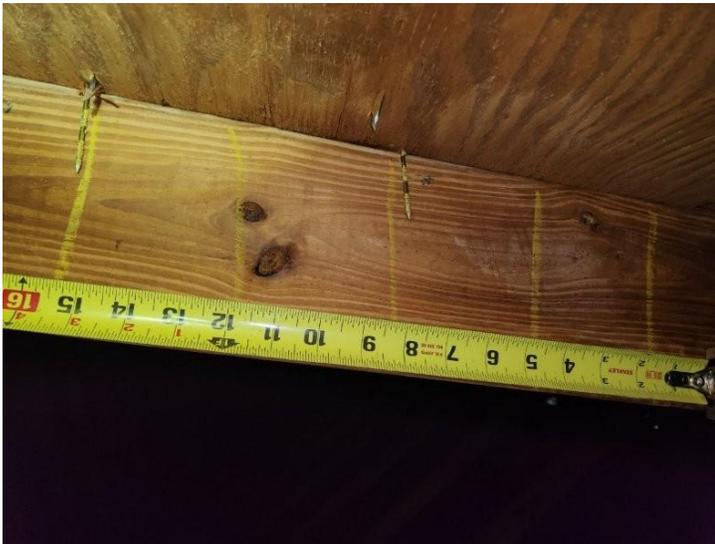
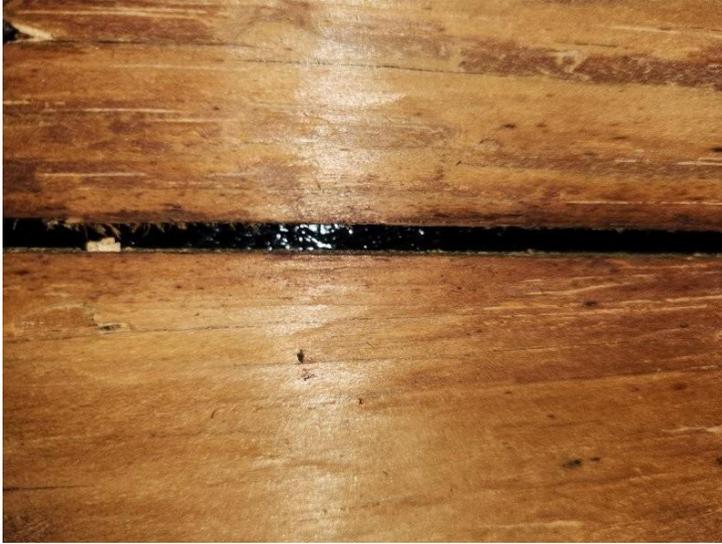
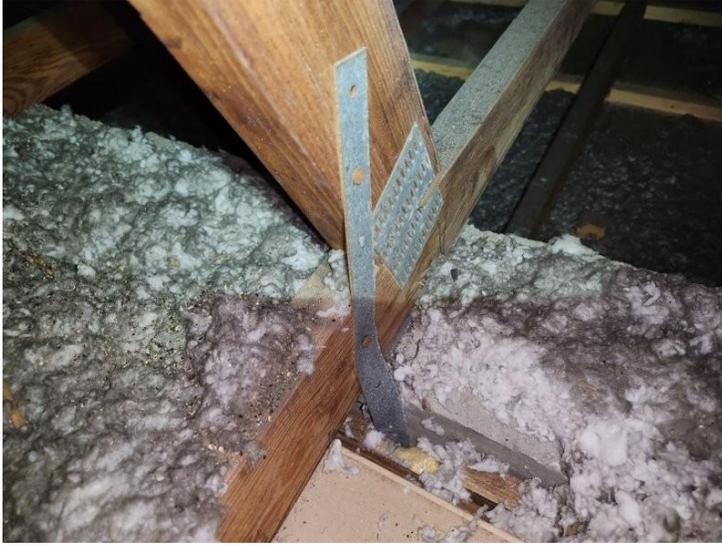
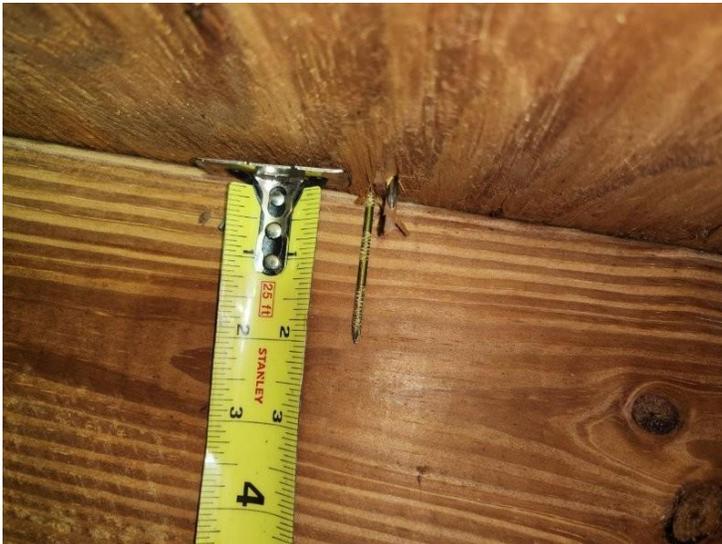
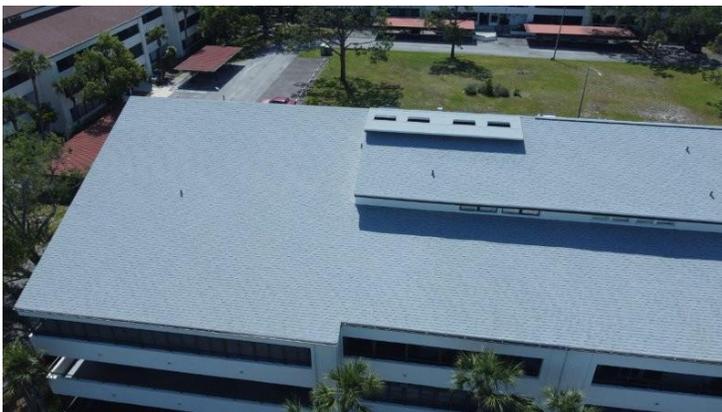
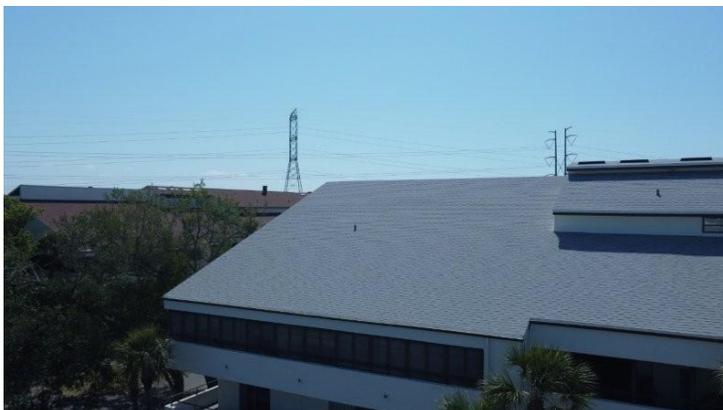
Comments: | Level C
Inspection verified 1/2" plywood roof deck attached with 8d nails at a minimum 6" on the edge & 6" in the field. |

Comments: | Toe Nails
Inspection verified embedded straps fastened with less than three nails. |

Comments: | Yes
SWR was verified at time of inspection. The Secondary Water Resistance verified is a self-adhering peel and stick. |

Roof Construction
