# Windstorm Mitigation Report

Inverness Condominium II

Clearwater, FL

## Windstorm Mitigation Report (OIR-B1-1802)

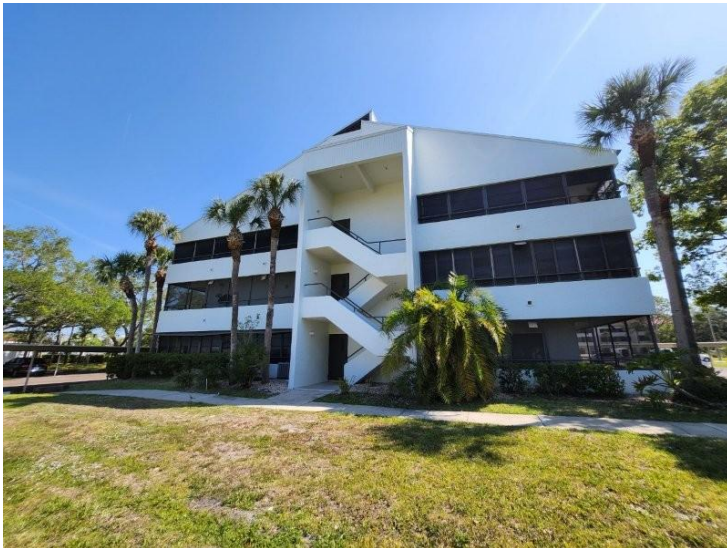
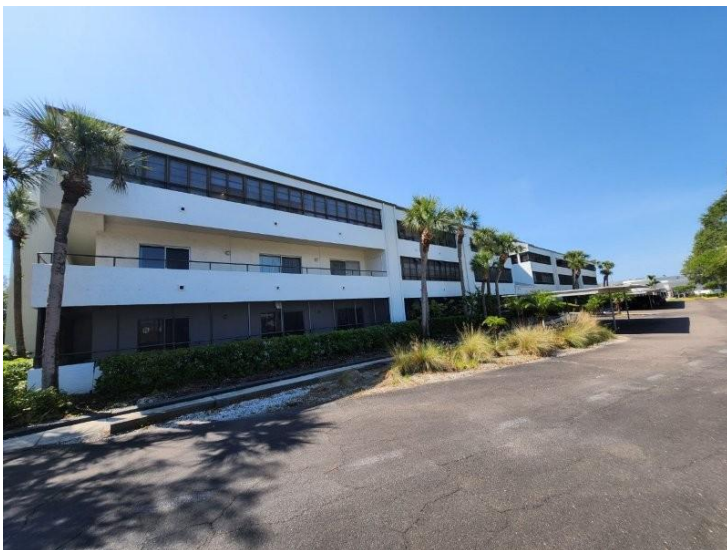
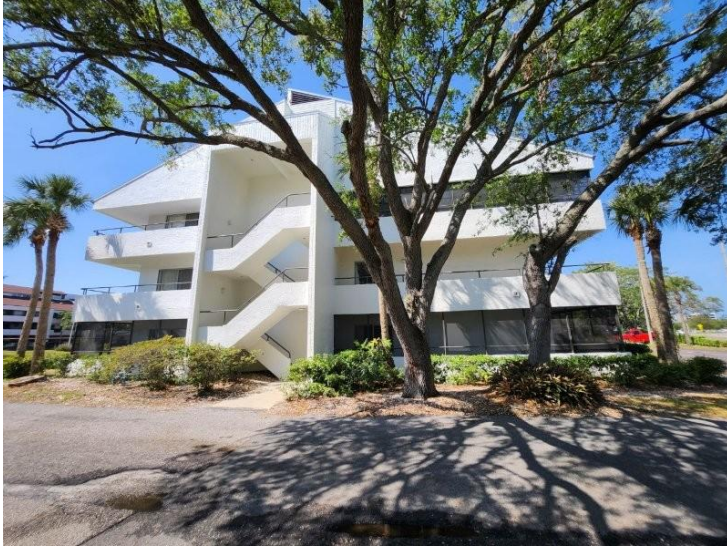
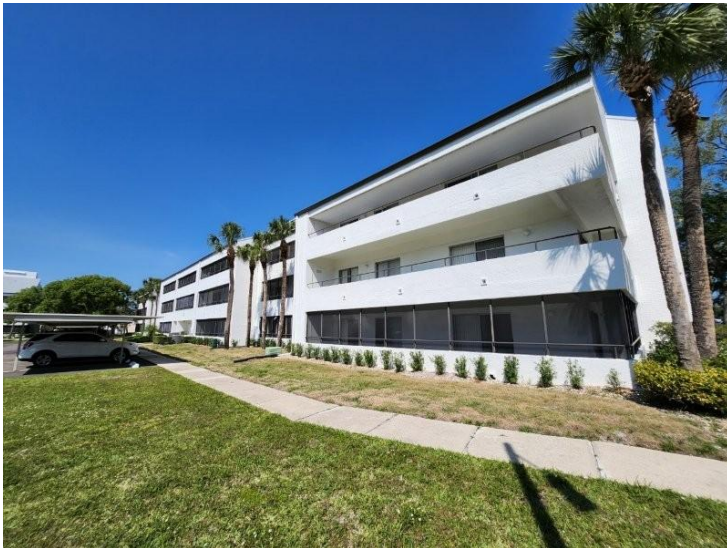
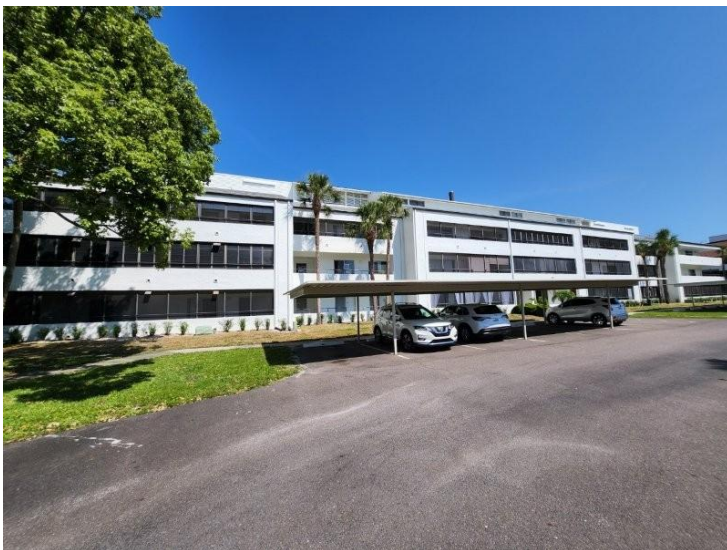
Exterior Elevation

| <b>7. Opening Protection:</b><br>Comments: | <b>None or Some Glazed Openings</b><br>Inspection verified no opening protection. |

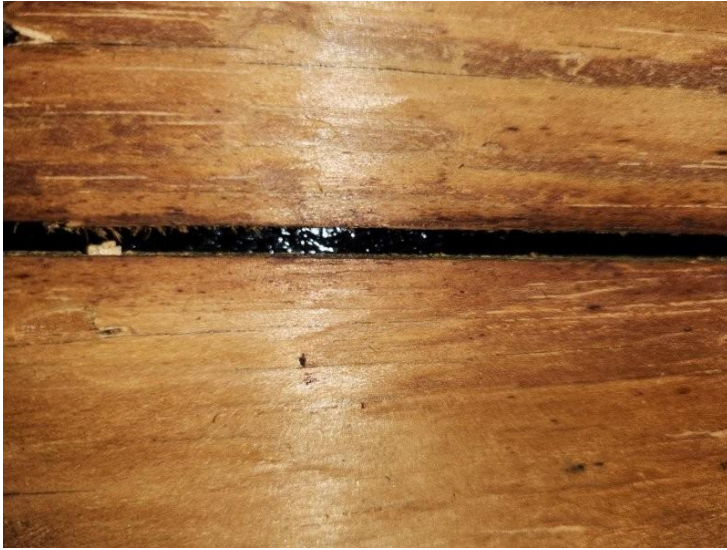
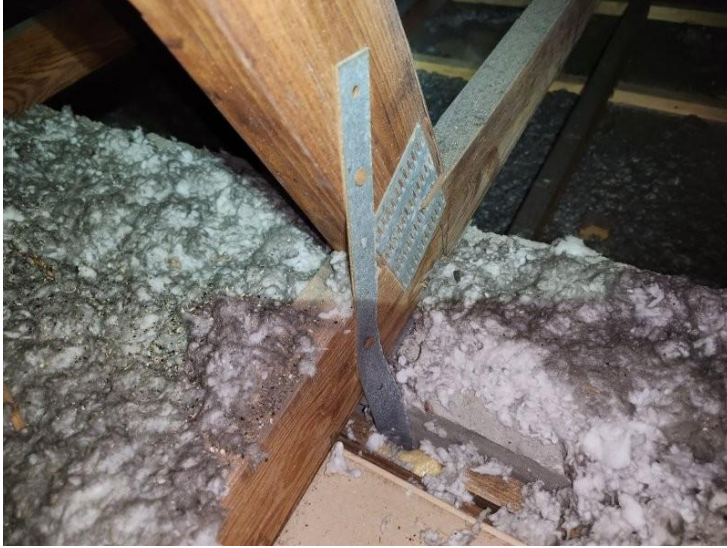
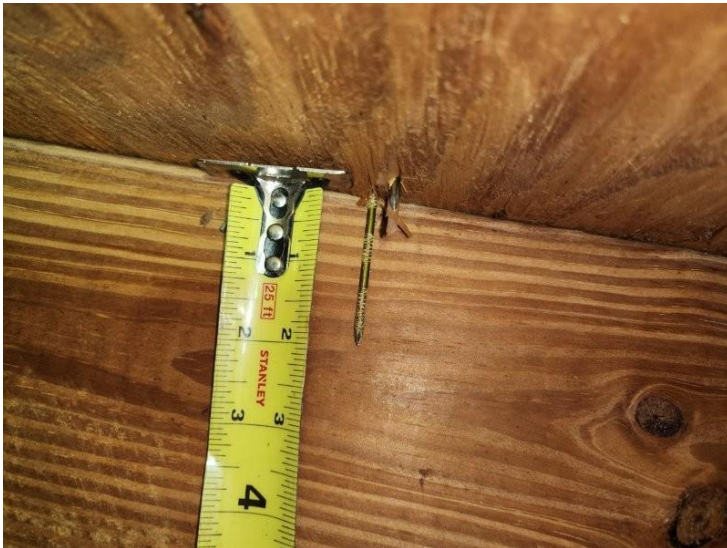
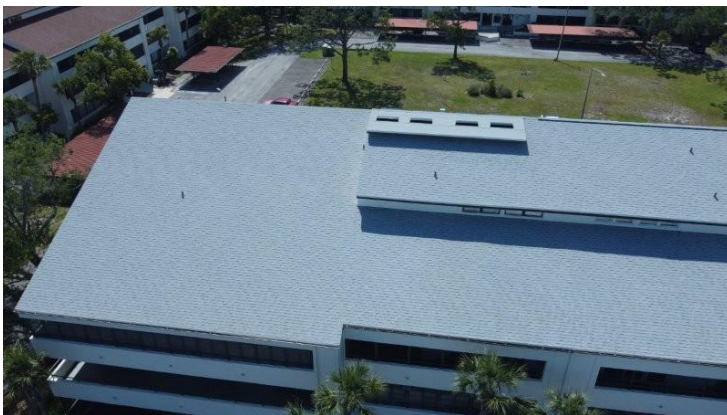
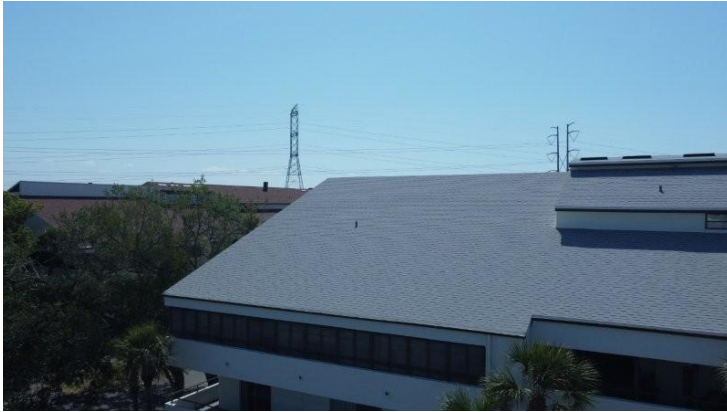
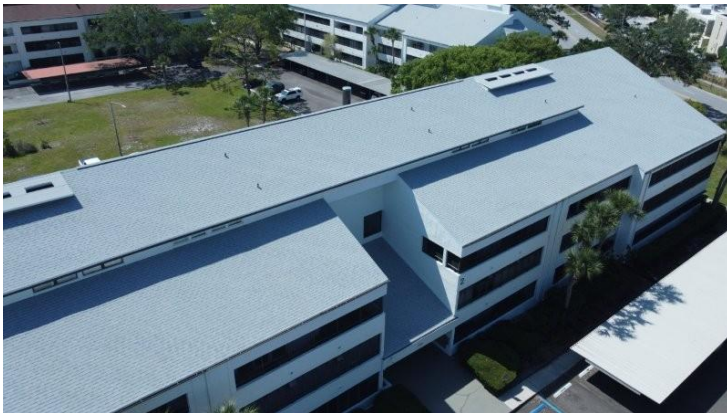
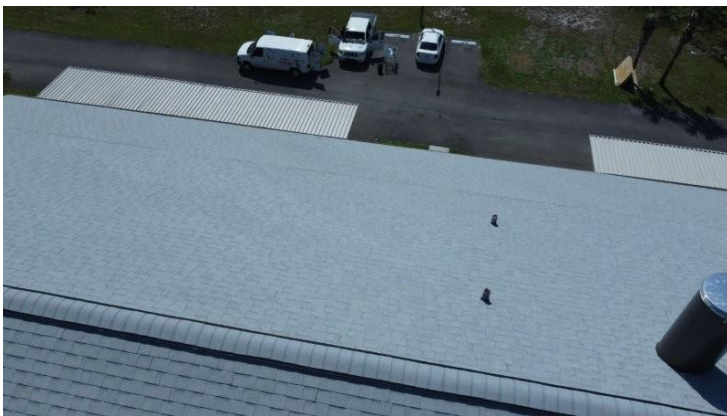
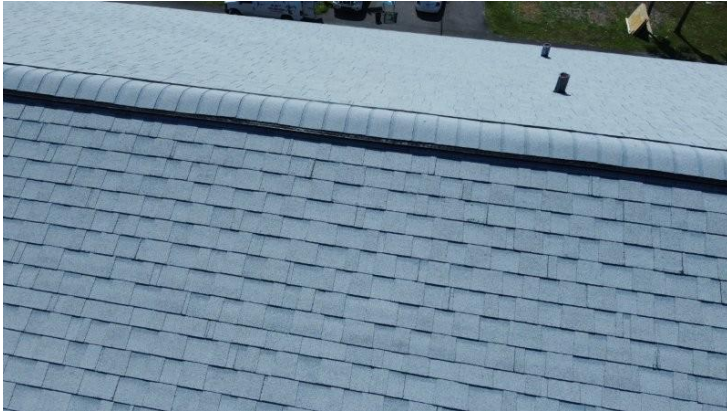
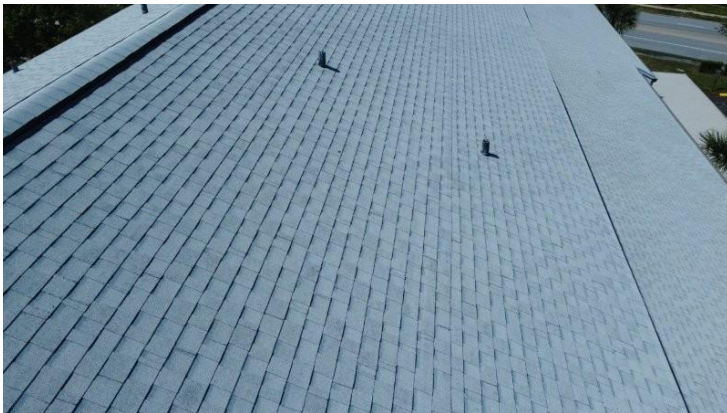
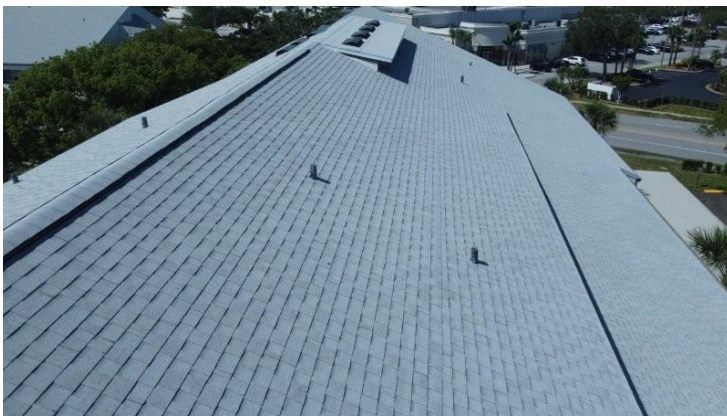
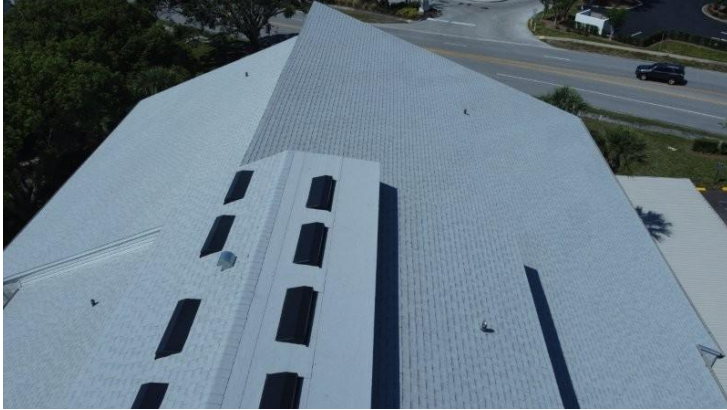
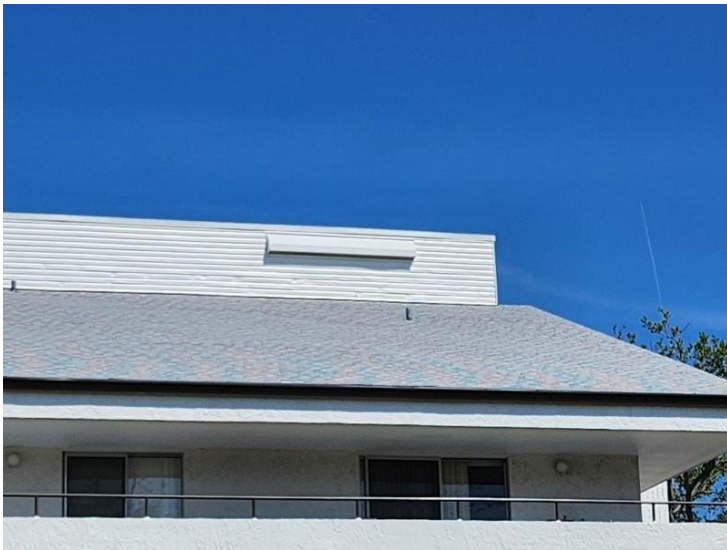
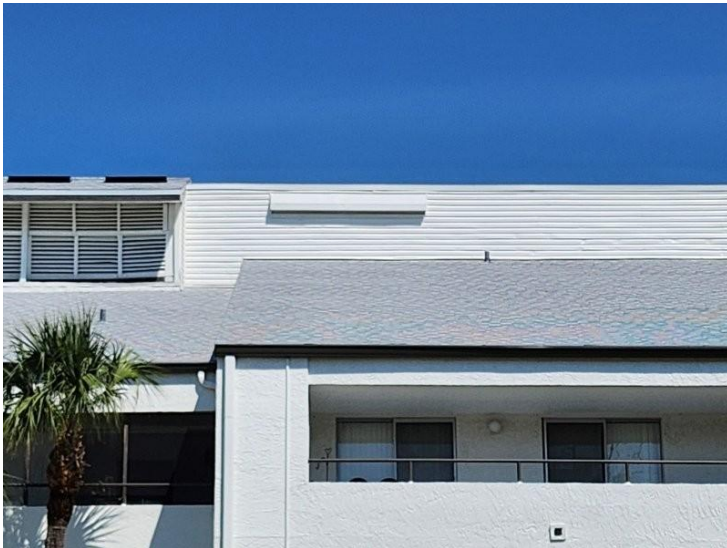
Roof Construction

| <b>3. Roof Deck Attachment:</b><br>Comments: | <b>Level C</b><br>Inspection verified 1/2" plywood roof deck attached with 8d nails at a minimum 6" on the edge & 6" in the field. |
| <b>4. Roof to Wall Attachment:</b><br>Comments: | <b>Toe Nails</b><br>Inspection verified embedded straps fastened with less than three nails. |
| <b>5. Roof Geometry:</b><br>Comments: | <b>Other Roof</b><br>Inspection verified a gable roof shape. |
| <b>6. SWR:</b><br>Comments: | <b>Yes</b><br>SWR was verified at time of inspection. The Secondary Water Resistance verified is a self-adhering peel and stick. |

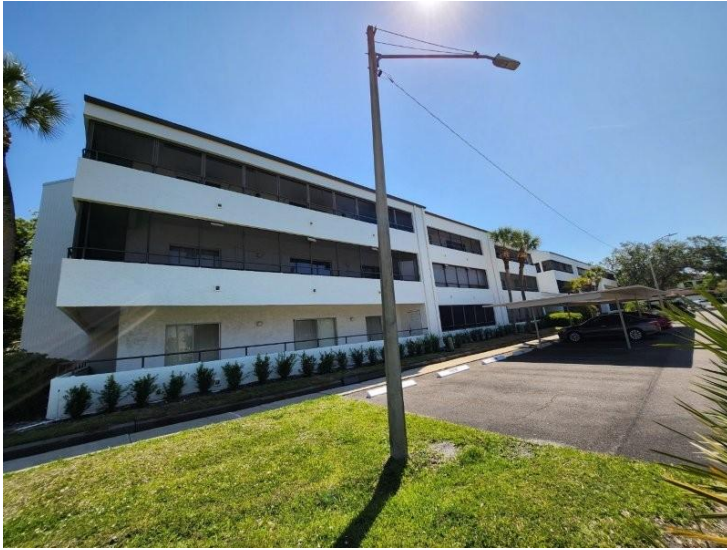
Exterior Elevation

| <b>7. Opening Protection:</b><br>Comments: | <b>None or Some Glazed Openings</b><br>Inspection verified no opening protection. |

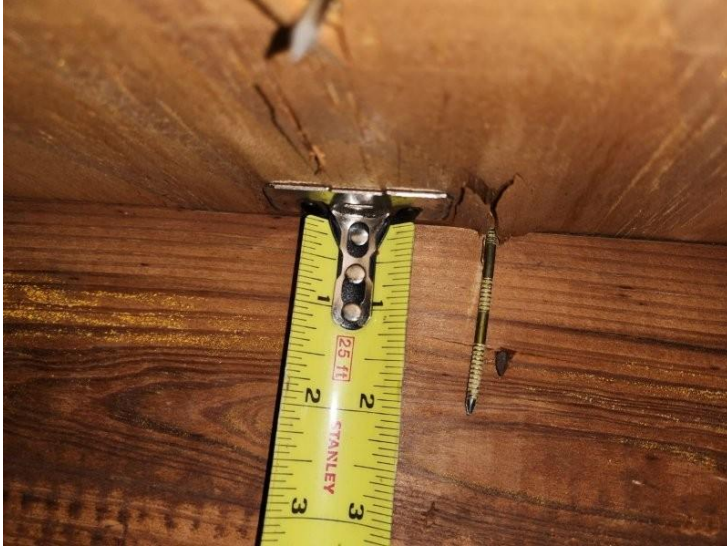
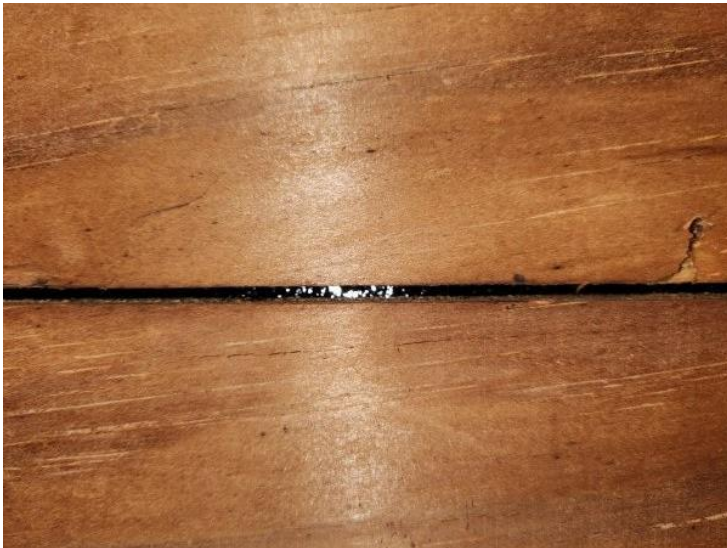
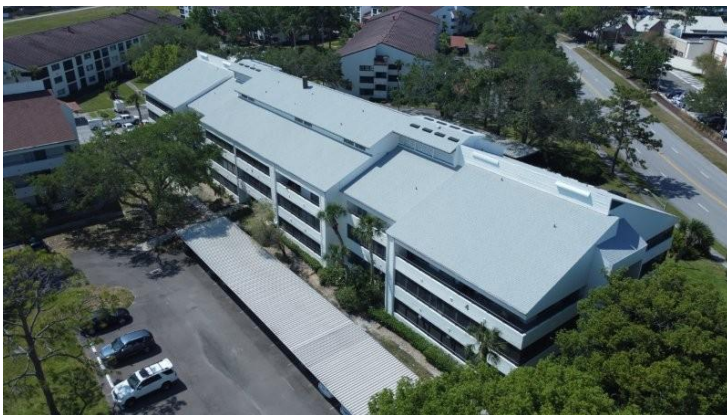
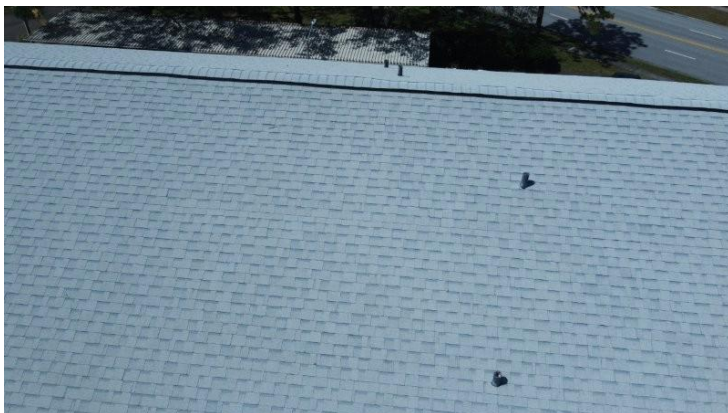
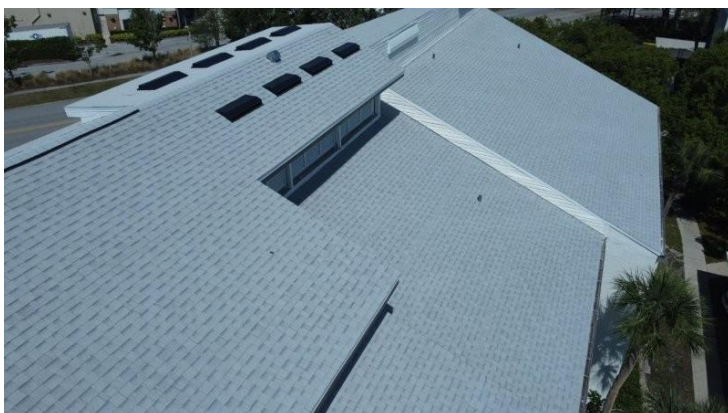
Roof Construction

| <b>2. Roof Covering:</b><br>Comments: | <b>FBC Equivalent</b><br>The roof covering was replaced in 2024. The roof permit was confirmed and the permit number is BCP2024-100216. This roof was verified as meeting the building code requirements outlined on the mitigation affidavit. |
