# CSI ARCHITECTURAL METAL, INC. TEST REPORT

TAS 125 UPLIFT RESISTANCE TESTING OF 1/8" ALUMUINUM 1100 ROOF PANEL

Q6264.01-450-18 R1

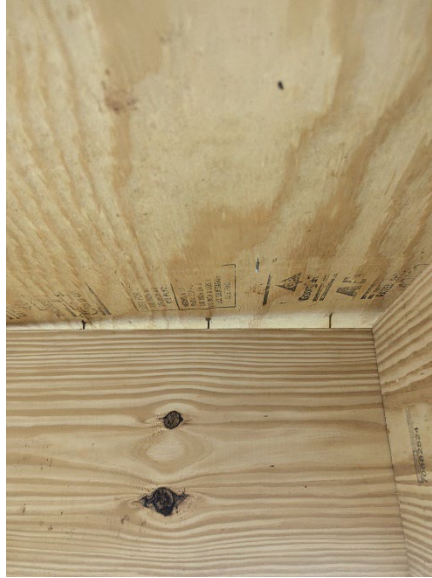
**Photo No. 4**  
**Plywood Failure – Specimen #3**

| TEST TITLE | OBSERVATIONS | DEFLECTION MEASUREMENTS | RESULTS |
|---|---|---|---|
| Supplemental Loads<br>-277 psf | Plywood pulled away from<br>2x12 | Reference Table No. 6 | FAILED |
