Report Date: 12/23/2021 9:29 AM  
 Test: 3 Point Bend Test  
 Batch: Unnamed

Specimen ID	Date	Time	Type	Width
Clear400Crack_1_12232021_092900	12/23/2021	9:29 AM	3 pt. Bend	6.000in

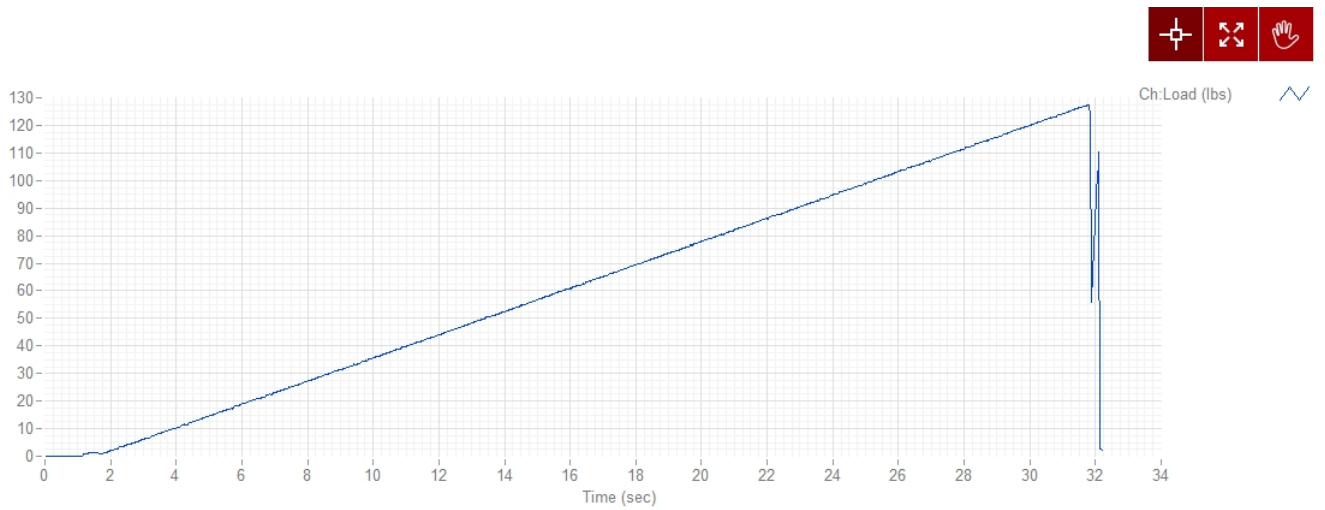
Specimen ID	Depth	Span Length
Clear400Crack_1_12232021_092900	0.250in	9.842in

MaxLoad	MaxStress
Unit	lbs	PSI
Lower limit	0.000	0.000
Upper limit	0.000	0.000
	127.524	5020.378

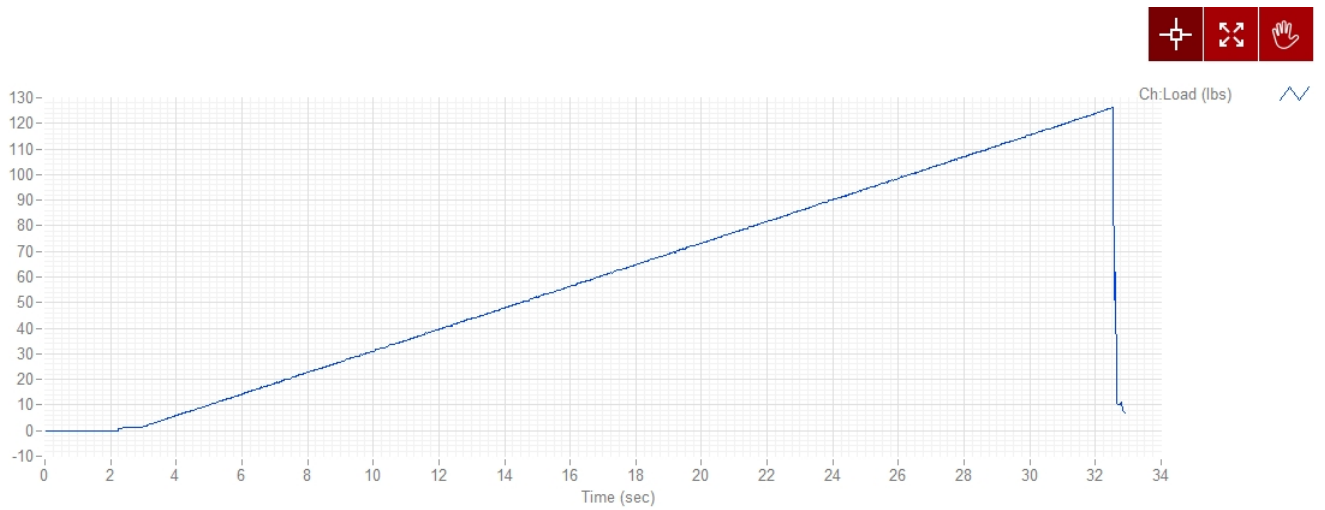
Specimen ID	Date	Time	Type	Width
Clear400Crack_2_12232021_093055	12/23/2021	9:30 AM	3 pt. Bend	6.000in

Specimen ID	Depth	Span Length
Clear400Crack_2_12232021_093055	0.250in	9.842in

MaxLoad	MaxStress
Unit	lbs	PSI
Lower limit	0.000	0.000
Upper limit	0.000	0.000
	126.044	4962.110

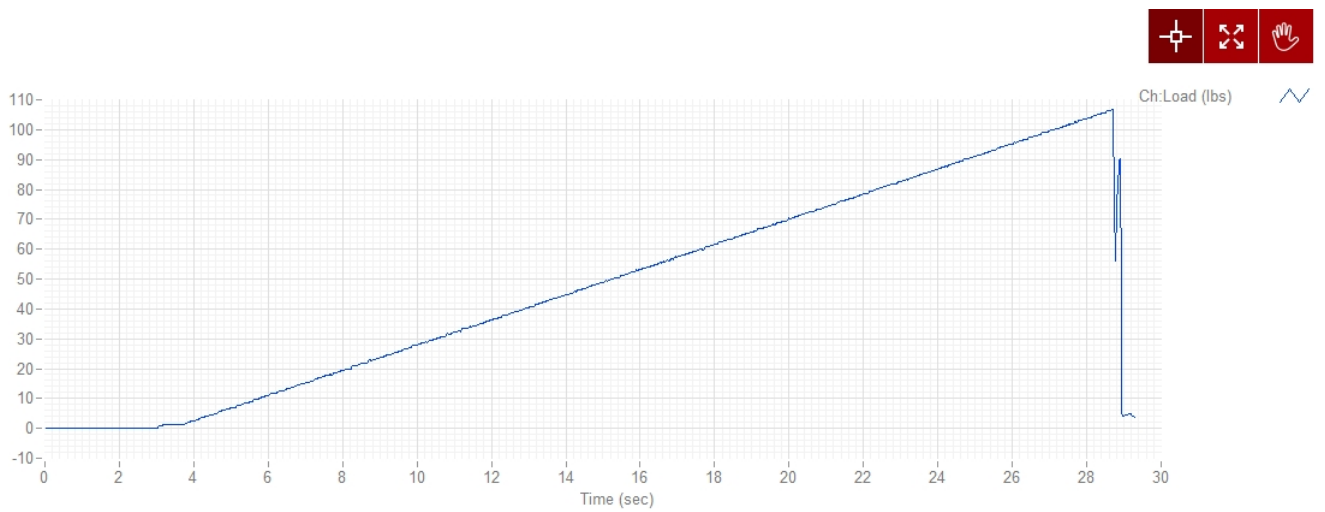
Specimen ID	Date	Time	Type	Width
Clear400Crack_3_12232021_093242	12/23/2021	9:32 AM	3 pt. Bend	6.000in

Specimen ID	Depth	Span Length
Clear400Crack_3_12232021_093242	0.250in	9.842in

MaxLoad	MaxStress
Unit	lbs	PSI
Lower limit	0.000	0.000
Upper limit	0.000	0.000
	106.907	4208.713
