Proposed Development of Employment Uses  
Former Furtho Pits, Old Cosgrove Road, Old Stratford  
Northamptonshire

## LVIA Review

October, 2025

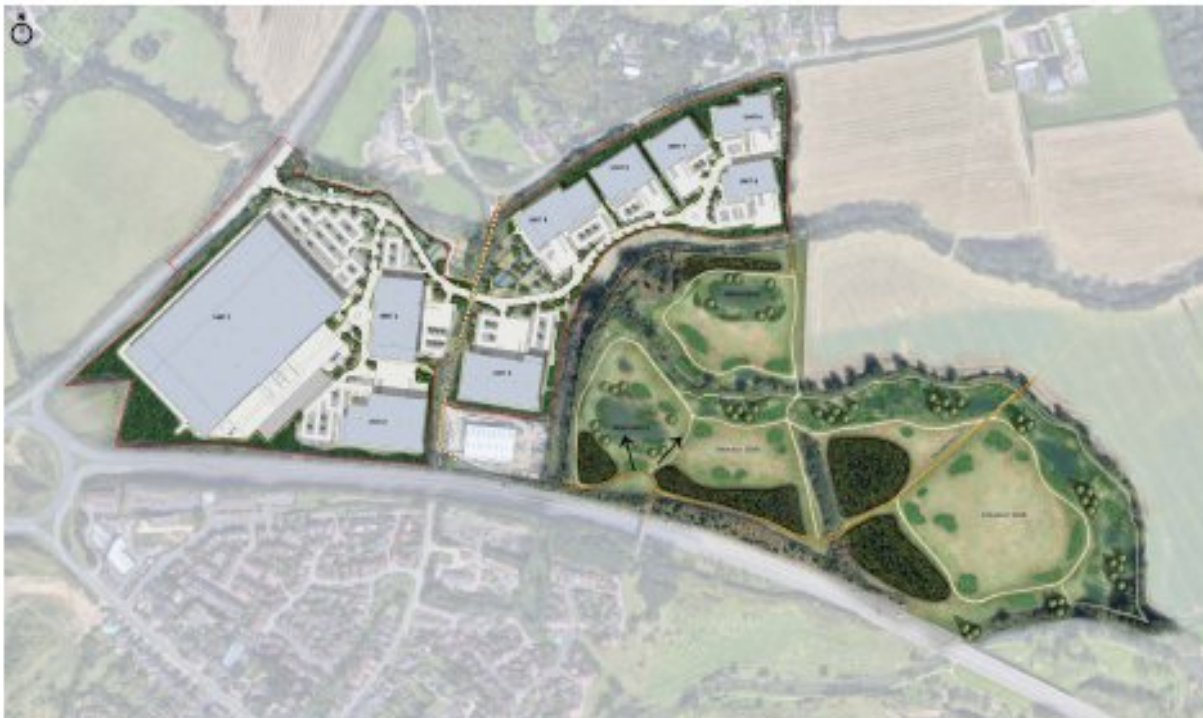
**Figure 1.2: Illustrative Masterplan**

- 1.6 The western and central parts of the site, amounting to c43%, are proposed to be developed for employment (B2/B8) and supporting uses, with an emphasis on logistics businesses. These uses would be accessed from a new spine road forming a junction with the A508. The remainder (57%) of the site, east of the Old Stratford Arm, would become a Country Park. This would accommodate attenuation lakes to manage runoff from the site, and is shown as brown shading on Figure 1.1. The illustrative masterplan is shown in **Figure 1.2** below.

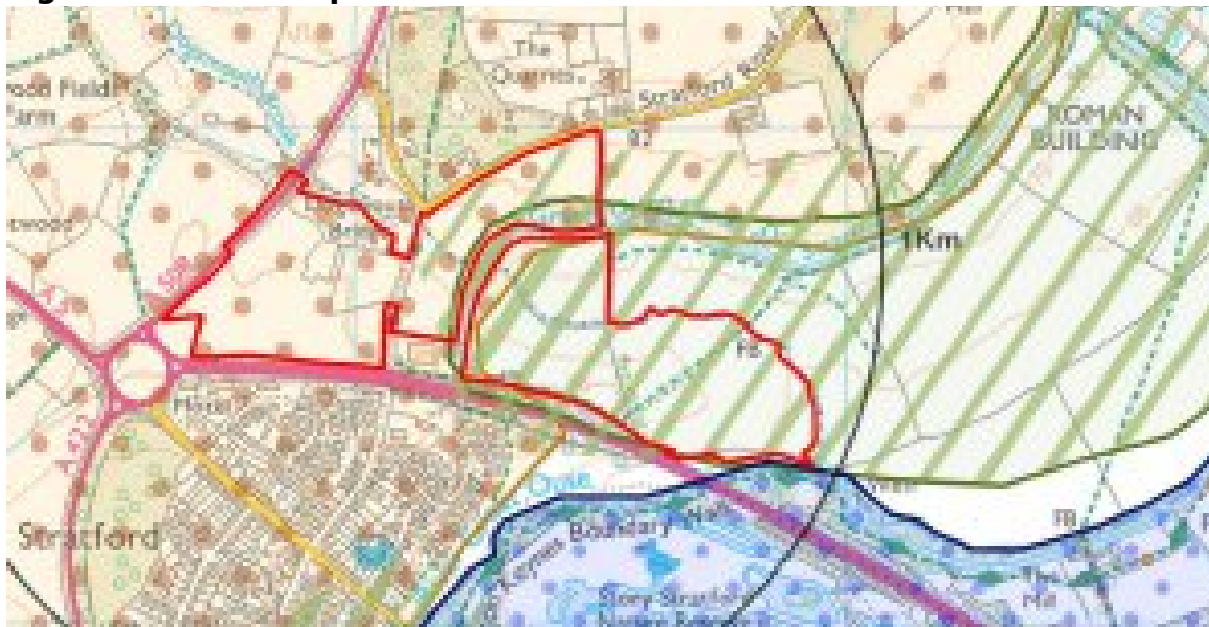
**Figure 2.1: Landscape Character Area Plan**

2.1 Table 6.06 of the LVIA sets out the published landscape character types (LCTs) and areas (LCAs) that relate to the site. Selected LCAs are shown on LVIA Figure 6.7, an extract from which is reproduced in **Figure 2.1** below, and may be summarised as follows:

- County-level LCTs 6: Undulating Claylands and 17: River Valley Floodplain
- County-level LCAs 6a: Tove Catchment and 17b: River Tove Floodplain
- Milton Keynes LCT 2: River Valley and LCT 2c: Ouse Urban River Valley

Green cross-hatch = River Tove Floodplain  
Brown stipple = Tove Valley  
Blue stipple = Ouse Urban River Valley

- 2.2 The nomenclature of these LCTs/LCAs can be misleading. As mentioned previously, the site is located within the valley of the Dogsmouth Brook, and therefore does not form part of the Tove catchment. The floodplain in which the eastern part of the site is located relates to the Dogsmouth Brook and the adjoining River Great Ouse, not the River Tove.
- 2.3 The site occupies a transitional location where the valley of the Dogsmouth Brook widens as it flows south-eastwards from the locally-elevated Undulating Claylands, before merging with the floodplain of the Great Ouse. Reflecting this, the LVIA divides the character of the site roughly into two halves, with the western and central parcels (where built development is proposed) forming part of the valley

- 2.4 In addition, the Ouse Urban River Valley categorisation of MK LCT2C reflects its setting to the south, which comprises the built-up areas of Wolverton and Stony Stratford. The intrinsic character of the valley itself, dominated by the green corridor of its floodplain and adjoining slopes, remains predominantly rural. Urban influences are confined to the A5 and occasional glimpses of surrounding neighbourhoods and the MK Waste Recovery Park at Old Wolverton.

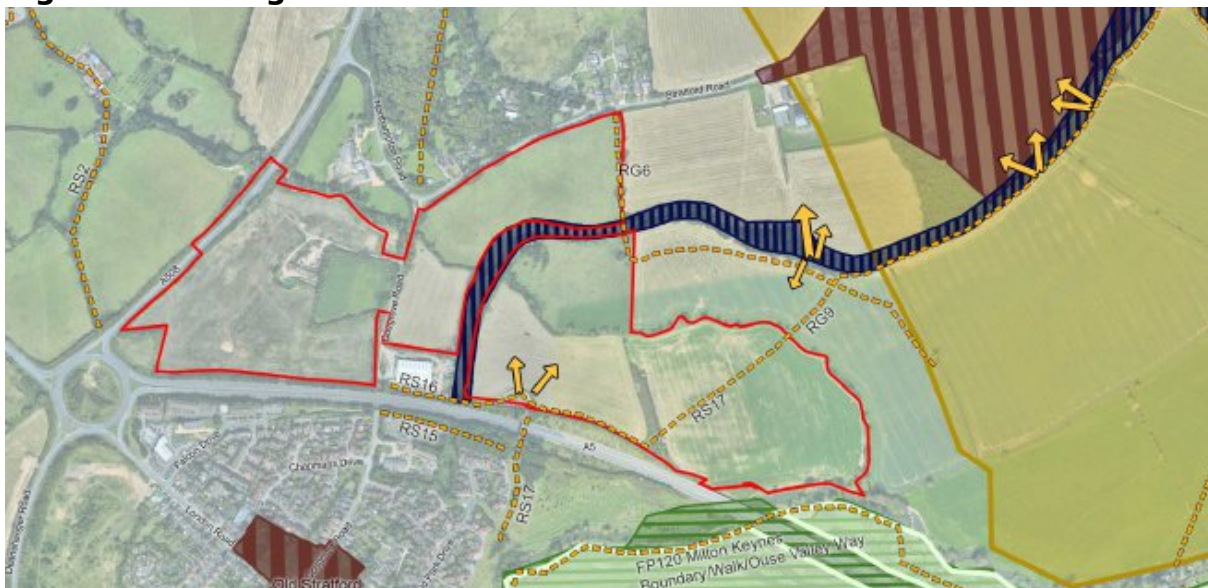
**Figure 2.2: Designations Plan**

- 2.11 However, as shown on LVIA Figure 6.3: Designations Plan, an extract from which is reproduced in **Figure 2.2** below, the Old Stratford Arm, which separates the central and eastern parts of the site, lies within the GUC Conservation Area (CA). Views towards the CA from the elevated southern edge of the site adjacent to the A5 (within the eastern parcel) are identified as "important views" in the CA Appraisal.

The vertical dark-blue hatching which traverses the site is the GUC Conservation Area  
The pale brown area to the east of the site is the SLA  
The yellow arrows show protected views from the GUC CA Appraisal

- 2.13 Figure 2.2 shows that the southern end of the Tove Valley Special Landscape Area (SLA) extends across the floodplain and valley slopes north of the Great Ouse to the east of the site. The boundary of the SLA comes to within c75m of the site. Most of this part of the SLA, defined to the north/north-east by the Old Stratford Arm and the Iron Trunk section of the GUC, falls within the ZTV for the development (LVIA Figure 6.6).

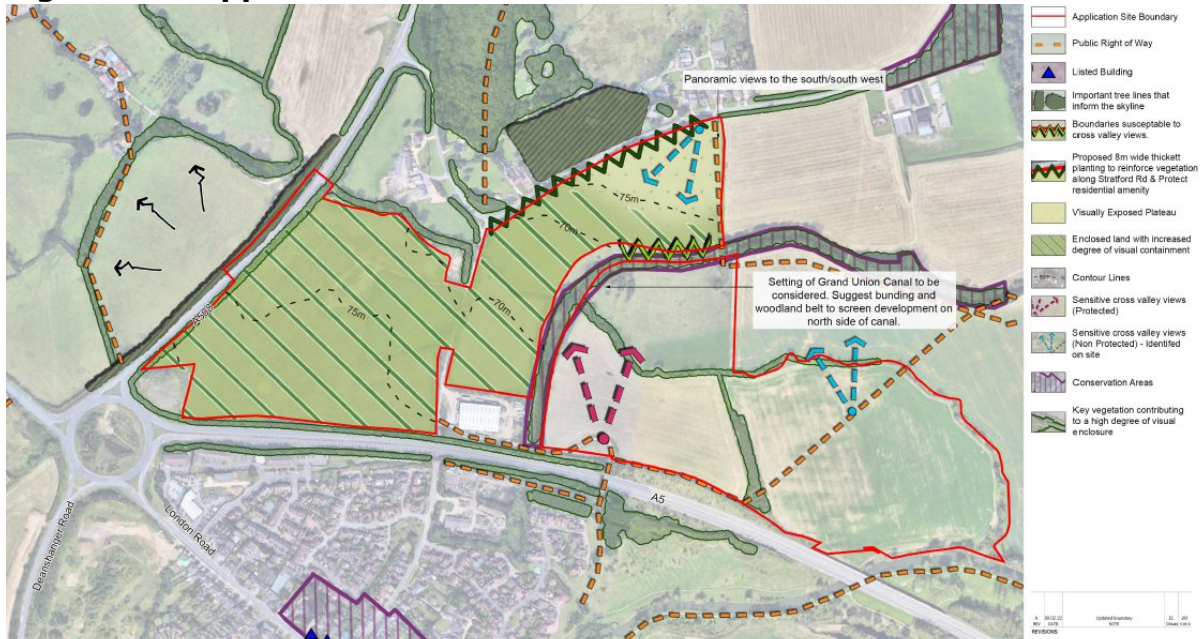
**Figure 2.3: Opportunities and Constraints Plan**

- 2.12 In addition, LVIA Figure 6.4: Opportunities and Constraints Plan, an extract from which is reproduced in **Figure 2.3** below, identifies two "sensitive cross-valley views" locations within the site: One from the PRoW crossing the eastern parcel, and the other from the PRoW close to the elevated north-eastern corner of the central parcel. Both of these views are towards the GUC CA, and are interrupted to varying degrees by trees along the Old Stratford Arm. The CA forms part of the site boundary, allowing its visual influence to extend across parts of the eastern and central parcels of the site.

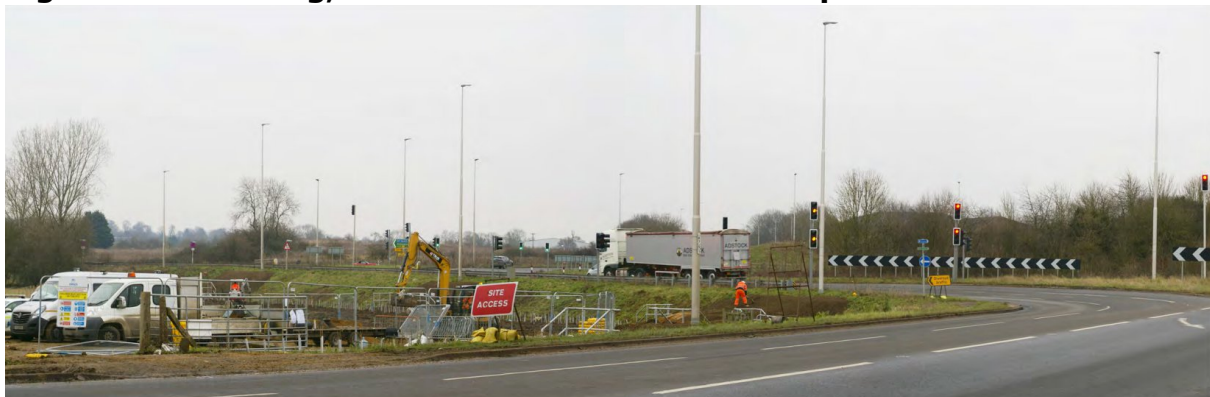
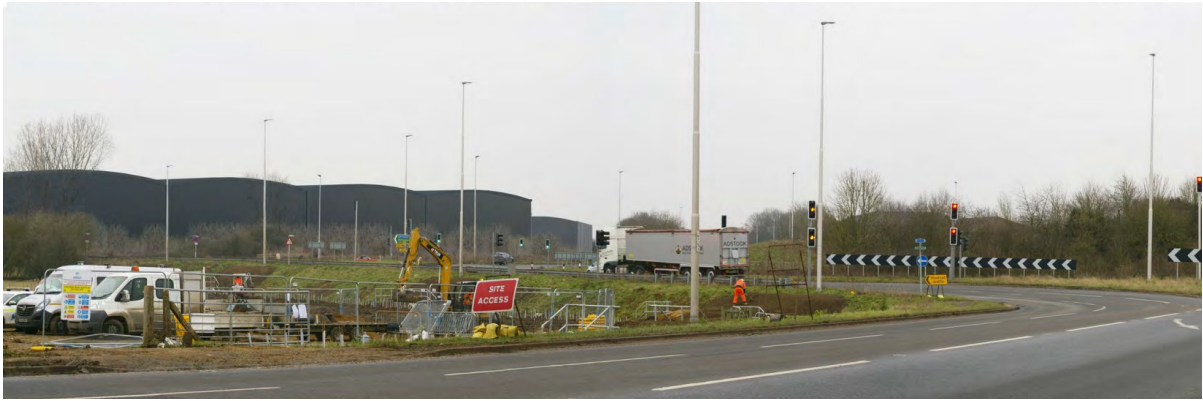
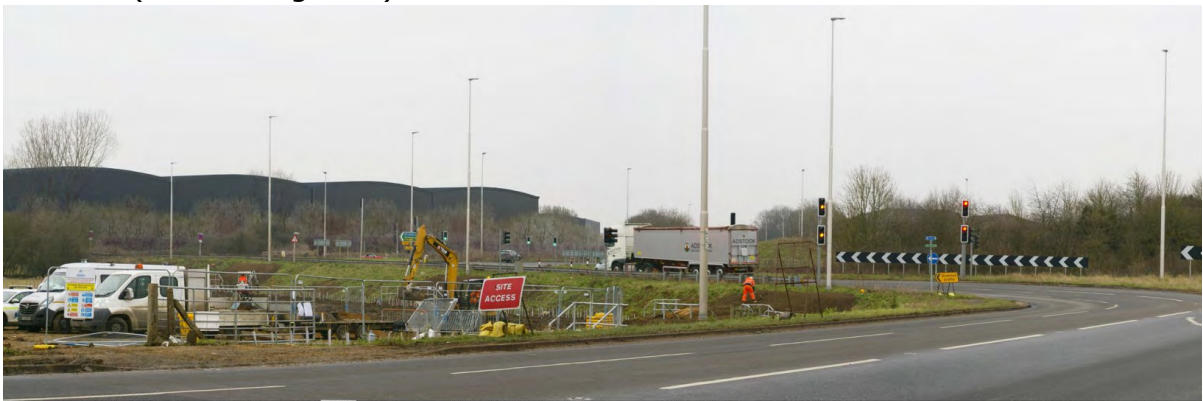
**Figure 5.1: Existing, Y1 and Y10 Versions of Viewpoint 10**

Existing View

Y1 View (initial mitigation)

Y10 View (established mitigation)

- 5.17 A related matter is the nature of the impact on the modelled views. In the majority of cases, the existing baseline views retain a largely rural character defined by greenfield uses and a sense of openness. Built development is rarely a feature, and is dominant in only one view (VP10 – the A5 roundabout, see above). Emmett’s warehouse, which is locally prominent, can be glimpsed from several locations, but is conspicuous in only one view (VP12b).

The photography has been captured in January, i.e. representative of winter conditions. It is good practice to also provide comparative summer photography (June to September). Viewpoint 10 has a large amount of blur present which suggests the

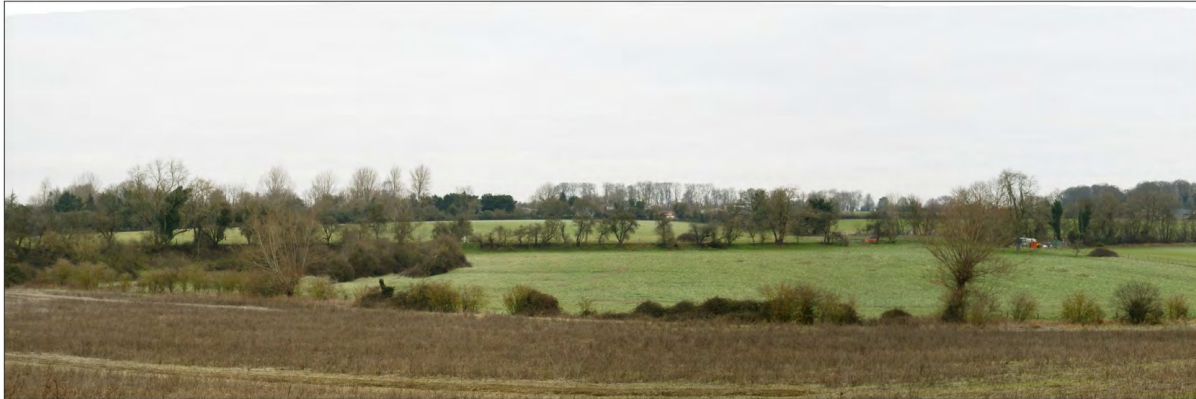
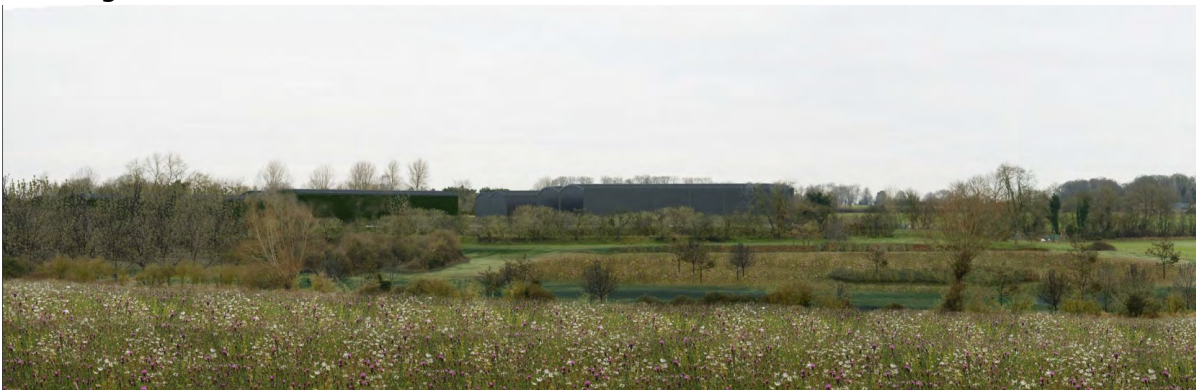
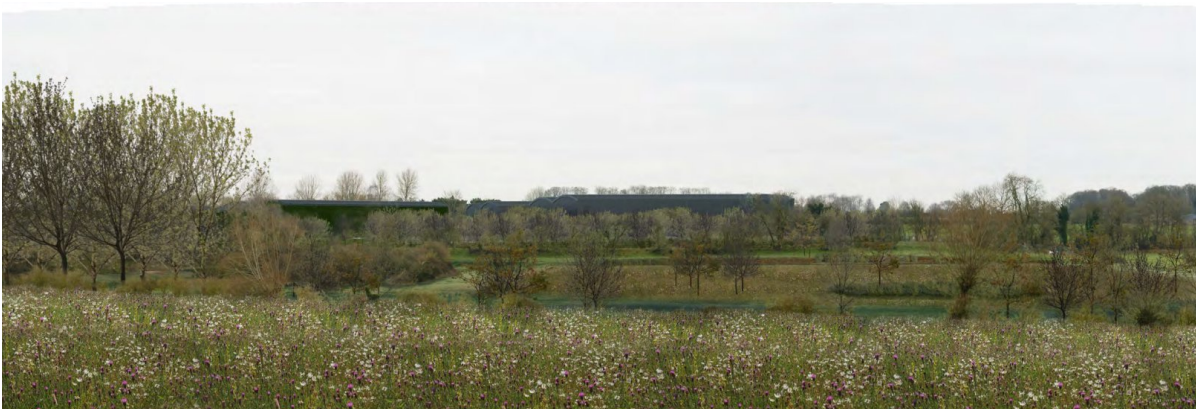
**Figure 5.2: Existing and Y1/Y10 Versions of Viewpoint 3b**

- 5.30 This benefit, however, does not translate into a significant beneficial effect that is reported as such in the LVIA. Of the montage views, only one (VP3b) is located within the country park, whilst a second (VP6a) shows part of the country park occupying the fore/middle ground of the view. The predicted impact on View 3b is shown in **Figure 5.2** below.

Existing View

Year 1 View (initial mitigation)

Year 10 View (established mitigation)

- 5.31 The obvious impact of the development at Year 1 is to introduce warehouse buildings as a built horizon across just over half of the view, competing with and
