Marl Mining Activity and Negative Repercussions for Two Hillside Villages (Northern Italy)

Abstract: Coniolo and Brusaschetto, are two small towns located in the Monferrato area of the Alessandria Province, northern Italy. These communities have similar histories related to development and subsequent abandonment of marl quarry activity that began more than a century ago and continued until recently. Quarrying occurred until soil conditions, water infiltration, and excessive depth made cost of extracting and lifting material prohibitive. Quarries consisted of tunnels located directly beneath the towns at about 150 m below ground surface. Collapse of the tunnels led to surface subsidence and destruction of overlying homes and much of the municipal infrastructure. In the early Twentieth Century, regulations pertaining to mine and quarry safety were typically deficient, entirely absent, or not followed. Extractive activities of non-energy mineral resources from quarries and mines were and continue to be widespread in Italy, which currently ranks fifth among what are now countries of the European Union (EU). Mining sites are present in all regions of Italy, particularly in the northern

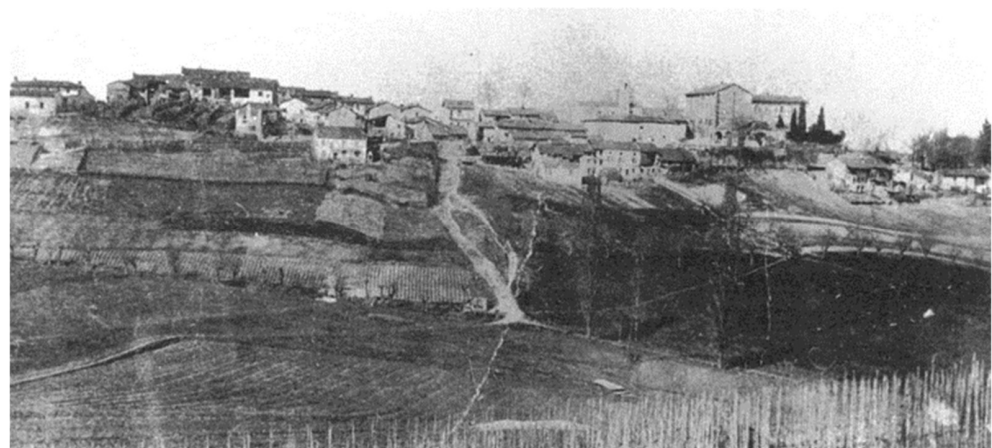
Figure 4. Coniolo hamlet in a photograph taken at the end of the 19th century. The village was abandoned, then completely demolished in 1907. Today, only few ruins of it are visible, called “Coniolo Rotto” (Broken Coniolo), hidden in a thick forest [46].

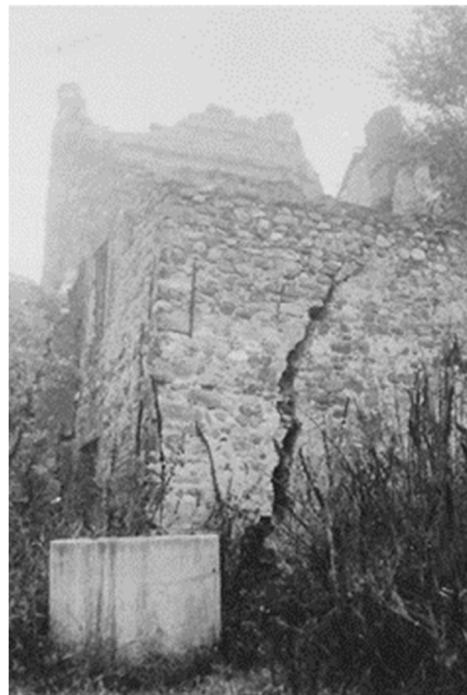
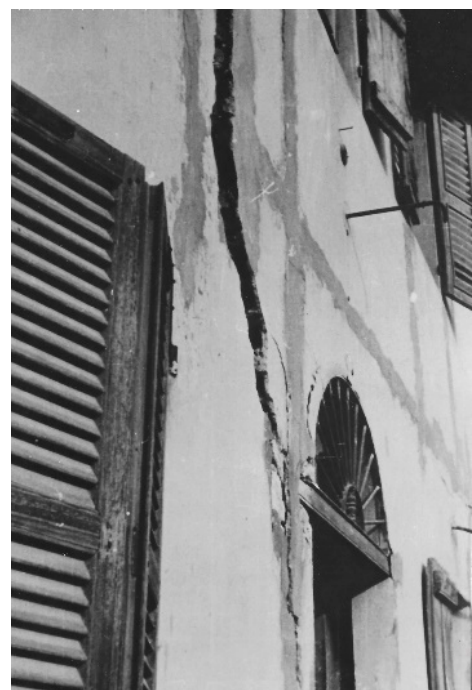
Figure 5. Damage in Brusaschetto: (a,b) images taken in the mid-1950s showing two seriously damaged buildings in the village (CNR IRPI Archive); (c,d) photos taken in 1990: a house and the church show large cracks in external walls [46].

Brusaschetto suffered a similar fate. The village, established in the 1890s, suffered surface collapses due to underground mining. In the early Twentieth Century, it was decided to abandon the hamlet because houses were badly damaged (Figure 5). In some cases, quarry operations caused damage to houses even at a very considerable distance [37] from the processing area. In 1931, a protection zone was demarcated northeast of the settlement, beyond which companies could not push tunnel excavation and exploitation. Explosive blasts were still clearly felt by the population above ground. In 1955, a governmental commission proposed relocation of Brusaschetto to a quieter area. In 1956, a decree was issued by the President of the Italian Republic to include Brusaschetto among villages to be relocated at the expense of the Italian state. Semi-detached houses were built as row houses that did not remotely possess the features of these farmer's previous homes. Moreover, the new location of Brusaschetto Nuovo (New Brusaschetto) was an unfortunate choice, because it was situated in an area historically flooded by the Po River. Population decline occurred slowly, as shown by census numbers, from 80 inhabitants in 1971 to 54 in 1991. The latest phase of the decline occurred in response to Po River floods that hit the area in November 1994 and October 2000, resulting in final abandonment of the remaining small buildings, their demolition, and transformation of Brusaschetto into a ghost town [43].
